Change Order

Radcliff Elementary School Renovation
- Phase 3
1145 S. Dixie Boulevard
Radcliff, Kentucky 40160

CHANGE ORDER NUMBER: 010**DATE:** August 18, 2011**OWNER:** ☒**ARCHITECT:** ☒**CONTRACTOR:** ☒**FIELD:** ☐**TO CONTRACTOR (Name and address):**

Project Radcliff Elementary - Phase 3

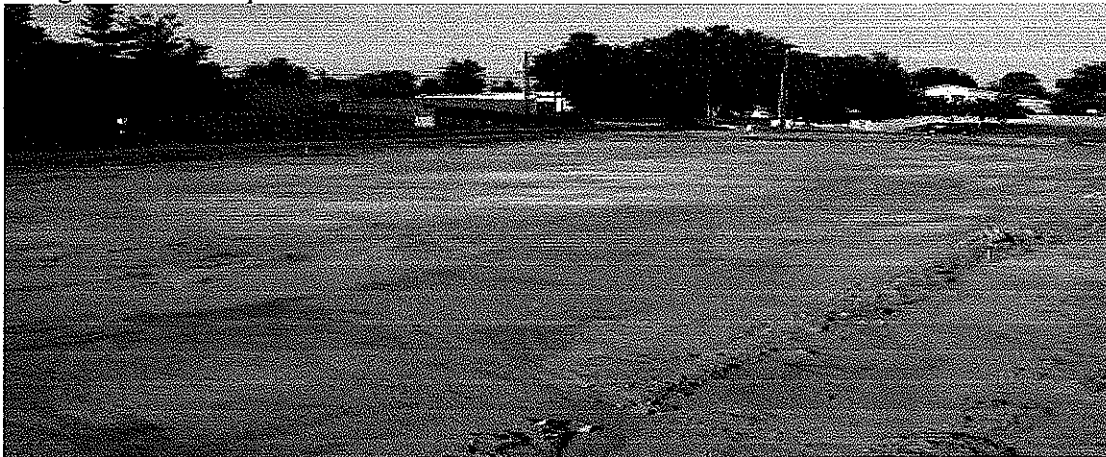
AEI was on site for undercutting of soils in south parking area. South parking area was deemed too wet for soil removal in the am. Service area roadway was cut 6-8" down to sub-grade and then proof rolled. Little to no deflection was noted.

South parking area with water visible.

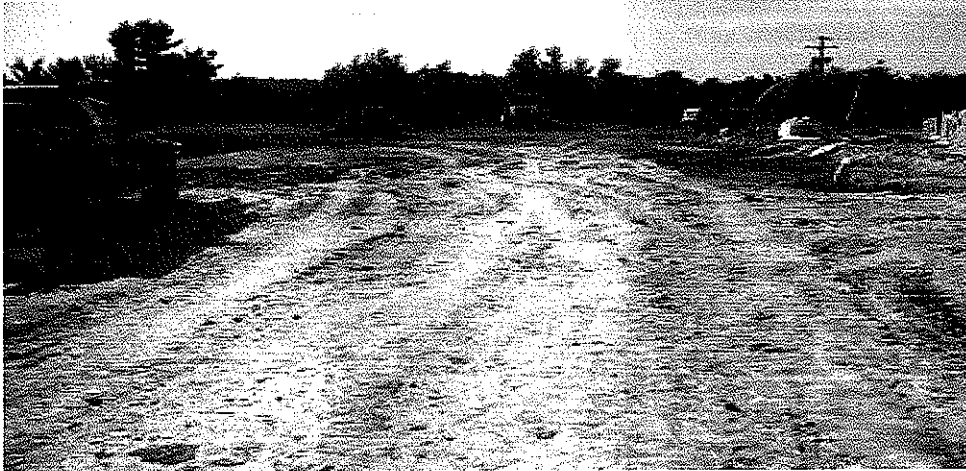
Service roadway.

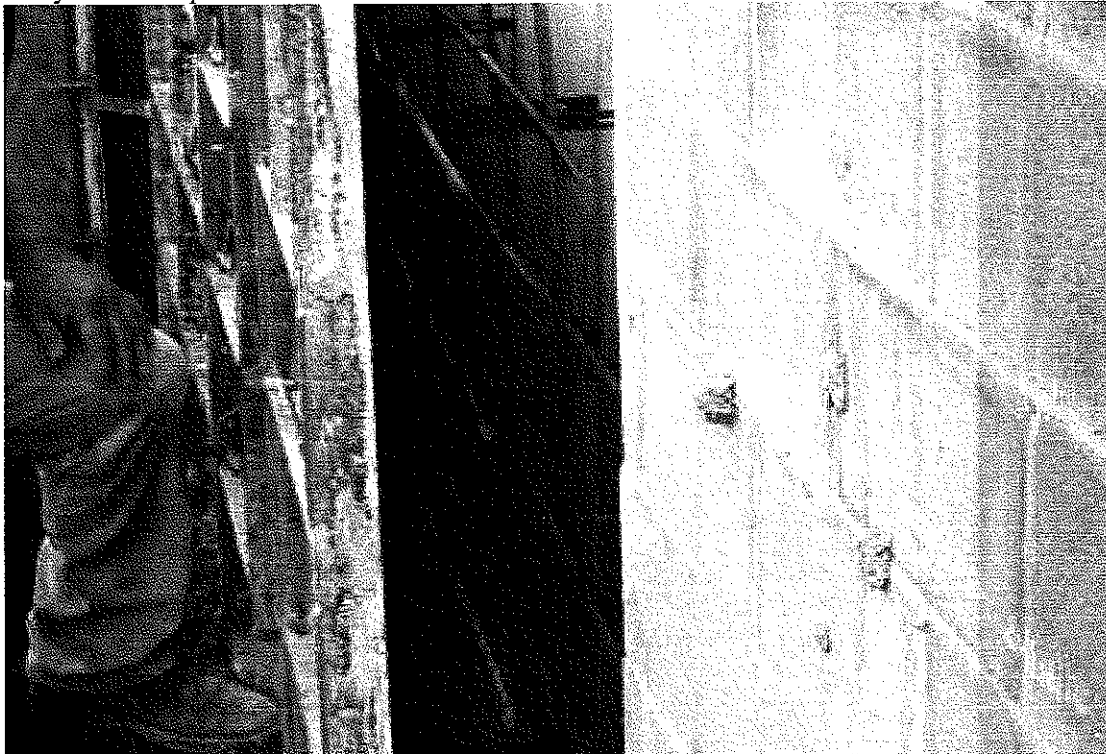
Loading dock wall was formed and reinforced while on site. All reinforcing steel was in place prior to concrete being poured. A sample was obtained at the middle of the load and four samples were molded. Tests are as follows: slump- 5.75, temp- 87F.

Reinforcing for wall.

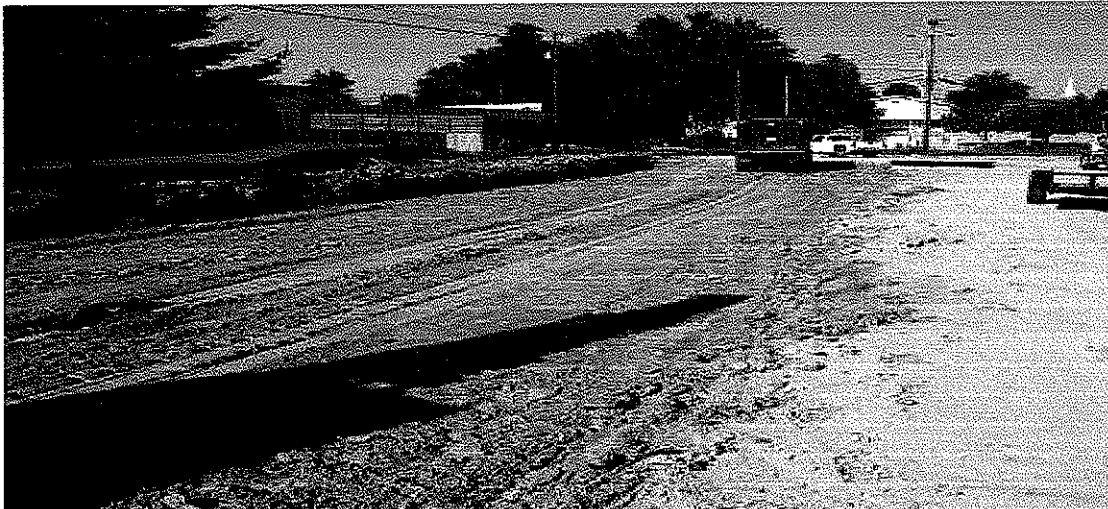
AEI was on site for undercut observation at Radcliff Elementary School. South parking lot on the extreme south quadrant was undercut approximately 30-37" below original elevation. Undercut area ran the entire length of proposed lot and was roughly 34-39' wide. Suitable soil was encountered an average of 2.5' below original grade. All topsoil/ unsuitable material was excavated from site. After all soil had been cleared from undercut, further compaction of sub-grade was obtained by passing over it with a smooth drum roller.

Entrance way rear.

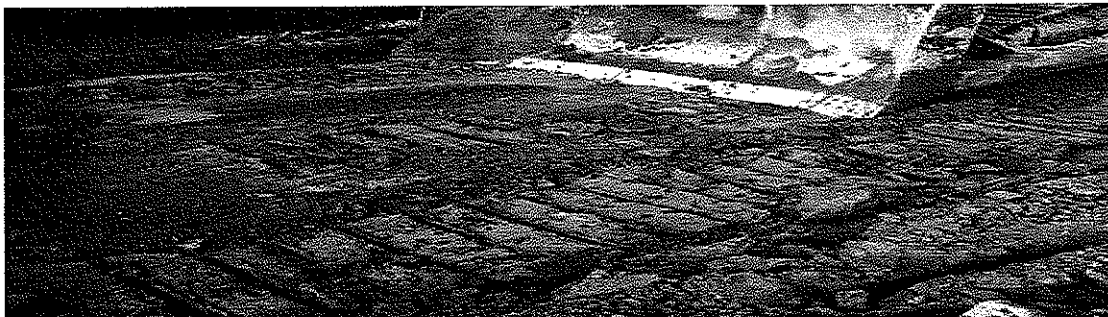
Central portion of undercut.

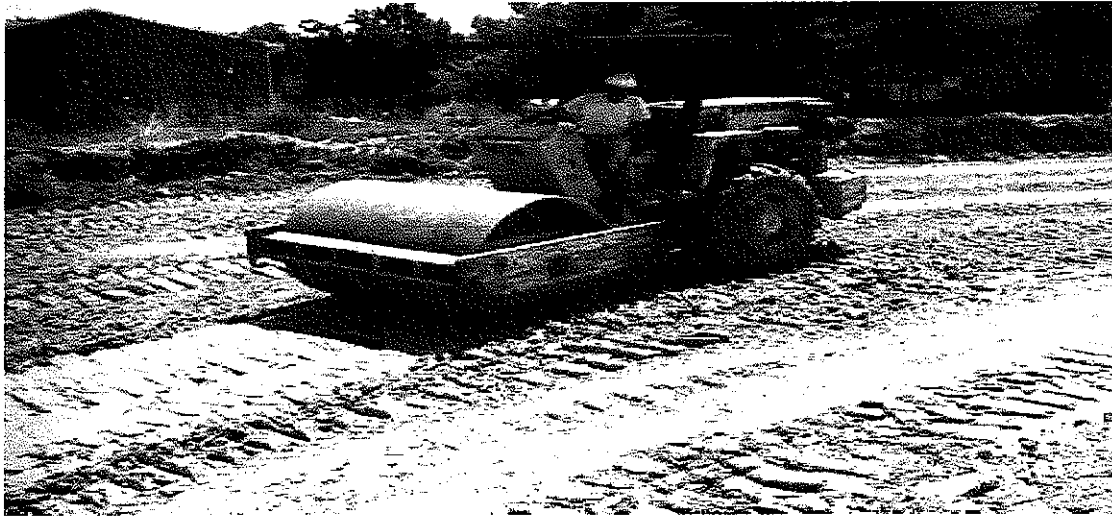
Roller in action.

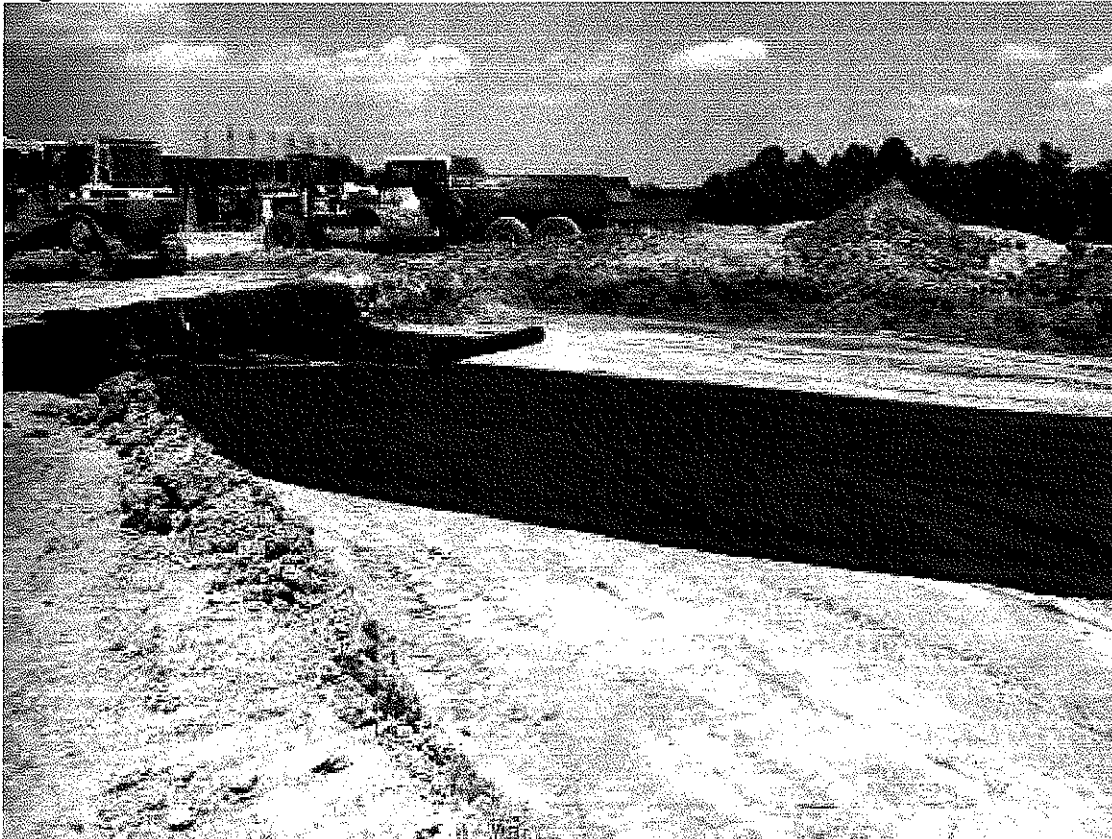
End of undercut with fabric being placed.

After area was compacted with roller, mesh fabric was placed in the bottom of the excavation. Stone/concrete rubble was then trucked in places as backfill material up to original elevation in about 80 % of area.

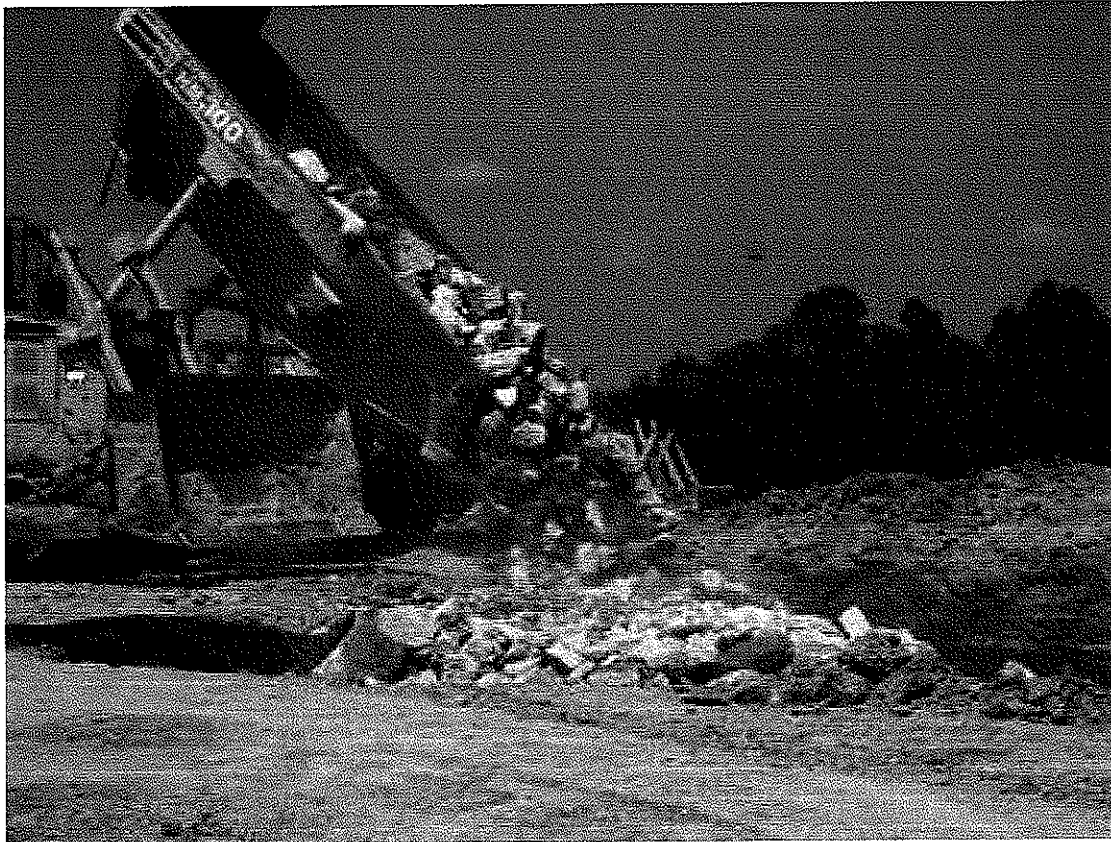
Stone placement on east end.

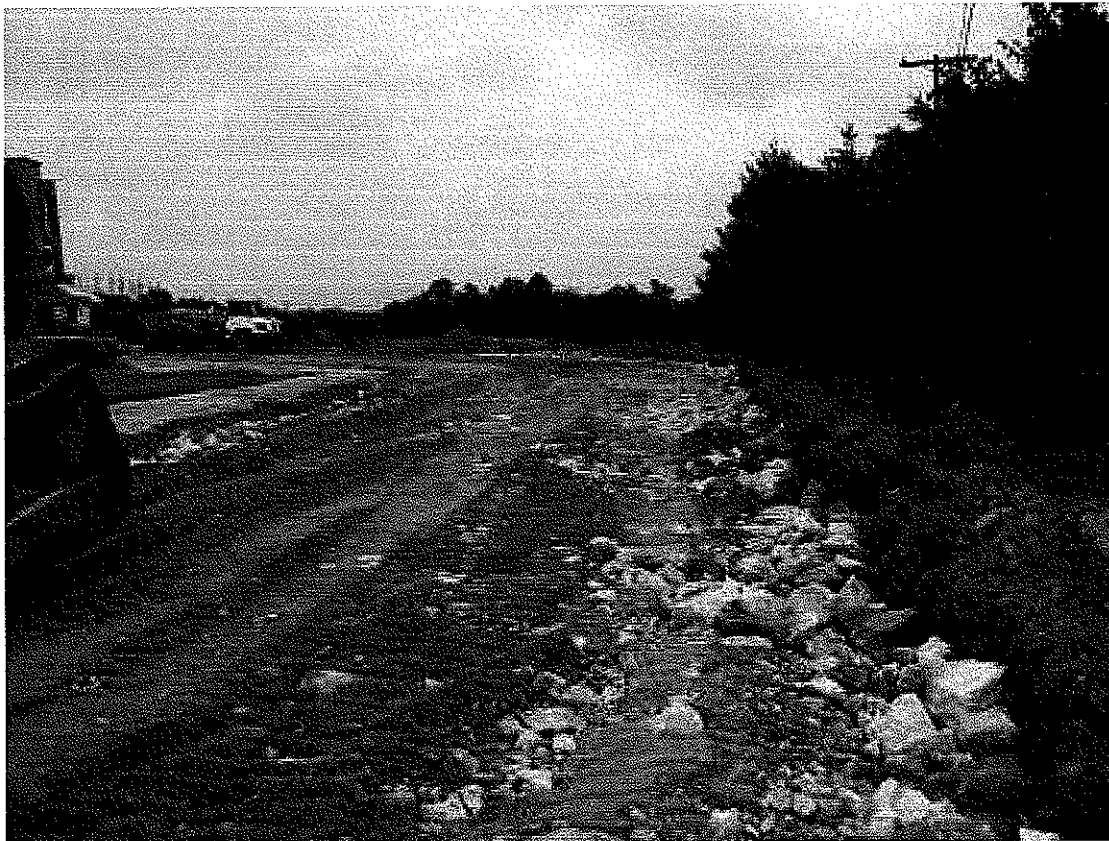
AEI was on site again to document stone backfill in south parking area. Eighty percent of backfill was completed previous night. Rubble rock was again trucked in from off site area and placed in one large lift to original elevation down the length of the excavation. Dozer blade was used for grading along with track rolling for added workability of stone.

Backfilled excavation, before fines were added.

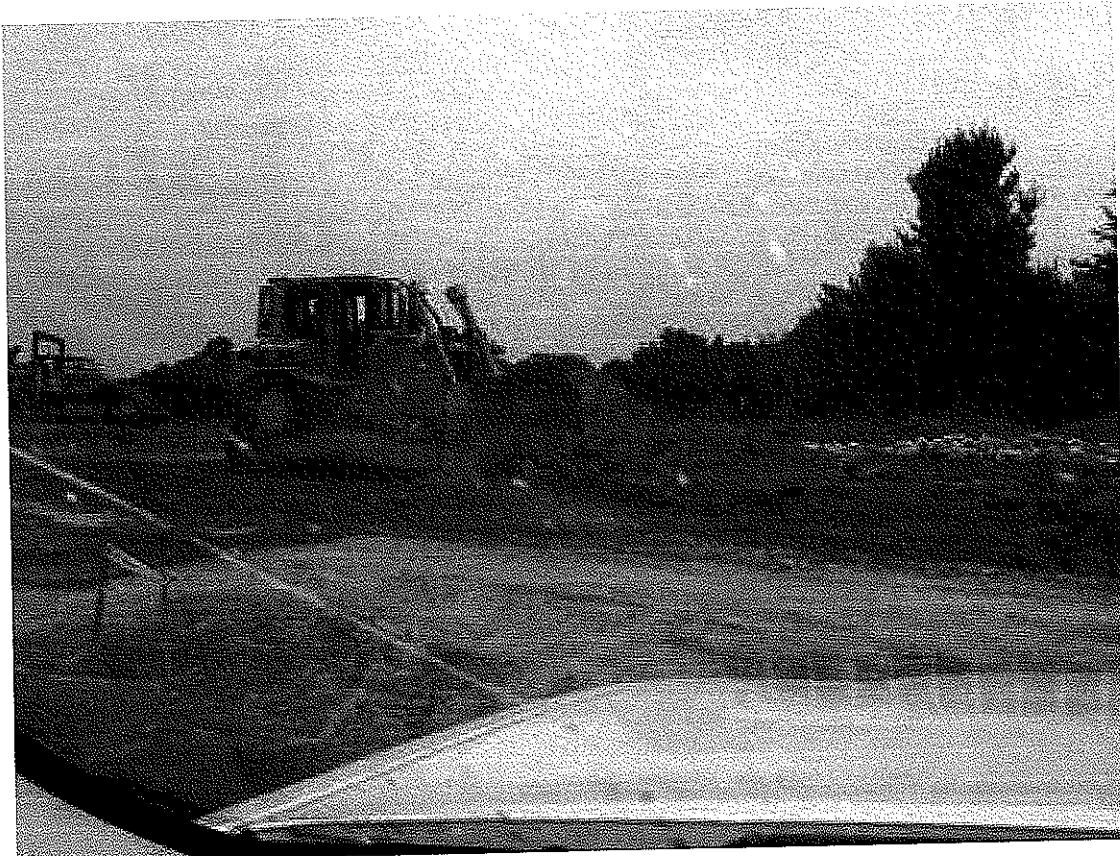
Spreading of fines.

A thin layer of aggregate fines were placed on top of the rubble rock to act as a capping agent. This should reduce infiltration of water as well as provide a working platform for the soil backfill.

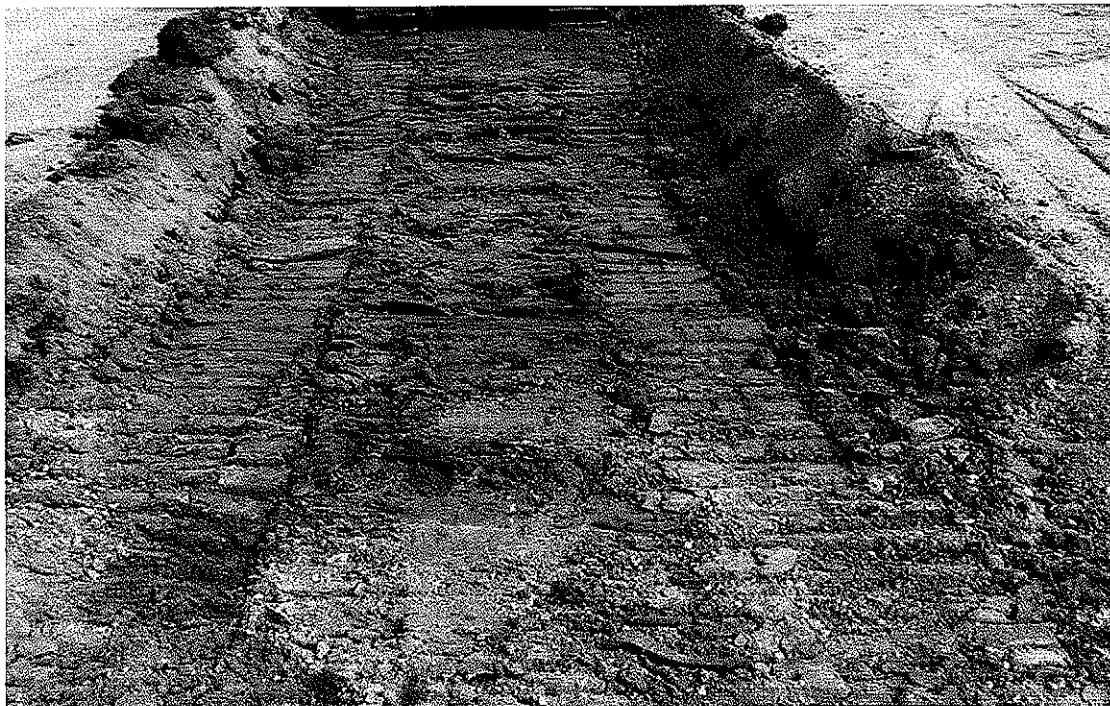
A fully loaded tri-axle dump passed over areas in a random fashion from south access road down to south parking lot and back. Moderate to severe pumping/ rutting was observed in proof-rolled areas. A small test cut was excavated with dozer to find suitable soils at 2' below original elevation. Undercutting of area was recommended and began shortly after evaluation.

Test excavation down to suitable soils.

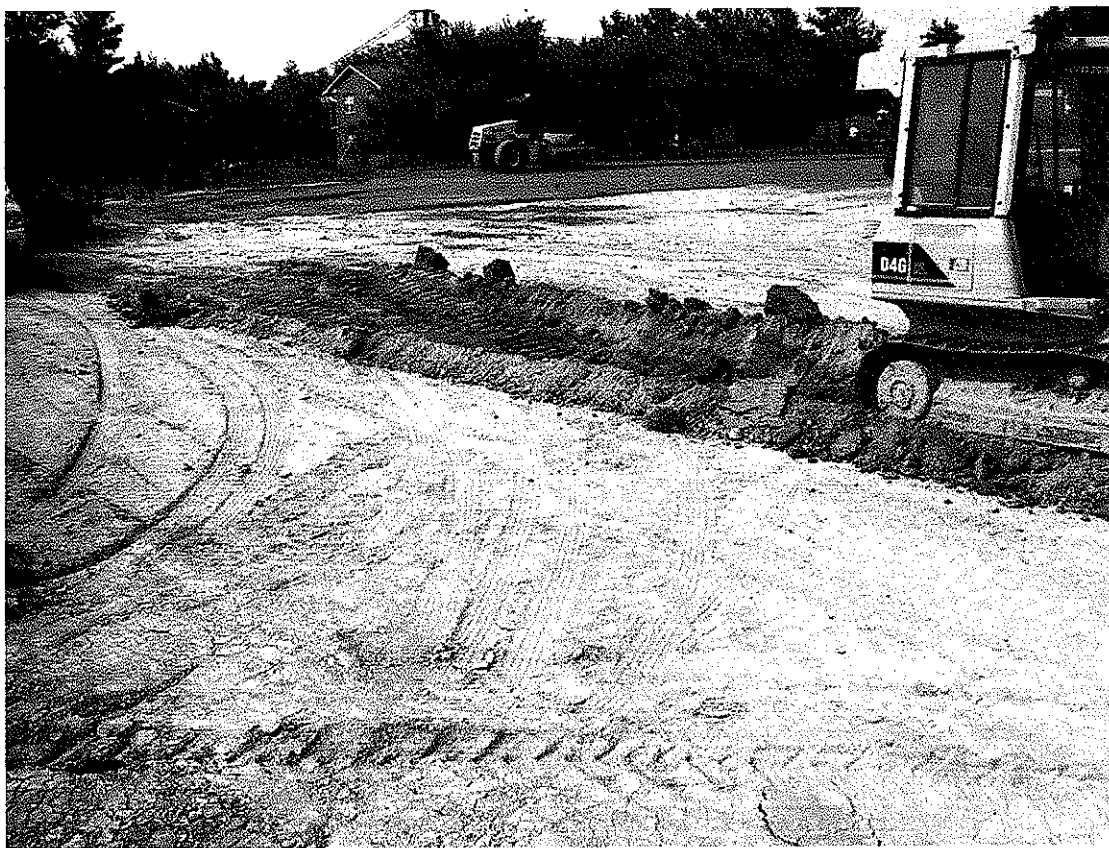
Proposed cut area.

Cut area was approximately 37' wide, by 92' long, with an average depth of 24".

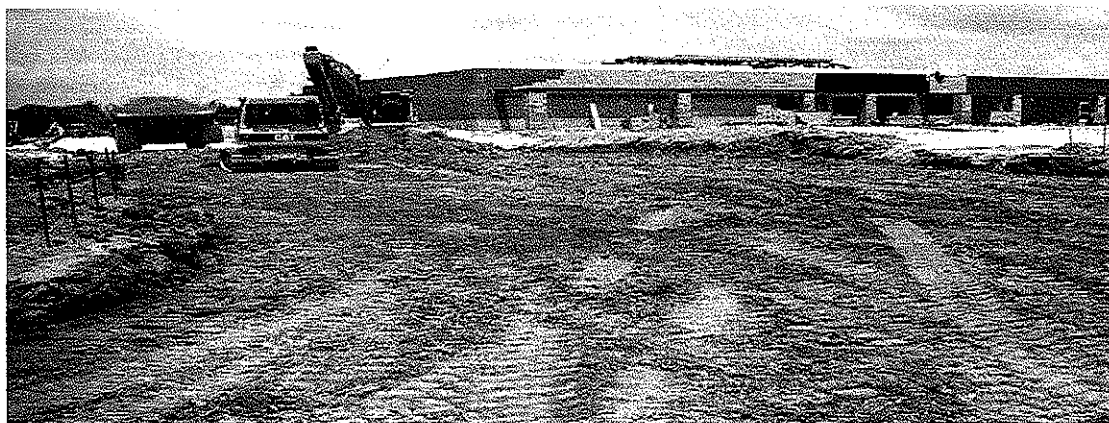
Undercut area at finish point.

After soft areas were excavated, a smooth roller was used for added compaction and removal of any loose material. Another proof roll was conducted on the area and showed little signs of rutting at an average of 2' below original elevation.

Fabric was again placed in bottom of excavation as a bridging aid before stone backfill was trucked in. After fabric was down and secured, backfill was placed in excavation in one large lift and worked in with dozer blade to original elevation. Backfill was completed by the end of the day.

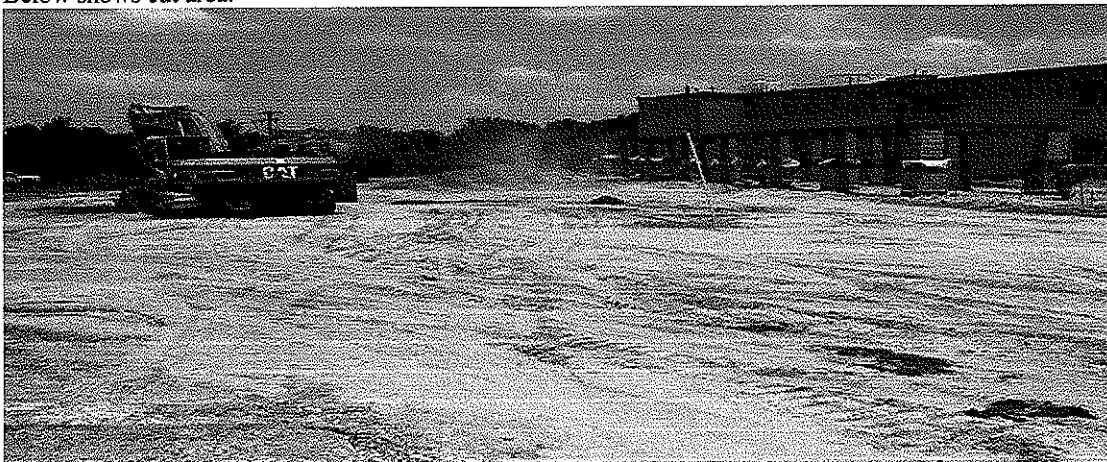
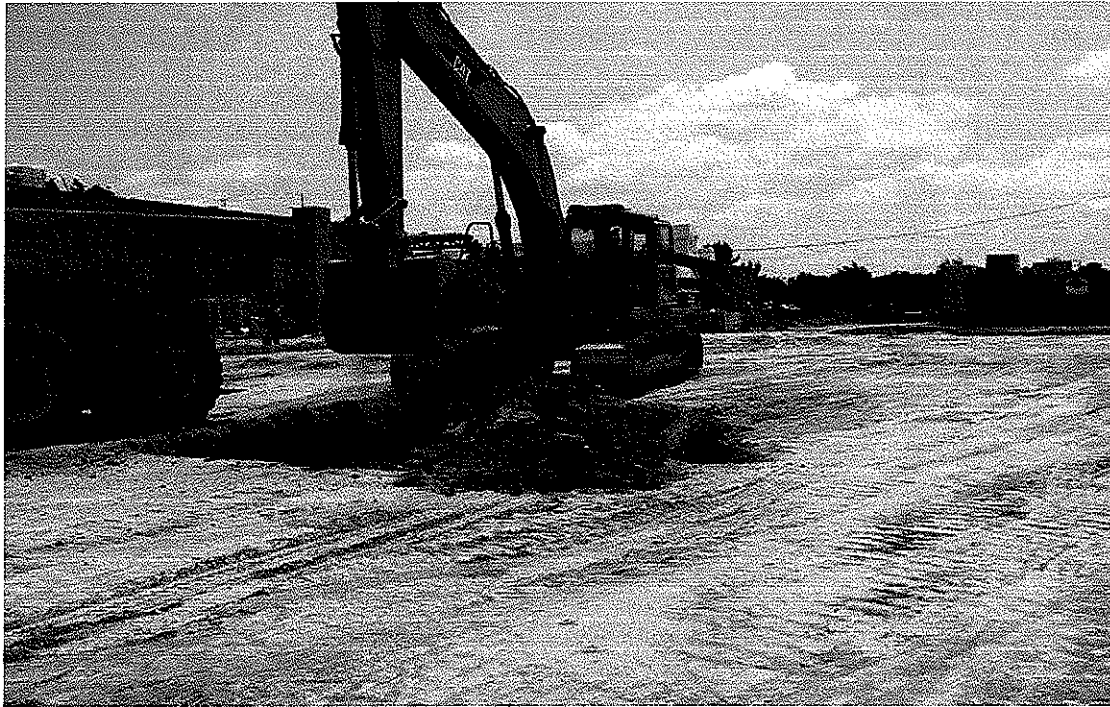
Access road down to bus loop was cut to subgrade and proof- rolled to identify any unsuitable material. A fully loaded rear dump passed over the area in a random fashion and showed acute to moderate pumping/ rutting in areas tested. Undercut was again recommended and began shortly thereafter.

Below shows cut area.

Excavation in process

Cut area was approximately: 105' long, an average of 39' wide, and an average depth of 2.0'.

After all unsuitable soils were removed, the bottom of the excavation was again rolled with smooth drum roller and geotextile fabric was placed before stone backfill was placed.

After fabric was placed and secured, rock was trucked in and spread over the excavated area in one lift and spread with a dozer blade to original elevation.

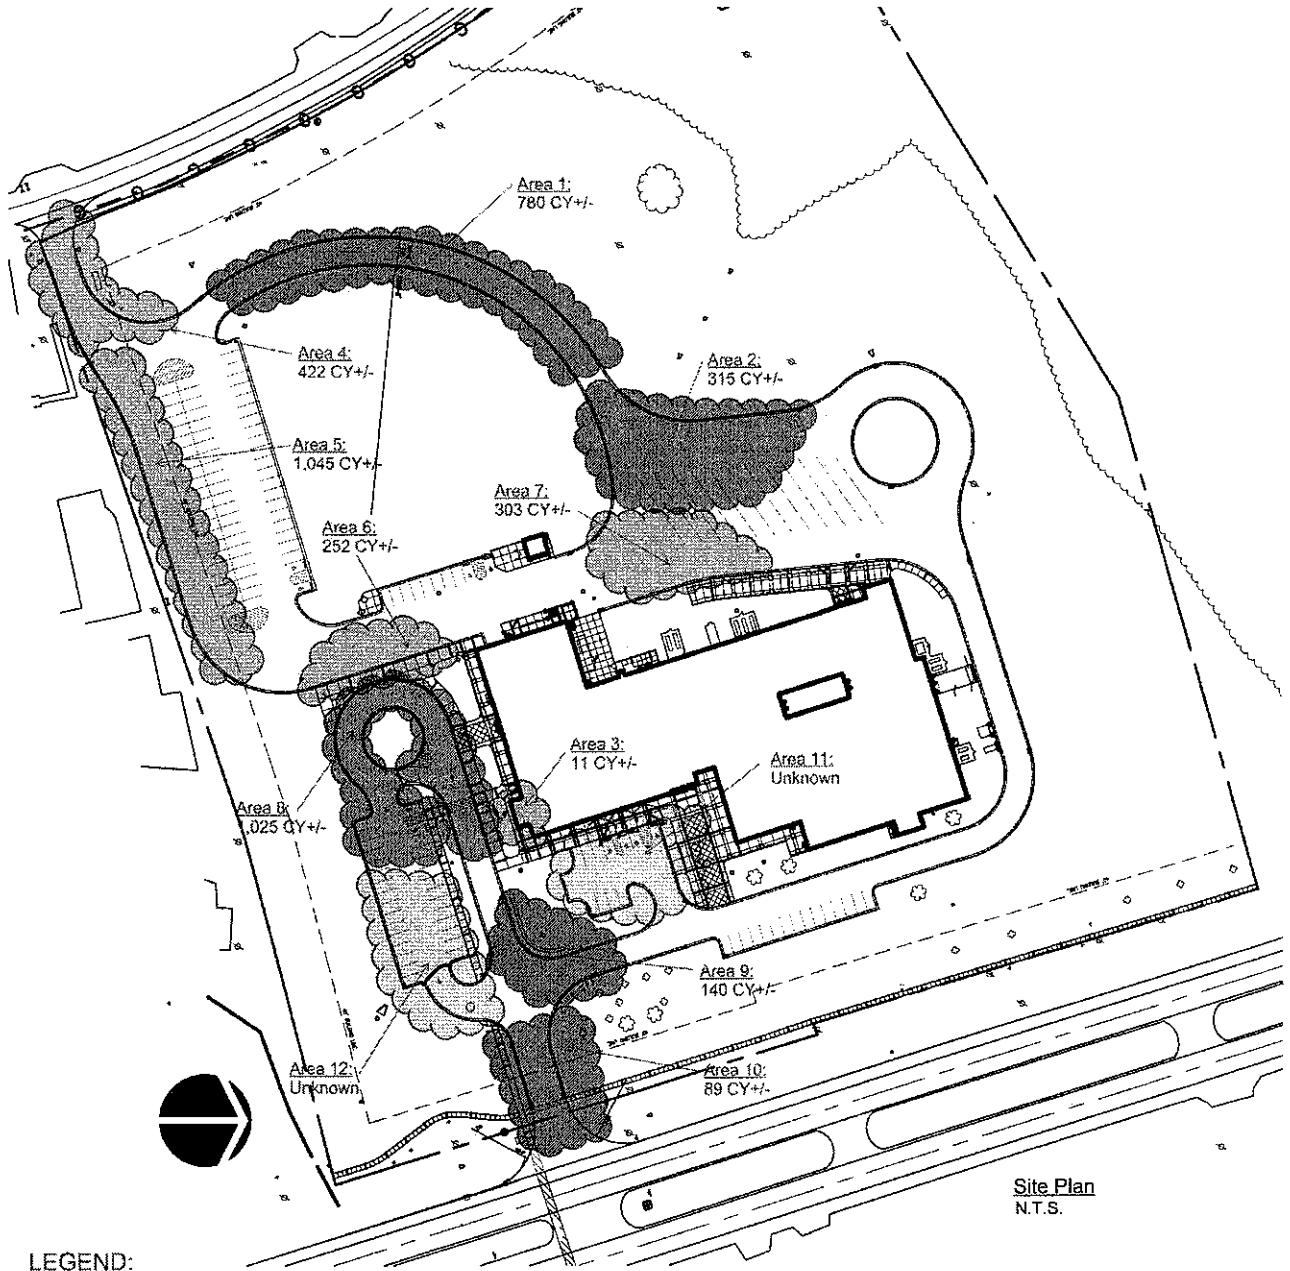
Area 1: (February 2011) - Contains approximately 780 cubic yards that was undercut due to unsuitable soils and replaced with rubble concrete fill material. The site contractor installed geotextile fabric below the fill material. The site contractor, at no additional cost to the Owner, conducted this work in order to stay on the aggressive construction schedule, as well as to have the bus loop usable by buses per the construction phasing schedule.

Area 2: (April 2011) – Contains approximately 315 cubic yards of undercut unsuitable soil material and replaced with rubble concrete fill material. The site contractor installed geotextile fabric below the fill material. The school board approved the additional cost associated with this work, via Change Order No. 4.

Areas 3 through 7: (July 19, 2011) – Contains approximately 2,033 cubic yards of undercut unsuitable soils material and replaced with rubble concrete fill material. The site contractor has agreed to install geotextile fabric below the fill material. The additional cost associated with this work will be submitted to the school board via Change Order No. 10.

Areas 8 through 10: (After July 29, 2011) – Contains approximately 1,254 cubic yards of undercut unsuitable soils material that will be replaced with rubble concrete fill material. The site contractor has agreed to install geotextile fabric below the fill material. The additional cost associated with this work will be submitted to the school board as a future change order request once final quantities have been identified.

Areas 11 and 12: Potential undercutting and fill material may be required in these areas. When site excavation begins in these areas, it will be determined whether unsuitable soils are present. Should the unsuitable soils contain higher clay content, lime stabilization may be considered as method for remediation. The site contractor has also agreed to dig test holes in order to estimate depth of any unsuitable soils prior to site construction in these areas.
