CONSTRUCTION PROGRESS MEETING MINUTES - #10

Re: Renovation to Radcliff Elementary School – Phase 3
SCB Project No. 1004

Date: November 23, 2011

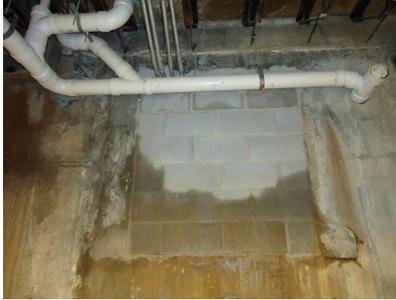
Water infiltration through sealed existing coal chute. The area of saturation of the coal chute is approximately 3-5 feet below exterior grade. The coal chute is located in Storage Room 002.

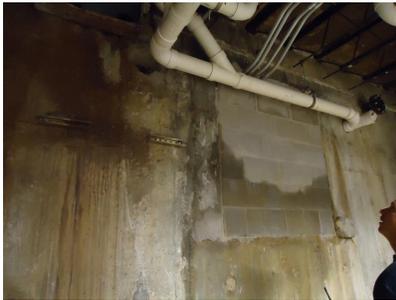
The existing concrete walls adjacent to the coal chute also show signs of water infiltration. These surfaces were “wet” to the touch.

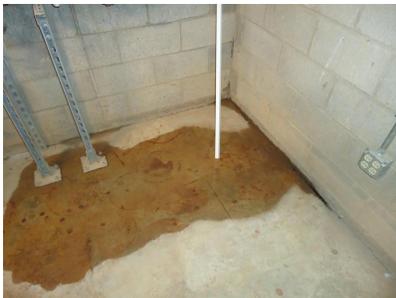
Across the room from exterior wall of the coal chute, standing water was noted at the southeast corner of Storage Room 002. Upon closer investigation, it appeared that water infiltration was occurring from under the existing concrete slab – hydrostatic pressure.

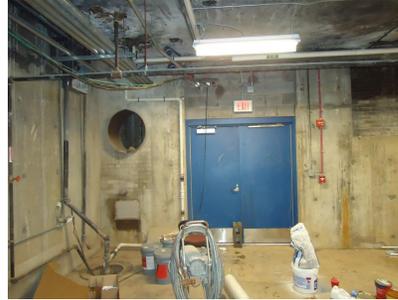
The hole into the existing chimney at left of exterior double-doors is to be infilled per construction documents.

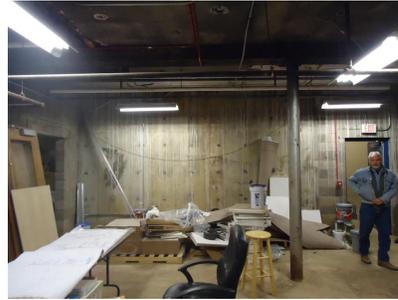
Per construction drawings, “the contractor shall fire safe and seal all existing and new penetrations in existing walls and/or new walls (and/or floor above where applicable) as required to achieve rated construction as indicated. All abandoned existing openings shall be infilled as required to achieve rating as indicated.”

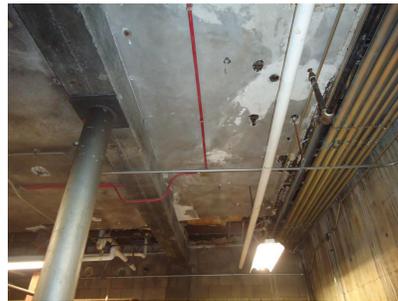
Per demolition drawings “Remove existing plaster ceiling assembly at underside of steel floor or roof joists above, including plaster, mesh, and any furring.”

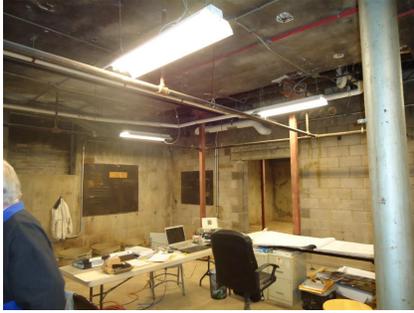
Per construction drawings and room finish groups, the lower level areas Storage Room 001, 002, and 003, are to have existing exposed concrete floor, no new wall base, new paint at existing/new walls, and paint to exposed structure above. All new and existing exposed lintels to receive paint. Existing steel columns to receive paint.

Several new light fixtures and other MEP items are currently supported by existing plaster ceiling above. Refer to MEP construction drawings for requirements.

Owner to verify if these spaces are not to receive new finishes indicated per construction documents.

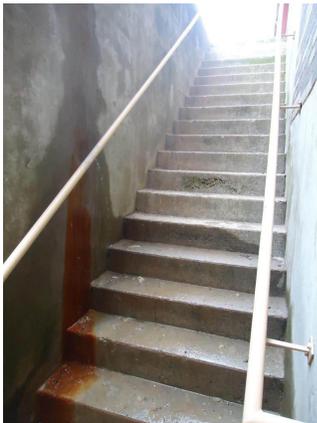
During construction and excavation at west side of existing exterior stair to lower level, Morel Construction installed sheet water-proofing material along face of existing stair on west side only. Per construction drawings, the “Contractor to clean, patch, and repair exterior basement stairwell (including concrete slab, concrete steps, & concrete foundation walls) for like new appearance. Provide water repellent and patch over all surface areas to eliminate existing water infiltration. Provide protection of exterior floor drain and piping as required for new work.”

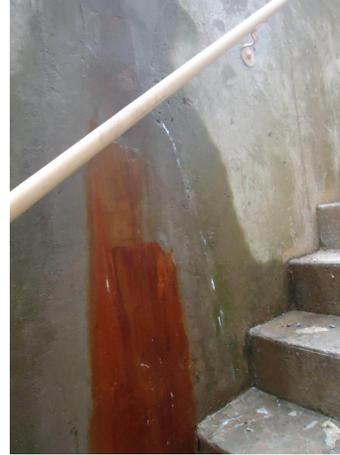
There is a steady stream of water leaking through the existing exterior concrete stair to the lower level storage area. There is also visible signs of water infiltration through the capped and sealed coal chute, as well as up through existing floor slab in this area. Please refer to photos and additional report information at the end of these meeting minutes.

Currently, there is a steady stream of water shooting out of the existing exterior concrete stair retaining wall after significant rainfall. Just below this is a horizontal crack within the stair wall from which rust-stained water has been infiltrating.

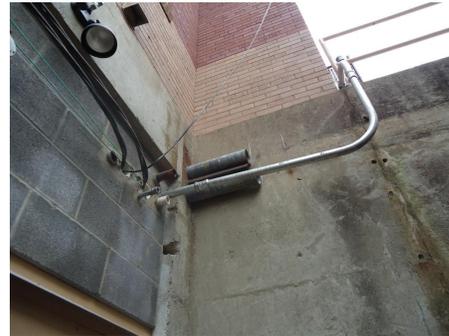
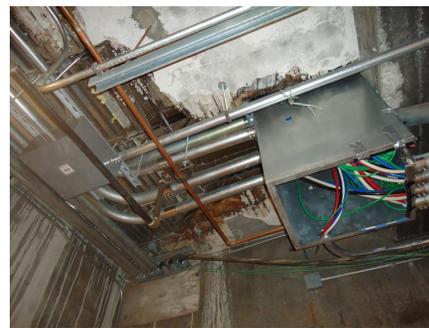
Conduits installed for temporary construction power need to be removed, walls patched and repaired per construction documents.

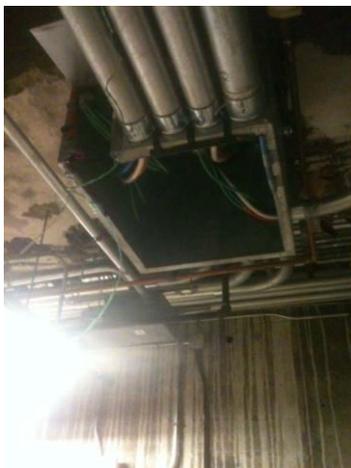
Junction Box in Basement

1. Basement
 - a. Remove all existing conduit and piping not in use.
 - b. Junction box where feeders are coming in has been cut. Should be replaced.
2. General Note – remove all construction debris and excess material from mechanical fenced in areas.

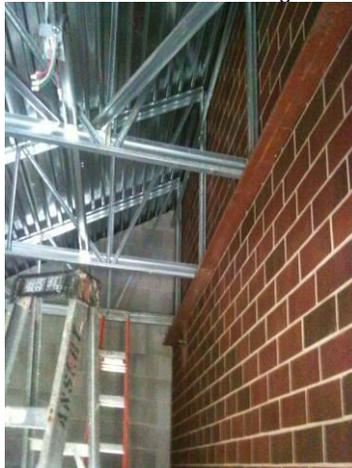
Fire Protection at Child Storage

18. Child storage area sprinkler heads are poking through the wall. See picture. They are not within 12" of the peak of the roof. There was originally supposed to be a drywall ceiling in this area but it was deleted and Owner received a credit. Is there anything that can be done about the fire protection? We may have to go back to a drywall ceiling. STW to investigate.

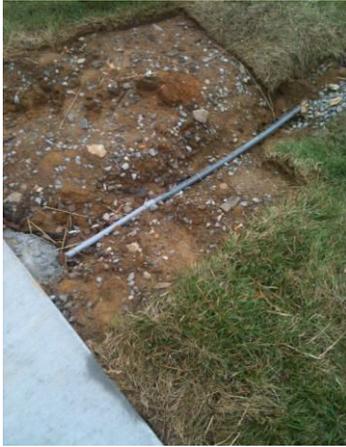
Exterior Conduit

17. Exterior conduit at the front entry, the owner is okay with the L-beam in the wall and then fishing fire alarm cable as required in the cavity of the wall and putting a decorative covering box that is not obtrusive over the conduit.
