FINAL COMPLETION PUNCHLIST REPORT

Re: Renovation to Radcliff Elementary School – Phase 3
SCB Project No. 1004

Date: January 18, 2012

EXTERIOR SITE PUNCH LIST REVIEW

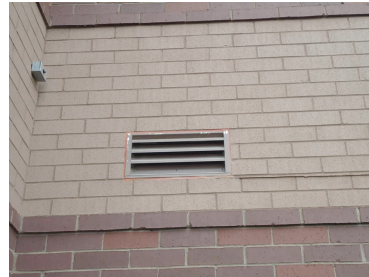
24. Red sealant around louver painted to match existing adjacent face brick stain.

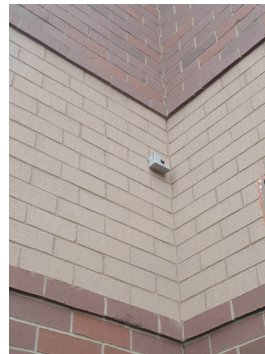
25. Verify if electrical outlet box was to have been removed.

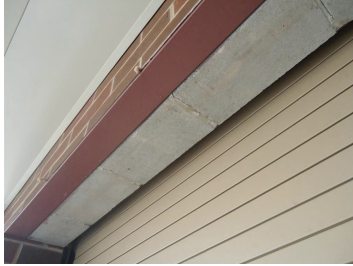
32. Paint exposed masonry lintel at overhead door.

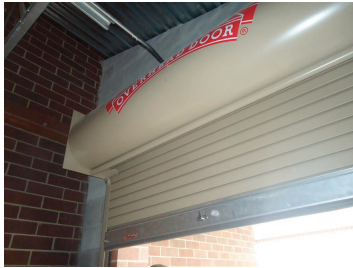
33. Per project specifications section 08334 – Overhead Coiling Doors, pull-down straps or pole hooks to be provided for overhead doors more than 84 inches high. Overhead door E129 at Preschool Playground Storage 129 should have received one of these items.

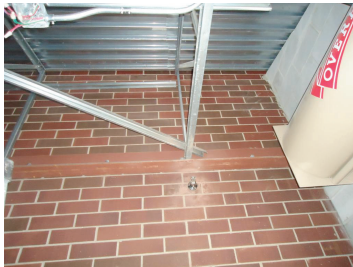
34. Due to the use of sidewall freeze-proof sprinkler heads in the exterior Preschool storage, the gypsum ceiling was removed, as the sprinkler heads would have been above the ceiling height. However, the sprinkler heads are too low from roof deck above in order to meet sprinkler code. STW and SCB to verify and coordinate solution with Morel.

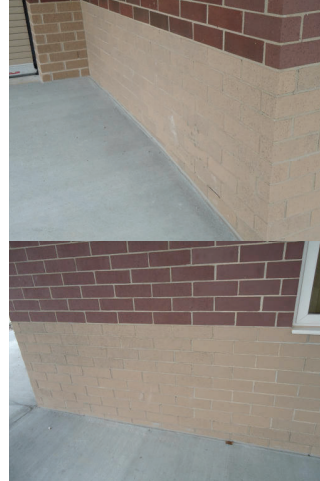
38. Insufficient accent color brick stain.

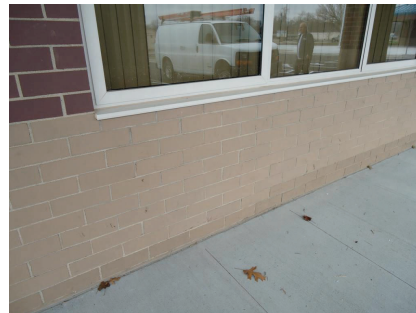
42. Insufficient accent color brick stain.

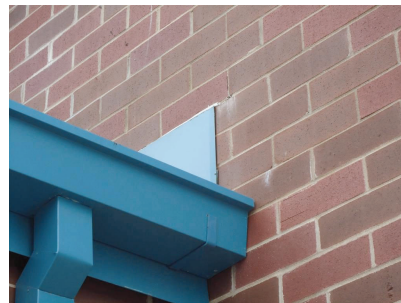
47. Inadequate sealant at metal roof flashing.

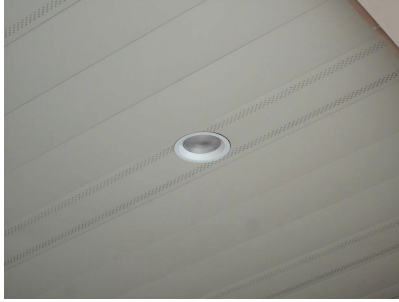
49. Readjust recessed can light fixture inside main entry masonry portico.

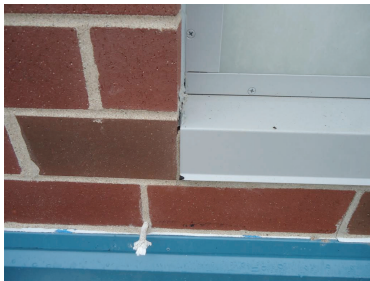
53. Seal gaps around perimeter of aluminum window frames at Cafeteria clerestory window. Seal gaps at aluminum window frame seams. *(Contractor to confirm completion of this item).*

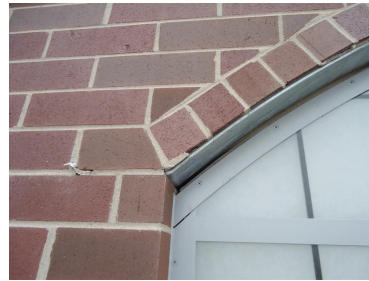
54. Incomplete installation at head of aluminum window units at Cafeteria clerestory window, typical. Paint exposed steel lintels. Seal gaps at aluminum window frame seams. *(Contractor to confirm completion of this item).*

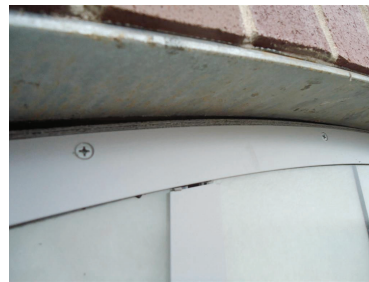
55. Lacking sealant around perimeter of aluminum window units at Cafeteria clerestory windows. Paint exposed steel lintel. *(Contractor to confirm completion of this item).*

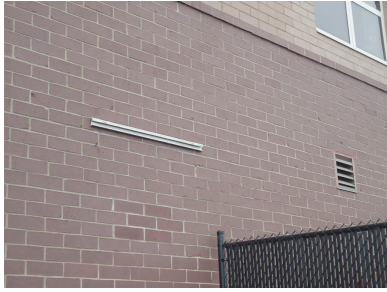
2. Remove existing metal bar and repair brick stain below existing bar.

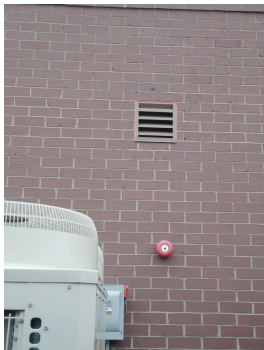
4. Red sealant around louver painted to match existing adjacent face brick stain.

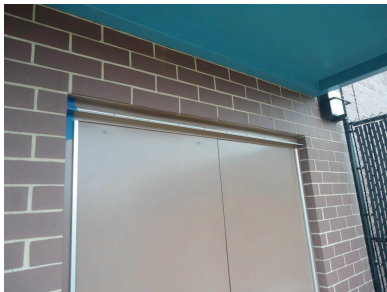
9. Remove blue tape from exterior doors.

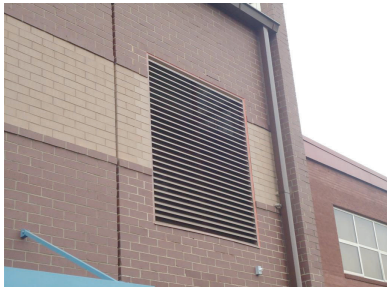
10. Red sealant around louver painted to match existing adjacent face brick stain.

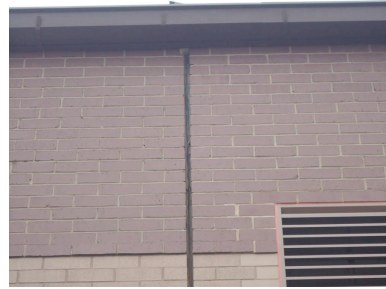
11. Repair and replace building expansion joint material, full height.

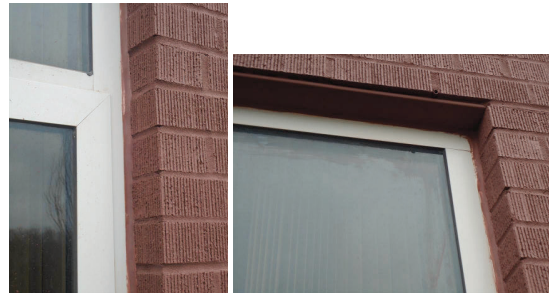
13. Remove brick stain from perimeter window sealant.

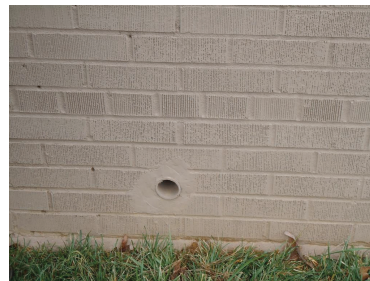
14. Verify exposed open PVC piping.

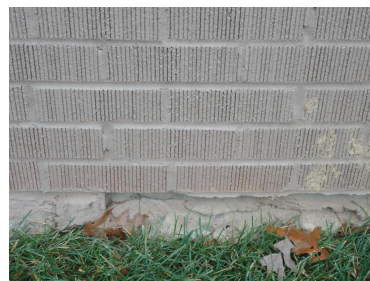
16. Existing concrete base at grade of existing exterior brick wall is in disrepair. SCB to discuss with Owner potential options for addressing these existing conditions.

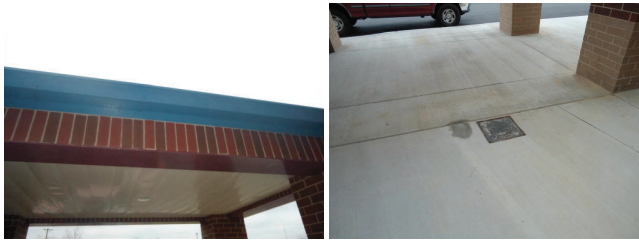
4. Leak at gutter at bus walkway cover.

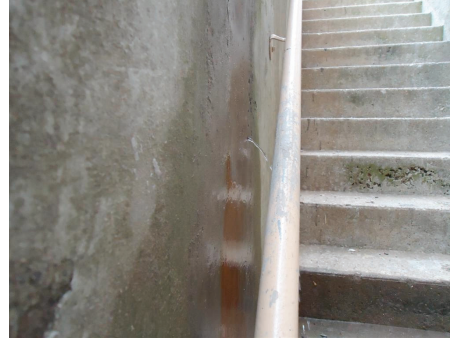
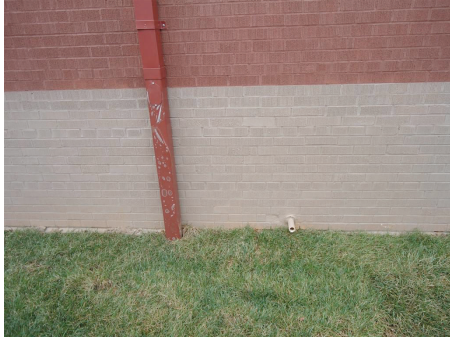
8. Verify exposed open PVC piping.

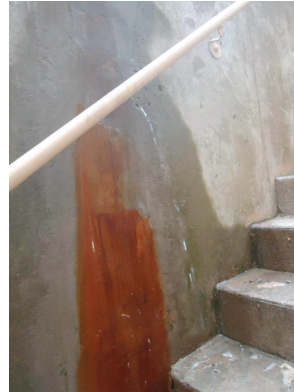
19. Substantial water infiltrating through existing concrete stair to lower level storage area. Water infiltration through stair also “rust” color.

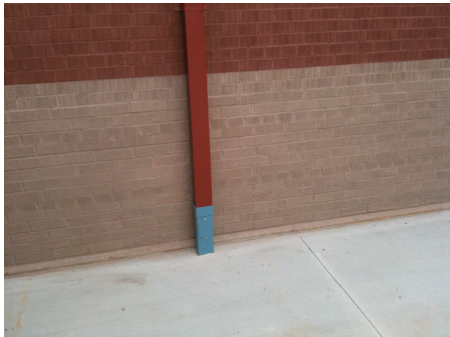
12. Incorrect downspout boot color at two locations (both sides of existing stair).

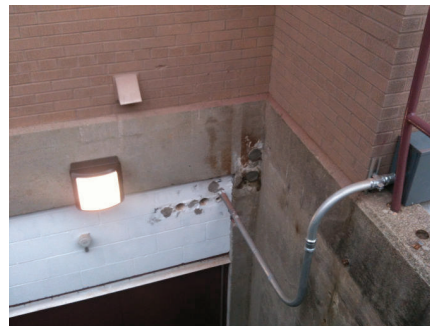
20. Patch holes from removed conduit penetrations in existing exterior wall.

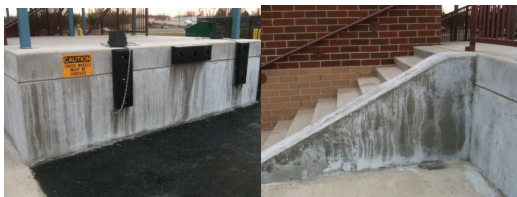
14. Remove white substance and staining from poured concrete Kitchen loading dock and stair.

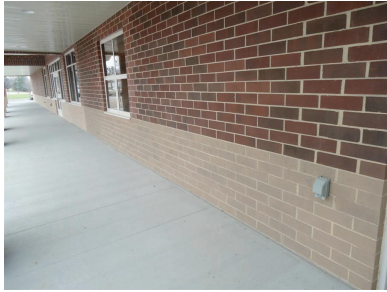
15. Insufficient accent color brick stain. Remove dirt and white substance from face brick.

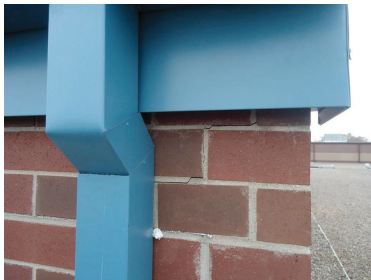
16. Crack in face brick masonry, southeast corner of Cafeteria clerestory. *(Contractor to confirm completion of this item).*

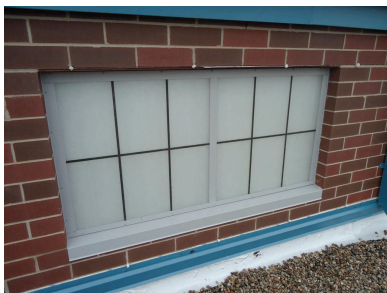
17. Trim weep ropes and flashing at clerestory windows at Cafeteria. *(Contractor to confirm completion of this item).*

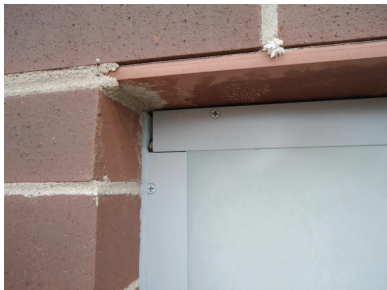
18. Excessive gaps in aluminum window frames at Cafeteria clerestory, typical all sides. Paint exposed lintel. *(Contractor to confirm completion of this item).*

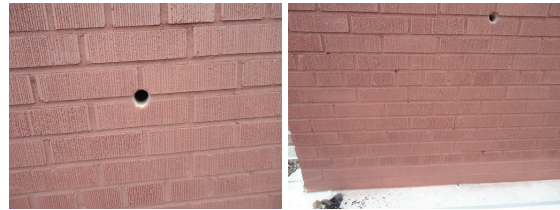
19. Patch holes in existing face brick, typ. *(Contractor to confirm completion of this item).*

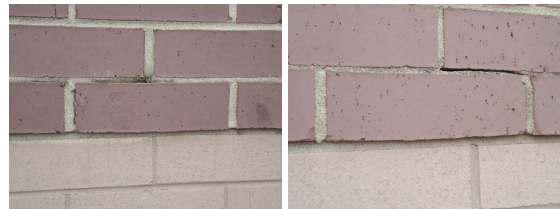
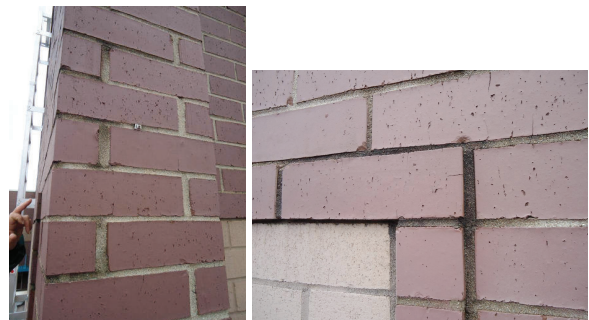
20. Insufficient pointing at existing brick mortar joints. *(Contractor to confirm completion of this item).*

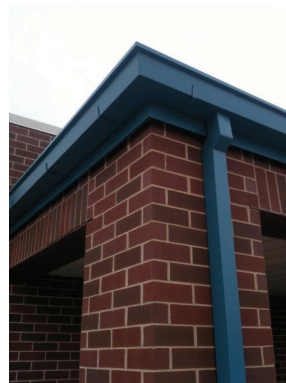
Note: Gutter at far west corner of walkway cover has reported to be leaking.

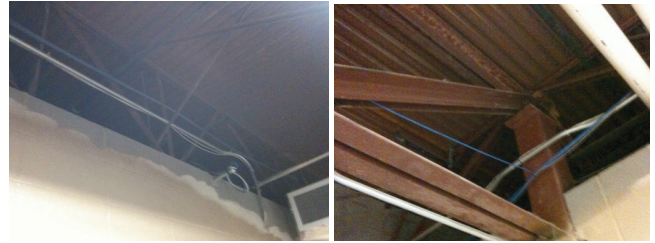
Note: Per Phase 1 construction, this room was to have received “SO” unrated incidental use separation partition around entire perimeter of this room. Walls were to have been full height and all penetrations in the perimeter walls sealed. However, at time of review, the new west masonry wall was not extended full height to underside of floor decking above, nor were penetrations through perimeter walls sealed. The “SO” rating for this room requires it to be sealed from adjacent spaces.
