RE: North Middle School
Roof Test

Project: North Middle School, Vine Grove KY - Masonry Wall Drainage Testing

At your request, Building Diagnostics Group, Inc. (BDG) visited the North Middle School building located at 100 Trojan Way, Vine Grove KY 40175 on April 11, 2012 to perform masonry wall drainage testing.

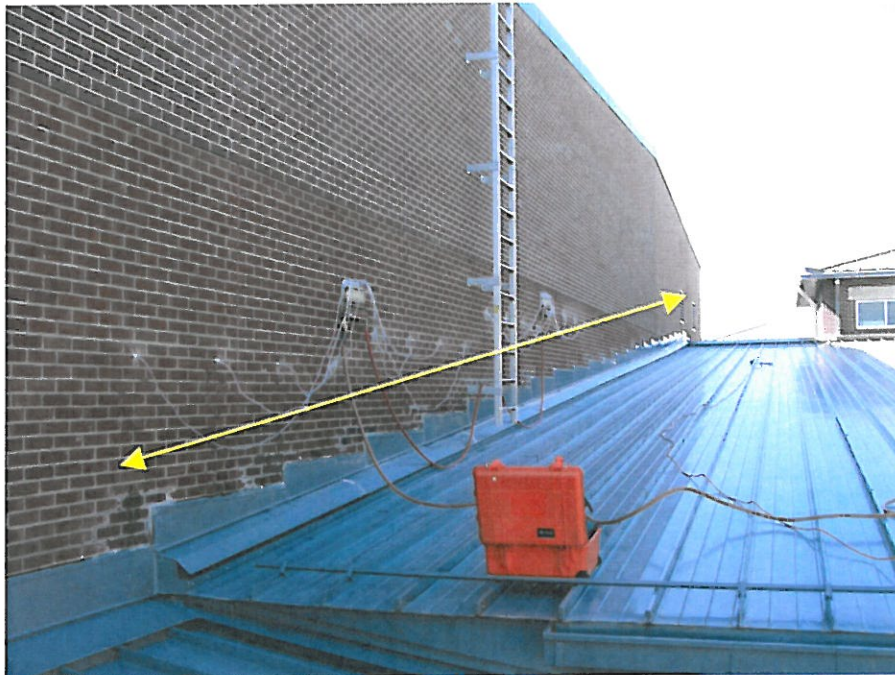
Since the test location was along a rake detail on the gymnasium upper wall, we began testing from the lowest point of the adjoining roof, as the thru-wall flashing along this wall was step-flashed from the base to the ridge. Initially, we ran the test manifolds in full capacity by injecting water at a rate of .032 gal/min in each of the sixteen drilled injection ports, for a total of forty-two feet. Water appeared within the interior almost immediately. We then, and for the remainder of the testing, limited the testing to only include two injection ports at a time. This would allow us to determine the general location of the flashing failure(s). Test duration varied from ten to twenty minutes per location. We documented water dripping from the steel angle in twenty-four separate locations. These intrusions occurred during the testing of sixteen separate tests, starting at the base (see P1) and continuing up to the peak of the ridge.

(P1) – Overall view of test area

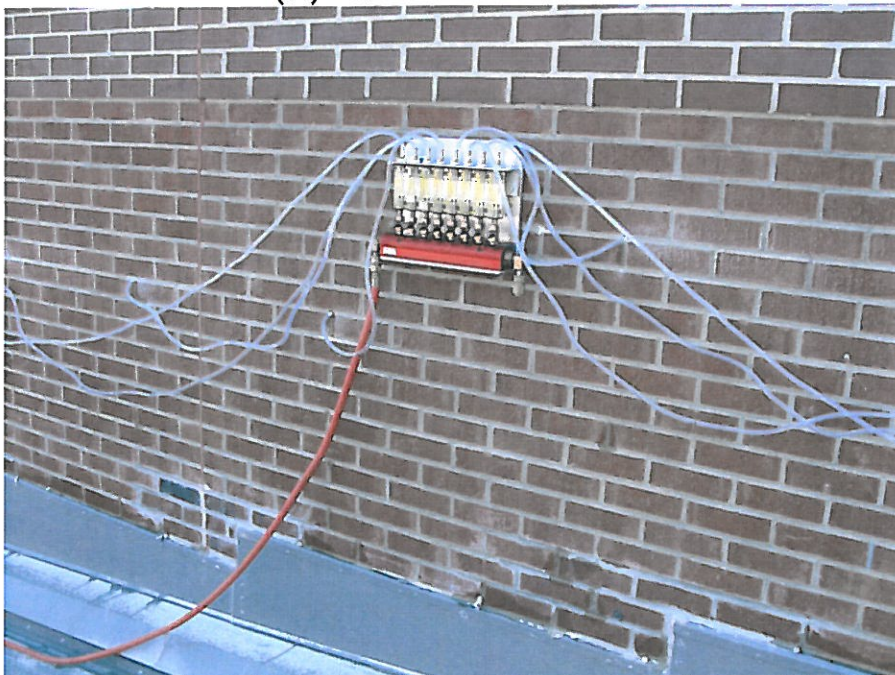
(P2) – Test apparatus – Water was injected every 32 inches

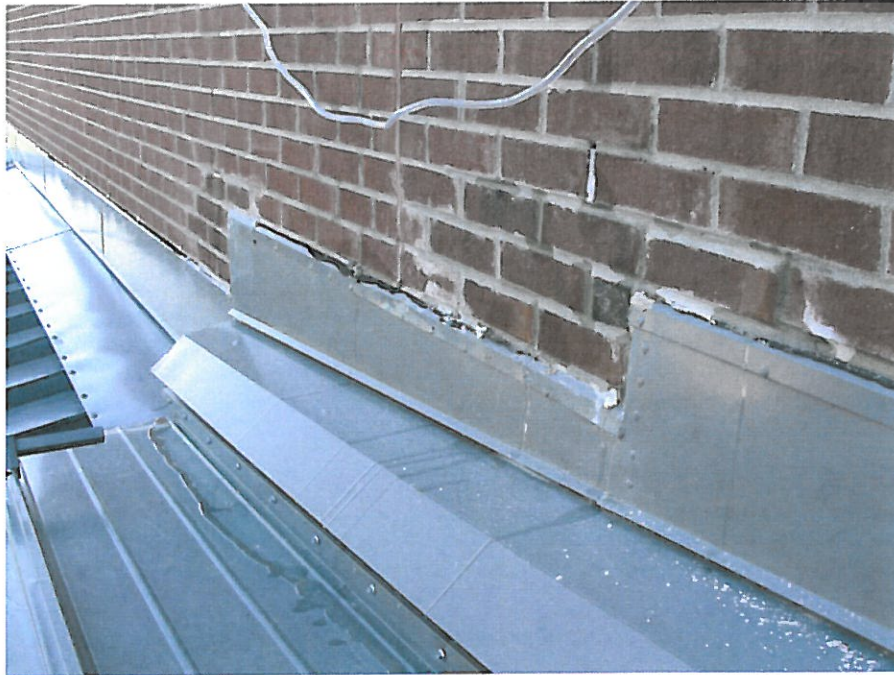
(P3) – Testing in progress

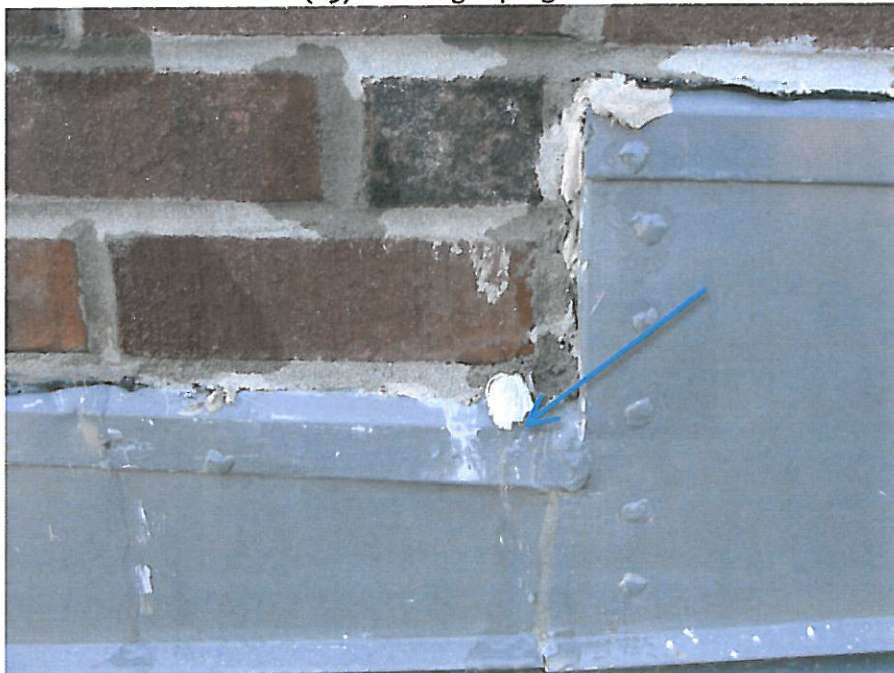
(P4) – Drainage from base flashing (thru-wall) was observed during testing

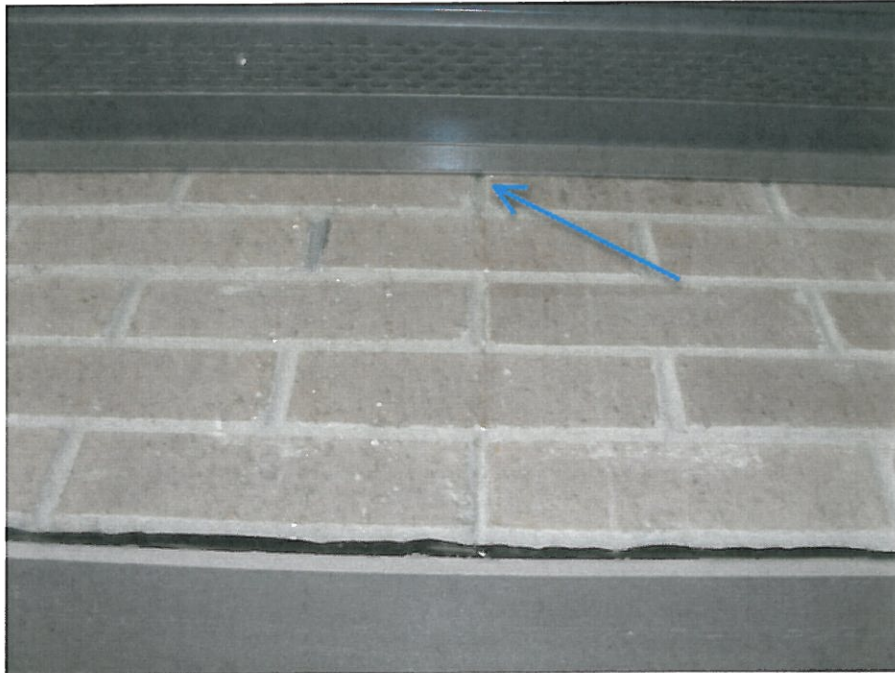
(P5) – Water penetration observed from above exterior soffit

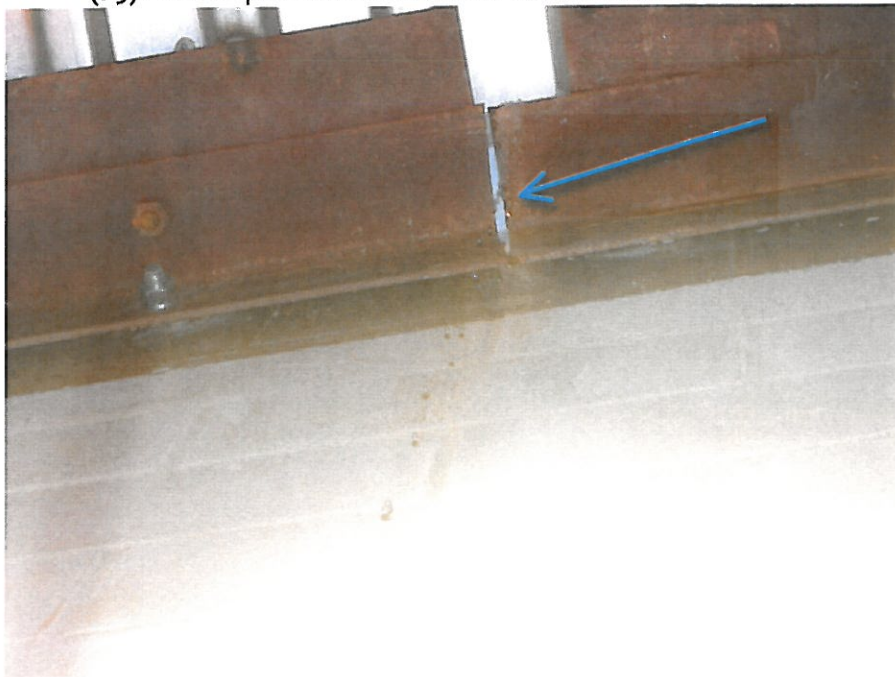
Without destructive testing we can only speculate that an inadequate flashing detail exists within the wall cavity. In some cases, the water intrusion appeared to build up (static head) prior to “over-flowing” on to the steel angle. This may indicate a possible deficiency in the sealant joint along the termination bar.

(P6) – Water penetration observed from gap at steel angle

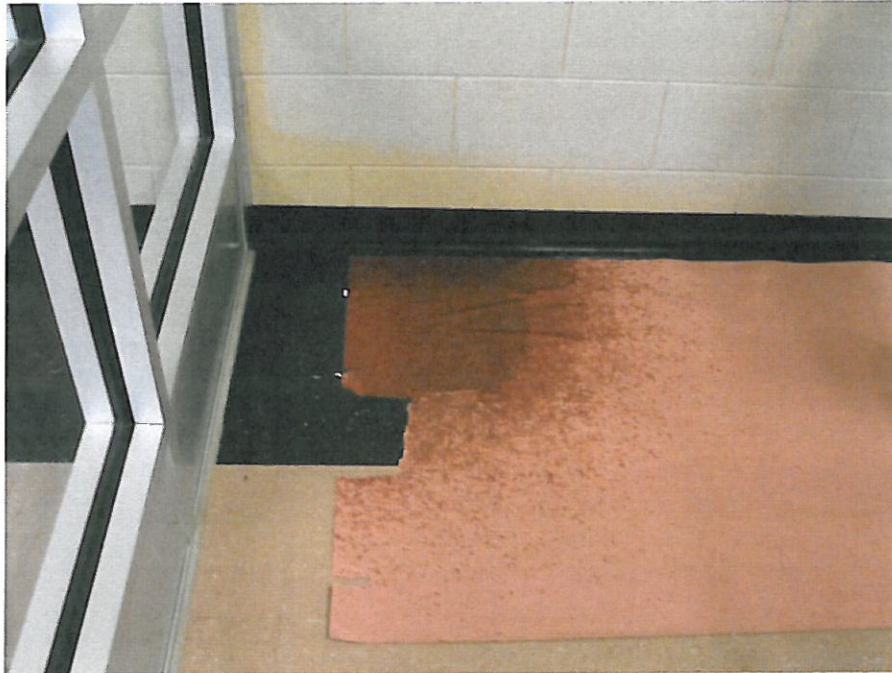
(P7) – Testing in progress

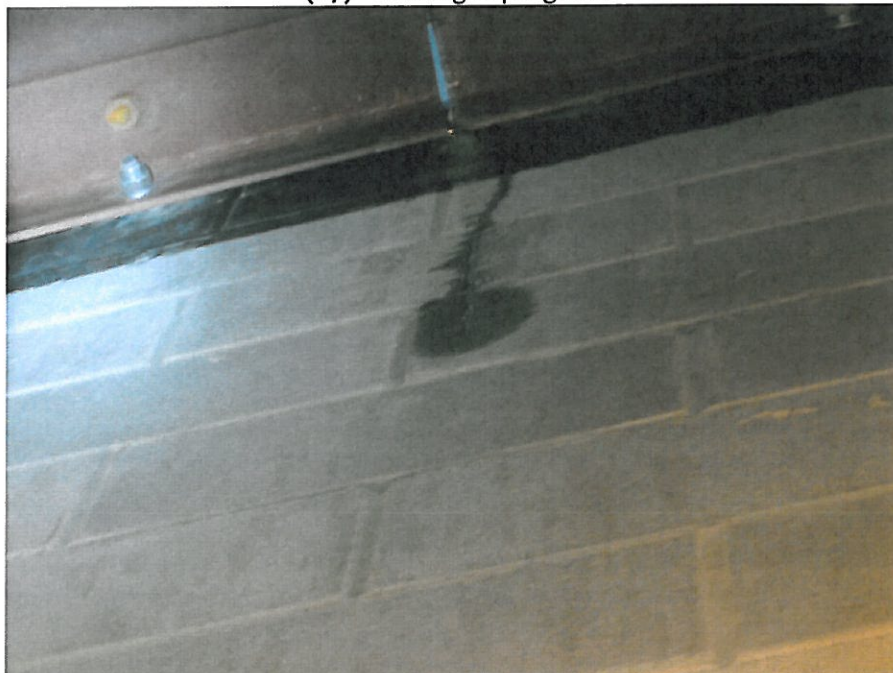
(P8) – Water observed dripping down CMU wall from gap in steel angle

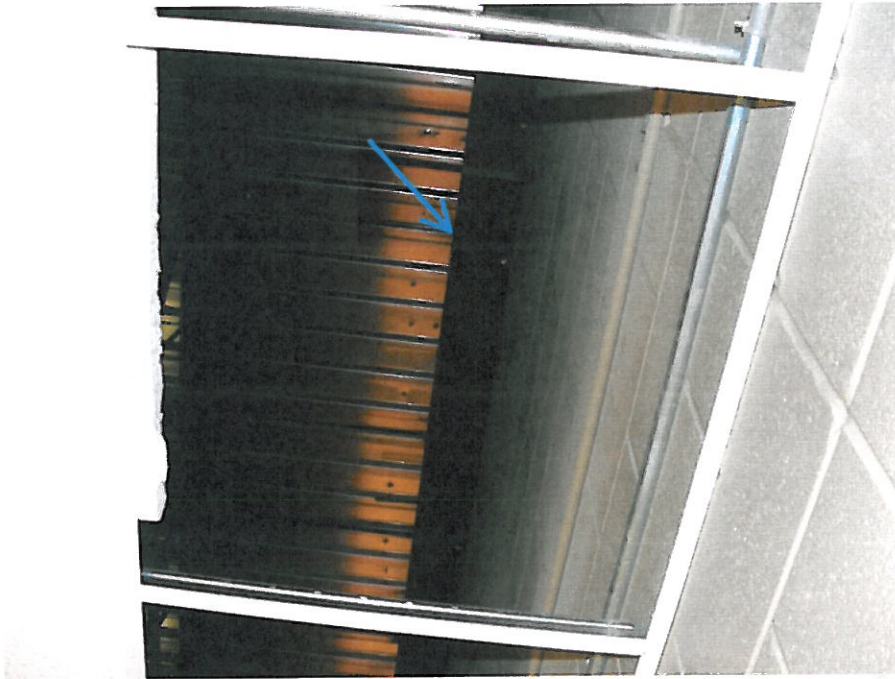
(P11) – Water intrusion began dripping rapidly. Above P10 (previous page)

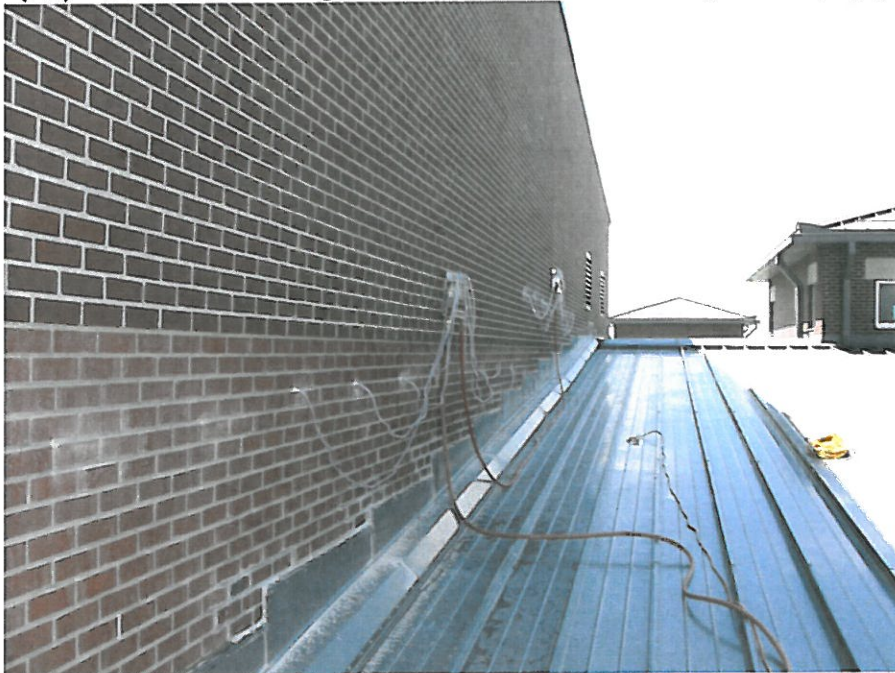
(P12) – Upper portion of roof (toward ridge)

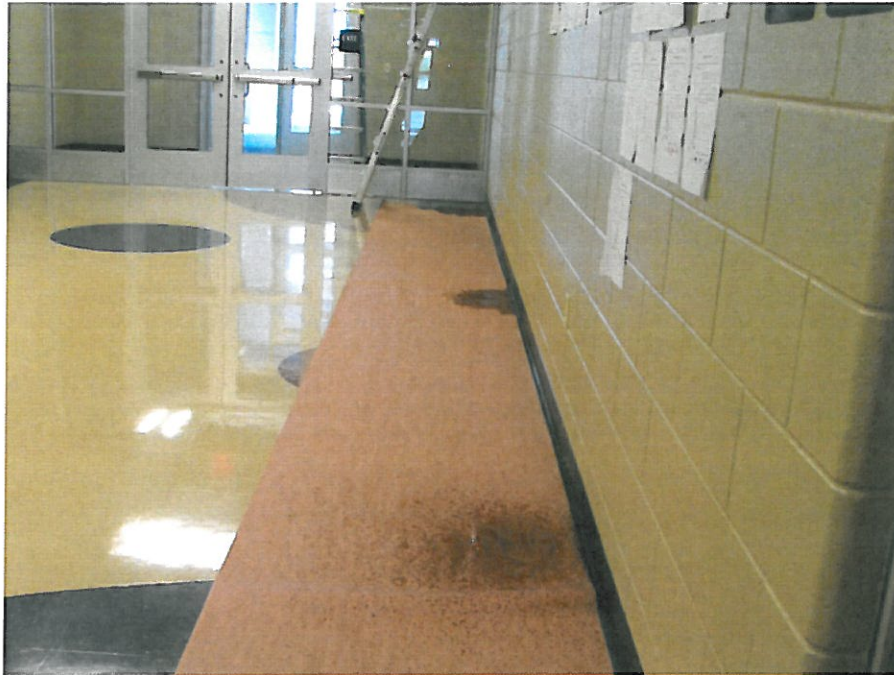
(P9) – Testing in progress

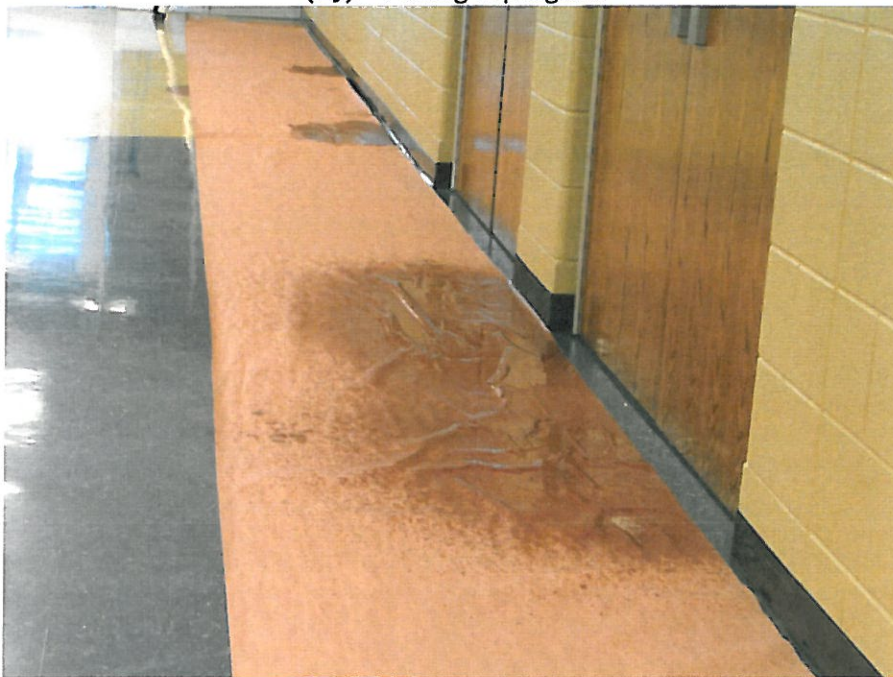
(P10) – Testing in progress
