PR #: Three (3)

TO: David Beiersdorfer Jr.
Endeavor Construction
977 State Route 28
Millford, Ohio 45150RE: Gallatin Co. Alternative School & Field House
Gallatin County, Kentucky
BG 12-133
RTA 0914

DESCRIPTION: Soil Condition Proposals at the Plan-South Alternative School & Field House Building Pad Area (a follow up to the response to RFI#004).

Re: Subgrade and Geothermal Well Observation
Gallatin County Alternative School & Field House
Warsaw, Kentucky

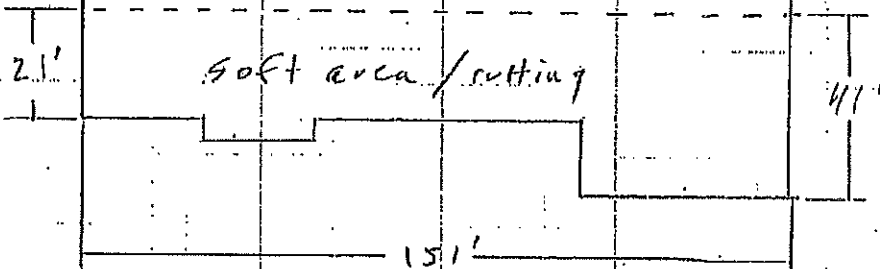
Subject Subgrade

S&ME observed the building pad subgrade. Based on discussion with Mr. Jones, it is understood the north section of the building pad was previously a parking area and stability in the area is not a concern. The south area of the building pad, as shown on the attached sketch, was previously proofrolled and ruts were observed to depths of 6 to 8 inches. Hand augering was performed at several locations. Weak clayey silt soils were encountered to a depth of approximately 12 inches. The soils observed would typically become unstable when exposed to excess moisture.

Note: Dimensions provided by Endeavour Construction,
S&ME confirmed.

S&ME recommends the soft soils be cut to a depth of 12 inches below subgrade. The soils should be replaced with crushed stone base (Kentucky Department of Highways Standard Specification Item 805.15 or similar crushed stone material).
