PROJECT:	Gallatin County High School Field House	JOB NUMBER:	2228
CLIENT:	Gallatin County Board of Education	WEATHER:	Sunny, 40s
CSI PROFESSIONAL:	Daniel Huffaker, S.I., C.E.T.	DATE:	Monday 26 February 2013

KBC Special Inspections - Summary of Observations

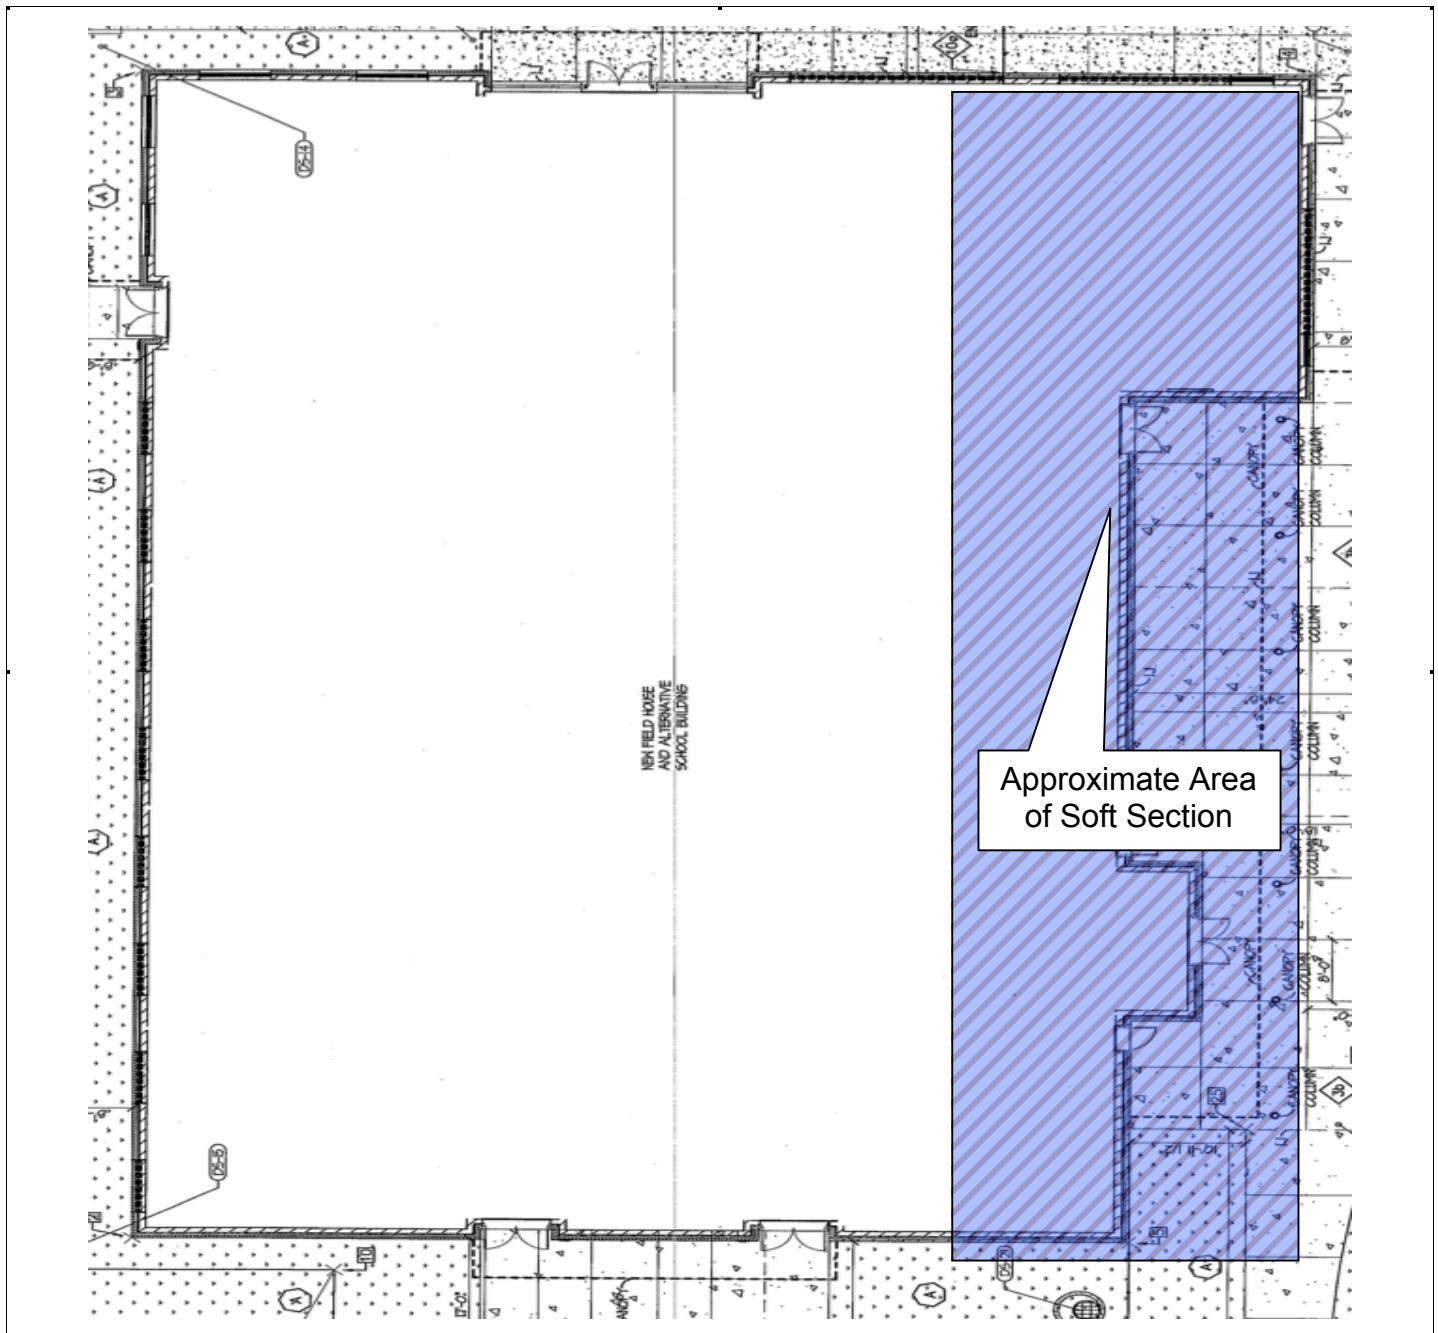
The CSI Professional observed a proofroll of the building pad using a loaded triaxial dump truck. Profrolling consisted of the loaded truck routing over the subgrade in forward and backward motion, then moving laterally one tire width and repeating the motion until the exposed subgrade had been rolled. The proofroll revealed a soft area on a portion of the area as noted in the highlighted area on the plan sheet below.

Legend = Approximate area of soft material noted during proofroll

It was recommended to contact Ross Tarrant Architects for directions regarding the soft material encountered. Mr. Lanigan determined that he did not want to risk opening up the soft section prior to projected inclement weather. Mr. Lanigan spread densely graded aggregate (DGA) over the section that revealed no pumping in order to protect that portion from wet weather.

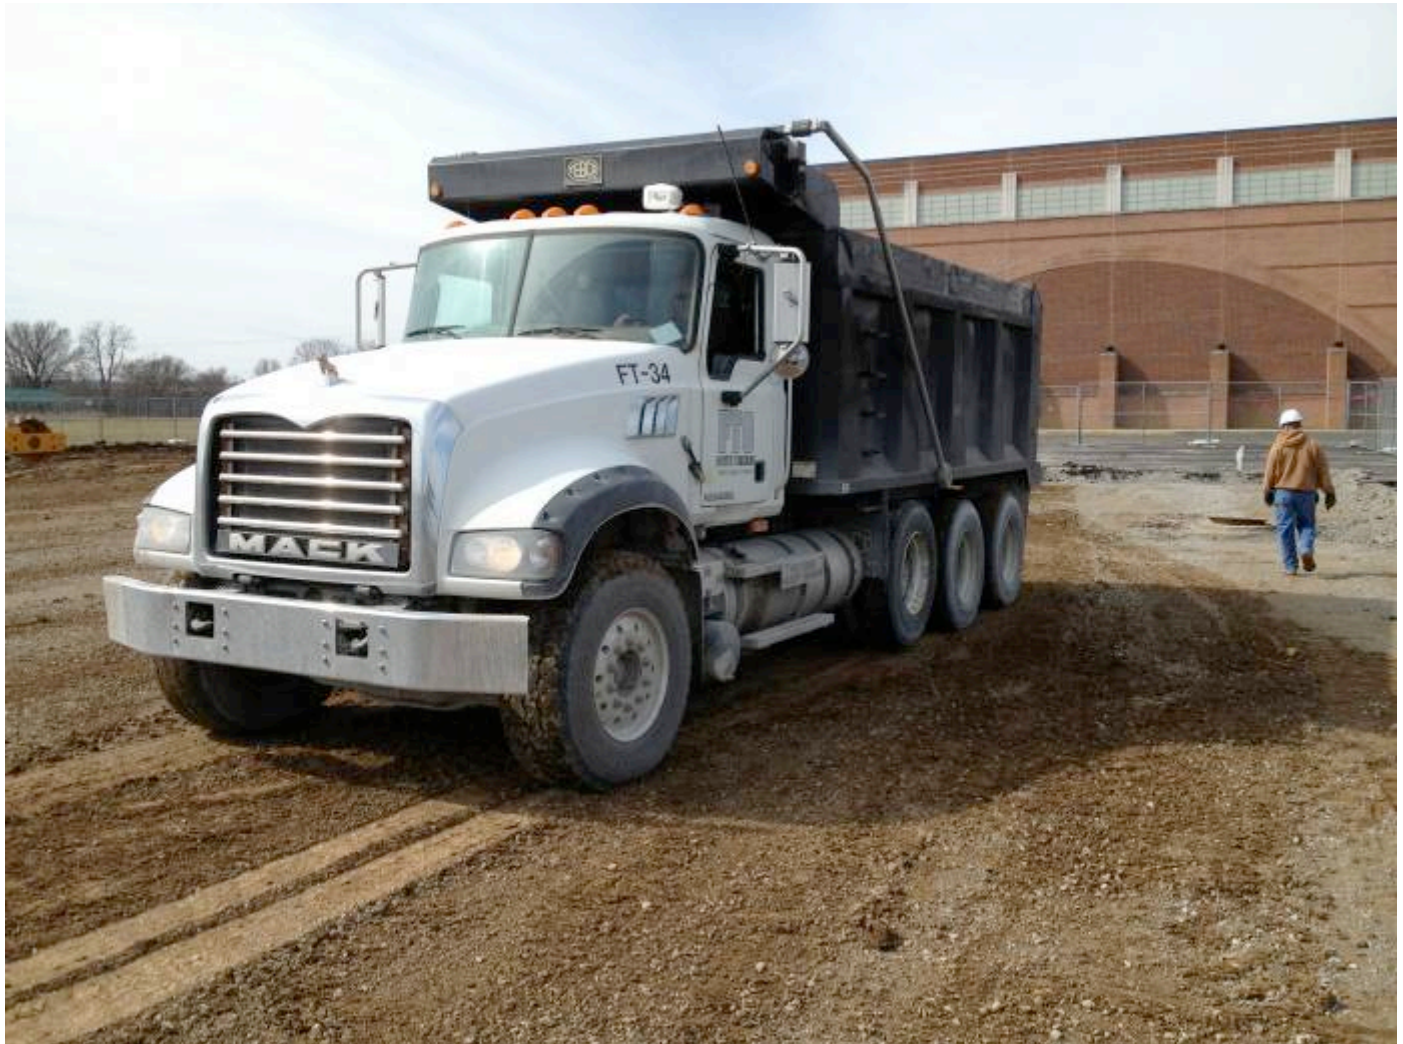
Photo 1: Observation of Proofroll via Triaxial Dump Truck

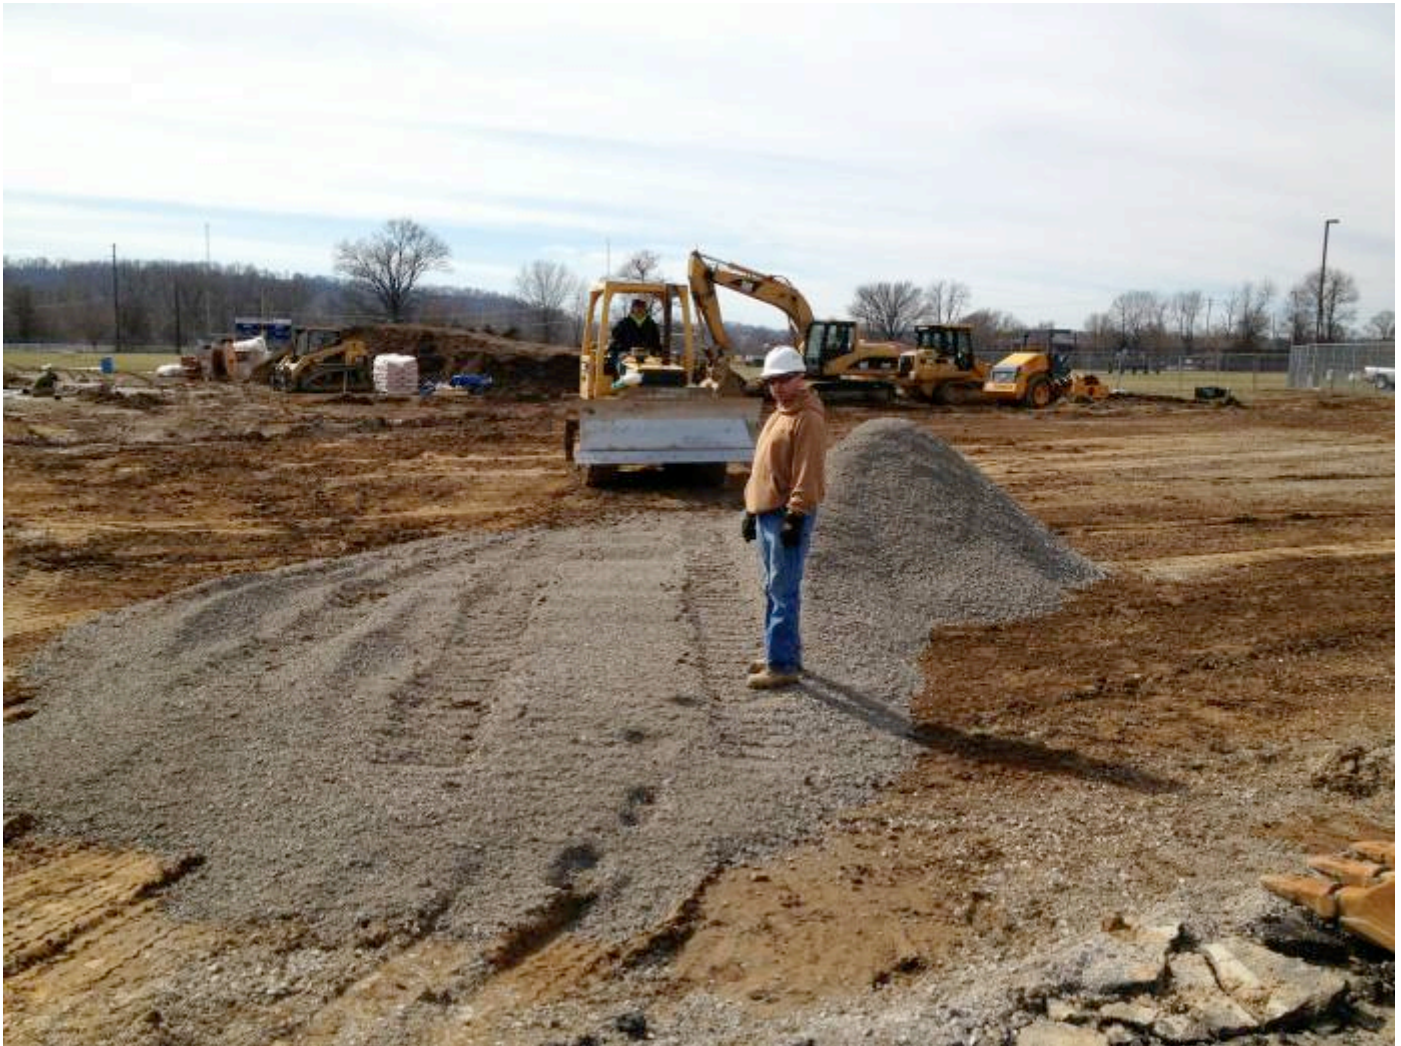
Photo 2: Loose DGA Placement

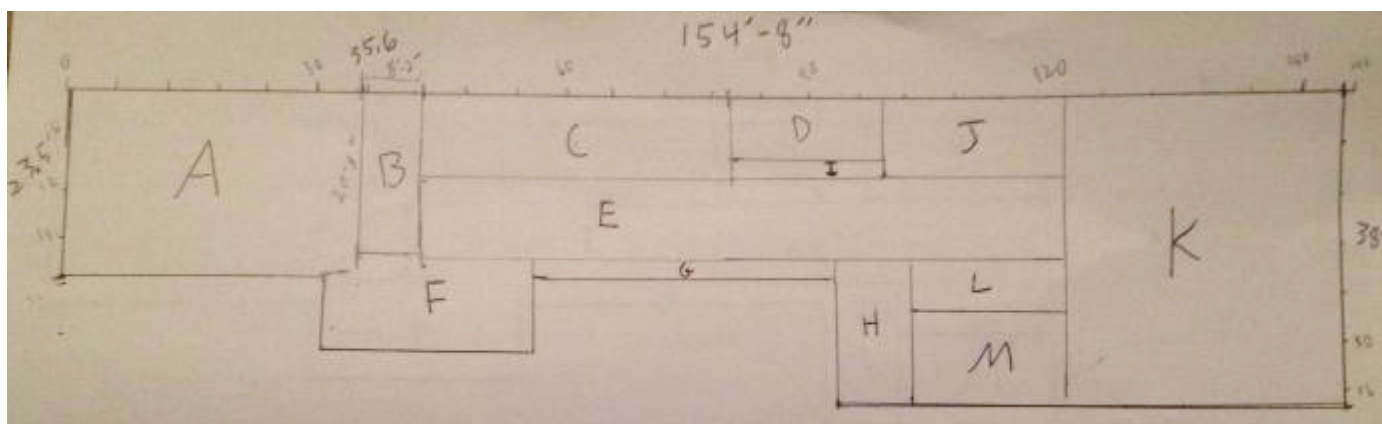
Figure 1: Approximate Drawing of Undercut Areas

The CSI representative observed the undercutting of the rear section of the building pad where soft material had previously been encountered during proofrolling on February 15, 2013. The section was undercut to a more bearable material at approximately 2 feet below existing grade. Mr. Lanigan cut the remainder of the section to this depth. A proofroll was conducted for the bottom of the undercut by the contractor utilizing a loaded dump truck weighing approximately 27,000 pounds. Some areas exhibited rutting and pumping. Mr. Jones, Mr. Lanigan, Mr. Whalen, and the CSI representative contacted Ross Tarant Architects and described the soil conditions. Ross Tarant directed that the rutted areas be skimmed down to suitable material and backfilled with soil fill from the on-site borrow area. The rutted sections were skimmed down. Mr. Jones and the CSI representative measured and recorded the undercut as noted on figure 1 and table 1. Total undercut was observed to be 415.81 cubic yards.

Section	Width ft	Length ft	Depth ft	Volume Ft ³	Volume Yd ³
A	23.50	35.5	2.08	1,735.24	64.27
B	20.67	8.17	3.21	542.09	20.08
C	10.67	37	2.125	838.93	31.07
D	8.25	18	2.67	396.50	14.69
E	10.67	78	2.54	2,113.94	78.29
F	9	24.75	2.21	492.28	18.23
G	2.5	35	2.21	193.38	7.16
H	16.67	9	2.17	325.57	12.06
I	2.42	18	2.5	108.90	4.03
J	10.67	23	2	490.82	18.18
K	38	33	2.33	2,921.82	108.22
L	5.33	23	2.33	285.63	10.58
M	11.33	23	3	781.77	28.95
Total Feet ³				11,226.85	Sum Volume Cubic Yards
Volume Cubic Yards:				415.81	415.81

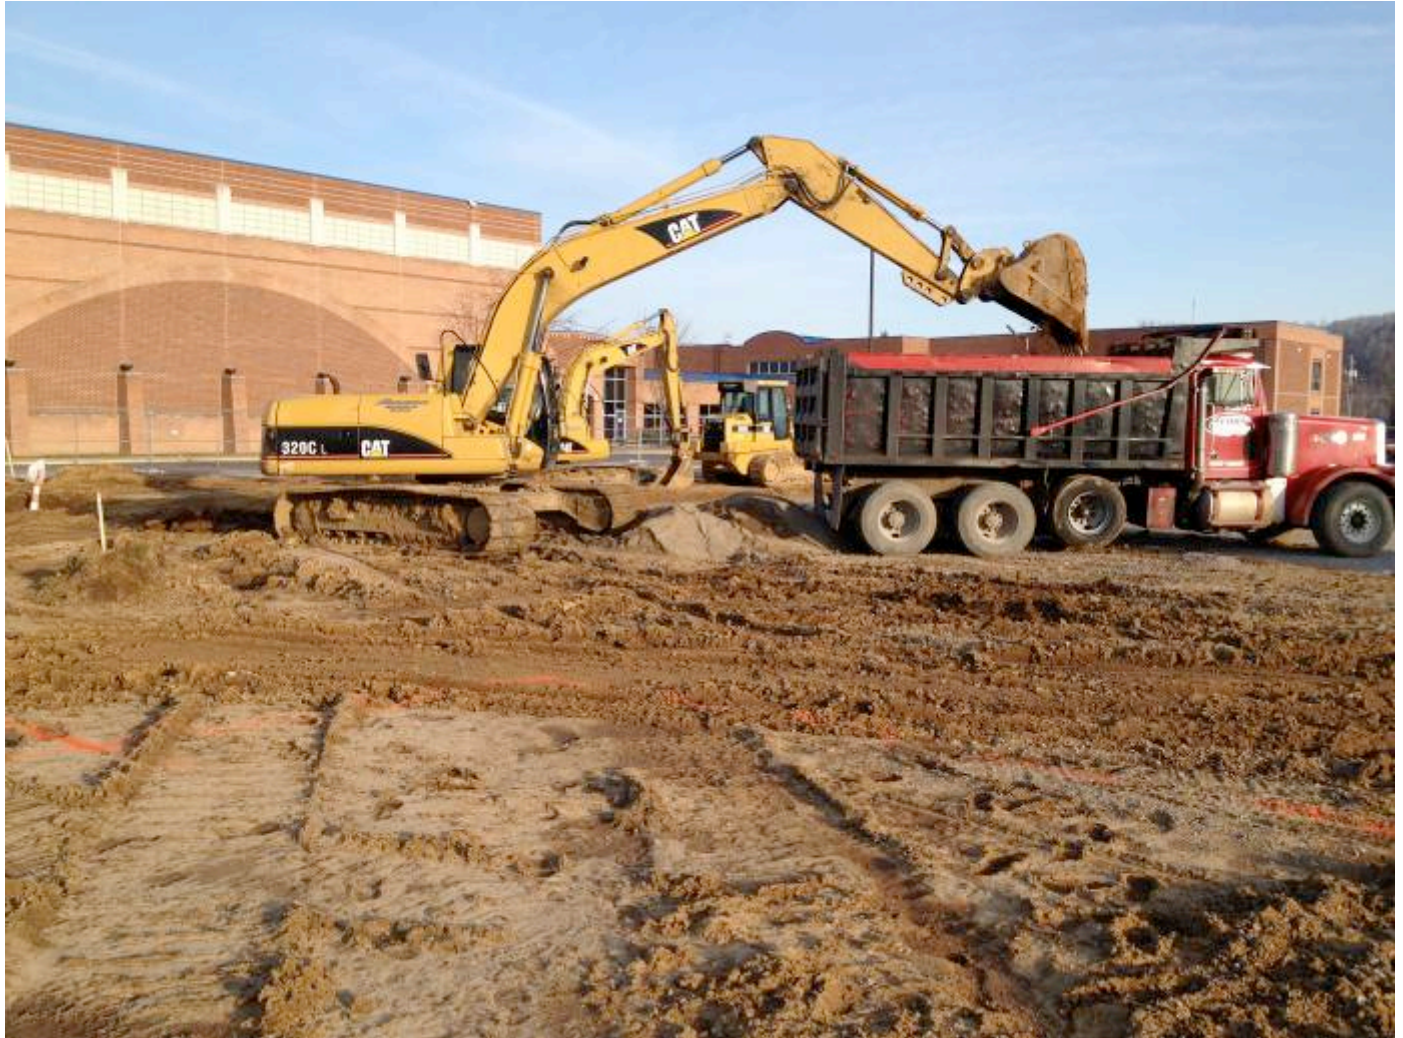
Photo 1: Excavation of Soft Area via Caterpillar 320C Excavator

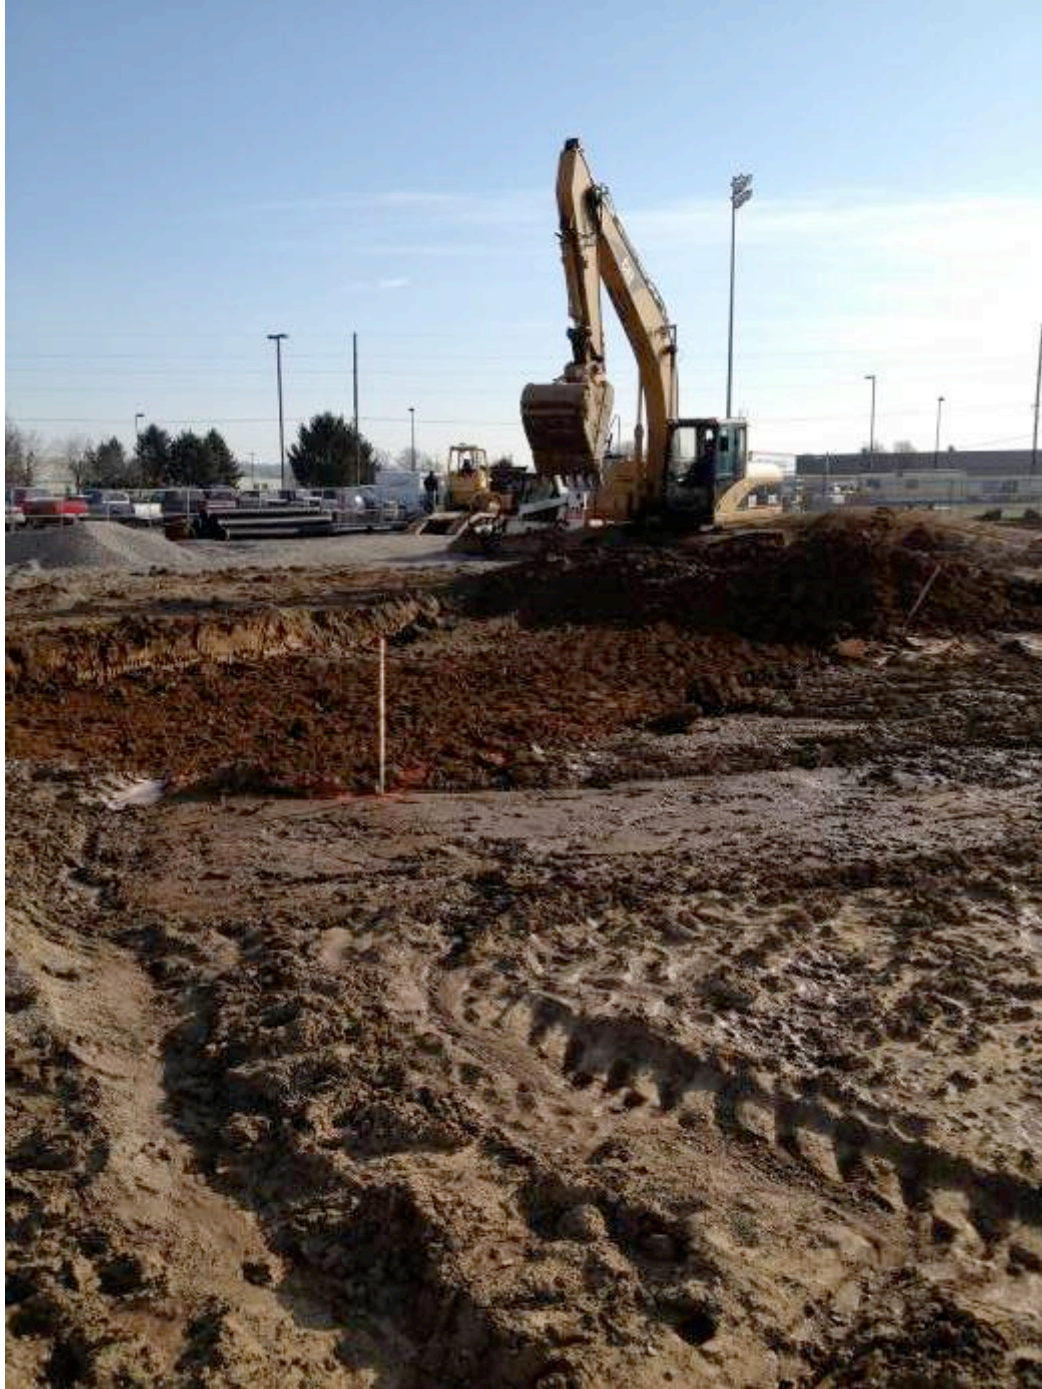
Photo 2: Excavation of Soft Area via Caterpillar 320C Excavator

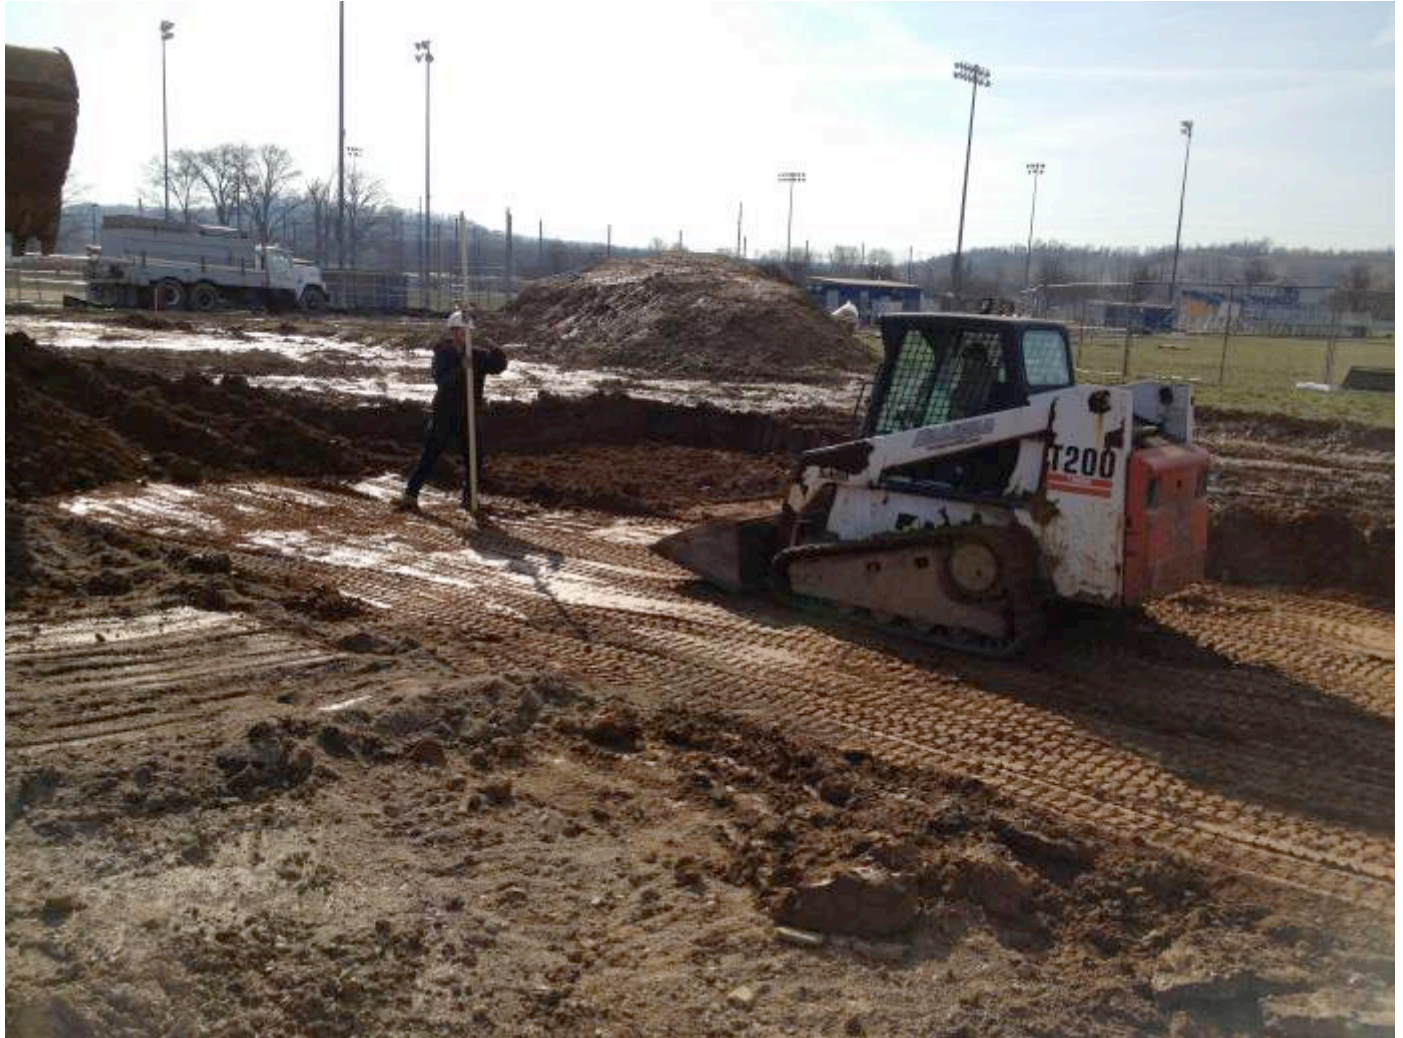
Photo 3: Grading of Undercut via Bobcat T200 Skid Steer

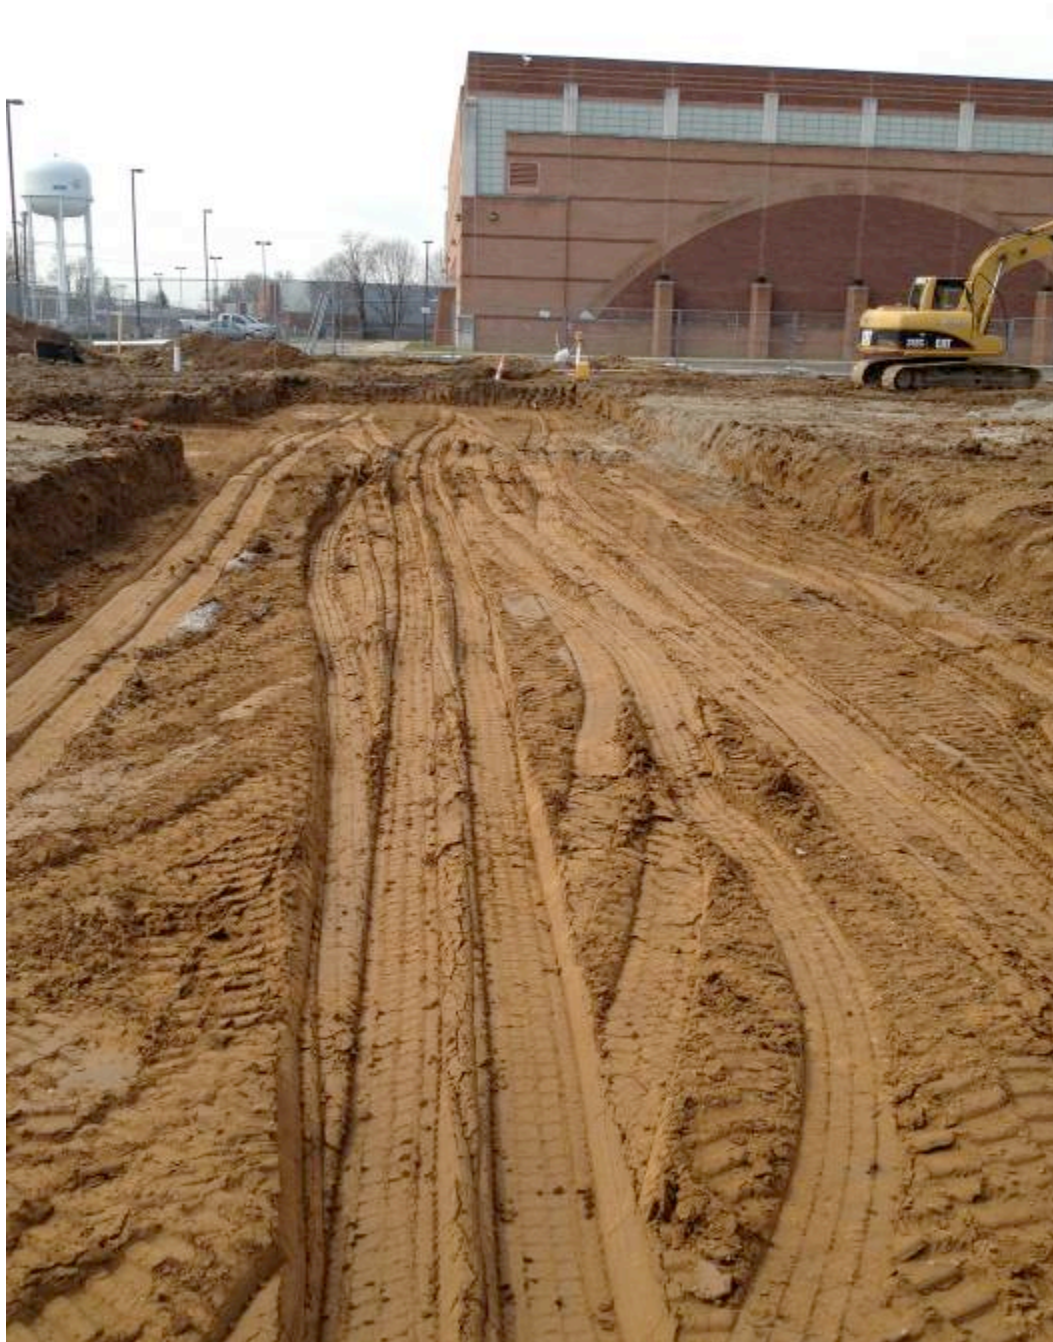
Photo 4: Undercut Section after Proof-Roll

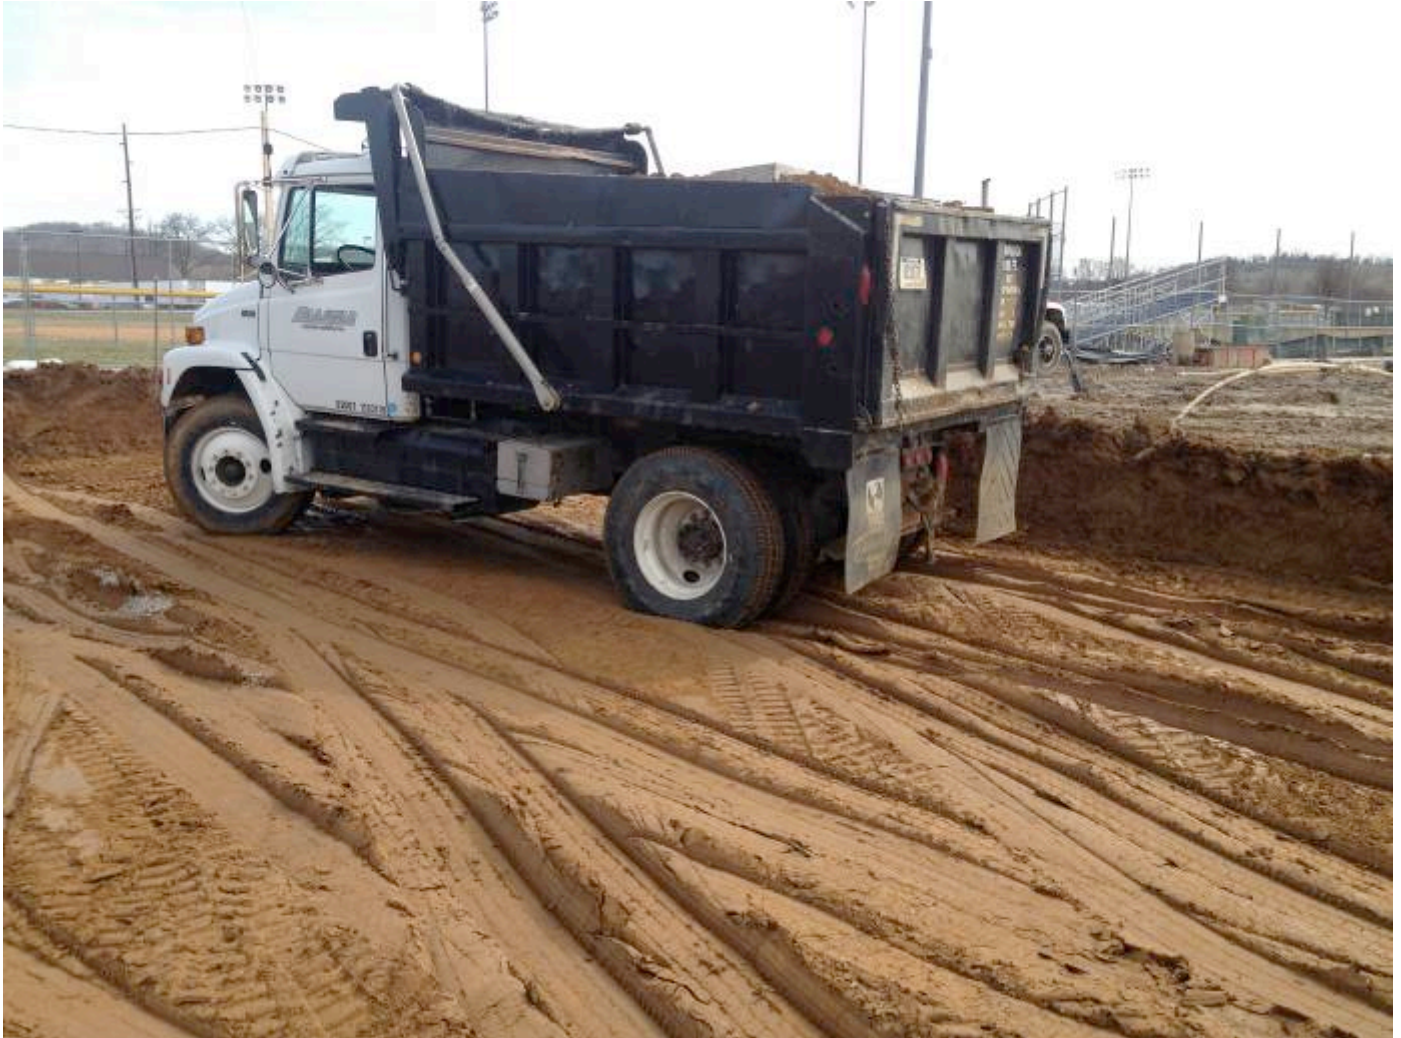
Photo 5: Dump Truck Employed for Proofroll

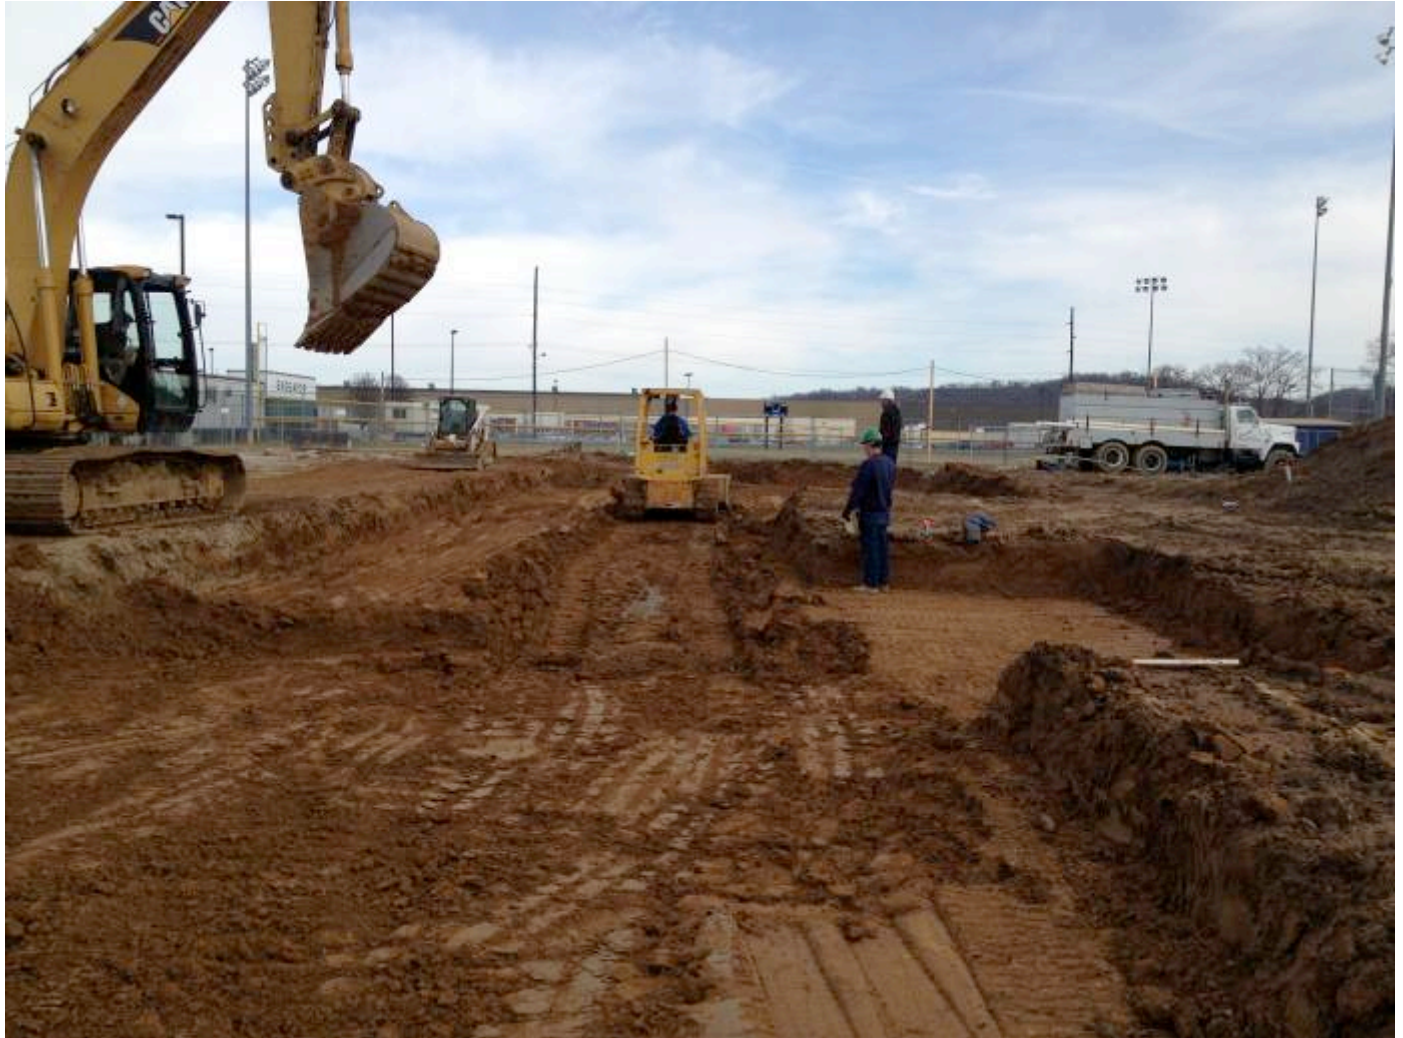
Photo 6: Undercut of Unsuitable Sections

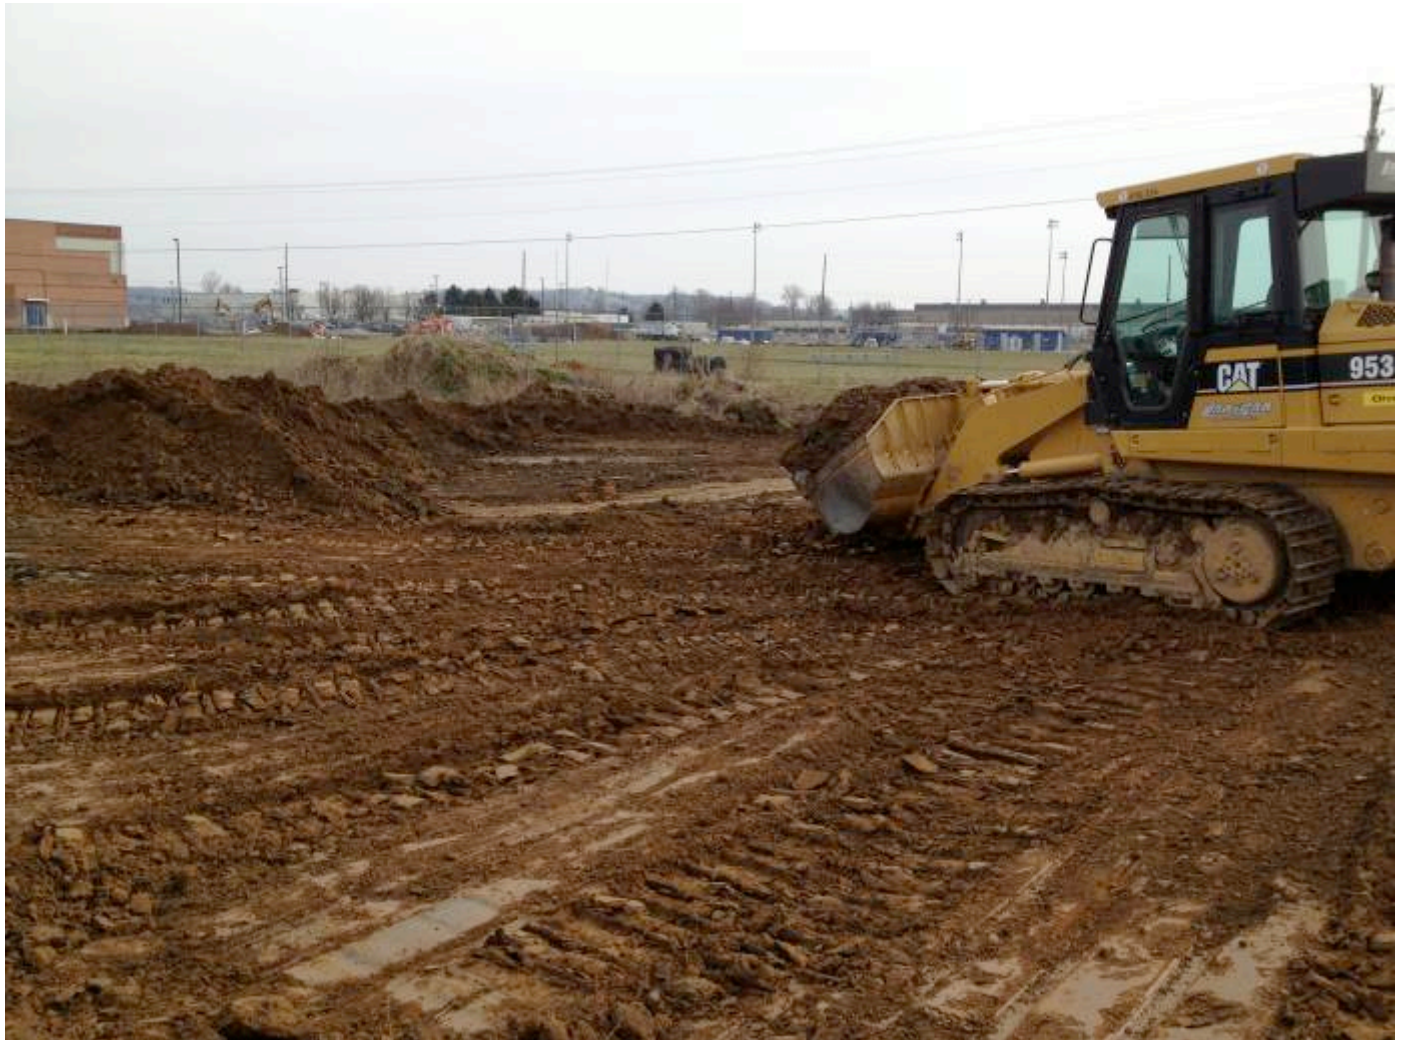
Photo 1: Excavation of Borrow Area via Caterpillar 953 Highlift Loader

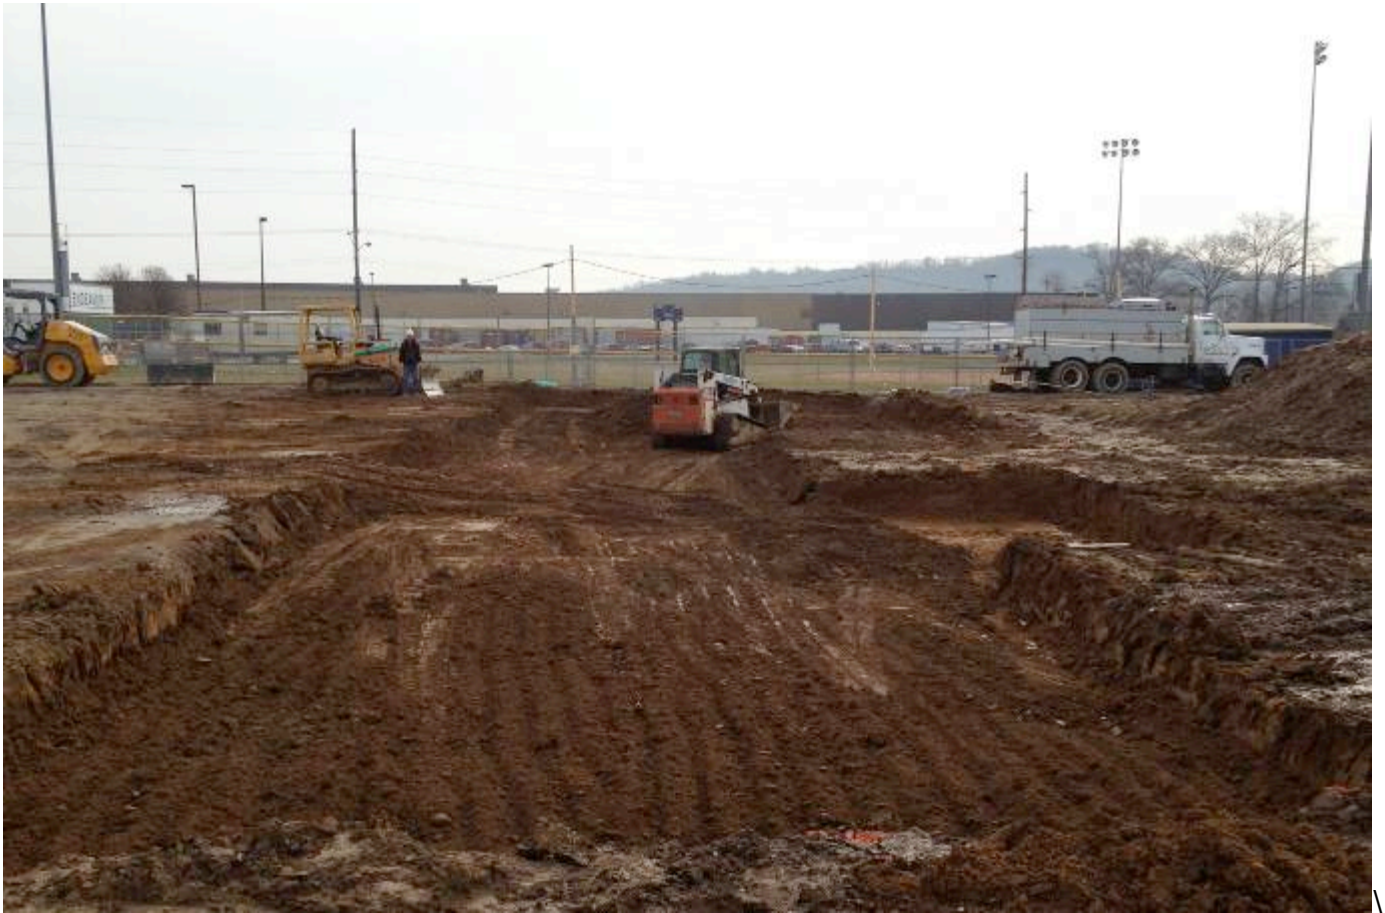
Photo 2: Fill Area During Placement of First Lift

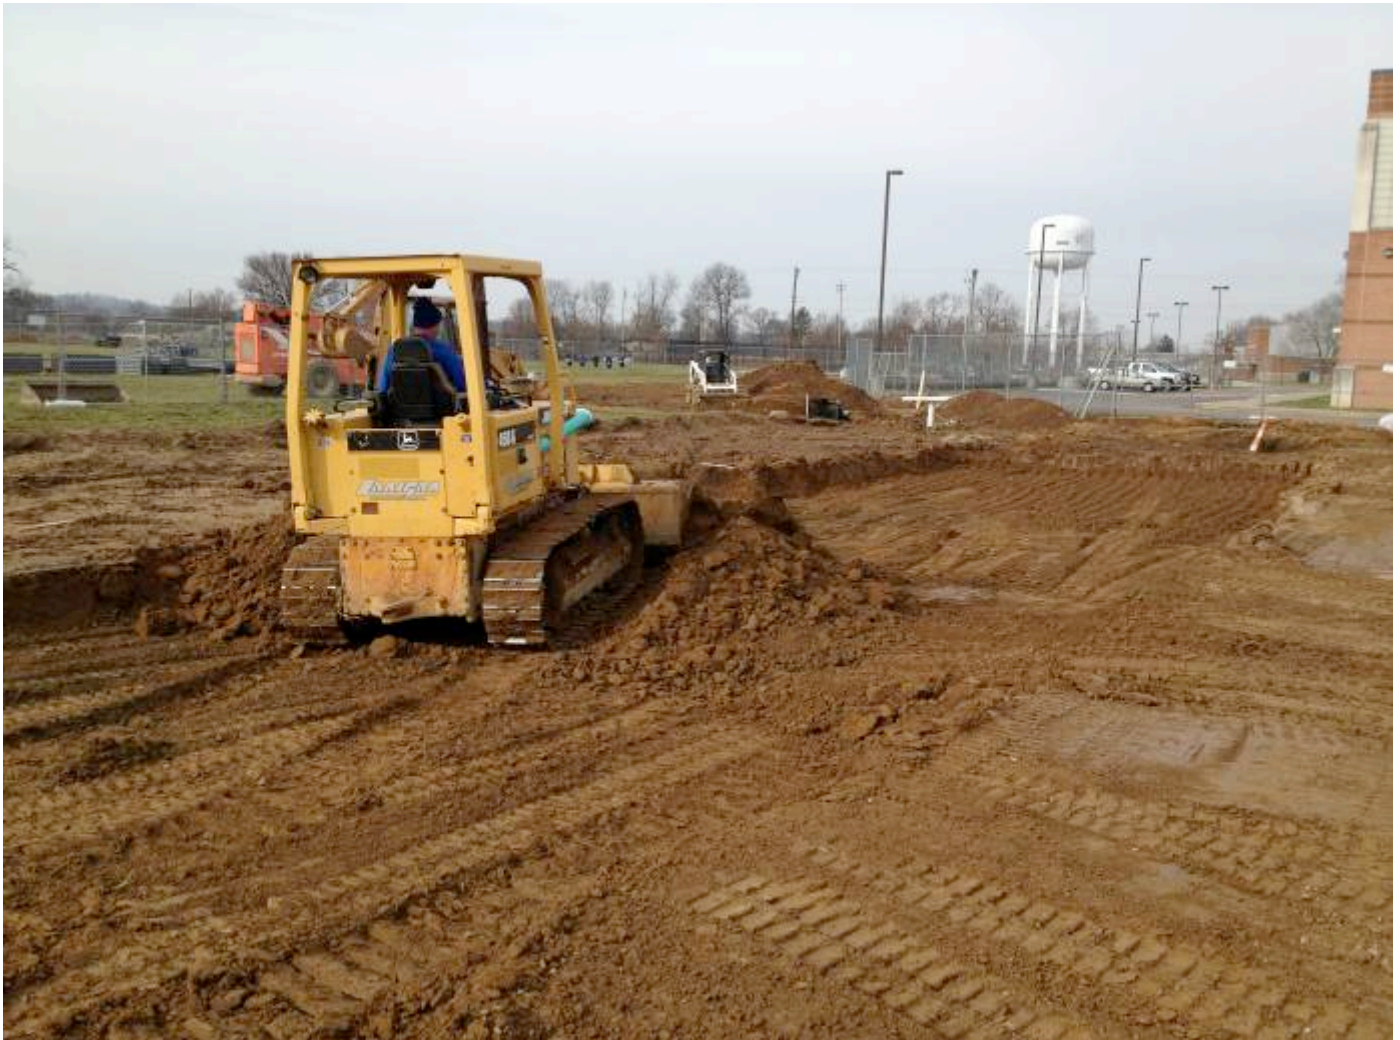
Photo 3: Material Spread via Deere 450G Bulldozer

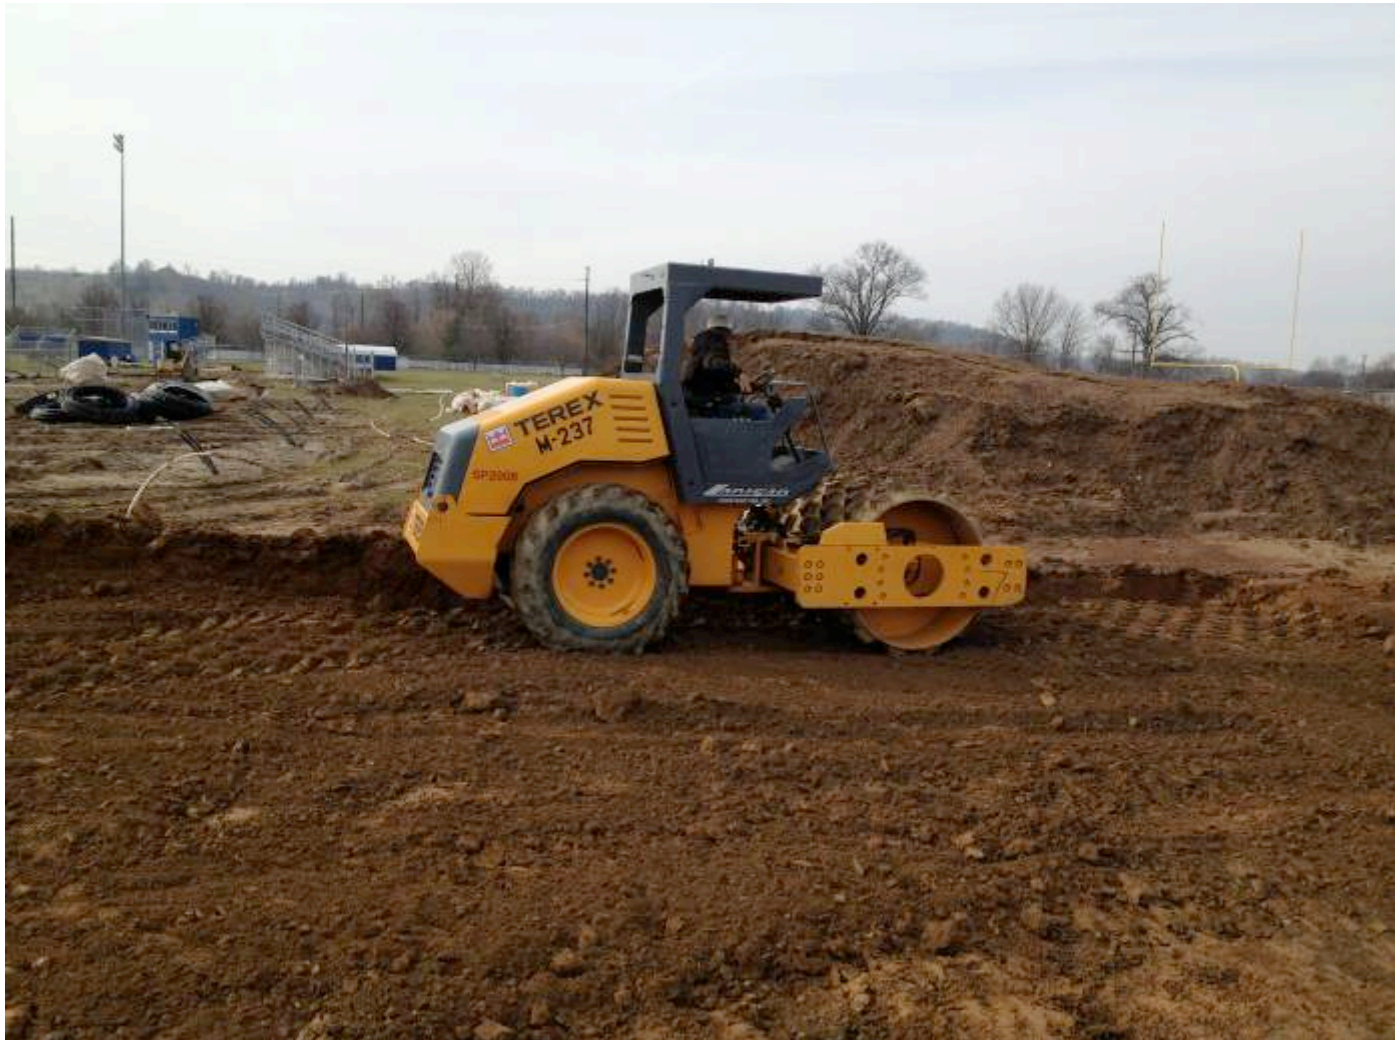
Photo 4: Compactive Effort Applied via Terex M-237 Vibratory Sheepfoot Drum Roller
Vibrations only applied to lifts 3 and 4

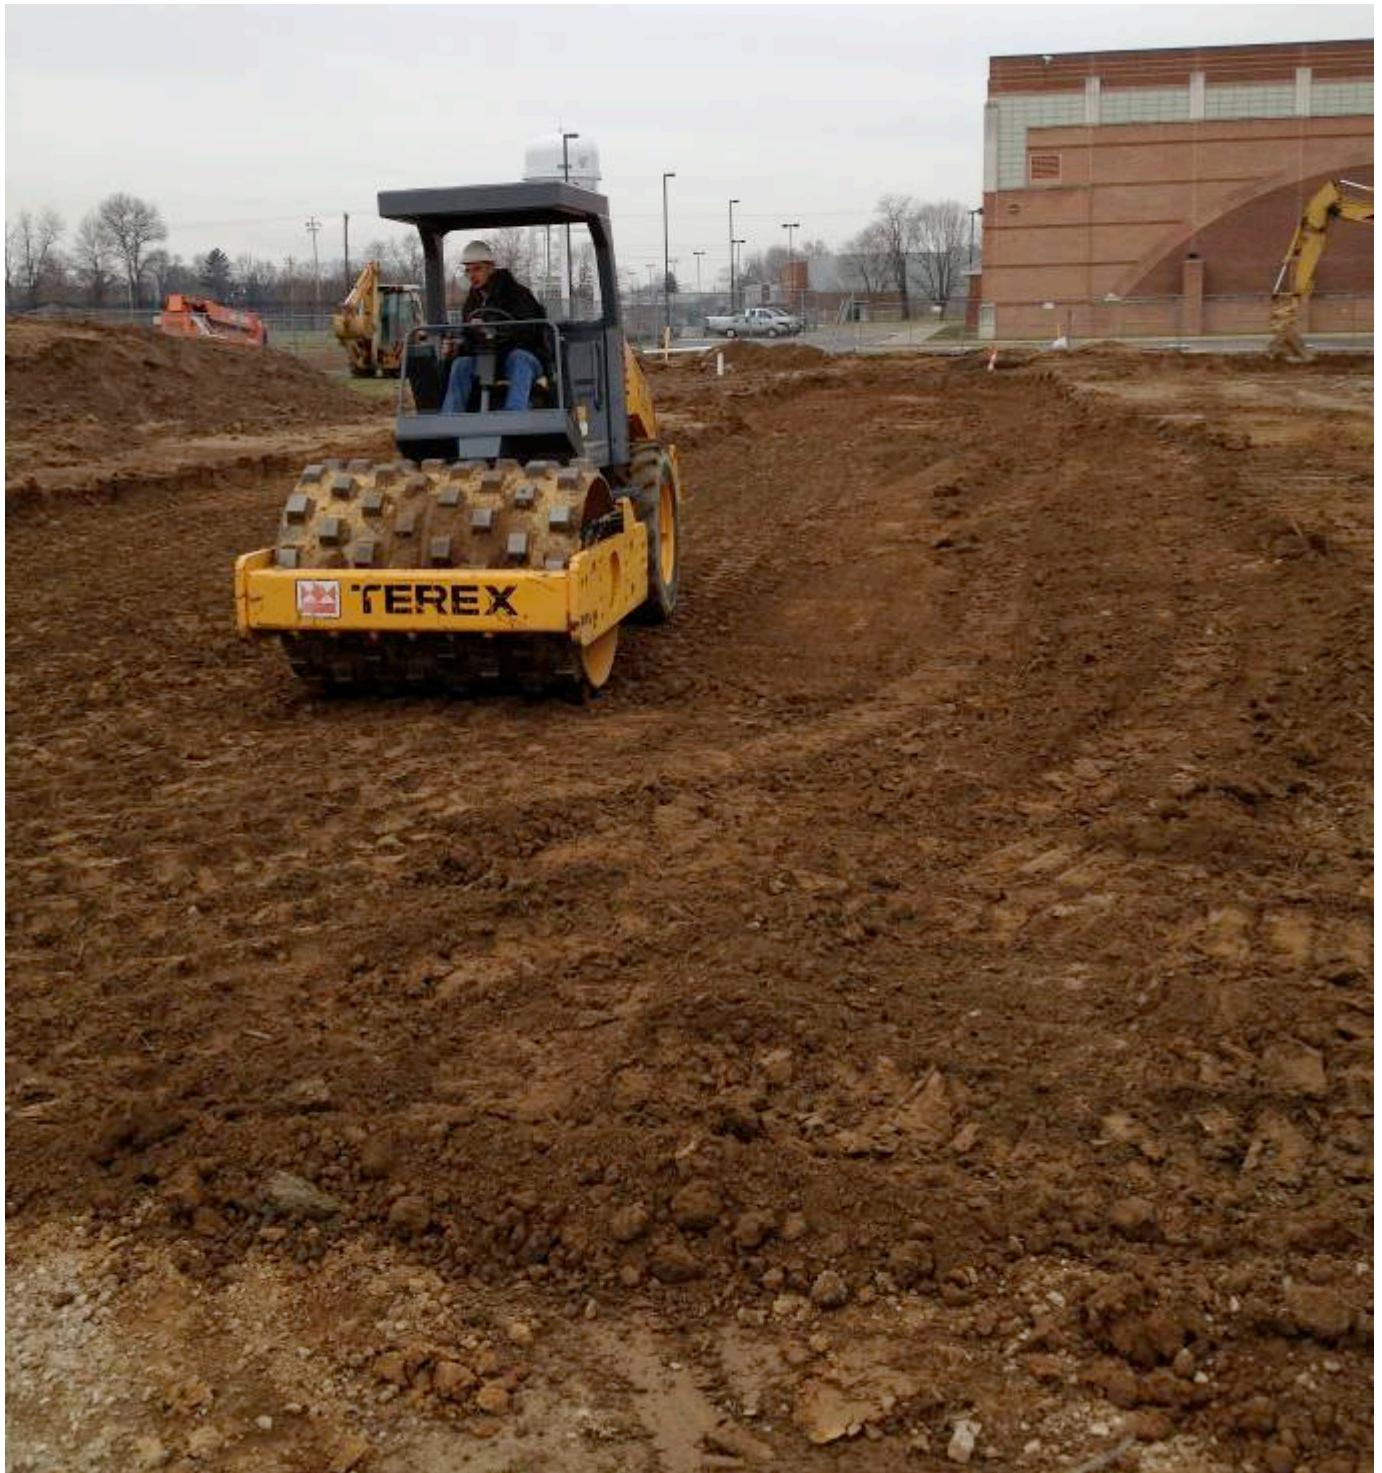
Photo 5: Compactive Effort Applied via Terex M-237 Vibratory Sheepsfoot Drum Roller
