PROJECT:	Gallatin County High School Field House	JOB NUMBER:	2228
CLIENT:	Gallatin County Board of Education	WEATHER:	Sunny, 40s
CSI PROFESSIONAL:	Daniel Huffaker, S.I., C.E.T.	DATE:	Monday 26 February 2013

KBC Special Inspections - Summary of Observations

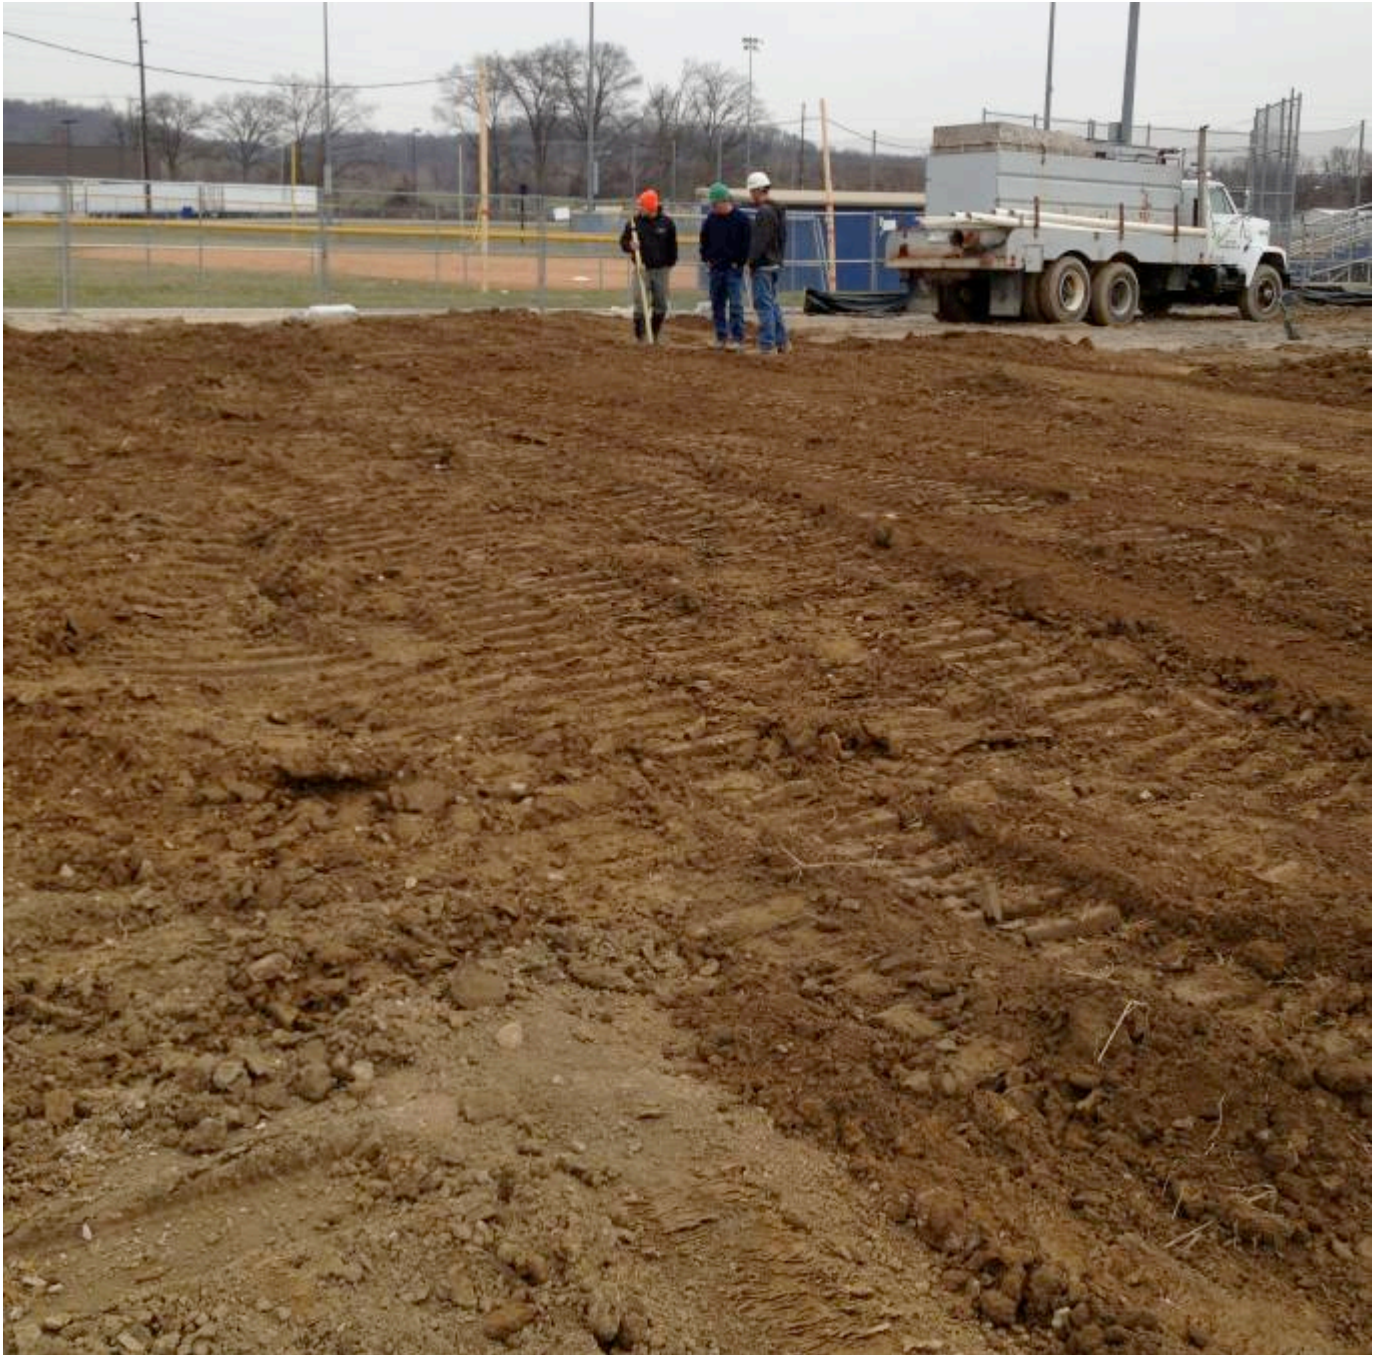
Photo 6: Verification of Grade on Lift 4

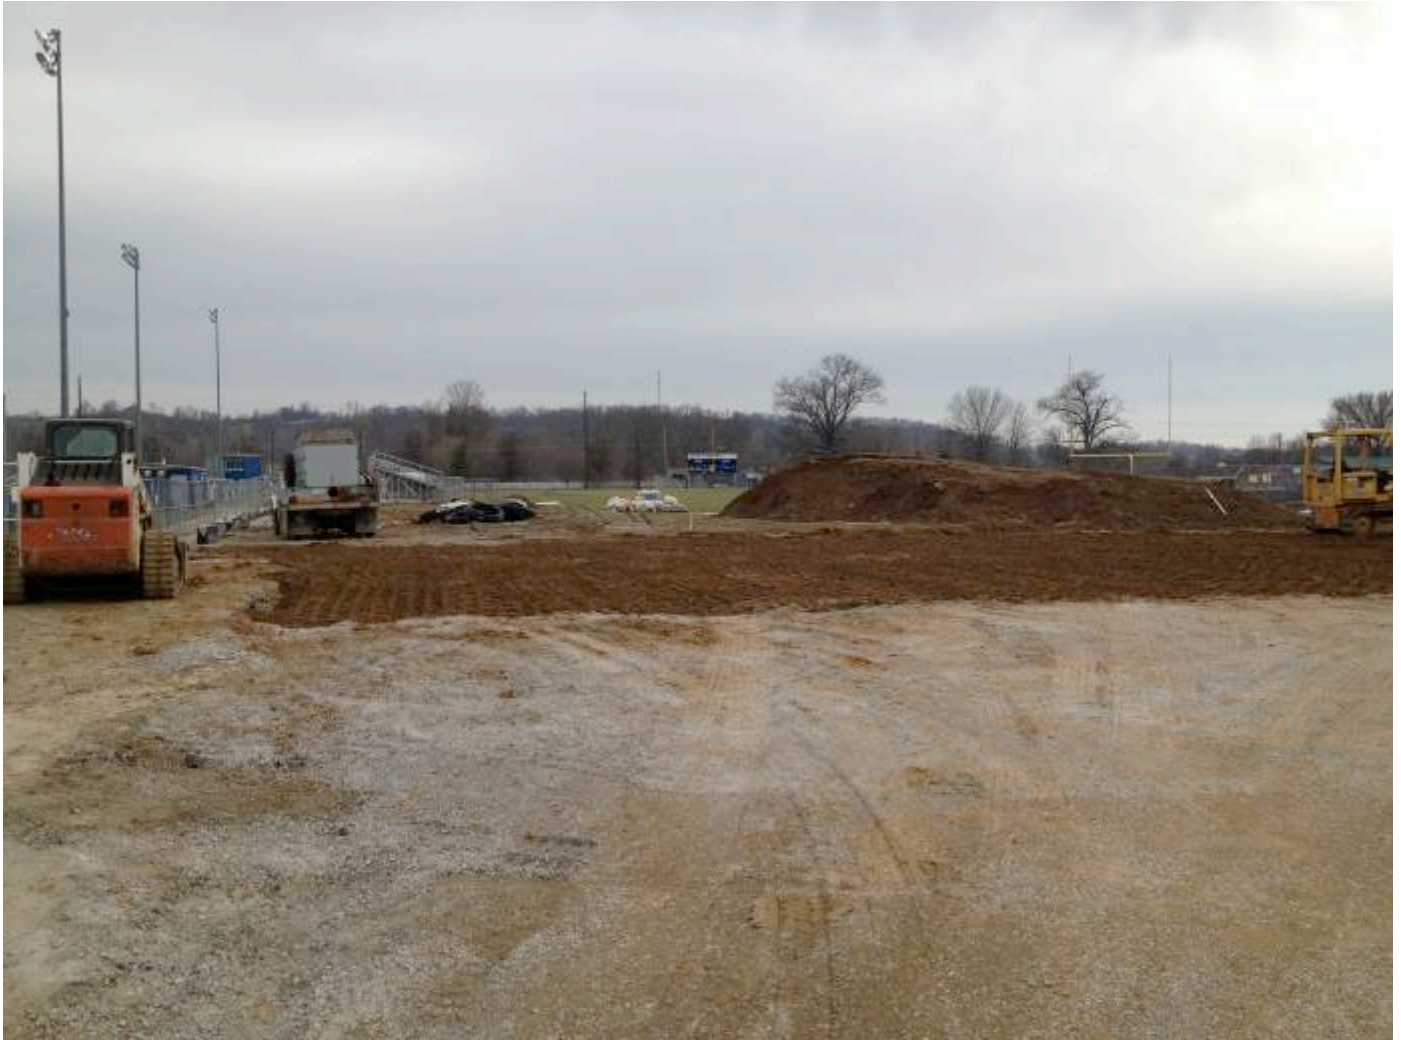
Photo 7: Grade at End of Day
