April 25, 2013

RE: Gallatin County Alternative School & Field House  
Gallatin County, Kentucky  
BG 12-133  
RTA 0914

Field observations were made Wednesday April 25<sup>th</sup> as noted below. Weather was partly cloudy and in the low 60's.

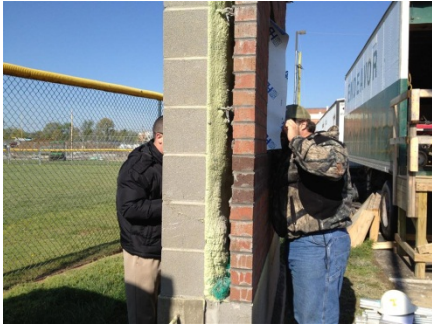
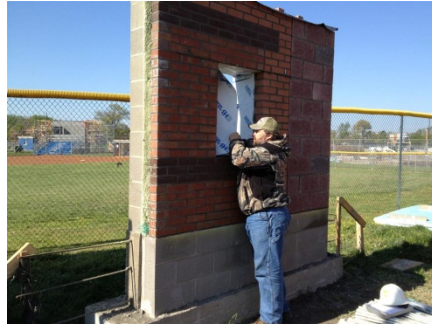
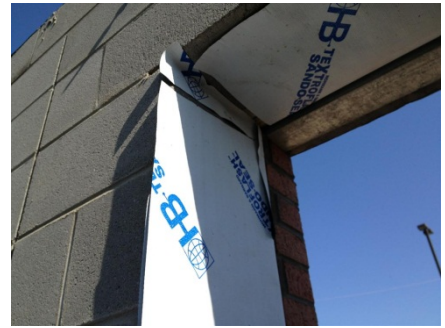
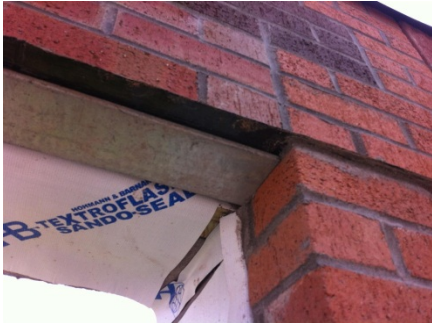
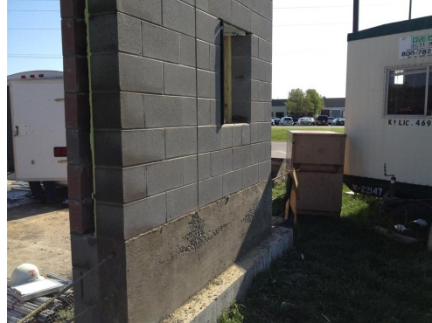
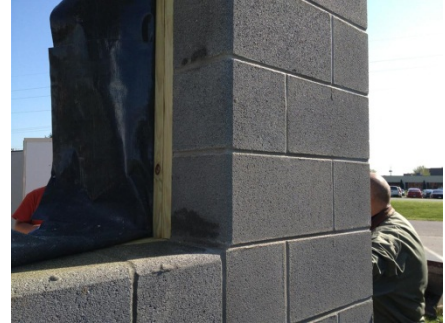
1. Mock Up Wall construction is in progress and the following was noted.
  - a) Final comments will be made upon completion.
  - b) Mock up wall appeared to be correct size and masonry pattern.

- c) Masonry cleaning and sealing was not complete.
  - d) Window was not installed.
  - e) Flashing at window and through wall locations were reviewed with installer.

- f) Weeps were installed in some location and no vents were present.
    - i) Vents and weeps are required at the bottom of the wall as well as above openings in an alternating pattern.

- ii) Vents are required at the top of the wall and below window openings.
  - g) Wood blocking was discussed.
    - i) Designed detail has 5/4" and 2x6 on all sides of openings.

- ii) It is acceptable to install 5/4" and 2x6 at the head and (2) 2x4 at the jambs and sills at masonry openings.
  - h) Steel angle lintel appears to have been installed with the short leg on the horizontal. S3.1 Veneer Lintel Schedule shows 5x3 1/2x1/4 to be installed long leg horizontal. There are no known openings where this applies in the project except for the mock up wall.

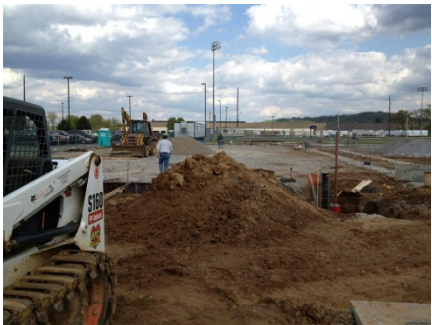
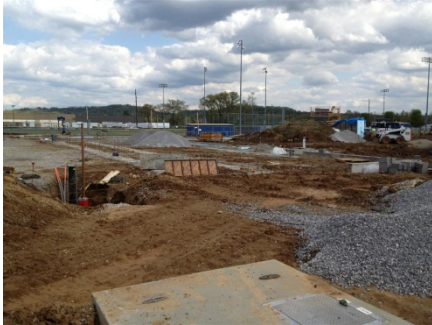
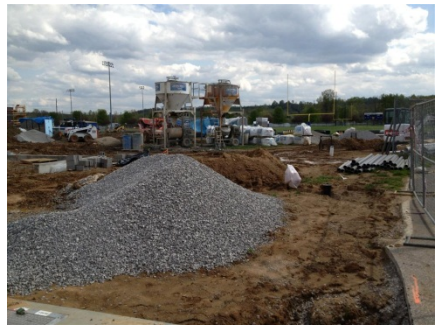
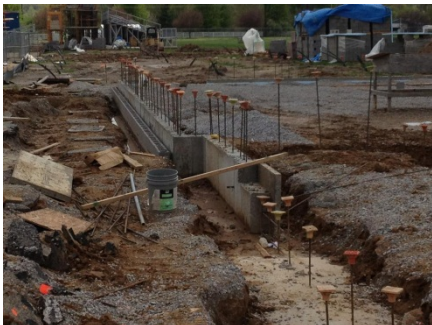
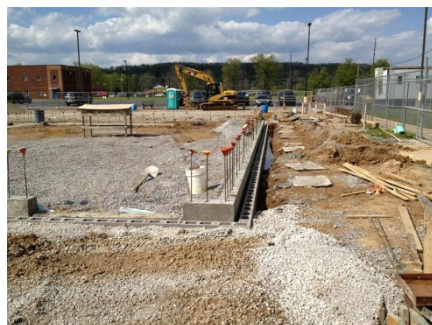
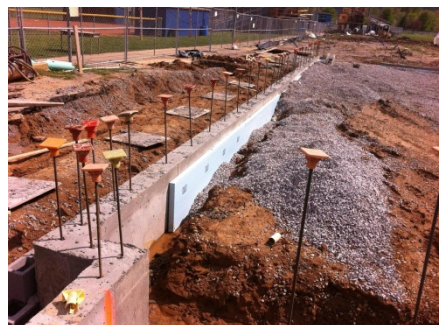
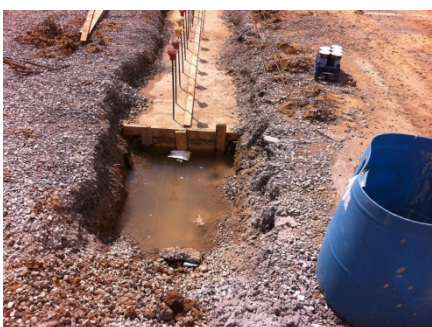
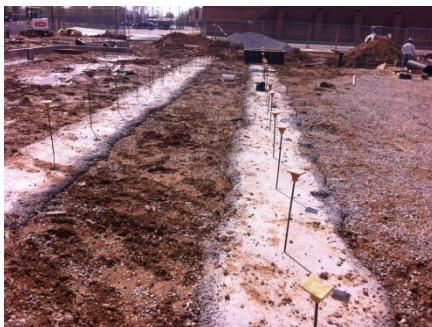
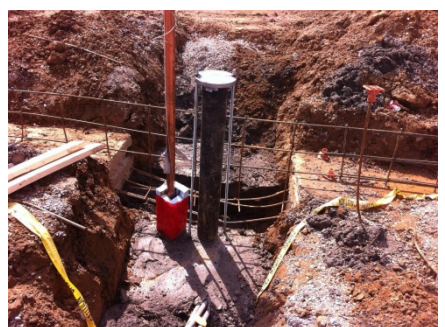
2. Exterior footing installation, under-slab trenching, dropped footing and gravel sub-base at the Alternative School / Field House is ongoing.

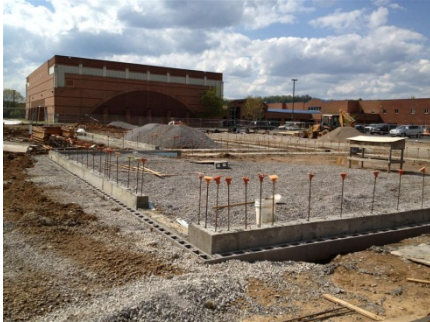
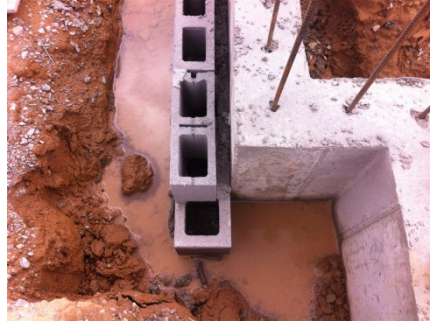
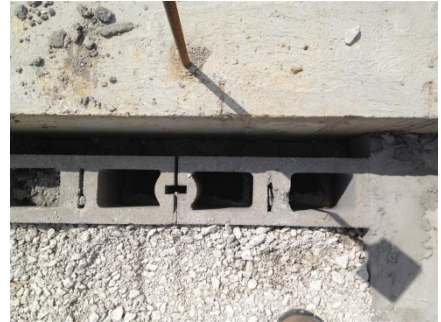
3. CMU has been installed at the exterior wall footing in several areas at the Alternative School/Field House building
- a) At a recent Progress Meeting, it was agreed that the 4" CMU below grade shown in detail 4/S2.1 could be installed as 6" CMU instead.
  - b) It was observed in the field that several areas of installed CMU at the exterior walls were 6" CMU stacked on 8" CMU.
  - c) Masonry contractor stated that some areas installed were 6" CMU stacked on 6" CMU.
  - d) It was agreed that the existing installation of 6" CMU stacked on 8" CMU is acceptable provided:
    - i) All remaining exterior wall CMU below grade is to be 6".
    - ii) All installed CMU are grouted fully and area between CMU and concrete stem wall are grouted full per the detail.

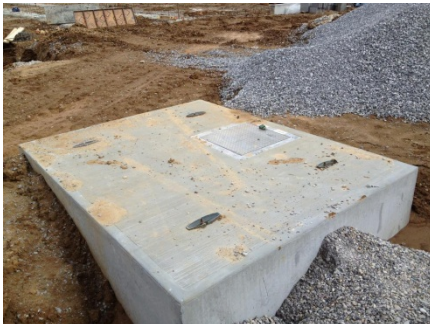
4. Water / Fire Service Vault has been installed.

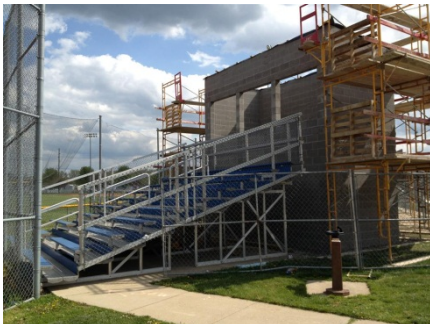
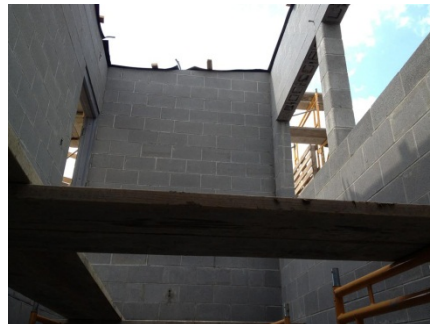
5. CMU wall construction and electrical rough-in at Softball Press Box is ongoing.

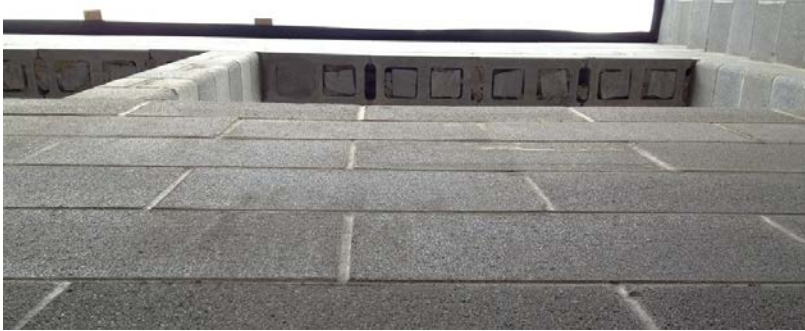
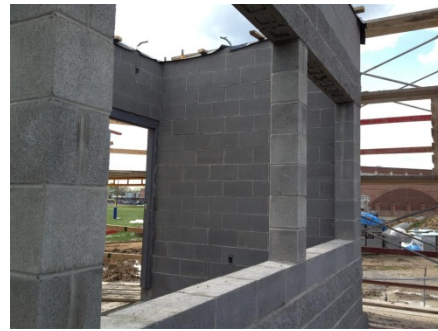
6. Open bottom of split-face CMU was observed where bond beams were expected at the Soft Ball Press Box.
- a) Further conversation has found that CSI observed the installation. SDG is satisfied with the type of construction installed in lieu of a bond beam as documented. The quality of installation will likely require additional construction and instruction is forthcoming.

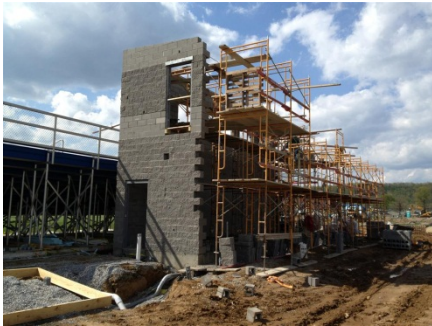
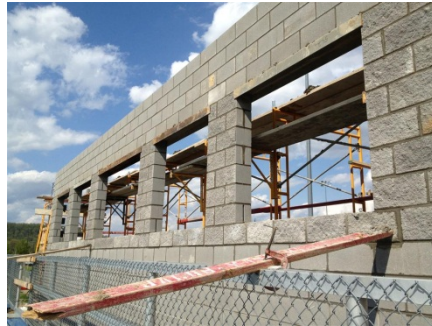
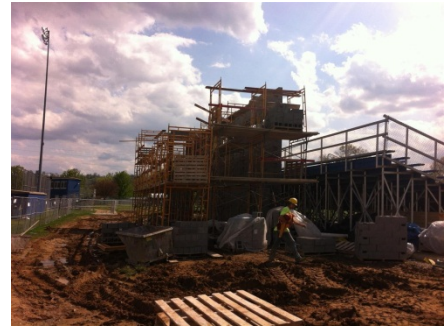
7. CMU wall construction and electrical rough-in at Football Press Box is ongoing.

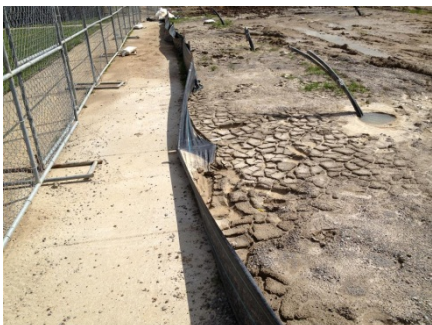
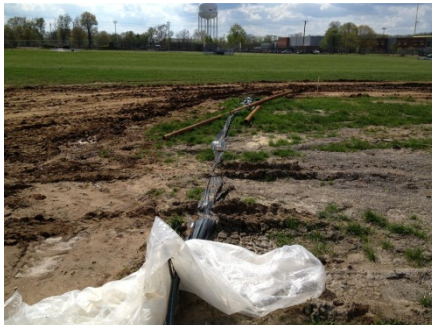
8. Silt fence was observed falling or damaged. Silt fences need to be repaired and maintained throughout construction as needed.

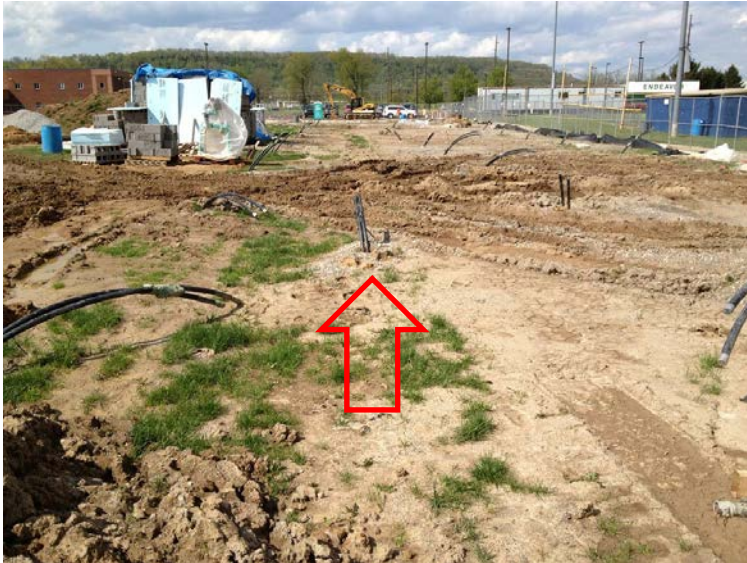
9. Geo-thermal well digging is complete.
- a) An additional well was observed. The Superintendent stated this was added in coordination with CMTA to maintain an equal length of piping run between the (3) rows when (1) well could not be drilled to full depth.
  - b) CMTA is researching the installation and may have additional instructions concerning the 31<sup>st</sup> well.
