May 23, 2013

RE: Gallatin County Alternative School & Field House  
Gallatin County, Kentucky  
BG 12-133  
RTA 0914

Field observations were made Thursday May 23<sup>rd</sup> as noted below. Weather was partly cloudy and in the upper 70's.

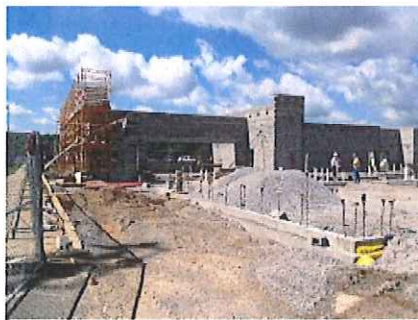
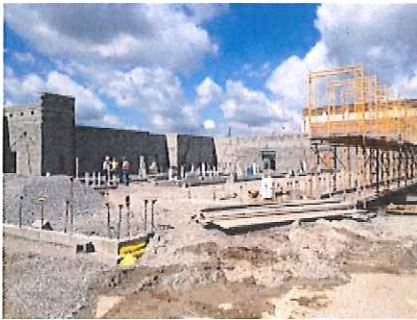
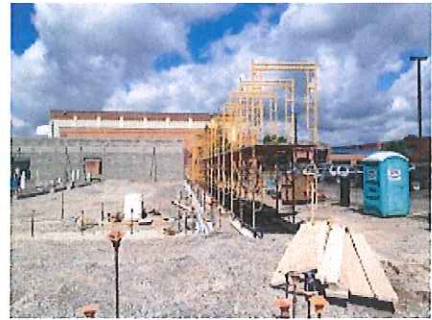
1. Field House masonry is underway.

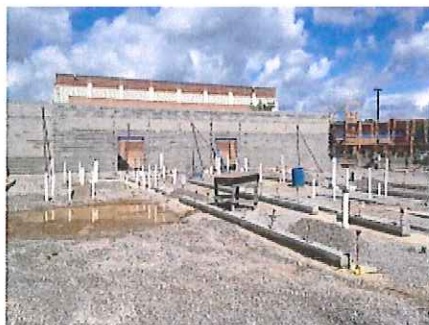
2. Field House below slab plumbing and electrical is being installed. Some electrical conduit is to be relocated to above ceiling per on site conversation with contractor and CMTA.

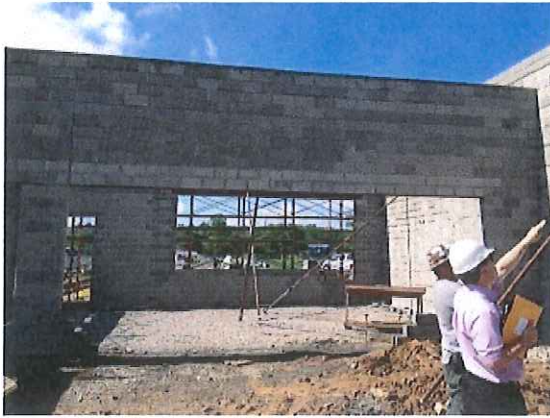
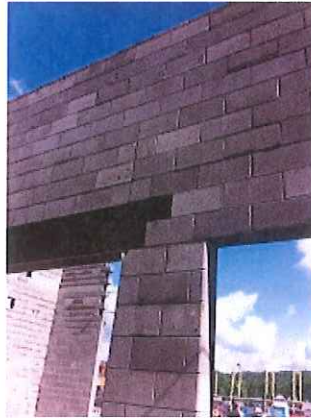
3. Masonry installation at beam between Cardio and Weight rooms was reviewed by mason and RTA on site. Installation was acceptable and no change is required at window head as installed.

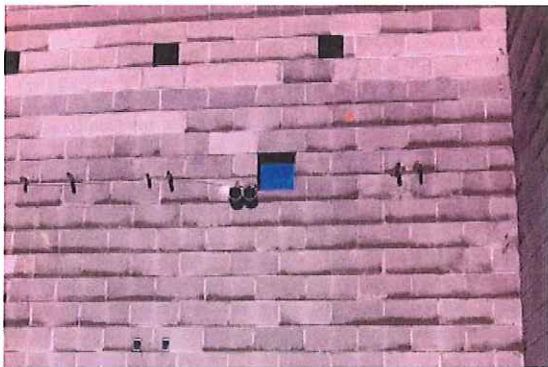
4. Openings in masonry walls for mechanical ducting were discussed at the Cardio room. Contractor is to verify elevation does not conflict with bond beams for upper and lower roof as well as finish ceiling heights. Preliminary indications in the field are that all items have been considered and installed correctly.

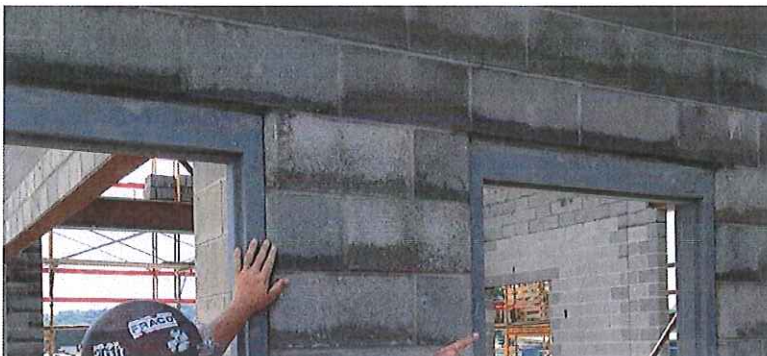
5. Masonry door heads were reviewed at Cardio and Weight room. Mortar joints were found excessive and future door frame installations are to be done more carefully. Contractor stated sealant installation would minimize visual impact of wide mortar joint. No new action is required at this time.

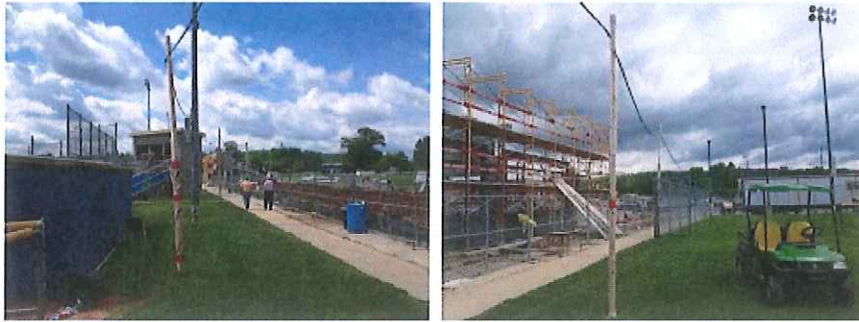
6. Overhead temporary electrical lines and poles have been relocated.

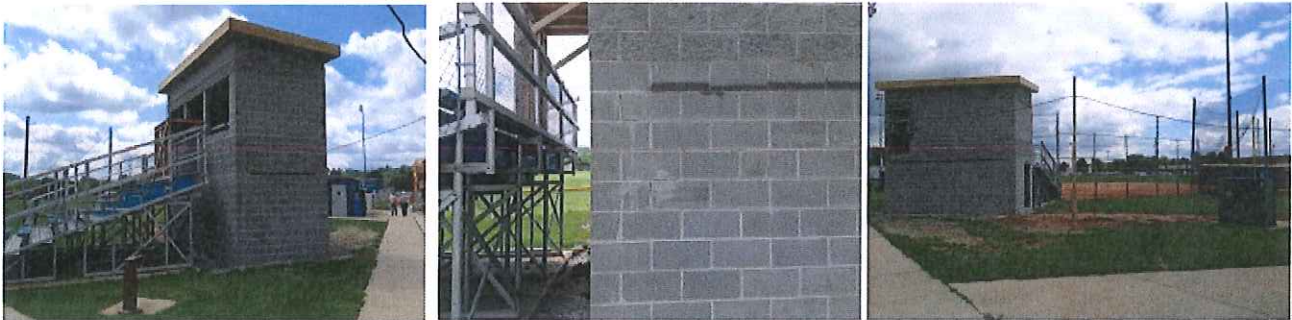
7. Softball press box masonry and wood framing is complete. Block fill and painting are to begin shortly. Grout or mortar was observed on the face of the CMU. Care is to be taken with cleaning CMU and block fill placement to insure excess grout or mortar does not telegraph through the finish paint.

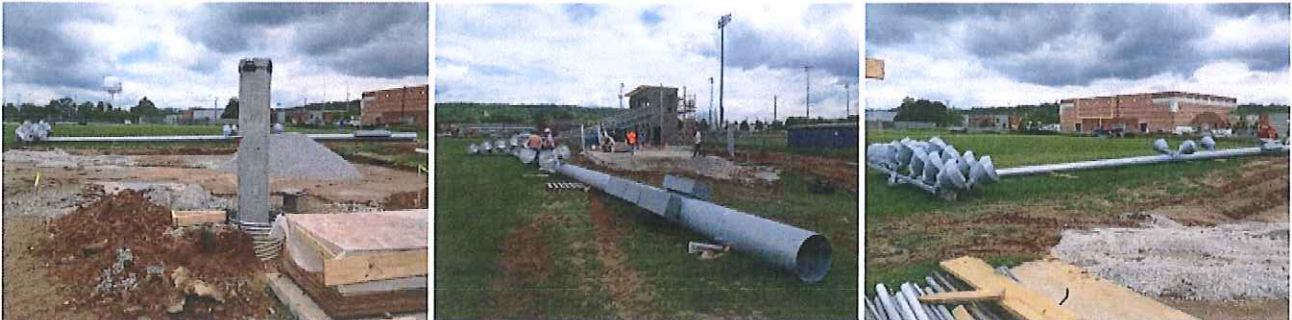
8. Football light pole bases are installed and light poles with fixtures are stored on site.

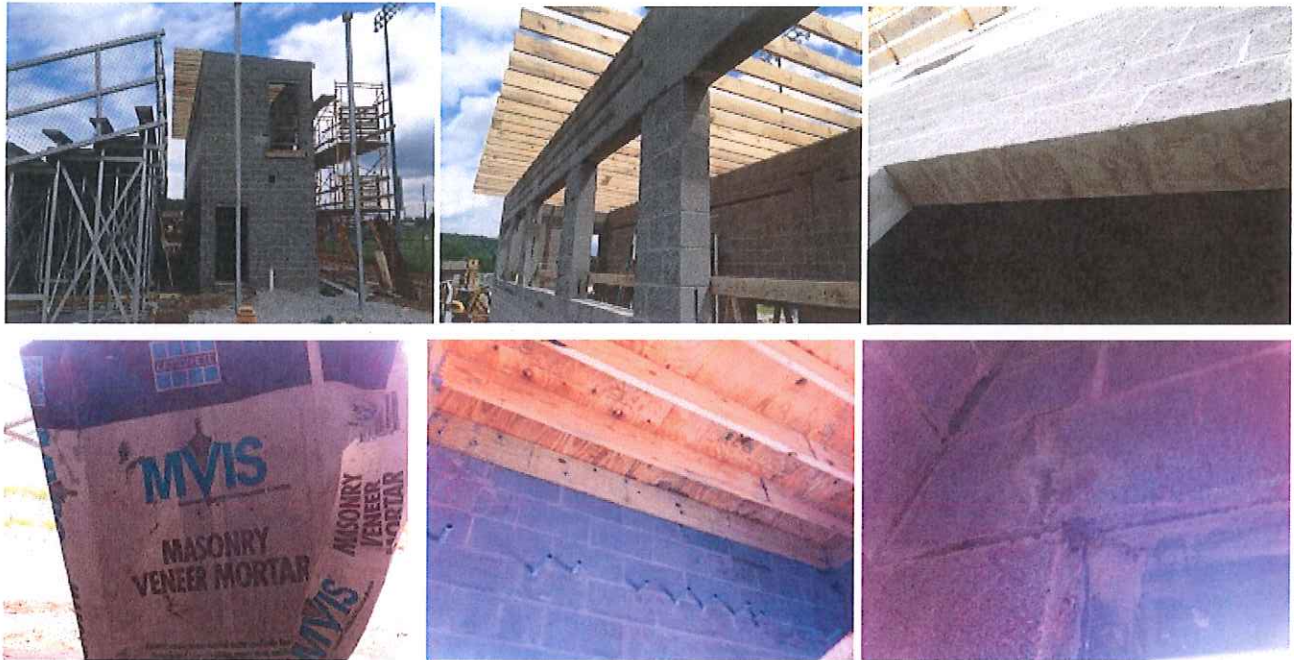
9. Football Press Box Masonry installation and cleaning is complete. Wood floor and roof framing is under way. Masonry infill was in place at split-face window headers. Finish is to be relatively smooth and match adjacent surface before receiving paint. Broken CMU was observed at interior Concessions door head which has been patched. Surface is to be relatively smooth and match adjacent surfaces before receiving paint.

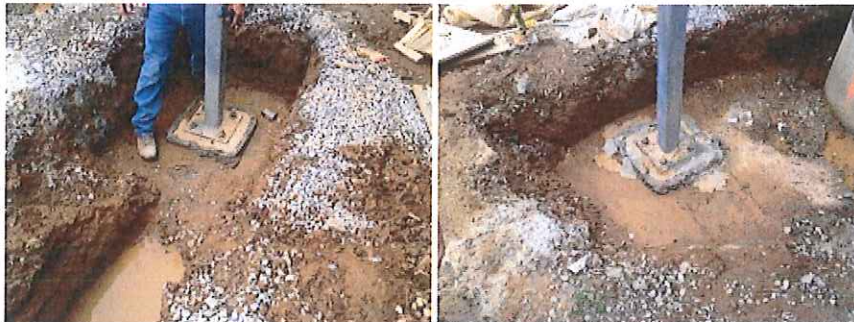
10. Football Press Box column bases and columns have been installed. Additional testing of the footings may be required. Surface hardness of top of footing was demonstrated by multiple hammer strikes.

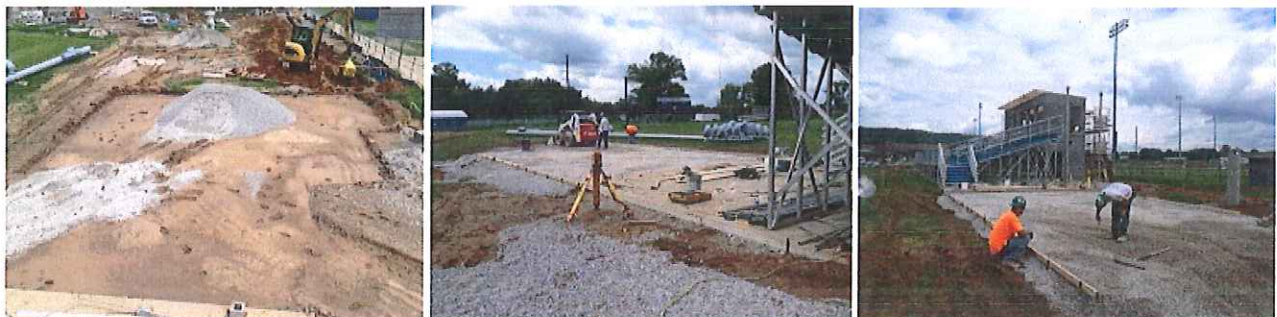
11. Concrete Bleacher pad sub grade is being prepared for concrete pour.

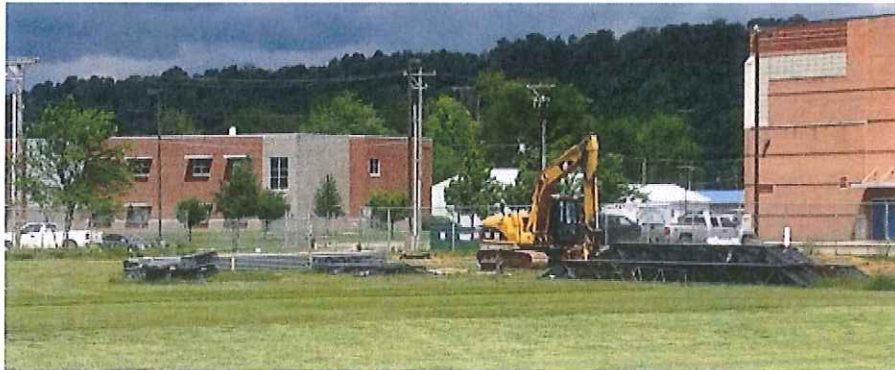
12. Steel joists and decking are being stored on site.

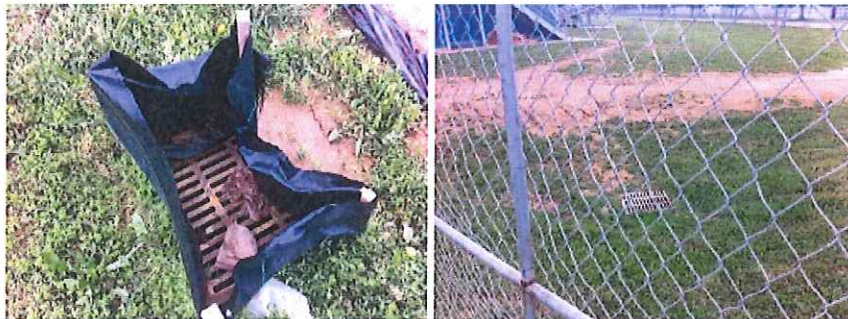
13. Drywell inlets were observed at the south east corner of the site near the existing baseball press box. One inlet is protected, but the silt fence is failing and debris is present. The other inlet is not protected. Additional silt fencing shown on drawings SWPPP was not present. Construction entrance with tire wash is also not present. This is shown on drawing SWPPP and the flexible location was addressed in Addendum #1. If it is acceptable to the owner and the tire wash is not to be installed, further discussion is required regarding credit to the owner.
