MEMORANDUM

GOP Limited
Structural Engineers

DATE <u>March 9, 2015</u>	_____ PHONE _____
CLIENT <u>NKCES Coldspring Facility</u>	_____ MEETING _____
TO <u>Mr. Curtis Hall</u>	xxx _____ FIELD REPORT _____
FROM <u>Doug Crawford</u>	xxx _____ MESSAGE _____
PROJECT NO. _____	_____ RESPONSE REQUESTED _____
PROJECT NAME <u>1929 Building</u>

SUBJECT Parapet Failure

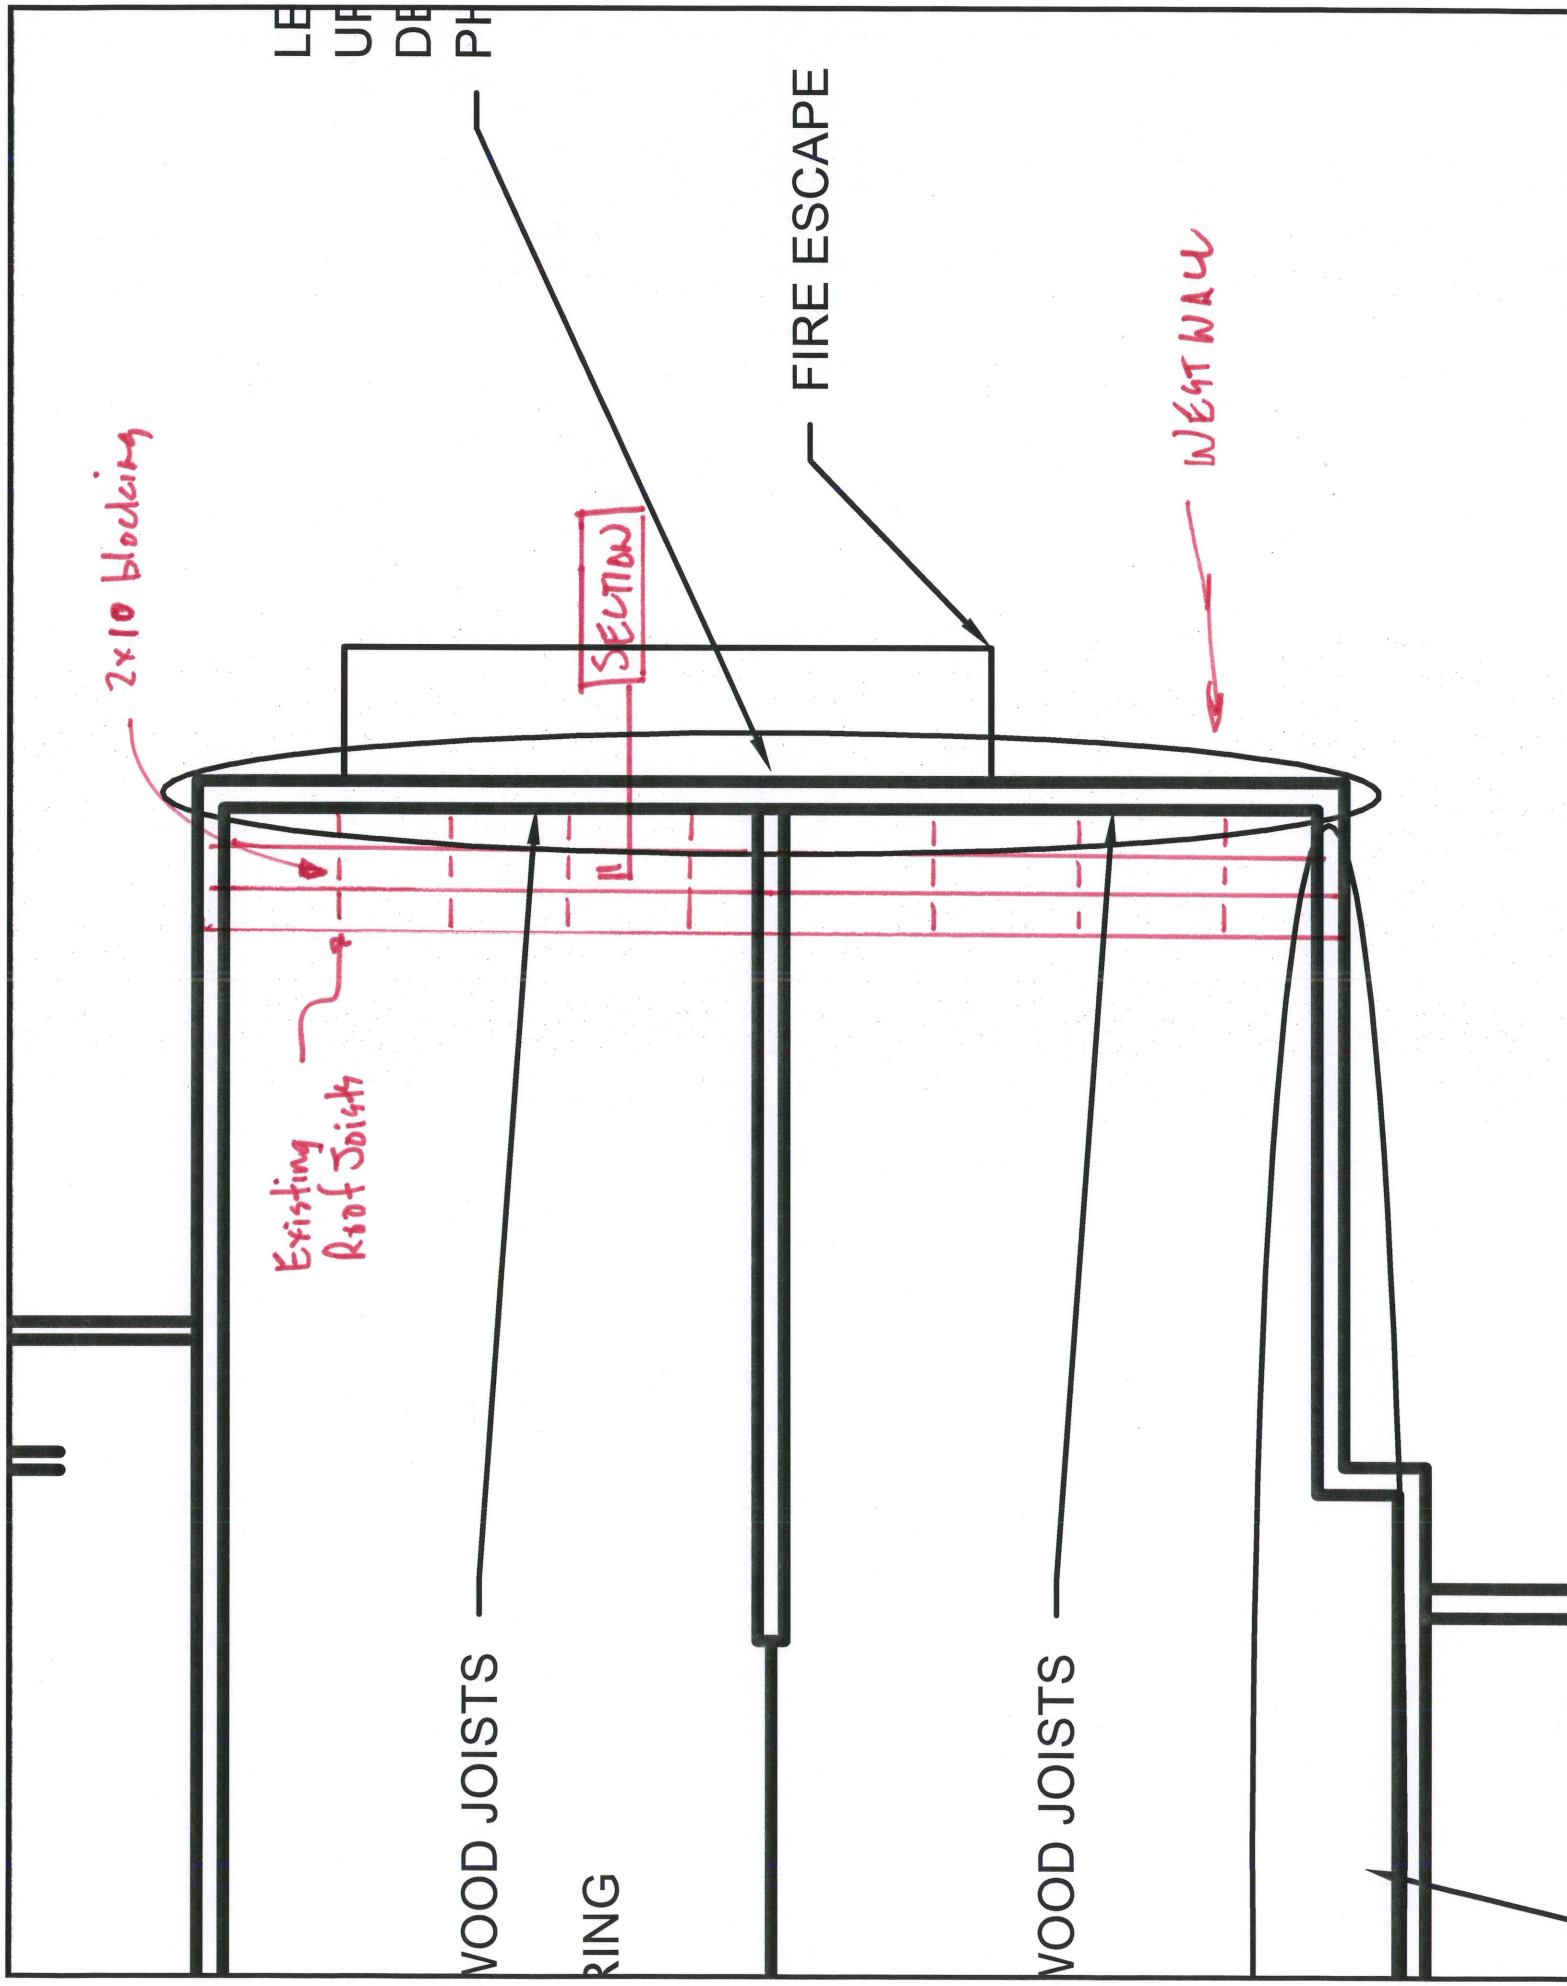
1929 BUILDING:

Observing from the roof top, I observed the cap flashing along two-thirds of the west wall and up to the northwest corner was pulled off the top of the wall. It was not apparent what caused this condition, but because of it, nearly a dozen brick were broken from their mortar bed. You and I promptly removed all the loose brick at the corner and checked the remaining length of wall for additional loose brick and re-attached the metal cap flashing. A connection to the wall could not be made this date, but it was snugly replaced on the top of wall.

Observing the remainder of the north and west wall revealed significant deterioration of window lintels and rolling and bulging brick. The poor conditions began at the upper level window lintels that were significantly rusted and were expanding enough to push the brick up and created a rolling affect to the top of the wall. This occurred for most of the length of the west wall and also along the north wall. The roof slopes down from north to south, creating a nearly three foot high parapet at the south wall of the building. This parapet was leaning toward the roof and moved slightly when pulled on by hand. Additional brick were loose in this corner as well and some separation and cracking was occurring on the inside corner below the roof.

In November 2014, I had observed the facility for the purpose of preparing a due diligence condition report. I had noted at that time the condition of this wall and had taken several pictures. Upon leaving the site on this date, I reviewed these older pictures and compared to the current conditions. Based on this review, I have determined that significant movement has occurred in some portions of the wall since November. Therefore, I have am directing you to get this portion of parapet wall removed as soon as is possible. If removal is not an option in the next few weeks, bracing the parapet by means as detailed on the attached sketch is required. If the parapet is removed, temporary roofing will be required to maintain water tightness until permanent repair can be accomplished.

The work options described above are a temporary fix-only, until a permanent repair can be accomplished later in the spring. The maximum time allowed before permanent repairs are required for the "braced" scheme is two to three months. When equipment is on site to remove or brace the west wall, up close review of the north wall upper lintels will be required to further determine the extents of repairs required on this wall.
