## **Hardin County Early College and Career Center**

### **Project Closeout Update**

October 7, 2015

Re: Hardin County Early College and Career Center  
SCB Project No. 1309

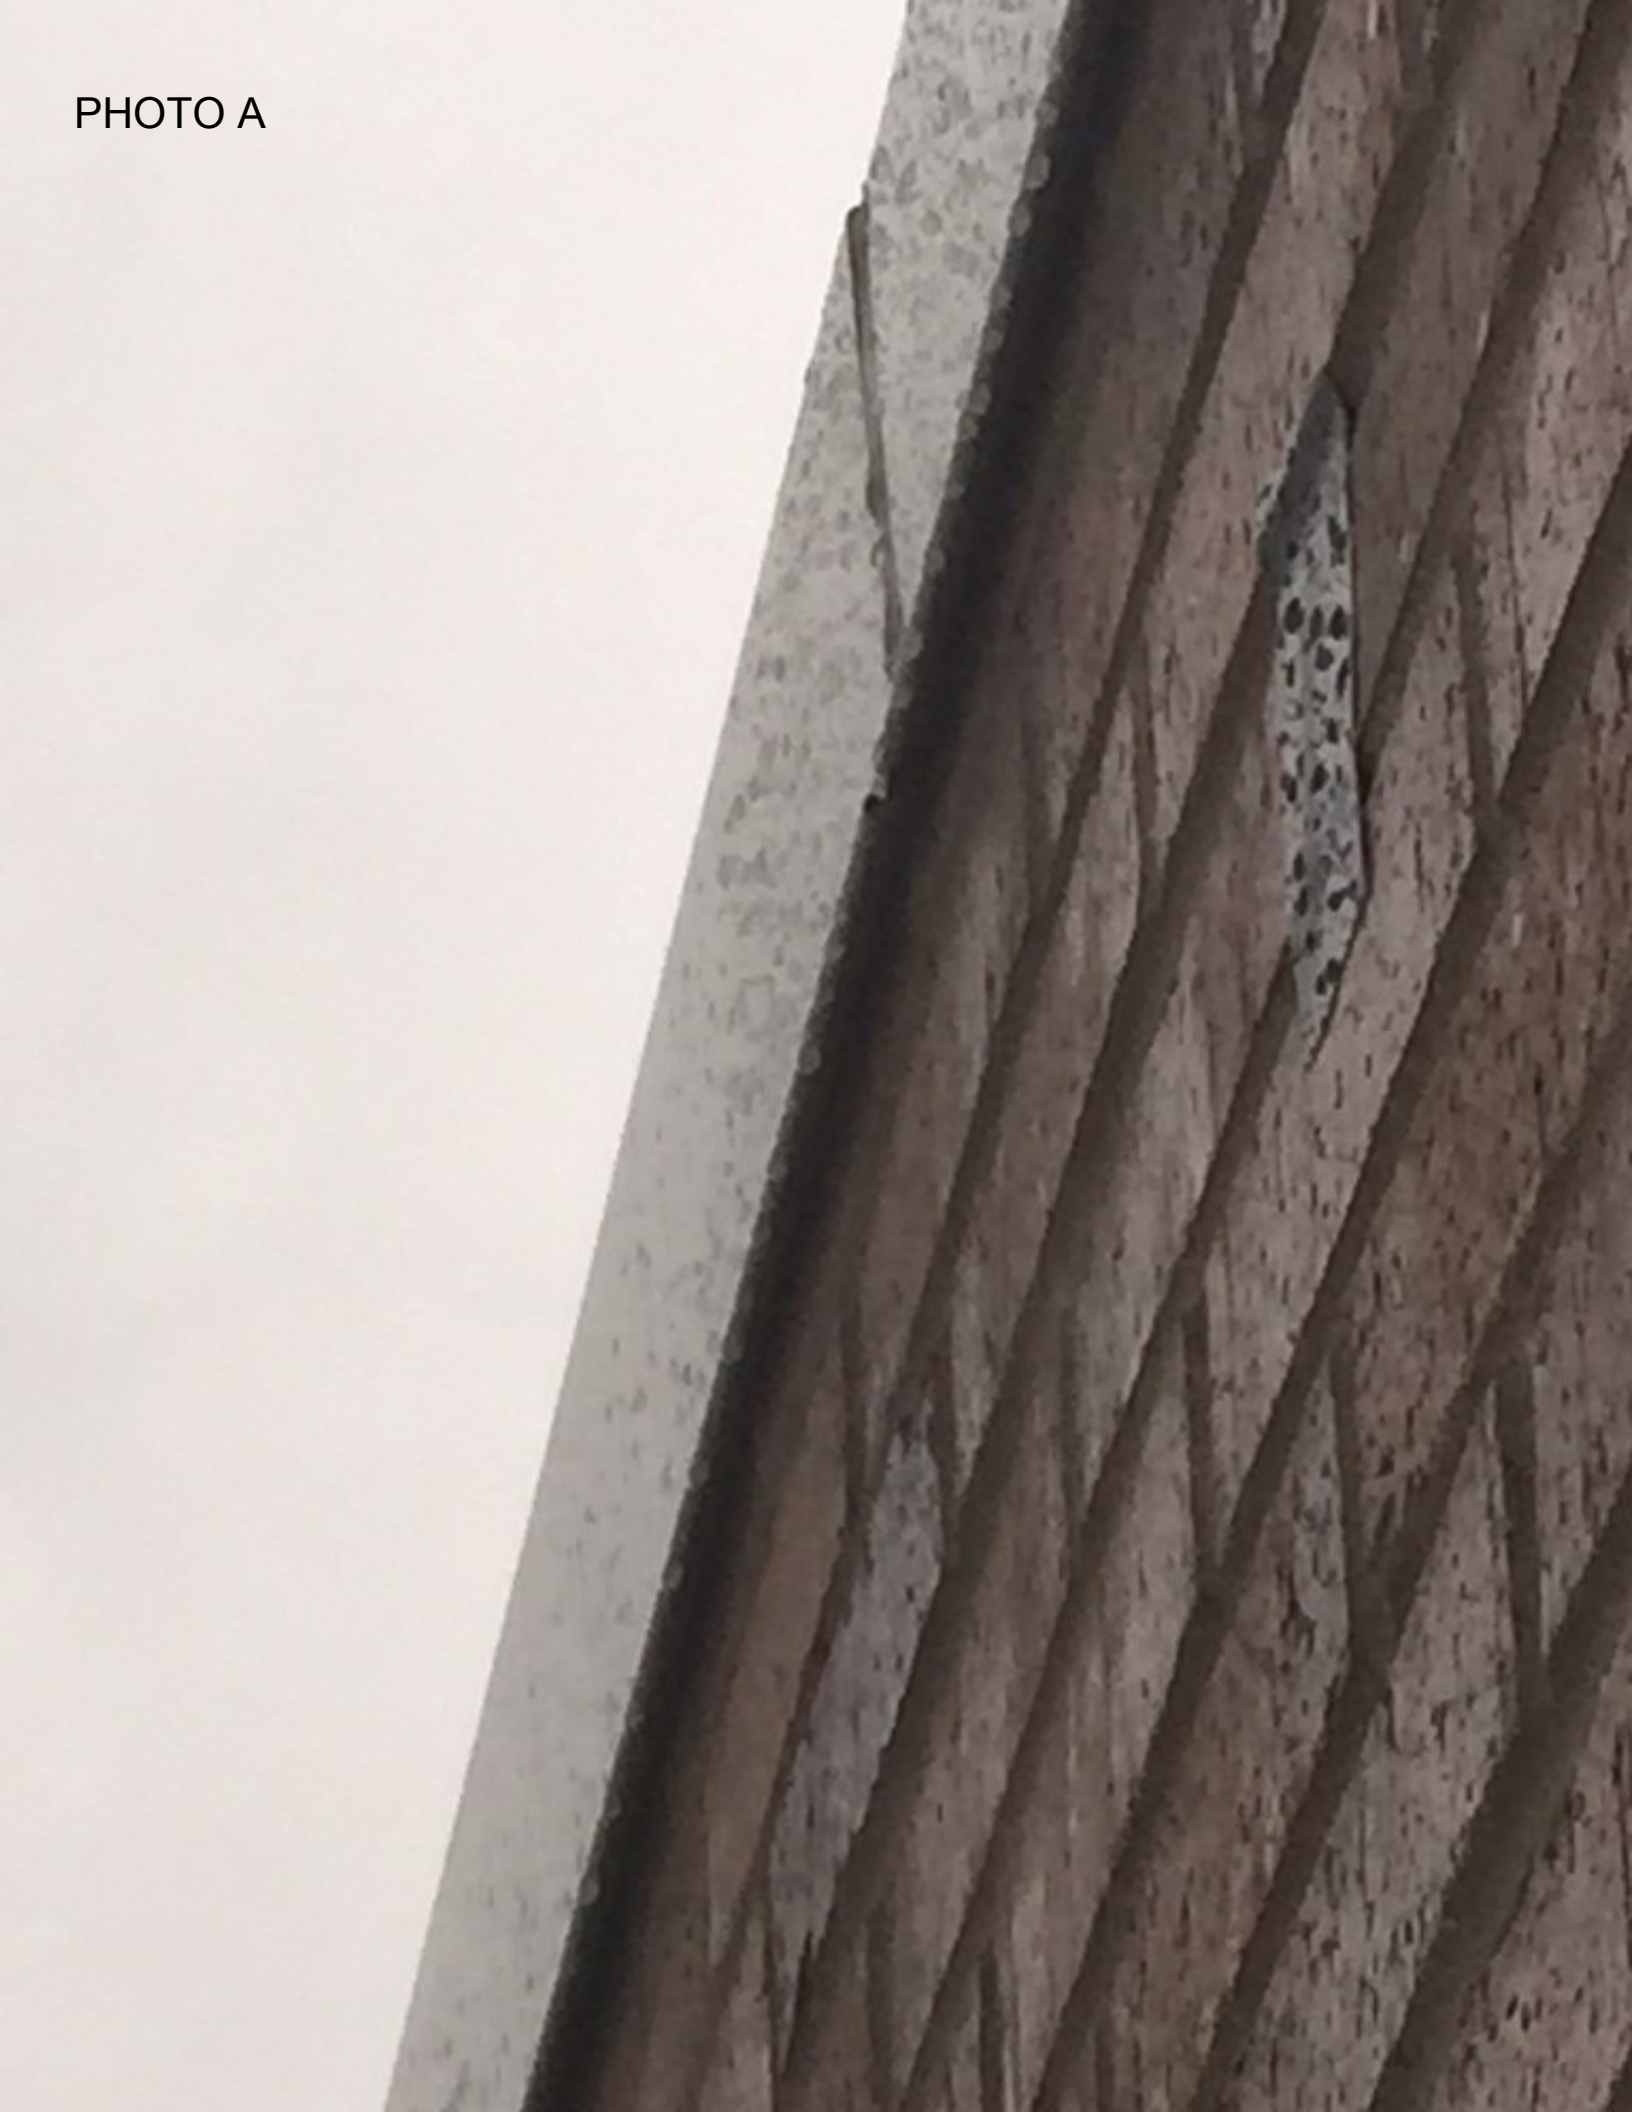
PHOTO A

1. The parapet coping does not fit the parapet thickness. A sizable gap is present at the brick side of the parapet wall that is large enough for wind driven rain that collects at the bottom of the drip edge to be driven up and under the parapet coping and into the cavity. Per Detail B/A1.5, this coping was to be installed on a galvanized metal cleat at each face of the parapet. It is unclear if the parapet cap was installed according to the detail (on metal cleat at each face). **See attached Photo A.**

- a. Remove the existing parapet cap and install a parapet cap that conforms to the wall thickness on a continuous galvanized metal cleat as detailed.
- b. Remove the existing reglet flashing and install thru wall metal flashing as detailed. The flashing shall extend a minimum of 4" up the face of the ICF and shall be lapped per SMACNA standards.
- c. Remove cavity vents (high and low) and re-install in wall and tuckpoint around each location to eliminate all gaps.

- a. Remove the existing parapet cap and install a parapet cap that conforms to the wall thickness on a continuous galvanized metal cleat as detailed.
- b. Remove existing cavity vents and weeps. Tuck point all voids in masonry wall.
- c. Provide membrane flashing as recommended by Tremco full height of masonry wall at all high wall to low roof conditions to maintain the roof warranty. Provide manufacturer's standard lap detail at membrane flashing below and extend new membrane flashing up and over full width of parapet under parapet coping.

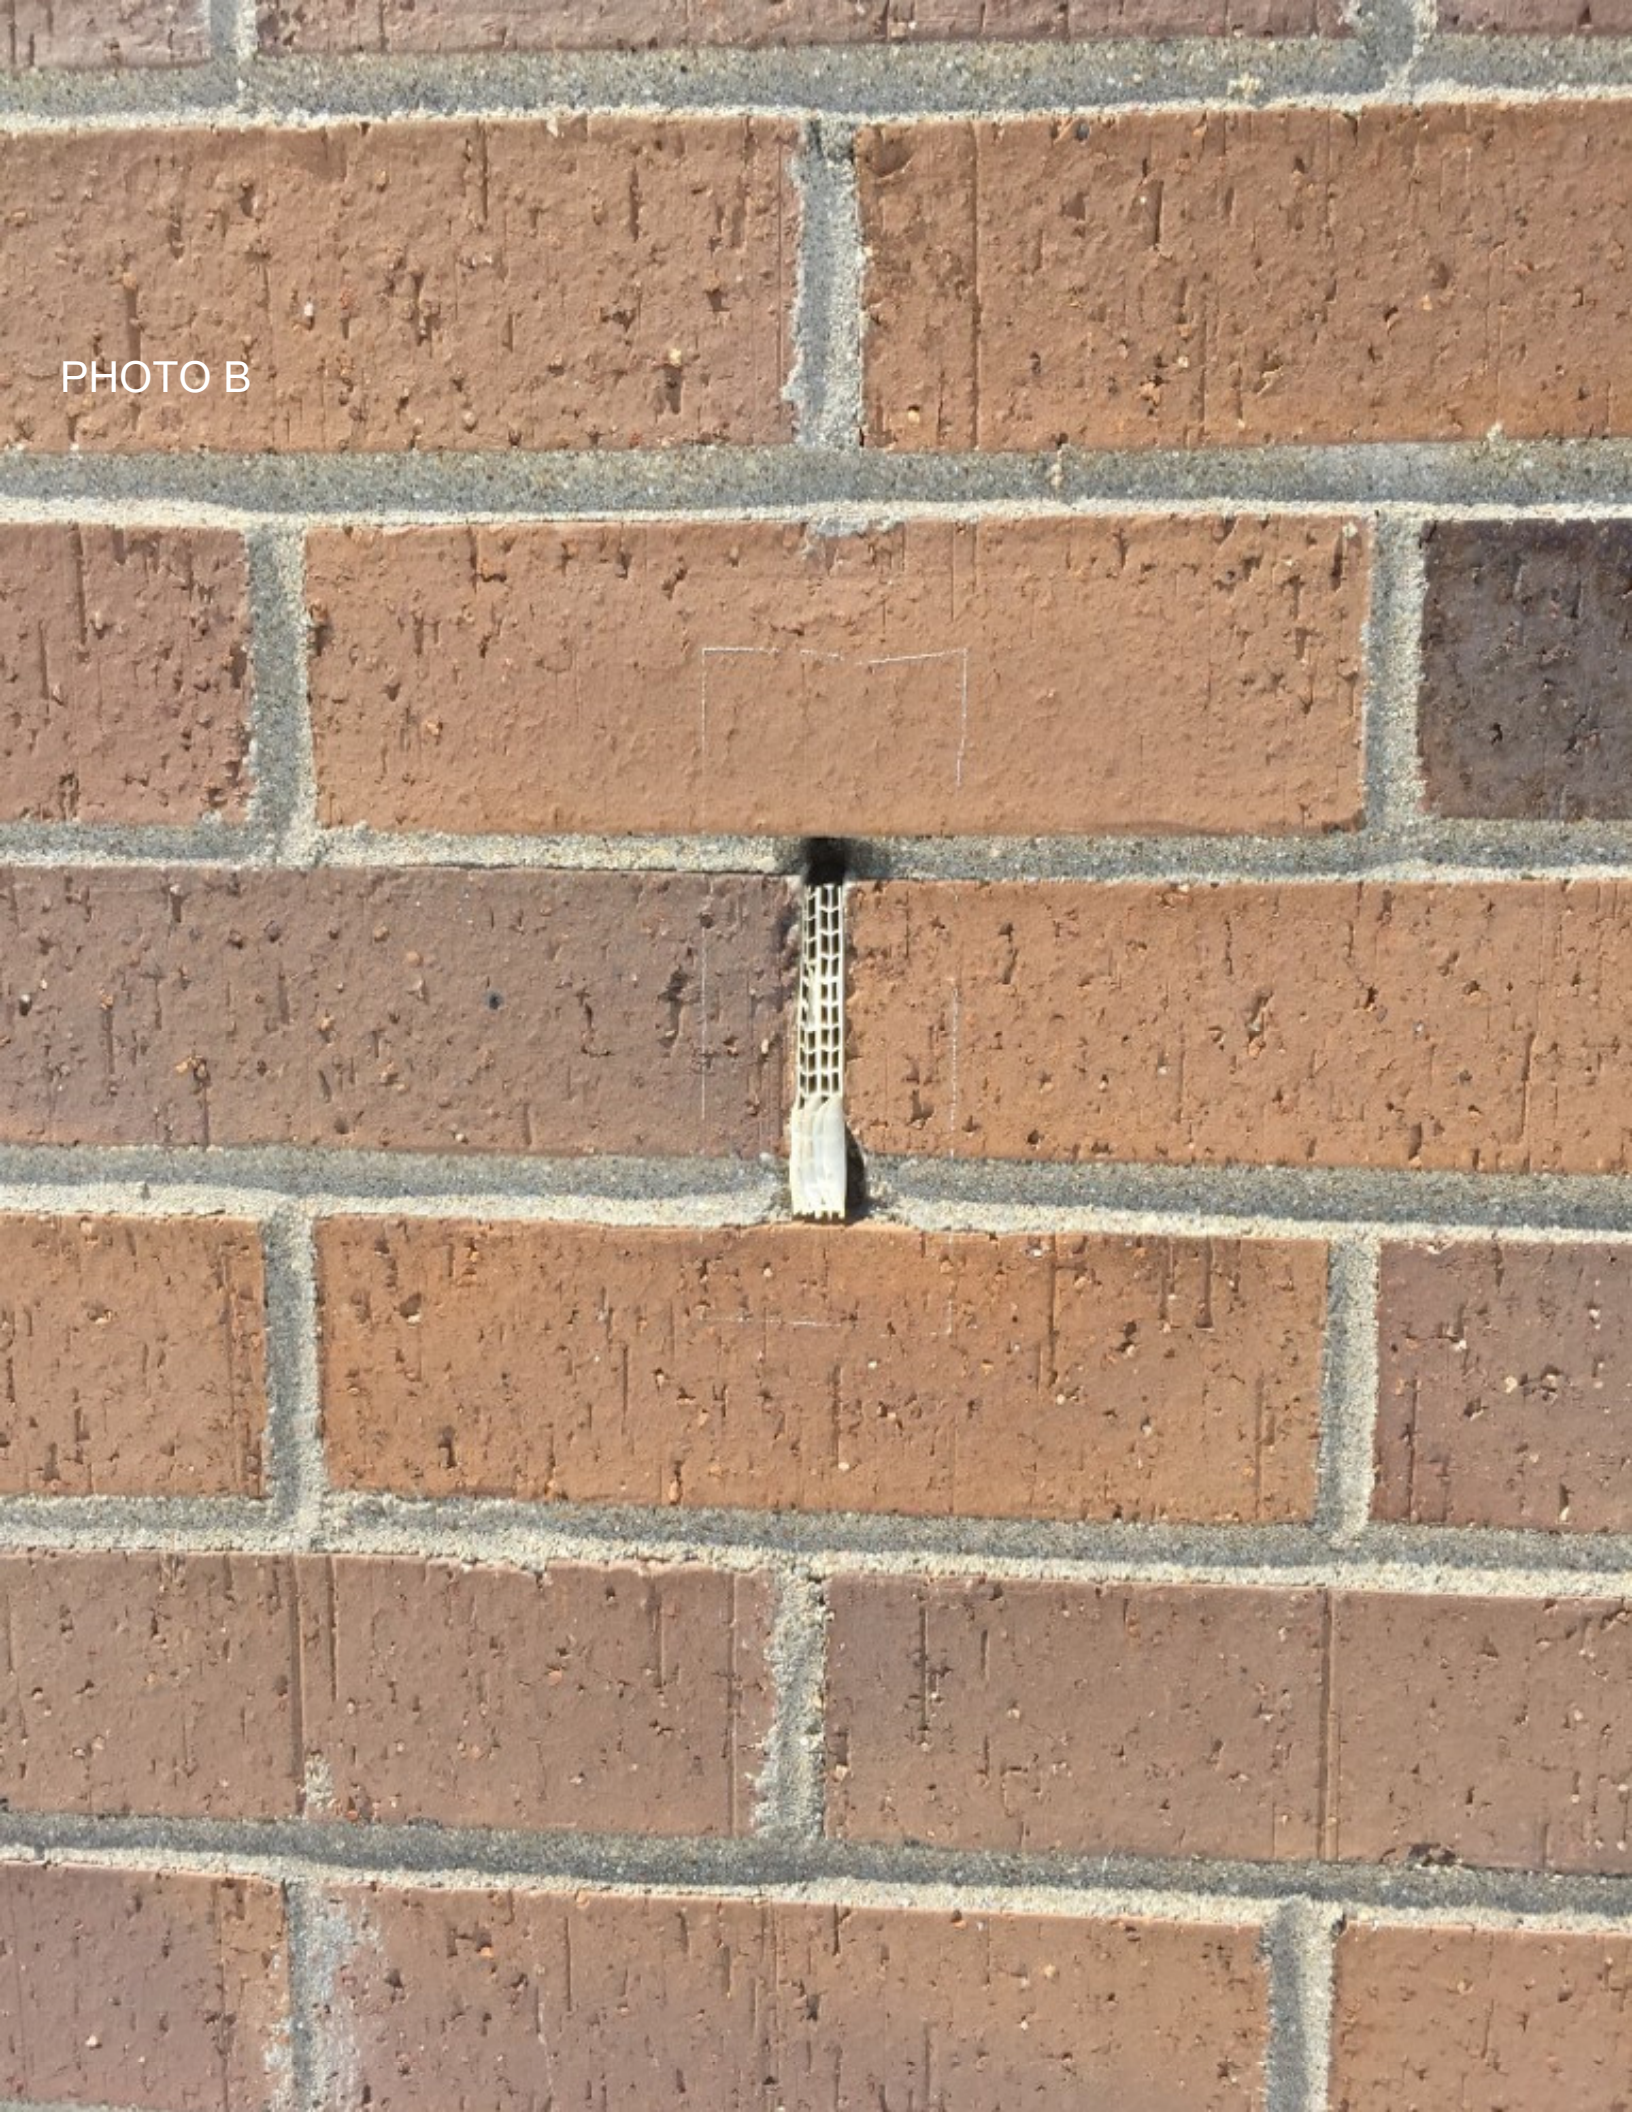
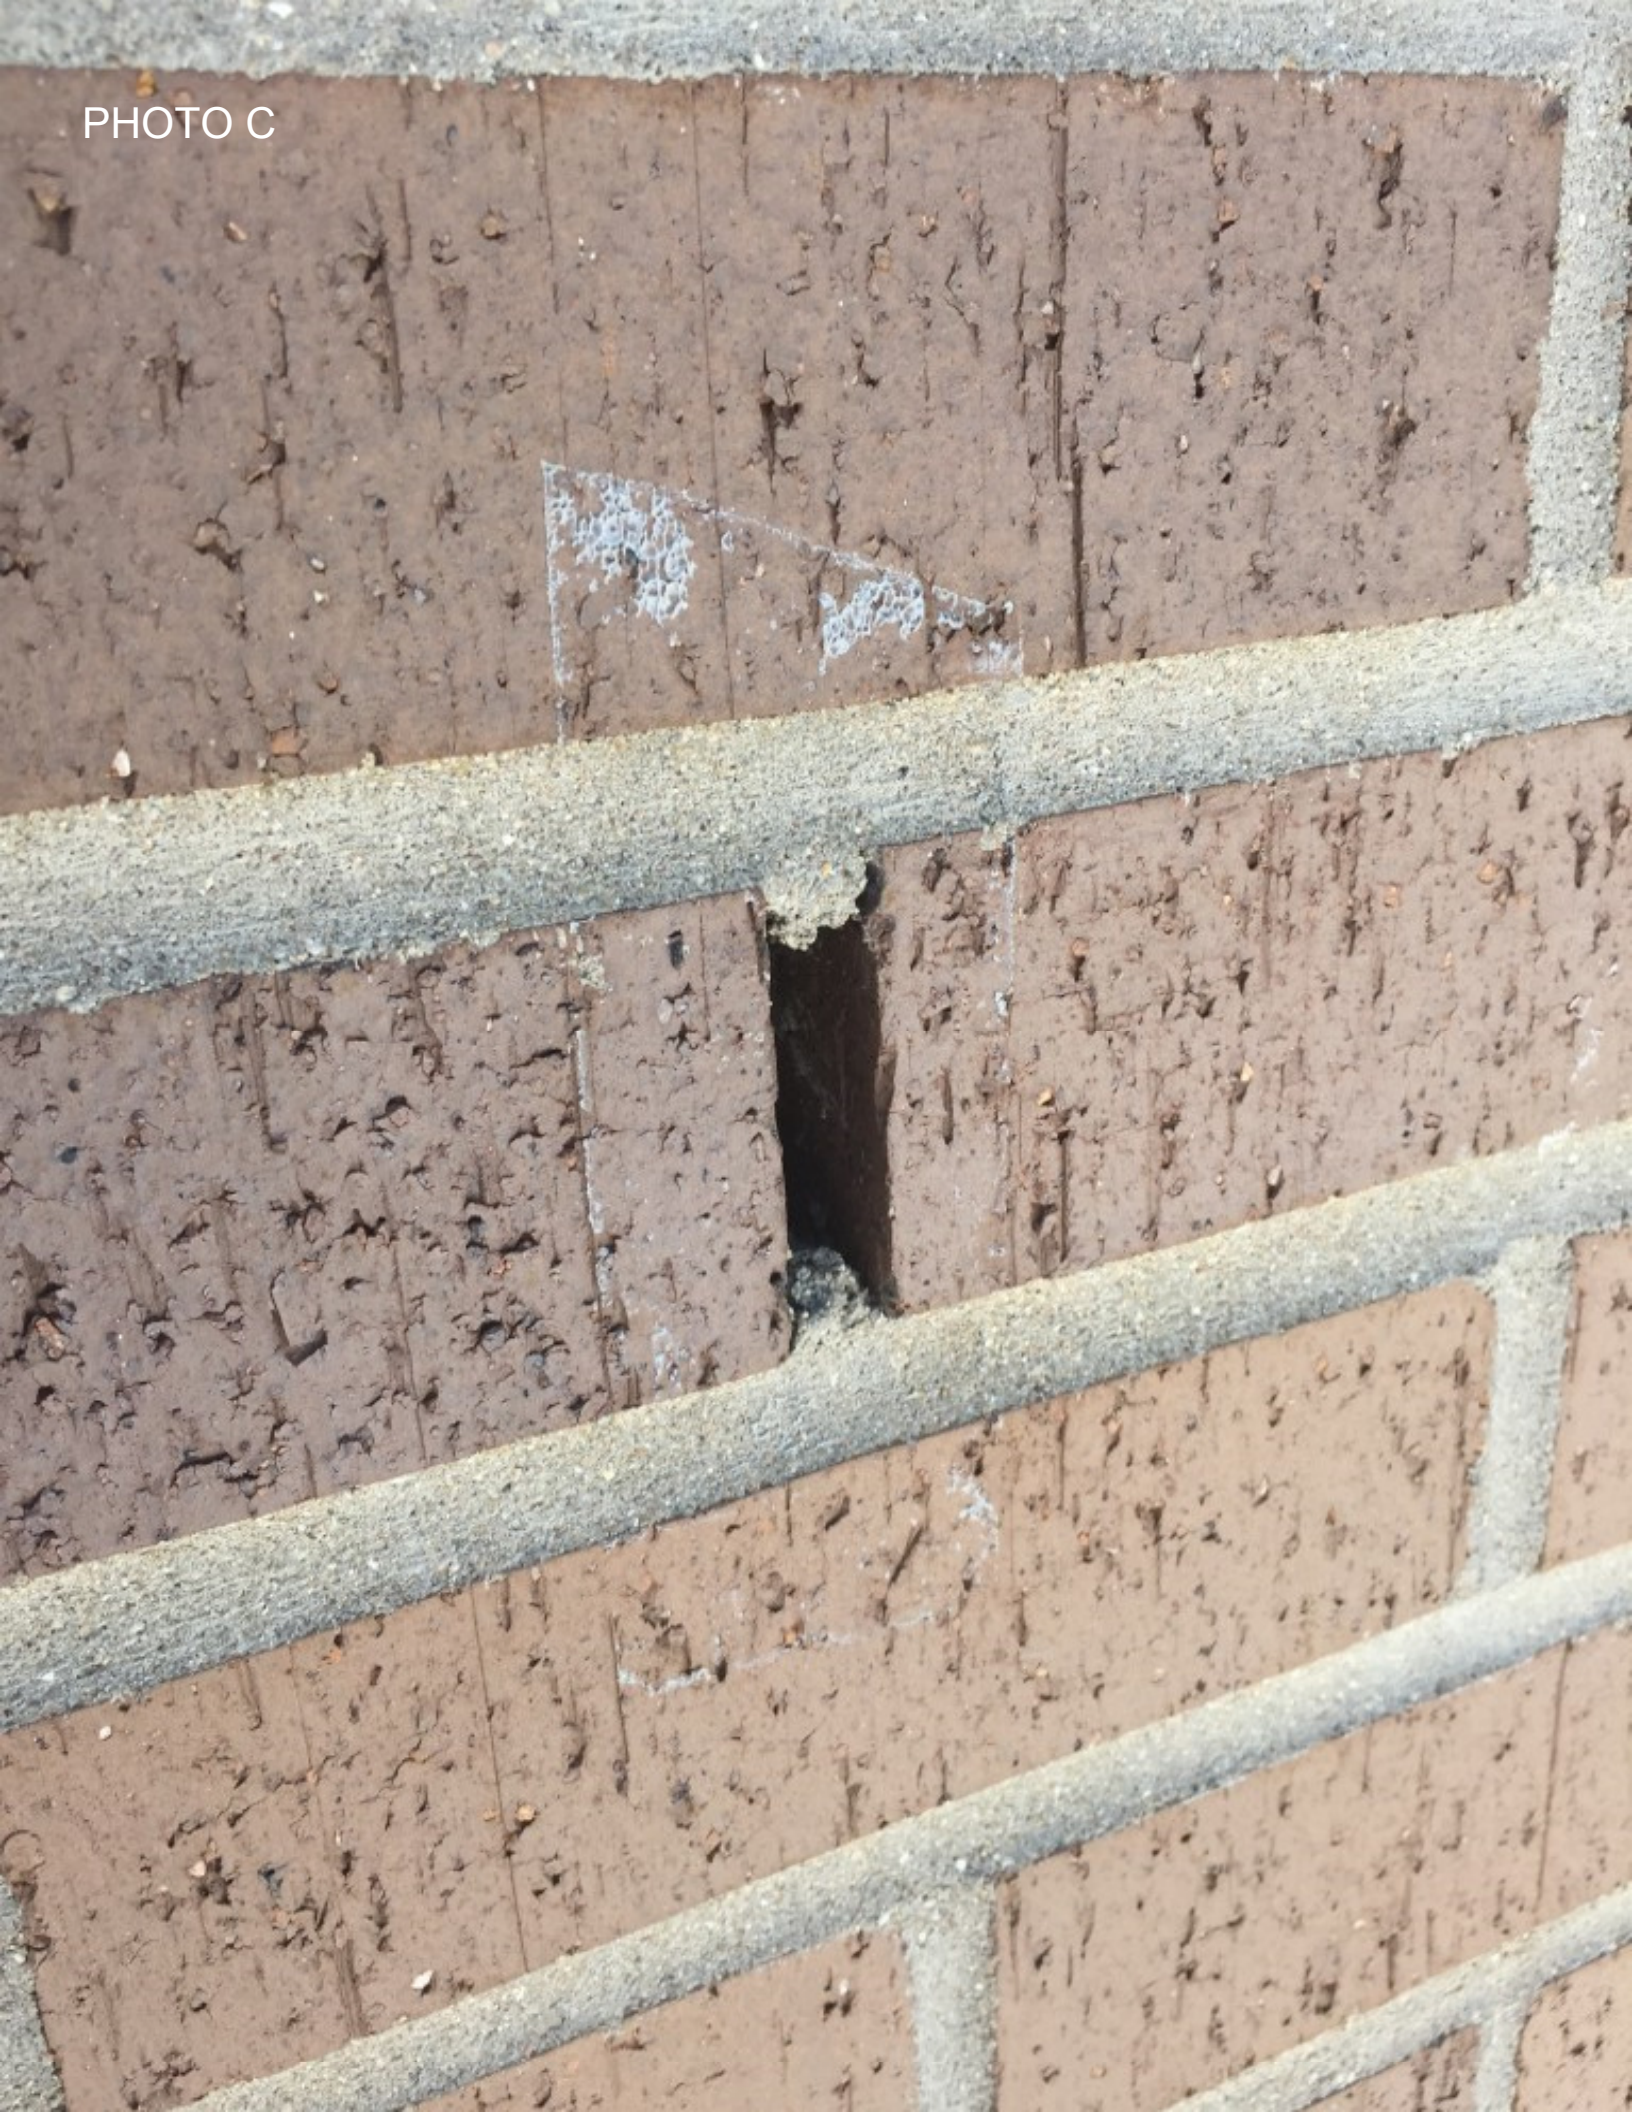
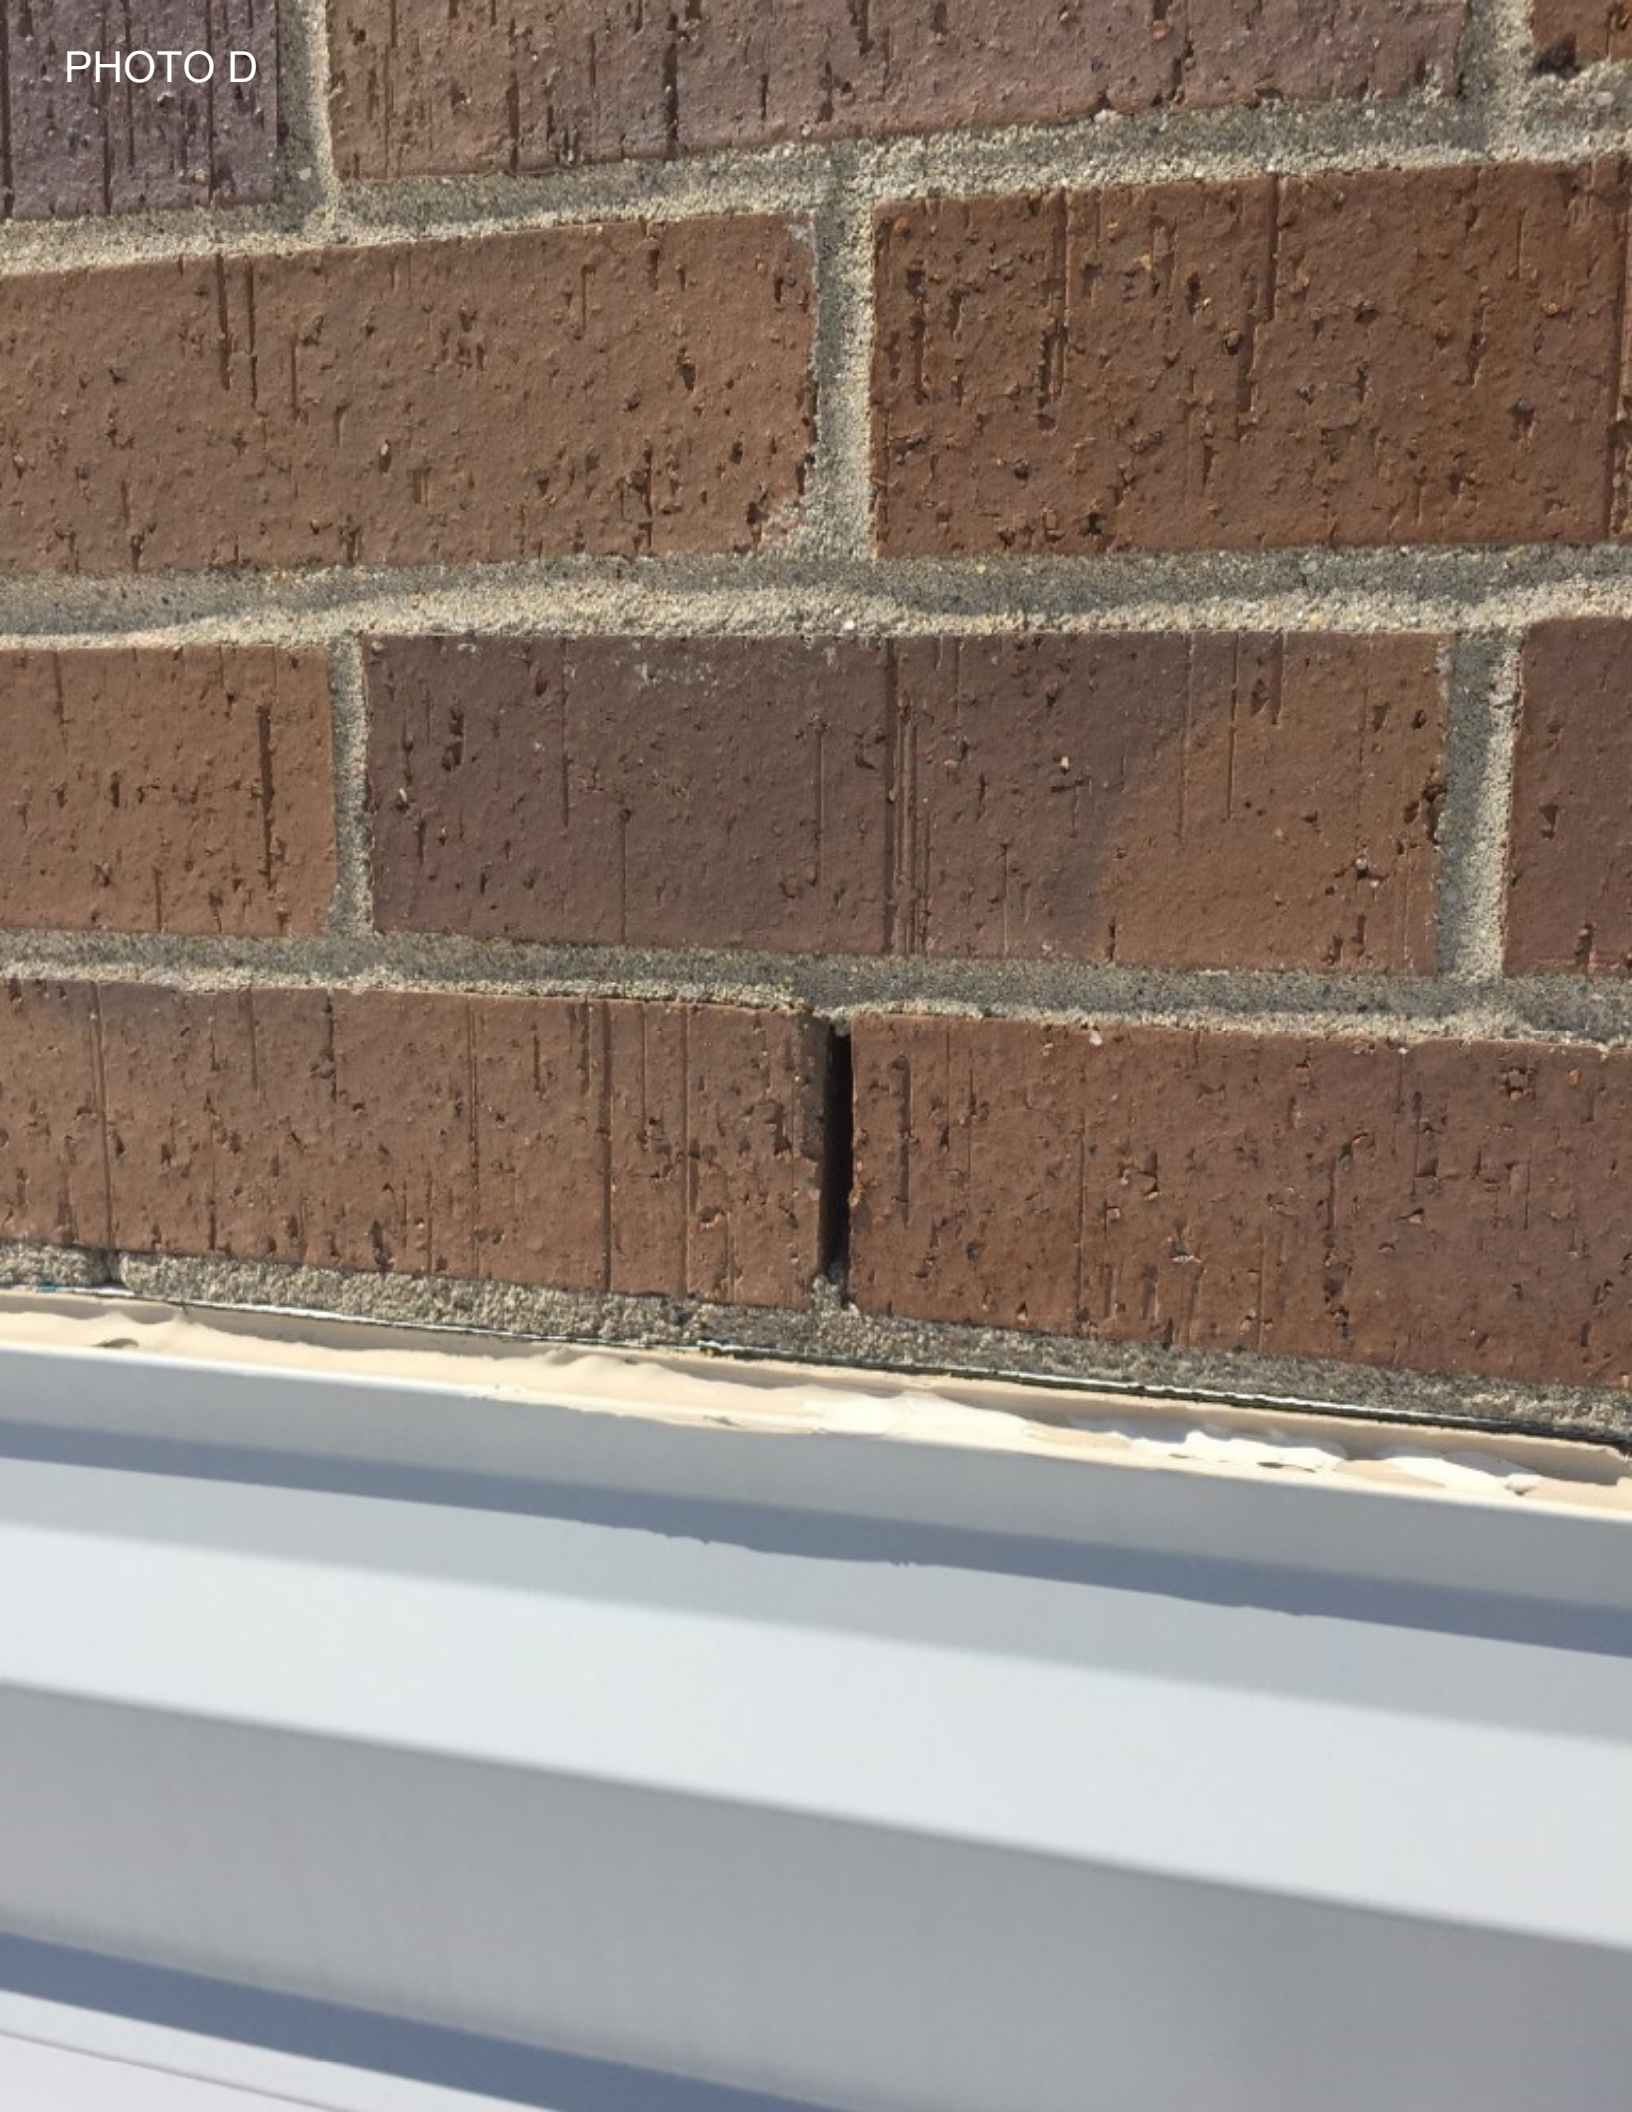
2. The installation of the cavity vents by the mason is poor and does not reflect basic industry standards. Large gaps exist around the cavity vents that allow wind driven rain to enter the cavity wall. At many locations, the cavity vents are doubled up while at other places, the cavity vents are not present at all. **See attached Photos B, C, and D.**

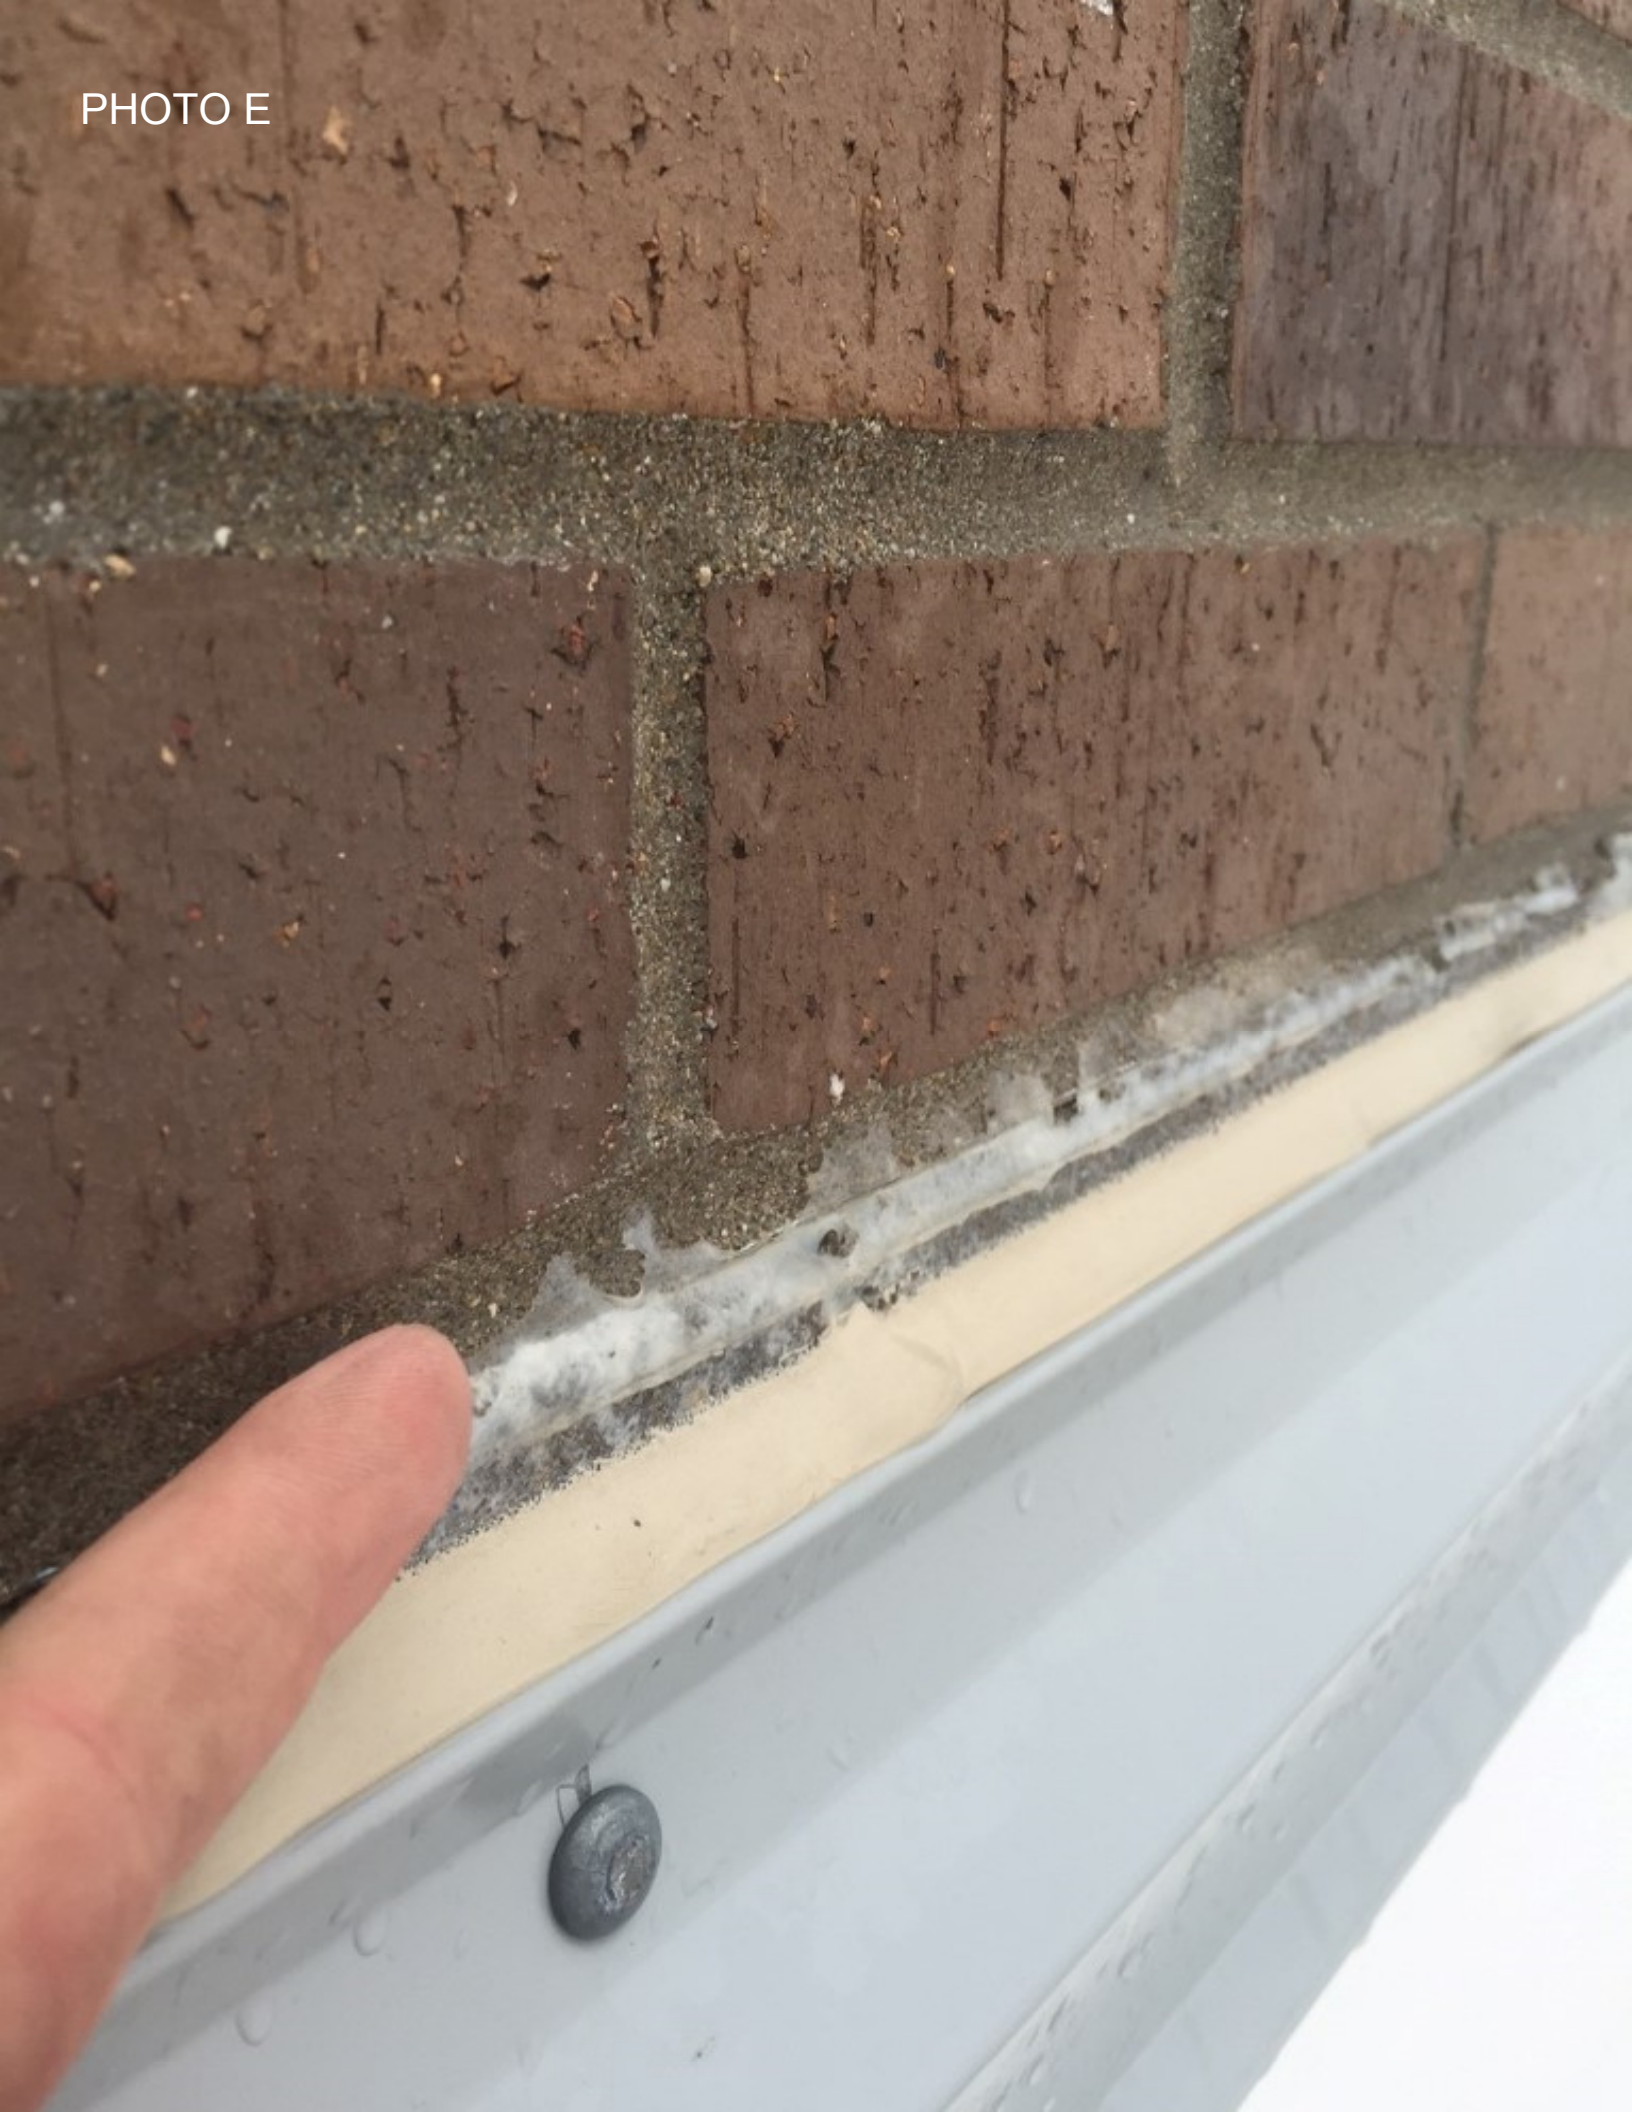
PHOTO E

3. Refer to Detail E/A4.2. Self-adhered thru wall flashing with weeps at 16" o.c. was detailed at this condition. During construction, the detailed thru wall flashing was omitted by the contractor. Subsequently, a request was made to install a reglet flashing at this location. At that time Sherman Carter Barnhart cautioned Morel Construction that the reglet flashing was not equal to the detailed thru wall flashing and all responsibility for maintaining a water tight condition was the responsibility of the Contractor.

The installed reglet flashing was cut into the 4" cmu below the membrane flashing. Approximately 1" of the cmu remains exposed to the weather without any protection. This exposed masonry contributes to the introduction of the water to the wall cavity by essentially acting as a sponge that collects water from the face of the wall and allows it to enter the cavity below the flashing. **See attached Photo E.**

Repeated efforts to remedy the incorrectly placed reglet flashing with caulk have resulted in areas in which the membrane flashing that extends through the wall is caulked shut and the water is trapped within the cavity with nowhere to go until it overwhelms the flashing and enters the building below. At some of these locations, the cotton rope weeps are no longer present.
