MURPHY - GRAVES - TRIMBLE, PLLC
ARCHITECTURE | PLANNING | INTERIORS

GC BURKHEAD PUNCH LIST REVIEW

Review date 7/20/2016

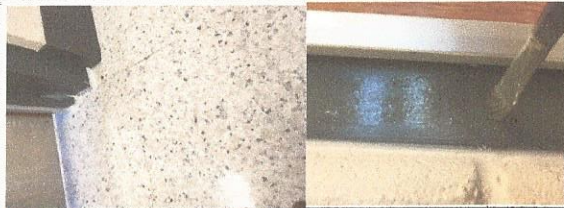
Vestibule 500:			
There is daylight present in the top left corner of the exterior aluminum door frame. Adjust to close the gaps.		Complete per pics rec'd on 7-21-2016	DB
Paint needs to be cleaned off on the interior doors. There is white paint on the gray frame. Also the bottom of the frame needs to be touched up. The paint doesn't go all the way to the floor.
