## PROGRESS REPORT

### HARDIN COUNTY SCHOOLS JT ALTON MIDDLE SCHOOL – RE-ROOF PROJECT

**Project No:** 201665  
**Date:** August 18, 2016  
**Time:** 6:00 PM  
**Location:** Hardin County Board of Education

Title
Progress Report Aug. 5

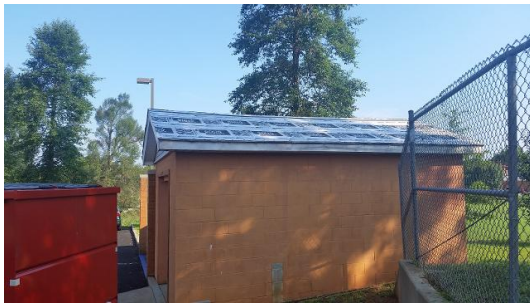
**Photo 1**

Out building dried in with new underlayment

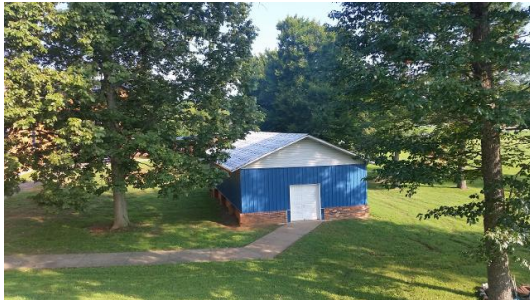
**Photo 2**

2nd out building dried in with new underlayment

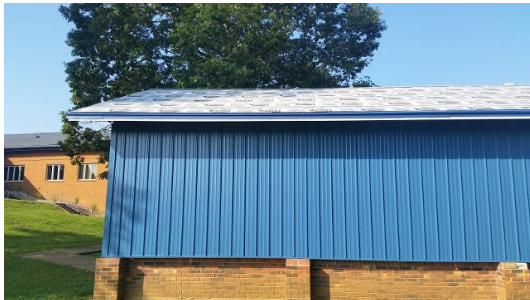
**Photo 3**

Blue metal matches well to new blue metal.

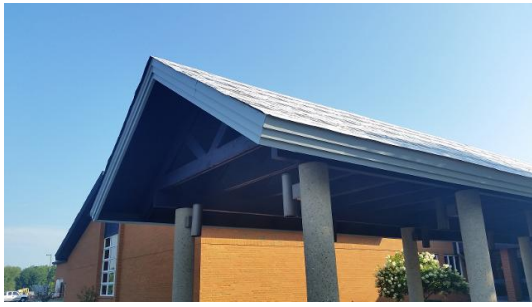
**Photo 4**

Trim metal has begun and is complete on the entrance canopy.

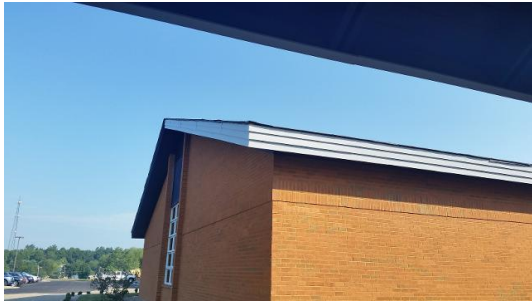
**Photo 5**

New metal trim covering fascia.

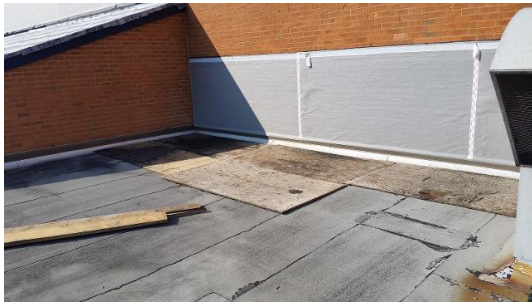
**Photo 6**

Plywood in place to protect modbit roof from damage from scaffolding.

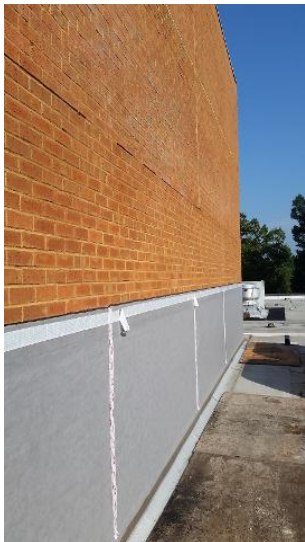
**Photo 7**

Air/Vapor barrier has begun to be installed on masonry walls.

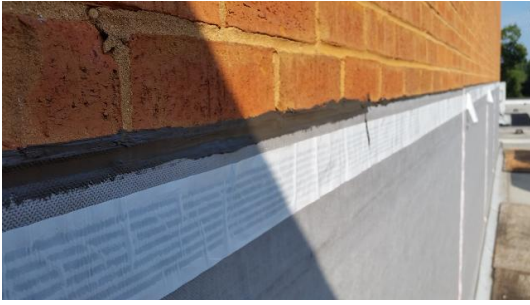
**Photo 8**

Note the self sealing adhesive strip and the seam that is caulked at the end of work day to prevent water from getting behind the barrier.

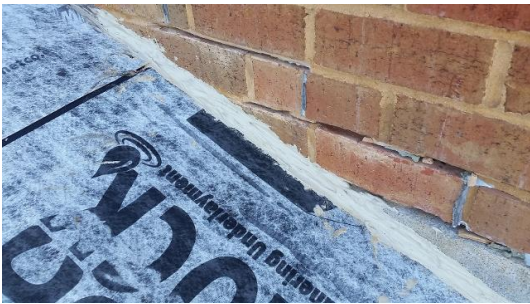
**Photo 11**

Areas where no counter flashings are present a temporary sealant is installed until wall panels / new trim cover these areas.

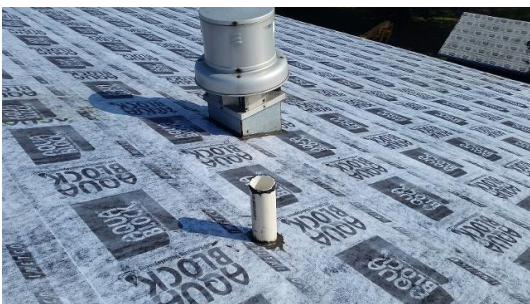
**Photo 12**

Sealant around each penetration.

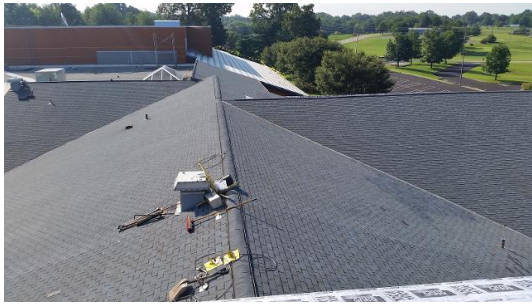
**Photo 13**

Area left to be torn off and underlayment installed.
