PROGRESS REPORT

**HARDIN COUNTY SCHOOLS
JT ALTON MIDDLE SCHOOL – RE-ROOF PROJECT
JT ALTON MIDDLE SCHOOL – TRUSS REPAIRS
DISTRICT FACILITY PLAN UPDATE**

Project No: 201665
Date: October 11, 2016
Time: 6:00 PM
Location: Hardin County Board of Education

Facility: James T. Alton Middle School

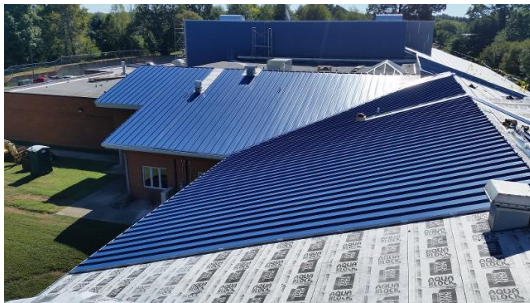
Photo 1

Panels on rear to date.

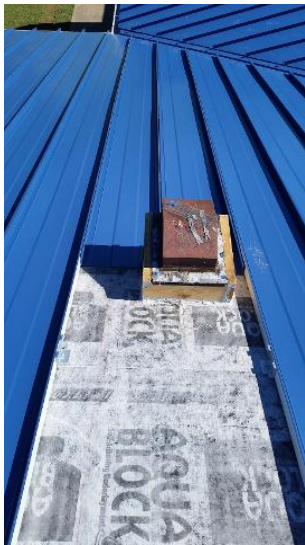
Photo 2

Old rusted vent to be replaced and new curb built to accommodate the metal panels.

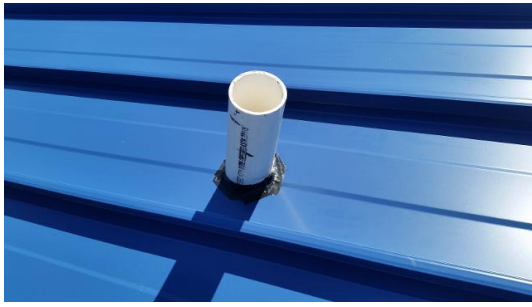
Photo 3

All pipe penetrations have been in the middle of the panels so far. None have had to be moved.

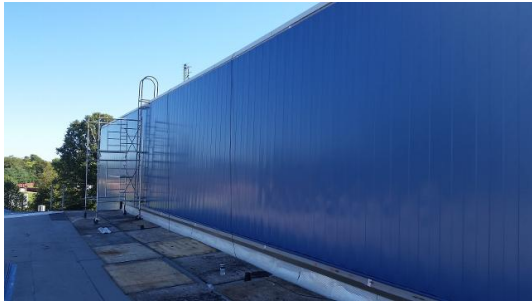
Photo 4

Left side of gym wall with panels installed.

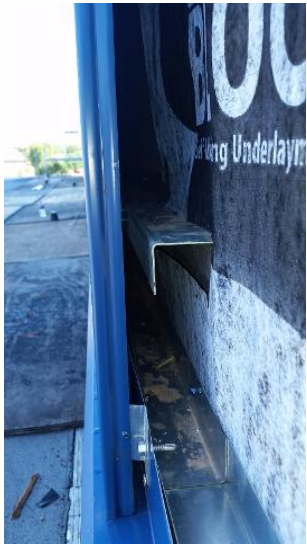
Photo 5

Wall panels installed over z bars.

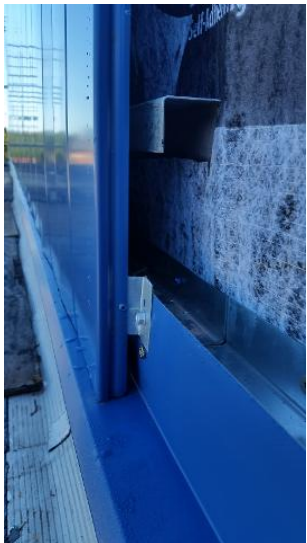
Photo 6

Shows how metal panels terminate at skirt.

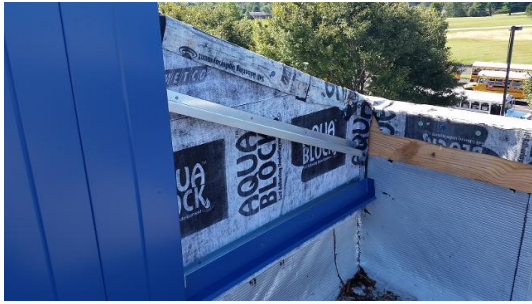
Photo 7

Detailed area to be installed later.

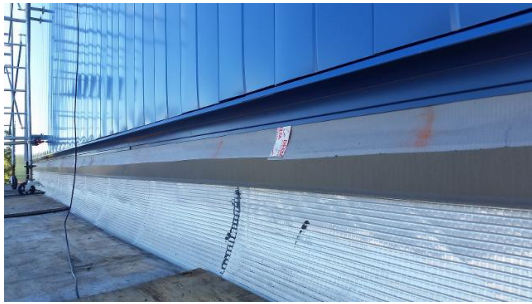
Photo 8

Wall panels with skirt above existing flashing. To be detailed further.

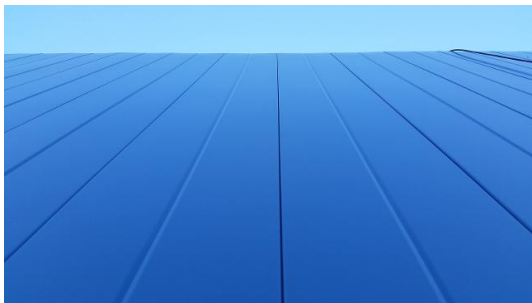
Photo 9

V-groove panels show no variance.

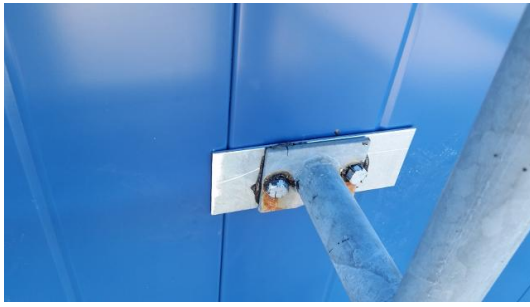
Photo 11

Ladder reinstalled into wall and properly sealed.

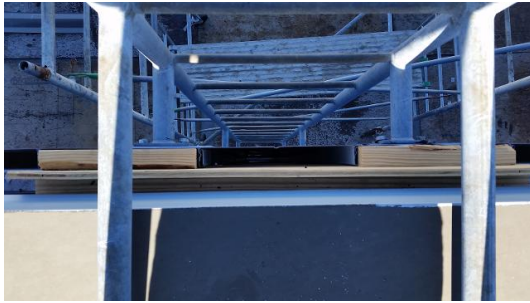
Photo 12

Ladder properly shimmed behind the panels.

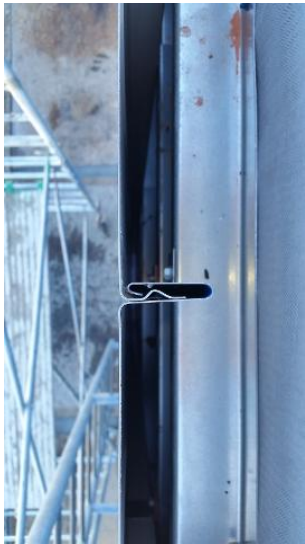
Photo 13

Interlocking panel design.

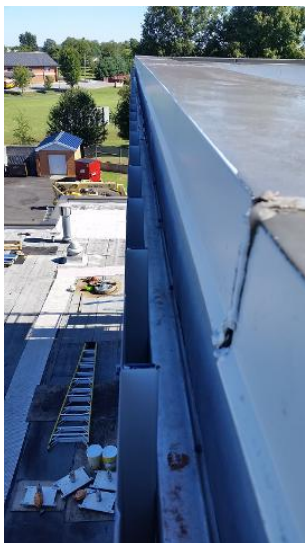
Photo 14

Head wall conditions to be detailed later.

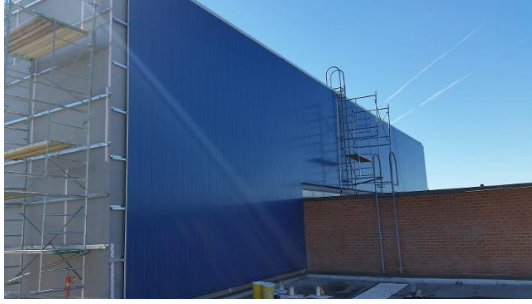
Photo 15

Completed wall to date.

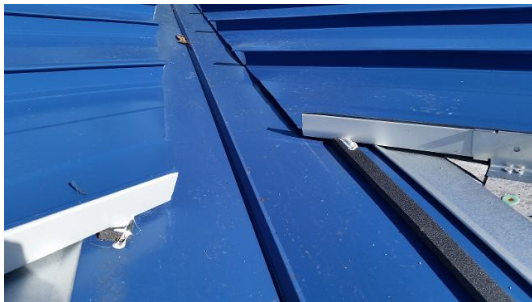
Photo 17

Panels installed properly at the valley with foam and sealant.
