## **Radcliff Elementary**

### **Project Closeout Update**

August 7, 2017

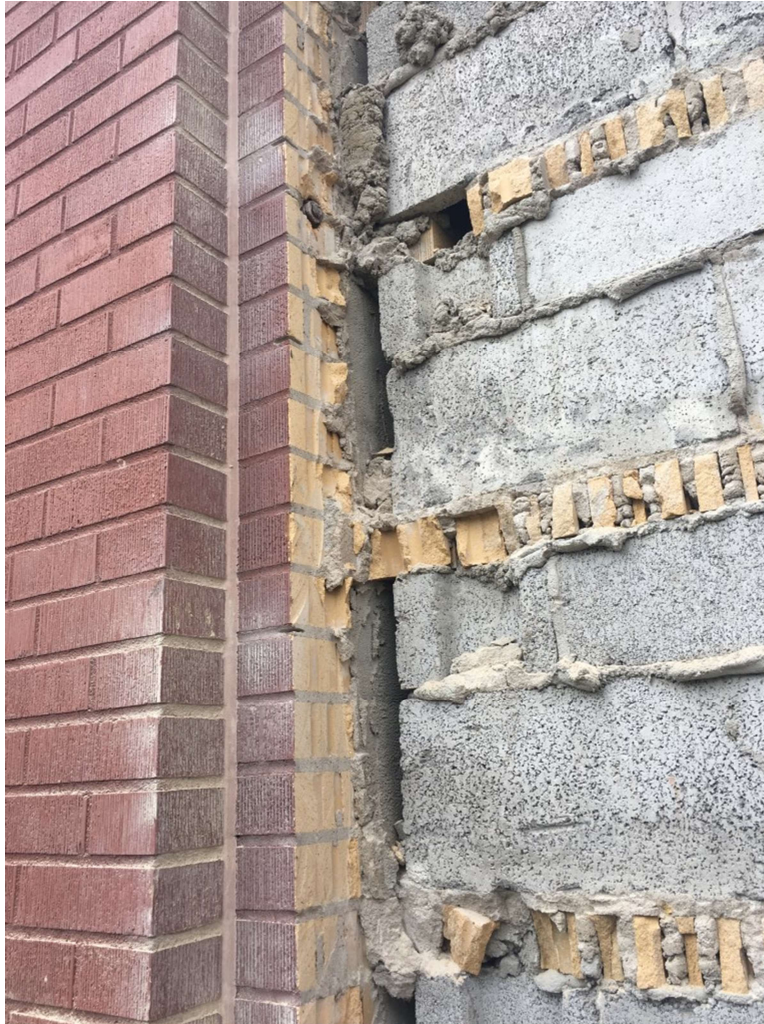
Image 1

Existing CMU backup that was not impacted by previous renovation projects shows significant gaps and voids that do not reduce or limit the penetration of water within the cavity of the existing CMU wall. Bailey's Masonry will be filling all voids in the existing CMU wall prior to applying bituminous damp-proofing and reinstalling insulation and brick veneer.

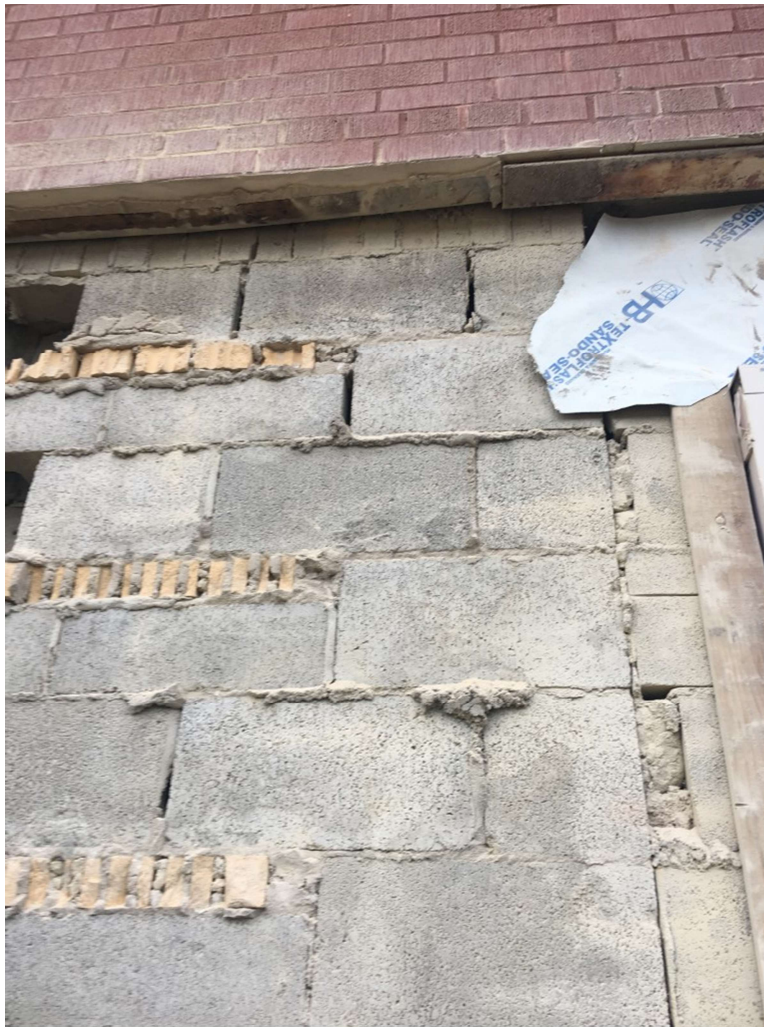
**Image 2**

Another image of the existing CMU backup that was not impacted by previous renovation projects.

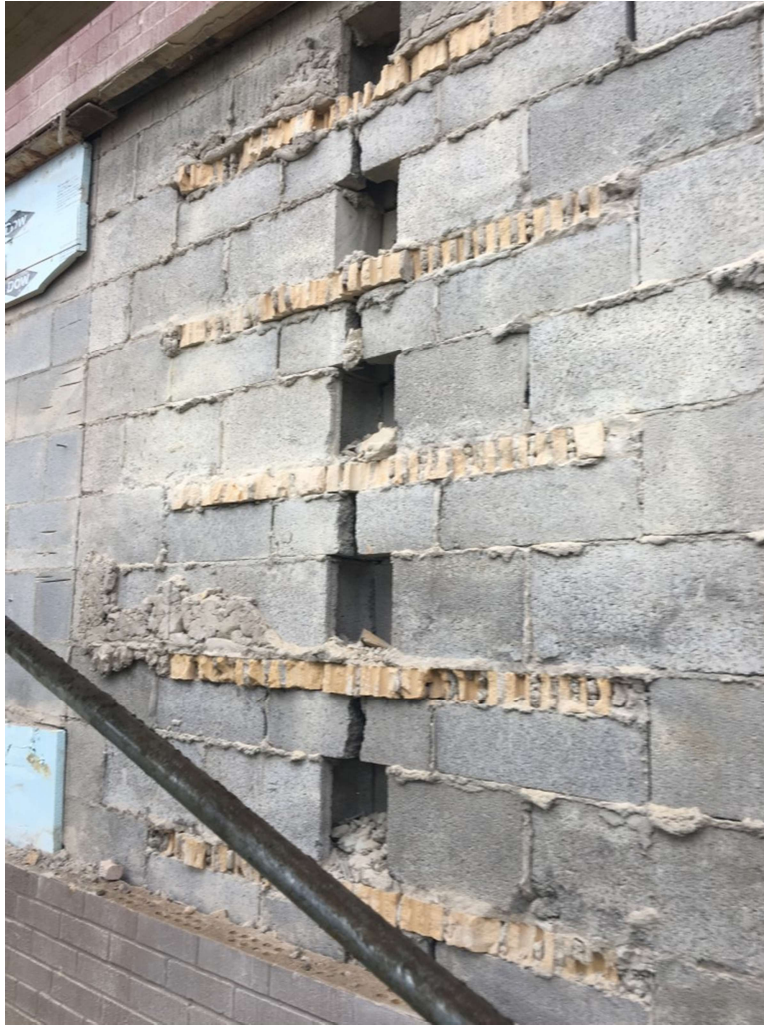
**Image 3**

Additional image of the existing CMU backup that was not impacted by previous renovation projects. SCB requested that the 6 ft (approx.) wide zones of original brick be removed so that any visual observations of obvious potential water infiltration areas could be addressed.

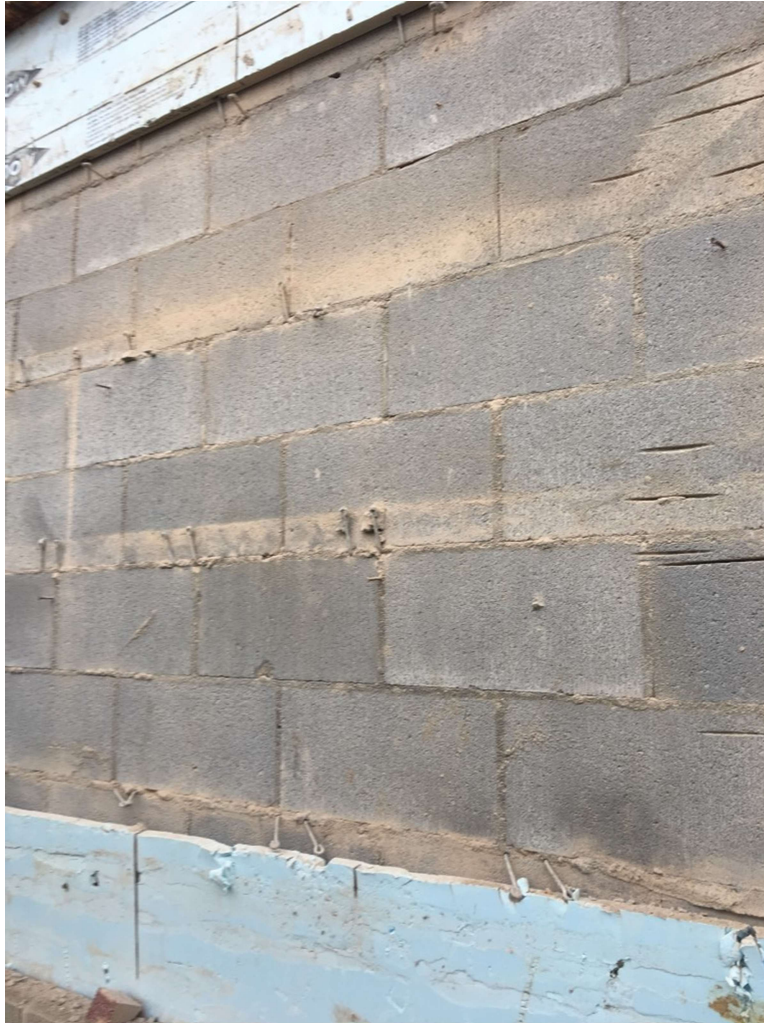
**Image 4**

CMU infill completed during the renovation of Radcliff Elementary did not have the bituminous damp-proofing installed at the new CMU as specified. Bailey's masonry has removed the brick and insulation to apply the bituminous damp-proofing at the CMU infill which was installed using light weight block that is more porous than the original CMU and therefore has the potential to wick moisture from the cavity unless the bituminous damp-proofing is present.
