Change Order

PROJECT (Name and address):	CHANGE ORDER NUMBER: 010	OWNER: ⊠
North Hardin High School Renovation	DATE: July 20, 2017	ARCHITECT: ⊠
TO CONTRACTOR (Name and address):	ARCHITECT'S PROJECT NUMBER: 1291	CONTRACTOR: ⊠
Morel Construction Co.	CONTRACT DATE: February 09, 2015	FIELD: □
627 West Main Street Louisville, KY 40202	CONTRACT FOR: General Construction	KENTUCKY DEPARTMENT OF EDUCATION: ⊠
Adjust unsuitable soil allowance - (\$19,1) Adjust utility allowance to reflect actual of Adjust masonry repair allowance to reflect Refer to attached documentation. The original Contract Sum was The net change by previously authorized The Contract Sum prior to this Change Of The Contract Sum will be decreased by the new Contract Sum including this Change Contract Time will be increased by Zeron Adjust and Decreased by Zeron Contract Time will be increased by Zeron Adjust and Decreased by Zeron Adjust and Decreased by Zeron Adjust and Decreased Box 2018.	ed amount attributable to previously executed (18.00) costs - \$2,174.00 ct actual costs - (\$1,937.00) Change Orders rder was his Change Order in the amount of hange Order will be	\$\ \begin{align*} \be

RE: NORTH HARDIN HIGH SCHOOL

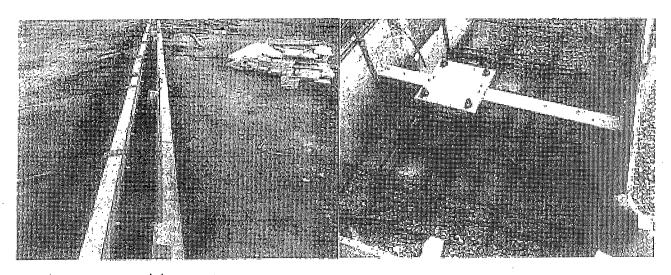
- Excavation of footings along existing south wall were being performed. Dynamic cone penetrometer testing was performed and yielded bearing capacities from 500 to 2000+psf. Areas falling below the required 2000 psf bearing capacity were excavated and tested incrementally until adequate bearing capacities were reached. Two areas of over-excavation were needed and measured 11'x5'x2' and 9'x5.5'x2'. Excavations were backfilled with #57 stone.
- At 9:20 am, imi arrived onsite to deliver 10+ yd³ of 4000 psi concrete. Reinforcing steel
 was inspected prior to pour and found to be in general accordance with drawing details
 and specifications. Bars were appropriately sized, spaced, and lapped. Reinforcement
 in footings were elevated on concrete chairs.

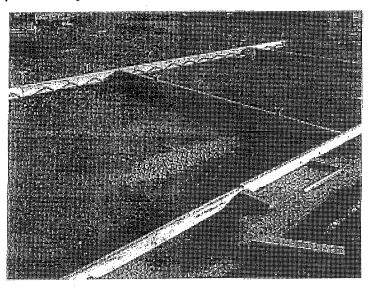
Upon arrival, the area to be poured was inspected. Rain from previous day had caused upper crust of DGA to be wet, however walking the area, subgrade seemed firm and no water was standing in the forms. Hole that had opened from utility trench settlement observed on previous day was filled with #57 stone.

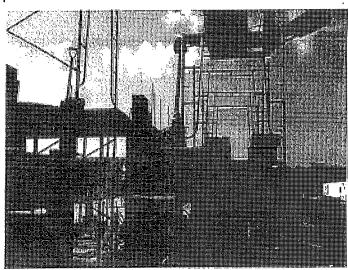
Upon arrival, masons were grouting. Inspector had not been notified. An inspection of visible rebar was made and reinforcement appeared in general accordance with drawing details and specifications.

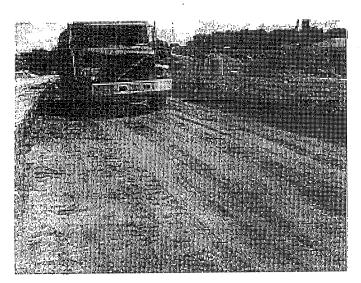
Prior to leaving site, a second area to receive pavers was proofrolled at the north end of the site. This area showed little to no signs of rutting or pumping.

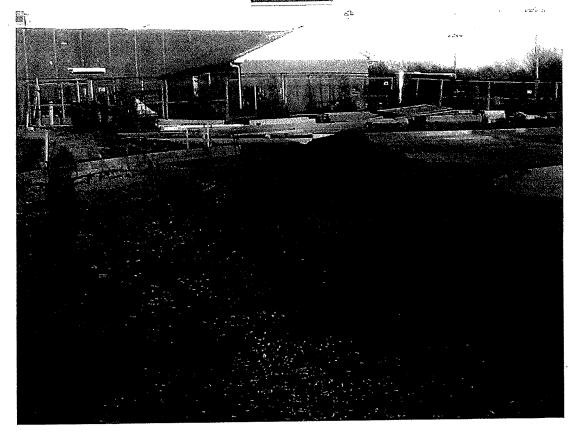
AEI was on site at the Hardin County High School to observe a proof roll for the driveway area of the new addition. The proof roll was observed over the parking and driving lanes of the new addition. An area in front of the ramp leading into the right side entrance experienced pumping and rutting. The area was proof rolled using a loaded dual tandem dump truck. AEI recommended undercutting the area no more than two feet. After undercutting the area AEI recommended backfilling the area with -8 stone, -6 stone, or -4 stone. The area was 25 feet in width and 50 feet long. If no more than two feet is undercut that would equal to 92.6 cubic yards.
