Radcliff Elementary

Project Closeout Update

September 11, 2017

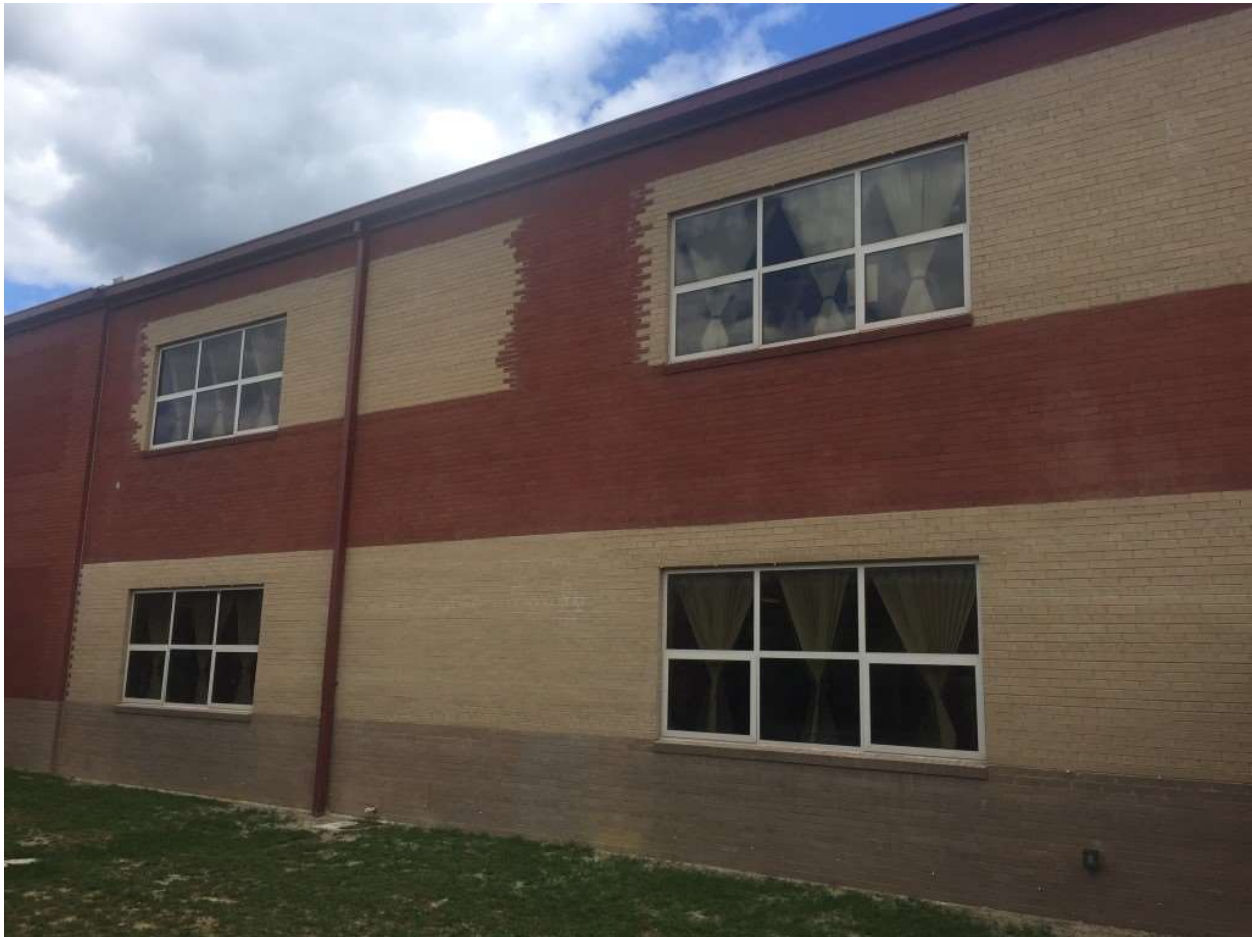
Image 1

Existing brick infill has been removed and replaced at Classrooms 147, 148, 213, and 214

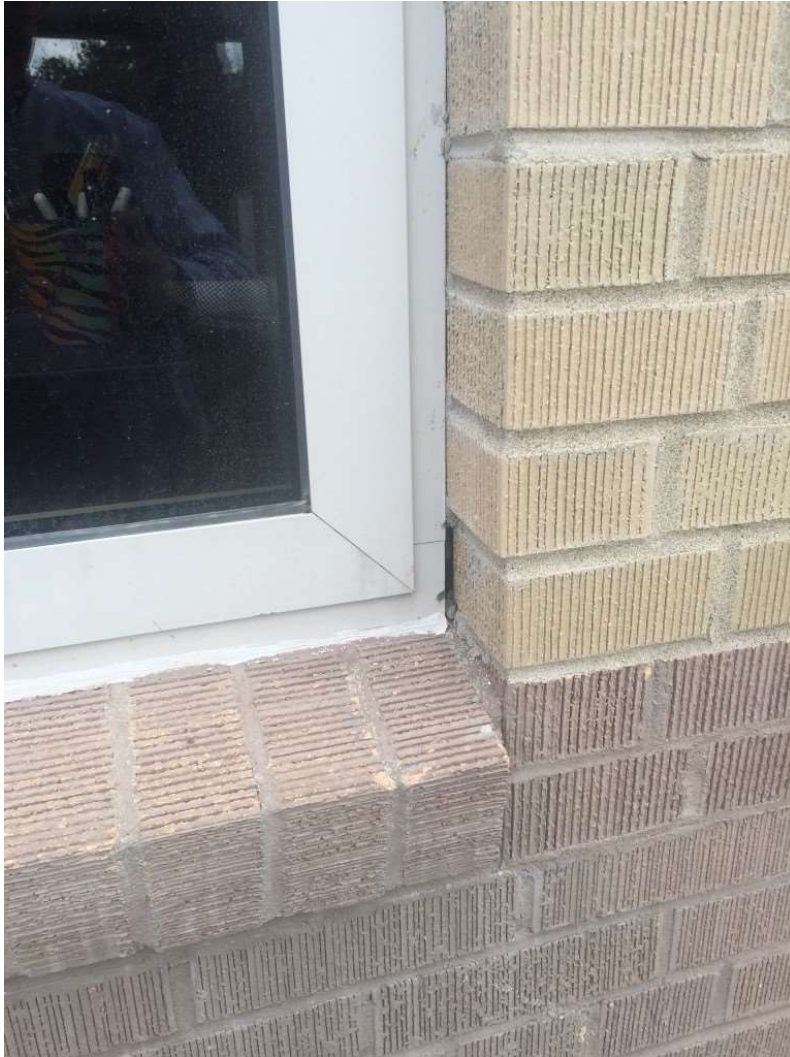
Image 2

Caulk around existing windows needs to be replaced.

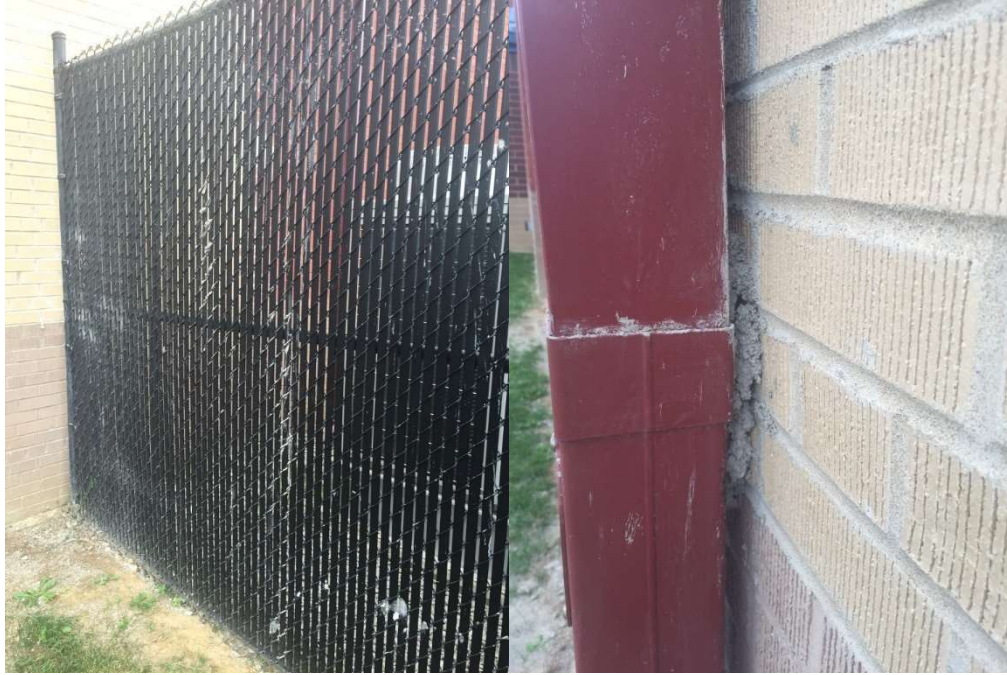
Image 3

Cleanup needs to occur around the construction area impacted by scaffolding and masonry work. This includes cleaning the existing fence at the mechanical equipment enclosure and removing excess mortar from behind the existing downspouts.

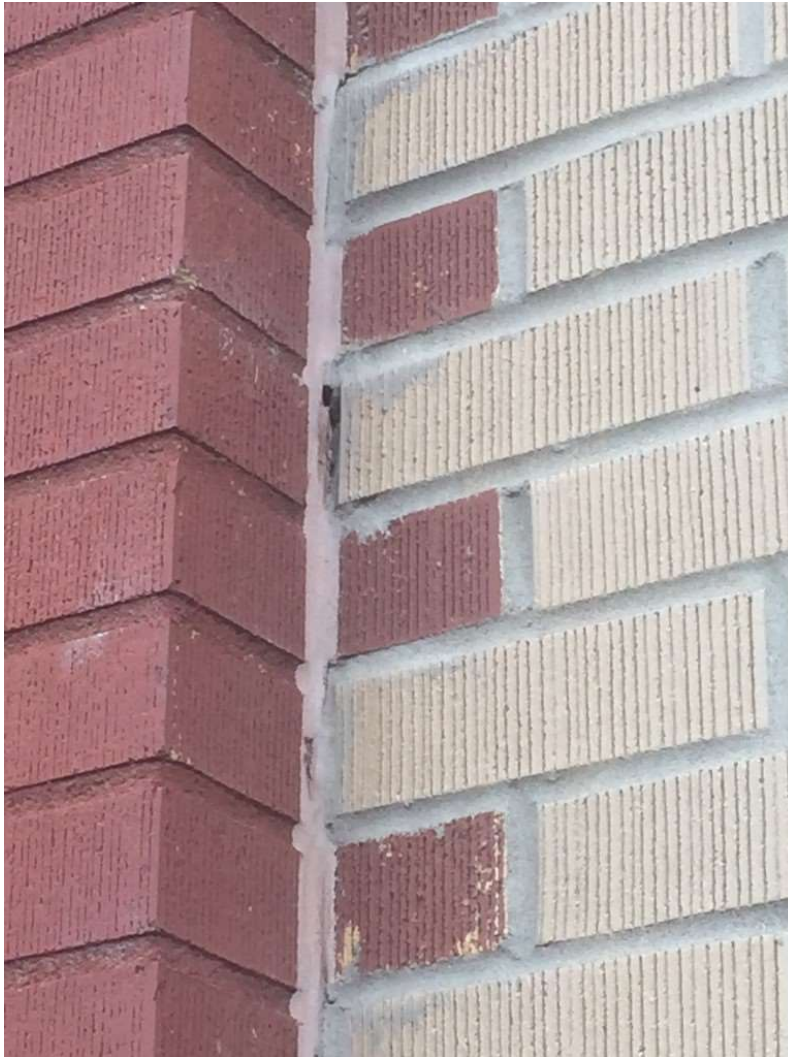
Image 4

Existing sealant joint at exterior needs to be removed and replaced adjacent to new masonry infill.
