Radcliff Elementary

Project Closeout Update

October 12, 2017

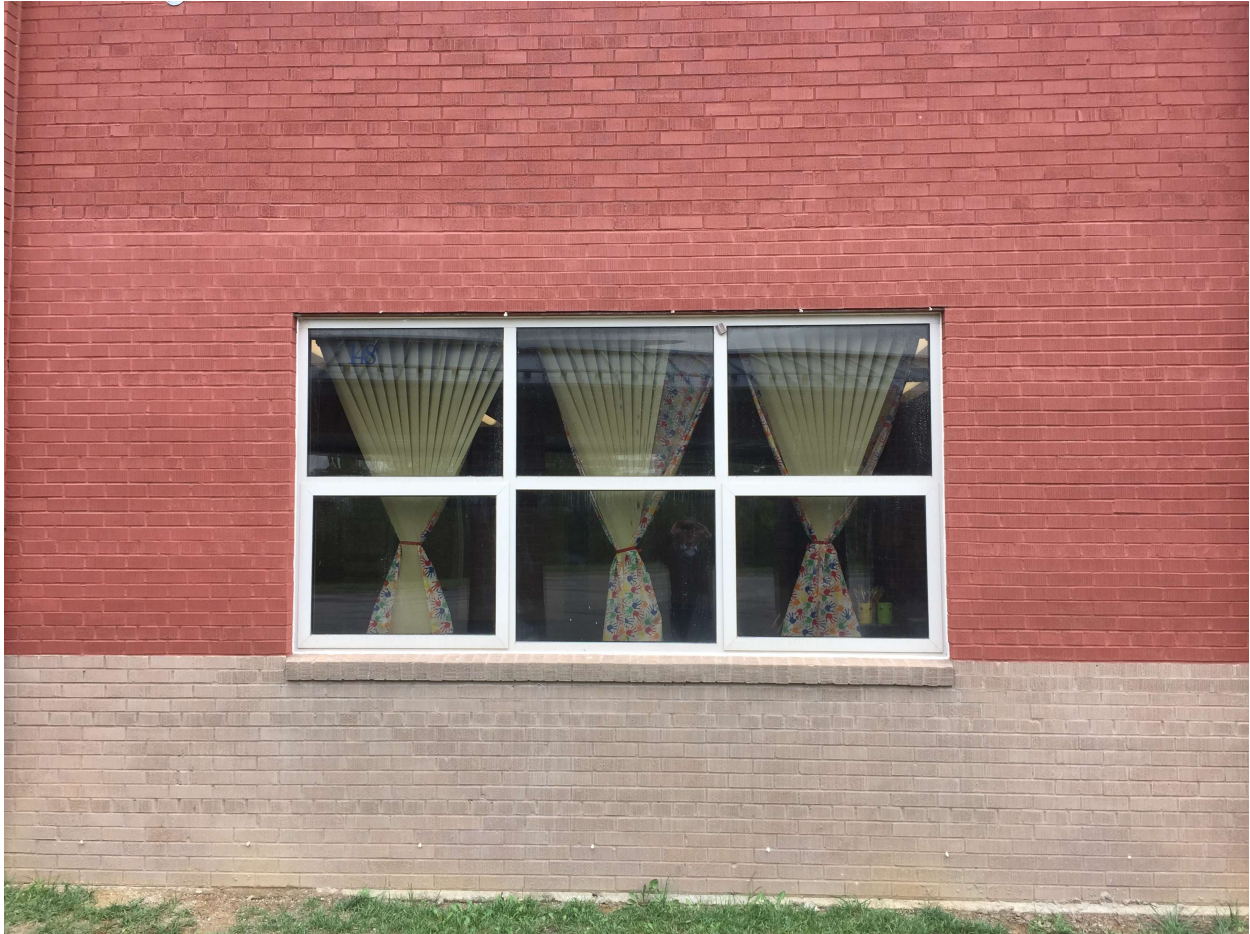
Image 1

Existing brick infill has been removed and replaced at Classrooms 147, 148, 213, and 214. Brick stain has been completed and sealant has been applied around the perimeter of the windows
