## FIELD OBSERVATION REPORT

### 2017.10

■ TO:	Kenton County Board of Education 1055 Eaton Drive Ft. Wright, KY 41017	■ DATE:	2017.10.25
ATTENTION:			
■ FROM:	Mark Perry mperry@pca-arch.com 1881 Dixie Highway, Suite 130 Fort Wright, KY 41011 V: 859.431.8612 • F: 859.431.8611	■ PROJECT:	Kenton County School District Ft. Wright Elementary
COPIES TO:	Mr. Danny Mann	PROJECT NO.:	2014-112

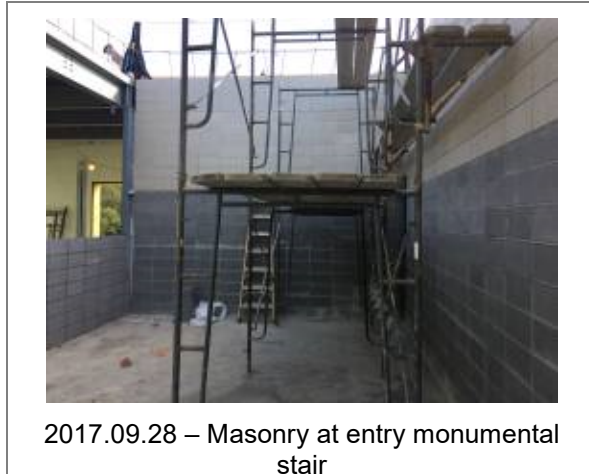
04.01: 2017.09.28 – Masonry installation at the new monumental entry stair was 75% complete at the 1<sup>st</sup> floor and was actively working at the south wall of the stair at the second floor. Interior masonry work was approximately 95% complete at the first floor.

2017.09.28 – Masonry at entry monumental stair

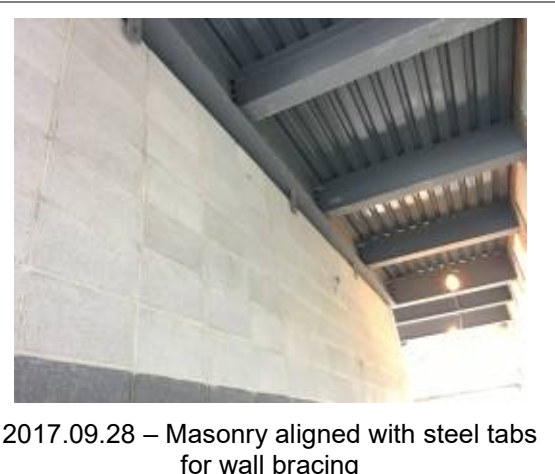
2017.09.28 – Masonry aligned with steel tabs for wall bracing

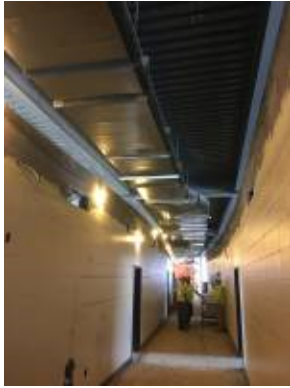
*20-28.01: 2017.09.28 – Ductwork installation was active on the southeast side of the first floor.*

2017.09.28 – Ductwork installed in corridor

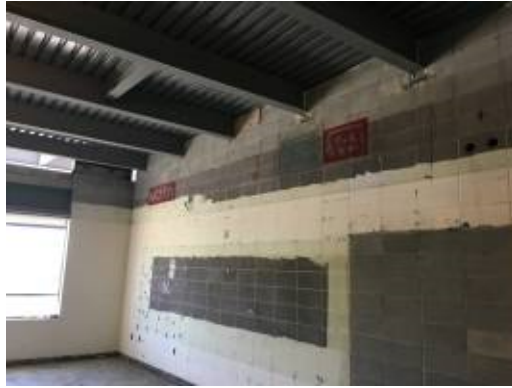
2017.09.28 – Layout of duct penetrations at existing classroom wall

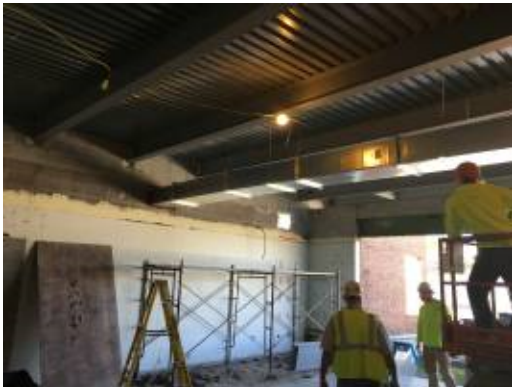
2017.09.28 – Active ductwork installation in 1<sup>st</sup> floor classroom

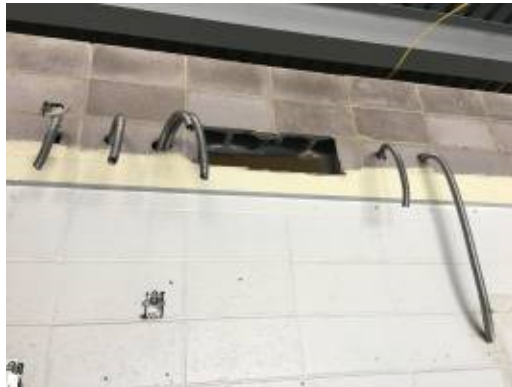
*20-28.02: 2017.09.28 – Conduits were observed extending out from classroom walls above ceiling line at first floor classrooms, indicating the electrician was working in conjunction with the mason.*

2017.09.28 – New electrical conduit in existing CMU classroom wall

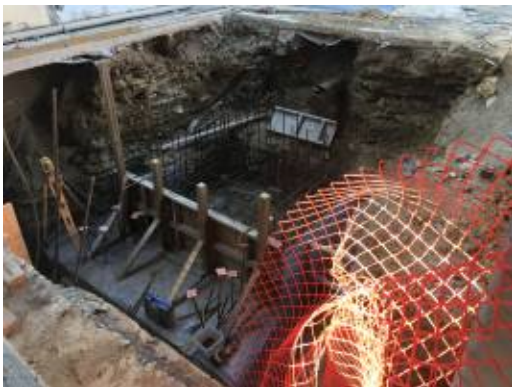
03.01: 2017.09.28 – Reinforcing and formwork were observed at the west end of the stairs to the basement, appearing ready for the next pour.

2017.09.28 – Formwork and reinforcing at west end of basement stairs

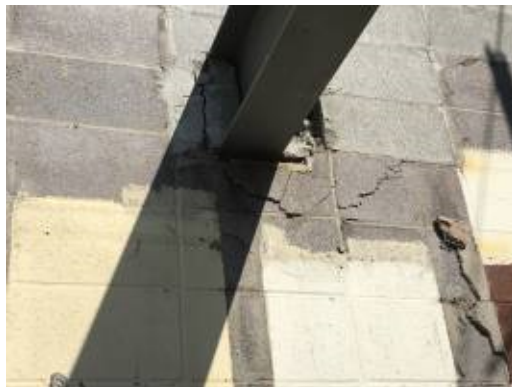
*05.01: 2017.09.28 – Damage was observed at the bearing end of an operable partition support beam.*

2017.09.28 – Damaged beam bearing to be repaired

*The contractor indicated a piece of equipment had impacted the support column at the other end. Repair was scheduled for the coming days.*

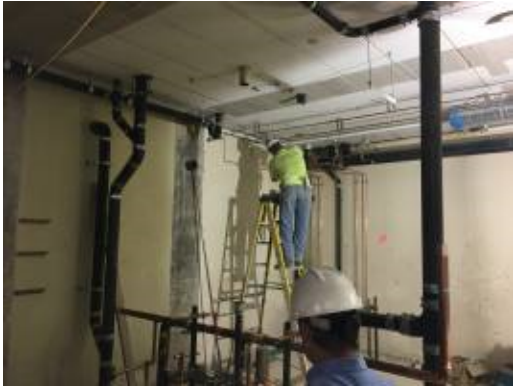
*20-28.03: 2017.09.28 – The plumber was actively working in the basement and appeared to be finalizing rough-in work through the slab above to the first floor.*

2017.09.28 – Plumber working at underside of 1<sup>st</sup> floor slab.

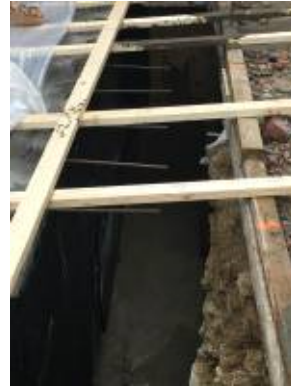
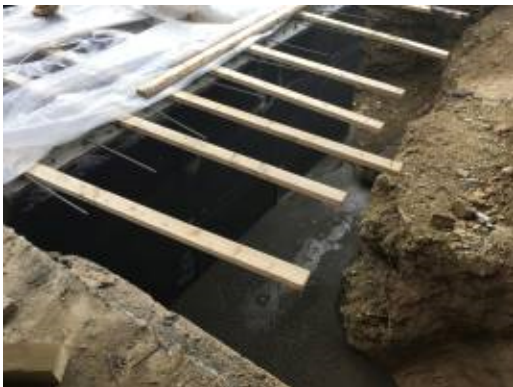
03.02: 2017.10.05 – Flowable fill was actively being poured around the concrete foundation of the basement stairs. Waterproofing was observed on the foundation walls.

2017.10.05 – Flowable fill and waterproofing at basement stairs

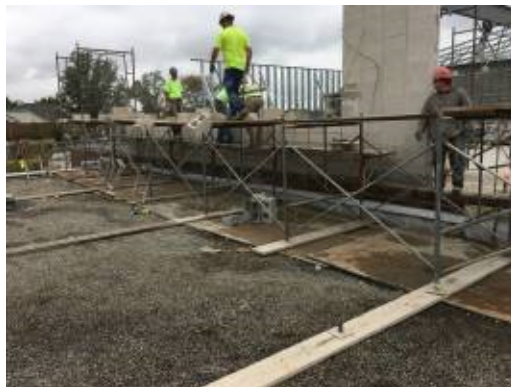
04.02: 2017.10.12 – Masons were actively working at the second floor south exterior wall of Phase 2 (along line EX-4). The CMU elevator shaft was complete as was the CMU wall along line EX-5.

2017.10.12 – Masons at 2<sup>nd</sup> floor, south end of Phase 2

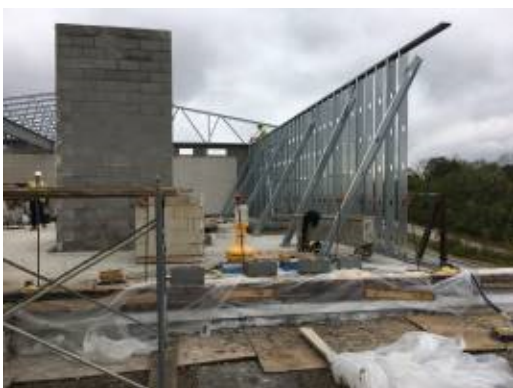
2017.10.12 – Stud framing and completed elevator shaft

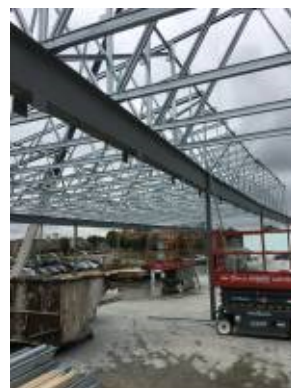
*05.02: 2017.10.12 – Cold form roof trusses were actively being installed from line EX-5 to the north. Cold form stud walls at the 2<sup>nd</sup> floor were framed and braced from line EX-4 to the north.*

2017.10.12 – Installed roof trusses

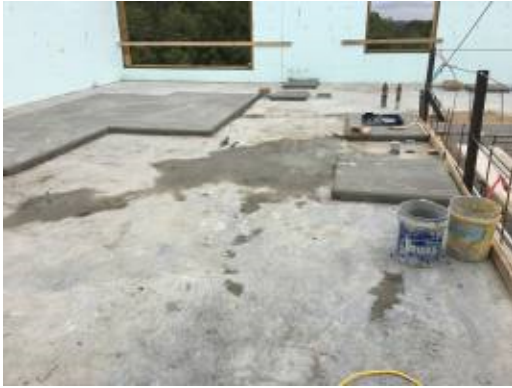
*20-28.04: 2017.10.12 – Housekeeping slabs had recently been poured at the northern most second floor mechanical room. The plumber was actively core drilling floor drain openings through the 2<sup>nd</sup> floor slab.*

2017.10.12 – Housekeeping pads at 2<sup>nd</sup> floor

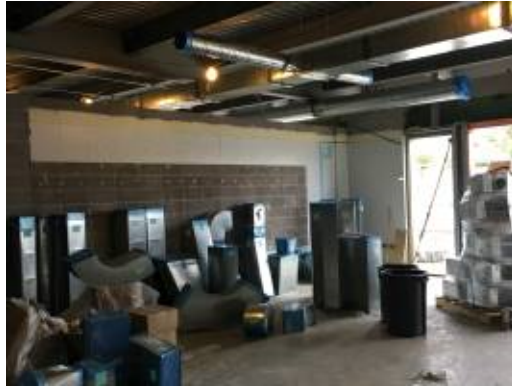
2017.10.12 – Ductwork at 1<sup>st</sup> floor

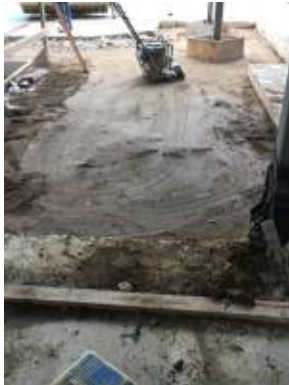
03.03: 2017.10.12 – Subgrade was being prepared and reinforcing dowels installed in preparation for infill slab on grade pour in the area of the southern stair.

2017.10.12 – Infill slab prep at 1<sup>st</sup> floor

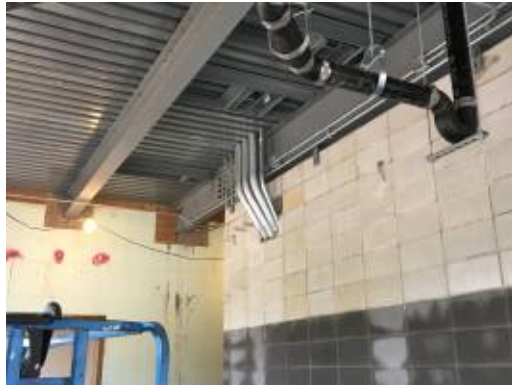
2017.10.12 – Conduit and plumbing below 2<sup>nd</sup> floor mechanical room

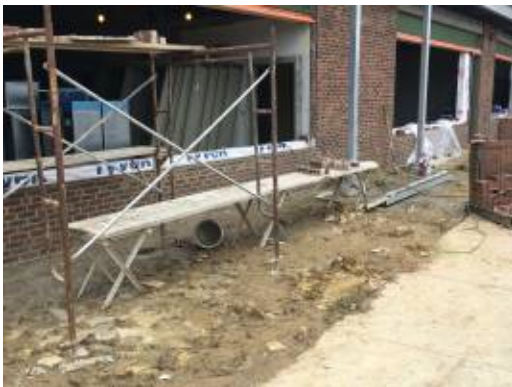
04.03: 2017.10.12 – Brick veneer around the west elevation window openings at existing walls was 90% complete.

2017.10.12 – Brick infill below window opening in existing wall

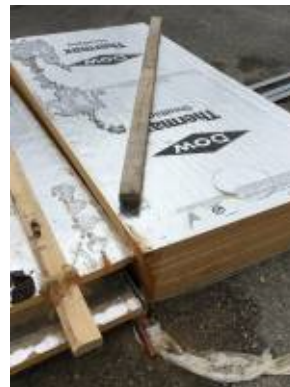
*07.02: 2017.10.12 – Insufficient / damaged insulation was observed on site. The contractor was advised to not utilize the insulation board on site.*

2017.10.12 – Rejected insulation sheathing

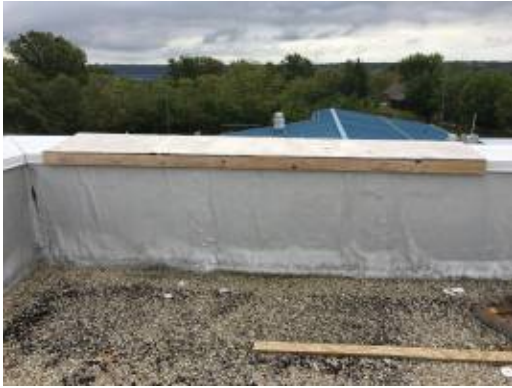
*07.01: 2017.10.12 – Deficiencies at Phase 1 metal wall panels and copings at the gymnasium were noted. The contractor was advised the District will initiate a third party assessment of the new wall insulation and the cost for that assessment will be back-charged to the contractor. Any remediation required will be at the contractor's expense. Additional issues at Phase 1 flat roof areas and incomplete lightning protection were also noted and the contractor given 10 days to address.*

2017.10.12 – Incomplete Phase 1 coping

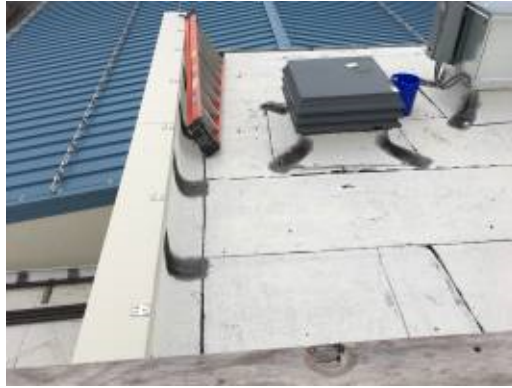
2017.10.12 –Needed cleanup at Phase 1 roof

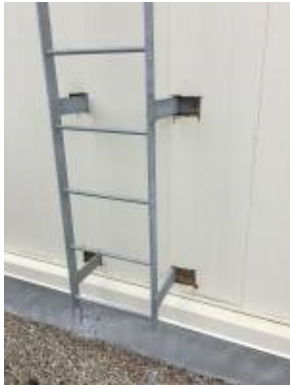
2017.10.12 – Improper ladder installation at new gym wall panels

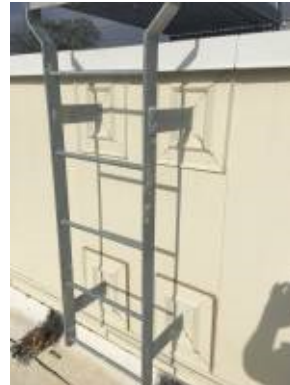
2017.10.12 – Proper ladder installation at new gym wall panels

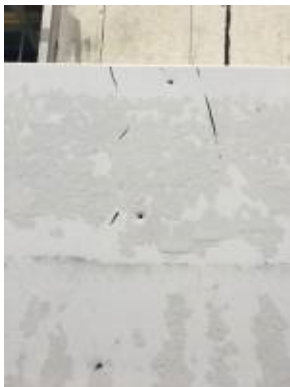
2017.10.12 – Holes in exg coping potentially allowing water into new wall insulation

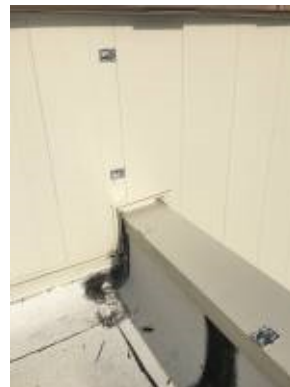
2017.10.12 – Incomplete Phase 1 lightning protection
