FIELD OBSERVATION REPORT 2017.12

■ TO:	Kenton County Board of Education 1055 Eaton Drive Ft. Wright, KY 41017	■ DATE:	2017.12.08
ATTENTION:	Mr. Rob Haney		
■ FROM:	Mark Perry mperry@pca-arch.com 1881 Dixie Highway, Suite 130 Fort Wright, KY 41011 V: 859.431.8612 • F: 859.431.8611	■ PROJECT:	Kenton County School District Ft. Wright Elementary
COPIES TO:	Mr. Danny Mann	PROJECT NO.:	2014-112

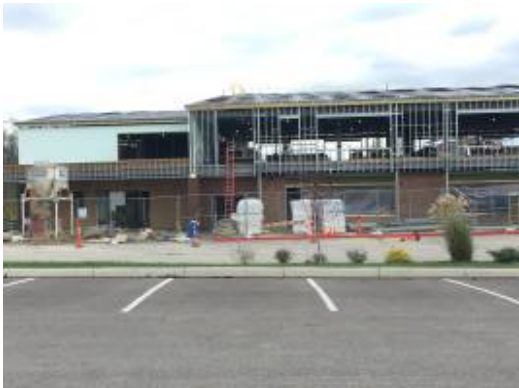
2017.11.18 West elevation

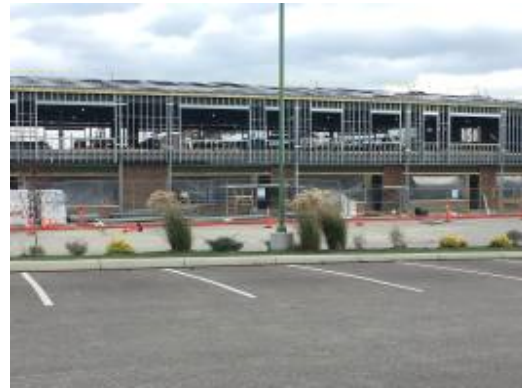
2017.11.18 West elevation

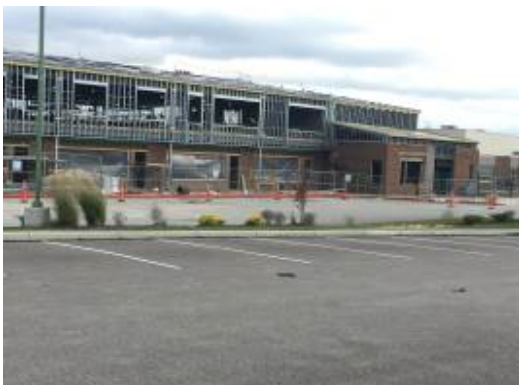
2017.11.18 – West elevation

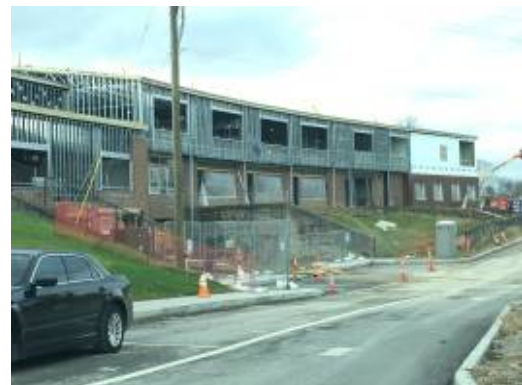
2017.11.18 East elevation

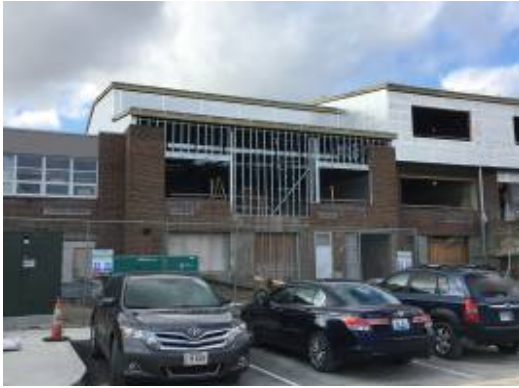
2017.12.07 East elevation

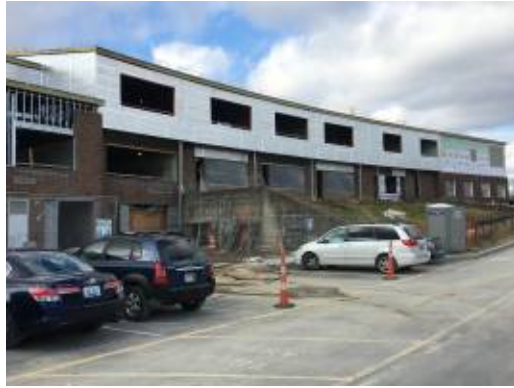
2017.12.07 East elevation

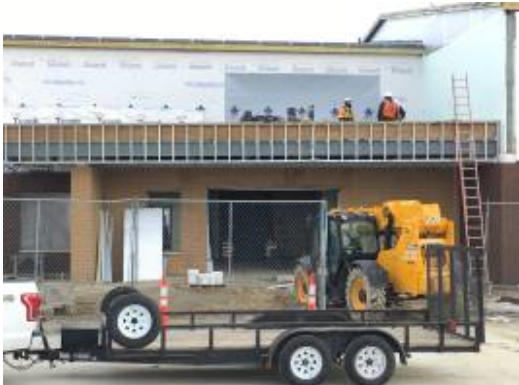
07.01: 2017.12.07 – The roofer was actively working on the flat roof install over the new entry. The single story shed roof areas to receive metal were dried in. Exterior walls to receive metal were 95% sheathed and taped. The contractor was actively working on some miscellaneous insulation infill and soffit insulation in advance of final taping and spray insulation scheduled for the following week.

2017.12.07 – Roofers at entry

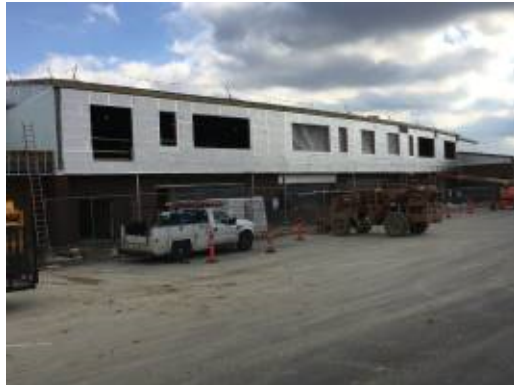
2017.12.07 West elevation

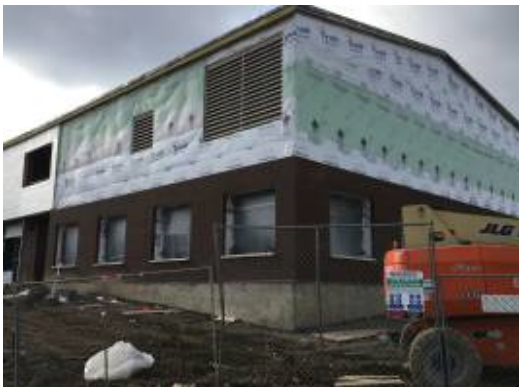
2017.12.07 Northeast corner

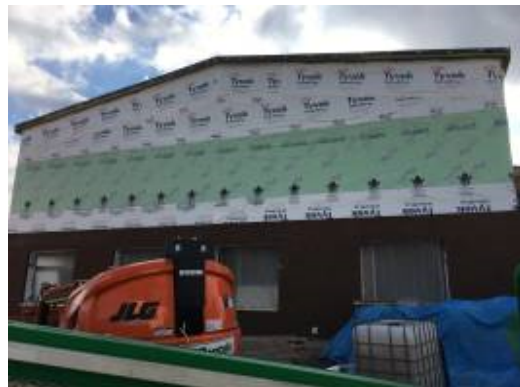
2017.12.07 North elevation

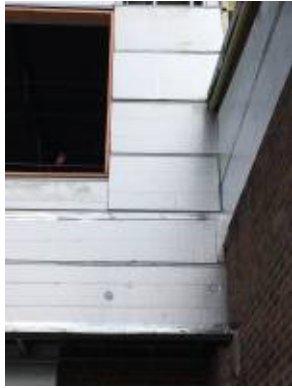
2017.12.07 – Untaped insulation near former entry

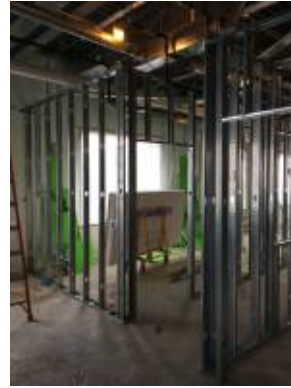
2017.12.07 – Admin area stud framing

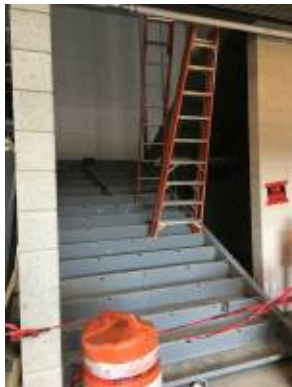
05.02: 2017.12.07 – All metal deck and steel work appeared complete. A steel worker was actively welding in the area of the north monumental stair. The upper flight of this stair as well as the middle egress stair were being re-fabricated to correct errors in the original fabrication preventing installation. According to the contractor the refabricated sections were expected in the coming days.

2017.12.07 – Monumental stair

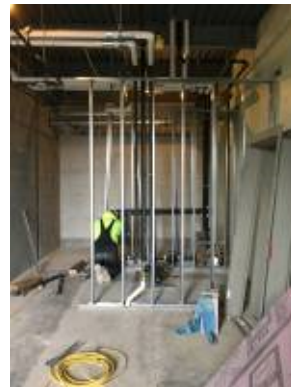
2017.12.07 – Plumber at staff restroom

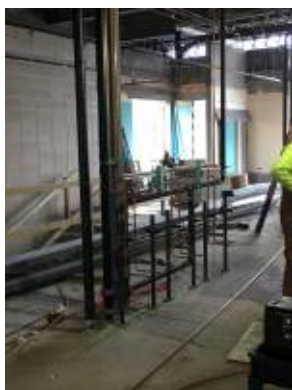
20-28.01: 2017.12.07 – Ductwork was essentially complete at the lower level. Main runs at the upper level were approximately 50% complete. The plumber was actively working at the restroom gang on the 1st floor, completing above slab work in what will be the chase walls in advance of the mason. Piping rough-in to the upper level appeared complete. Wiring pulls at the first floor were observed. The electrician was actively working at the second floor completing conduit rough-ins in advance of the masonry walls.

2017.12.07 – 1st floor restroom gang

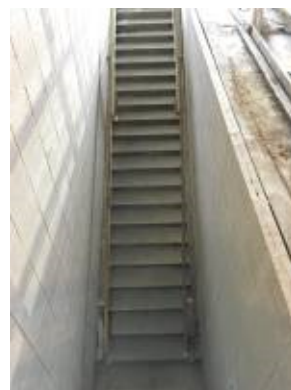
2017.12.07 – Stairs up from basement
