FIELD OBSERVATION REPORT

2018-08 (Scott HS)

■ TO:	Kenton County Board of Education 1055 Eaton Drive Ft. Wright, KY 41017	■ DATE:	2018.08.29
ATTENTION:	Mr. Rob Haney		
■ FROM:	Mark Perry mperry@pca-arch.com 1881 Dixie Highway, Suite 130 Fort Wright, KY 41011 V: 859.431.8612 • F: 859.431.8611	■ PROJECT:	Kenton County School District Scott High School – Phase IV
COPIES TO:	Mr. David Lloyd, Mr. Danny Mann, Ms. Carrie Hooten	PROJECT NO.:	2016-124

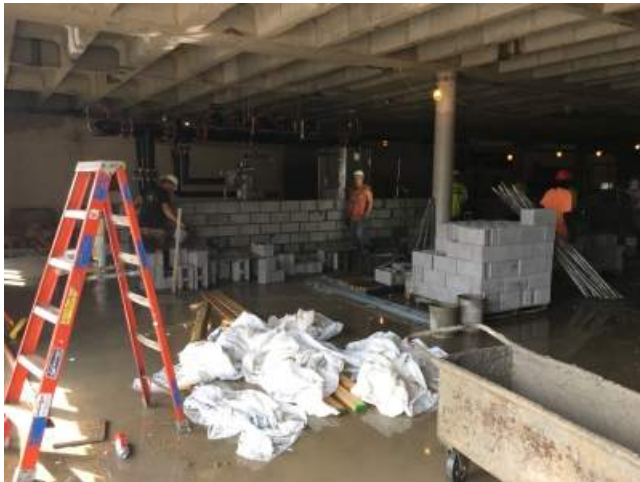
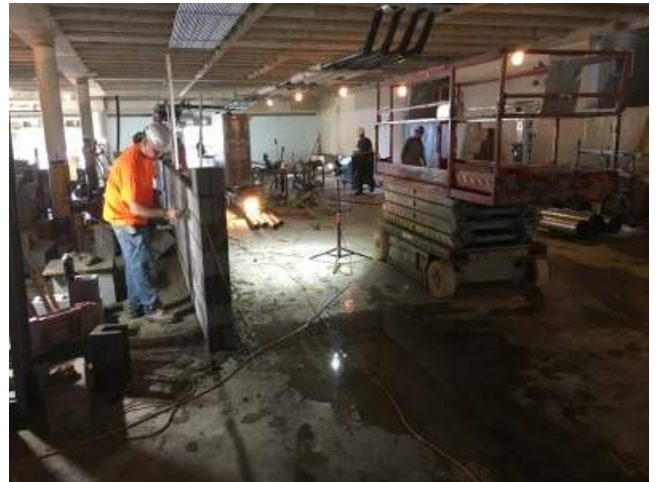
the underside of structural framing. The mason was actively working on the Lower Level in the area of the existing electric room.

2018.07.31 – Masonry installation @ lower level.

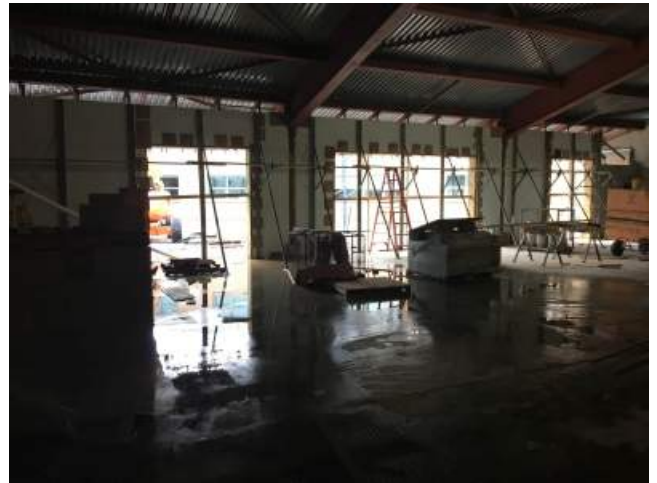
2018.07.31 – ICF @ multipurpose room.

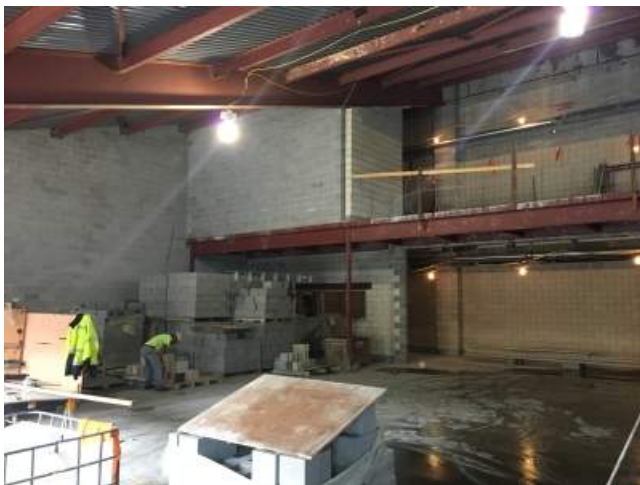
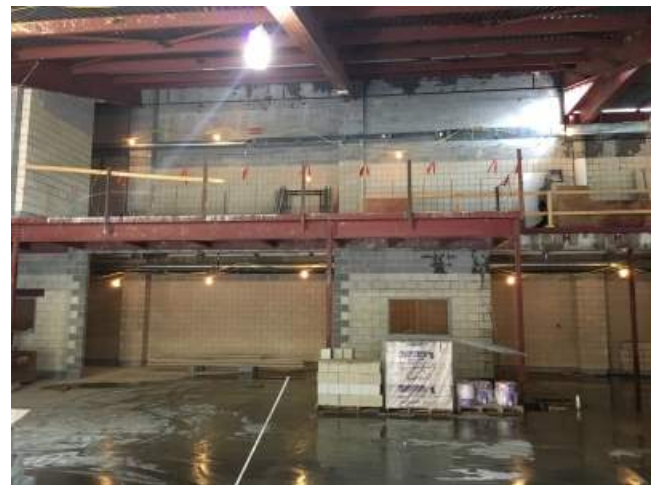
04.01: 2018.07.31 – Interior masonry walls at the west end of the multi-purpose room were complete, including the 2nd floor mechanical room. Masonry at the extents of floor infill to the east was also complete to

2018.07.31 – Completed masonry @ multipurpose room.

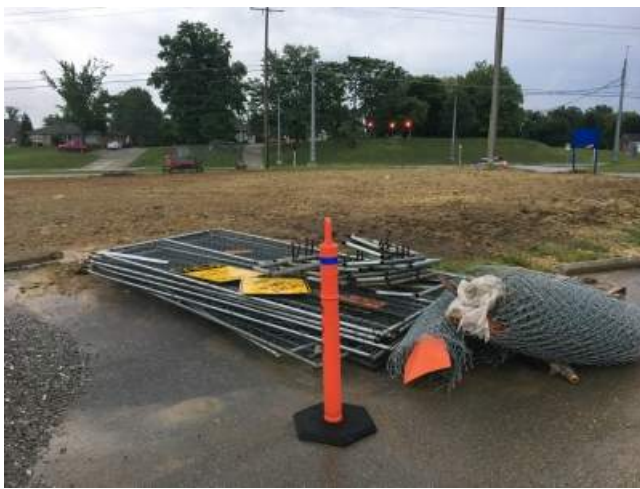
31.01: 2018.08.08 – The earth berm along Lonneman drive had been cut down meaning utility relocation was complete as well. DGA for the contractor lay-down area was in place. Excavation had also occurred along the south wall in advance of forming and pouring the new brick ledge.

2018.08.08 – Earth berm removed.

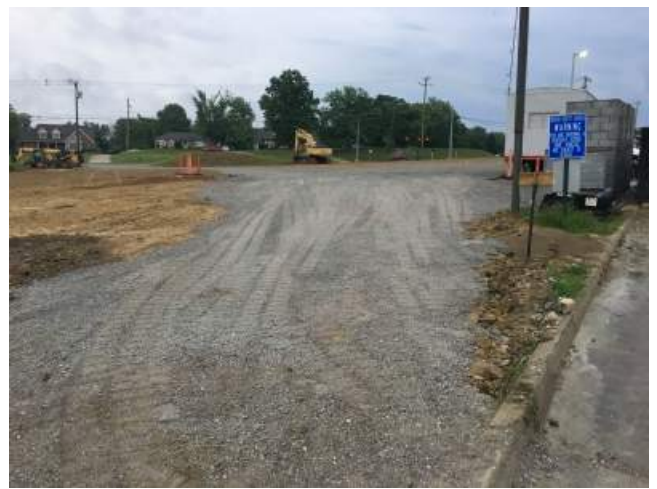
2018.08.08 – Lay-down area ready for use.

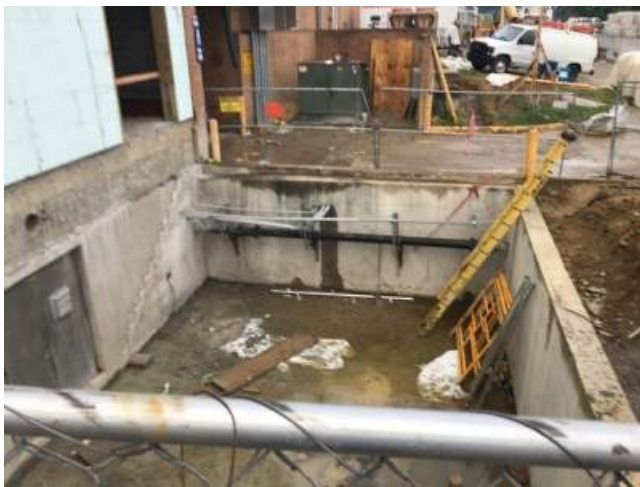
20-28.01: 2018.08.08 – The new water service main was in place through the former cooling tower area well and into the basement.

2018.08.08 – New fire main into basement.

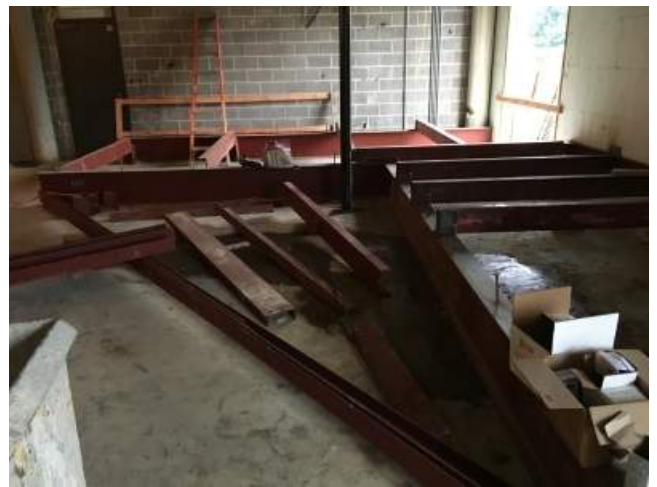
05.01: 2018.08.08 – Structural steel framing at the corridor ramp outside the band room was 60% complete.

2018.08.08 – Band corridor ramp framing.

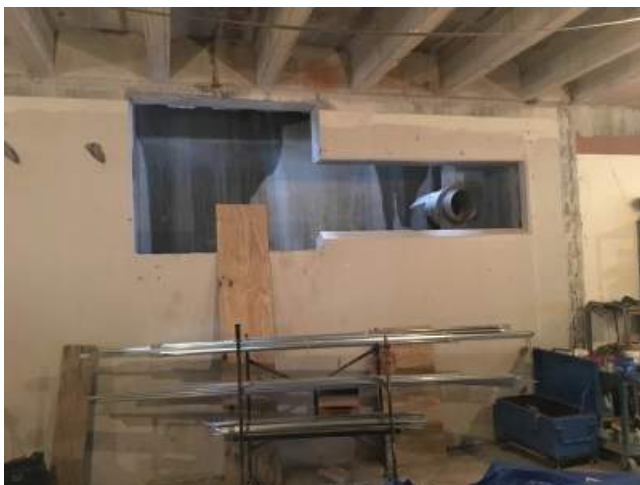
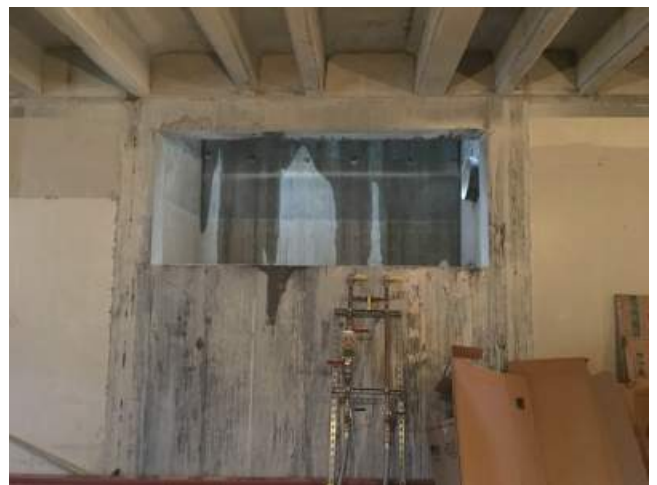
02.01: 2018.08.08 – New openings into the existing area wells had been cut.

2018.08.08 – New opening into area well.

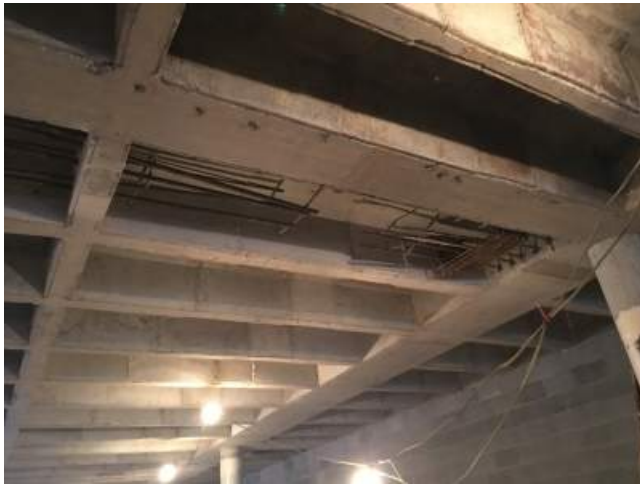
03.02: 2018.08.08 – Reinforcing was actively being installed at the underside of the upper level slab.

2018.08.08 – Reinforcing at underside of floor slab.

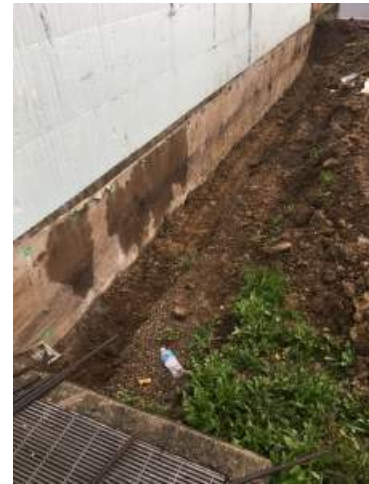
2018.08.08 – Excavation for new brick ledge.

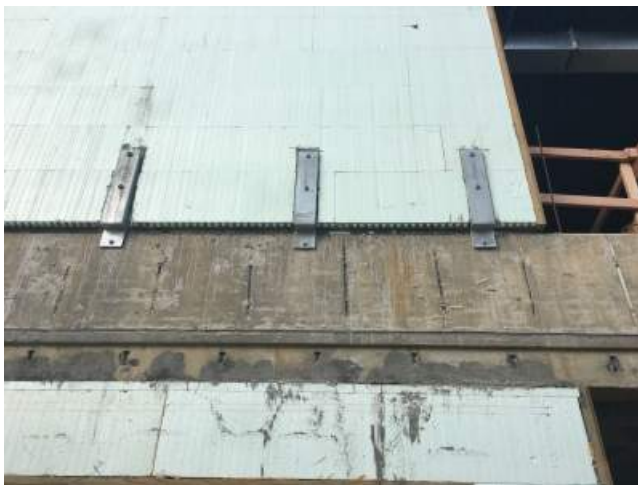
05.02: 2018.08.21 – Several steel channel supports for upper level brick ledge angles had been installed along Lonneman Drive. Steel framing at courtyard door canopies had been installed. Steel ties had also been installed to brace the lower level wall to the existing concrete structure.

2018.08.21 – Steel channel supports for brick ledge.

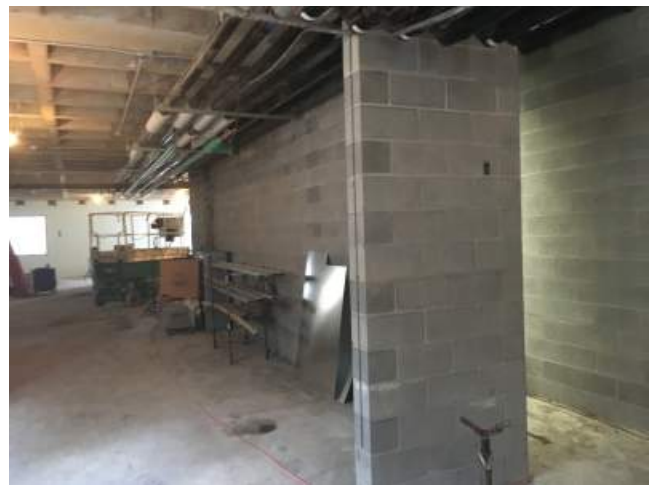
04.03: 2018.08.21 – Portions of masonry walls had been installed in the area of the lower level mechanical room as well as the larger electrical/mechanical room in order to facilitate the installation of electric panels. The mason was actively working in the latter area to extend walls towards the corridor. Five courses of wall were also in place at the band corridor ramp. Portions of masonry walls had also been installed at the upper level mechanical room and between classrooms at the northeast corner. Crews were actively working along the north wall of the north classroom corridor.

2018.08.21 – Masonry wall @ electrical/mechanical room.

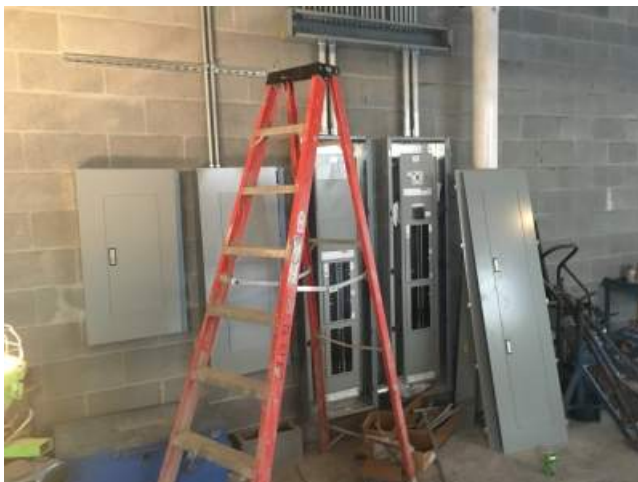
20-28.02: 2018.08.21 – Four electric panels had been installed at the lower level electrical/mechanical room. Other gear was staged for installation. New electrical conduit had been installed at the underside of the structure in this area as well as in the multipurpose room.

2018.08.21 – New electric panels.

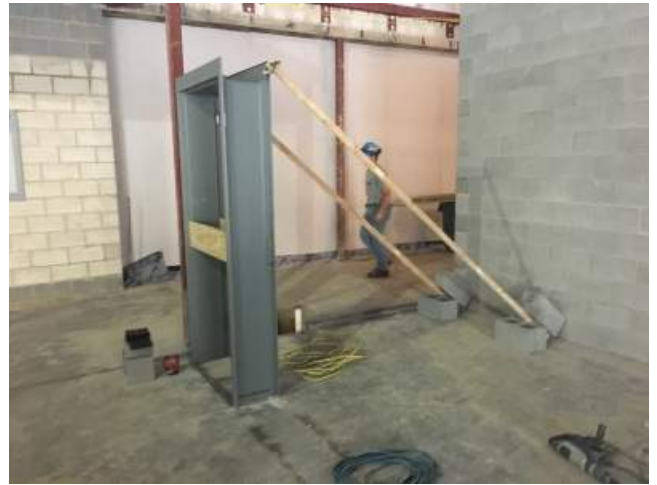
08.01: 2018.08.21 – The large multi-purpose room door frame was in place. Interior door frames along the east side were in place and braced in advance of scheduled masonry wall work. Door and window frames were staged for installation throughout the lower and upper levels. It appeared all interior frames had been delivered.

2018.08.21 – Door frame set and braced.

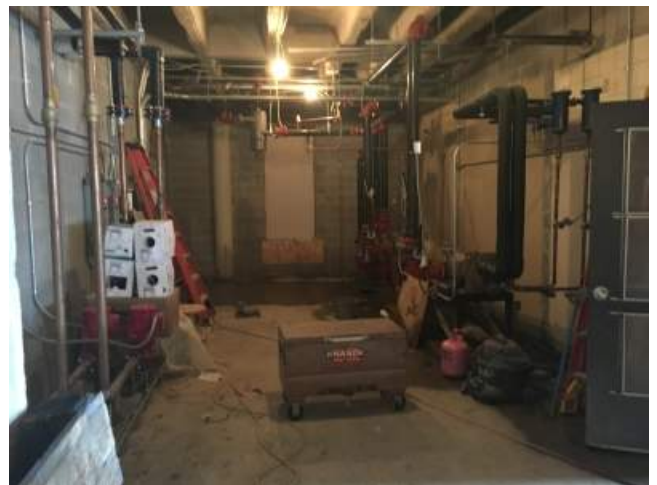
20-28.03: 2018.08.21 – The Beechgrove chiller was actively running. Ductwork had been installed in the vicinity of the upper level mechanical room and down the north classroom corridor.

2018.08.21 – Parts of the Beechgrove chiller installed.

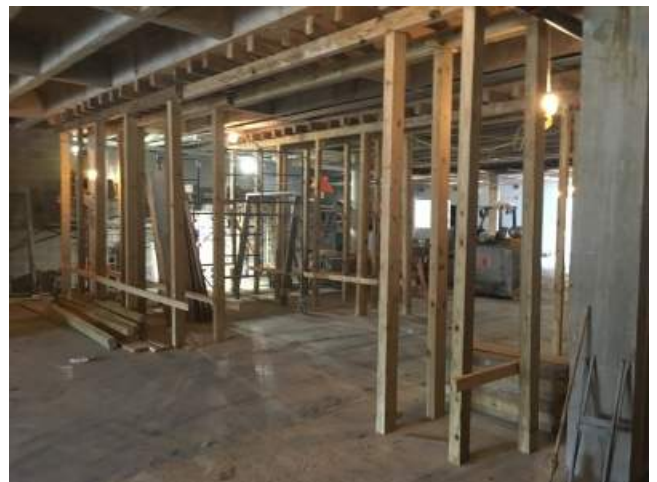
03.03: 2018.08.21 – Shoring was still in place below two of the five upper level slab reinforcing areas.

2018.08.21 – Shoring under new slab reinforcing.

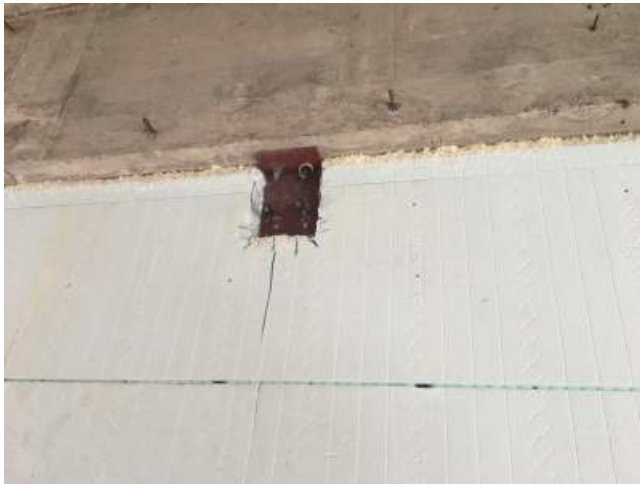
03.01: 2018.07.31 – ICF walls at the courtyard had been poured with the exception of an access opening to be poured at a later date. Bracing was still in place along the east courtyard wall. Lower level ICF walls along Lonneman Drive had also been poured with bracing still in place. Upper level walls were also complete except for access openings to be poured at a later date.

2018.08.21 – Lateral bracing at ICF along Lonneman.

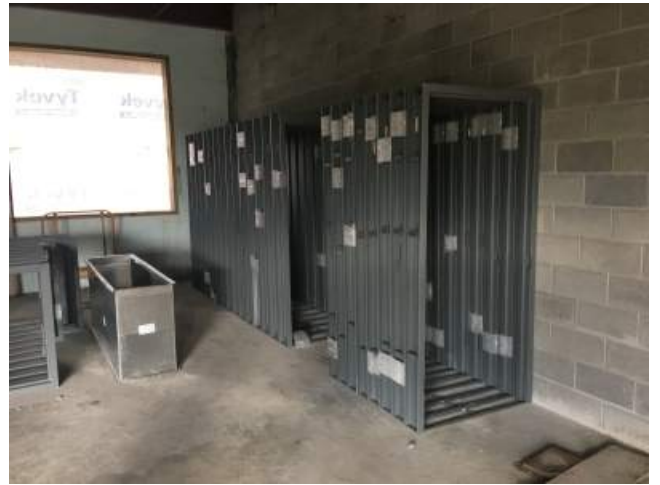
2018.08.21 – Hollow metal frames staged for installation.

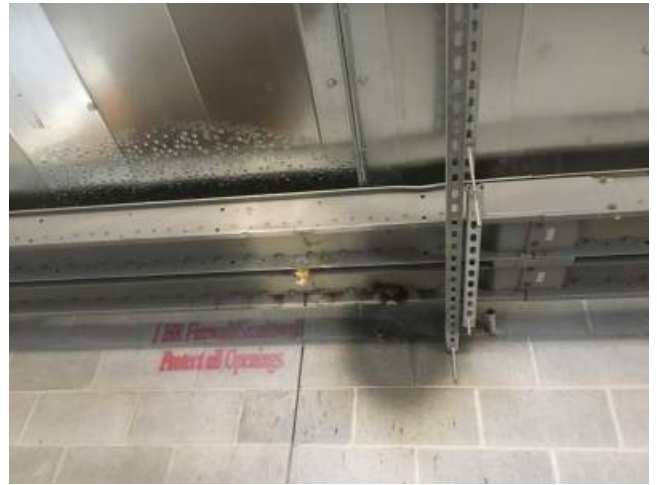
20-28.04: 2018.08.22 – Existing electric bus duct running through the area of renovation failed at some point during the overnight hours of the 21st/22nd. The failure appeared to be a short to ground in the vicinity of the doors into the auditorium sound booth. Distribution to the existing mechanical platform above the existing locker rooms was lost. As such, no mechanical equipment in the un-renovated spaces was operational and some power/lighting was lost in portions of those spaces as well.

2018.08.22 – Failed electric bus duct.

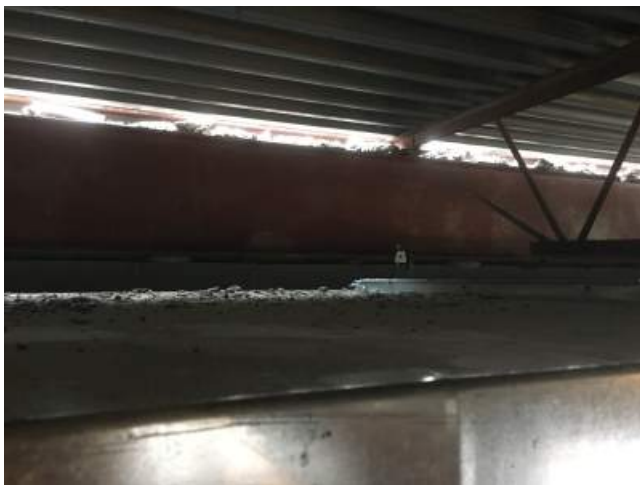
2018.08.22 – Daylight visible at wall above failure.

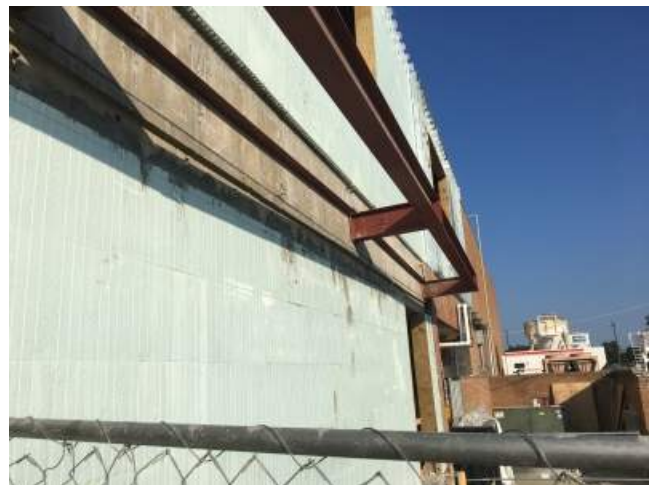
05.03: 2018.08.28 – Metal stud furring was being installed along Lonneman Drive. Structural steel was in place at the canopy.

2018.08.28 – Steel framing at canopy.

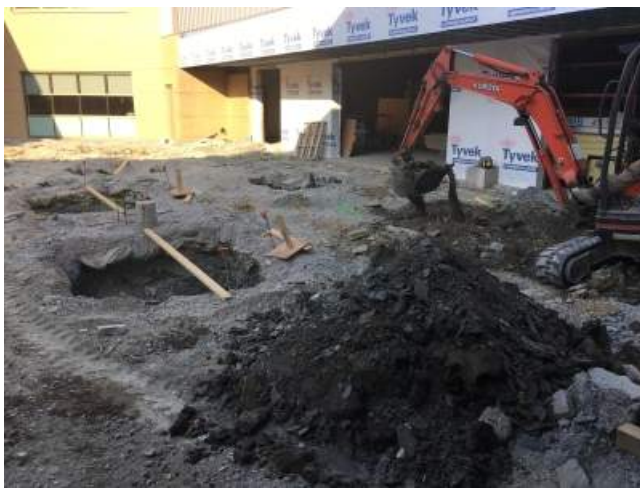
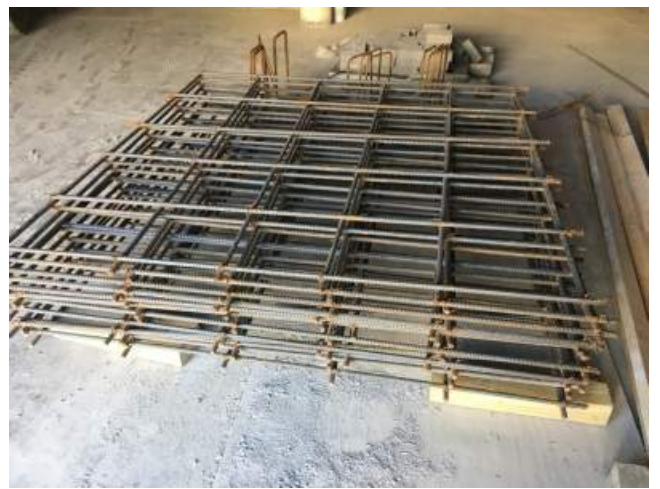
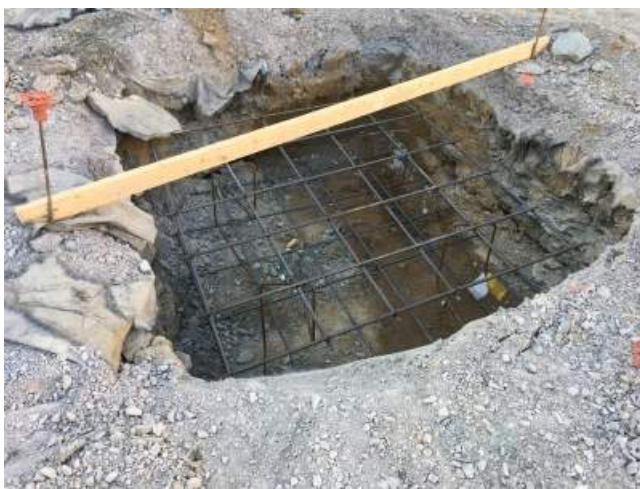
03.04: 2018.08.28 – Reinforcing steel was in place at several of the courtyard shade structure footings and rebar was staged for installation at others.

31.02: 2018.08.28 – Footing excavation for the courtyard shade structures was actively occurring. All but the final footing had been excavated.

2018.08.28 – Shade structure footing excavation.

2018.08.28 – Reinforcing for shade structure footings.

2018.08.28 – Shade structure footing prepared.

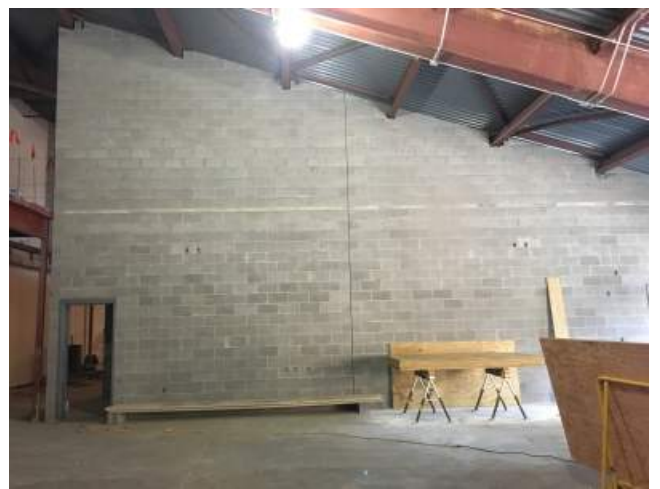
04.04: 2018.08.22 – The east wall of the multipurpose room was complete to the roof deck. A crew was actively working on the east wall of the north/south corridor outside of the temporary lower level corridor. Multiple crews were working on upper level corridor walls around the center mechanical/restroom core.

2018.08.28 – East wall of multipurpose room.

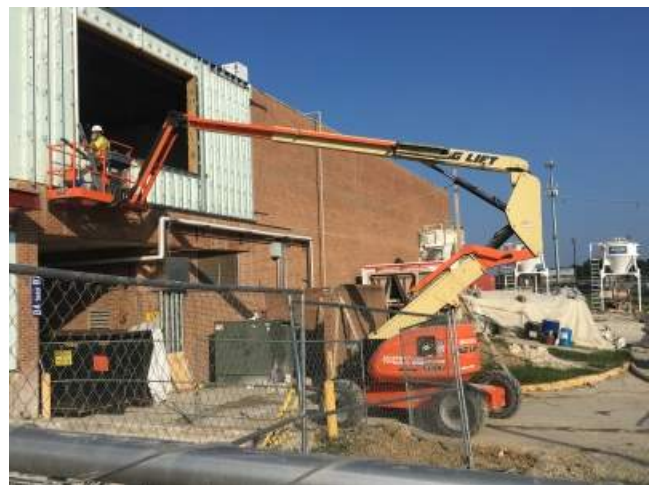
2018.08.28 – Installation of exterior furring.

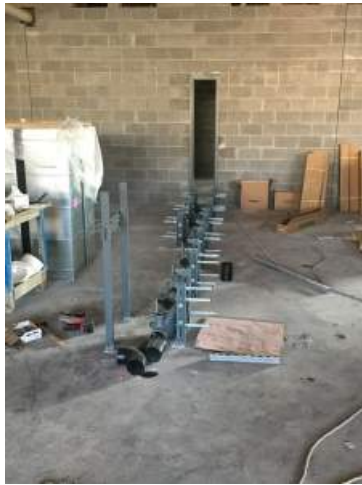
2018.08.28 – Plumbing carriers @ upper level.

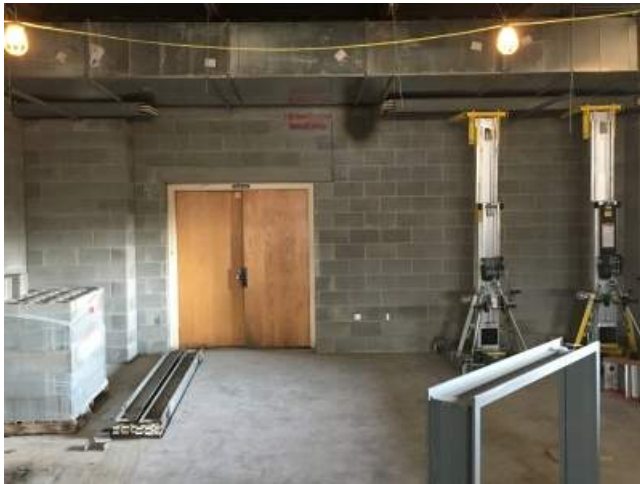
2018.08.28 – Bus duct failed section removed.

20-28.05: 2018.08.28 – Fixture carriers were in place at the upper level restrooms. The damaged section of bus duct had been removed.
