FIELD OBSERVATION REPORT

2018-09 (Scott HS)

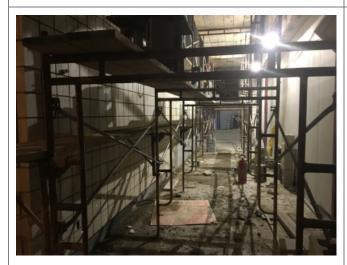
04.02: 2018.09.17 – The south wall of the monumental stair was complete up to the 2nd floor line.

2018.09.17 - South wall of monumental stair.
