FIELD OBSERVATION REPORT

2018.10

■ TO:	Kenton County Board of Education 1055 Eaton Drive Ft. Wright, KY 41017	■ DATE:	2018.10.23
ATTENTION:	Mr. Rob Haney		
■ FROM:	Ralph Cooper rcooper@pca-arch.com 1881 Dixie Highway, Suite 130 Fort Wright, KY 41011 V: 859.431.8612 • F: 859.431.8611	■ PROJECT:	Kenton County School District Hinsdale Elementary
COPIES TO:	Mr. Danny Mann	PROJECT NO.:	2017-074

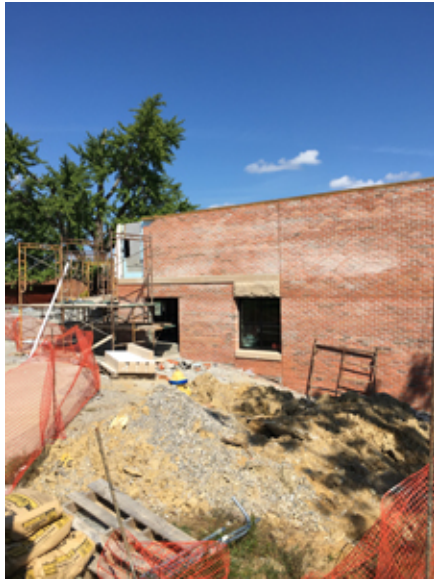
2018.10.01 – Installation of the exterior masonry is nearly complete.

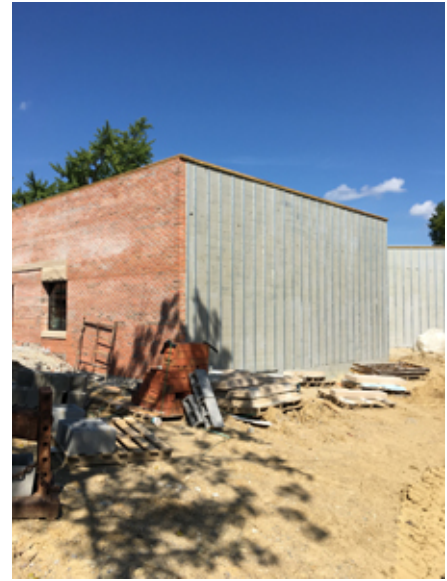
2018.10.01 – Installation of the exterior masonry is nearly complete.

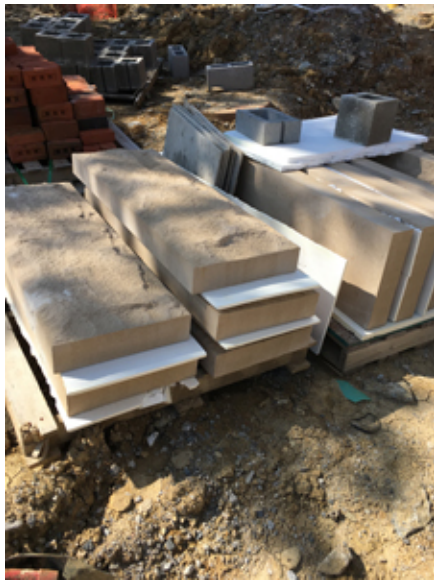
2018.10.01 – Cast stone for installation over the entry canopy.

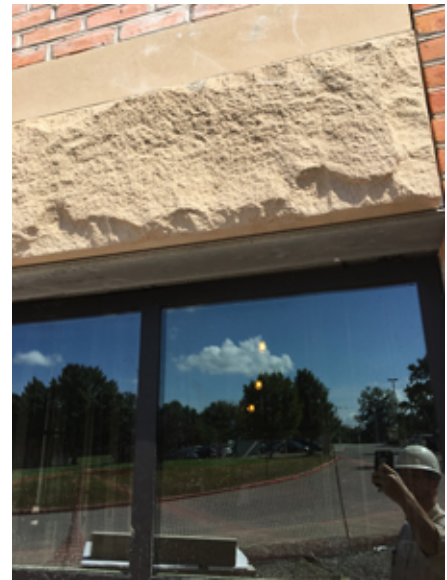
2018.10.01 – Detail of the cast stone over the Conference Room window.

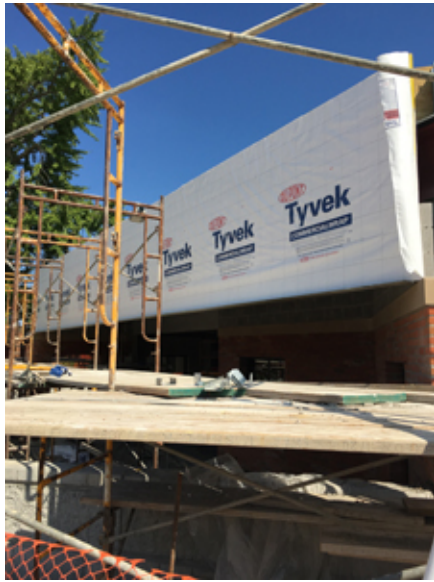
2018.10.01 – The framing and weather barrier has been installed at the entry canopy.

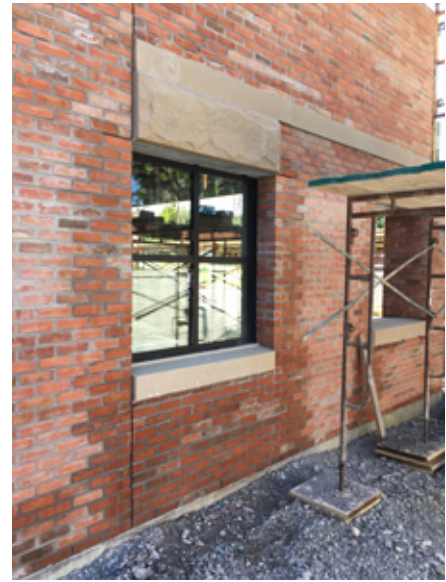
2018.10.01 – View of the masonry on the north side of the building.

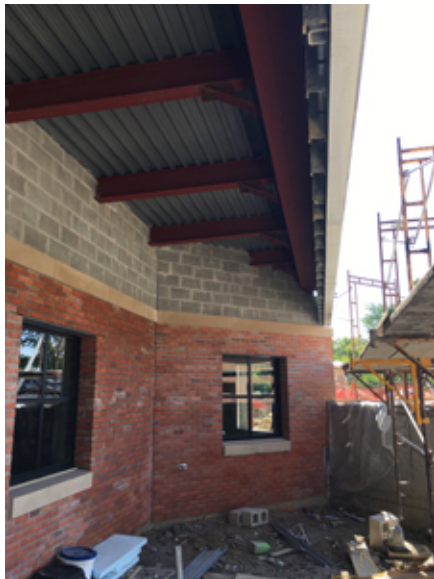
2018.10.01 – View under the entry canopy.

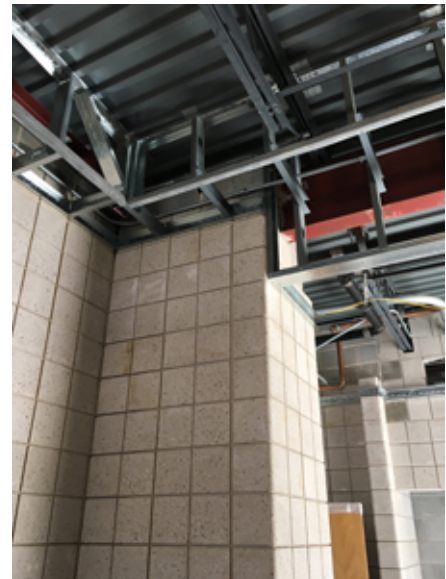
2018.10.01 – View of bulkhead in the Lobby area.

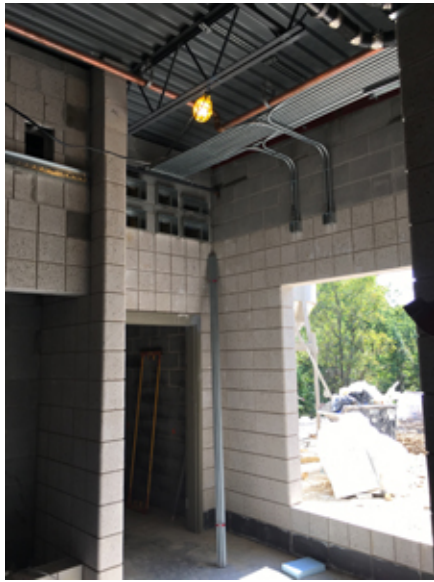
2018.10.01 – View of the Lobby Area near the Mechanical Room.

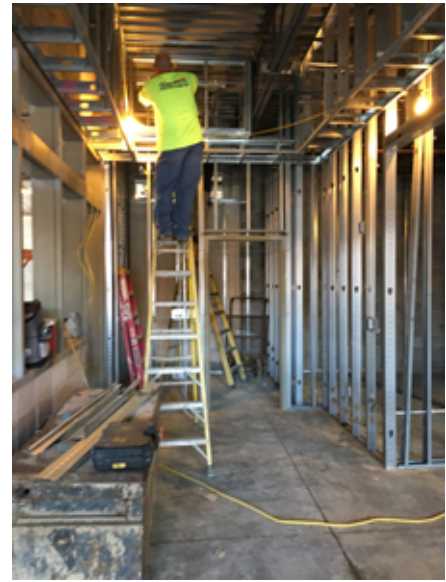
2018.10.01 – View of metal stud framing within the Office Area.

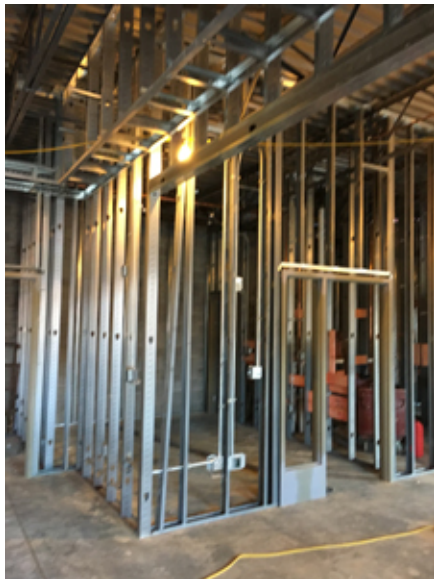
2018.10.01 – View of metal stud framing within the Office Area.

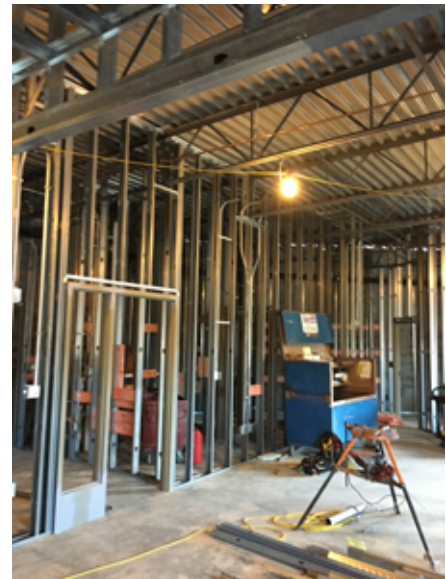
2018.10.01 – View of metal stud framing within the Office Area.

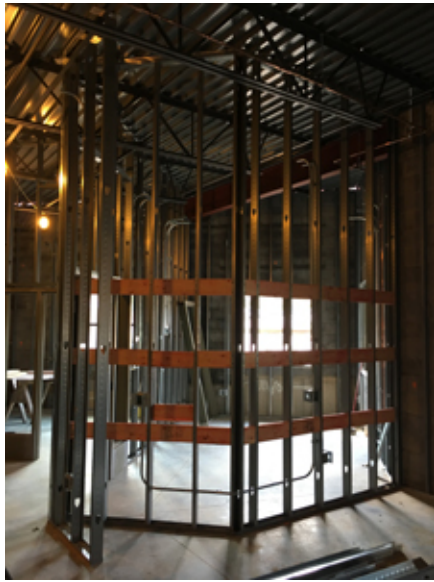
2018.10.01 – View of metal stud framing within the Office Area.

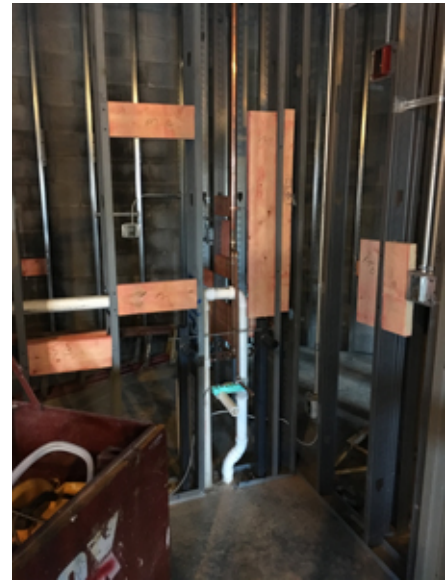
2018.10.01 – View of metal stud framing within the Office Area.

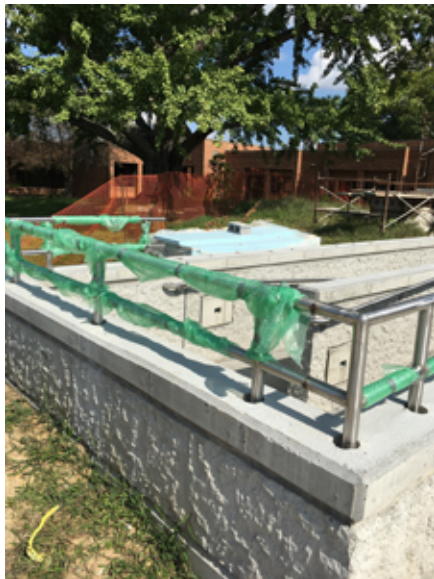
2018.10.01 – Installation of the stainless steel handrails and guards has started.

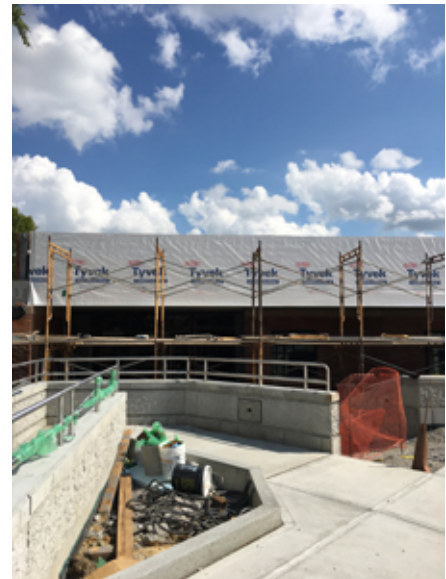
2018.10.01 – The framing and weather barrier has been installed at the entry canopy.

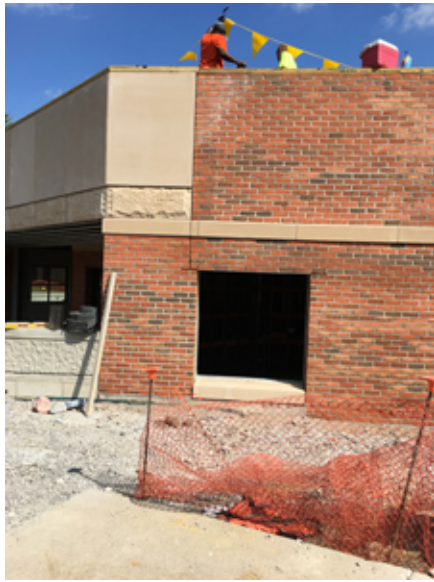
2018.10.08 – View of cast stone over the main entry canopy.

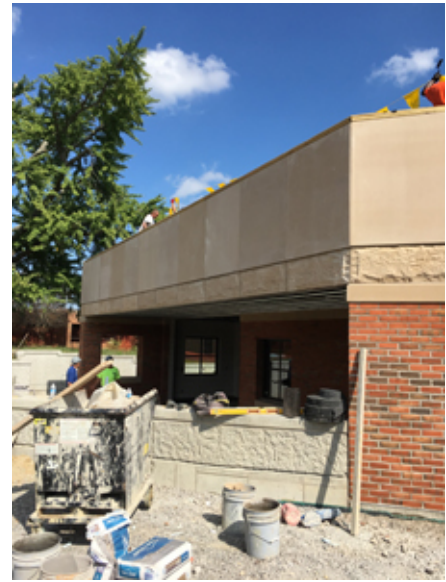
2018.10.08 – View of cast stone over the main entry canopy.

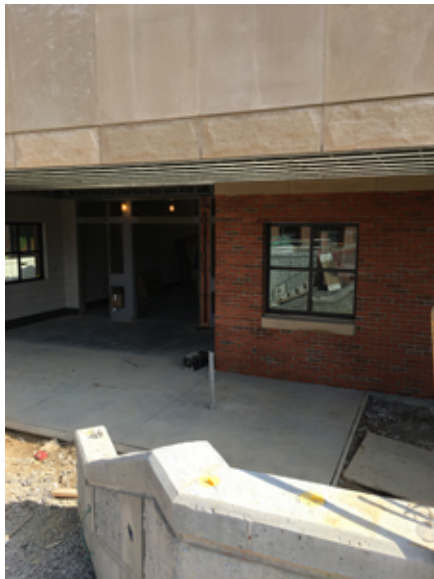
2018.10.08 – View of cast stone over the main entry canopy.

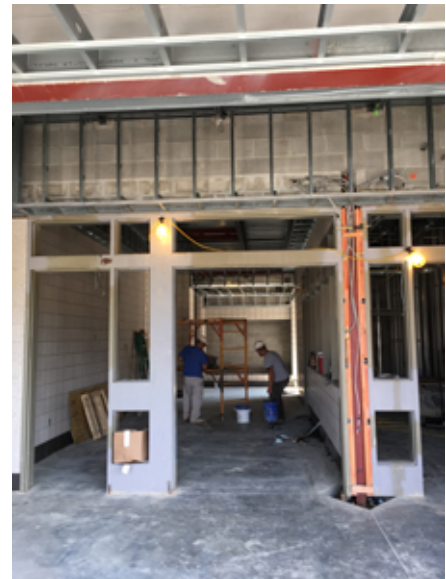
2018.10.08 – View of secure vestibule from the exterior.

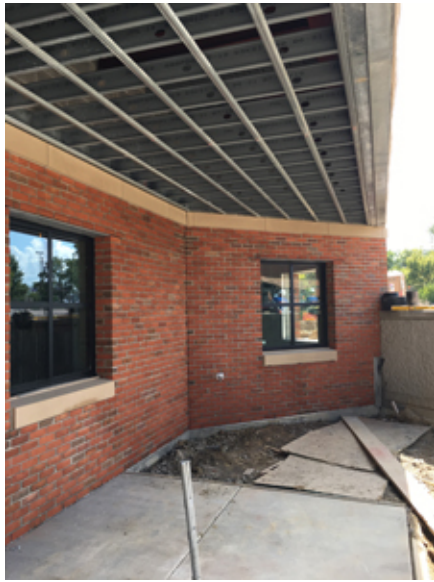
2018.10.08 – View of soffit framing at main entry canopy.

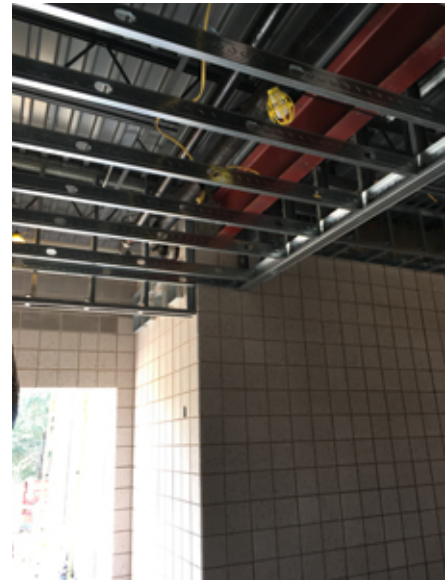
2018.10.08 – View of ceiling framing near the display case.

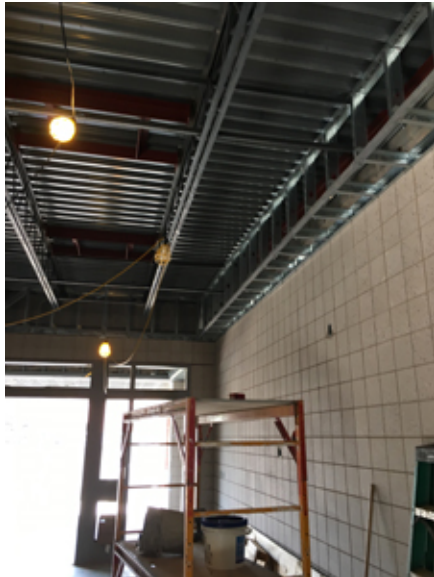
2018.10.08 – View of bulkhead framing in the Lobby Area.

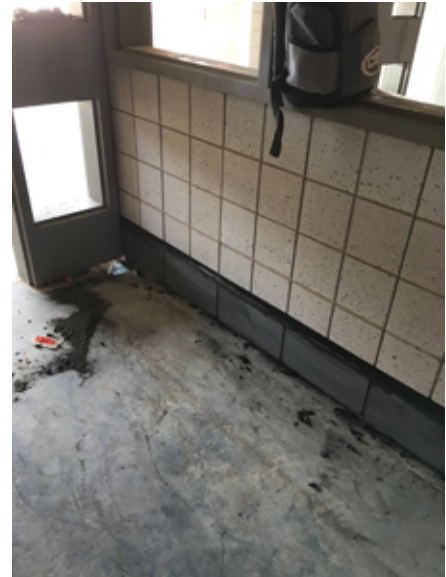
2018.10.08 – Installation of the structural glazed tile base in the Lobby Area is in progress.

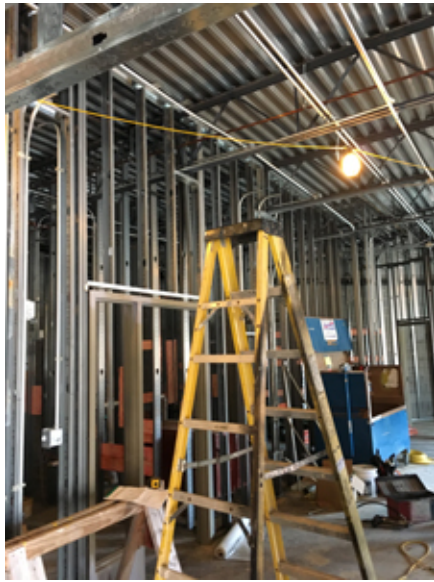
2018.10.08 – Installation of the office framing continues.

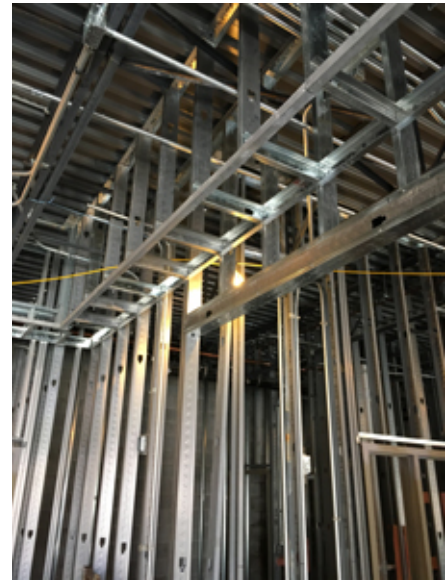
2018.10.08 – Installation of the office framing continues.

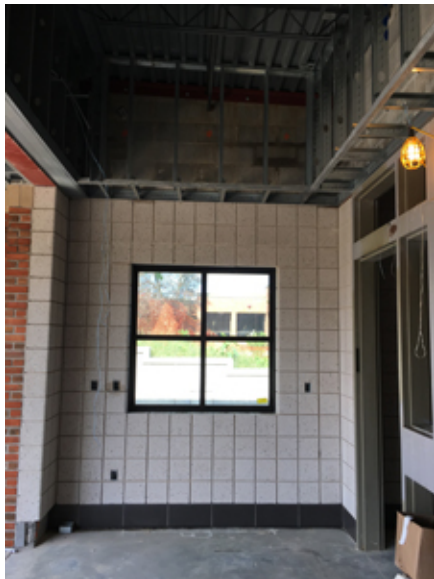
2018.10.08 – View looking north from the Secure Vestibule

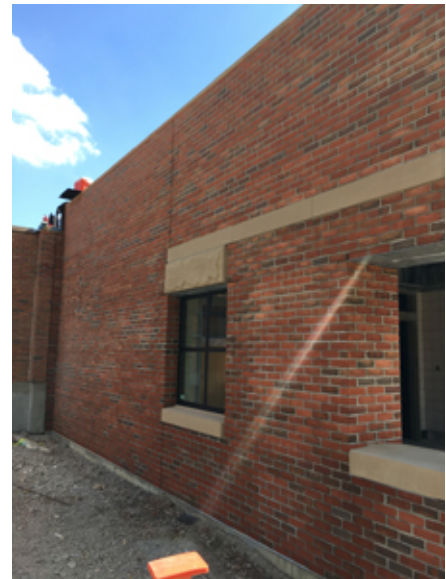
2018.10.08 – View of the north wall of the addition.

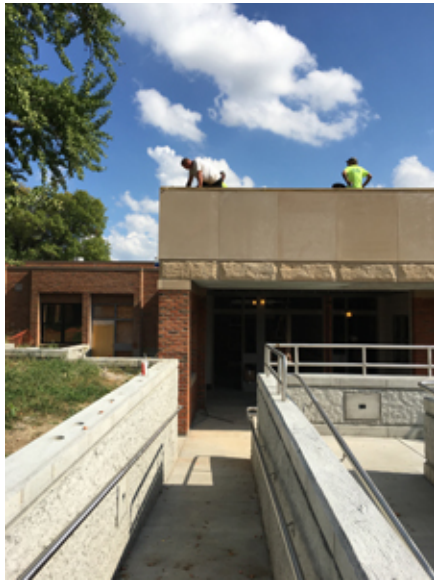
2018.10.08 – View of the new entrance as seen from the ADA accessible ramp.

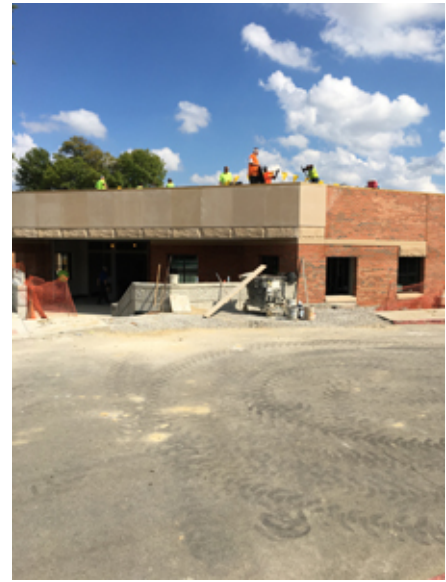
2018.10.08 – View of the addition as seen from the loop drive.

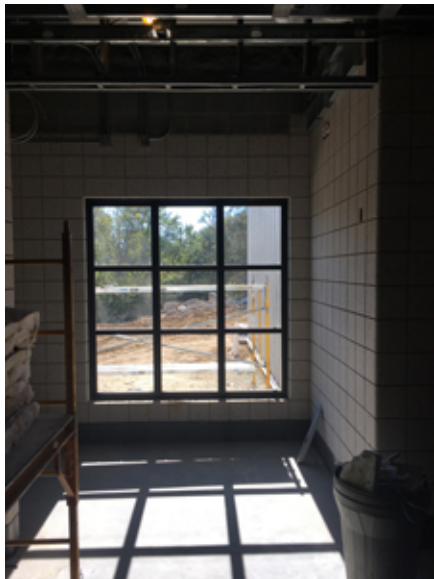
2018.10.23 – View of window at south elevation as seen from the display case.

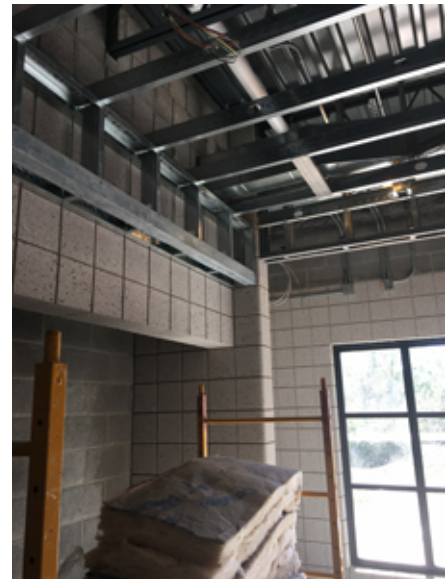
2018.10.23 – View of ceiling framing at the display case.

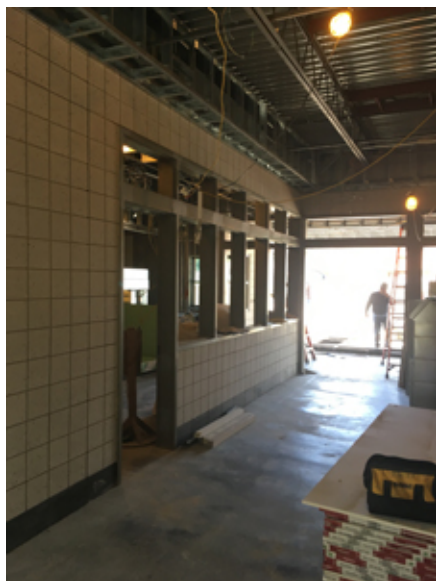
2018.10.23 – View of Lobby Area looking towards the entry area.

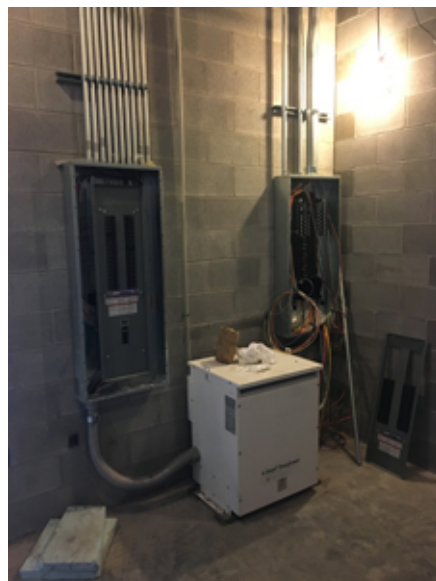
2018.10.23 – The electric panels and transformer have been installed.

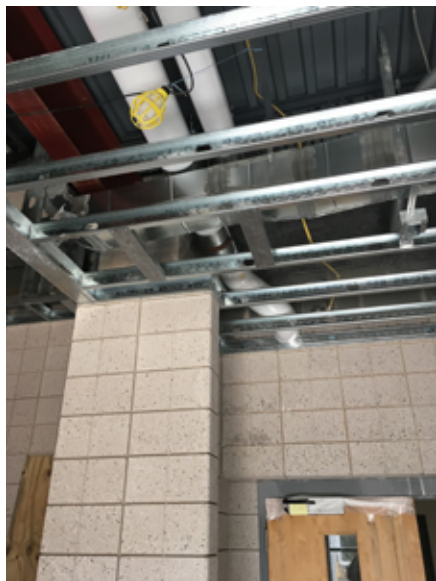
2018.10.23 – View of ceiling framing near the display case.

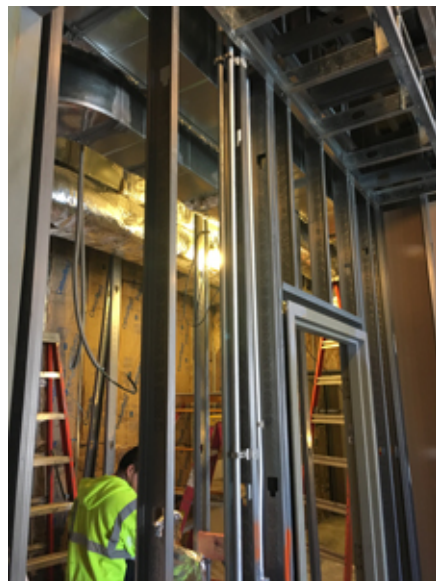
2018.10.23 – View of insulated ductwork installed in the office area.

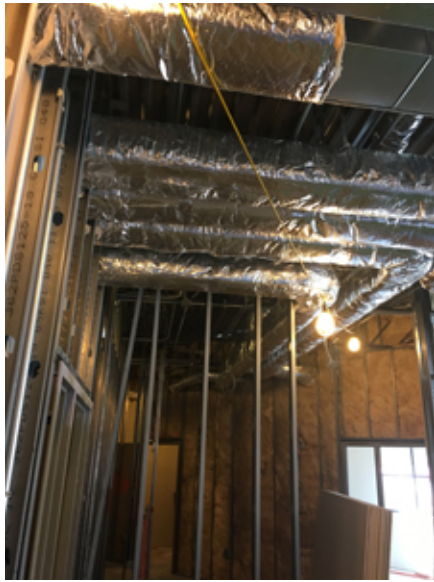
2018.10.23 – View of insulated ductwork installed in the office area.

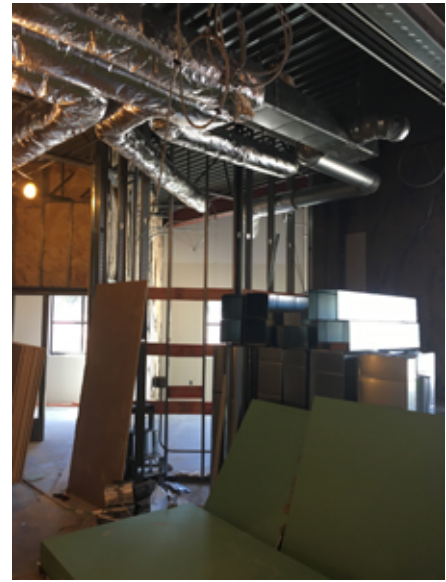
2018.10.23 – View of insulated ductwork installed in the office area.

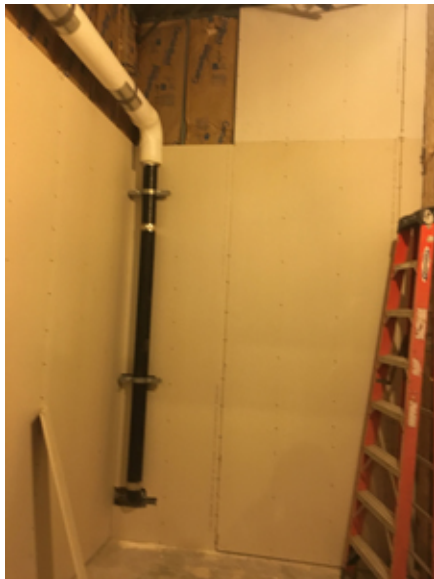
2018.10.23 – Insulation of the plumbing piping is in progress.

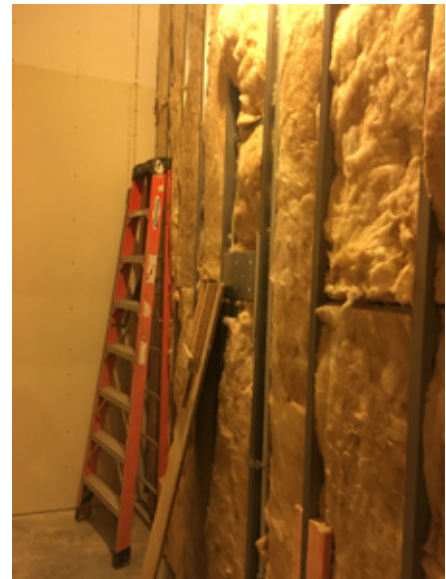
2018.10.23 – The exterior furred walls have been insulated.

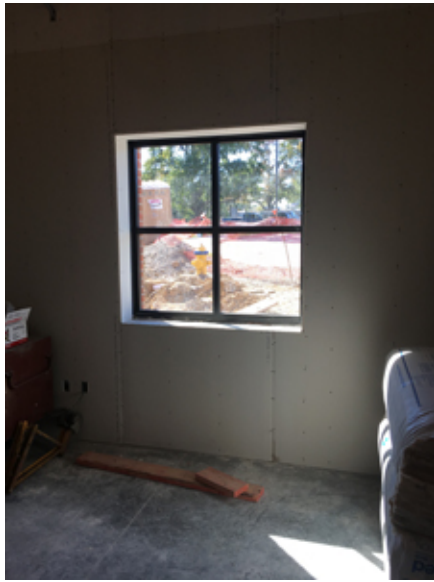
2018.10.23 – Installation of gypsum board has started.

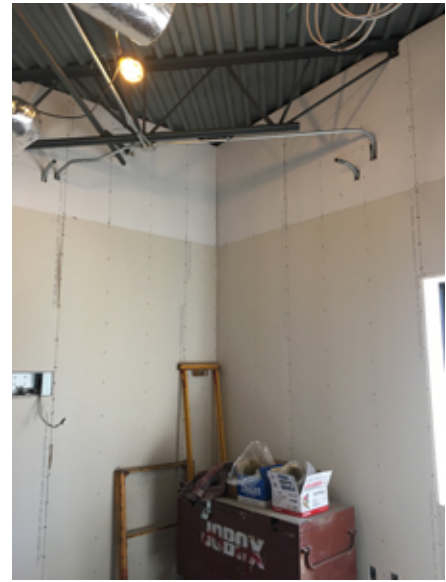
2018.10.23 – Installation of gypsum board has started.

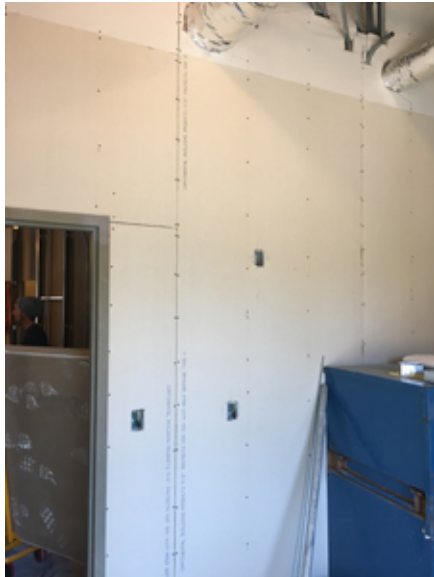
2018.10.23 – Installation of gypsum board has started.

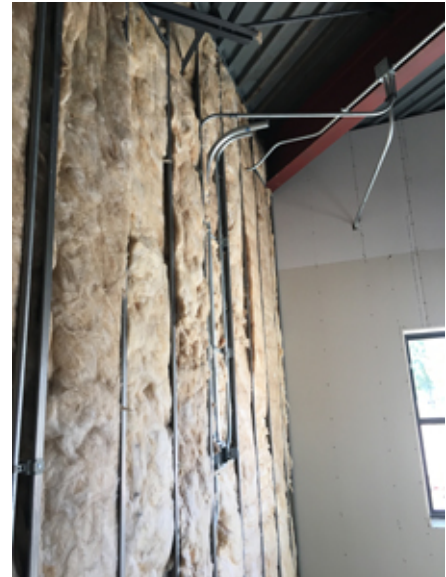
2018.10.23 – Sound attenuation insulation has been installed.

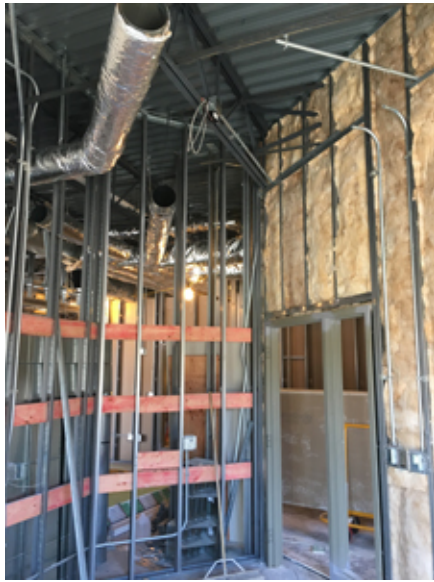
2018.10.23 – View of the ductwork and sound attenuation insulation.

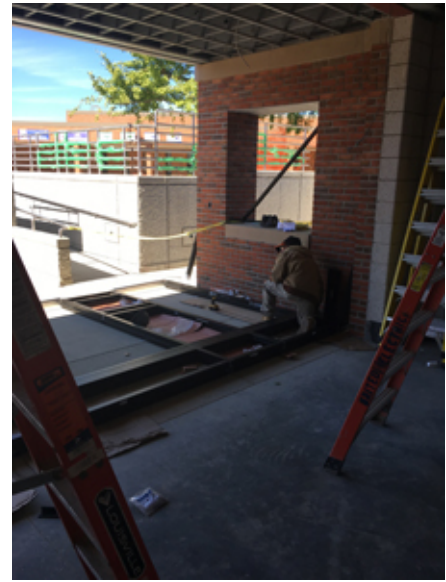
2018.10.23 – Installation of the entry storefront system is in progress.

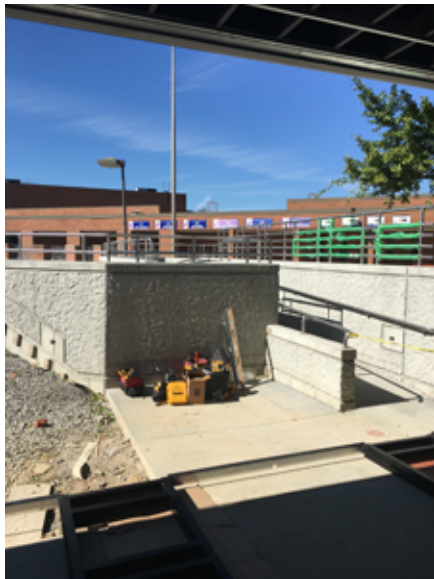
2018.10.23 – Installation of the stainless steel handrails continues.

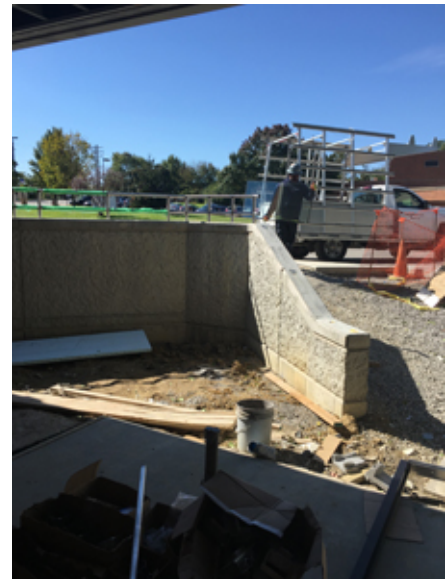
2018.10.23 – Installation of the stainless steel handrails continues.
