FIELD OBSERVATION REPORT

2018-10 (Scott HS)

■ TO:	Kenton County Board of Education 1055 Eaton Drive Ft. Wright, KY 41017	■ DATE:	2018.10.23
ATTENTION:	Mr. Rob Haney		
■ FROM:	Mark Perry mperry@pca-arch.com 1881 Dixie Highway, Suite 130 Fort Wright, KY 41011 V: 859.431.8612 • F: 859.431.8611	■ PROJECT:	Kenton County School District Scott High School – Phase IV
COPIES TO:	Mr. David Lloyd, Mr. Danny Mann, Ms. Carrie Hooten	PROJECT NO.:	2016-124

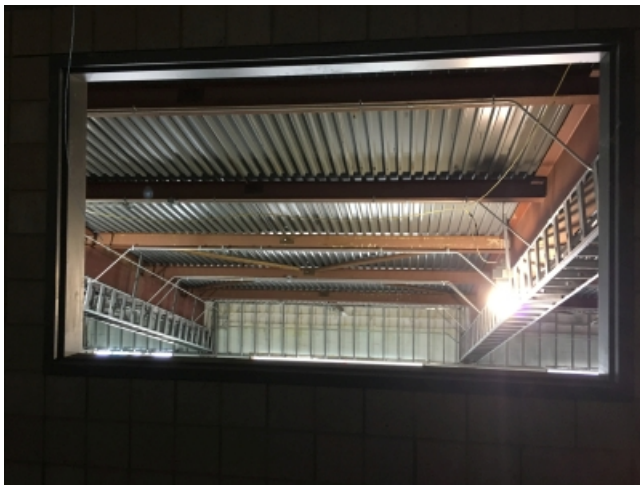
2018.09.25 – Looking into the multipurpose room.

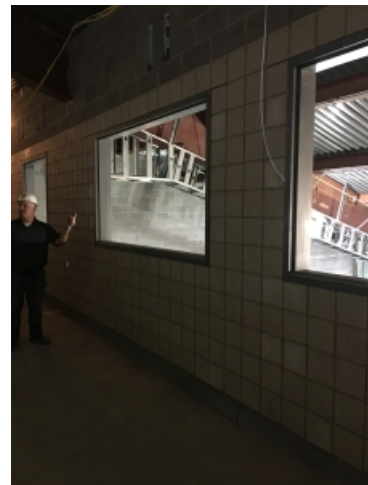
2018.09.25 – Upper level corridor into multipurpose room.

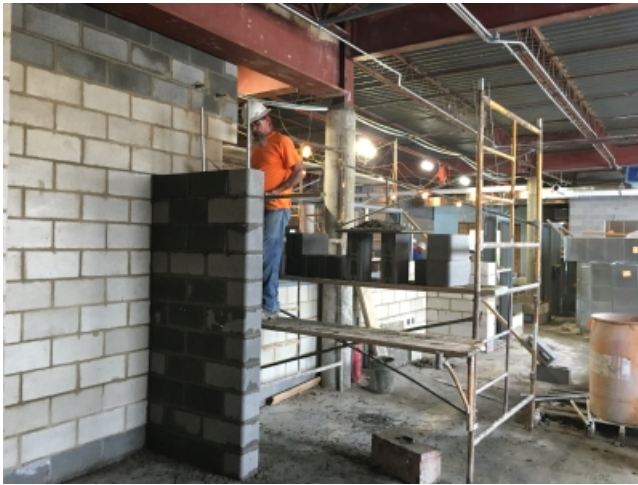
04.01: 2018.09.25 – Interior masonry installation was occurring at 2nd floor duct chases and courtyard side classrooms. Installation challenges at the 2nd floor firewall vestibule were discussed.

2018.09.25 – Upper level masonry installation.

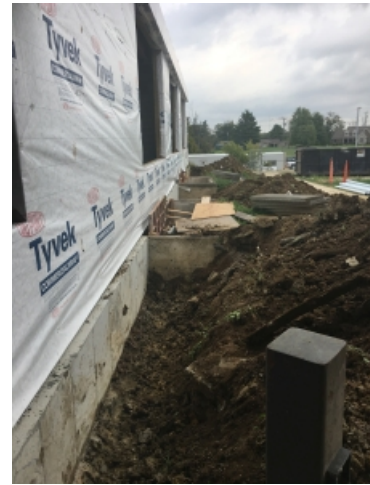
03.01: 2018.10.02 – The brick ledge along the south wall had been poured except at the area well infills. Forms were in place at the area well infills. Excavation had occurred along the east wall and reinforcing dowels were observed, though forms had yet to be installed. Reinforcing steel was in place at the east exterior stair landing along the east side of the building. Reinforcing mesh was also observed at the basement area well slab in advance of pouring. The interior ramp in the band corridor had been recently poured.

2018.10.02 – Brick ledge along south wall.

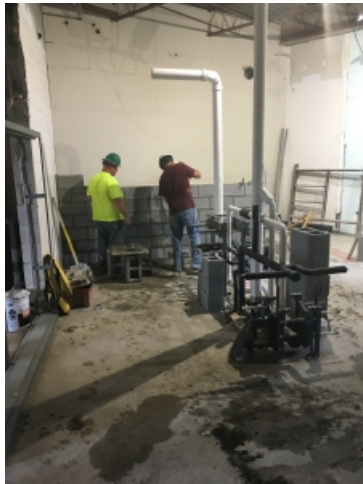
04.02: 2018.10.02 – The mason was actively working at the upper level staff restrooms. The courtyard classroom masonry was complete from the monumental stair to the assistant principal's office, except for

2018.10.02 – Masonry installation at staff restrooms.

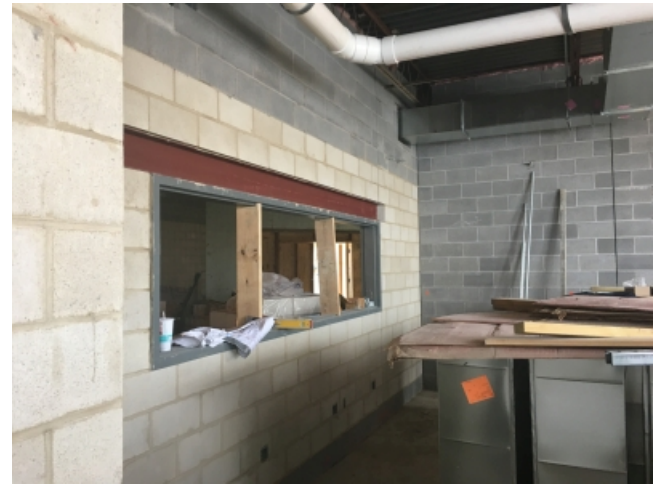
2018.10.02 – Interior window – courtyard side classroom.

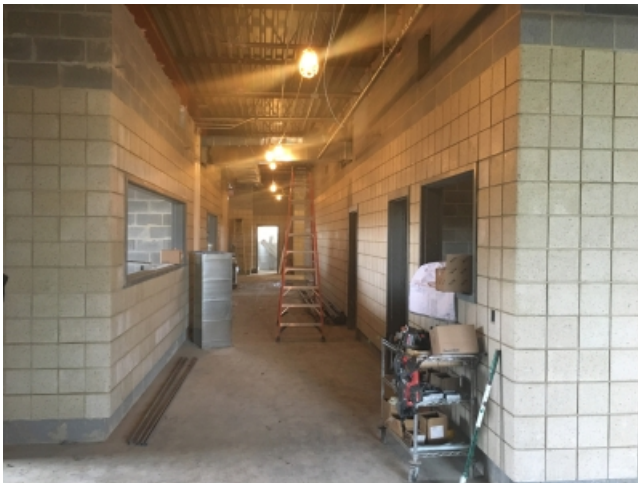
2018.10.02 – Upper level, south corridor.

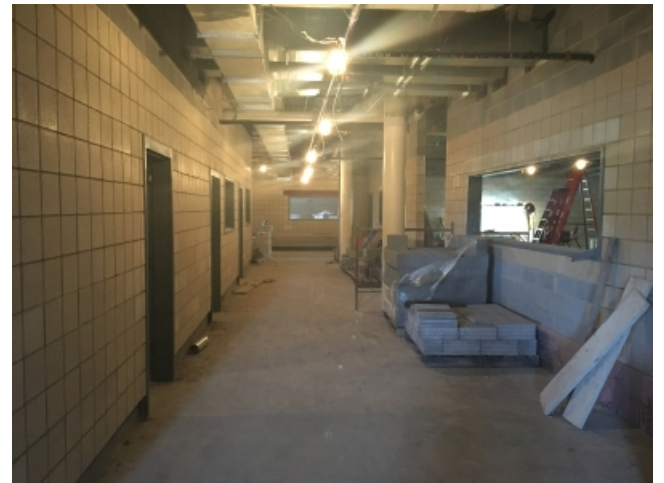
2018.10.02 – Upper level, north corridor.

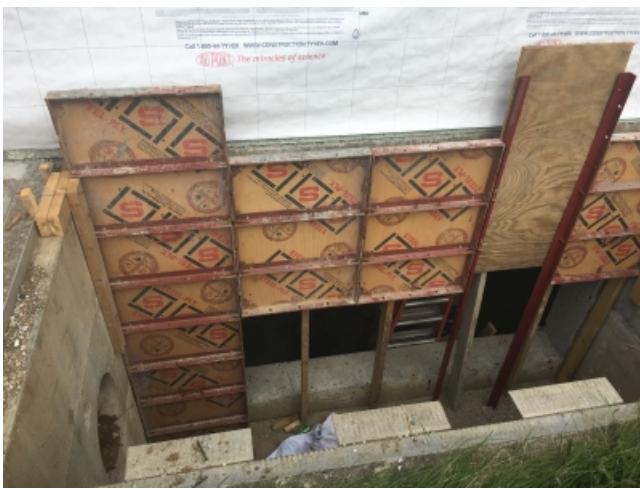
2018.10.02 – Formwork at area well infill.

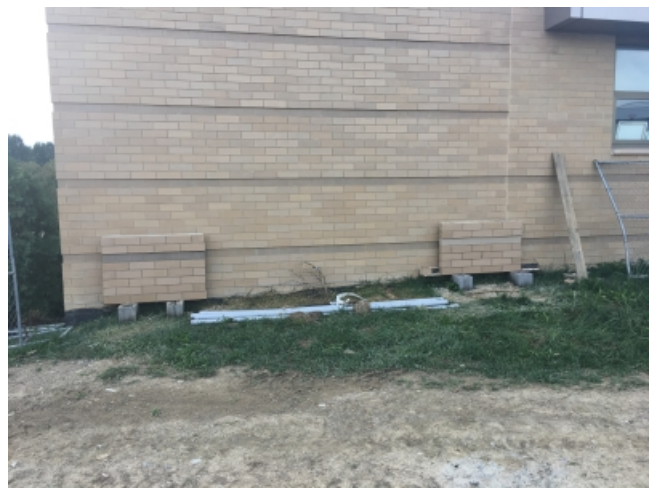
thin block at lintels. A second and third sample panel with different accent brick had been erected and one was selected for approval.

2018.10.02 – Second and third mock-up panels.

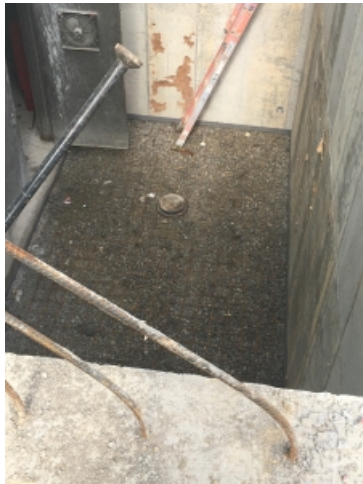
2018.10.02 – Basement access area well.

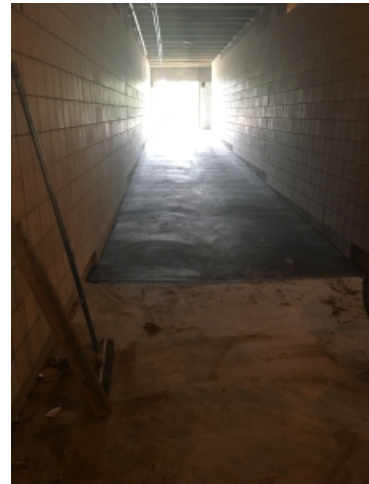
2018.10.02 – Band corridor ramp.

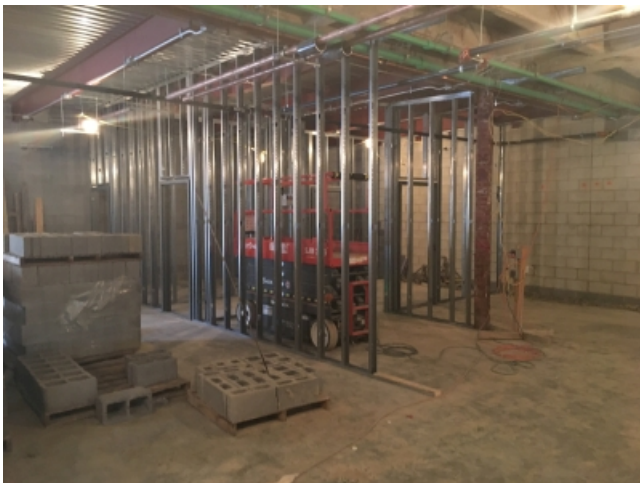
09.01: 2018.10.02 – Walls had been partially framed in the student resource area.

2018.10.02 – Framing at student resource area.

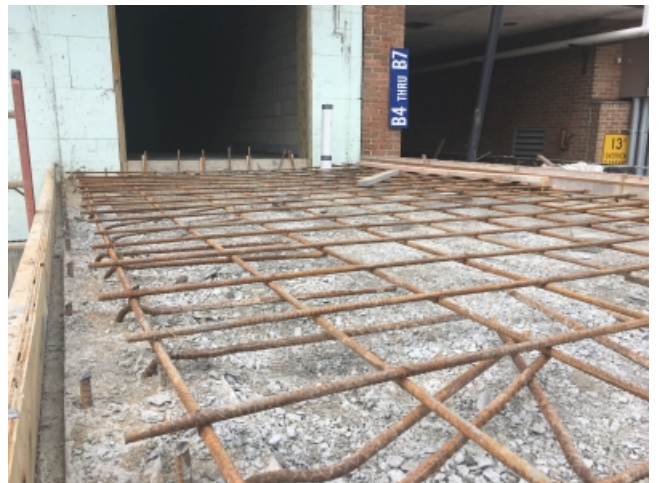
2018.10.02 – Reinforcing at east exterior exit landing.

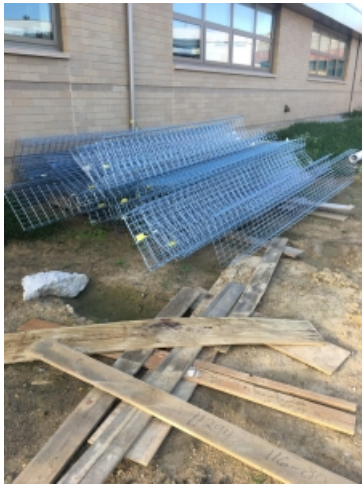
20-28.03: 2018.10.09 – Cable tray had been delivered to the site.

2018.10.09 – Cable tray delivery.

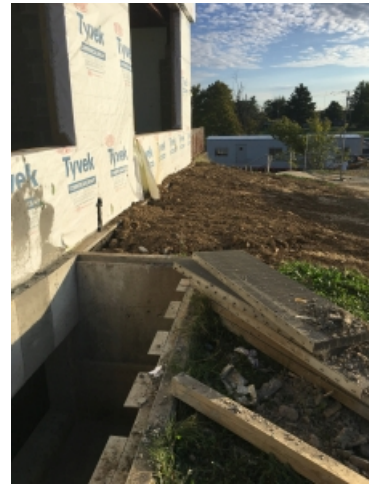
31.01: 2018.10.09 – Trenches along the south wall had been backfilled. Waterproofing was observed.

2018.10.09 – Backfill along south wall.

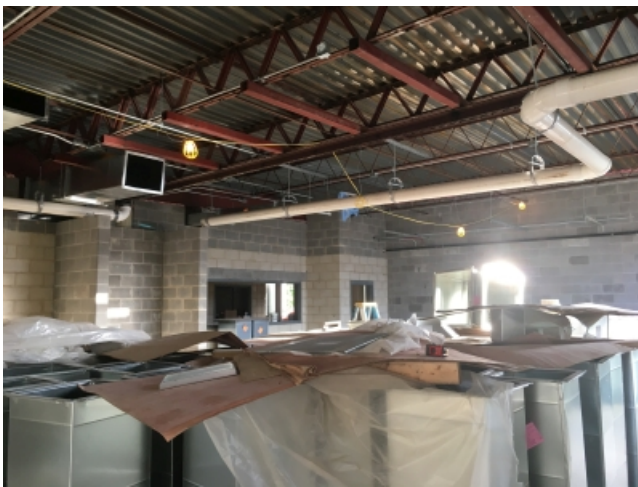
2018.10.09 – Roof overflow pipe installed.

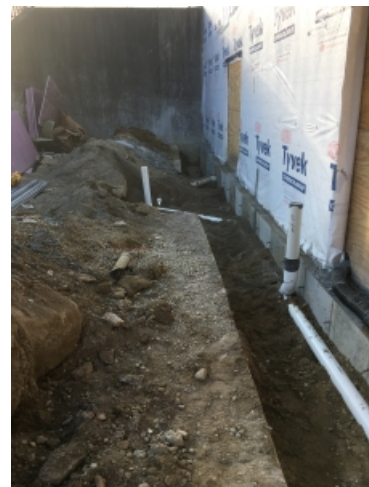
20-28.04: 2018.10.09 – Overflow roof leaders were largely roughed-in at the upper level. Downspout collectors were observed along the east wall.

2018.10.09 – Downspout collector – east wall.

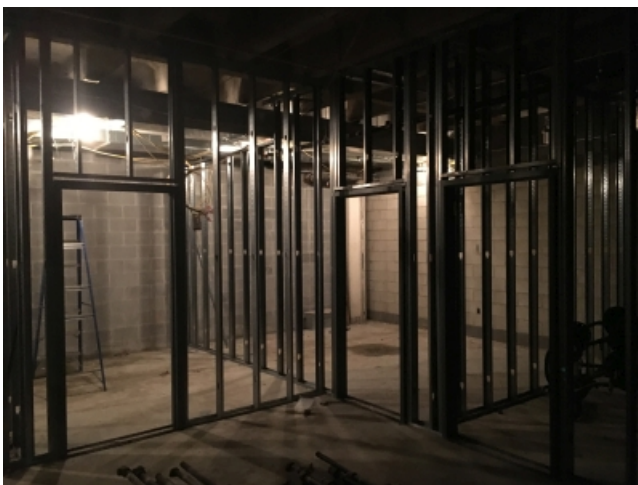
09.02: 2018.10.09 – Walls had been framed at the career center.

2018.10.09 – Career center framing.

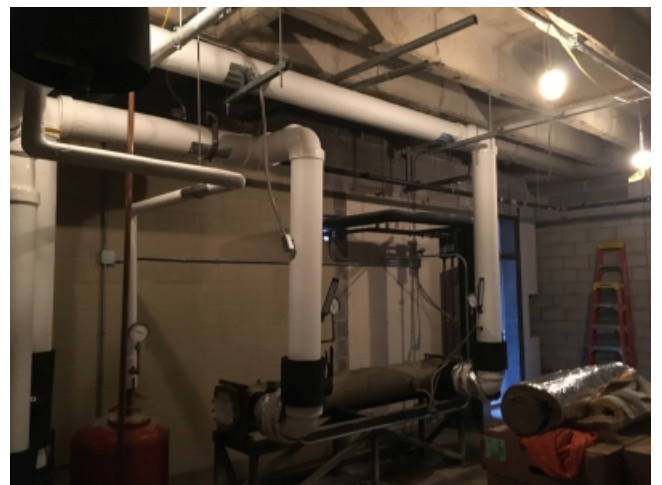
20-28.05: 2018.10.09 – The salvaged chiller barrel from Beechgrove had been insulated, along with the chilled water supply/return lines.

2018.10.09 – Insulated piping at Beechgrove chiller barrel.

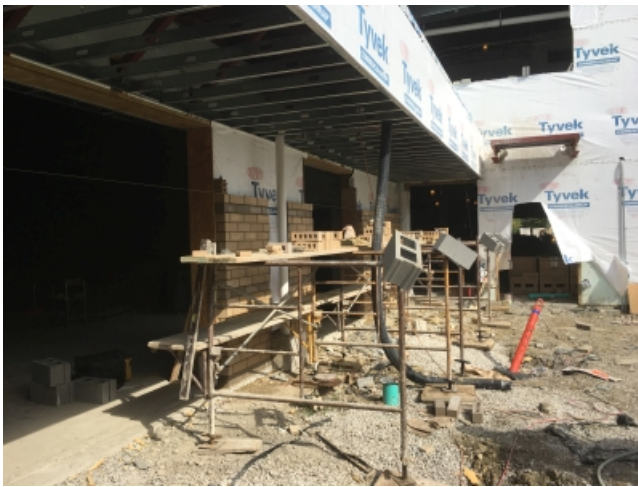
04.03: 2018.10.11 – Brick veneer was being installed at the north wall of the courtyard.

2018.10.11 – Brick installation at courtyard.

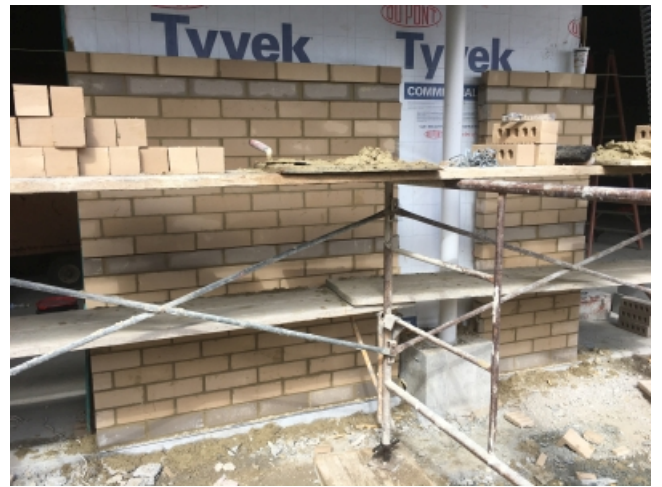
2018.10.11 – Brick installation at courtyard.

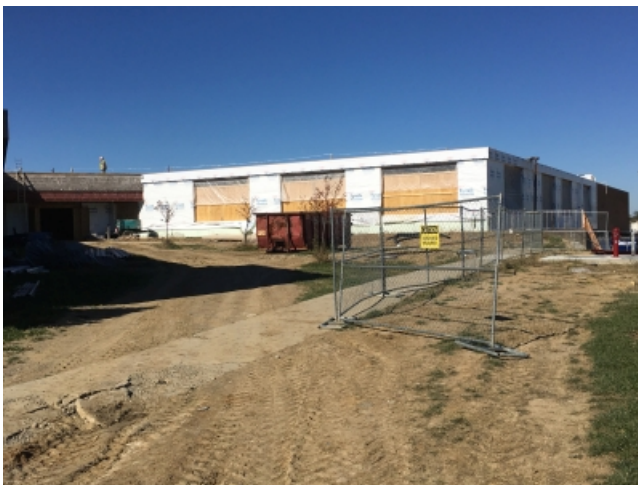
01.01: 2018.10.23 – Temporary window infill had been installed at most window openings in anticipation of approaching cold weather and the need to introduce temporary heat. Plywood had been installed at window openings with increased access risk.

2018.10.23 – Temporary infill at window openings.

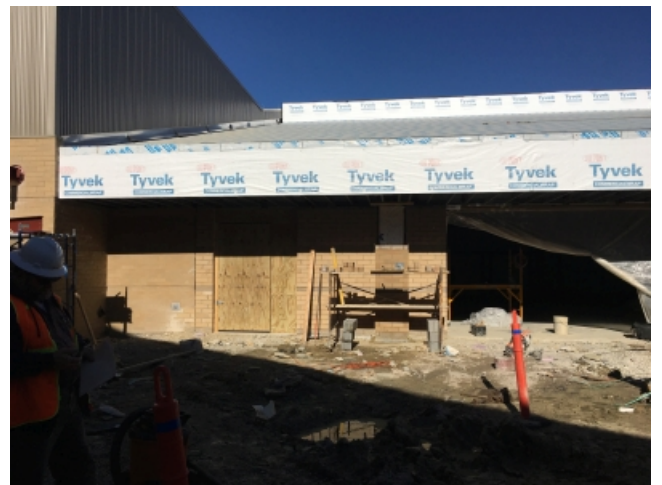
04.04: 2018.10.23 – Brick veneer installation was largely complete in the courtyard.

2018.10.23 – Brick at courtyard.

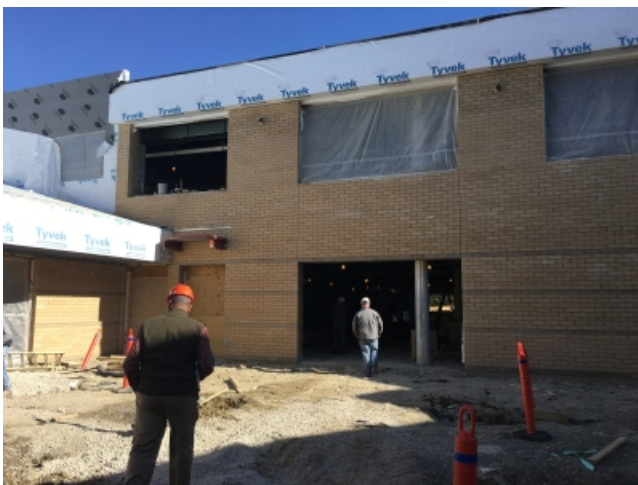
2018.10.23 – Brick at courtyard.

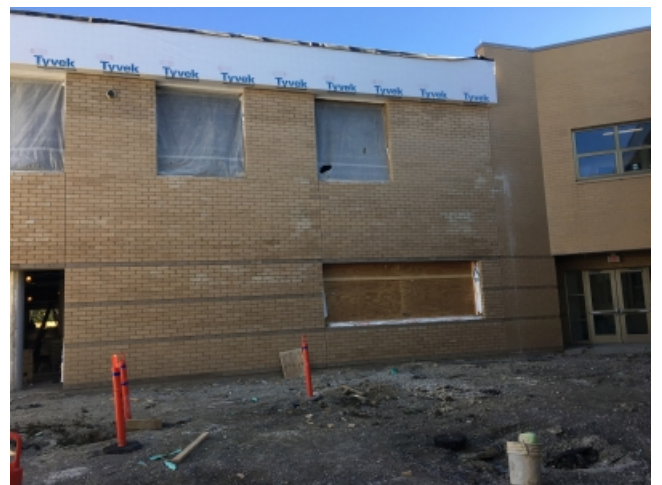
2018.10.23 – Brick at courtyard.

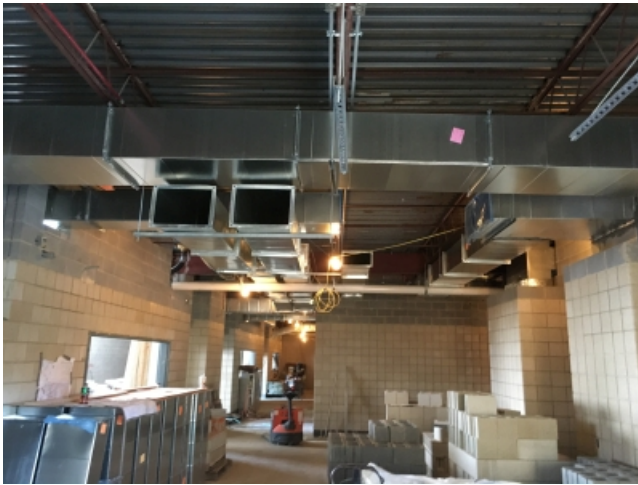
2018.10.23 – Upper level west corridor.

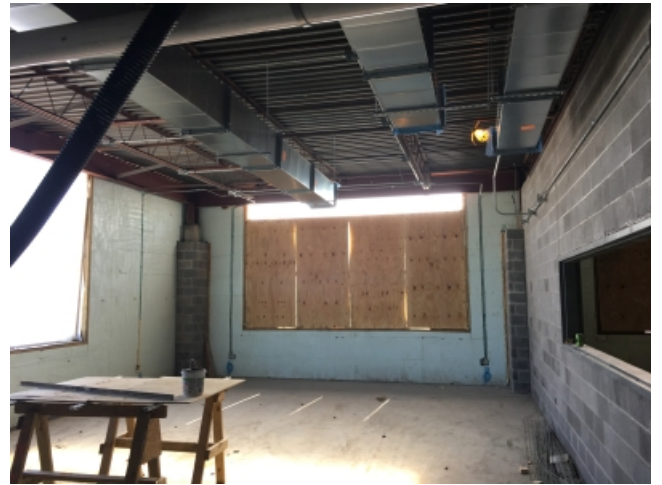
2018.10.23 – Upper level corner classroom.

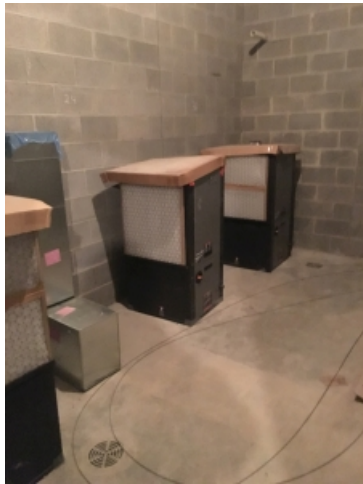
2018.10.23 – Upper level mechanical room.

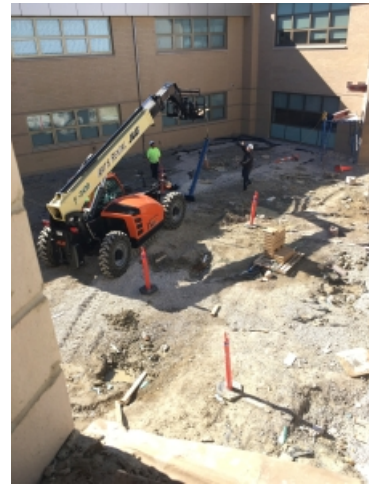
05.01: 2018.10.23 – Steel posts for the courtyard shade structures had arrived and installation had begun.

2018.10.23 – Shade canopy column being installed.
