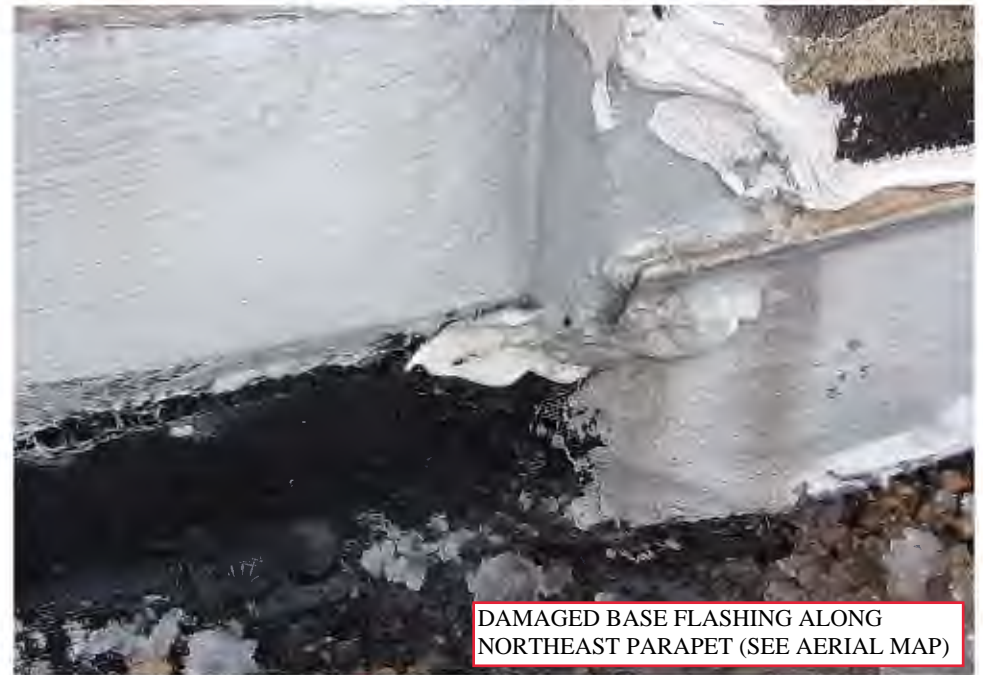
DAMAGED BASE FLASHING ALONG  
NORTHEAST PARAPET (SEE AERIAL MAP)

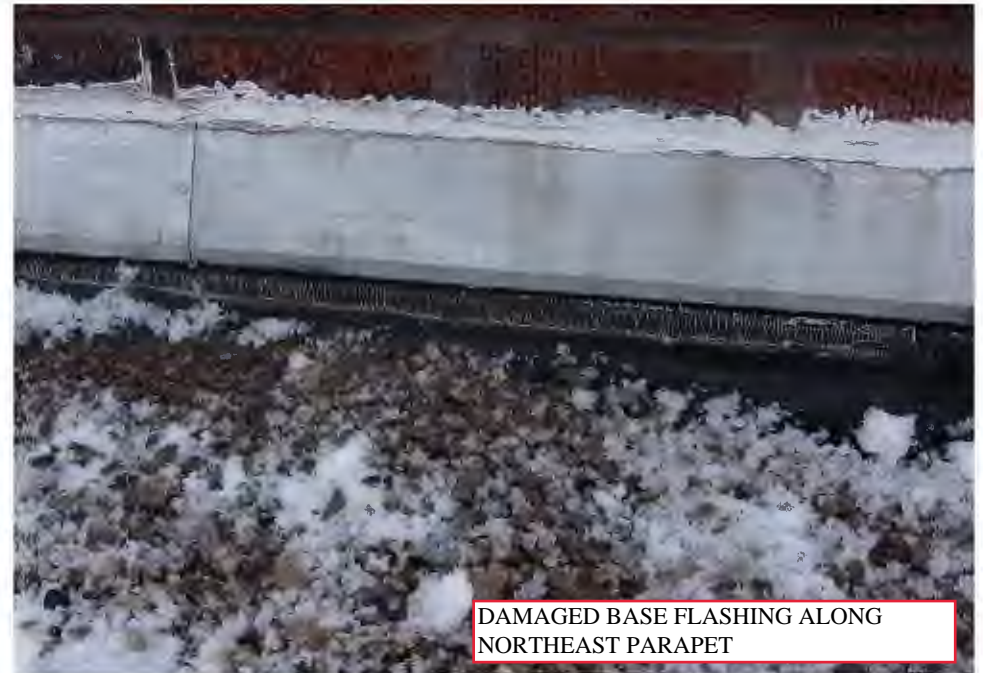
DAMAGED BASE FLASHING ALONG  
NORTHEAST PARAPET

REPLACE SMALL SADDLE AT  
SOUTHEAST AND SOUTHWEST  
CORNERS OF AUDITORIUM

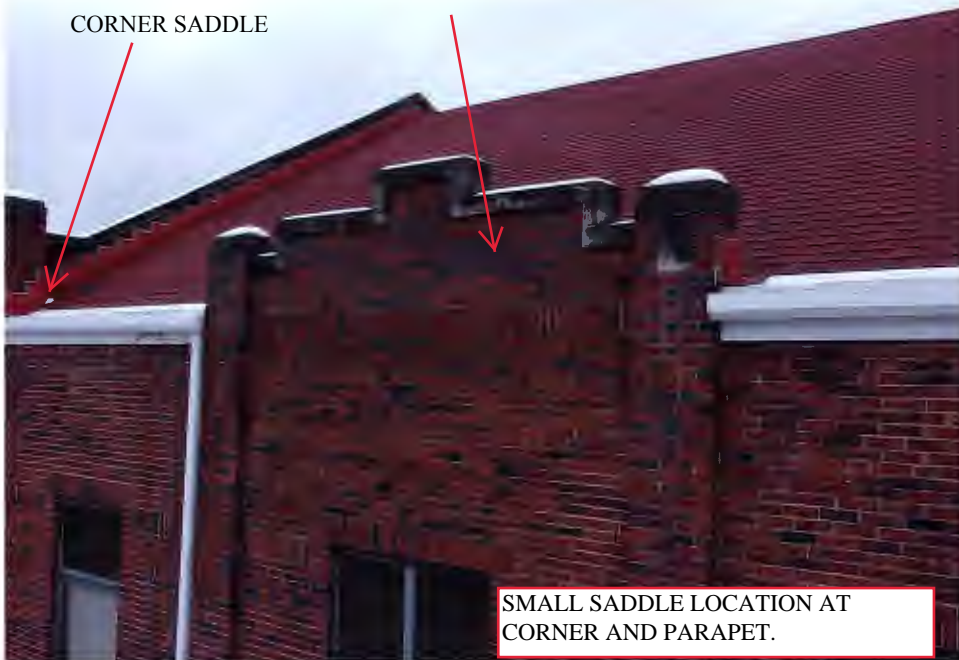
SMALL SADDLE LOCATION AT  
CORNER AND PARAPET.

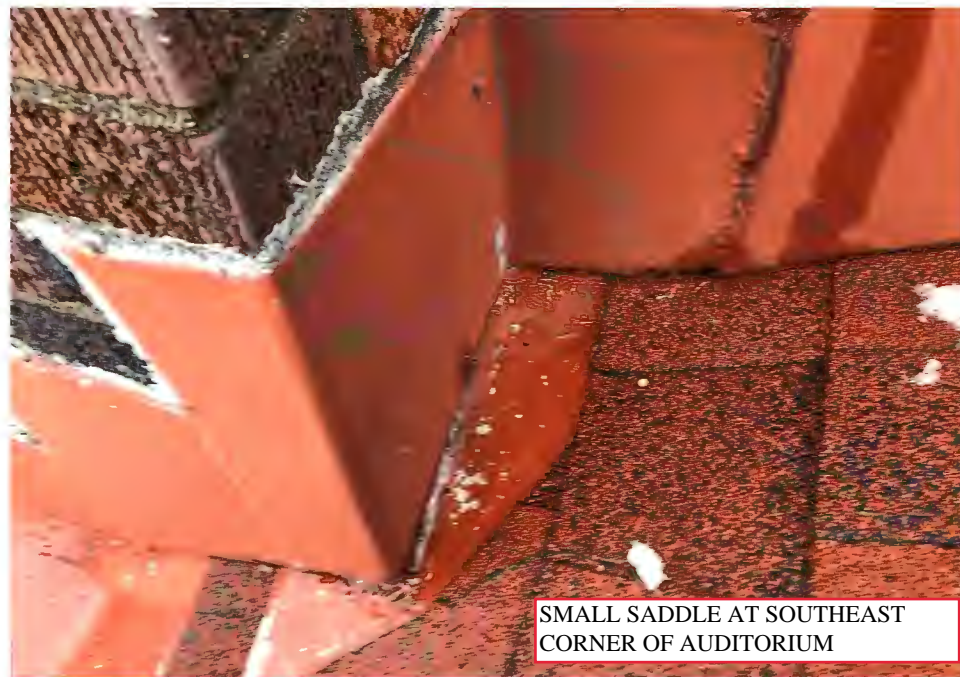
SMALL SADDLE AT SOUTHEAST  
CORNER OF AUDITORIUM

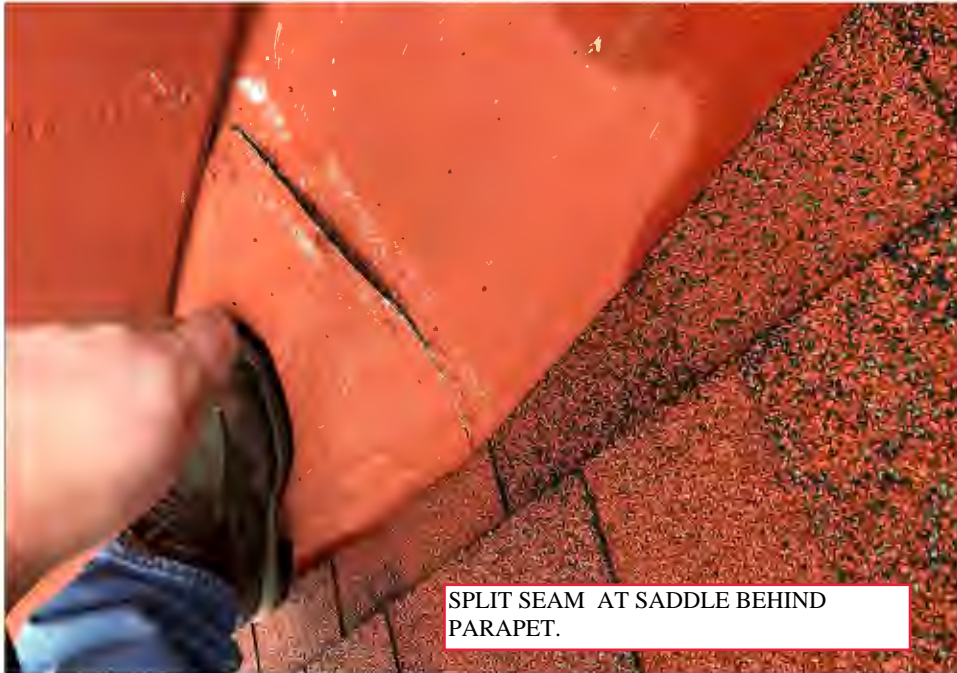
SPLIT SEAM AT SADDLE BEHIND  
PARAPET.
