Southgate Independent
School District

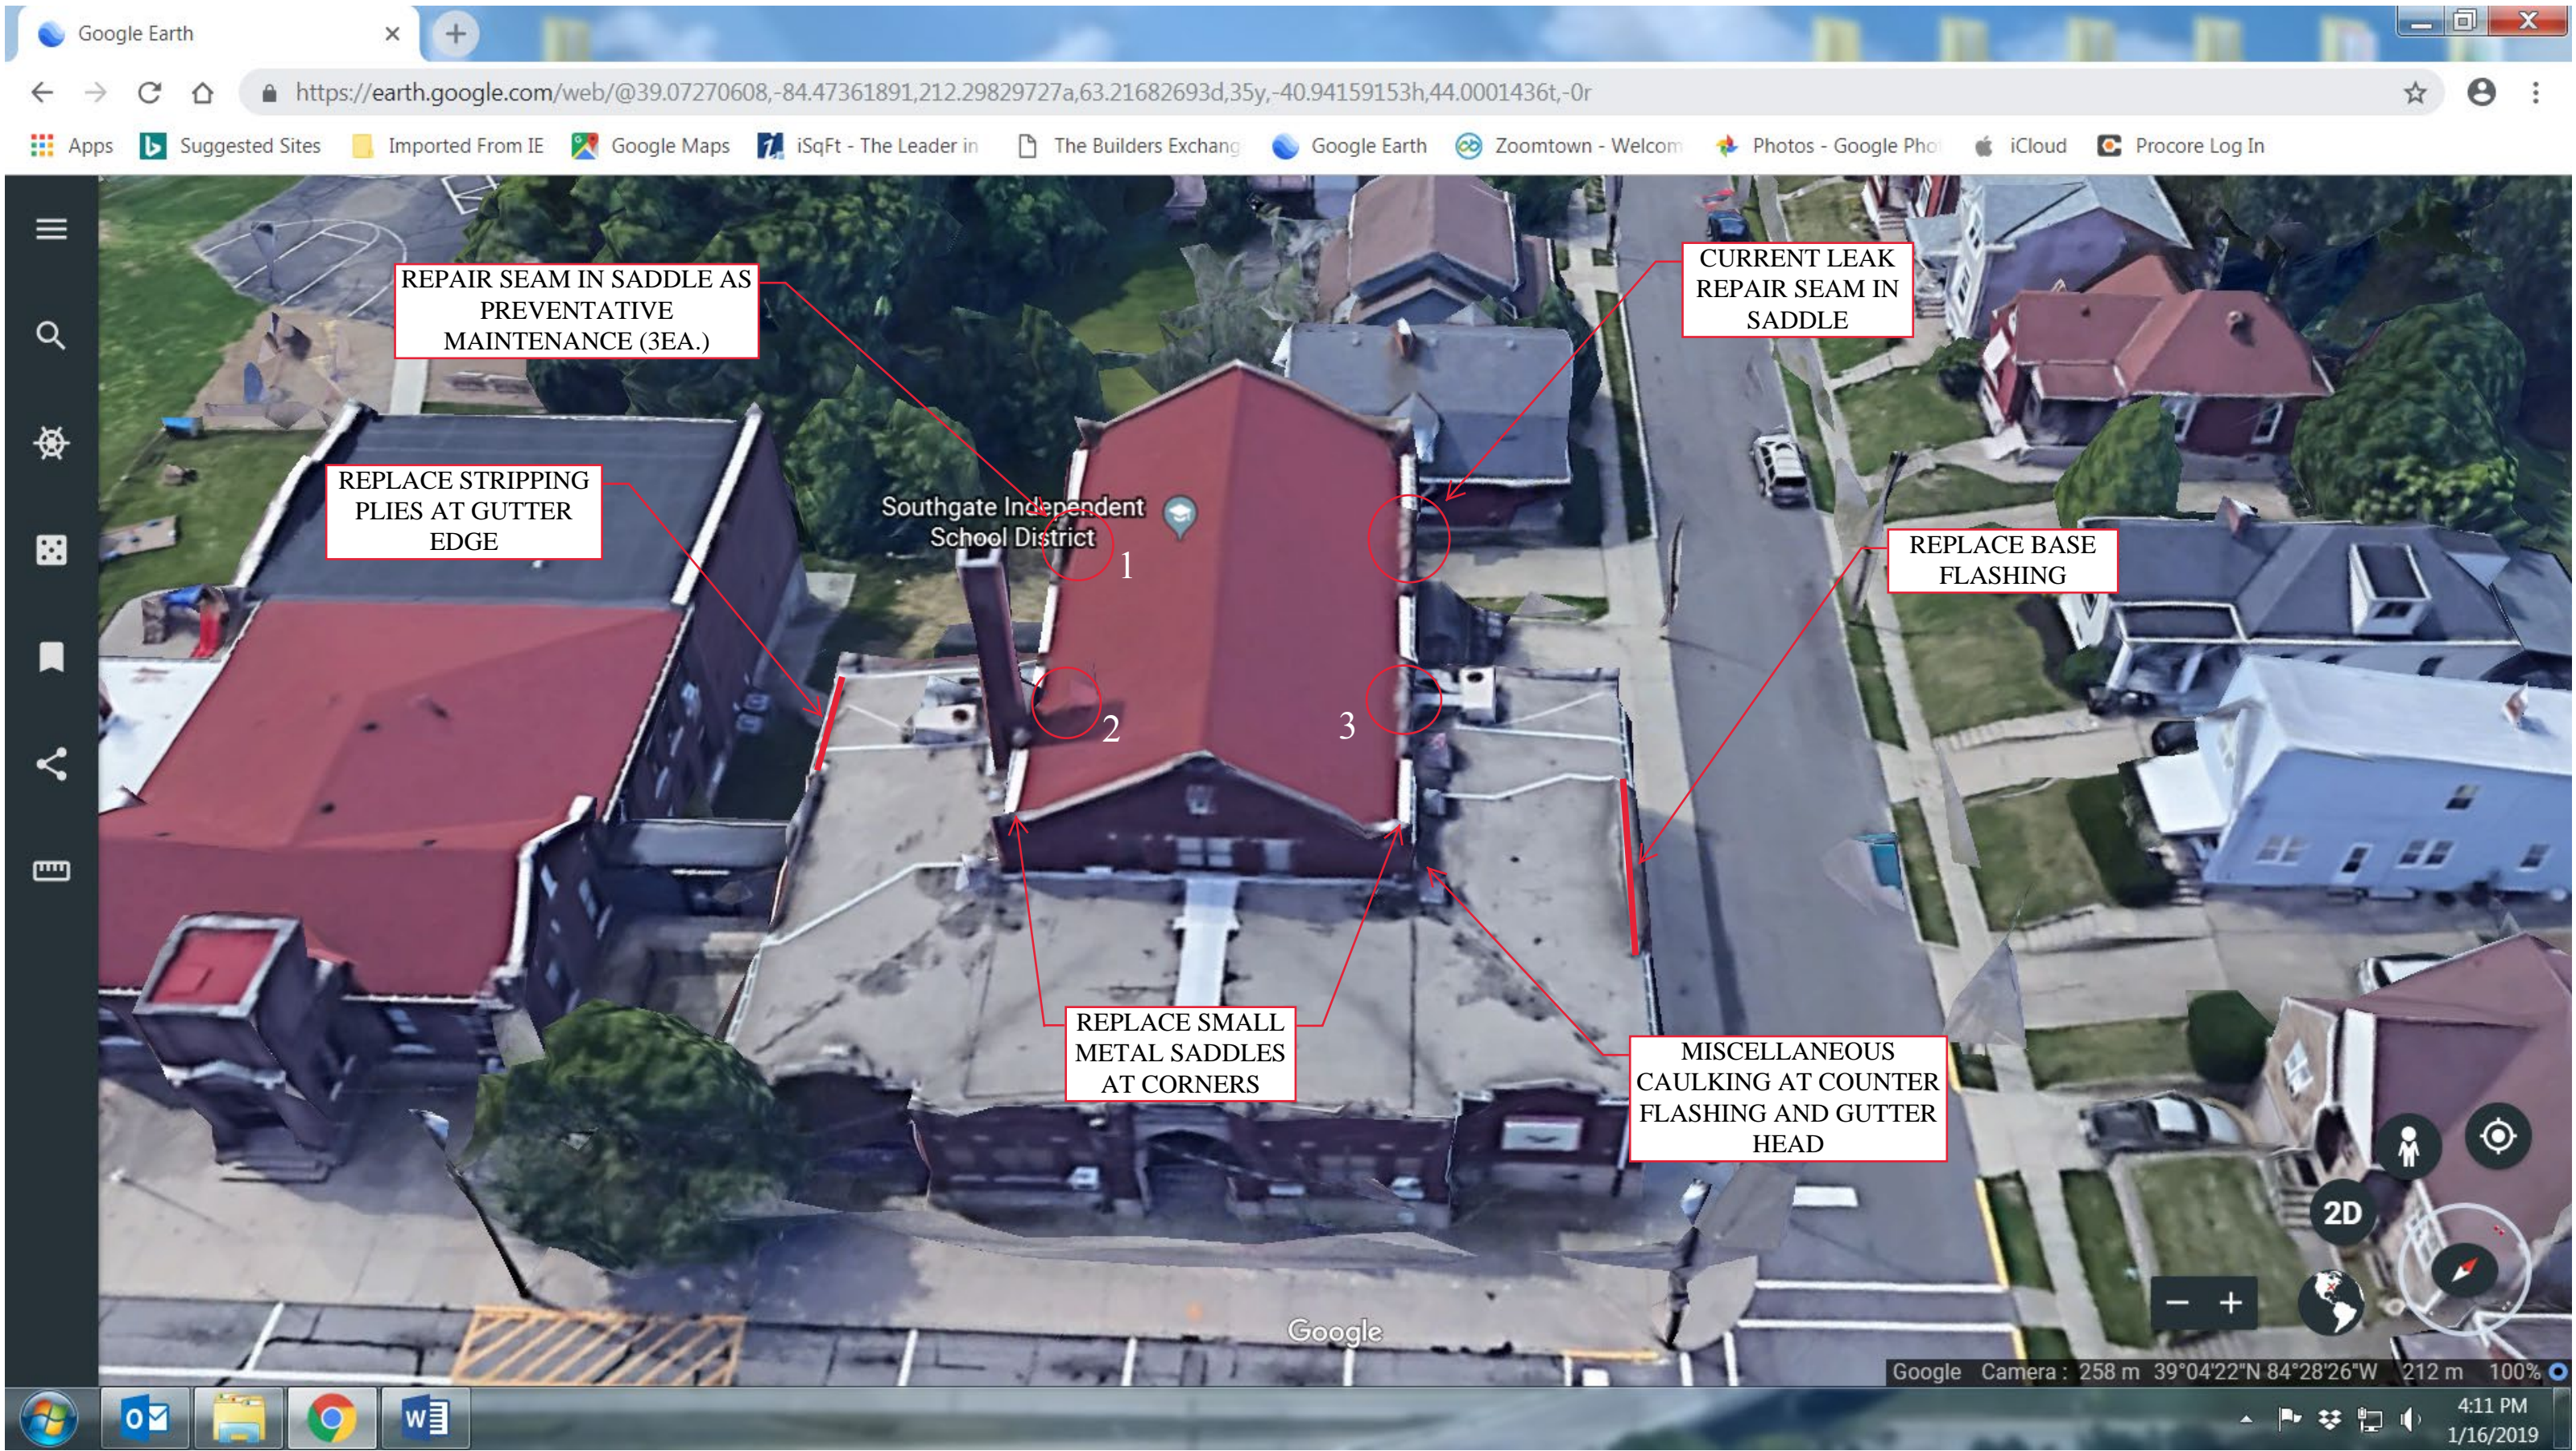
CURRENT LEAK
REPAIR SEAM IN
SADDLE

REPAIR SEAM IN SADDLE AS
PREVENTATIVE
MAINTENANCE (3EA.)

REPLACE STRIPPING
PLIES AT GUTTER
EDGE

REPLACE BASE
FLASHING

REPLACE SMALL
METAL SADDLES
AT CORNERS

MISCELLANEOUS
CAULKING AT COUNTER
FLASHING AND GUTTER
HEAD
