PROGRESS REPORT

HARDIN COUNTY SCHOOLS

NEW LINCOLN TRAIL ELEMENTARY SCHOOL NEW EAST MIDDLE SCHOOL

FIELD OBSERVATION REPORT

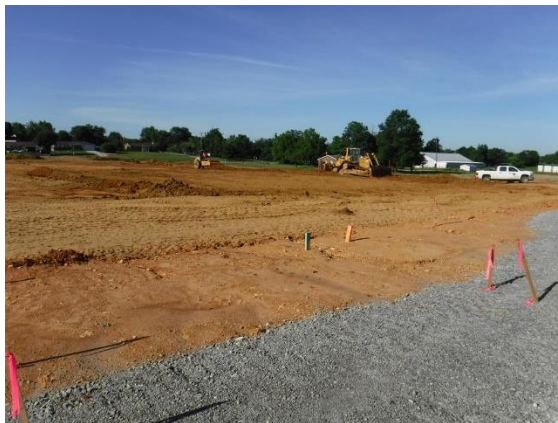
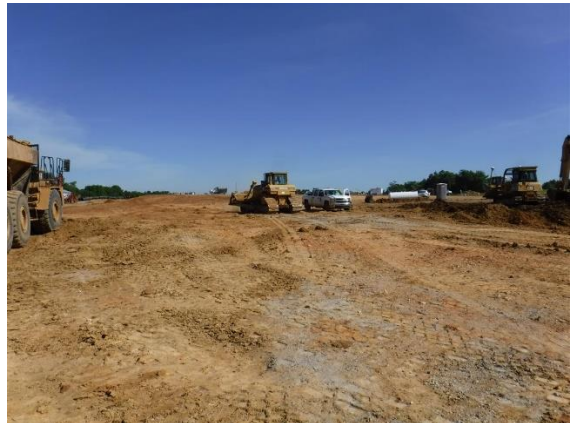
- a) Although the site is large. It is also somewhat narrow. The building is located at the high point which provides ample room for parking, circulation and the bus loop to the south of the building and provides great views of the site and countryside. Since the site drops off sharply to the north, this provides an excellent place to dispose of most of the storm water.

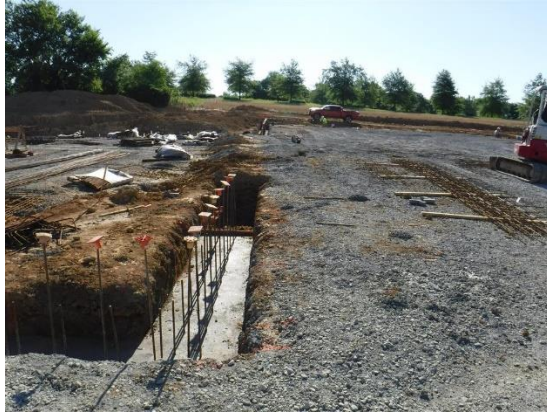
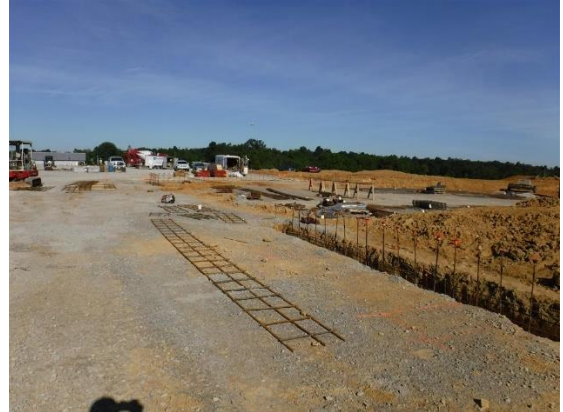
- b) The building pad is essentially in place. Gerald reported that they smooth the gravel at the end of the day after machinery has rutted it. In addition, footings are in place along a significant portion of the north side of the building. Gerald reported that the section of footing missing from the south side of the building will need to be dropped to allow for the sanitary sewer to enter the building. An RFI has been issued on this.

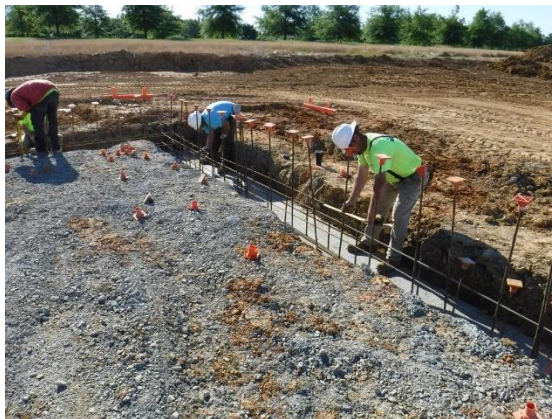
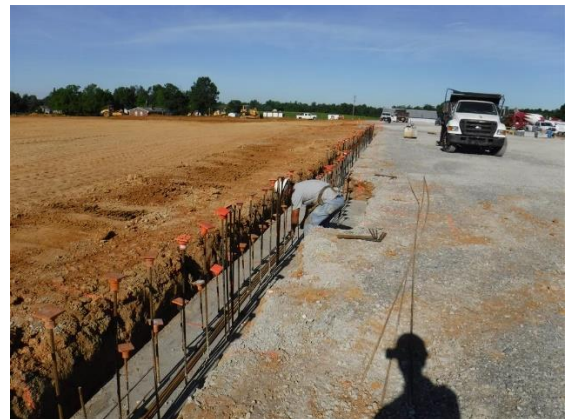
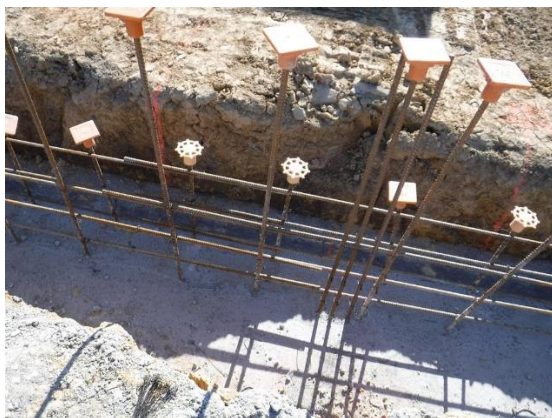
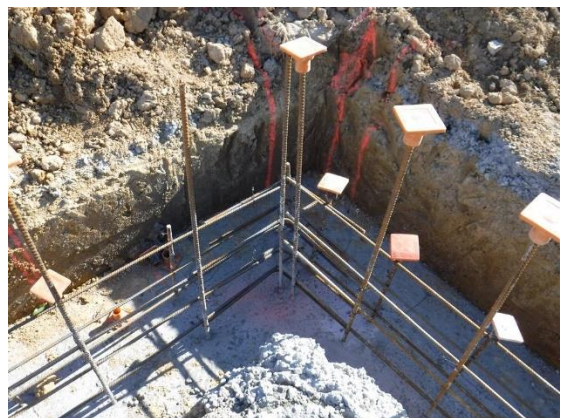
- c) Alliance was tying reinforcing steel to the dowels. Refer to the SPIN report for confirmation of spacing and quantities.

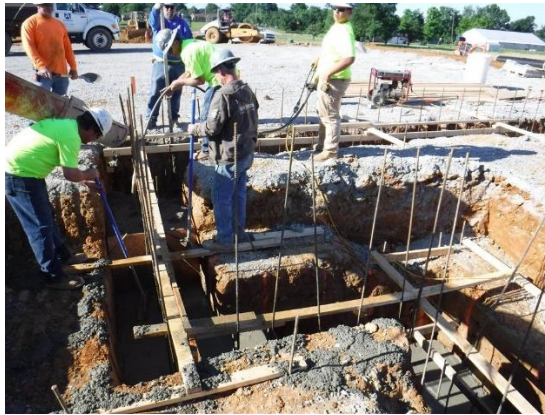
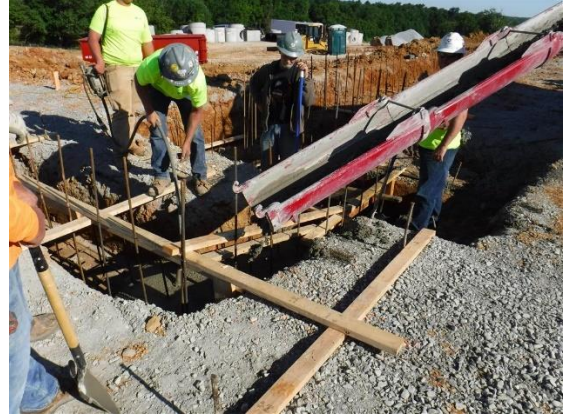
- d) Concrete footings were being poured. Solid Ground's field technician was retrieving concrete for cylinders. Blake reported that the concrete from the Elizabethtown IMI plan was of good quality with proper slump, density and compression rating when tested.

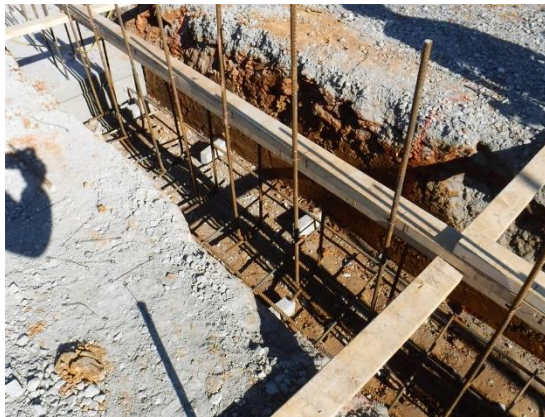
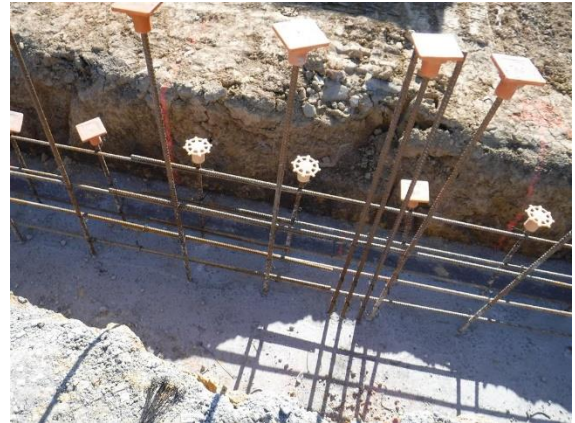
- e) The footings have the proper keyways at the ends of pours and the dowel spacing appears to be as indicated. Concrete brick was used to elevate the bottom rows of reinforcing steel off of the bottoms of the excavations. Refer to the SPIN report for dowel placement, spacing and size confirmation.

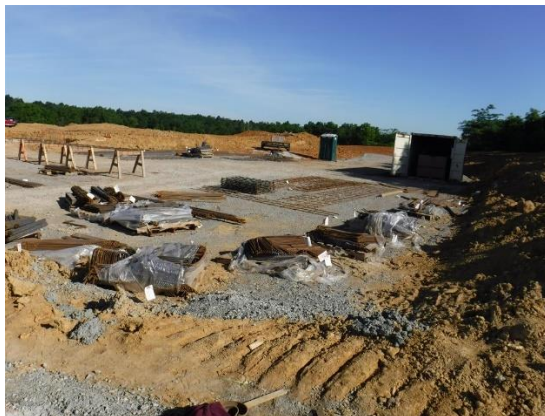
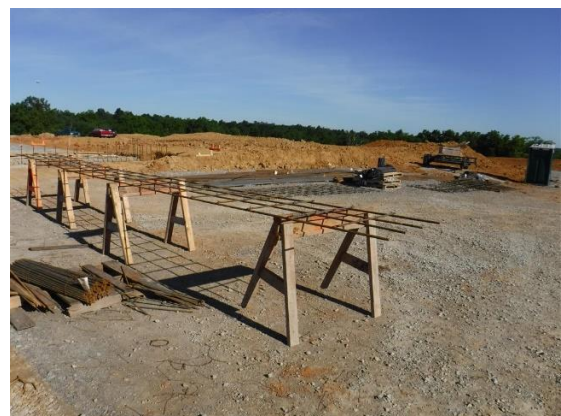
- f) Reinforcing steel is stockpiled on site. Footing matts are being prefabricated for insertion to footing excavations.

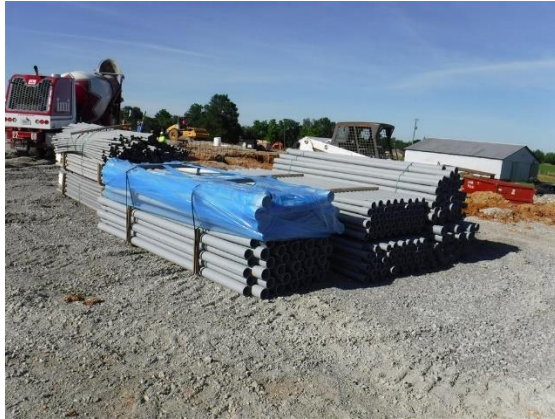
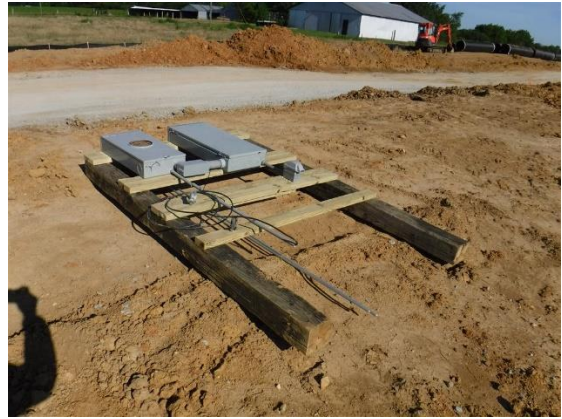
- g) Electrical conduit is stockpiled and will be used to provide the service into the site to the building. Temporary electrical panels have been prepared. Gerald reported that these will be installed after the installation of the large storm sewer on the west side of the site.

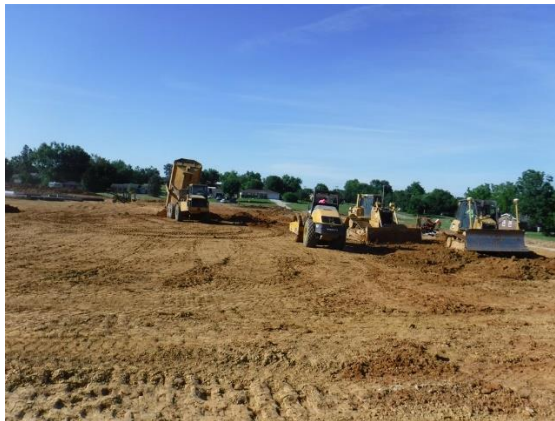
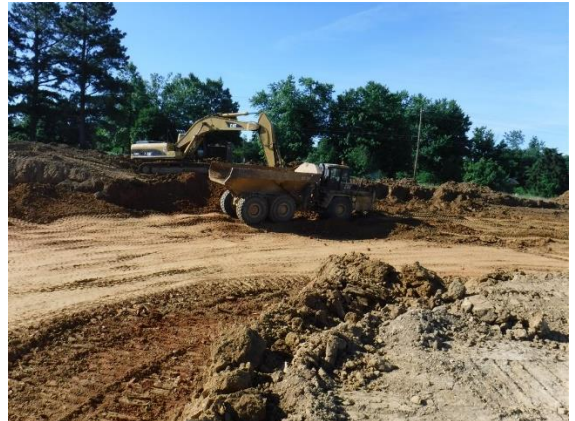
- h) Excavators were raising the site in the south parking area by moving earth from the higher southeast corner.

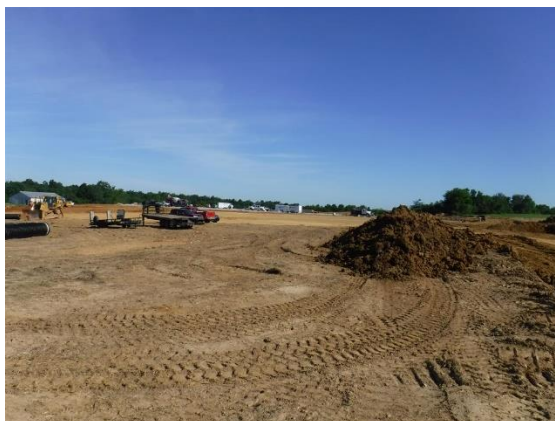
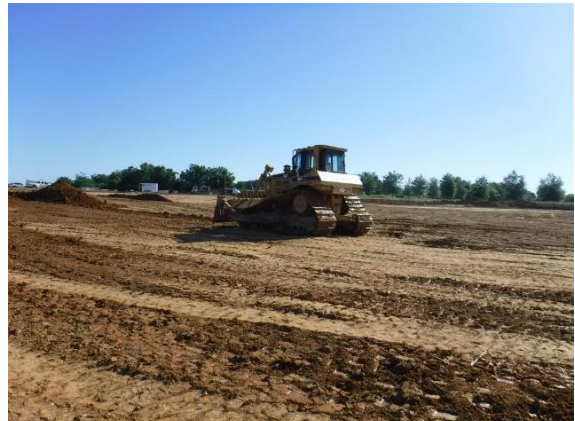
- i) Blake has reported some soils did not meet the compaction requirements on the initial pass and had to be ripped and reworked to achieve proper compaction.

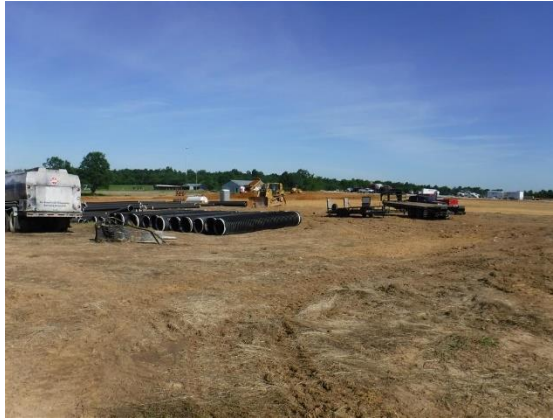
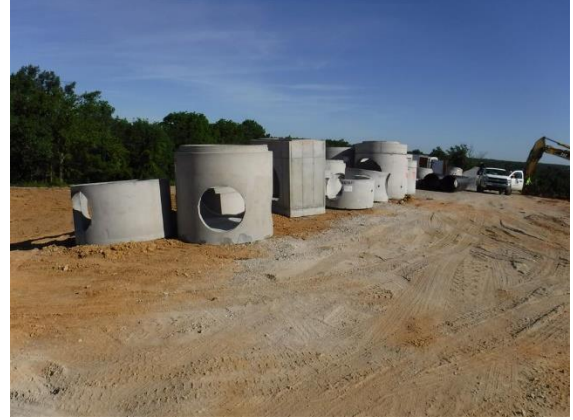
- j) Stockpiled storm piping was being moved from the south side of the west side of the site to provide the main storm water conduit. Precast concrete drainage structures are stockpiled on site.

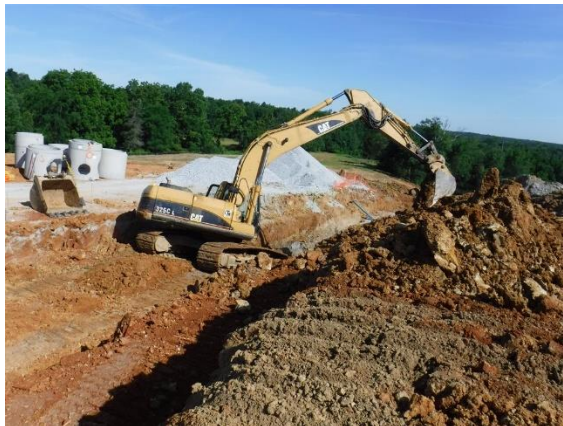
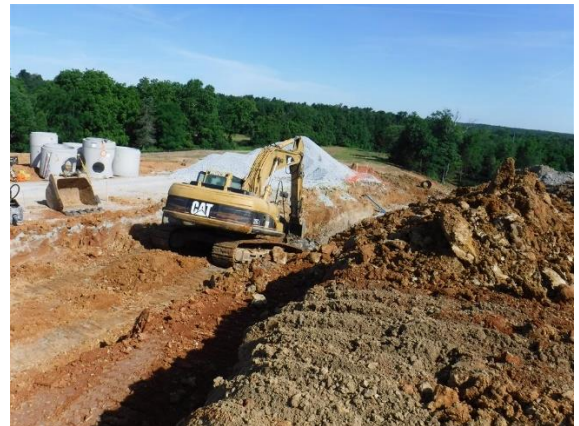
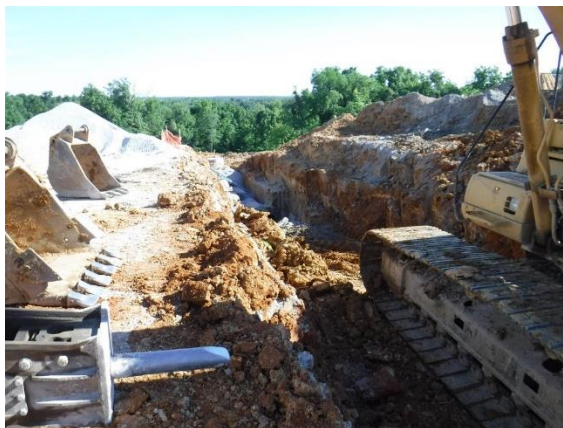
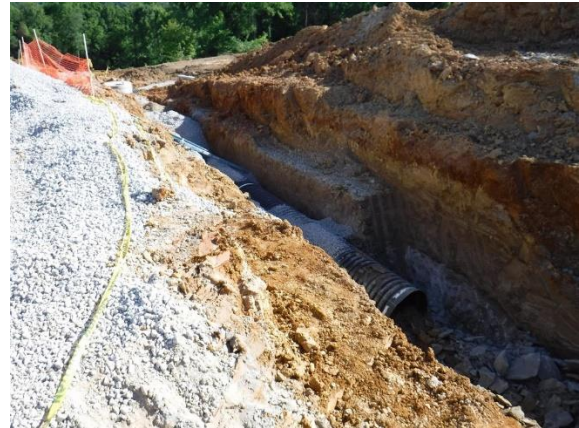
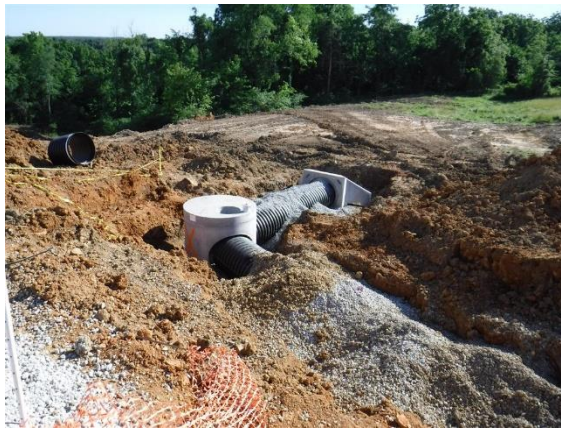
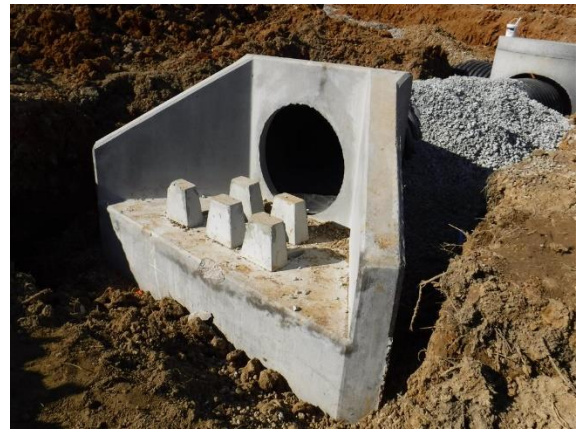
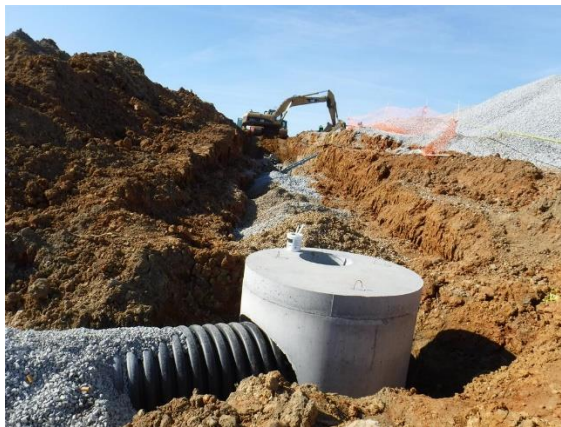
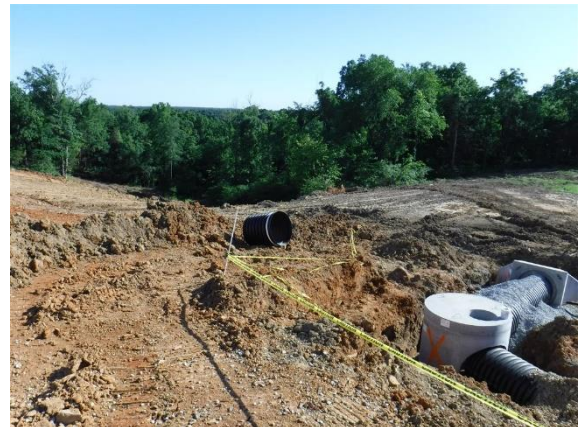
- k) The storm line was being laid down the hill to the headwall outfall structure into the natural swale to the north of the site. The excavator reported hitting some rock that he removed with a hoe ram.

- a. Keep as-built locations for sewer and other site utility work up to date.

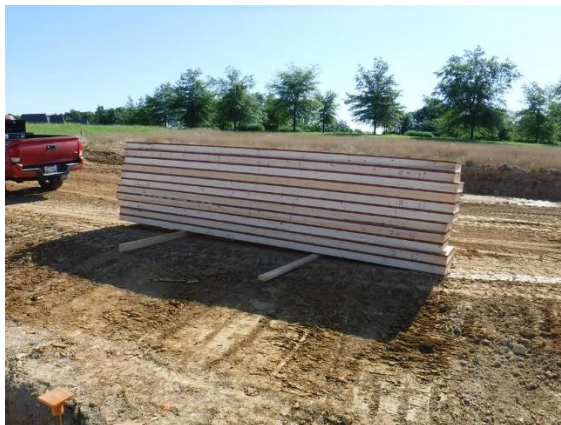
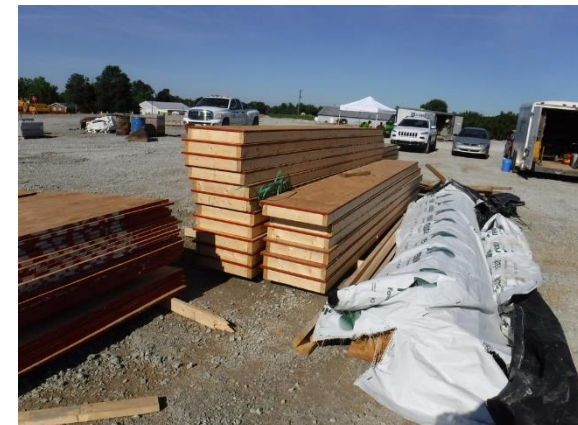
- I) Formwork for stem walls is stockpiled on the site.

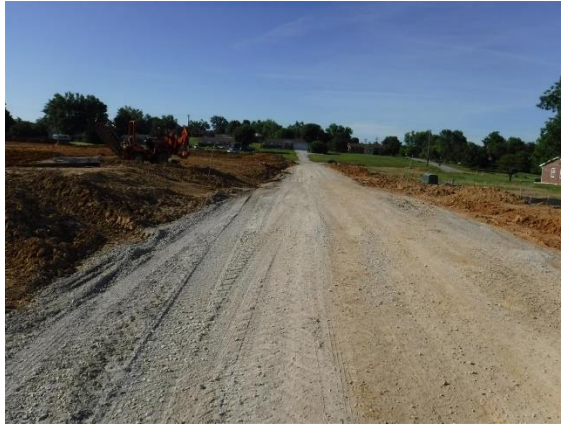
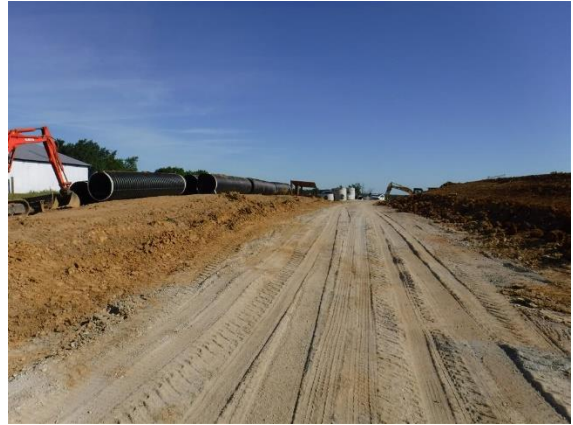
- m) The entrance roads into the site have been graded and covered with crushed stone.

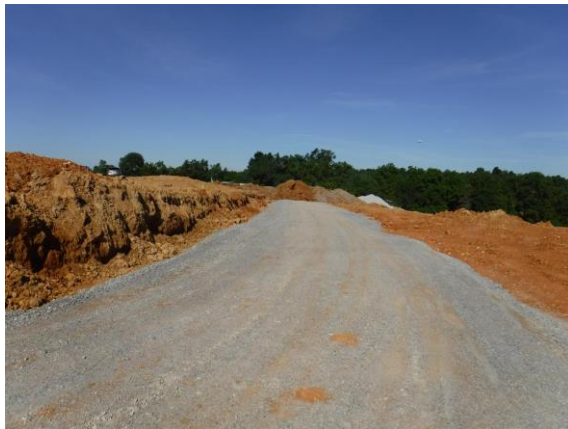
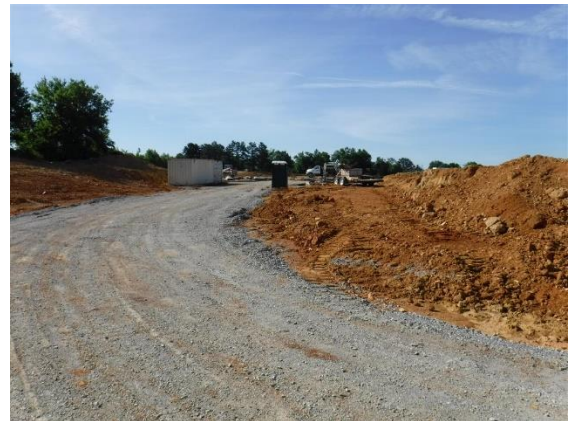
- n) The service road to the north of the building has been graded and covered with crushed stone.

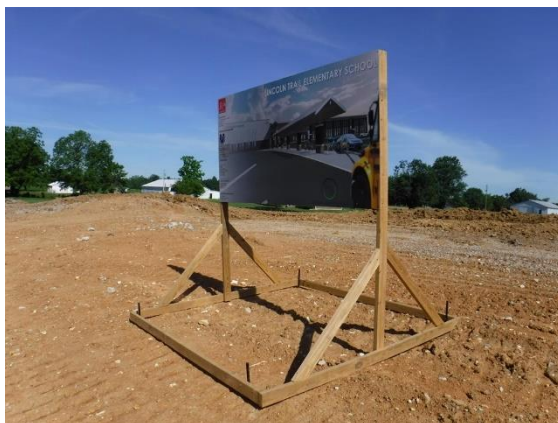
- o) Gerald located the site sign at the front of the site.

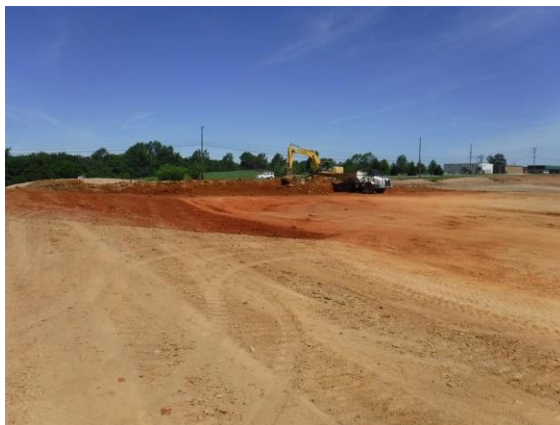
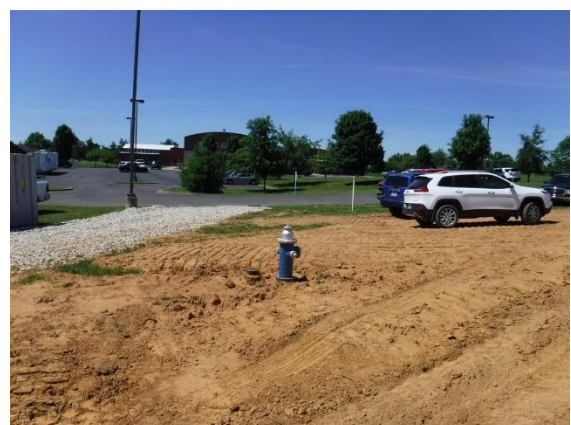
- a) With excavation and earth moving underway, work on the site has begun. The location off of New Glendale Road will not only be a functional location for the new school, but also affords easy access for construction activities. The adjacent Kentucky State Police post provides the added benefit of safety and security for the school and the construction site.

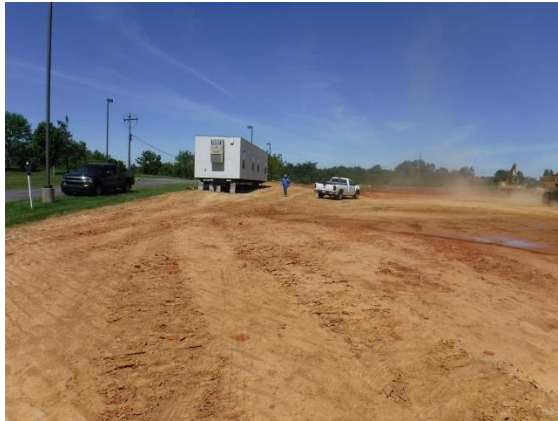
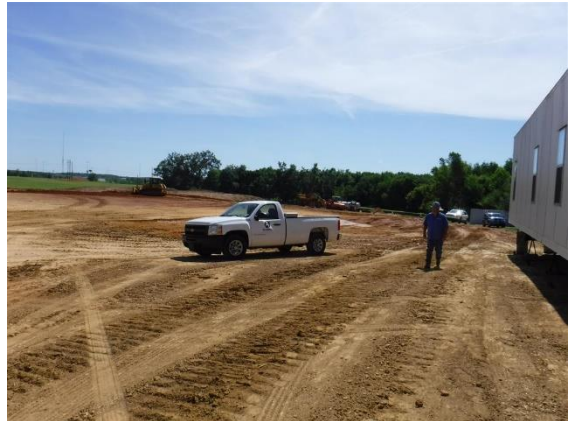
- b) The construction office trailer has been placed on the site. Dickie noted that he has moved in as of yet.

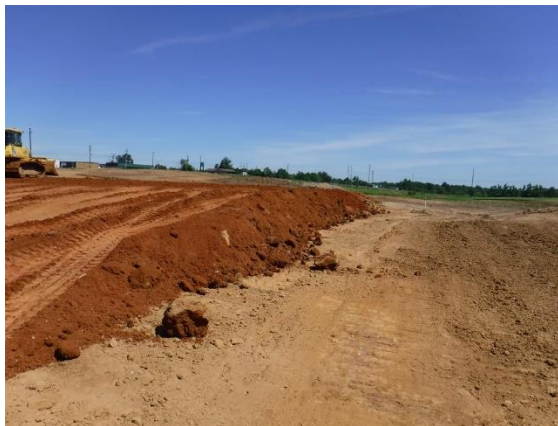
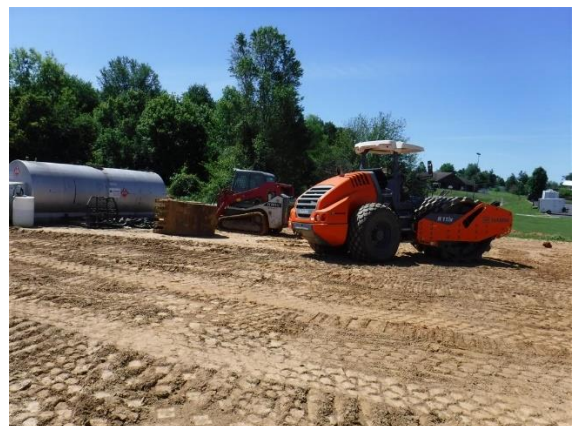
- c) The soils materials were relatively dry and workable. Rain is predicted over the weekend. Dickie said the excavator will seal the pad before the end of the day so that the rain will have a reduced impact on the material.

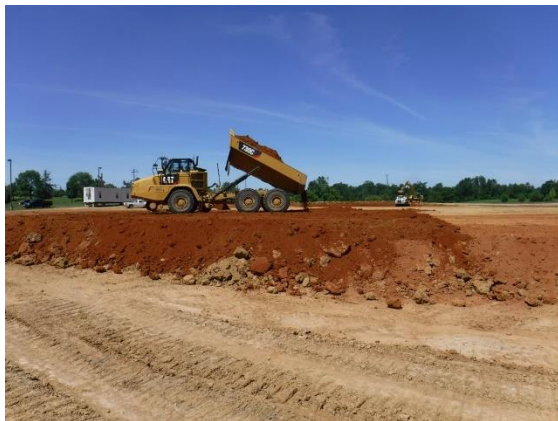
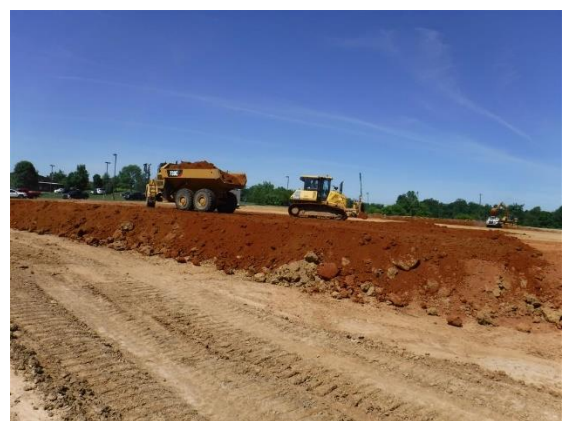
- d) Dickie reported that the excavators are using laser guided equipment to insure the placement of fill in lifts as required by the specifications. Thus far, the compaction reports have been within the specifications.

- a. Review SPIN reports on the placement of fill materials.

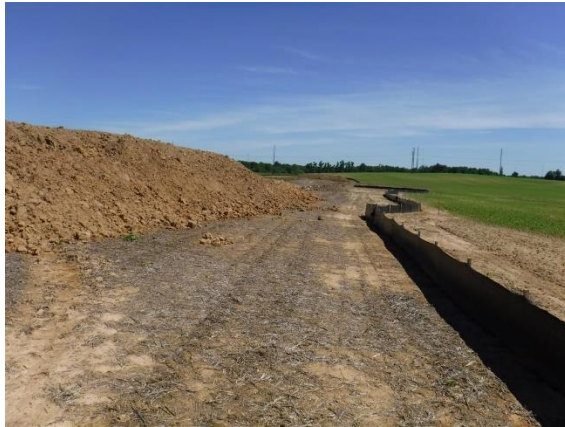
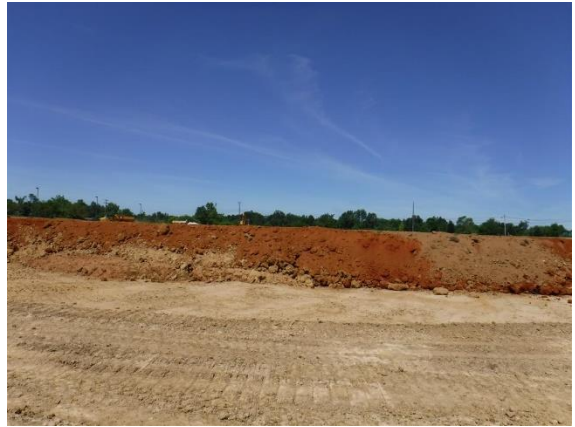
- e) The amount of fill placed thus far is evident at the lower elevations of the site.

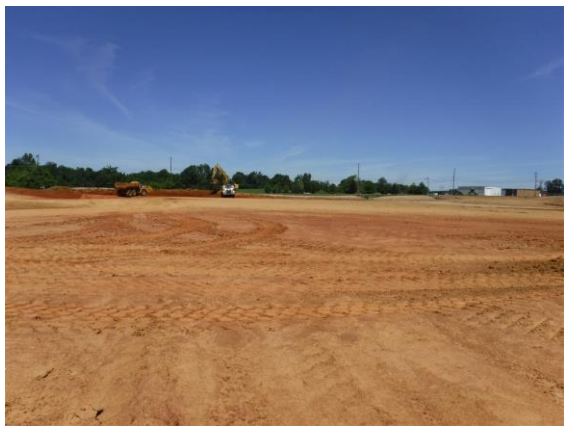
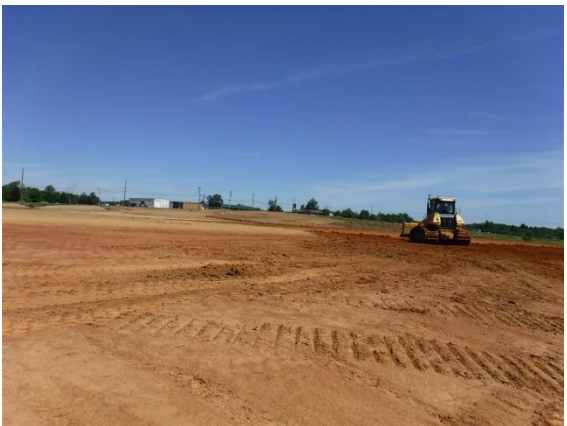
- f) Dickie reported that the goal is to have the building pad in place by the middle of next week. This will depend on the rainy weather predicted for the first of the week. He said that rain has been a factor thus far.

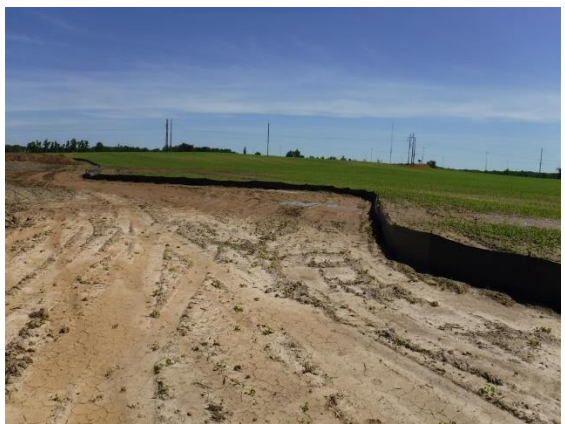
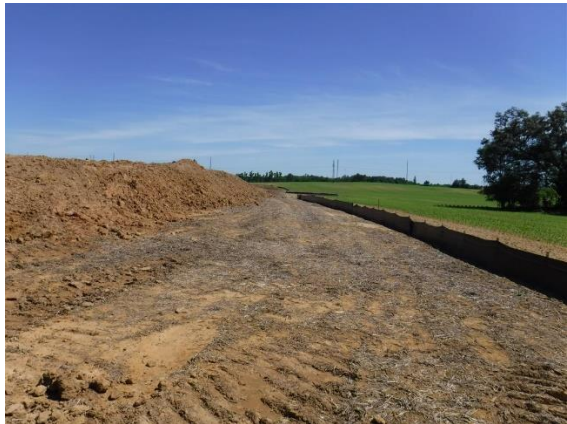
- g) As required by regulations, slit fencing has been placed around the site to control erosion and runoff.
