East Hardin Middle School, Hardin County Schools, Elizabethtown, KY 201752.01 -CA8

Date: 12/30/2019

Report No: 14

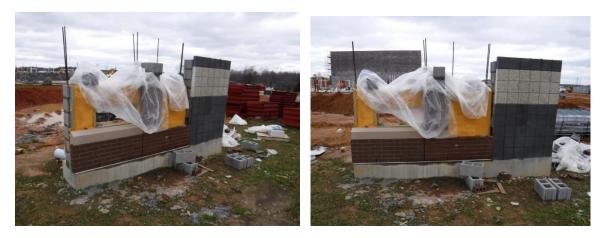
b) The mock wall needs to have the windows, metal trim, sealants, metal roofing and all other items indicated on the drawings added so that it can be evaluated for work quality.

- a. Develop a plan to repair slabs that are scheduled to be polished and submit to all for approval.
- b. Preparations for mockup slab and color options. The mockup wall must have all components indicated on the drawings for the wall and all components for the actual walls in the building. This is to allow JRA to review compliance with the details of construction of the wall.
- c. Maintain the Skudo system so that it protects the corridor slabs.

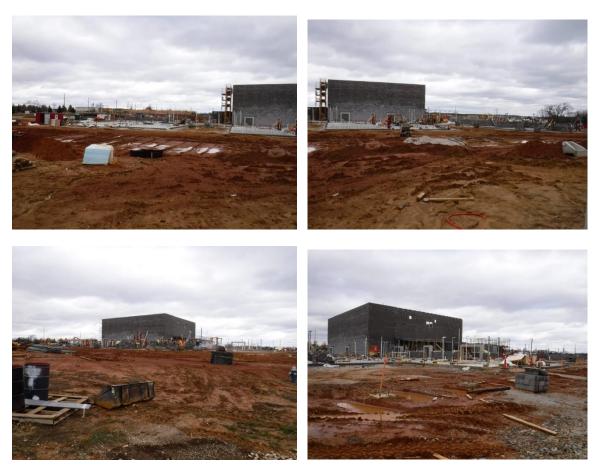
c) The tall Gym enclosure is laid up to roof joist bearing elevation. The steel roof framing is in place on the east side of the Gym enclosure.

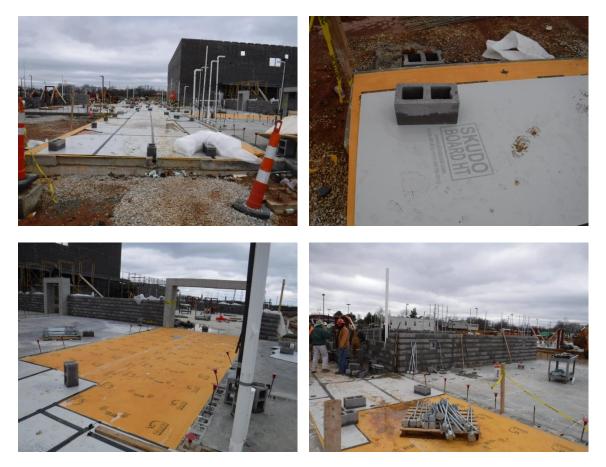
He also said that the severe wind during the early hours of this morning, caused some of the Skudo boards to become dislodged. As a temporary measure, Whittenburg has placed concrete block on the board. Dole said that when the block walls are laid on either side of the Skudo board, the block will no longer be required. The missing portions of the Skudo system need to be replaced and repaired.

d) The Skudo system was installed in area other than Area D where the scaffolding was in place. It will be installed there as soon as the scaffolding is removed. The scaffolding was being disassembled while I was on site. The severe winds that occurred early this morning dislodged some of the Skudo system. Whittenburg has anchored the system with concrete block placed on top of the system. Missing parts of the system will need to be replaced.

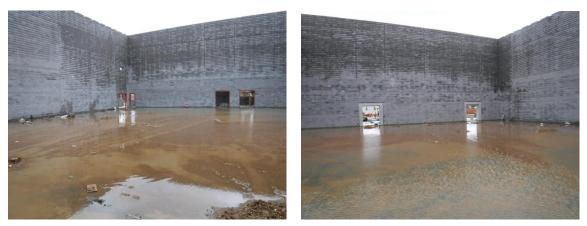
e) The north wall of the Gym is now in place, totally enclosing the Gym. Because the slab is recessed, the heavy rain on Sunday left water up to the surrounding slab elevations. A good deal of mud remains within the Gym area. When the weather improves, this needs to be cleaned.

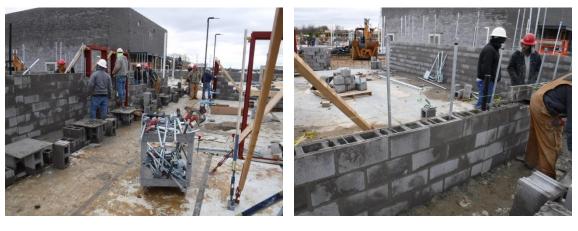
f) Block work was proceeding in Area B at the southeast corner of the building. This area consists of two stories of classroom space. The block will be laid up to the bearing elevation for the precast concrete planks that form the floor structure for the second floor.

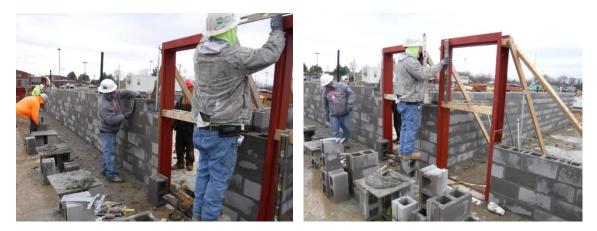
g) The general trades crew had set hollow metal door frames ahead of the masons laying block walls. The frames were being checked for plumb as the walls were being laid.

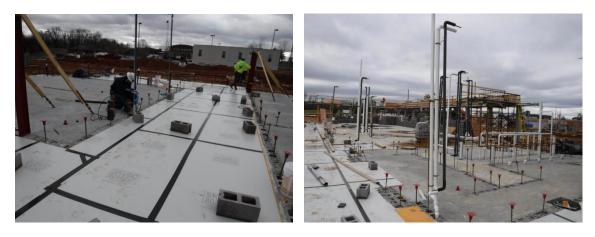
h) Plumbers were installing piping and rough ins ahead of the mason laying the block walls.

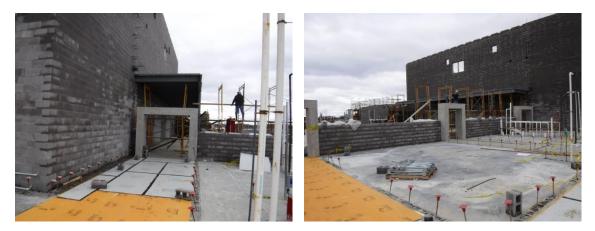
j) Steel roof framing was in place for the roof over the north-south corridor to the east of the Gym.

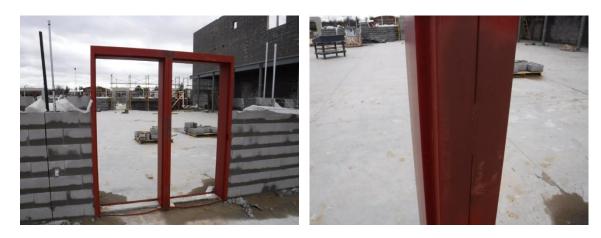
k) The double hollow metal frame at the Kitchen/Cafeteria has been welded together and installed.

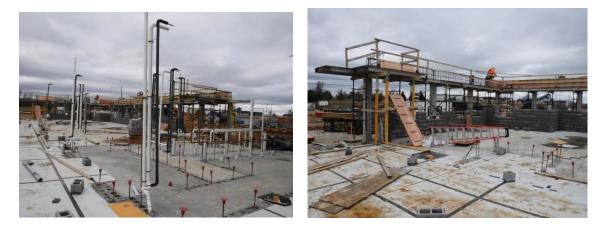
Whittenburg was erecting the forms for the concrete beam at the northwest side of Area A.

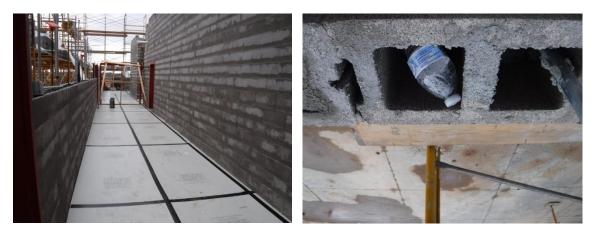
m) The block walls in Area D are acceptable. They will need to be detailed and cleaned. Make sure that all trash is removed from the walls.
