FIELD OBSERVATION REPORT

Lincoln Trail Elementary School, Hardin County Schools, Elizabethtown, KY 201752 -CA8

Date: 12/30/2019

Report No: 14

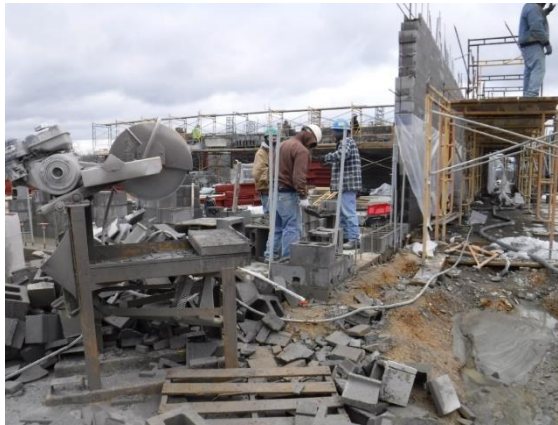
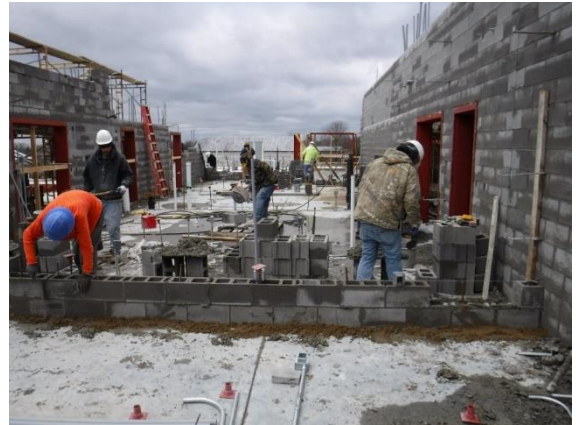
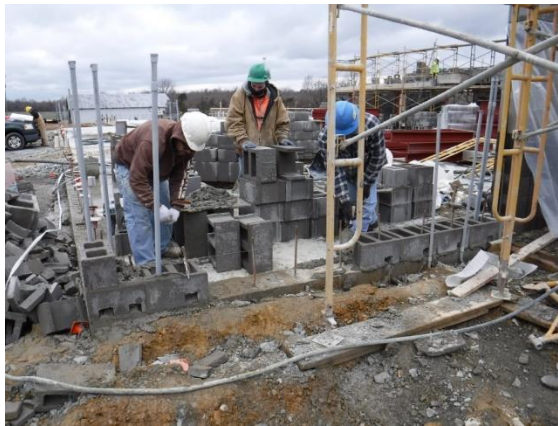
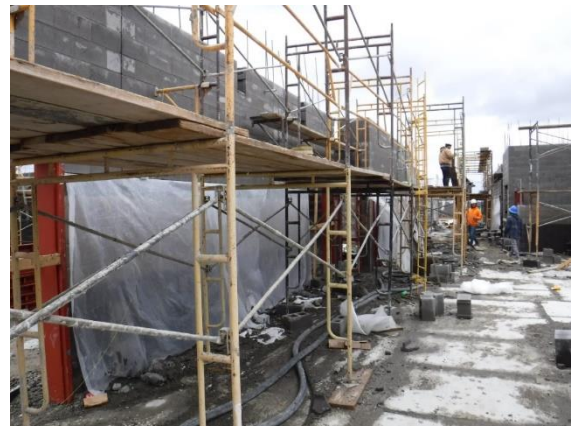
- b) Masons were laying interior concrete block walls in Area B and A. A large crew of masons and helpers were on site and working in several areas.

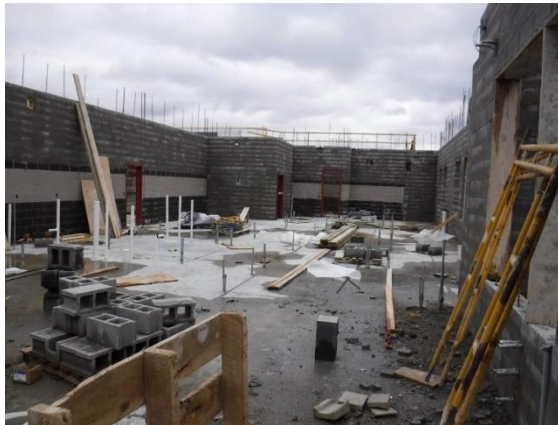
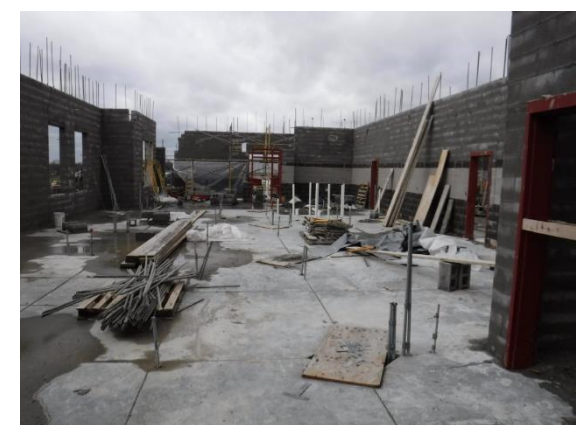
- c) The surrounding walls of the office area are in place.

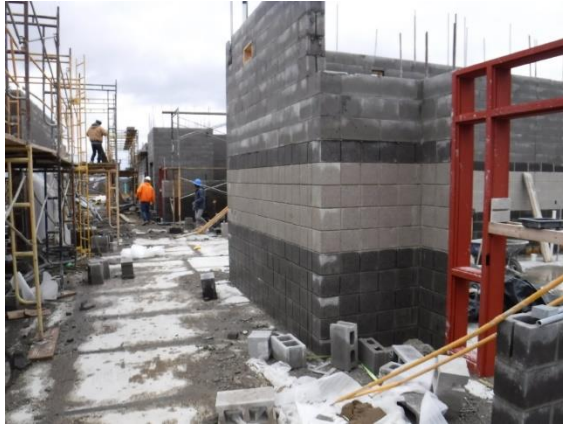
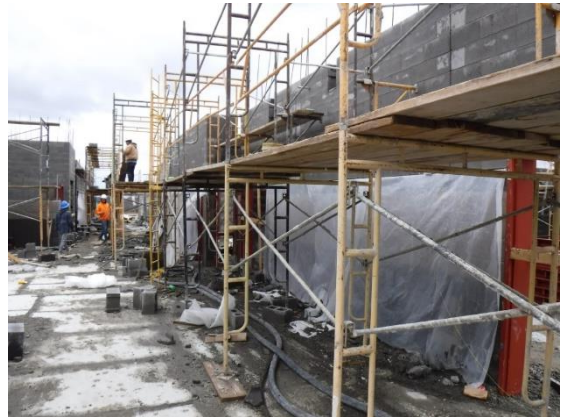
- d) The lobby area and north-south corridor are being defined by the block walls being laid.

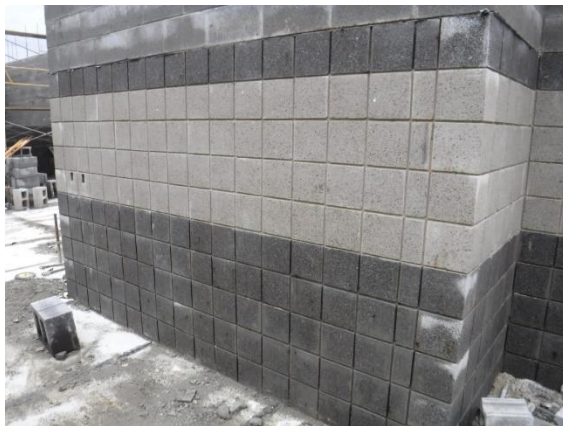
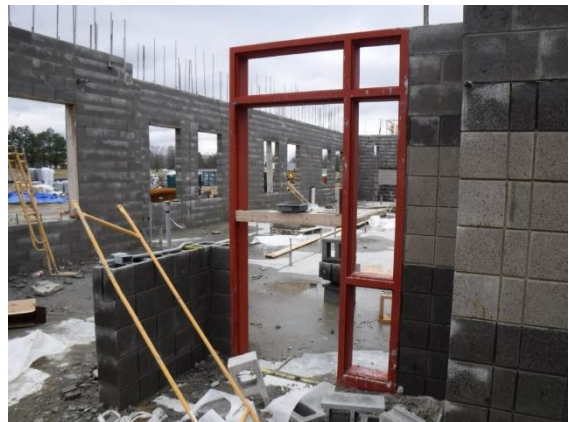
- e) The ground face block looks good, but still needs to be detailed and sealed. The outside corners of the ground face block do not have the bullnose radii that occurs on the block above them. A grinder with a built-in radius will be used on the ground face block to match the bullnose on the block above. This must provide a finished appearance.

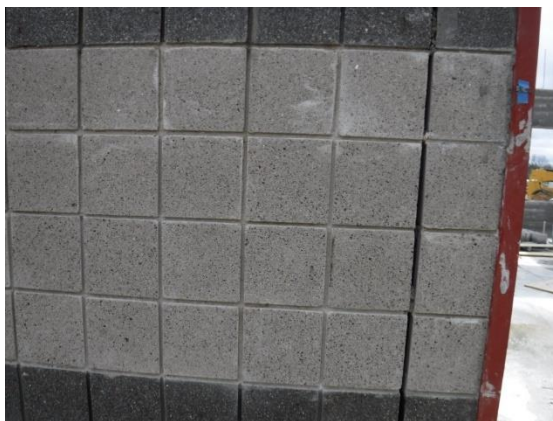
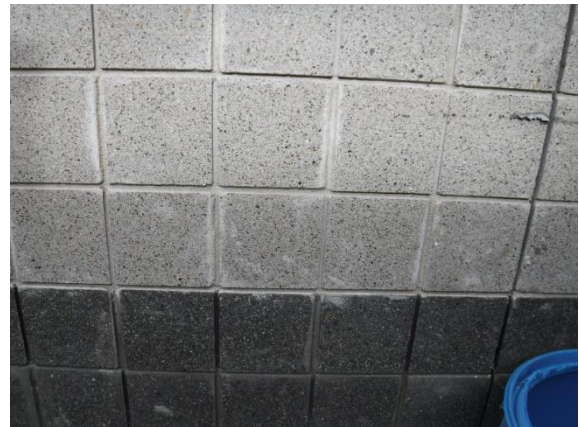
- f) The ground face block needs to be cleaned. The joints need to be tooled per the approved sample. If edges and corners need repair, this must be done to match the surrounding units.

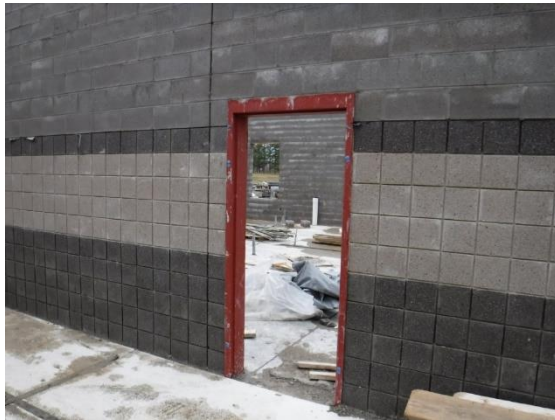
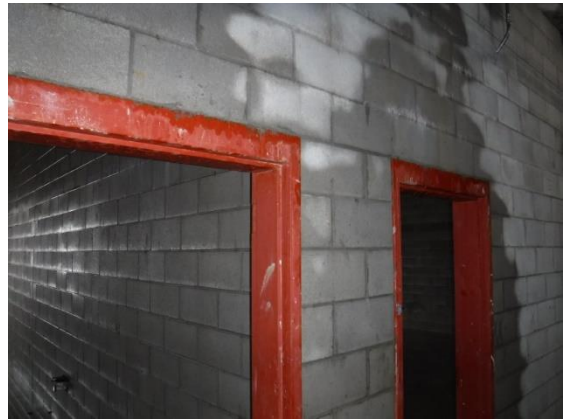
- g) Mortar needs to be removed from hollow metal frames without damaging the surface. If the primer is removed in the process of cleaning the mortar off, touch up primer needs to be applied before the frame rusts. Any surface damage needs to be repaired with autobody filler and ground smooth and reprimed.

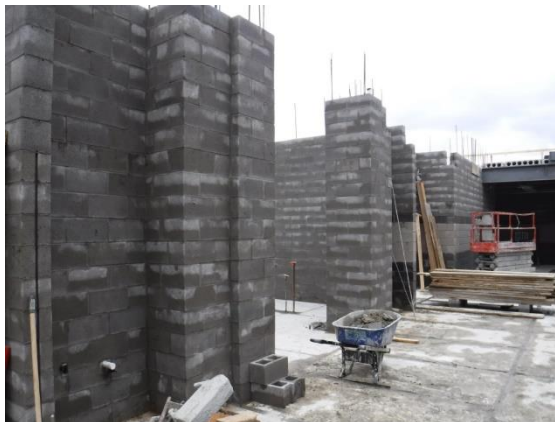
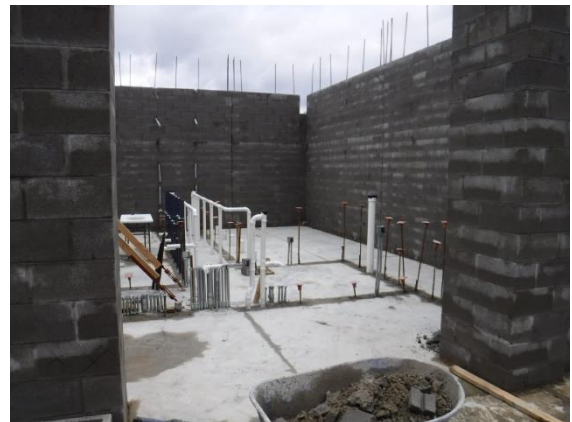
- h) The toilet on the east-west corridor is enclosed with block. The precast concrete planks will span over the top. Then the interior block walls will be laid.

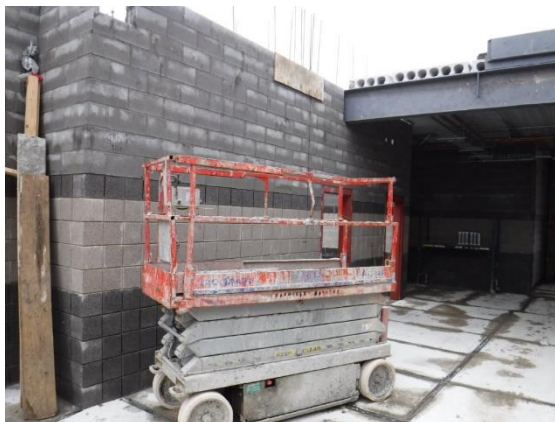
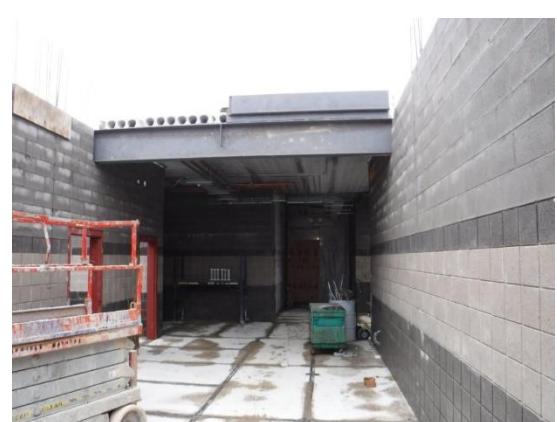
- i) The precast concrete planks have been placed into the east side of Area B.

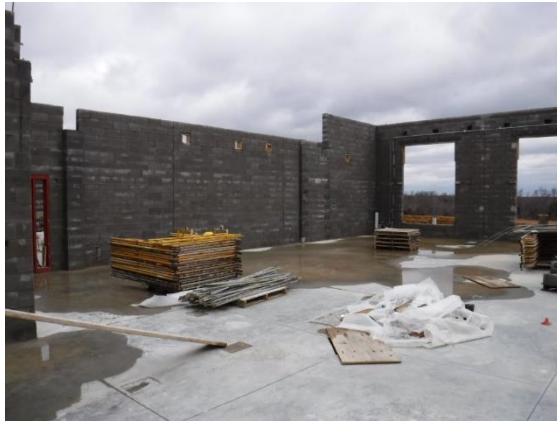
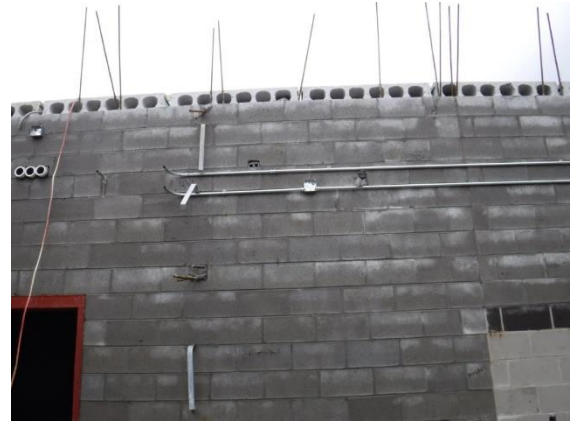
- j) Electrical and mechanical rough ins have been attached to the walls surrounding the library/media center.

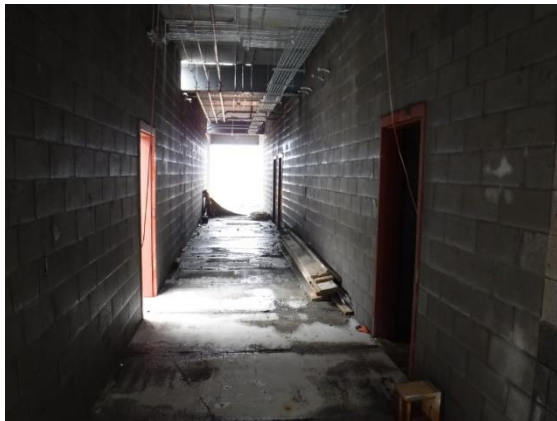
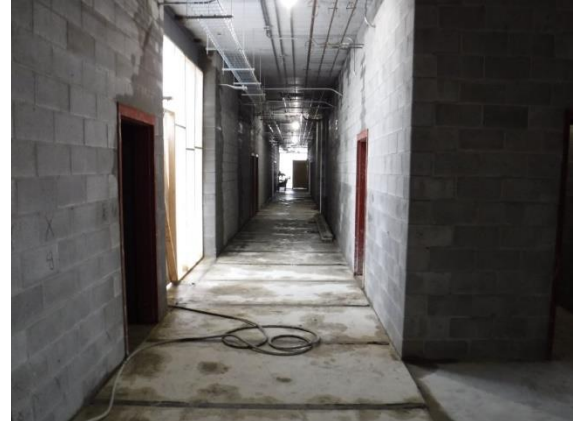
- k) No work was in progress in the enclosed portions of Area C and Area B.

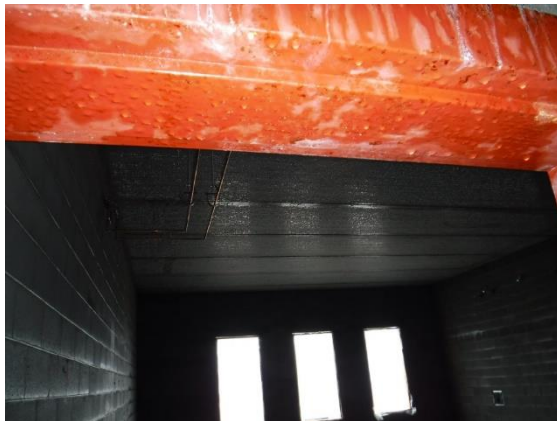
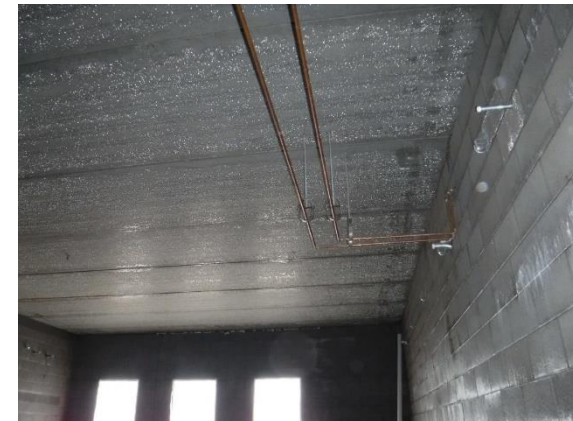
- l) After the heavy rain on Sunday, the walls and ceilings of the rooms were saturated with moisture. This partially the result of the water that is ponding on the floors.

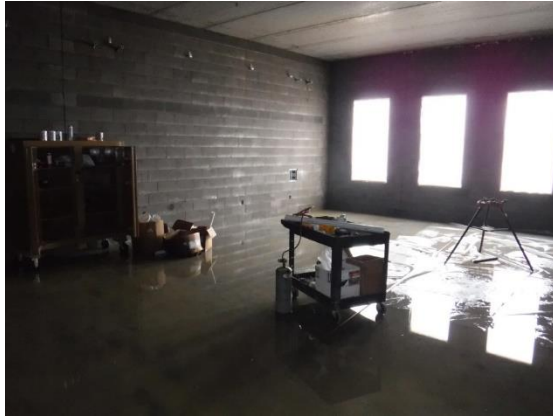
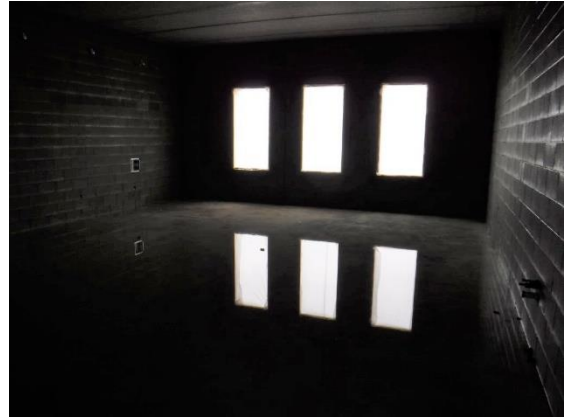
- m) The general trades contractor was going to remove the water ponding on the classroom floors. The Skudo system traps the water at the doorways thus causing about ½" of water to be trapped in the rooms.

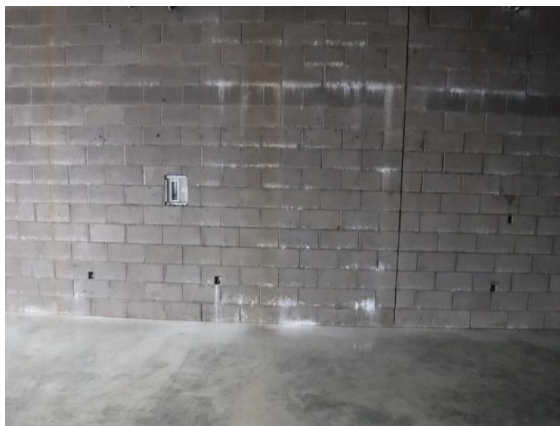
- n) Where the moisture has saturated the block walls, lime was wicking out of the block. This needs to be cleaned off of the block as the it is detailed.

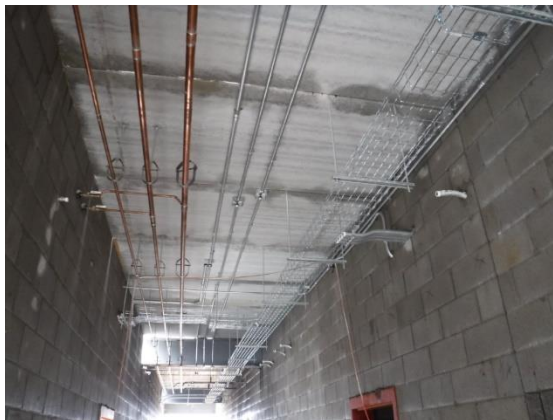
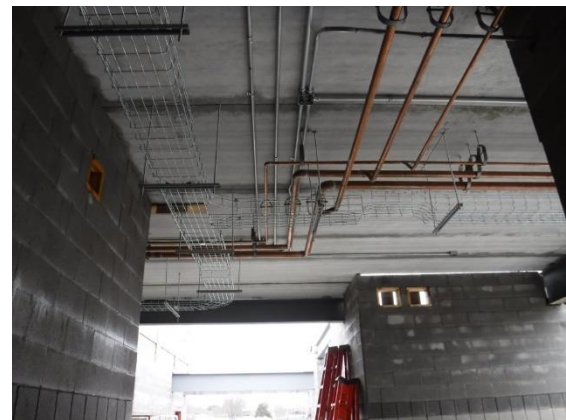
- o) Piping, conduit and cable tray rough ins are in place in Area C.

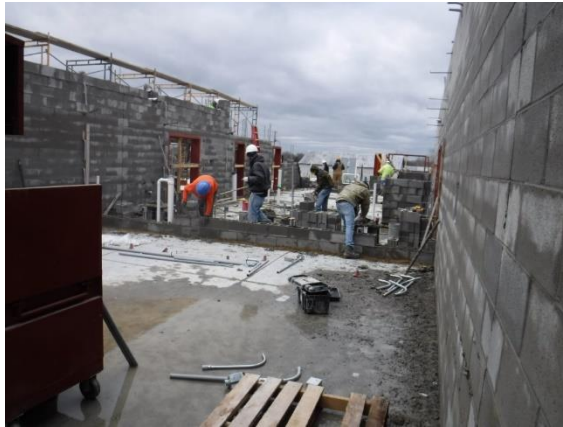
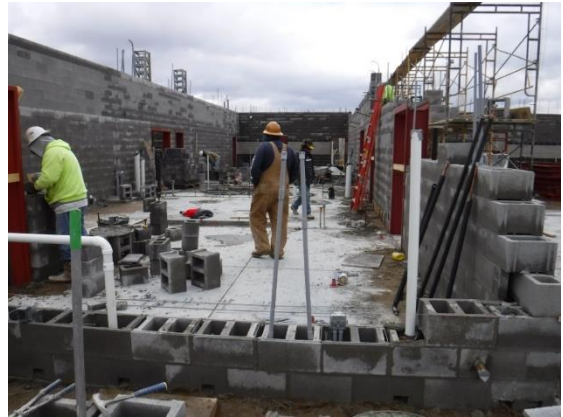
- p) Block was being laid in the Mechanical Room, PE Storage and Office and Music Classroom. These walls are between the Gym and the Cafeteria.

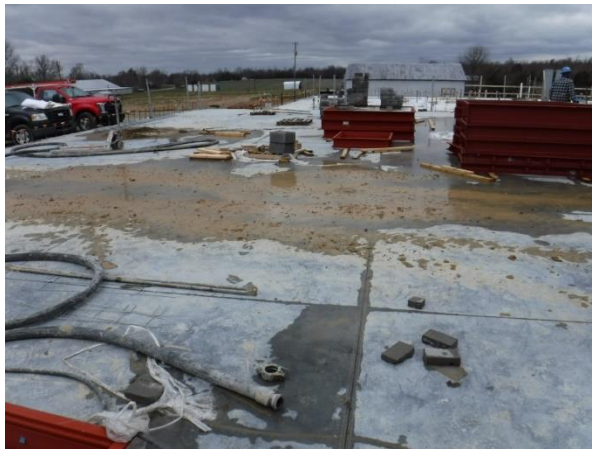
- q) The Kitchen walls be laid up after the walls supporting the precast concrete planks for second floor areas.

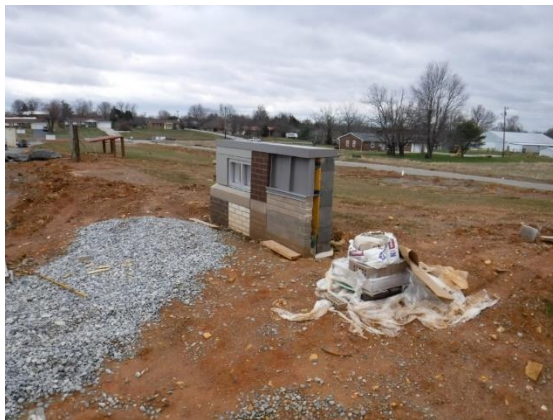
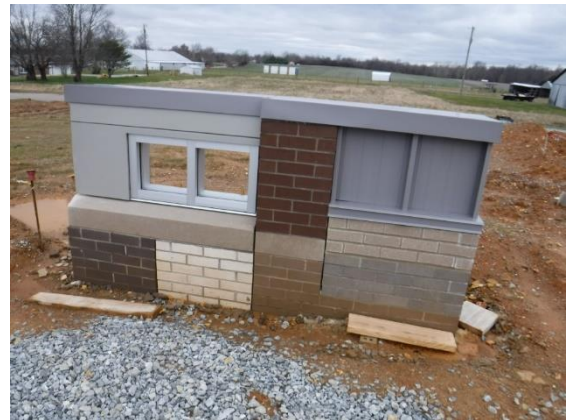
- r) The mock wall still needs trim and sealants to be complete.
