FIELD OBSERVATION REPORT

East Hardin Middle School, Hardin County Schools, Elizabethtown, KY 201752.01 -CA8

Date: 2/11/2020

Report No: 17

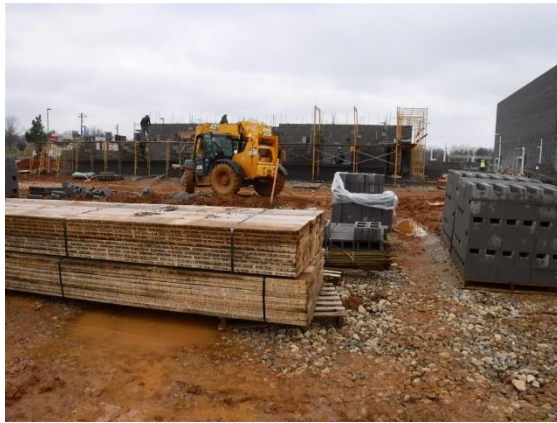
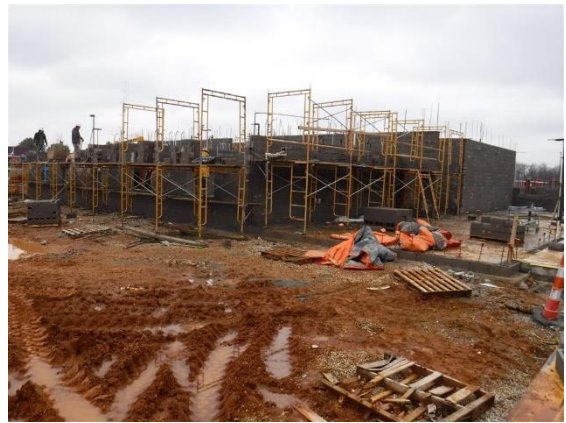
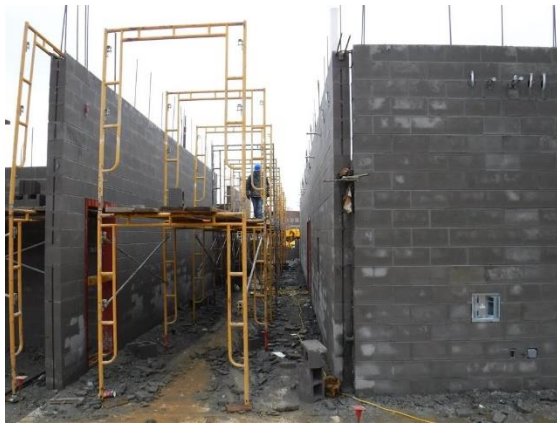
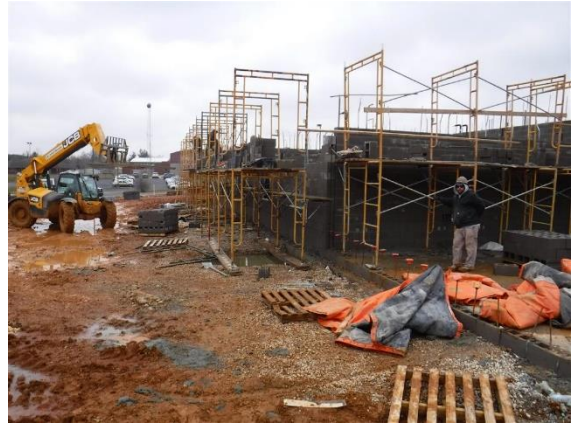
- b) Concrete block walls are being laid for the classrooms on the first floor in Areas B.

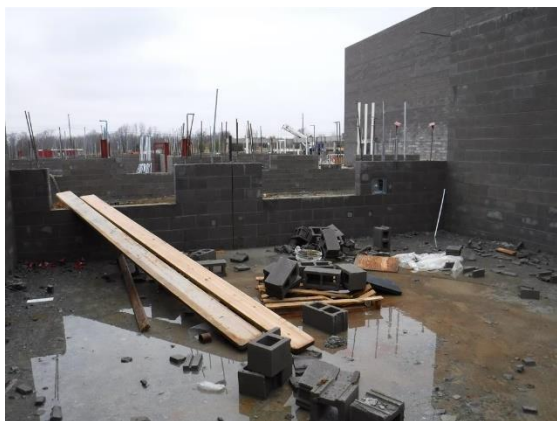
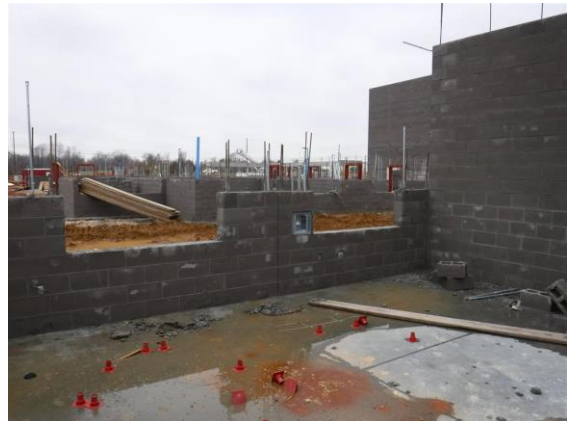
- c) As the Classroom walls are being laid, the data/power boxes for the TV monitors and the teacher's stations are being placed in the walls. The location of the teacher's station box is affected by the window location. In one case, the box is to the left side of the window to avoid having it too close to the corner of the room. Doyle said the locations of the boxes have been coordinated with HCS.

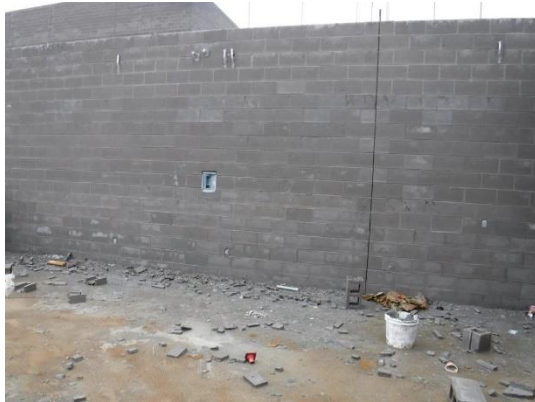
- d) Doyle said the HCS wanted the TV monitor box located in the center of the Classroom wall. The boxes in place appeared to be close to the center of the walls.

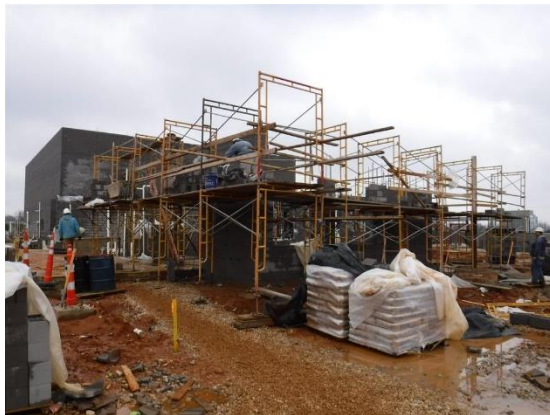
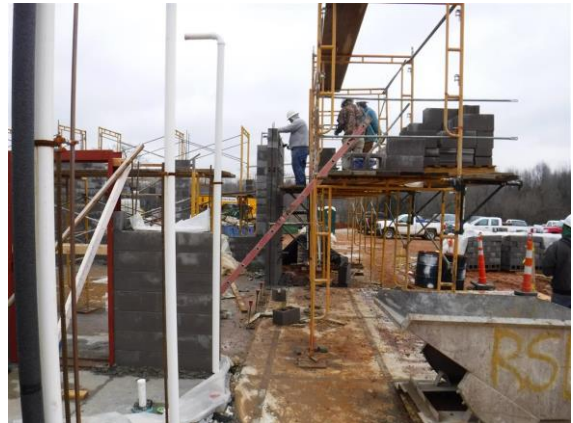
- e) Concrete block walls were being laid to the south of the fire wall for the Low Incidence Classroom.

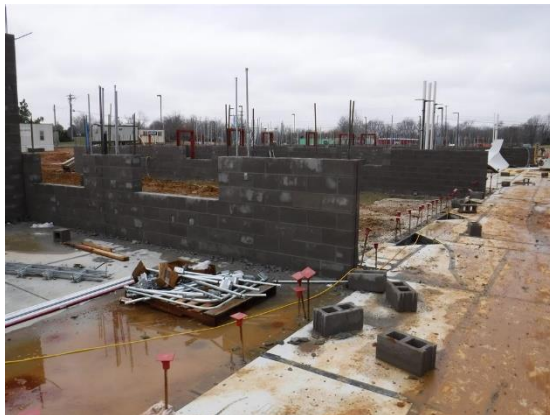
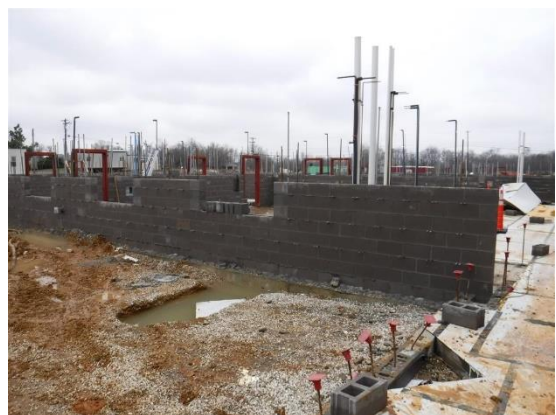
- f) Concrete block walls had been laid up to the first grout lift for the Classroom walls in Area A.

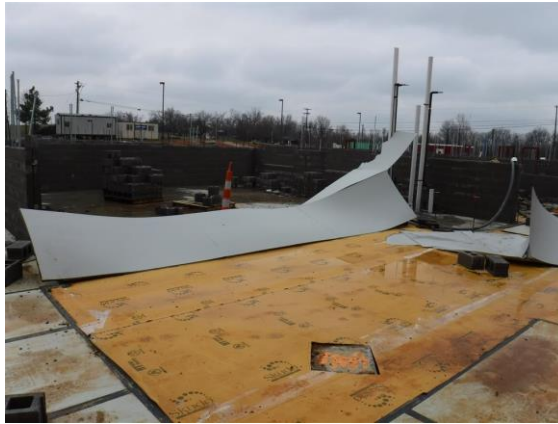
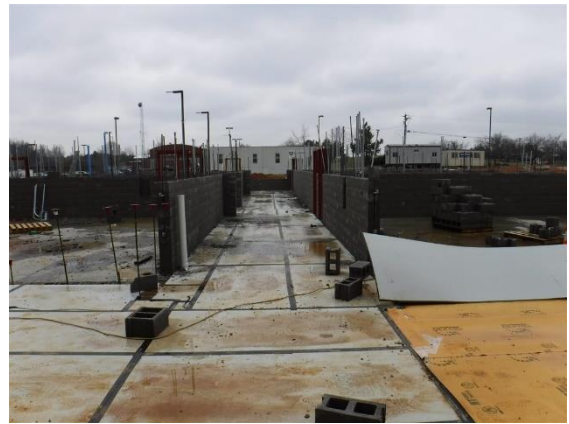
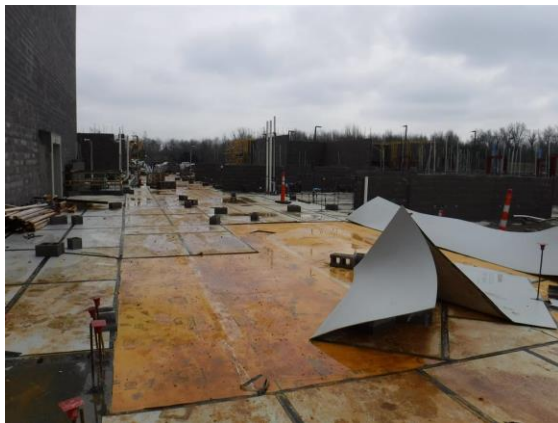
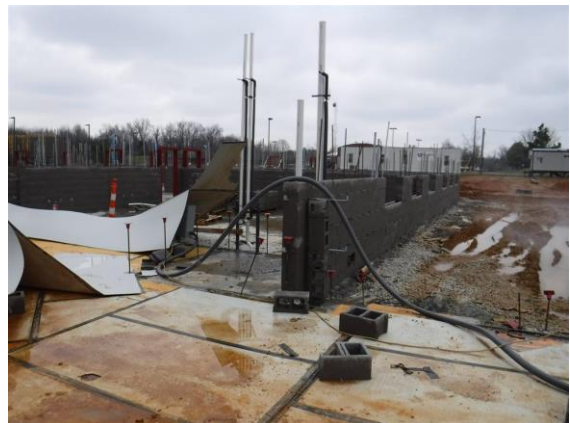
- g) The top layer of the Skudo protection board had blown up from the high winds experienced the night before. Doyle said that he had contacted Wittenberg to return to the site to make repairs. This occurred in spite of having concrete block located on the system.

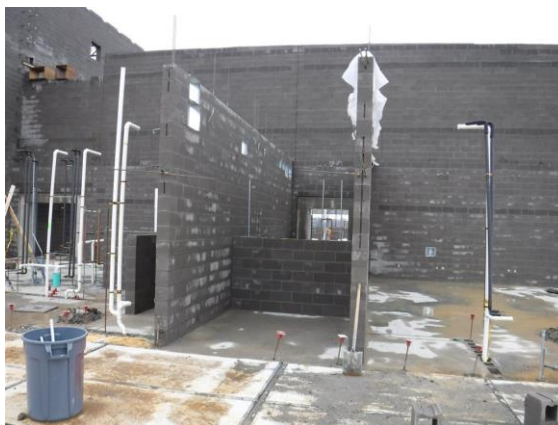
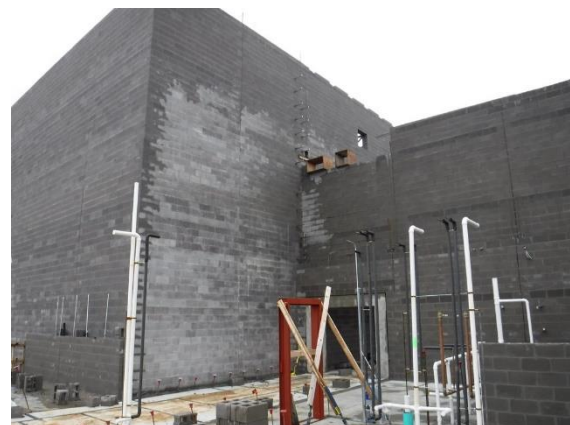
- h) The south wall of the cafeteria and some of the walls in Area B have been laid up to bearing elevation.

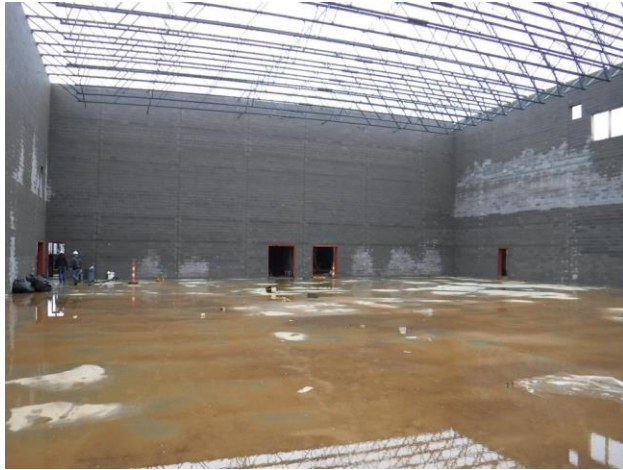
- i) The recessed Gym slab is holding water from the recent rains. The slab has not been completely cleaned due to the water.

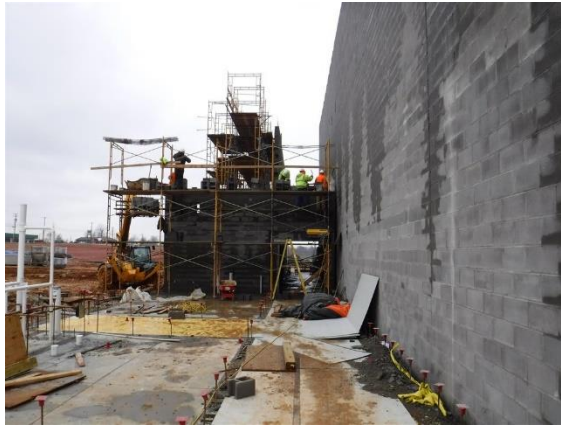
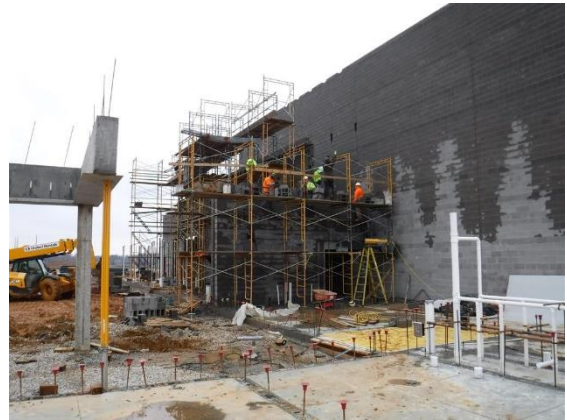
- j) Block was being laid on the mezzanine to the west of the Gym.

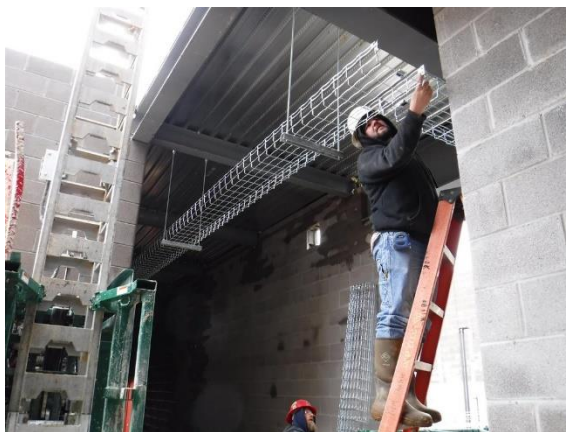
- k) Electricians were installing cable trays in the corridors in Area D.

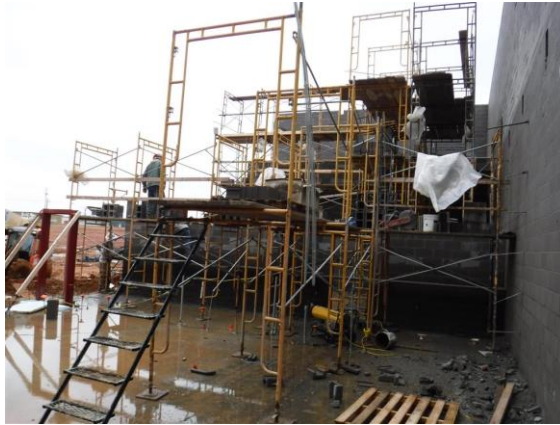
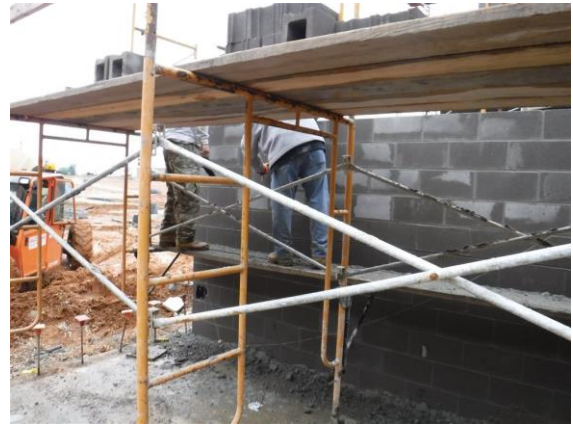
- l) Block was being laid in northern portion of Area D at the Band Classroom, and adjacent rooms.

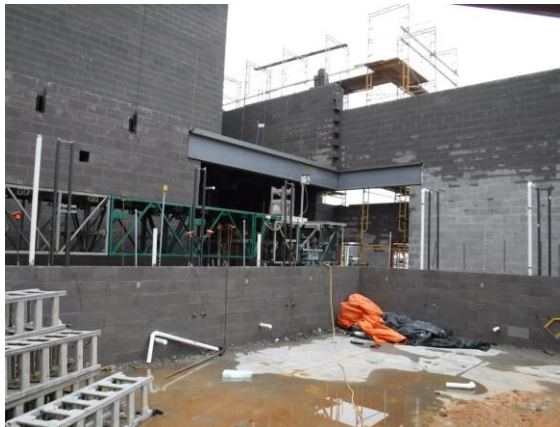
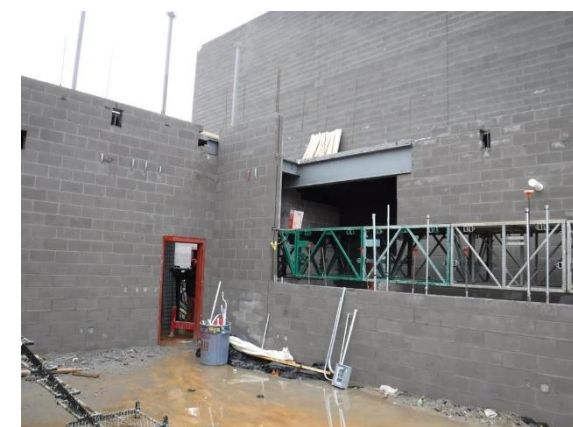
- m) The masons are using Hydrolifts for the high walls above mezzanine.

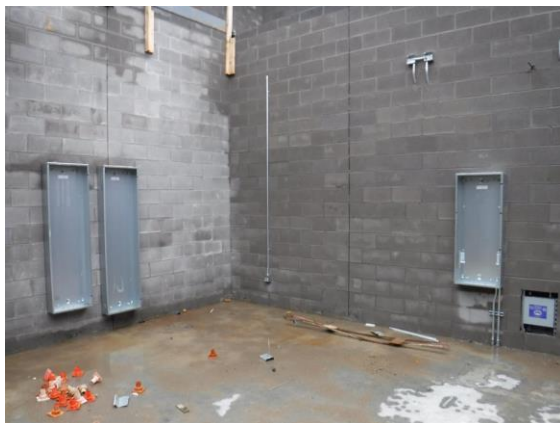
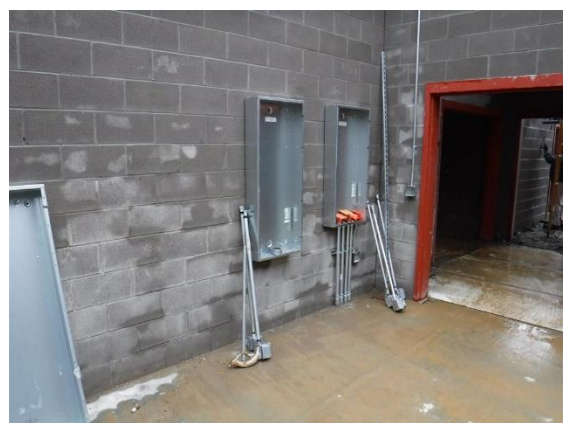
- n) Electrical rough ins have been started in the Mechanical Room.

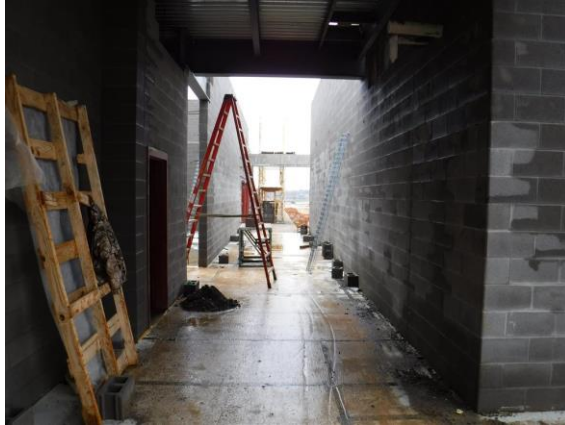
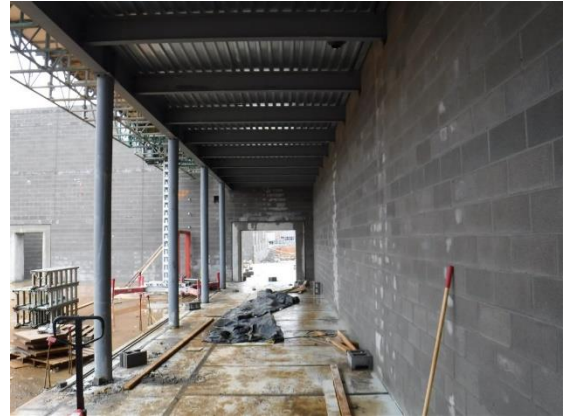
- o) The Skudo protection board system has been installed over the slab in the corridors under the mezzanine.

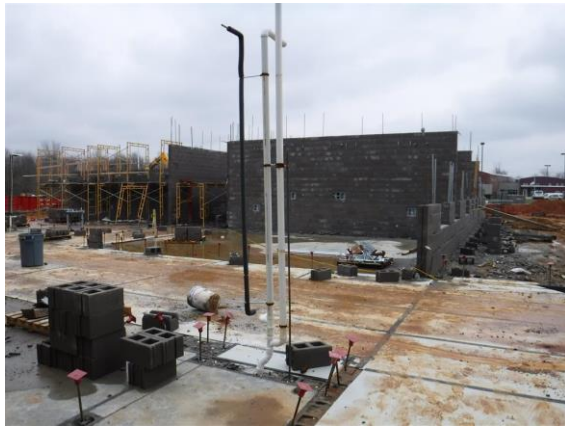
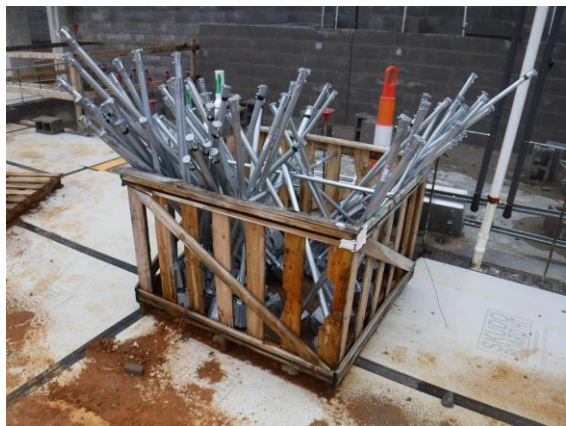
- p) The plumber has installed their rough ins ahead of the block walls. The high winds the night before had knocked one of these down. The electrician has prefabricated his wall box/conduits to place in the block walls as they are laid.

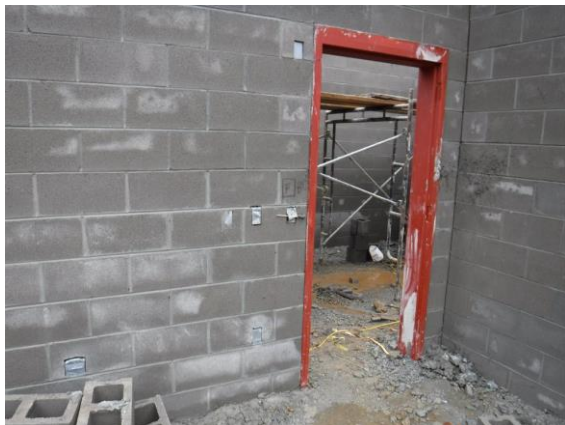
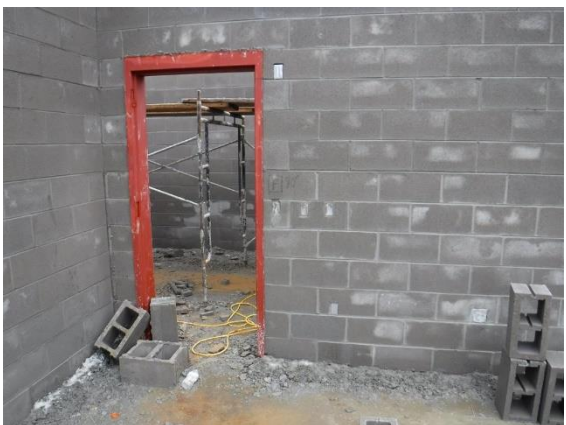
- q) Electrical back boxes are located near room entry doors. The block is generally cut tight to the boxes and should be covered with the finish plates when they are installed. The hollow metal door frames are being installed as the walls are laid up.

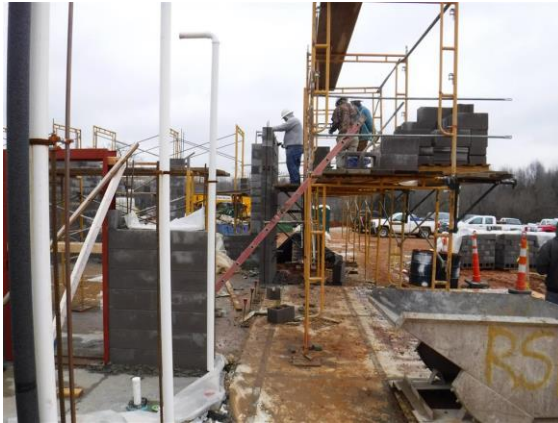
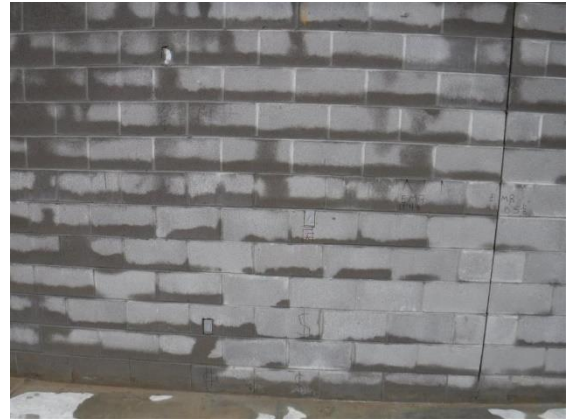
- r) Masons were tooling block joints as they were laid. These are generally acceptable. The normal amount of repairs will need to be made in the final cleanup of the walls.
