FIELD OBSERVATION REPORT

Lincoln Trail Elementary School, Hardin County Schools, Elizabethtown, KY 201752 -CA8

Date: 2/11/2020

Report No: 17

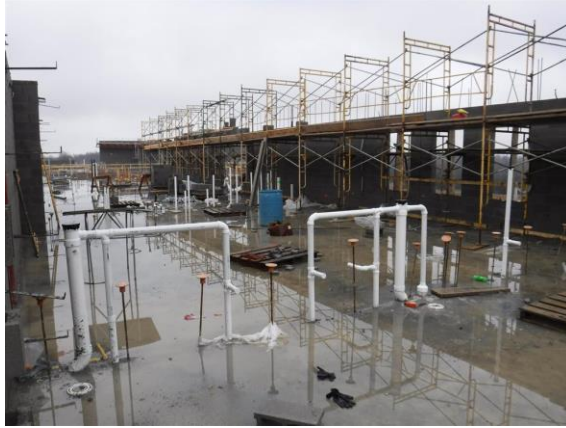
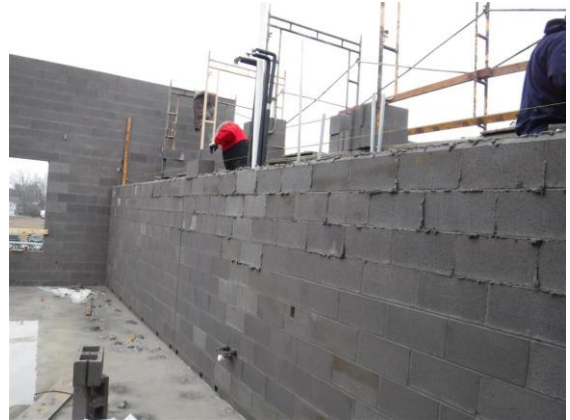
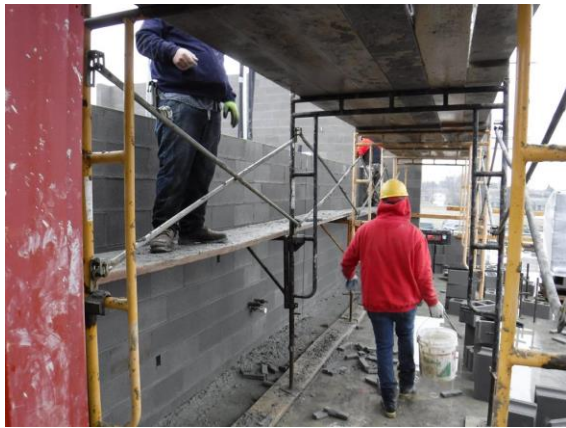
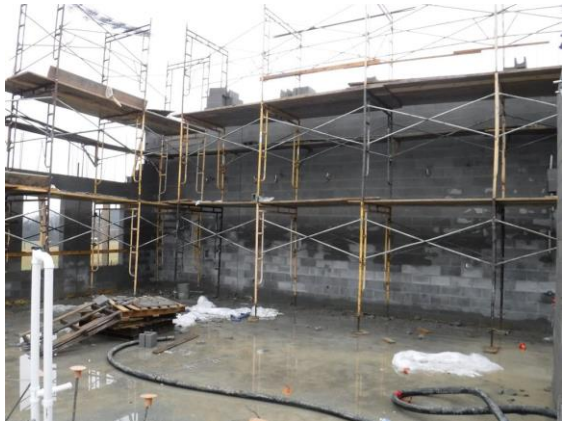
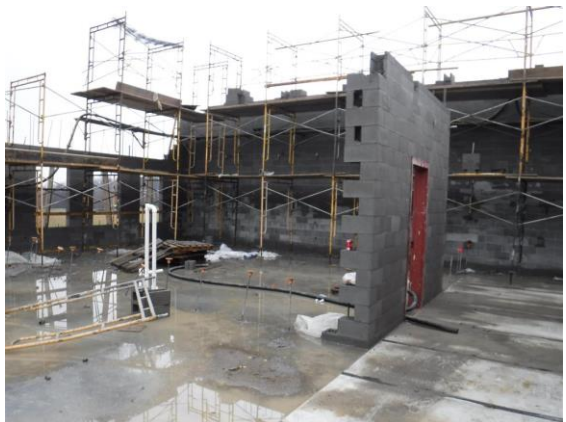
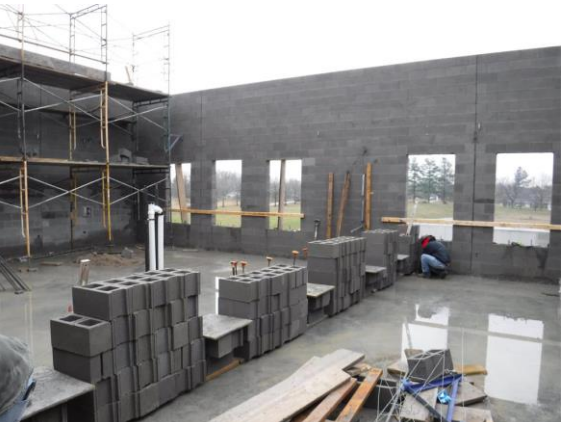
- b) Masons were laying block on the second floor dividing walls between classrooms for Area C. They had also laid exterior walls on the second floor of Area C and were grouting the east exterior wall.

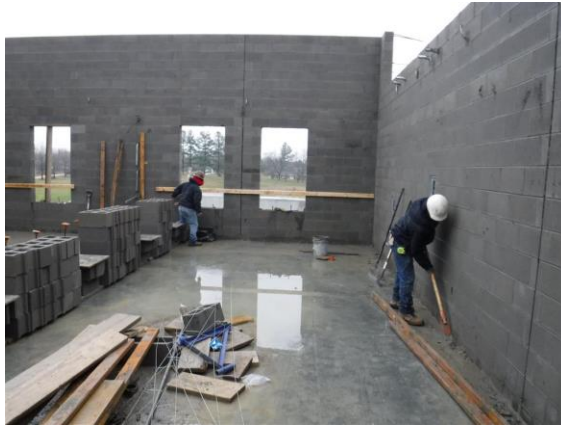
- c) Mason helpers were cleaning the slabs in the second floor Classrooms after the walls were topped out.

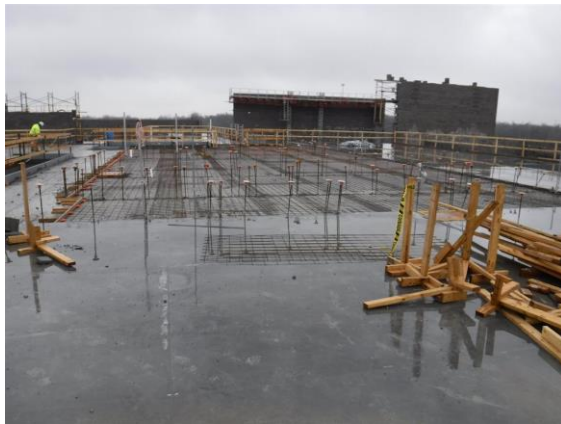
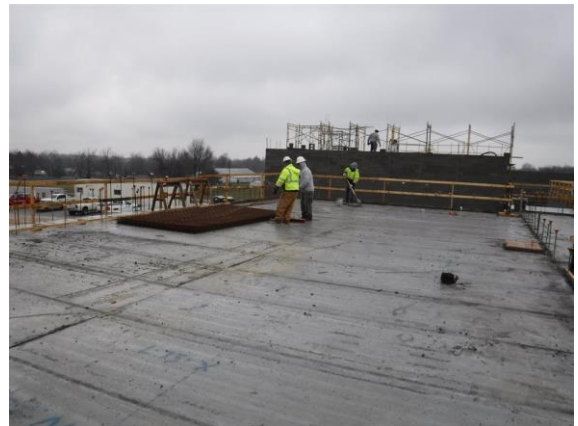
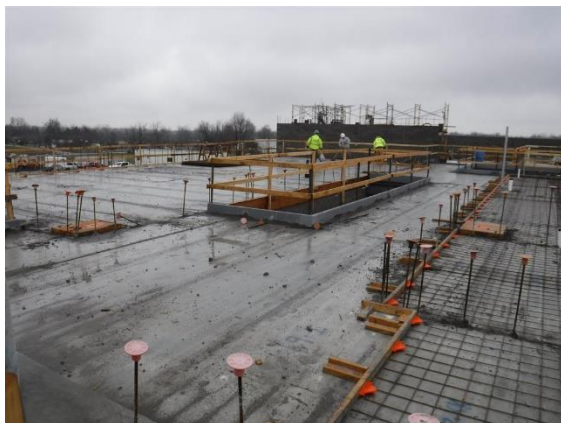
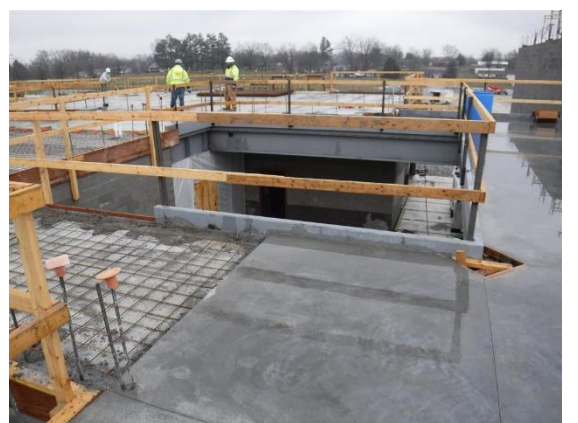
- d) From the second floor, all of the precast concrete planks are in place and are being readied for the topping slab.

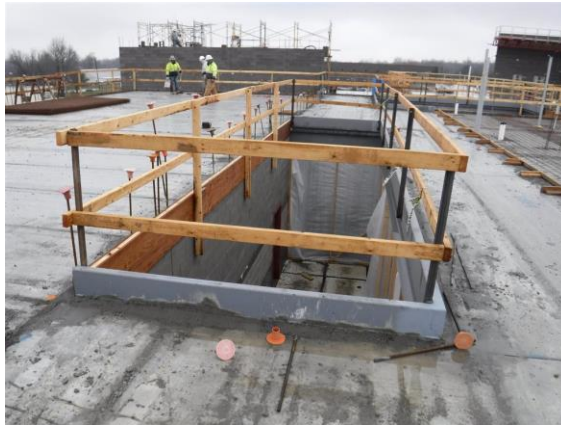
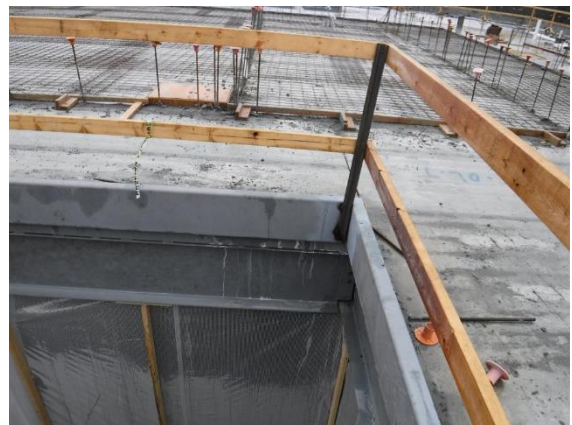
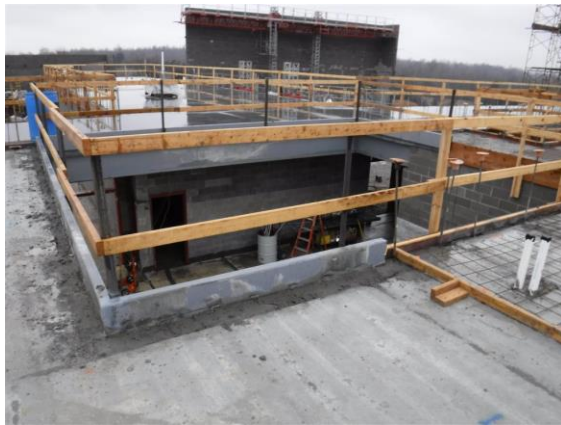
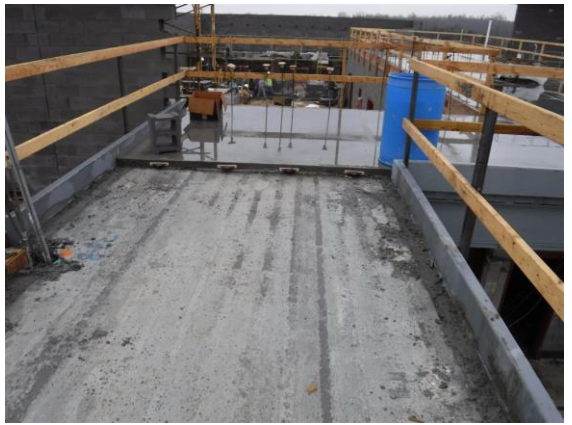
- e) Floor openings at the second floor were framed with steel tubes. The topping slabs will pour to the steel.

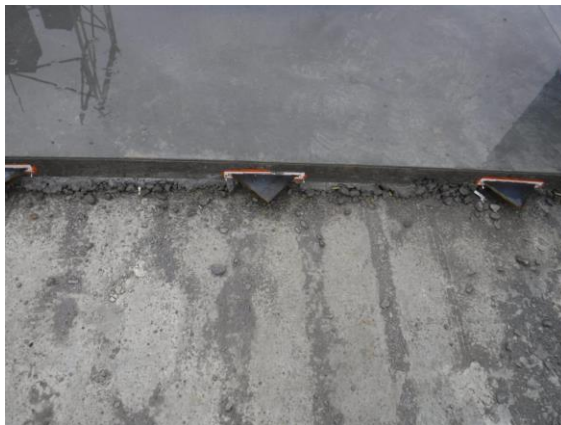
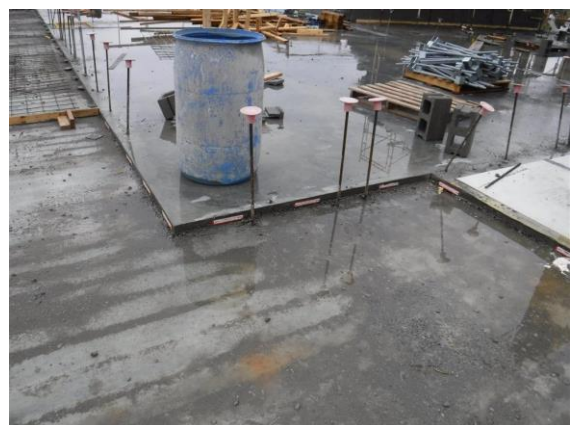
- f) Steel diamonds were in place at the topping slab edges from the previous pours.

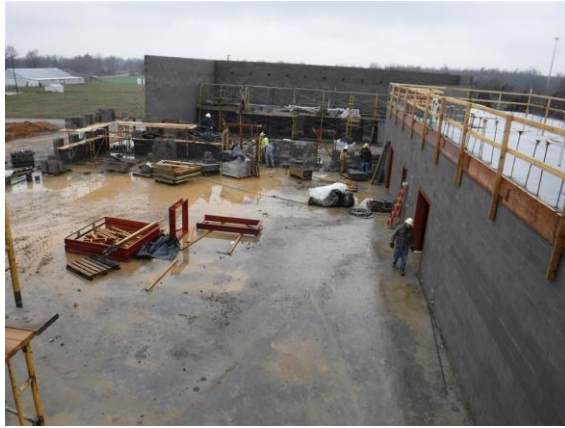
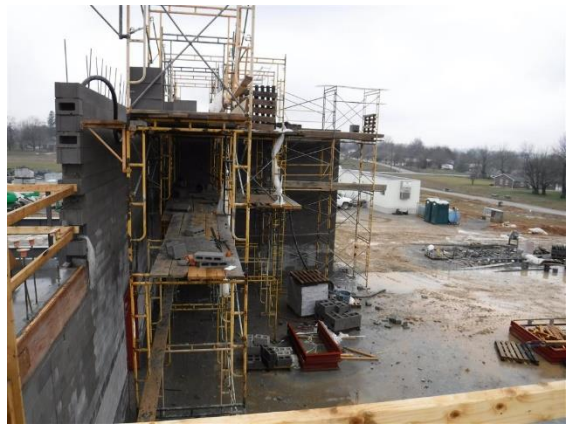
- g) From the second floor, this is the view of the exterior walls at the Kitchen/Cafeteria were topped out at several locations. The mechanical mezzanine is visible in the foreground of the image on the left.

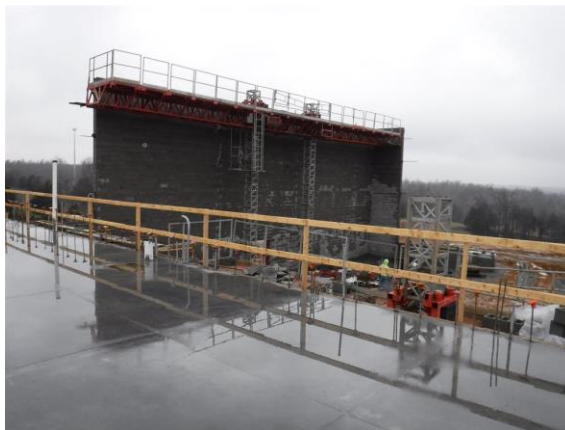
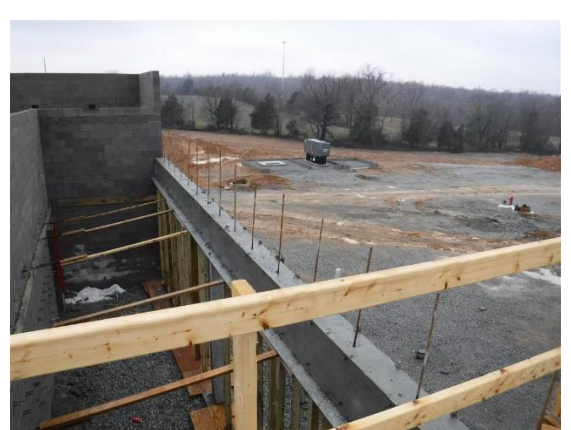
- h) The exterior concrete block walls for the Gym as viewed from the mechanical mezzanine and the rear of the second floor.

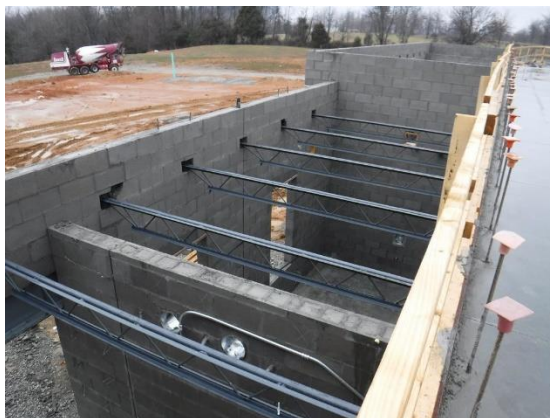
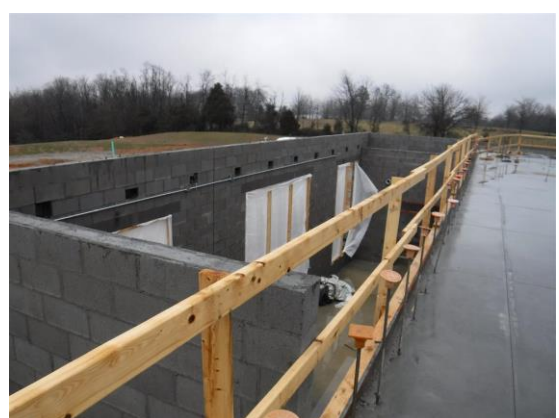
- i) As the second floor slabs are completed, the steel bar joists have been put into place for the roof area that covers the first floor.

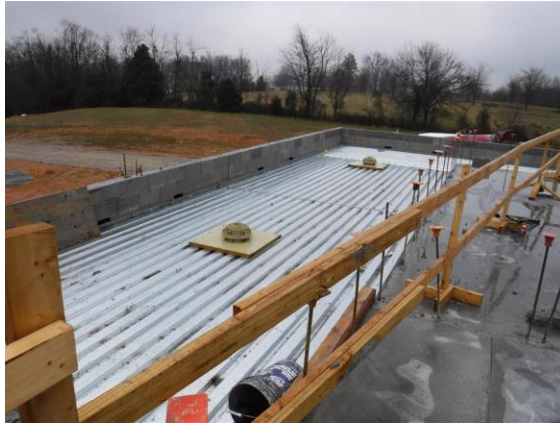
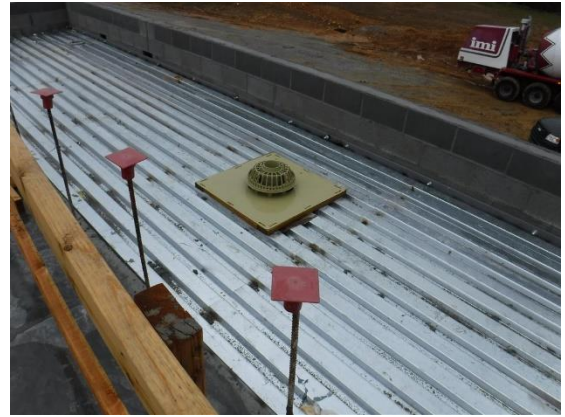
- j) Steel roof deck and roof drains are in place over a portion of the preschool rooms below.

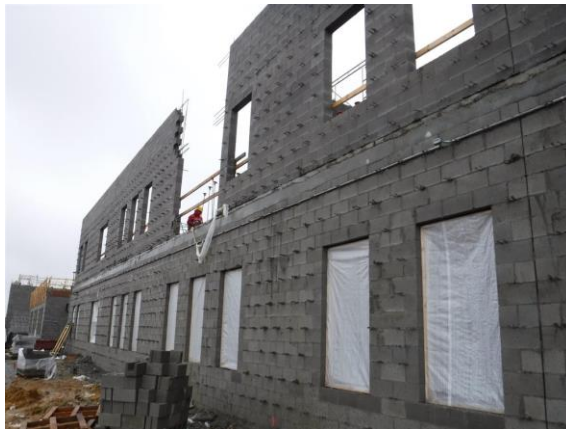
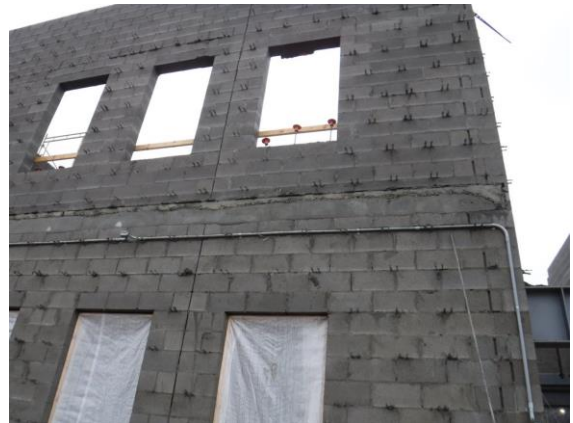
- k) From the ground at Area C, the full height of the block has been laid to the roof bearing elevation. Note the brick ties in place at the required spacing.

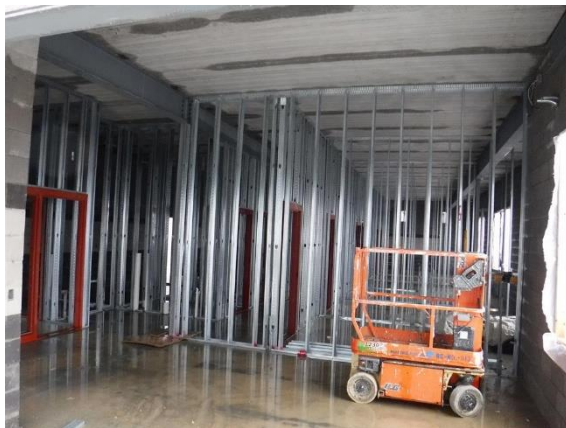
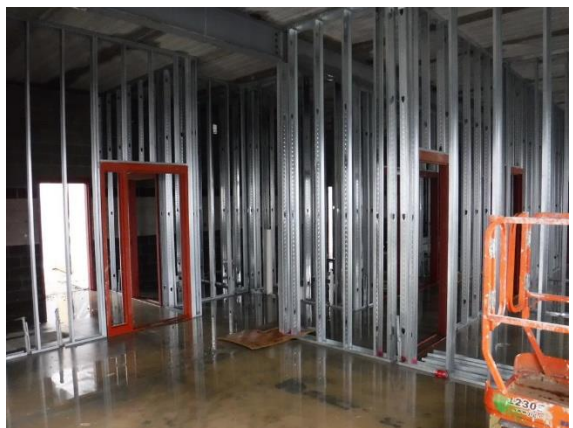
- l) Metal wall studs and hollow metal frames have been installed in the administrative area.

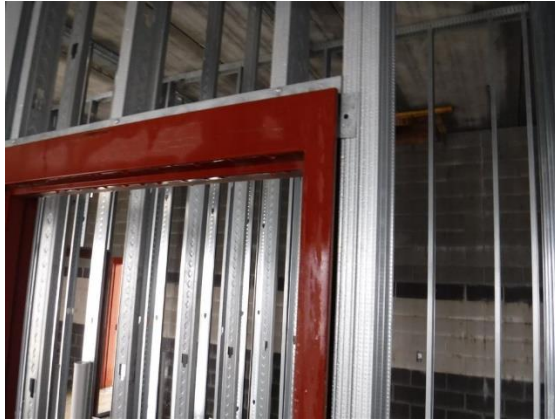
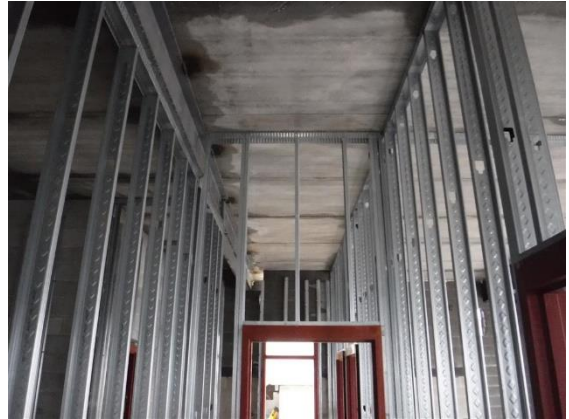
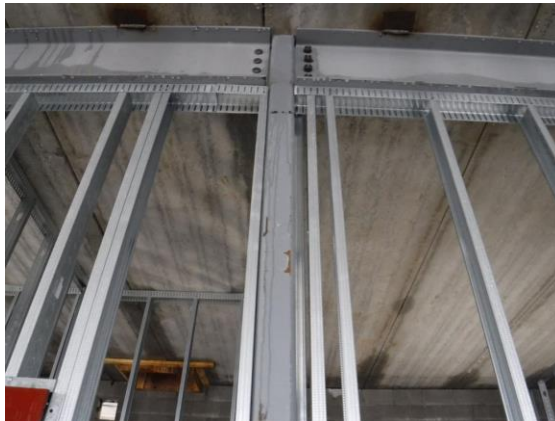
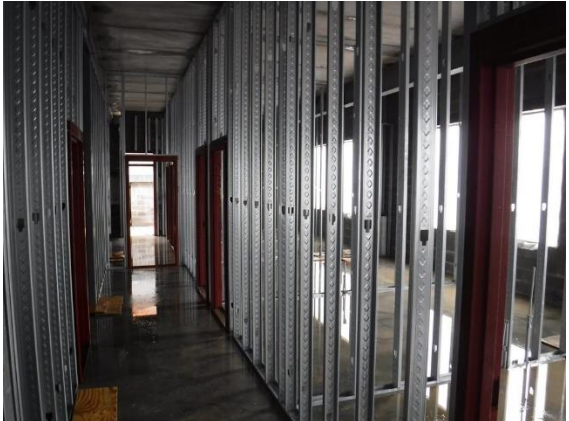
- m) Detailing of the metal studs around the hollow metal frames at the slab appears to be per the specifications. Double studs were used at jambs. A check of the frames, demonstrated that they were rigidly in place. Slip track was used at top of studs.

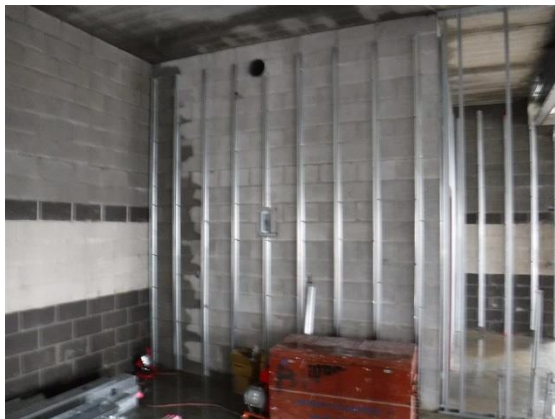
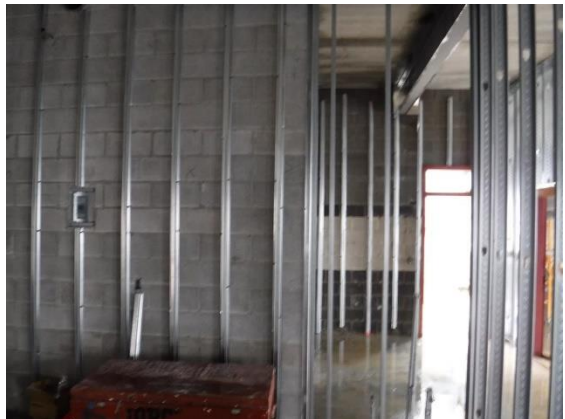
- n) Metal furring at the required spacing had been installed over block walls.

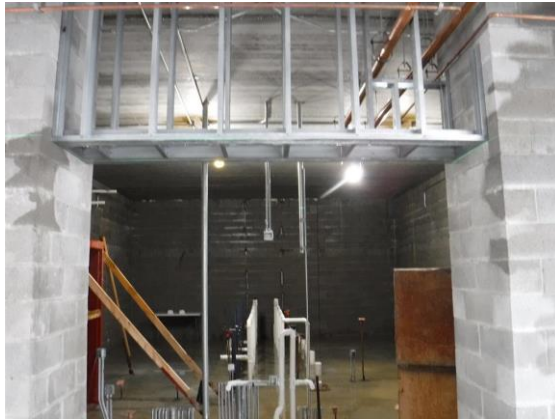
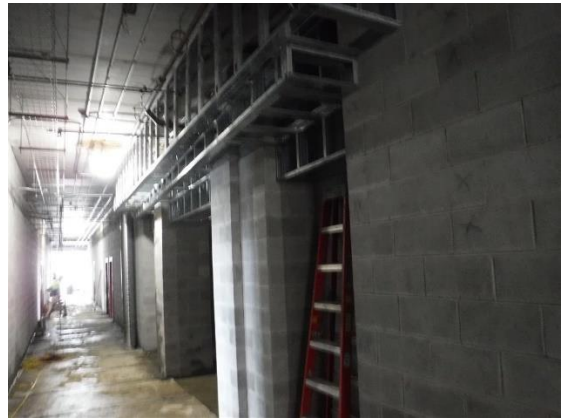
- o) Metal stud soffits were being installed at the entrances to the Toilets in Area B. Other soffits had already been installed.

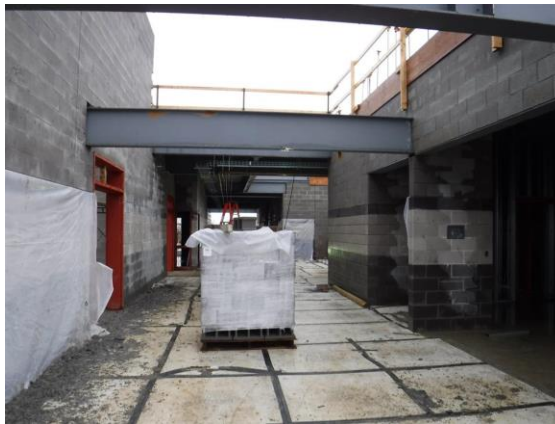
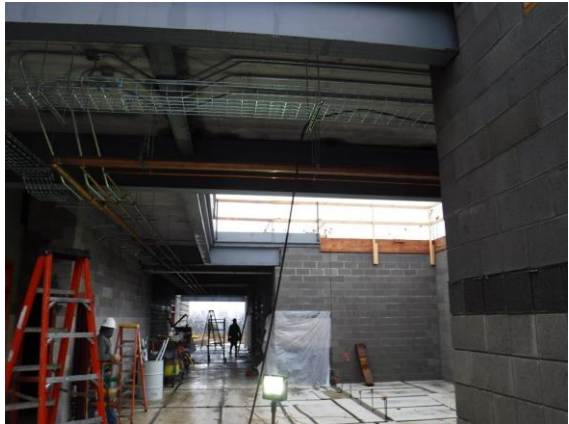
- p) The floor opening and cross corridor beams are in place at the lobby and south to north corridor.

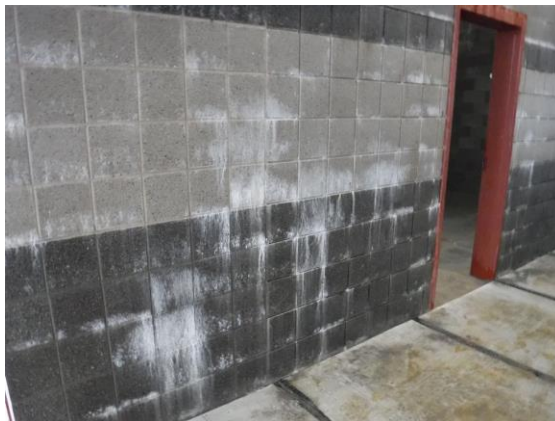
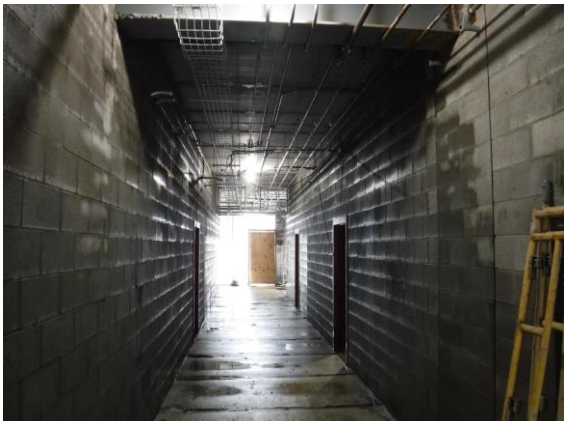
- q) Due to the excessive amount of rain, water from the second floor slabs is being directed into the floor areas and the block walls on the first floor. This is causing staining elements in the block to leach out. These will need to be cleaned when the building is enclosed.

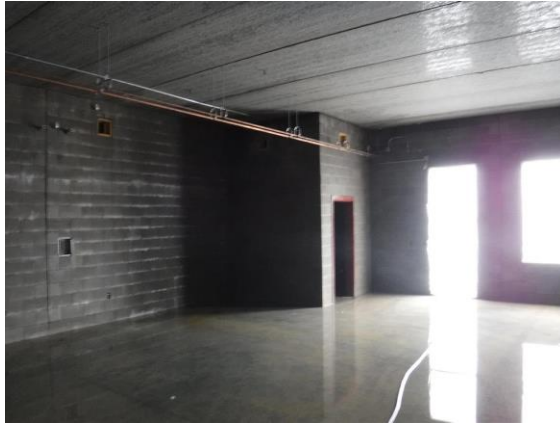
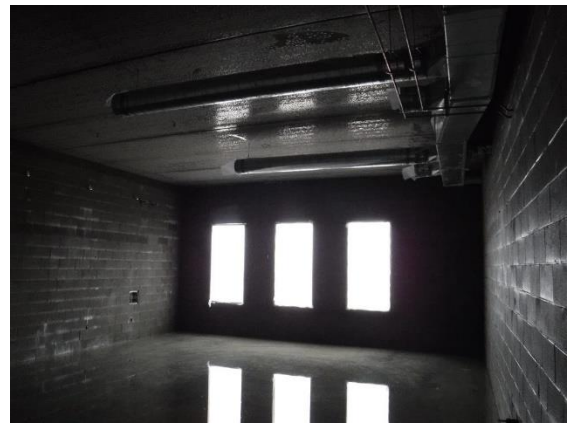
- r) The concrete planks above the first floor are dripping water and the first floor slabs are retaining water. The bulk of the water coming into the first floor is from the mechanical penetrations through the concrete planks. The water is trapped in the rooms by the raised Skudo protection board system in the corridors.

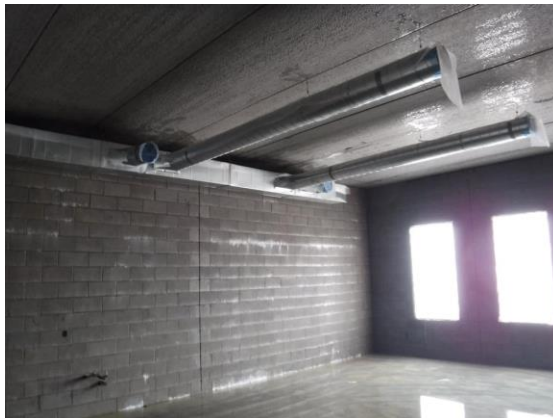
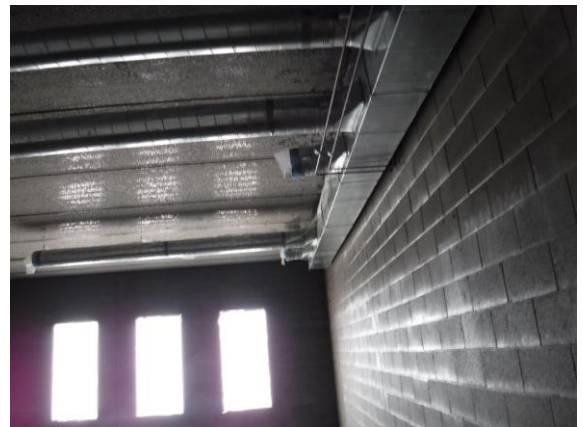
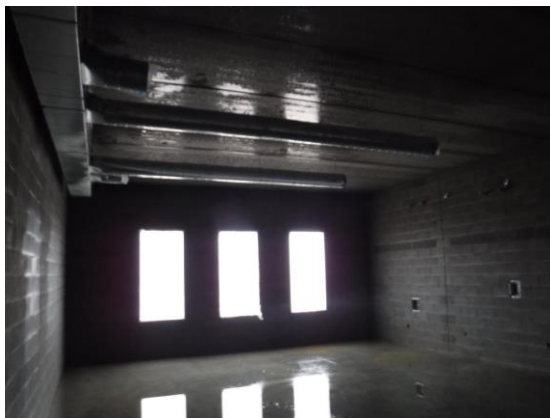
- s) Ductwork had been hung in the Area C Classrooms. Even though the area is enclosed and more ductwork could have been installed, the mechanical contractor was not on site while I was there. Gerald reported that the sprinkler contractor also needs to be on site installing their piping.

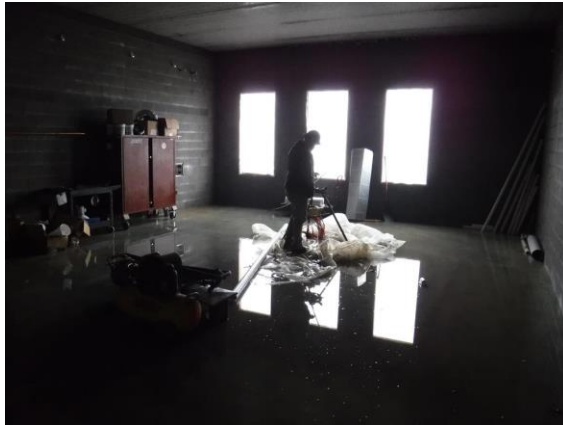
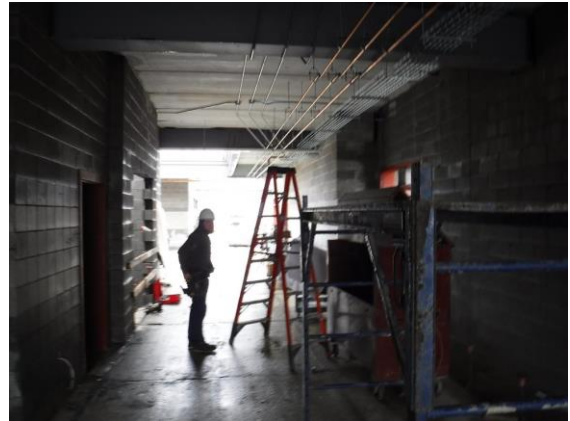
- t) The electrician and plumber were on site and were installing overhead rough-ins in Area B and C.

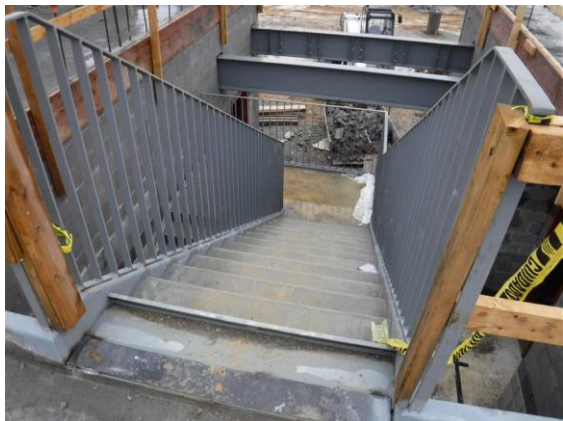
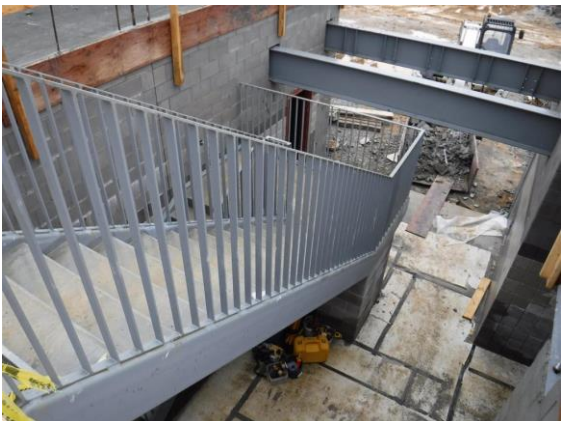
- u) The steel stairs and railings are in place in Area B. Since they are exposed to the elements until the roof is in place, these need to be monitored for rust. Missing primer needs to be replaced and any rust that is discovered needs to be removed as soon as possible.

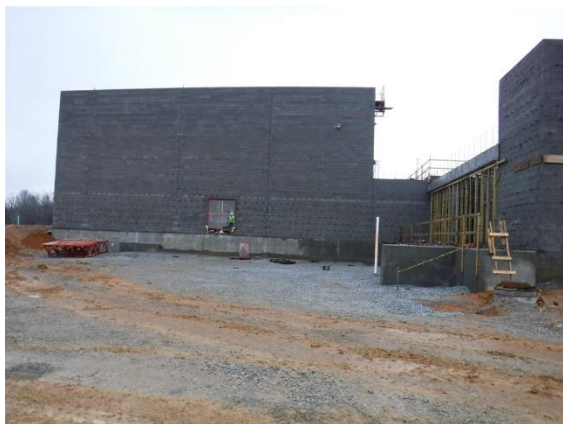
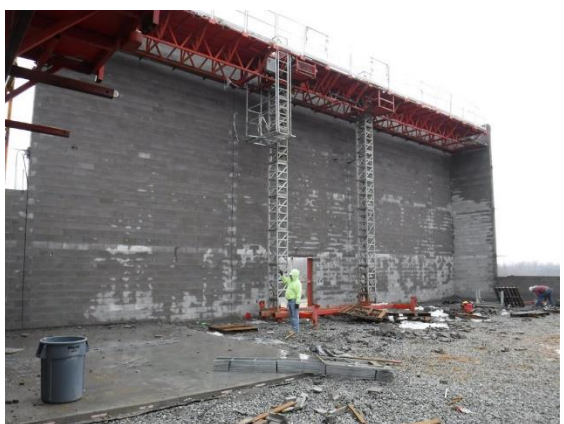
- v) The exterior block walls for the Gym are being laid up to roof bearing elevation.

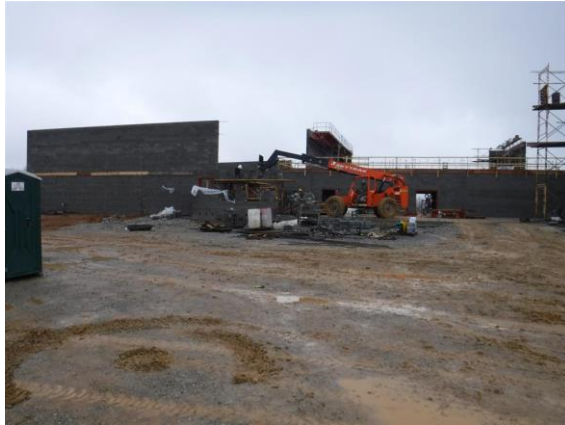
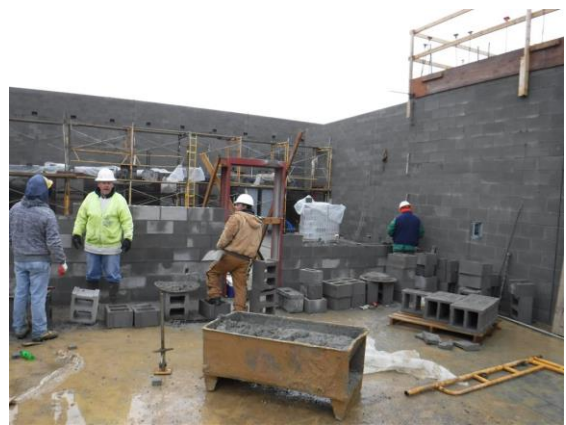
- w) The Kitchen/Cafeteria walls were being laid for the exterior and the interior.

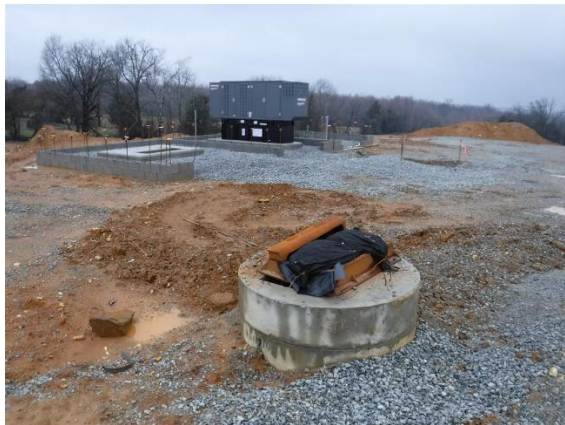
- x) The emergency generator is in place.

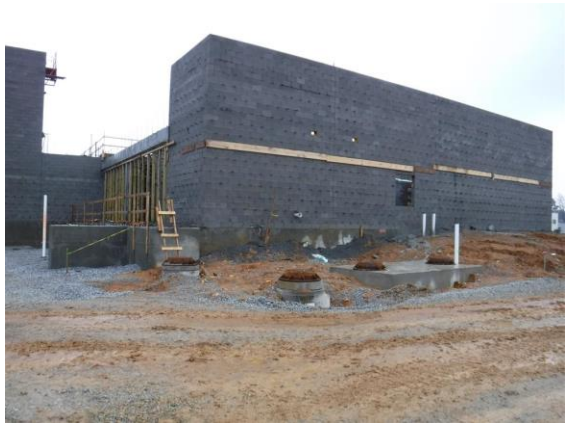
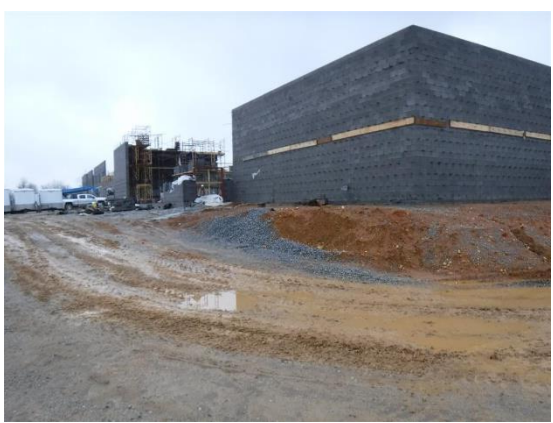
- y) The block at the exterior of the Kitchen is at roof bearing height.
