FIELD OBSERVATION REPORT

East Hardin Middle School, Hardin County Schools, Elizabethtown, KY 201752.01 -CA8

Date: 3/12/2020

Report No: 19

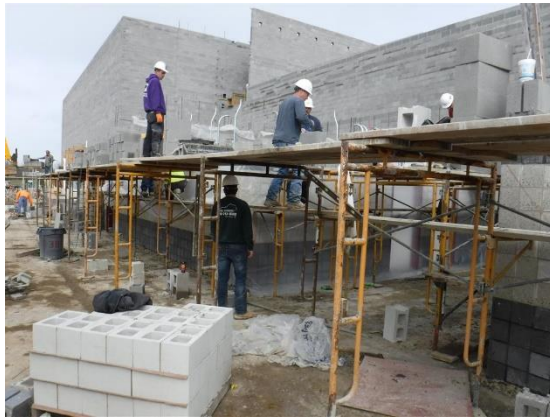
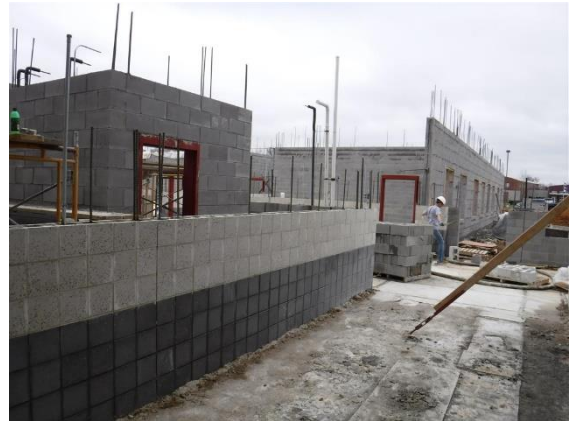
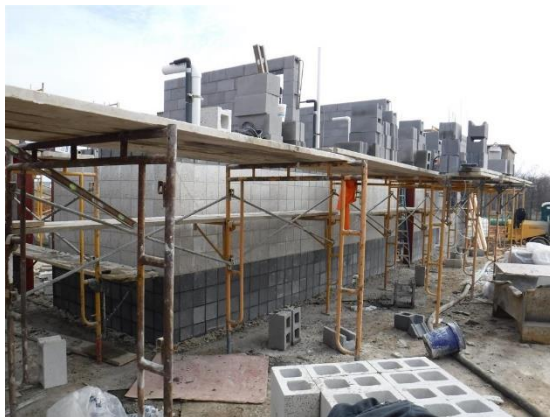
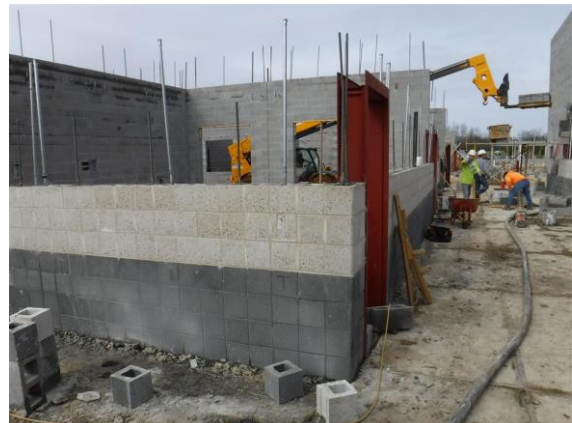
- b) Ground faced concrete block walls are being laid for the main east-west corridor on the first floor in Areas A and B.

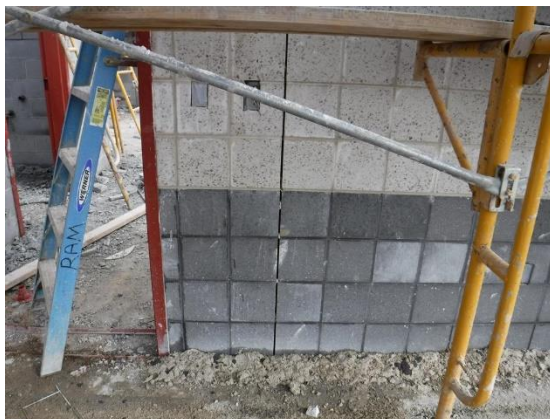
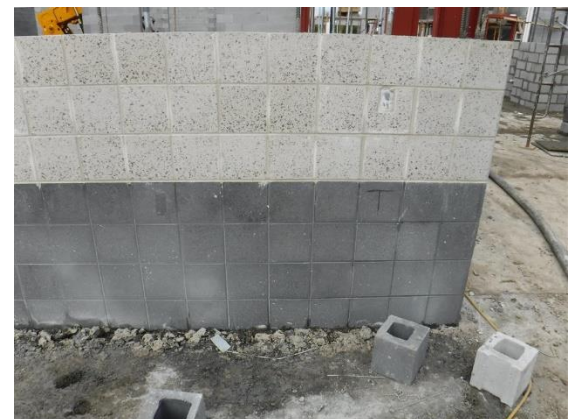
- c) The ground faced block needs to be cleaned and sealed. Overall the work is acceptable thus far. Block the block joints and the false joints have been filled with mortar and tooled with a concave joint. The joints at Lincoln Trail Elementary School are struck for the block joints and the false joints are left open.

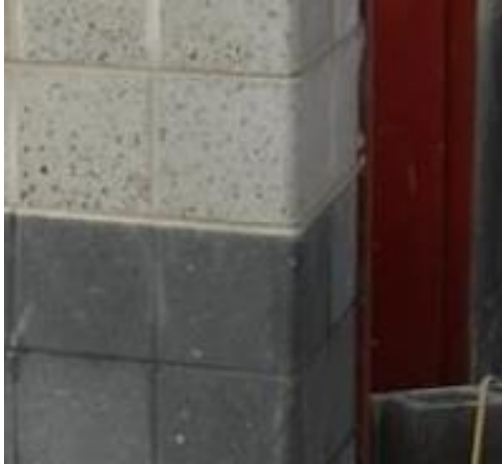
- d) The outside corners of the ground faced block have bullnoses as specified. These block cost about \$40 each. The mason is being extra careful to not damage these blocks.

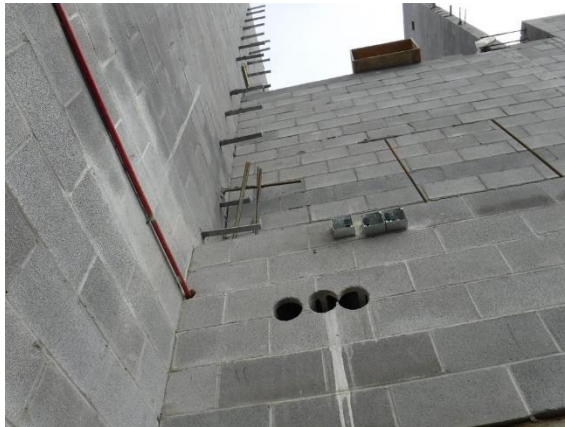
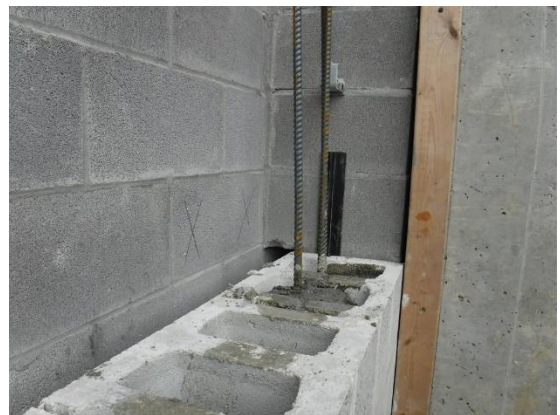
- e) The concrete block fire wall around the Gym and extending in front of the Cafeteria consists of two independent block walls. The wall ties sticking out of the Gym wall would tie these two walls together so they do not act independently. The ties will be removed and two courses of block will be cut free from the Gym wall.

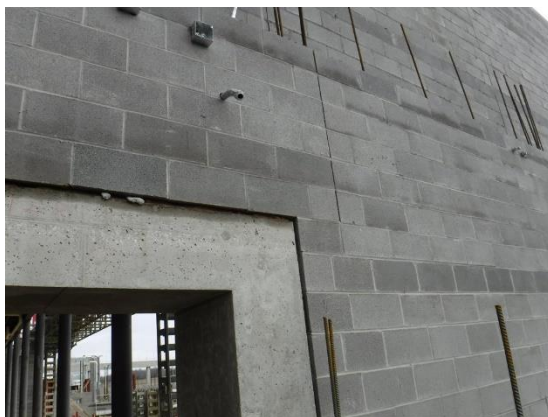
- f) Concrete block wall over the concrete portals at the fire wall, do not bear on the portals. The control joint at the end of the bond beam must be on the wall side of the portal.

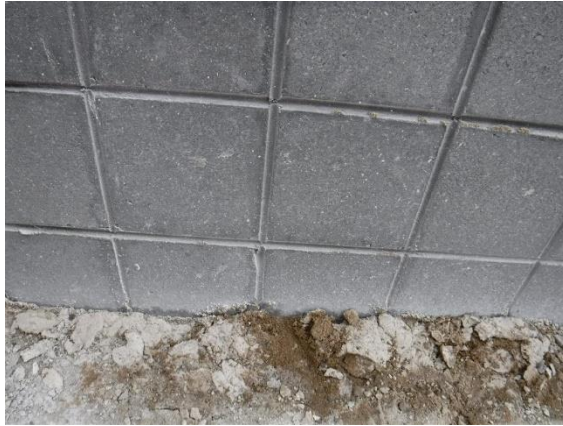
- g) Doyle said that the dark mortar can be successfully cleaned off of the ground faced block. It is important that the mortar not be left to harden in the block faces so the joint appears as a smear instead of a clean line just in the joint.

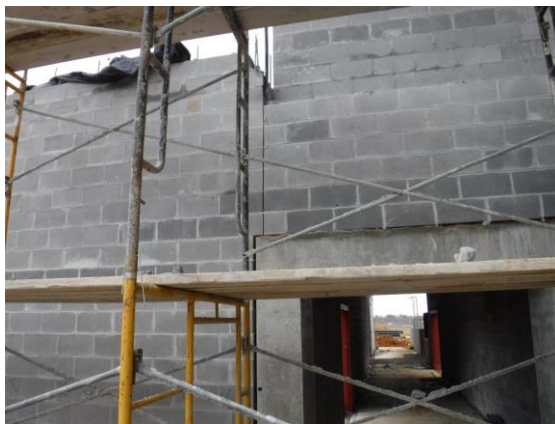
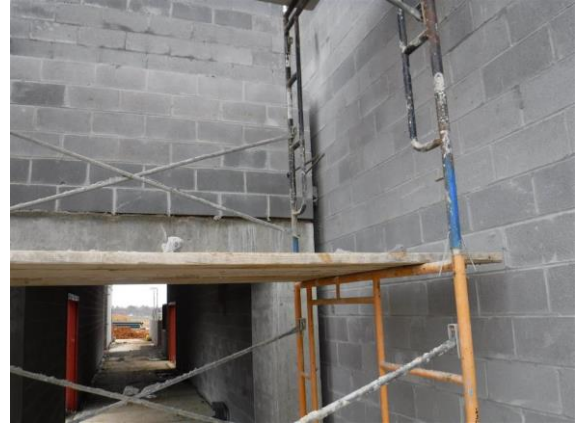
- h) The control joint on the west side of the Gym must be relocated to the end of the bond beam 8" to the west of the concrete portal. The wall above is temporarily supported above the portal. When the temporary materials are removed, the joint between the portal and the block will be filled with mineral wool insulation and fire resistant rated sealants to create a continuous fire barrier at the fire wall. The wall to the east side of the portal must tie into the outer layer of block running along the Gym wall so that it supports the east end of the block wall over the portal.

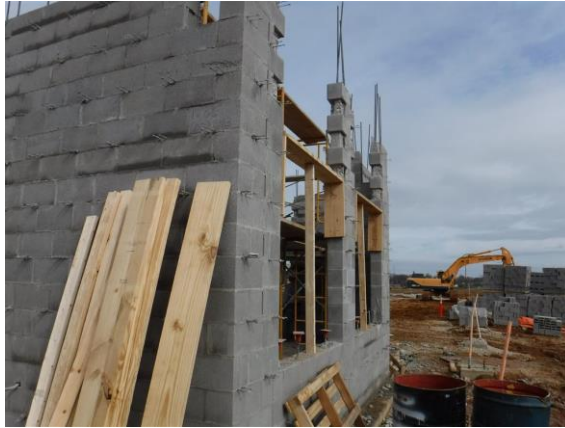
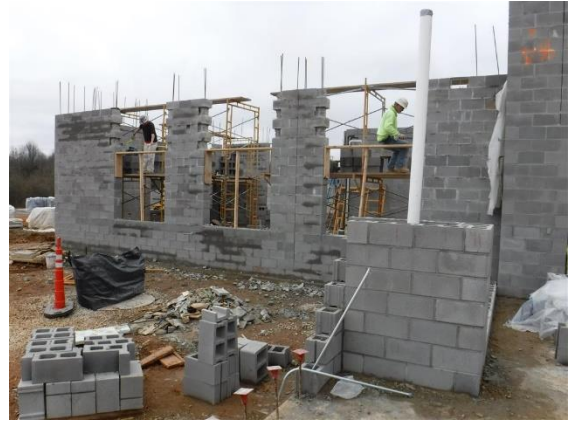
Doyle noted that the window openings on the east wing of classrooms that needed to be relaid from the head of the first floor windows up were in the process of being corrected. The mason built the openings for two story high windows not realizing that block is shown to be located behind the spandrel glass between the floors. Based on the report from Icon, portions of the fire wall at the Gym need to be reworked so the wall is continuous and it acts as two independent walls to protect each side of the fire area. While the overall quality of masonry work continues to be good, there will be areas where joints and block will need to be repaired to provide an acceptable substrate for the paint finish.

- i) Masons were reworking the exterior walls at the east side of Area B where the window openings were laid as if the windows would be two stories high. The block at the jambs has been cut back to reveal the grouted cells. JRA, Solid Ground and Icon have noted this discrepancy in their reports. The corrective measures cited was to remove the upper portion of the block and reinforcing to restore the wall to the original design intent.

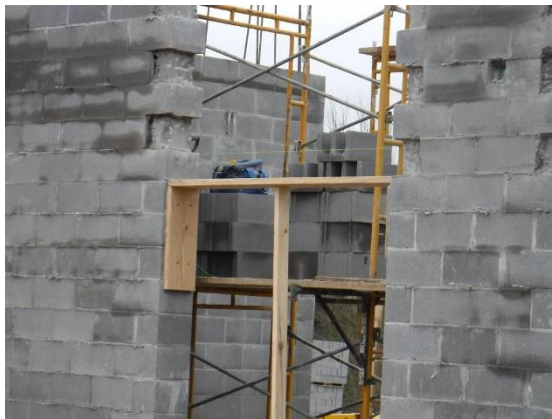
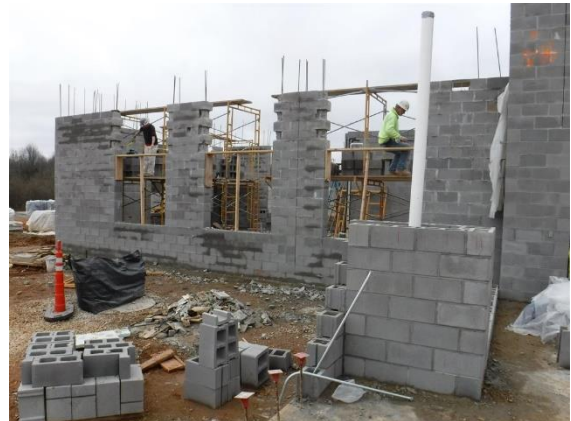
- j) Doyle and I observed the mason removing faces of every other course of the jamb block 8" from the jamb. This meant that the face on one side of the window opening was left in place at the bond beam. Doyle told the mason that the bond beams at the heads of the first floor windows must be installed with full 8" bearing on both sides including replacing the full face of the block to form a bond beam. Either the block and the grout at the bond beam must be removed so the beam can be fully installed or the mason can drill the grout the full 8" from the jamb and anchor the reinforcing with structural epoxy into the grout. Solid Ground needs to verify that the work is properly done in their SPIN reports. The outer webs of the block above the bond beam will be cut to form a "U" shape to fit around the grout. If this work cannot be done to provide full bearing and an acceptable appearance in the room side of the wall, the entire wall needs to be removed and relaid. The grout above the jambs needs to be bonded to the infill block cores.

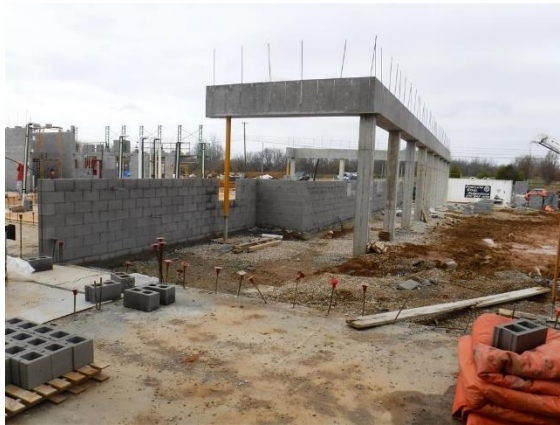
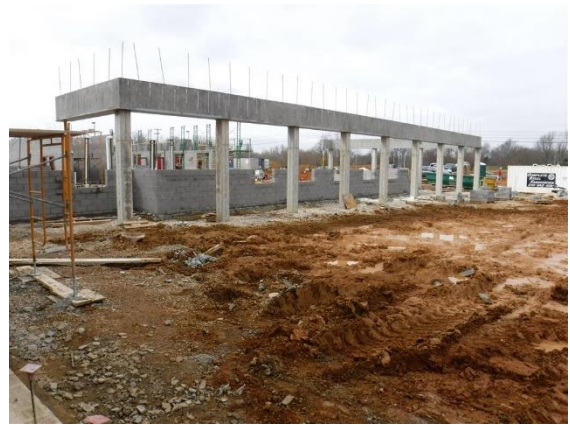
- k) Laying concrete block at the east end of exterior of Area A has begun.

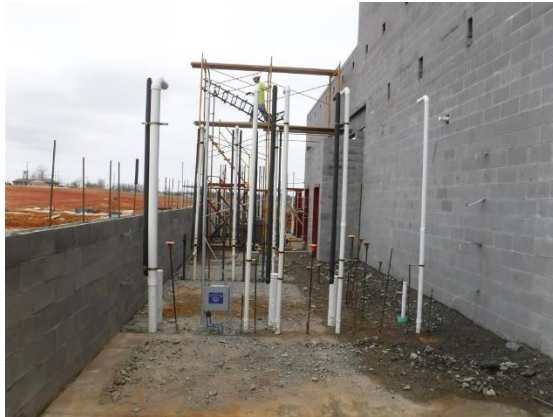
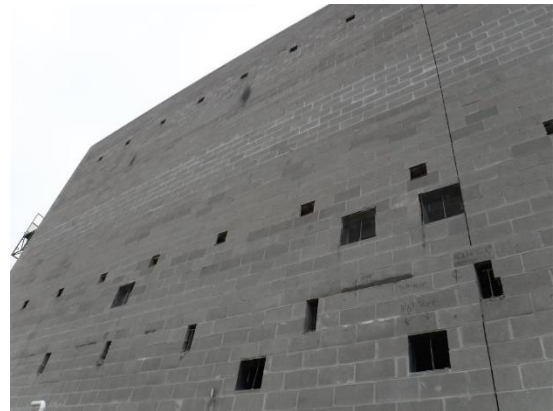
- l) The exterior block wall at the west side of the Gym has been started. The wall along the corridor and above the mezzanine is laid to roof joist bearing height. Openings in the wall are for mechanical penetrations from the mechanical mezzanine.

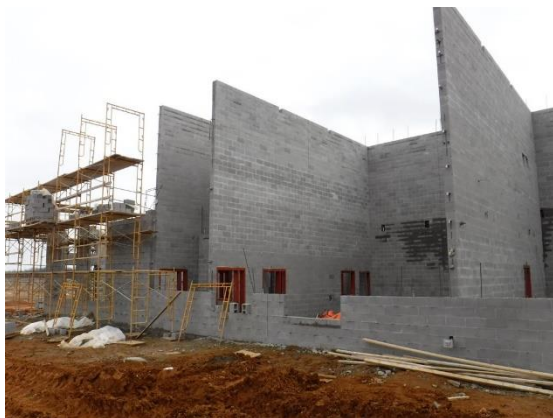
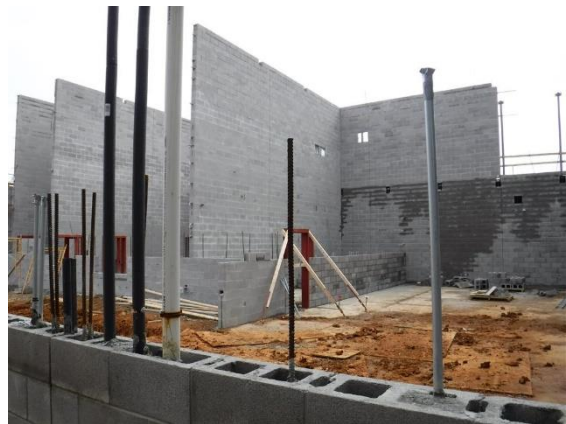
- m) Blockwork in Area D has been extended up to truss bearing height. Some of the trusses in the area bear on steel framing supported by columns above the mechanical mezzanine.

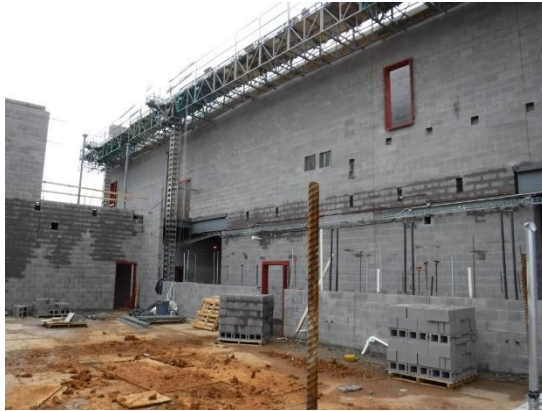
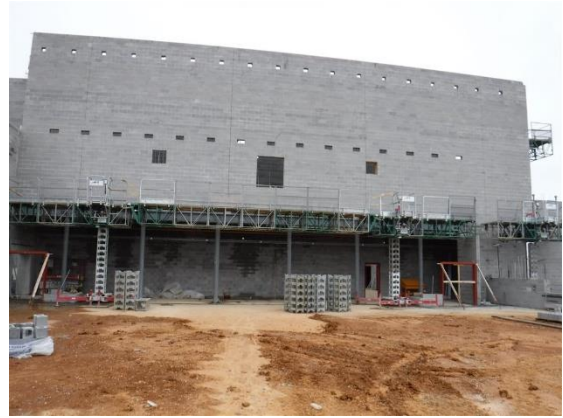
- n) Doyle noted that the use of the Hydro Lift scaffolding system has accelerated the blockwork in areas where it can be used. These are typically long walls that benefit from the long spans and supports the system employs.

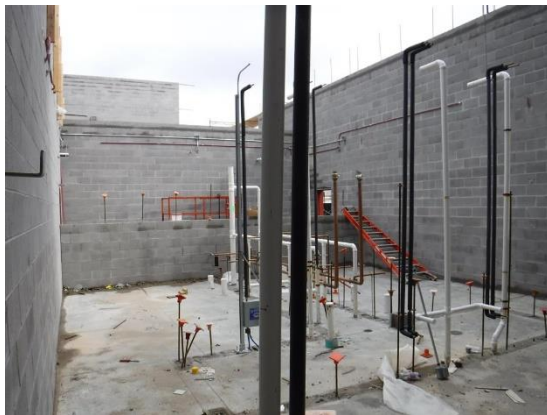
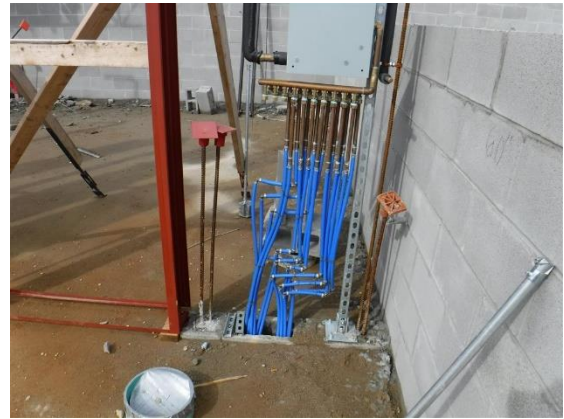
- o) Plumbing rough ins were installed ahead of the blockwork. The toilets have a concentration of plumbing piping. Another area with extensive plumbing rough ins is the kitchen. The blue PEX piping supplies water to the Kitchen drains to keep them from drying out and allowing sewer gases to escape into the Kitchen.

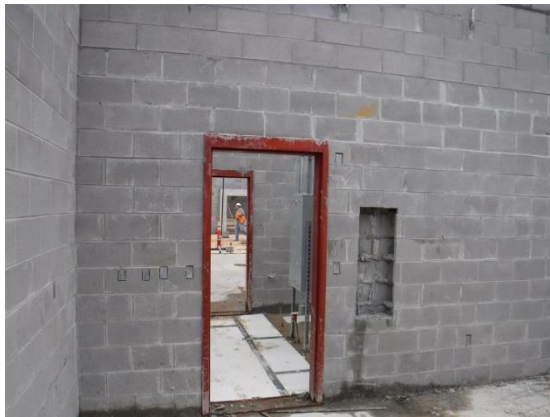
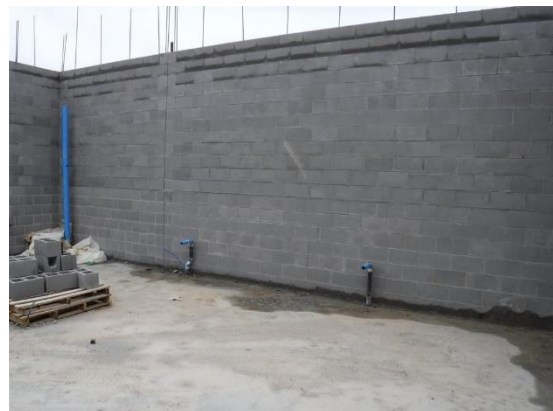
- p) The opening beside the doors into the Science Classrooms is for the spill kits. The blue piping is acid resistant drain piping.

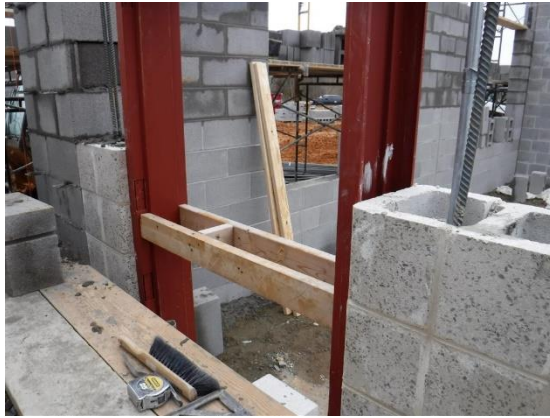
- q) Doyle noted that one of the door frames was scheduled to fit into an 8" concrete block wall but the wall is 12" wide at that point. JRA agreed that the frame could be located in the center of the wall so that the work could proceed. The base at the returns needs to be anchored to the bullnose corners so that it does not separate over time.

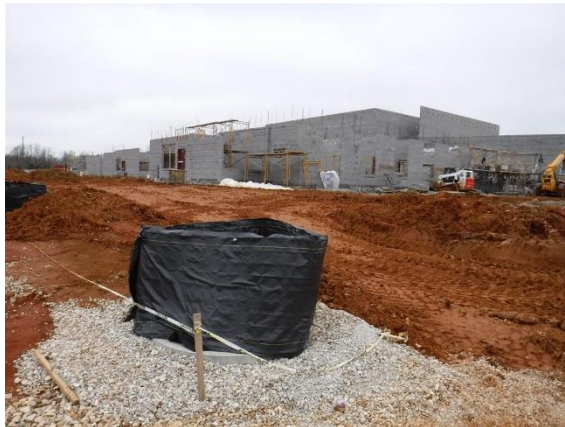
- r) Overall, a significant amount of blockwork has been installed. The addition of the steel framing and the precast concrete planks for the second floor of the classroom wing will allow for the completion of the walls.
