## FIELD OBSERVATION REPORT

Lincoln Trail Elementary School, Hardin County Schools, Elizabethtown, KY 201752 -CA8

Date: 3/12/2020

Report No: 19

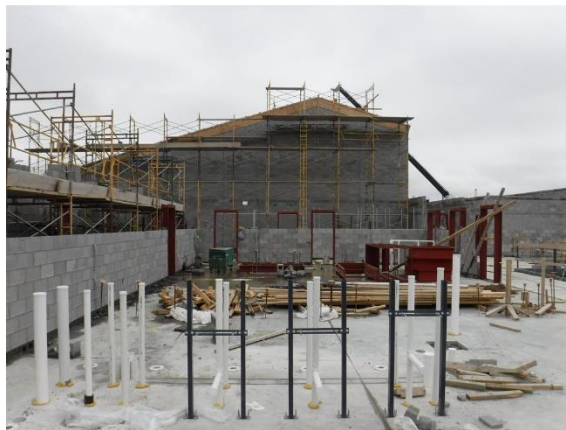
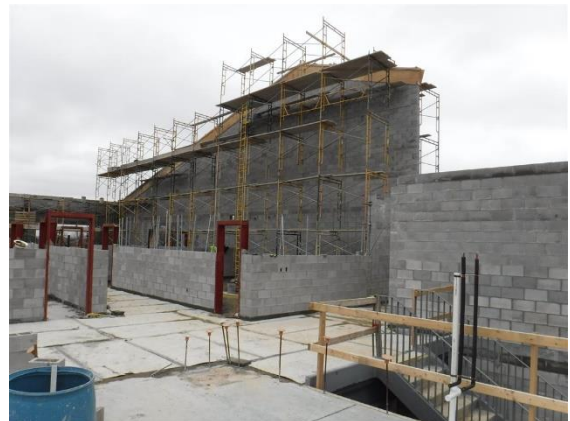
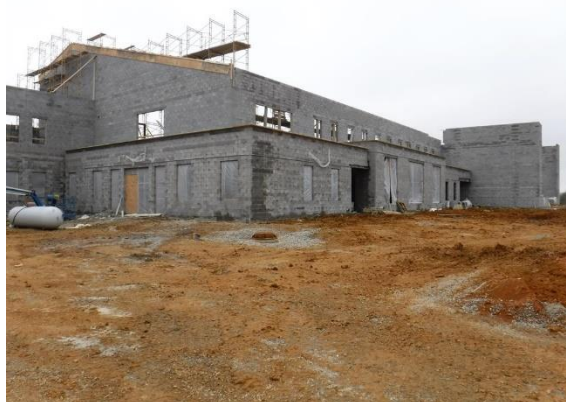
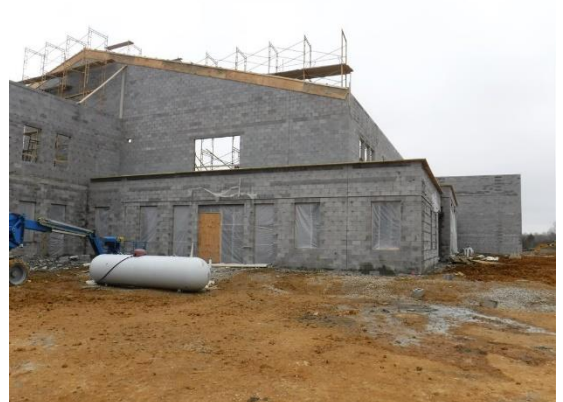
- b) The concrete crew had formed the raked beam at the west end of Area C. This will allow the roof trusses to be erected over Area C after the supporting steel is erected.

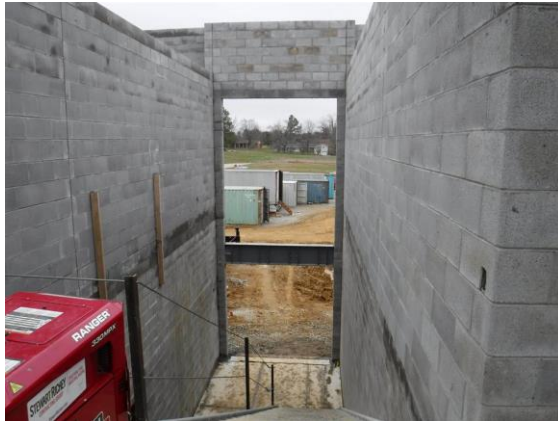
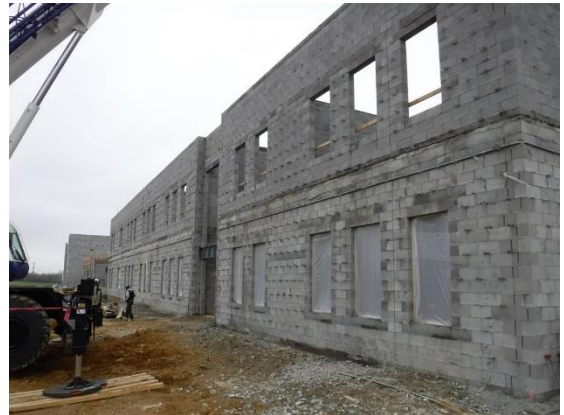
- c) Openings on the north and south side of Area C at the second floor were closed to create bearing for the roof trusses over Area C.

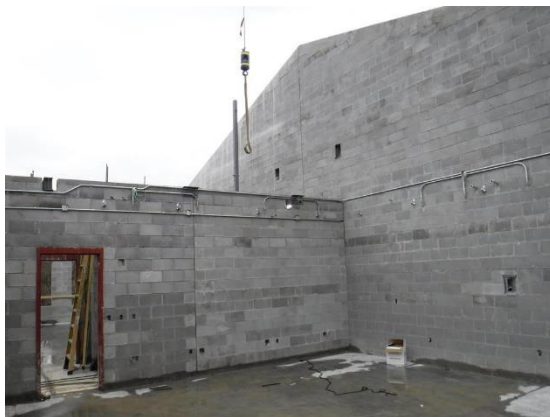
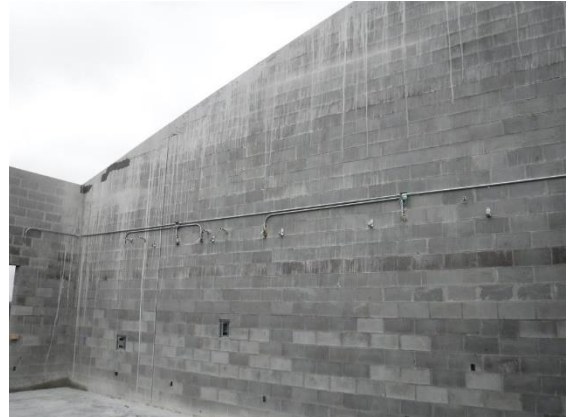
- d) The raked beam at the east end of Area C was ground for the truss outriggers. Some of the cement material flowed down below ceiling height. Gerald and I discussed methods to remove this for a suitable paint finish. The first of the steel columns had been erected that set on the top of the corridor walls for the truss bearing steel.

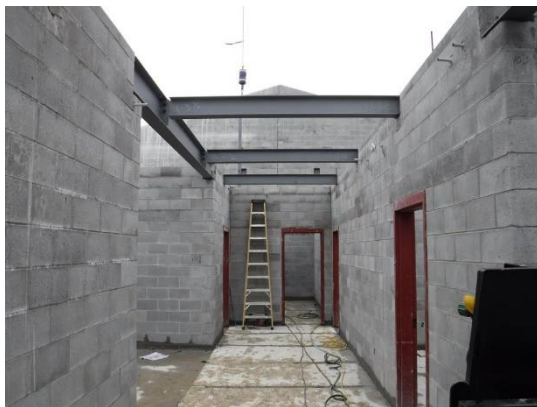
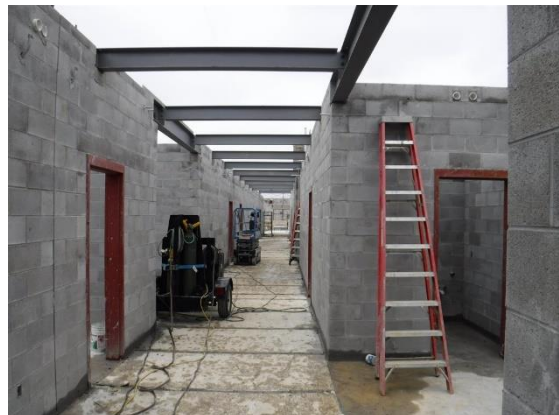
- e) The steel had been erected to support the mechanical mezzanine over the Area C corridor.

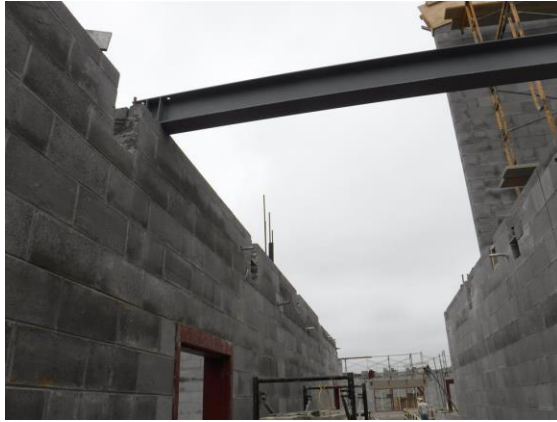
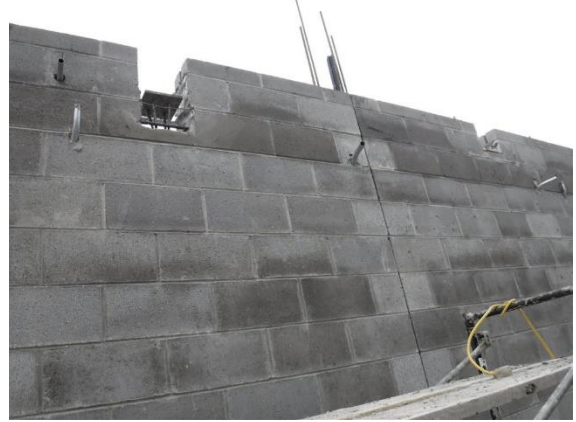
- f) Some of the beam pocket for the mezzanine support steel had to be adjusted. The erector is confirming that the steel is at the proper elevation. The mason will check future beam pockets with a laser level to insure the proper bearing elevation.

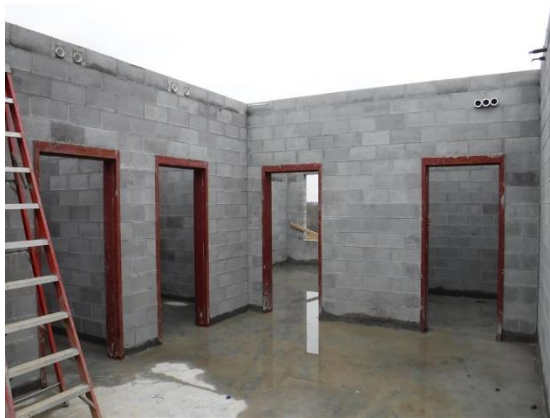
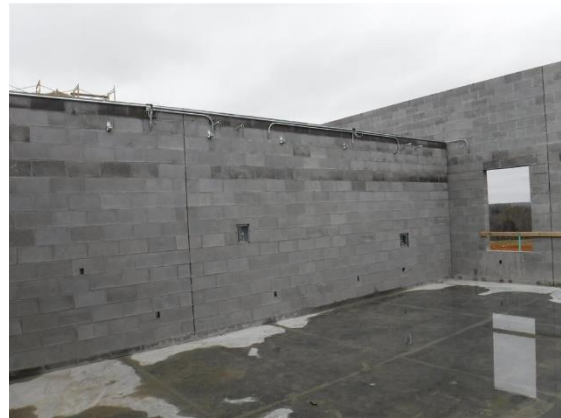
- g) The interior block walls for the second floor of Area C are in place. The electrician has installed conduits on the walls and has pulled wire in some cases.

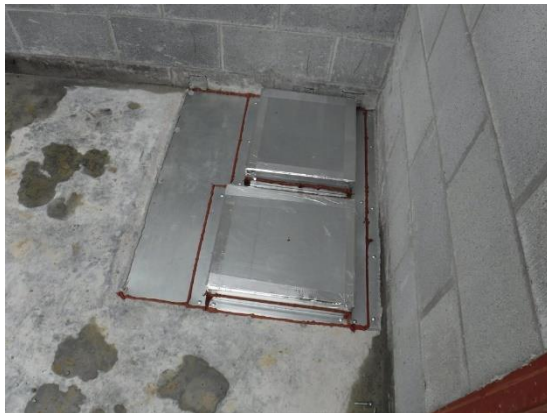
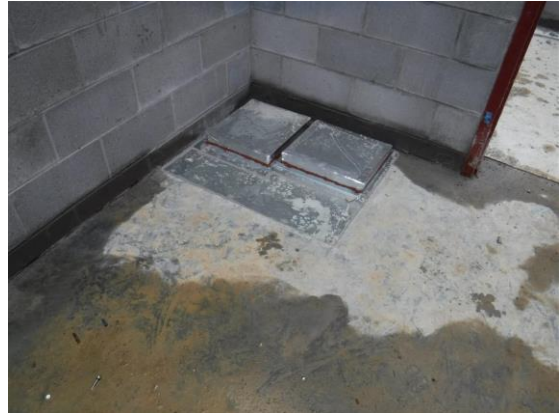
- h) Temporary seals for mechanical opening through the second floor slab in Area C have been replaced with permanent sheet metal seals that have fire sealant applied at the edges. The openings have been capped with sheet metal seals.

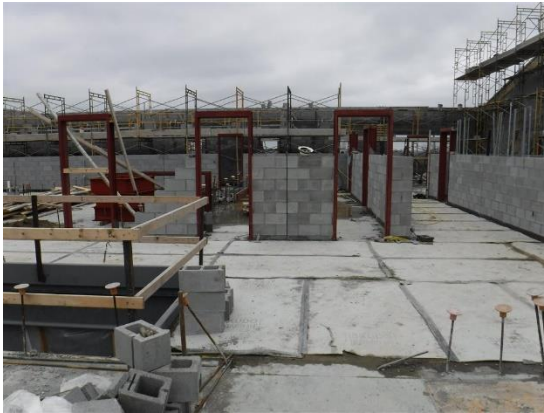
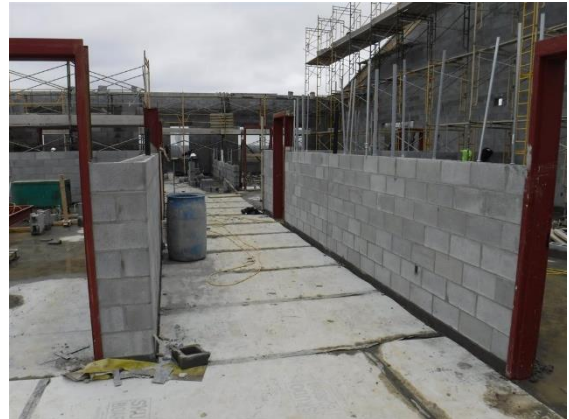
- i) Good progress is being made on the interior walls, door frames and rough ins on the second floor of Area B.

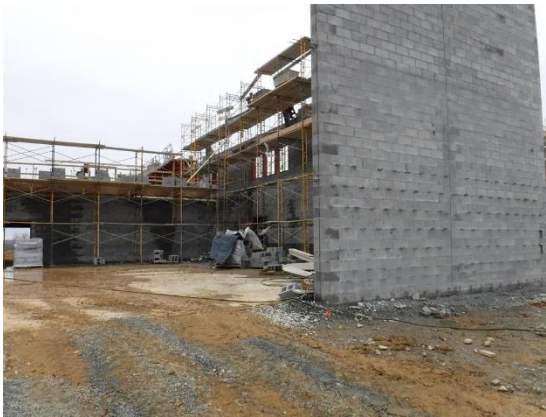
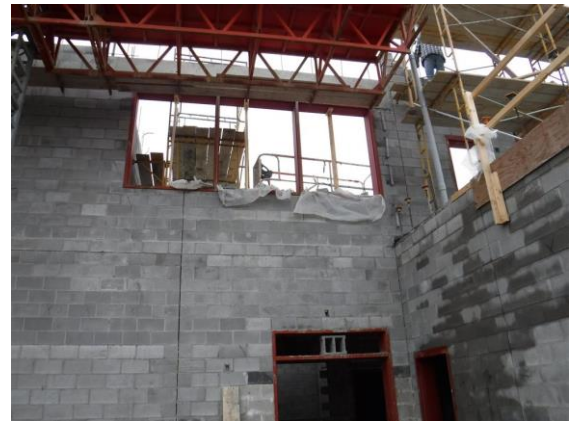
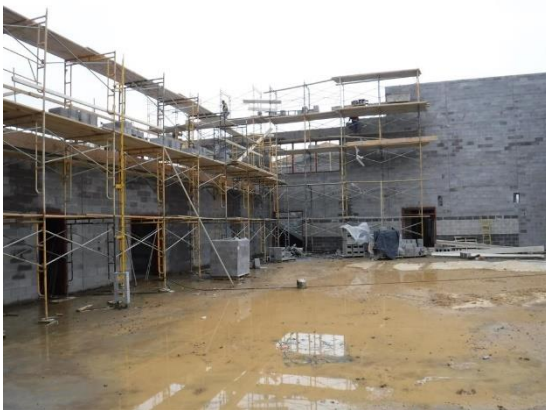
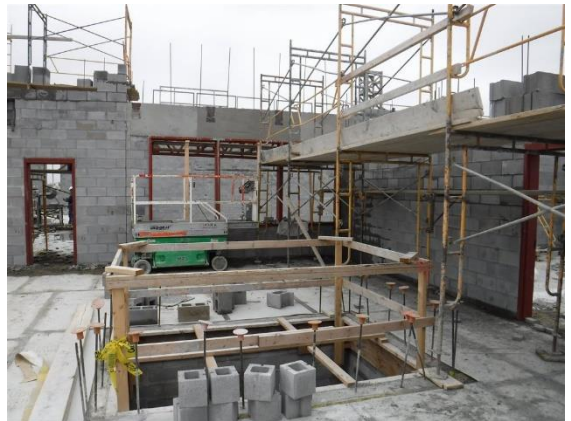
- j) Good progress is being made on the block wall at the east side of the Cafeteria bordering Area B on the second floor.

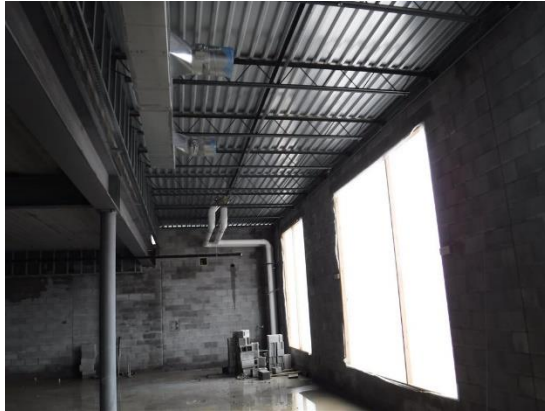
- k) Steel roof deck and joists has been placed at the north end of the Library/Media Center. This allows for the completion of the framing for the soffits in the Library/Media Center and rough ins below the roof area.

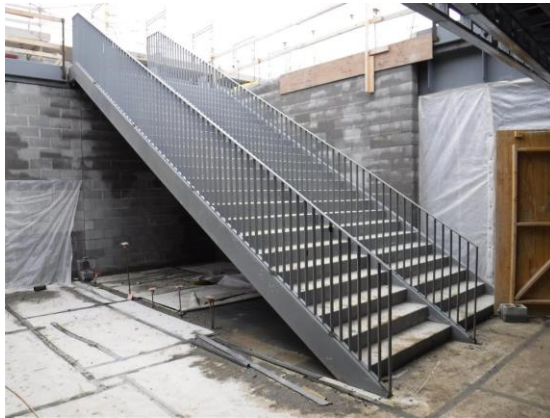
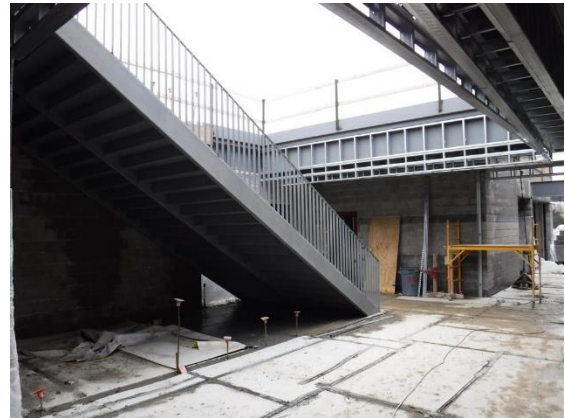
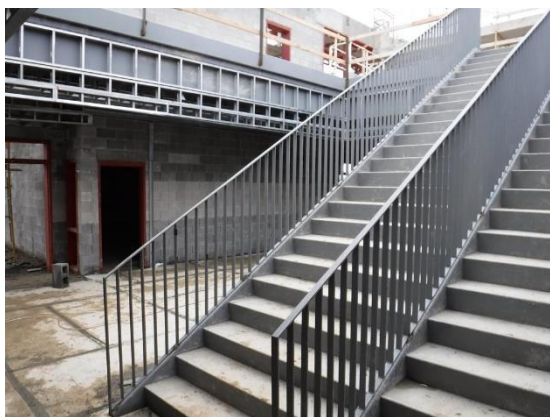
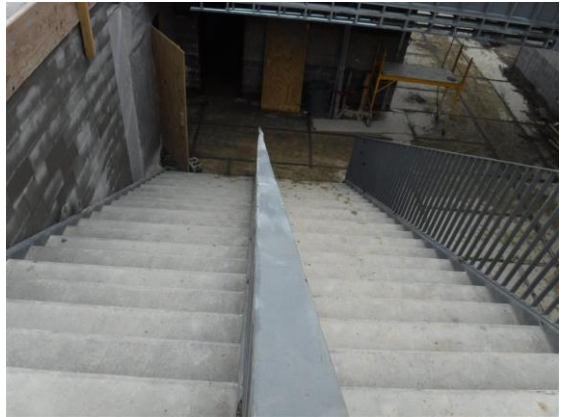
- l) The main stair is in place in the lobby of Area B. The tread pans have been filled with concrete. The steel railing needs to be straightened as the handrail caps are applied.

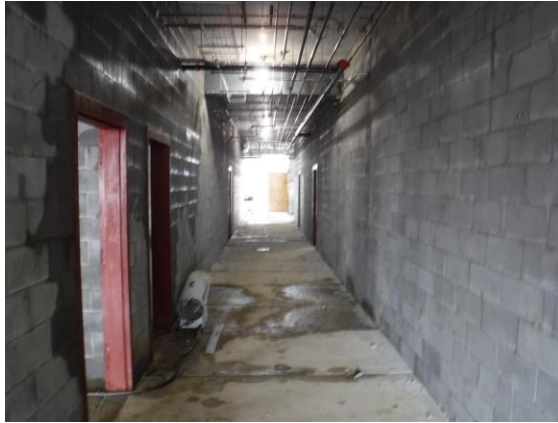
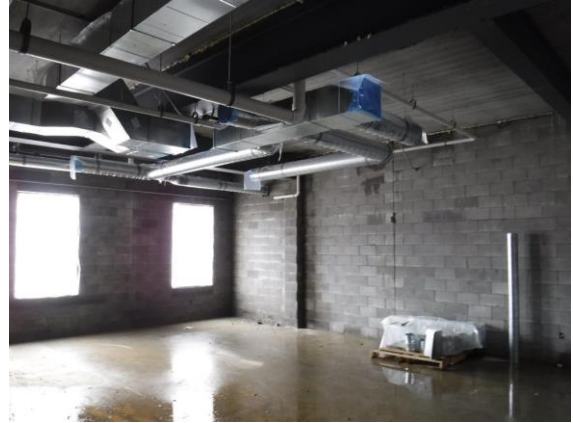
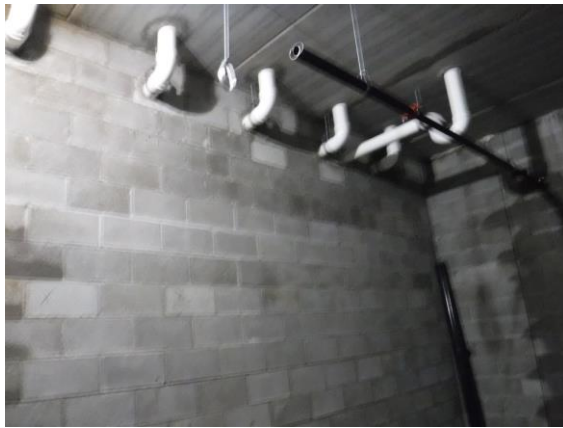
- m) Above ceiling rough ins are progressing above the first floor ceiling in Areas B and C. These include sprinkler, mechanical, plumbing and electrical work.

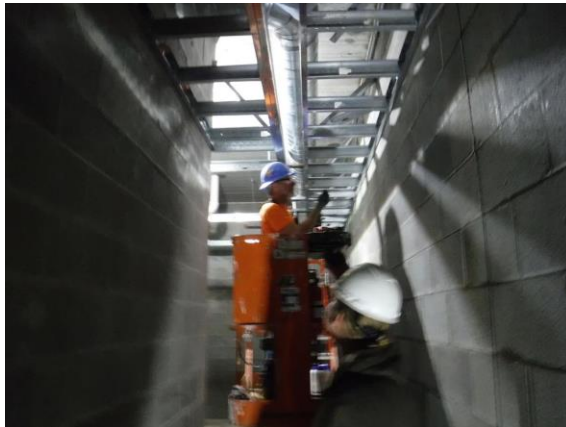
- n) Most of the framing for soffits in Area B and C are in place above the first floor. Framers were working in the toilets to complete these.

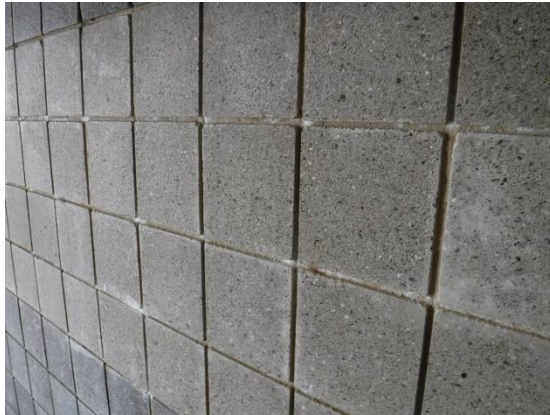
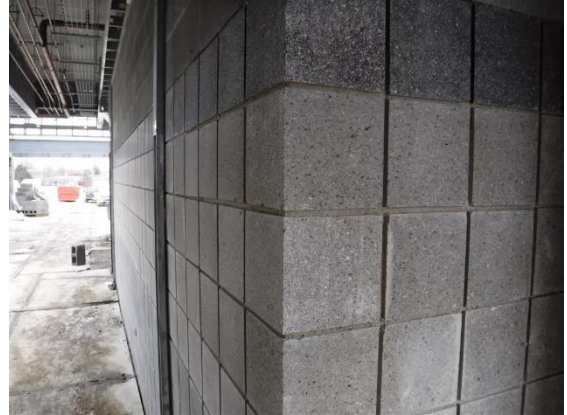
- o) Unlike East Hardin Middle School, the ground faced block joints at Lincoln Trail Elementary School have struck block and false joints. This gives a very different appearance. These joints were installed per the original specification. Alliance will obtain a price to fill these joints like those at the middle school. The bullnose corners will be created with a special bullnose grinder. This eliminates the very expensive bullnose block but adds the labor of grinding the corners and the replacement of any blocks damaged during the grinding process.

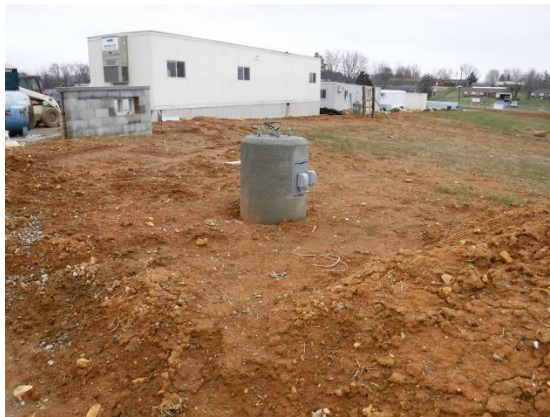
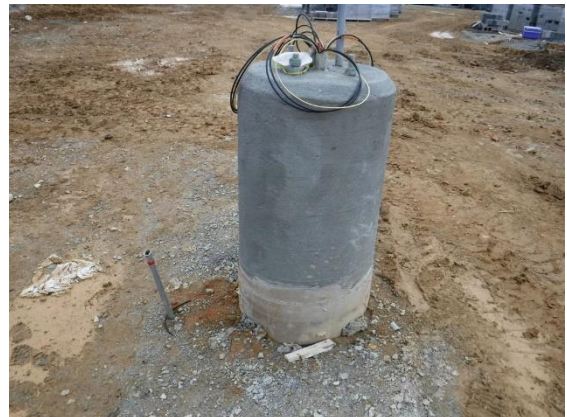
- p) The concrete light pole bases are installed around the site.

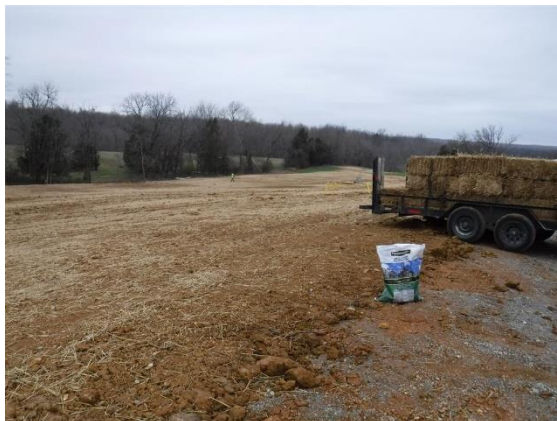
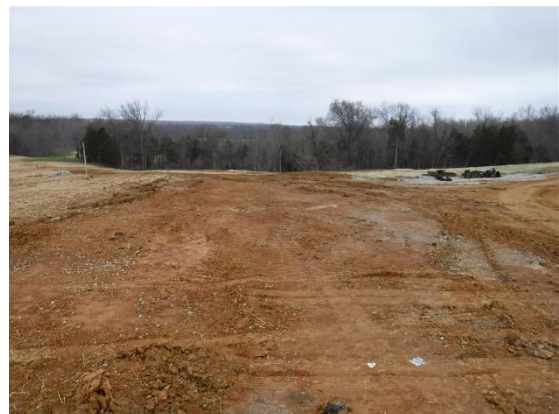
- q) Grass seed and straw mulch was being applied at the north end of the site.

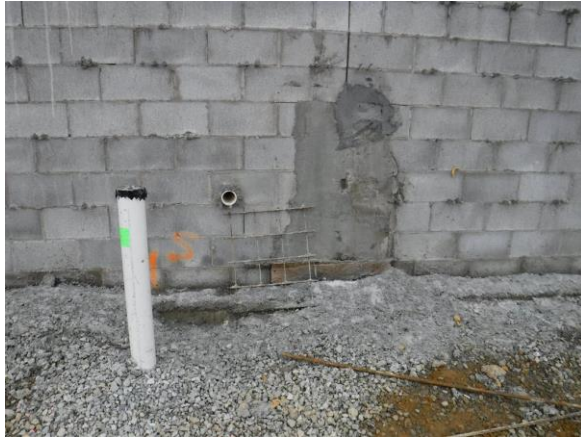
- r) The concrete repair of the exterior block wall at the end of the toilet plumbing chase has left the wall without brick ties in that area. Ties will need to be added before brick can be laid in this area.

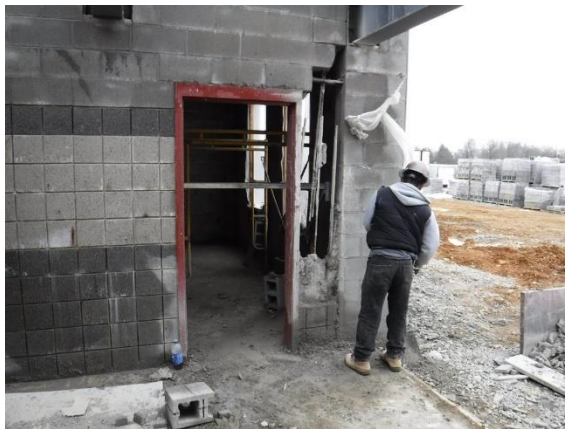
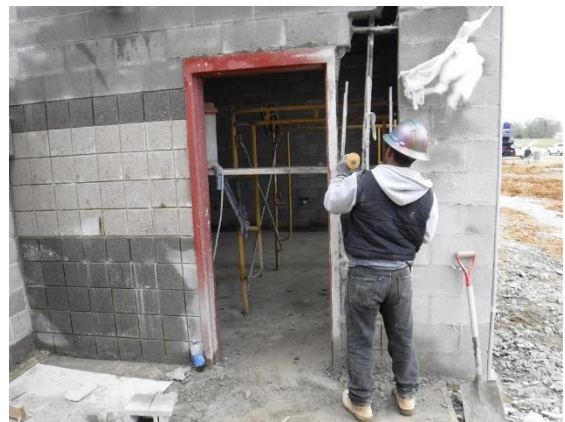
- s) The ground faced block and regular block that out of plane at the center stair was being removed in preparation for the repair to straighten this wall.
