## FIELD OBSERVATION REPORT

Lincoln Trail Elementary School, Hardin County Schools, Elizabethtown, KY 201752 -CA8

Date: 4/10/2020

Report No: 20

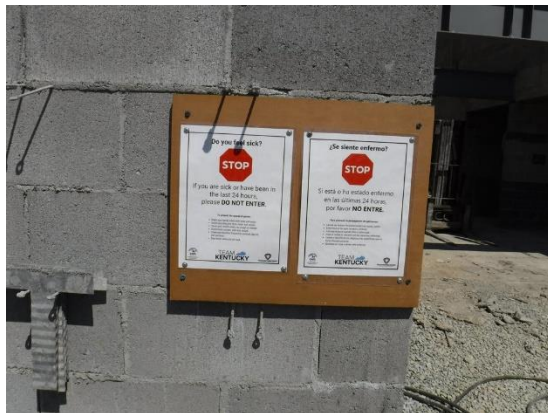
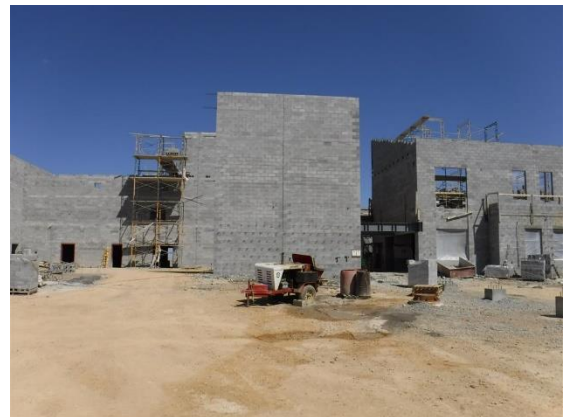
- b) Alliance has placed COVID 19 notices at the construction entrances to the building. Some of the trades have taken extra precautionary steps to avoid infection including additional notices and hand sanitizing stations.

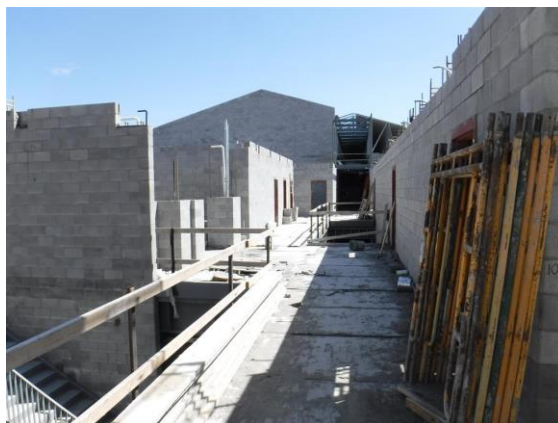
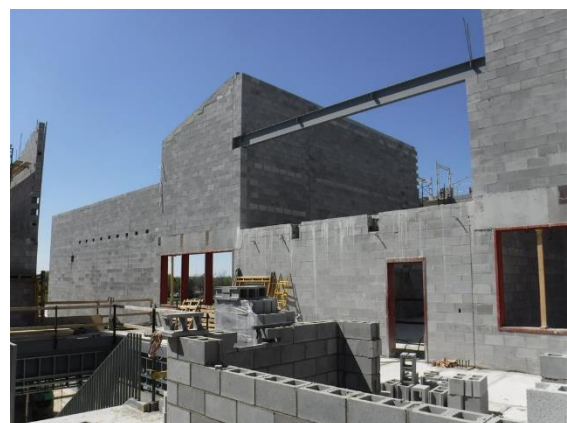
- c) The concrete crew had formed and poured the raked beam at the east end of Area B and at the east wall of the Cafeteria.

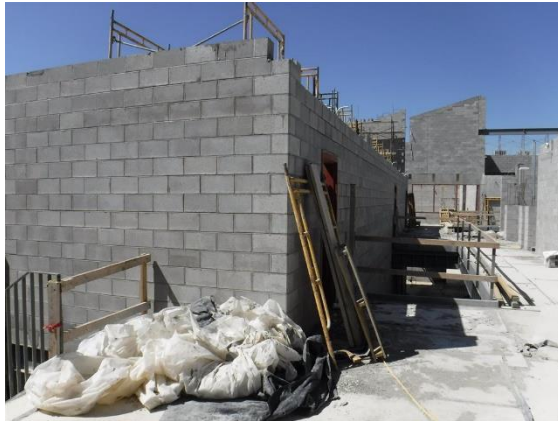
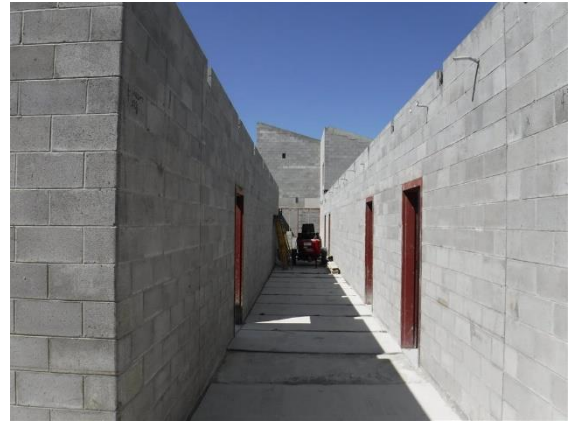
- d) Masons were laying block on the second floor of Area B. Several of the walls were laid up to the bearing height for the mechanical platform and the roof trusses.

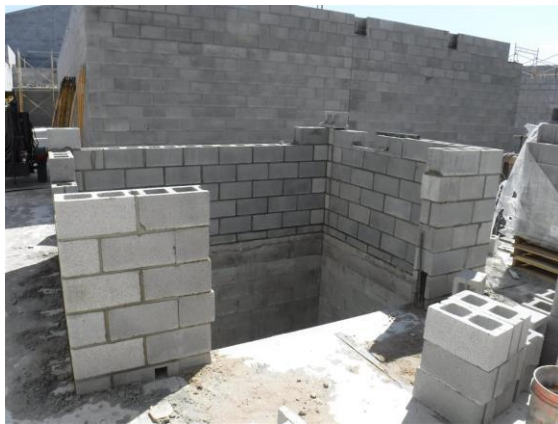
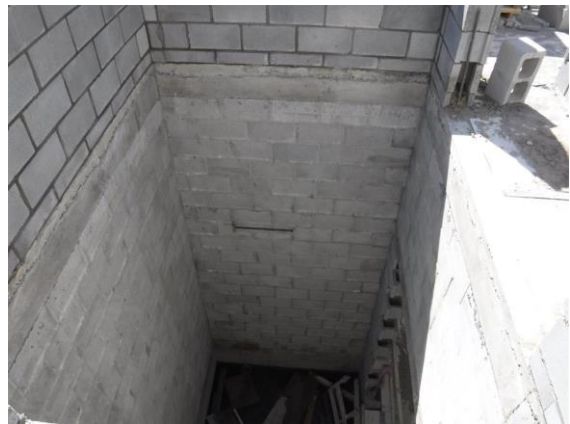
- e) The elevator shaft is being laid above the second-floor level. It will need to be capped before the roof trusses area installed. The carpenters need to erect a barrier at the opening.

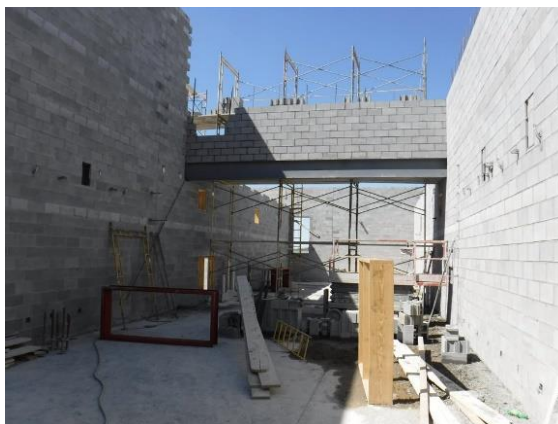
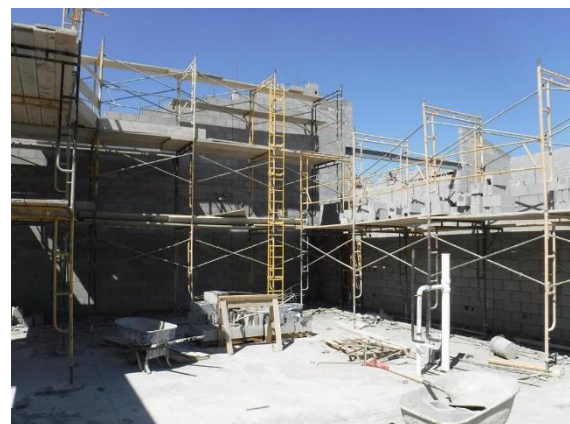
- f) Currently, the masons are concentrating on the rooms at the west side of Area B and the Computer Classroom.

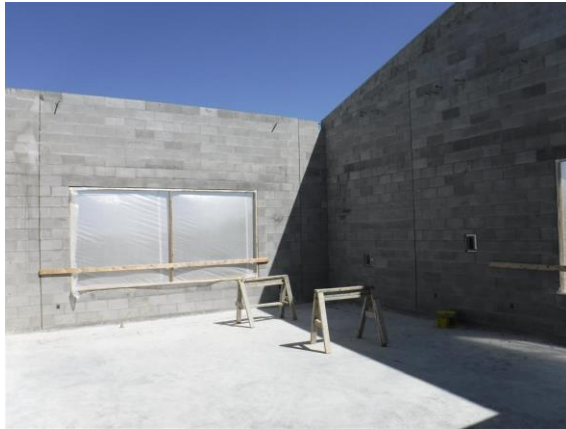
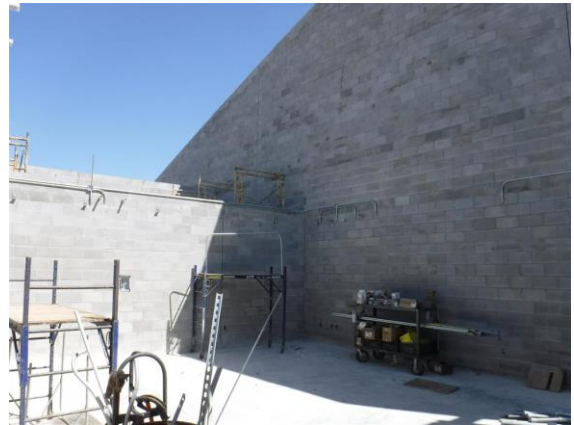
- g) Generally, the block work in completed room in Area B has been cleaned and detailed and looks good.

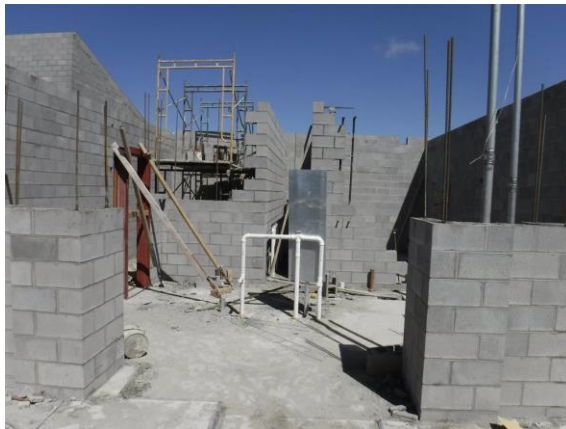
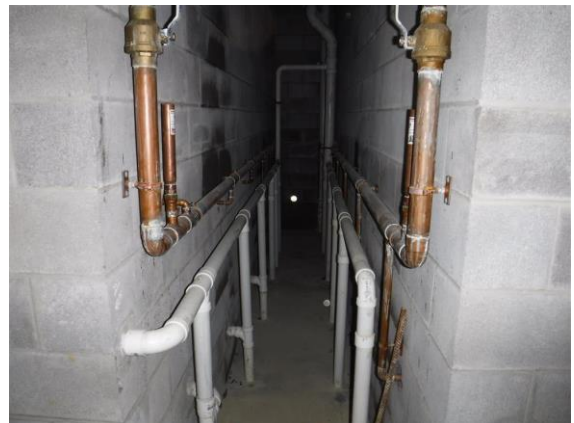
- h) Plumbing rough-ins have been installed ahead of blockwork in Area B.

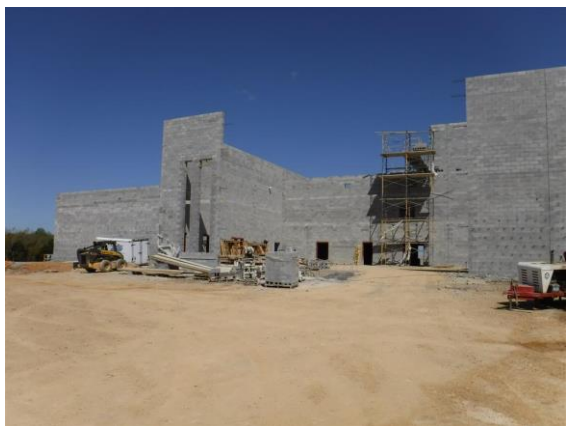
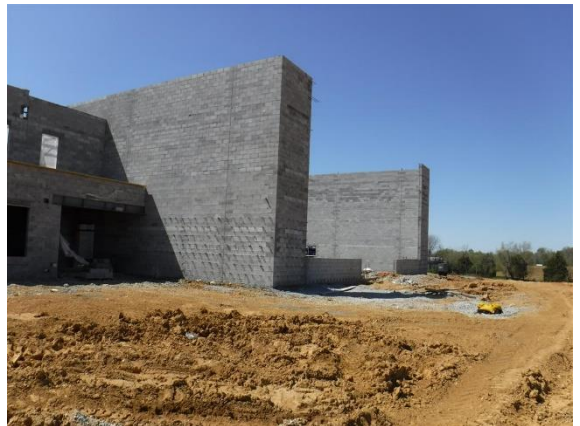
- i) The exterior walls for the Cafeteria and the Gym have not been laid to allow access to the areas and because the masons are concentrating on the second floor of Area B.

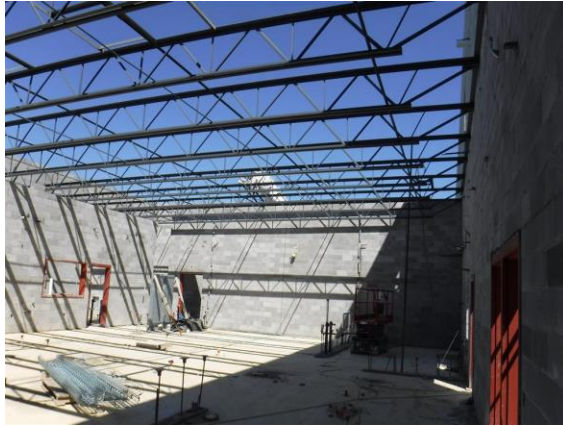
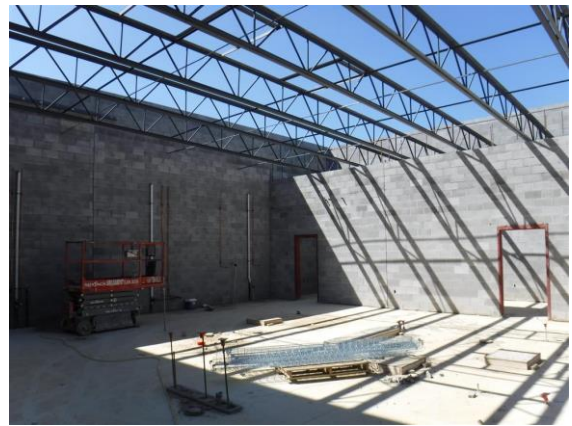
- j) Steel roof joists have been installed over the Kitchen. Once steel angles are welded into place, the roof deck and then the roofing can be installed. This will allow the Kitchen to be dried in so the masons can lay the interior walls on rainy days.

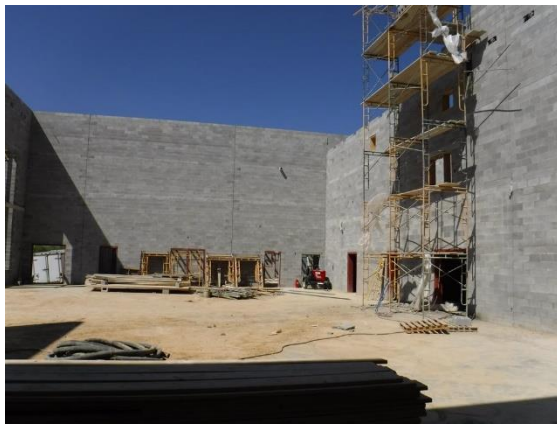
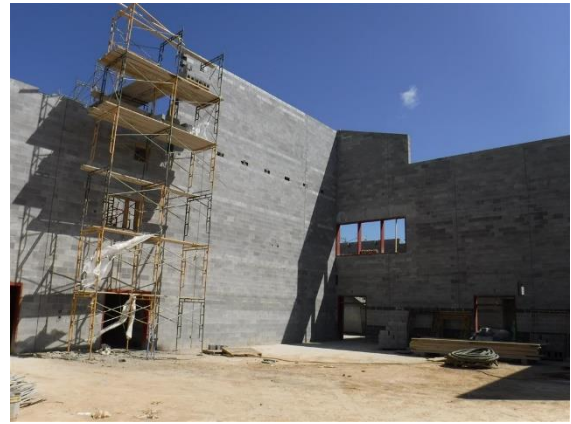
- k) The masons continue to complete the tallest walls around the mechanical platform between the Gym and the Cafeteria.

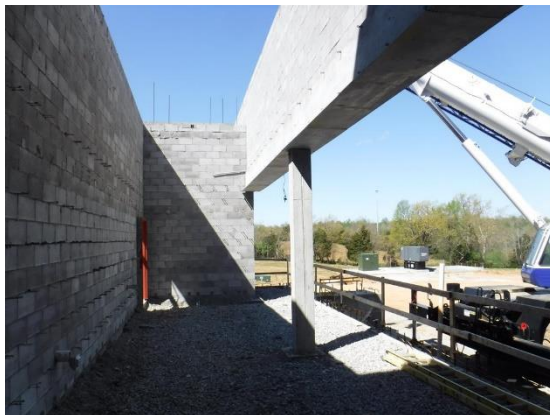
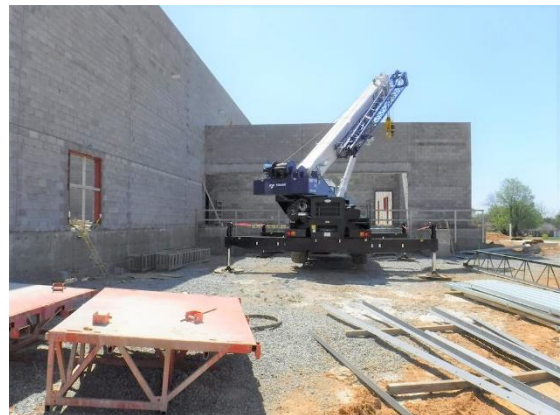
- l) The concrete beam supporting the block above the loading dock and the concrete dock are in place. Supporting steel and the roof deck and roofing will installed next.

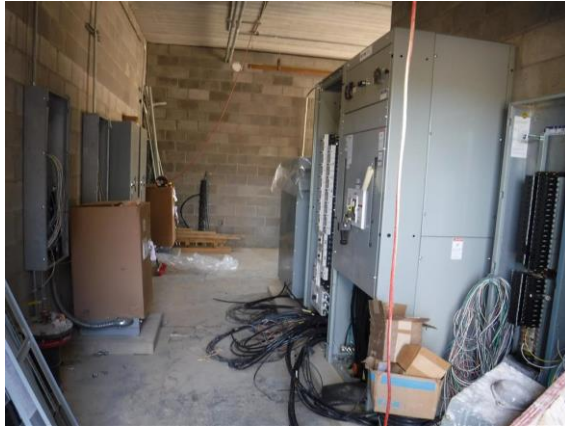
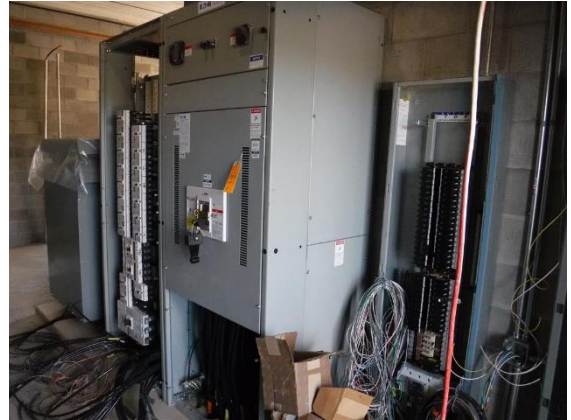
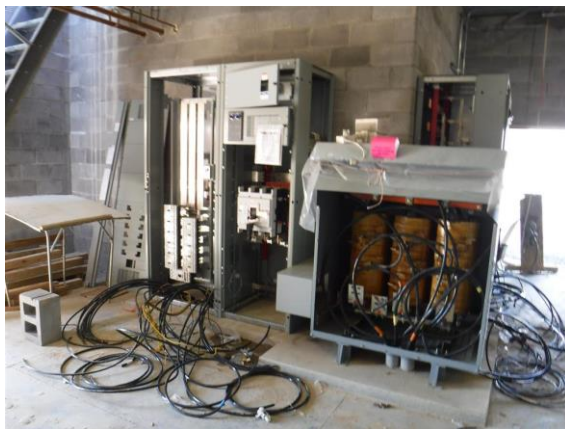
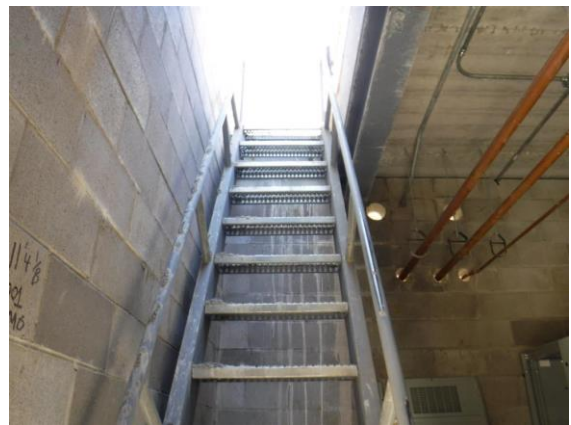
- m) Most of the major electrical enclosures in the Mechanical Room are in place along with the wiring feeding these devices. The ships ladder to the mechanical platform is in place.

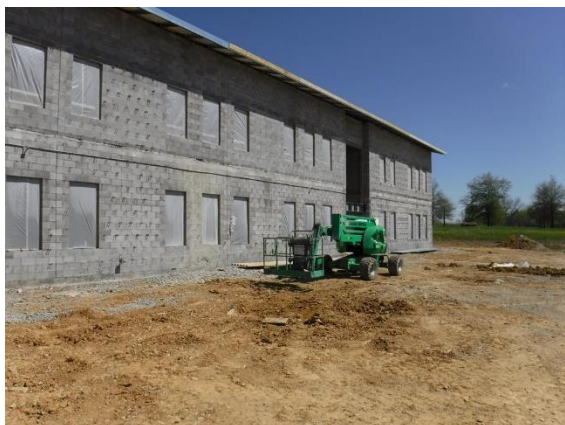
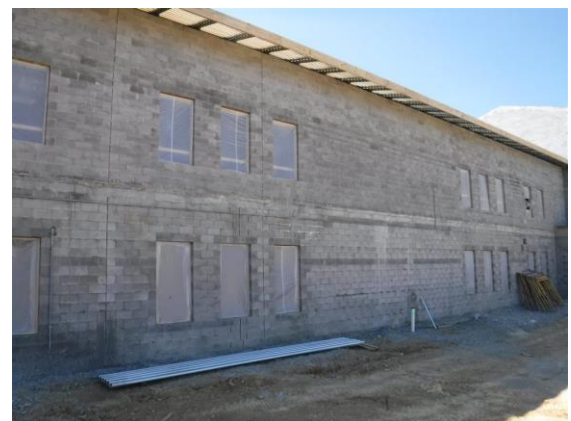
- n) Wood blocking is being installed around Area C in preparation for the installation of the metal roofing and trim.

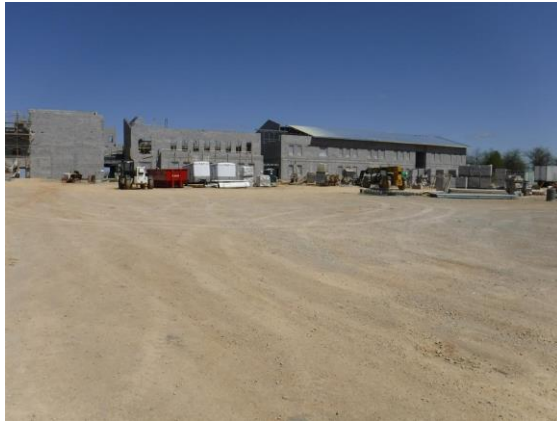
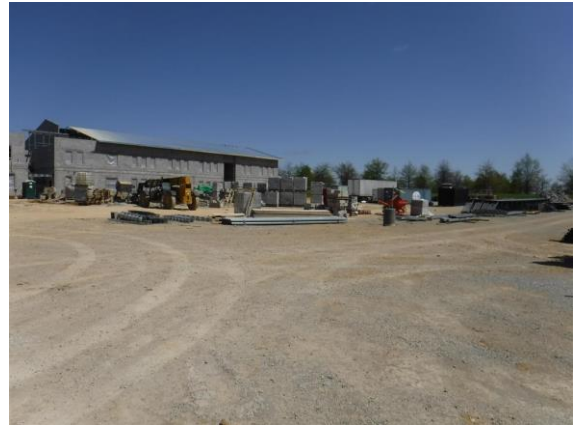
- o) From a distance, the roof deck over Area C is visible. Some decking and wood blocking at the east end remain to be completed.

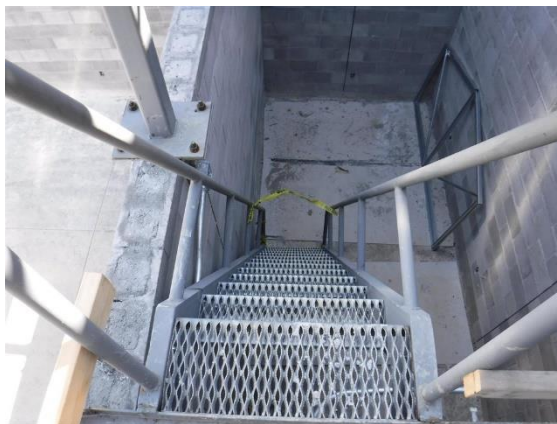
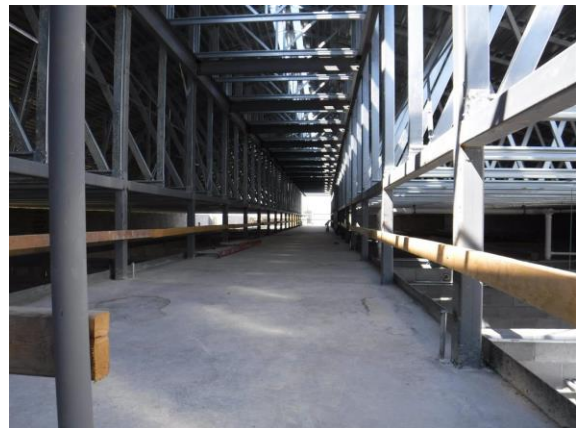
- p) The ladder and the mechanical platform serving Area C are in place. Access from the platform to heat-pumps serving the classrooms and other spaces will be readily available.

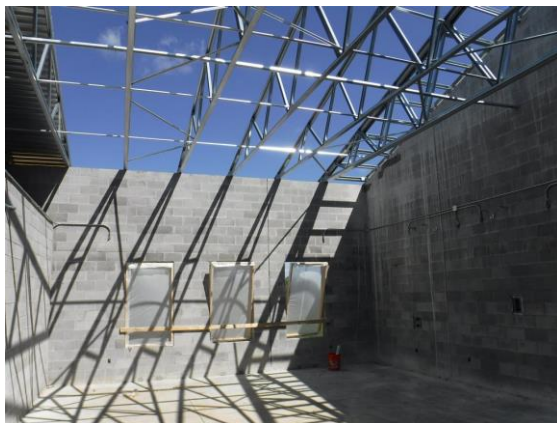
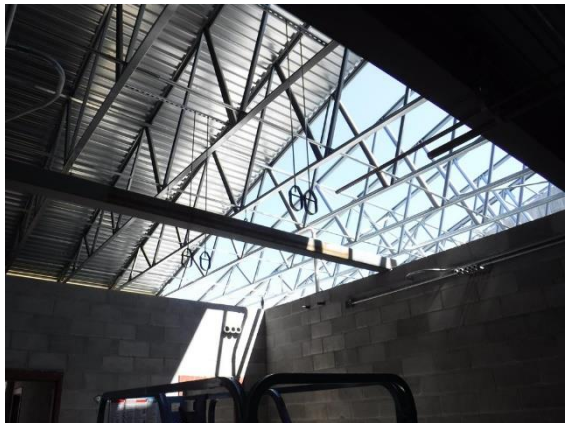
- q) Most of the roof decking is in place over Area C except at the east end. The light gauge metal trusses are in place and generally appear to be straight. The roofer needs to evaluate the roof deck for it providing a proper substrate for the metal roofing.

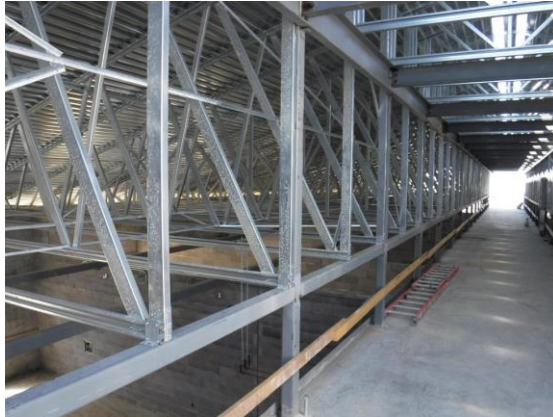
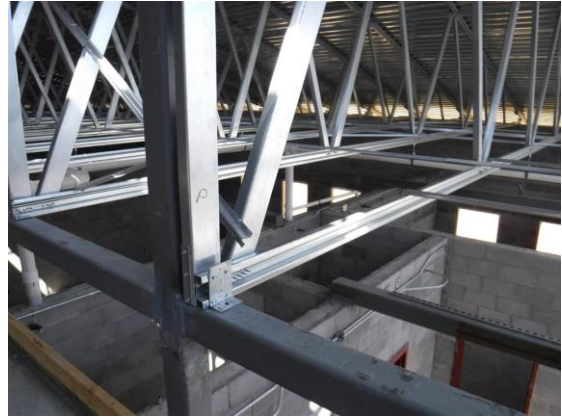
- r) From the mechanical platform there is a good view of the light gauge roof trusses and the bottom of the roof deck. From this vantage point these appear to be properly installed.

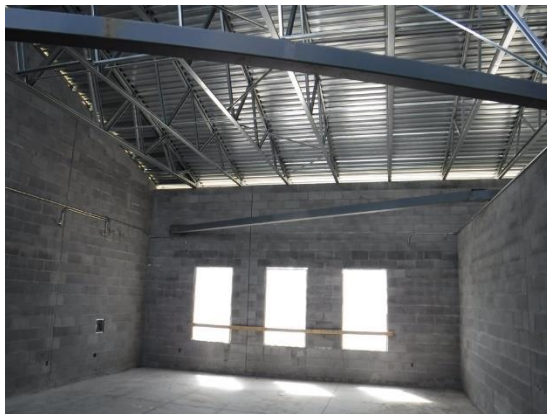
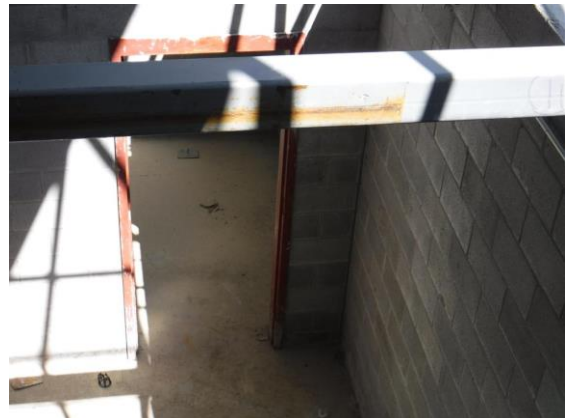
- s) Steel tube seismic bracing connects the tops of the walls above Area C. Where the primer has been scraped, the rust needs to be removed with a wire brush and touch up primer applied.

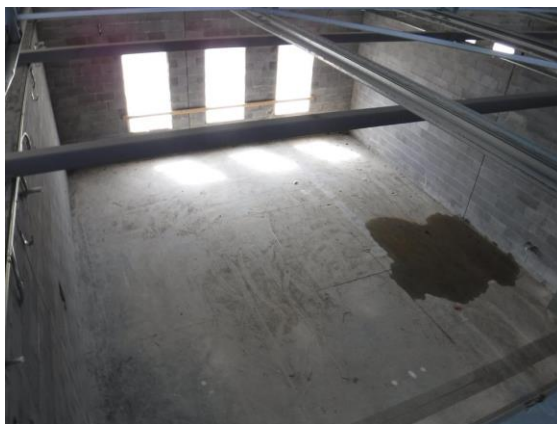
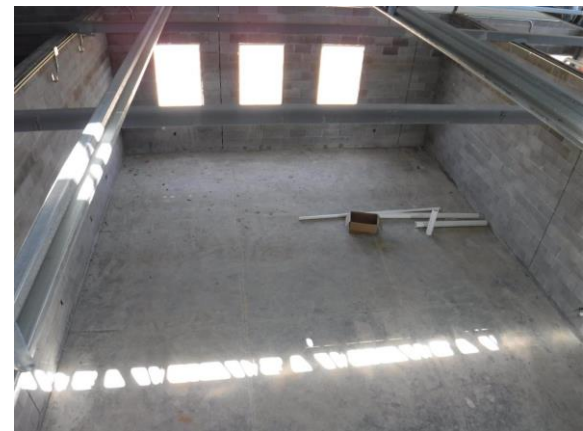
- t) On the day of my inspection, the second-floor rooms in Area C were mostly dry.

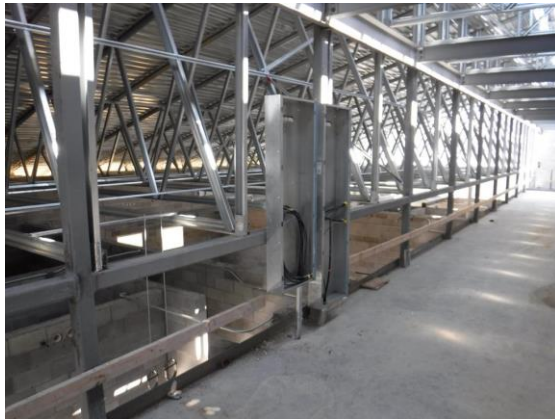
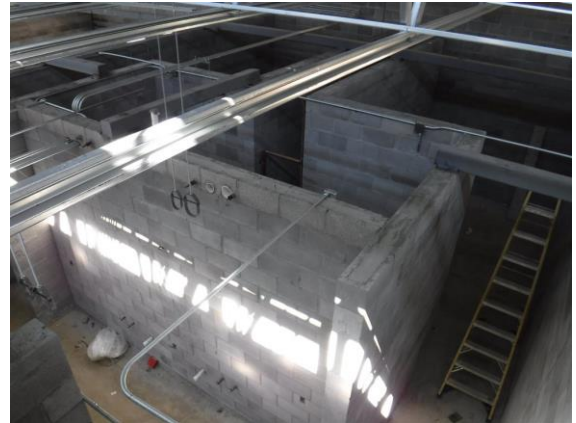
- u) From the mechanical platform, electrical rough-ins are visible on the platform and to the rooms below.

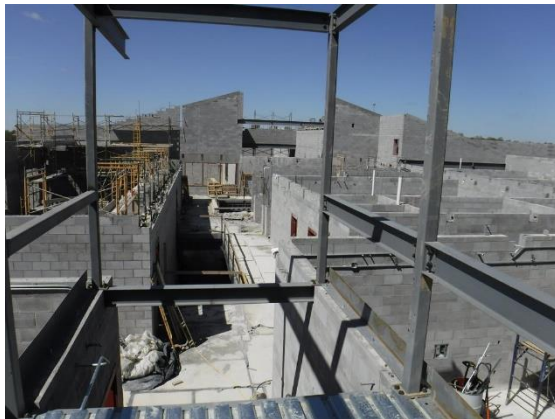
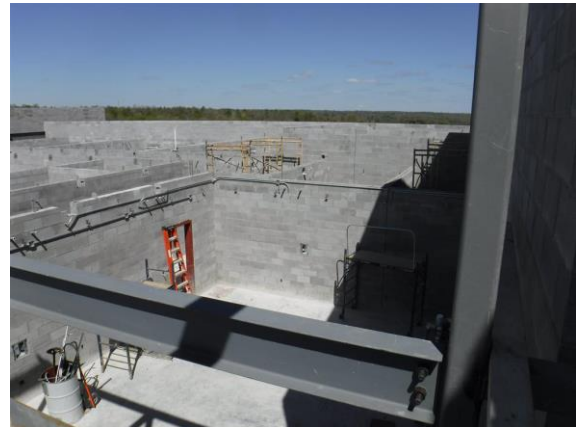
- v) From the mechanical platform, the work on the second-floor block walls is visible.

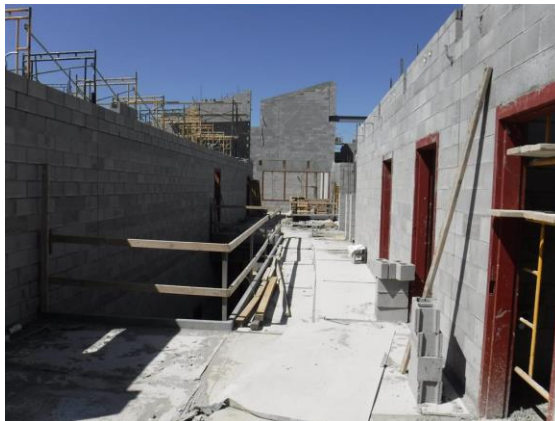
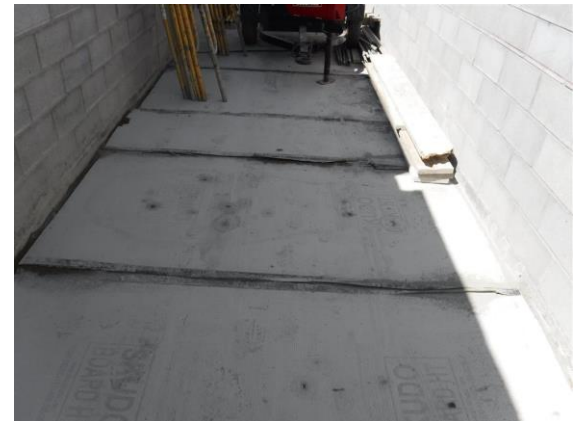
- w) Due to the recent severe weather, some of the Skudo board protection system on the second floor has been dislodged and needs to be repaired as soon as possible.

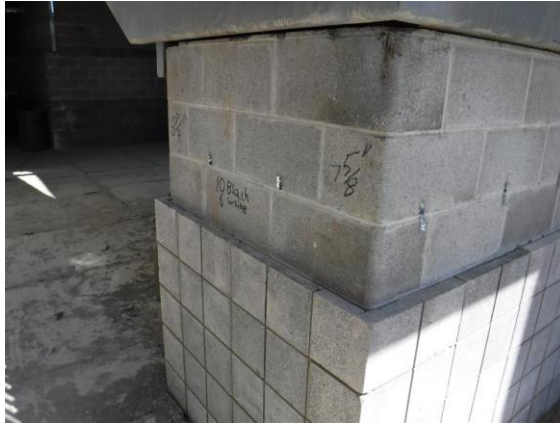
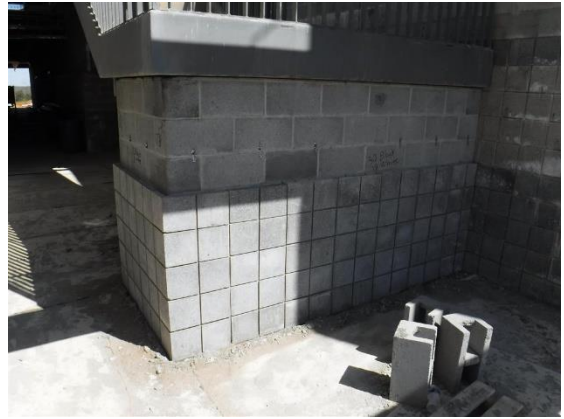
- x) Ground faced soaps were being placed over block under Stair ST-B.

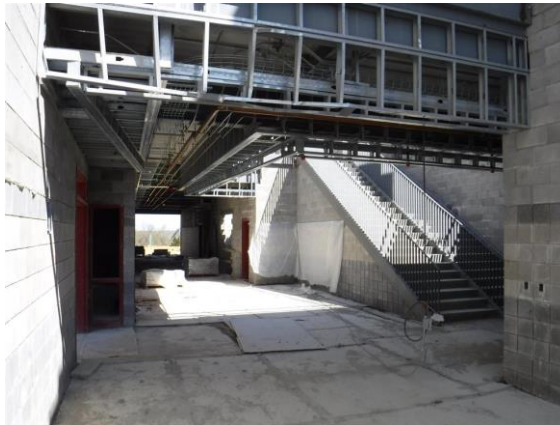
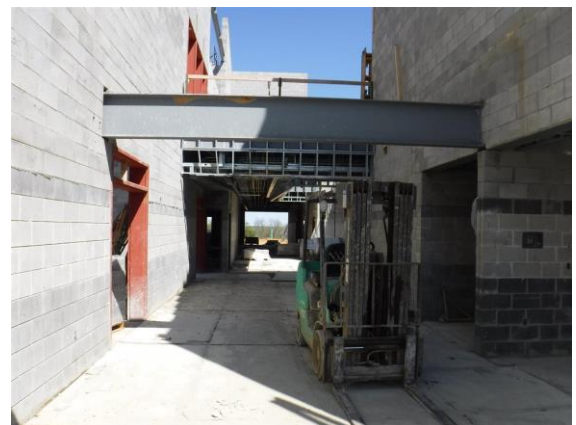
- y) The soffit framing at the main entrance had been damaged, probably by a lift. This needs to be repaired.

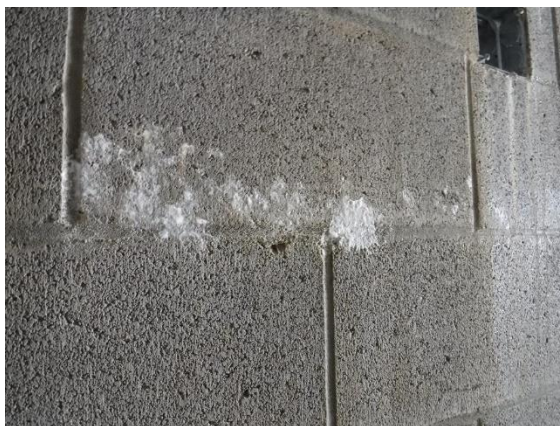
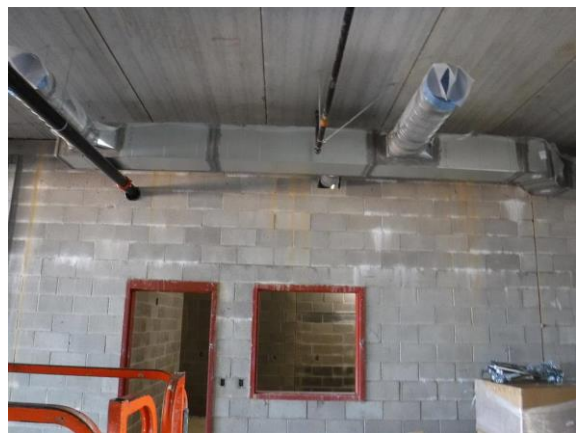
- z) Until the building is dried in, we will continue to see staining of the masonry. When the walls are dry, these stains need to be completely removed so the paint finish is not affected.

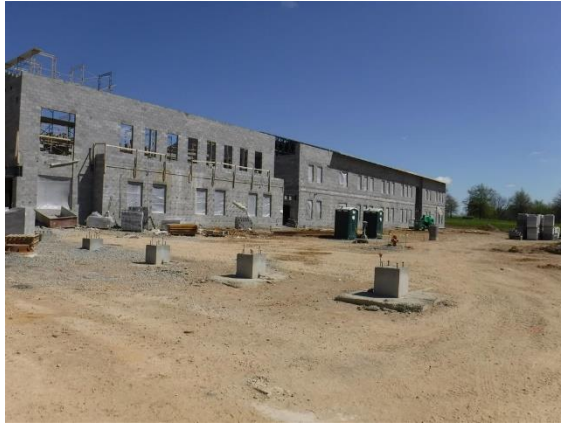
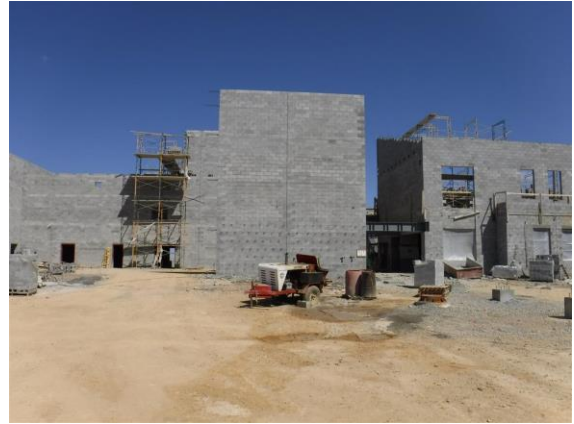
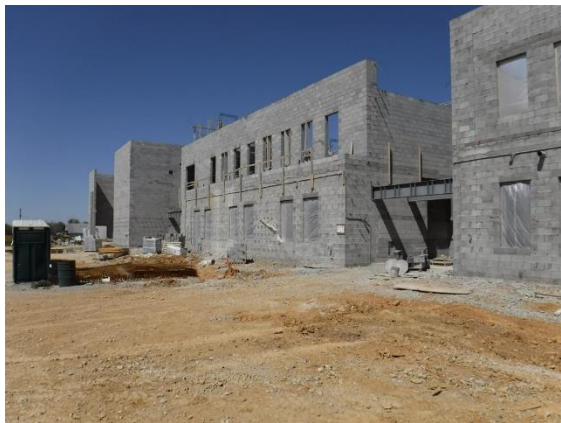
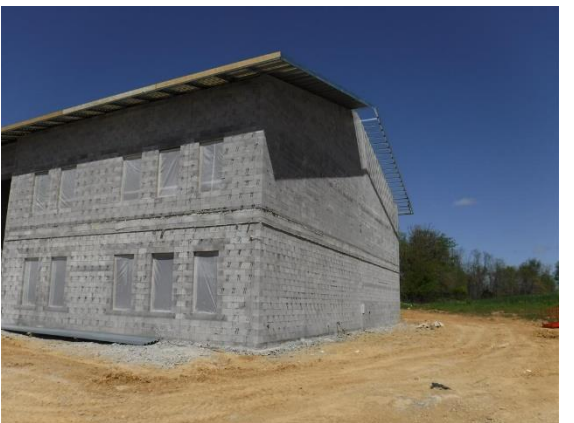
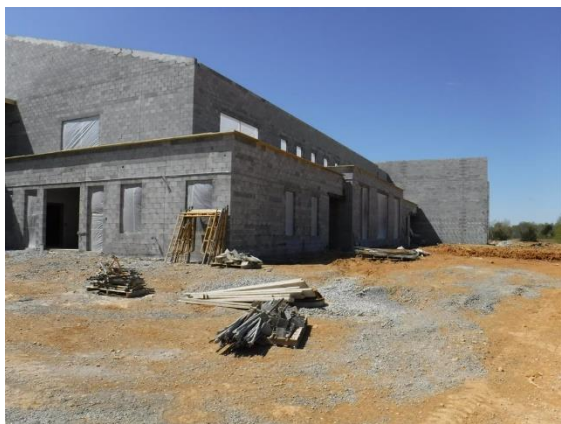
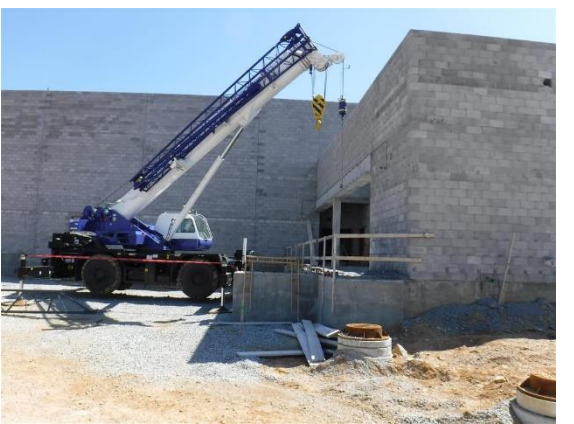
- aa) Overall, the final form of the building is taking shape. The installation of the roofing and brick in what should be prime construction weather will start to define the final appearance of the building.
