FIELD OBSERVATION REPORT

East Hardin Middle School, Hardin County Schools, Elizabethtown, KY 201752.01 -CA8

Date: 4/10/2020

Report No: 20

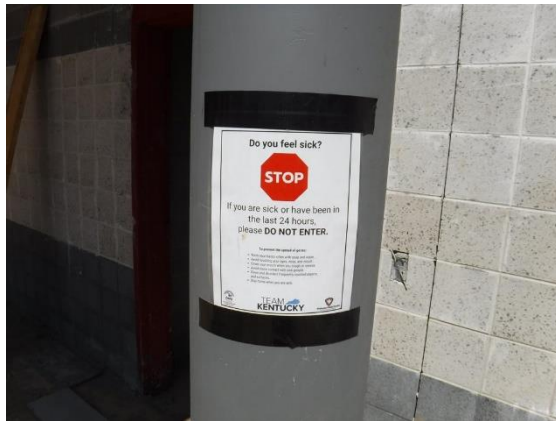
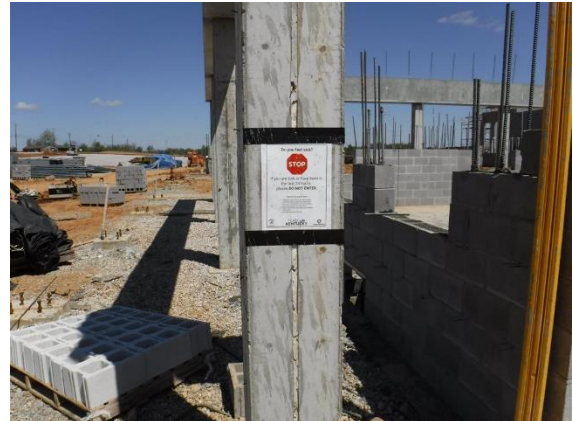
- b) Alliance has placed COVID 19 notices at the construction entrances to the building.

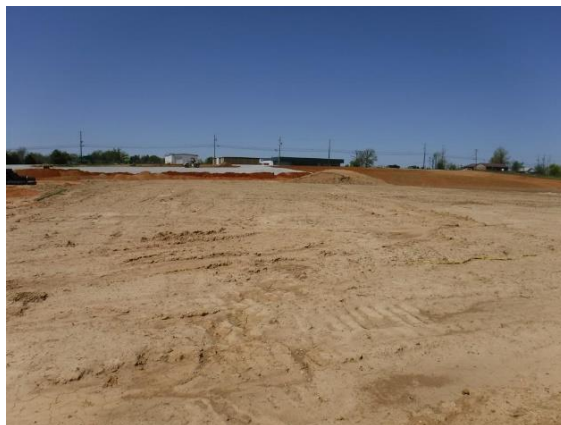
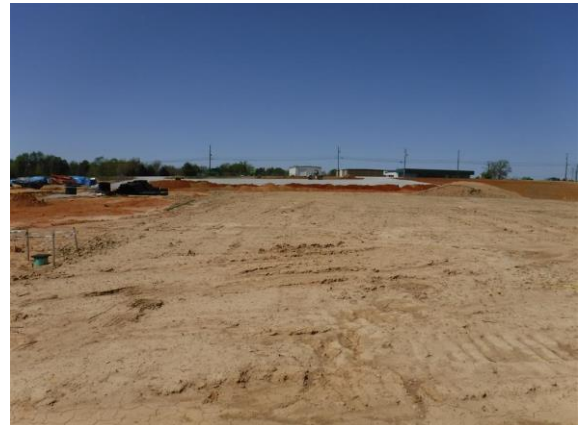
- c) Gravel has been placed for the parking lots to the north west of the building. This will be available as a laydown area for materials such as the roof trusses.

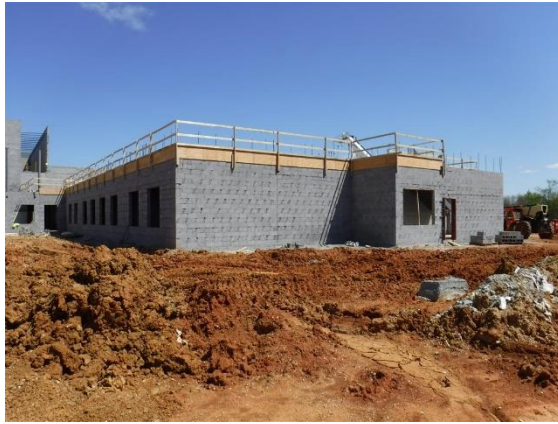
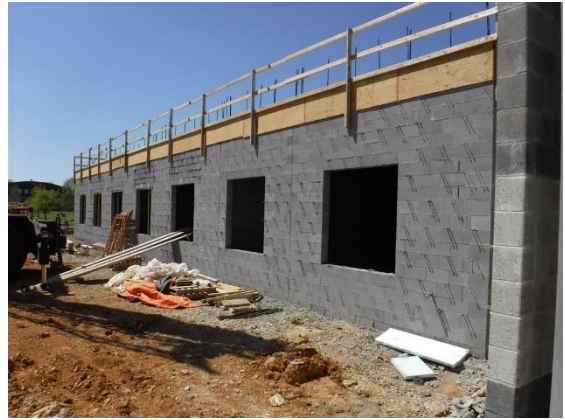
- d) The classroom window in Area B has been covered with precast concrete planks. The edges have been prepared for the pour of the concrete slab over the planks. With no work underway, there was no access to the second floor. Ladders had been removed and the stairs were not ready for traffic.

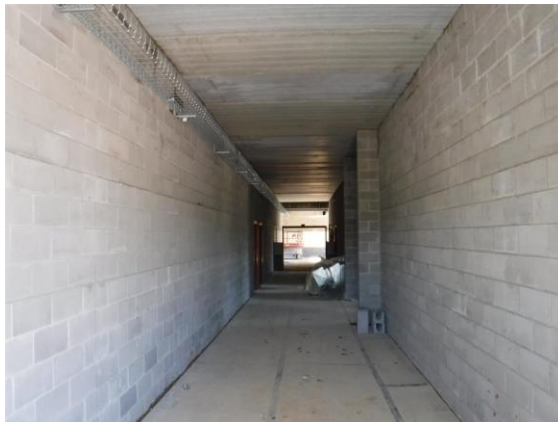
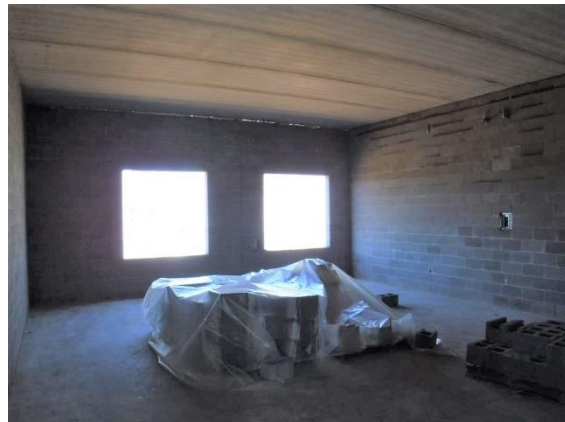
- e) The concrete planks are visible from below. Note that the electrician has already installed the cable tray to the planks in the corridor.

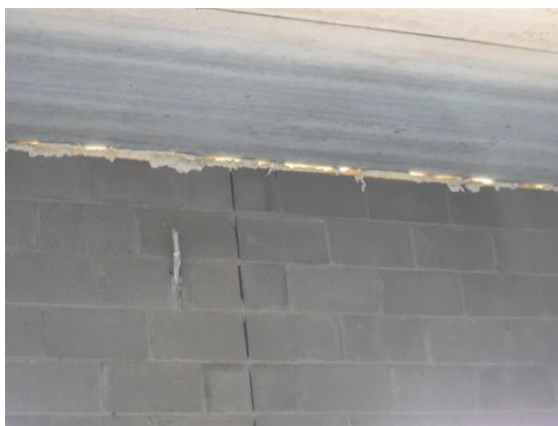
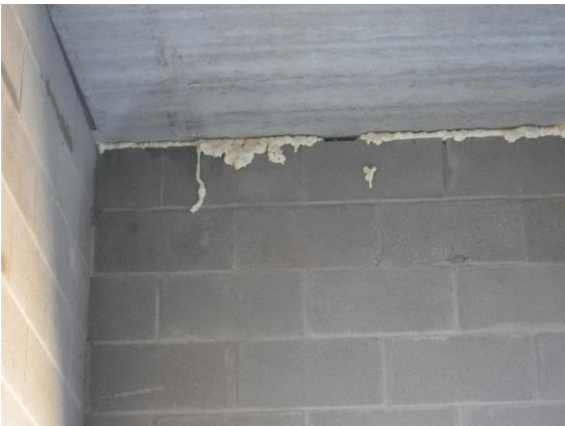
- f) Spray foam insulation has been placed in the joint between the tops of the block and the planks to stop cement runs during the slab pour. This material will need to be cut back since it is a flammable and cannot be exposed in the plenum.

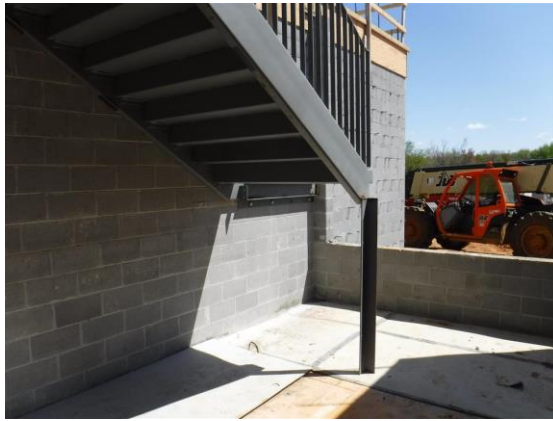
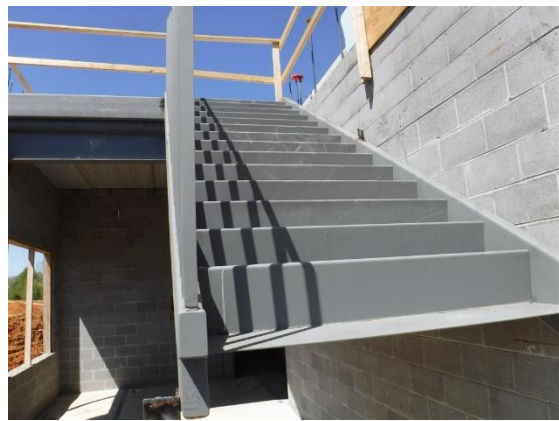
- g) The upper run of steel stair ST-E to the second floor of Area B is in place.

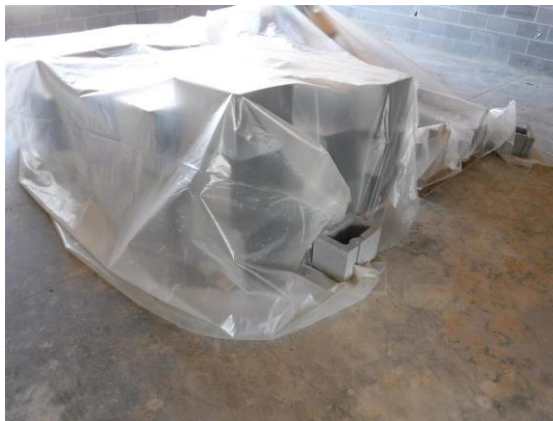
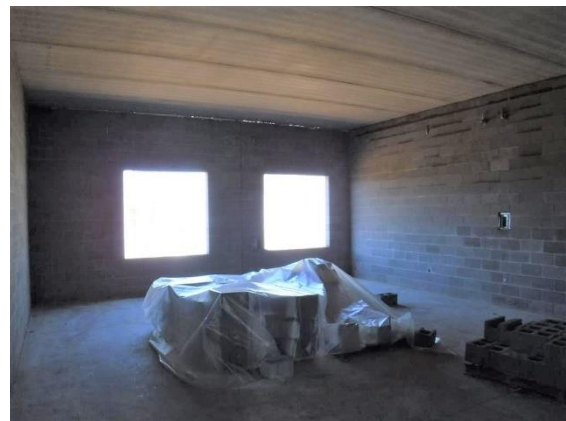
- h) Prefabricated steel ductwork is stockpiled in Area B to be installed to the bottoms of the planks.

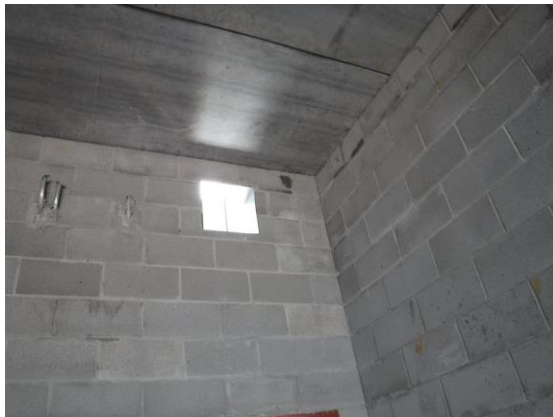
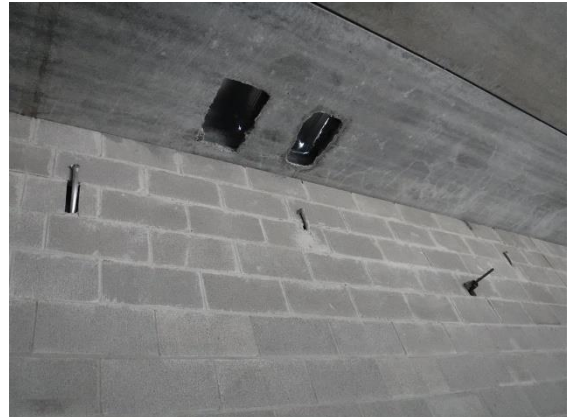
- i) Openings for mechanical ducts are in place in the walls and the planks. The openings in the planks are covered with sheet metal closures.

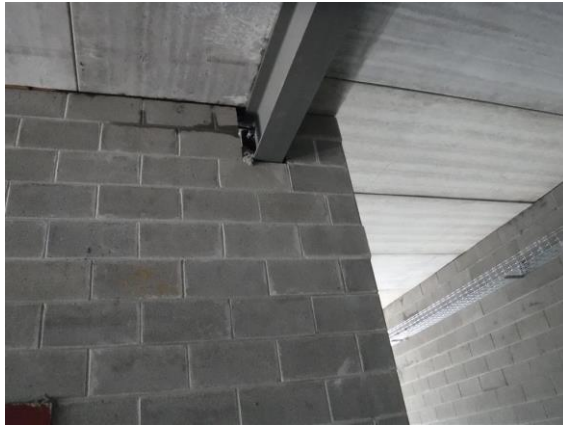
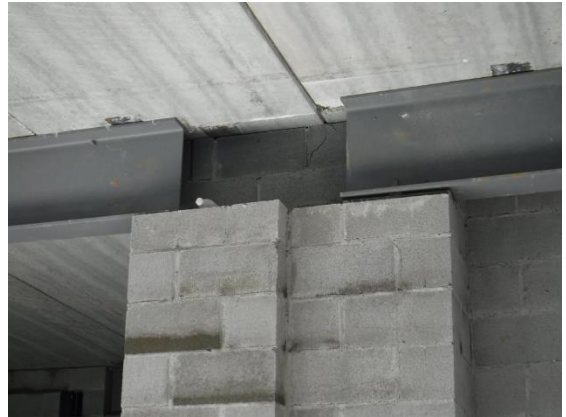
- j) The steel beams supporting the planks set on the block walls. In some cases, damaged block may need to be replaced.

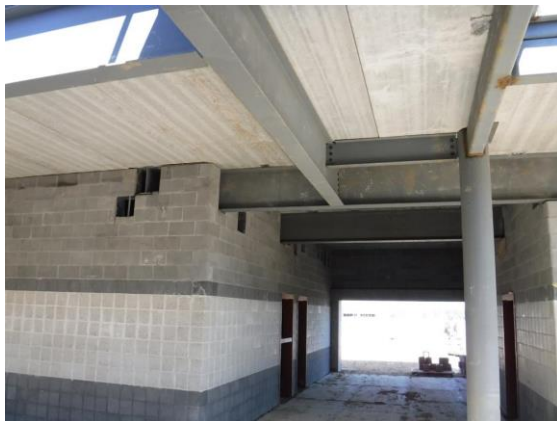
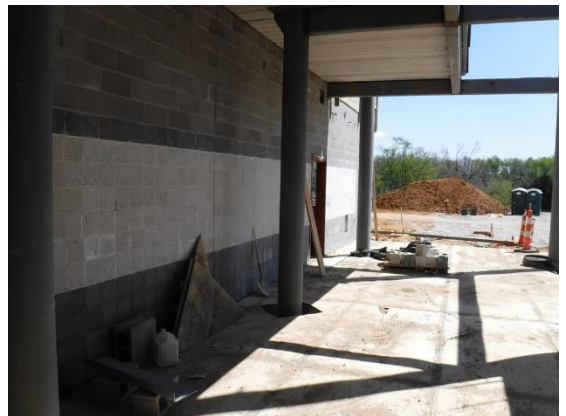
- k) Steel framing on steel columns are in place in the main corridor in Area B.

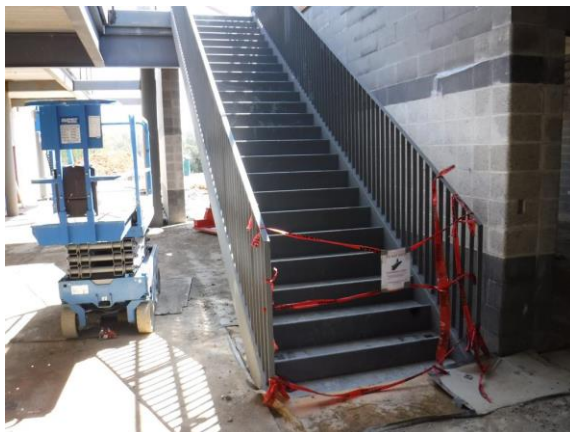
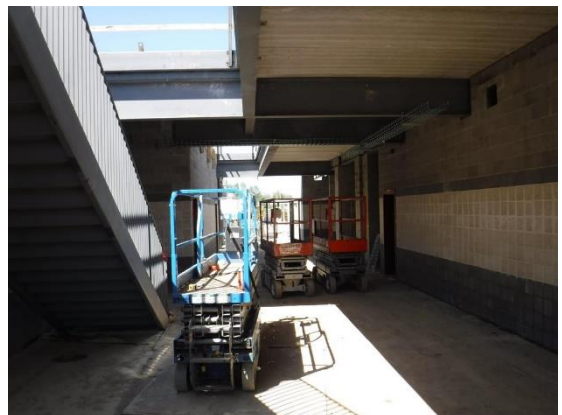
- l) Stair St-C is in place but will not be open for construction traffic until concrete is placed in the tread pans.

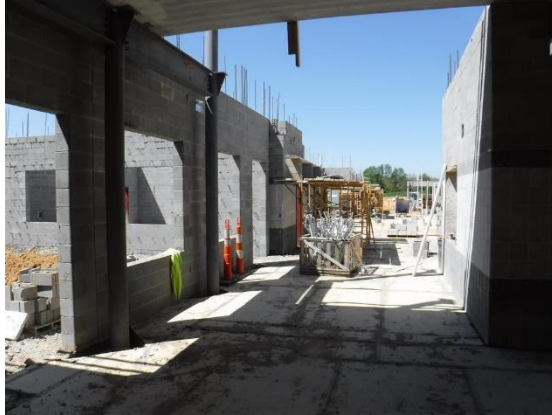
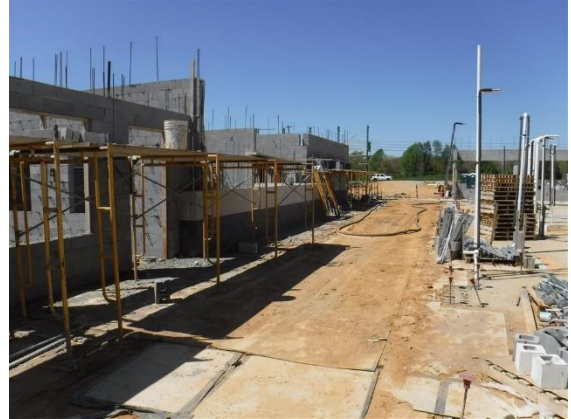
- m) Looking west along the main corridor, block walls in Area are visible all the way to the west side of the building.

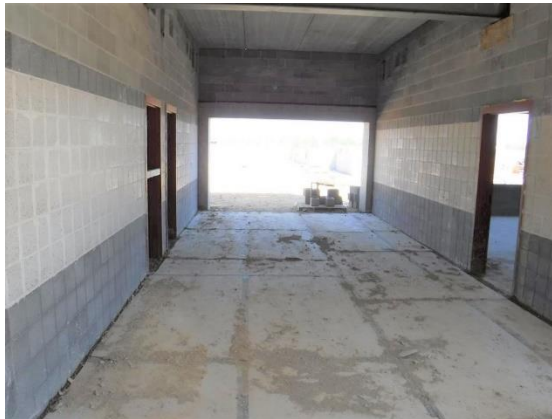
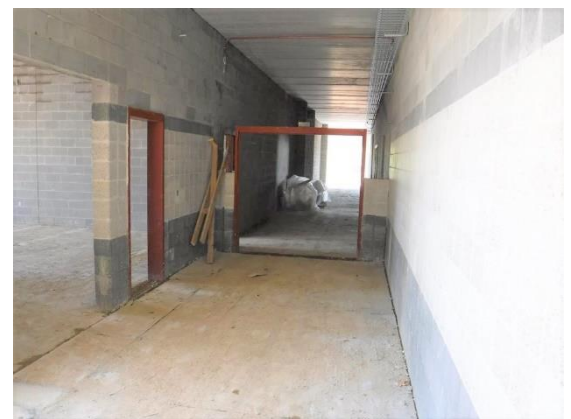
- n) In areas where the ground faced block has been cleaned, the walls look good.

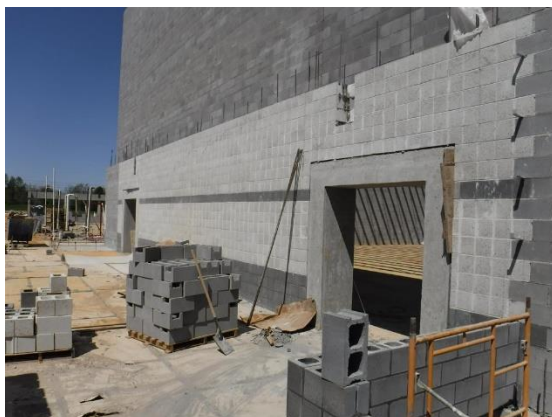
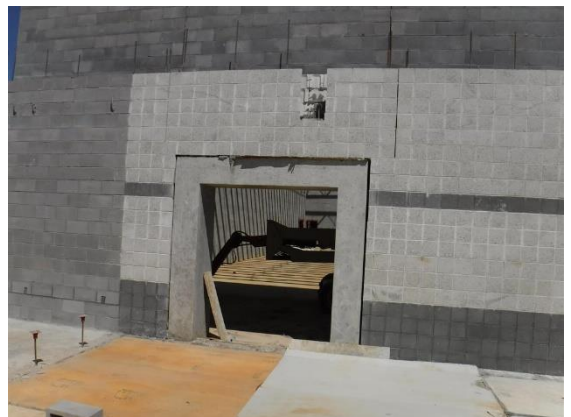
- o) The ground faced block at the entries into the Gym looks good. It appears that the control joints above the concrete portals are properly located.

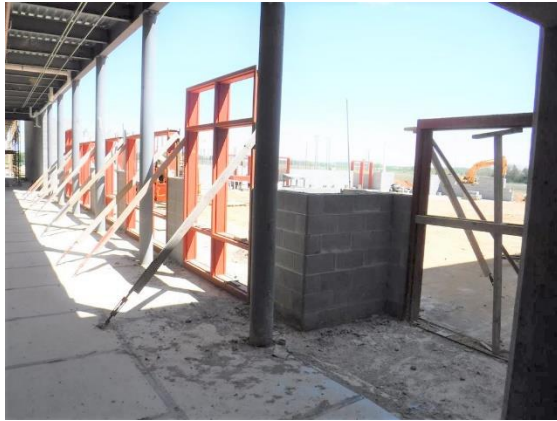
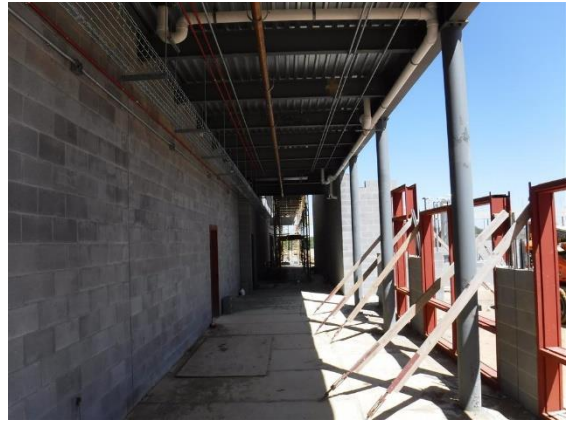
- p) The hollow metal frames for the doors and windows into the Cafeteria are in place for block after the walls are laid in Area A and D.

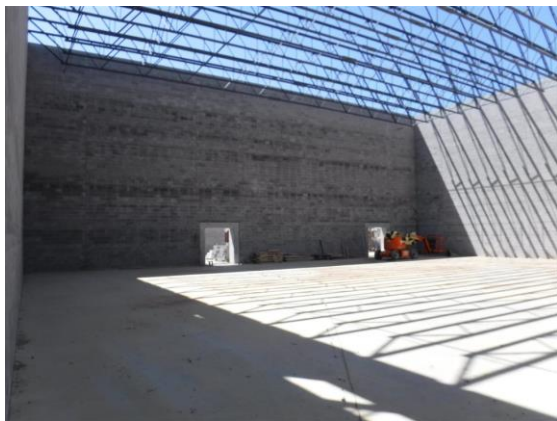
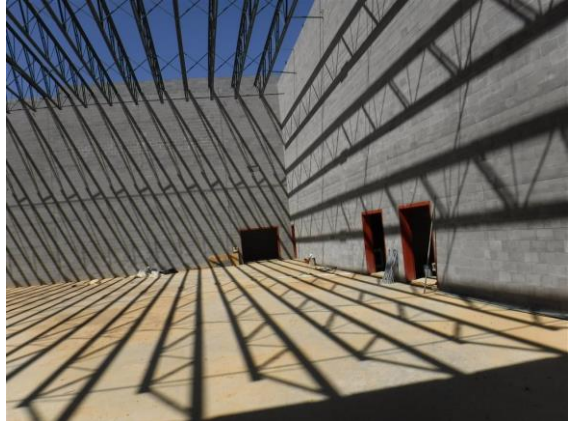
- q) With little work being done in the Gym, the slab has stayed relatively clean.

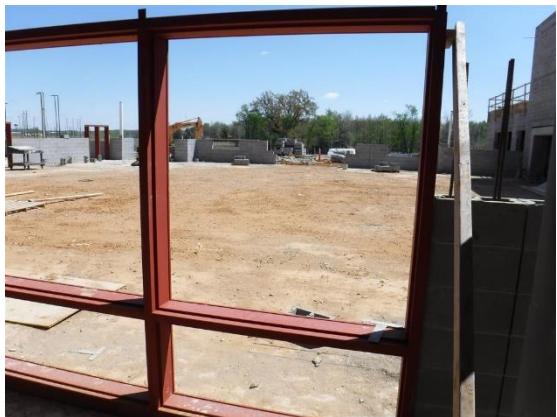
- r) Due to the amount of construction traffic across the Cafeteria slab, this area has a considerable amount of mud that should be cleaned as soon as possible.

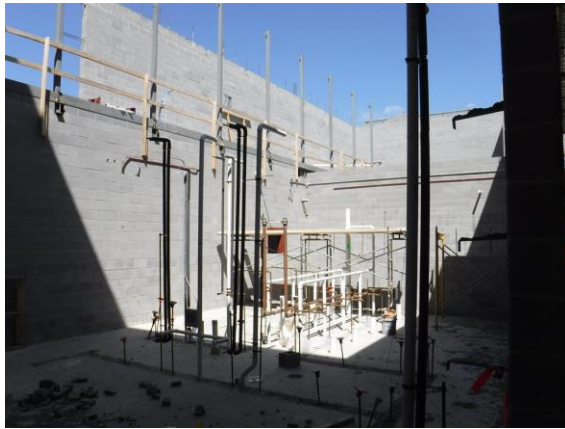
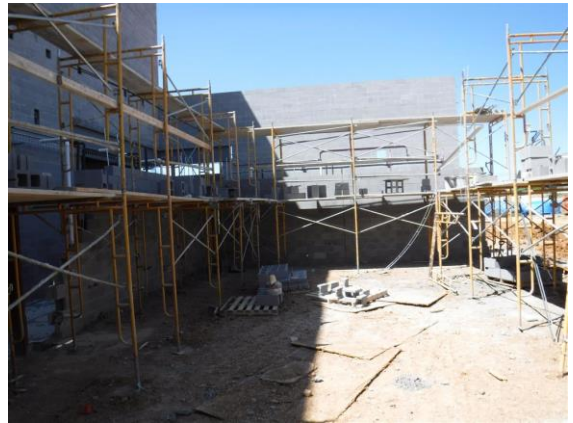
- s) The high walls in Area D are being laid up to roof bearing elevations.

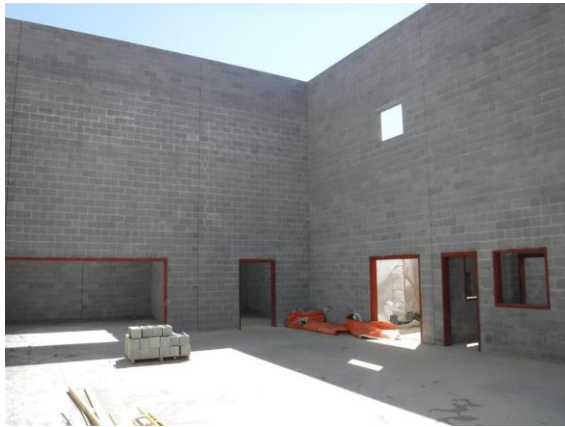
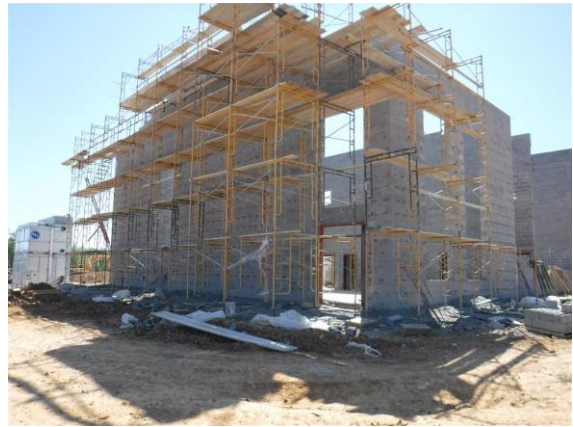
- t) Most of the walls in Area D are either topped out or are nearing topping out.

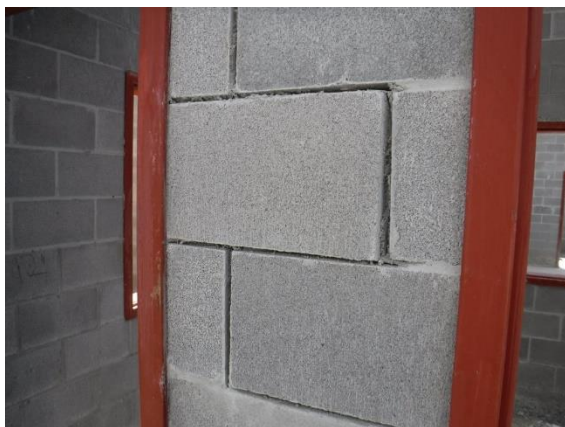
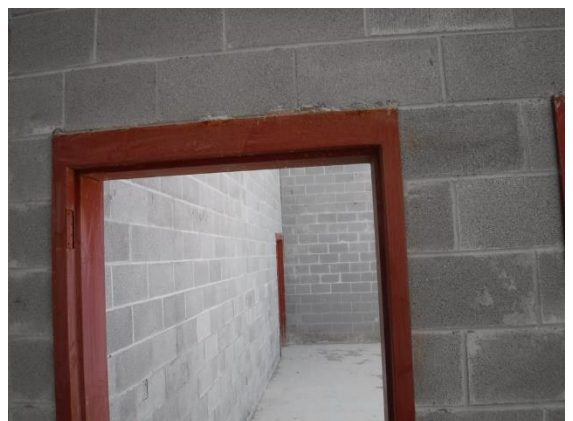
- u) Masonry repair work is ongoing. Mortar drips need to be removed from hollow metal frames.

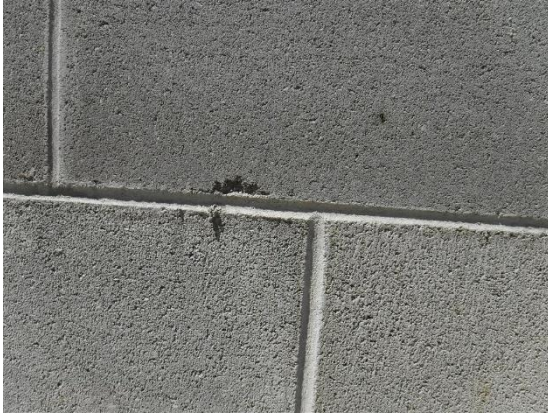
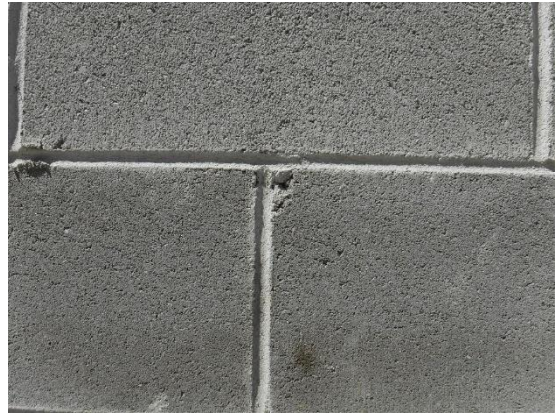
- v) Doyle has told the masons that cement matching block textures must be used for repairs to chipped block faces.

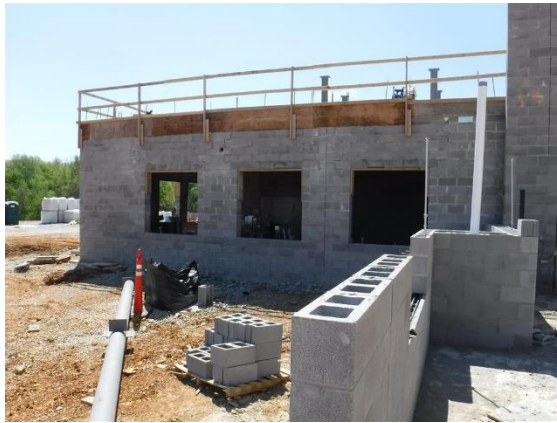
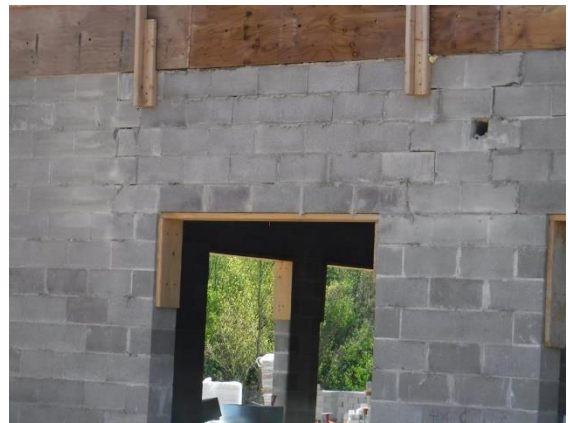
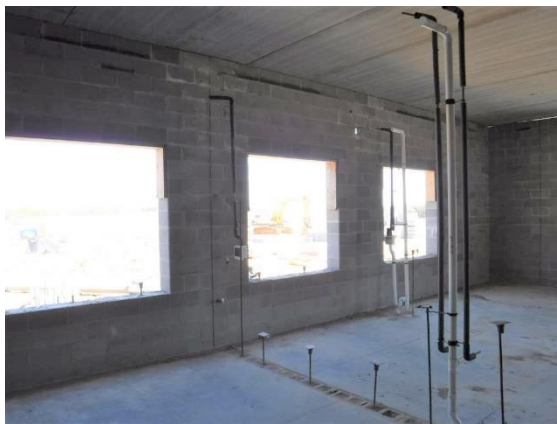
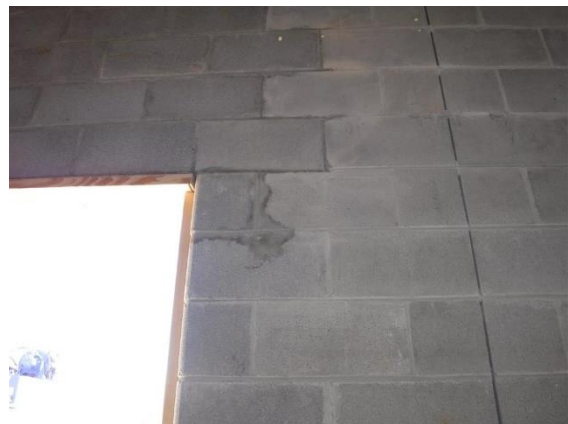
- w) The locations where the masonry window openings were corrected are very noticeable especially on the exterior side. Even though these will be covered, the block and mortar joints must be repaired so they provide continuous bearing for the loads above. On the interior, these areas must be repaired so they are indistinguishable from the other block. I am not sure that this is currently the case.

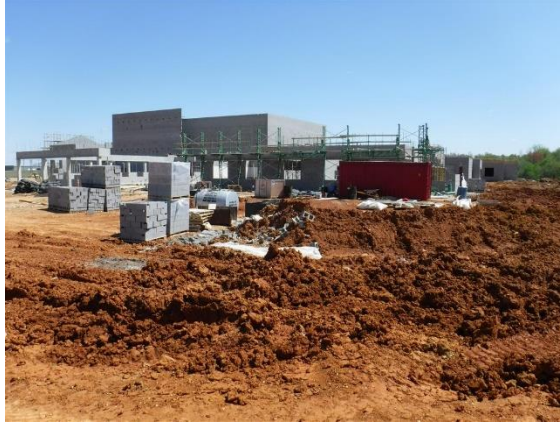
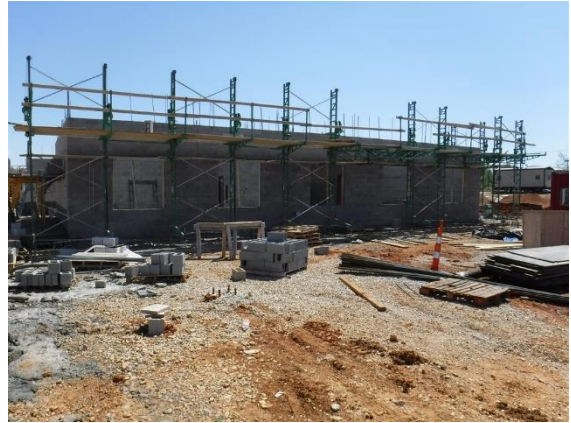
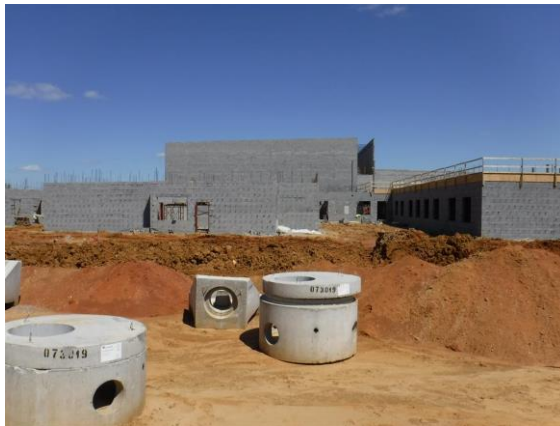
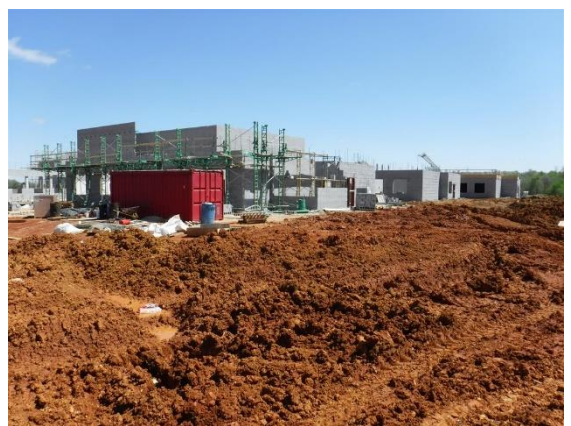
- x) Installation of the classroom walls in Area A is critical to the overall schedule. A considerable amount of progress has been made, but much remains to be done. Walls in the east classroom wing are at plank bearing elevation. Walls in the west classroom wing are nearing that elevation. When all of the walls are at plank bearing, the planks are installed, and the slabs poured the walls on the second-floor of Areas A and B can be laid.

- a. Maintain the Skudo system so that it protects the corridor slabs.
- b. Verify that the bearing elevations for concrete block wall are per the drawings. Doyle said that the mason will use laser levels to insure bearing elevations. Confirm that this is the case.

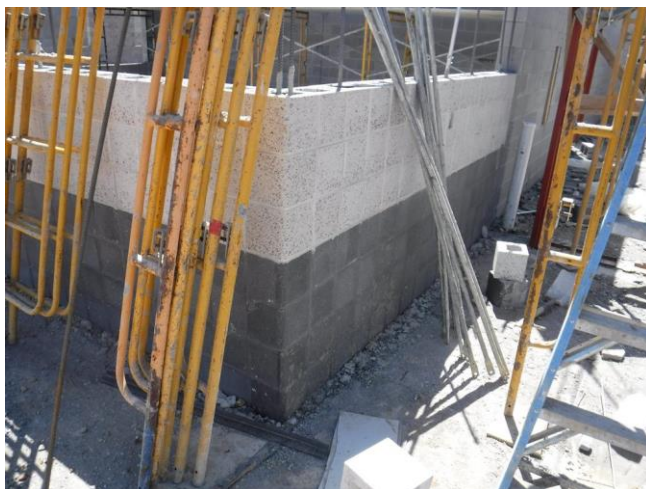
- y) Care needs to be taken to not damage the top edges of the ground faced block. Avoid laying materials against the top edge such as scaffolding and pipes.

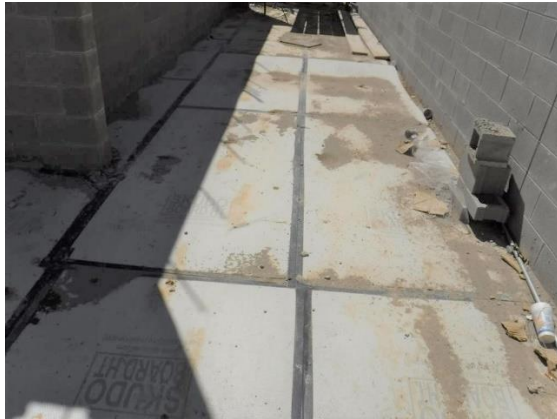
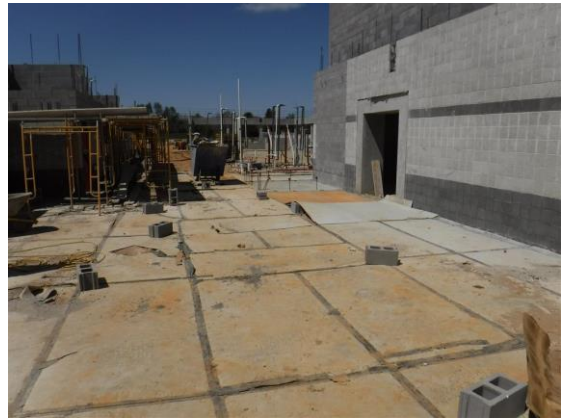
- z) The Skudo protection system has been damaged by winds and needs to be repaired as soon as possible.

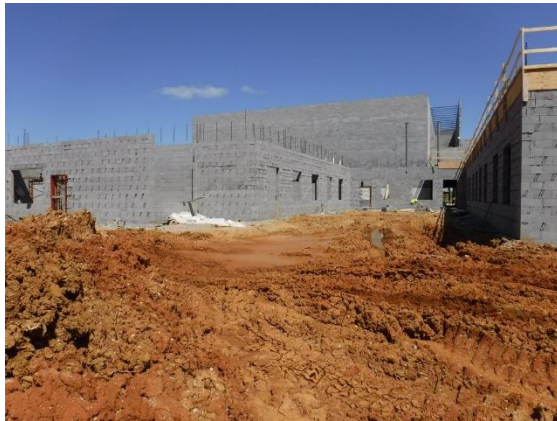
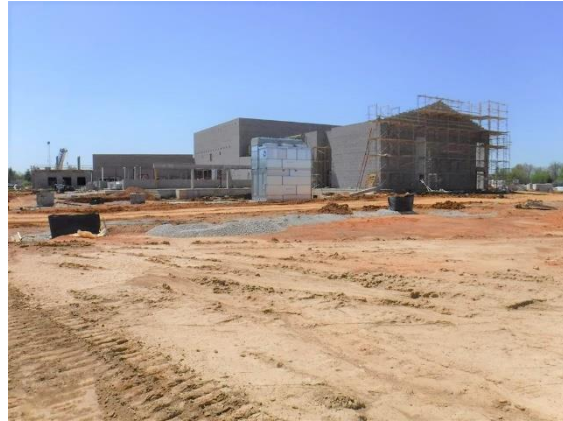
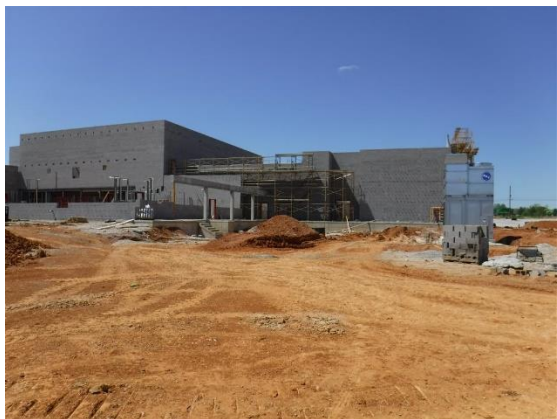
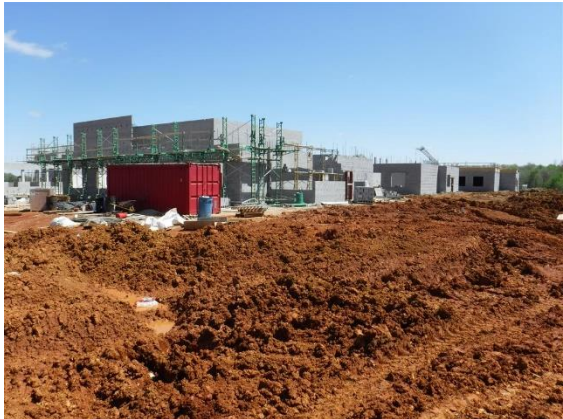
- aa) Viewed from a distance, one can see that a lot of work has been done but a lot of work remains to be completed.
