FIELD OBSERVATION REPORT

East Hardin Middle School, Hardin County Schools, Elizabethtown, KY 201752.01 -CA8

Date: 4/24/2020

Report No: 21

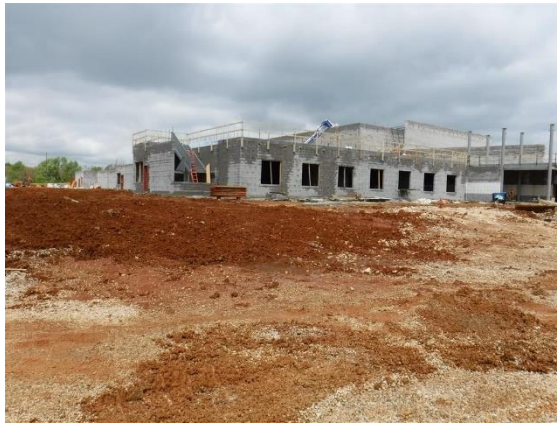
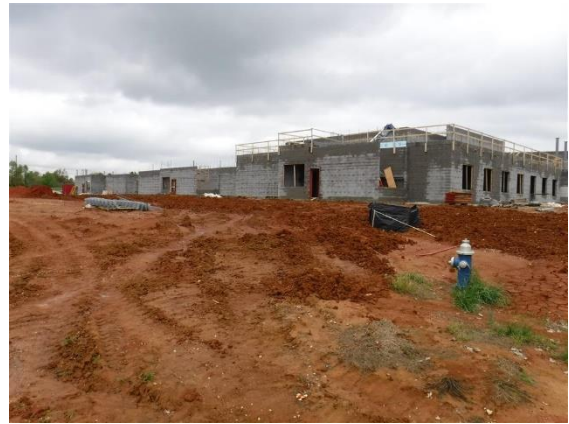
- b) From the southeast corner, the first floor walls for the three classroom wings are visible. The wing in Area B nearest the camera is ringed with wood barricades after the slab has been poured over the precast concrete planks.

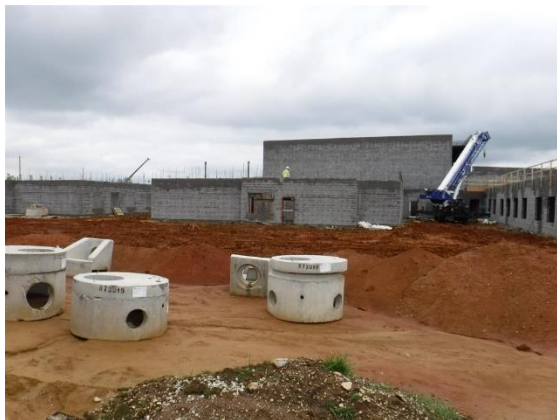
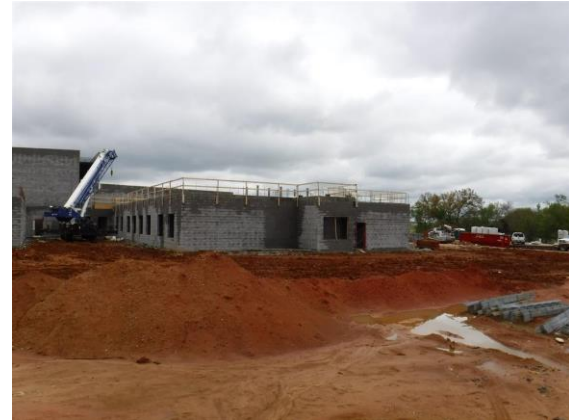
- c) The crane had been moved into the courtyard between classroom wings to lift steel members to the tops of the first floor block walls in Area A.

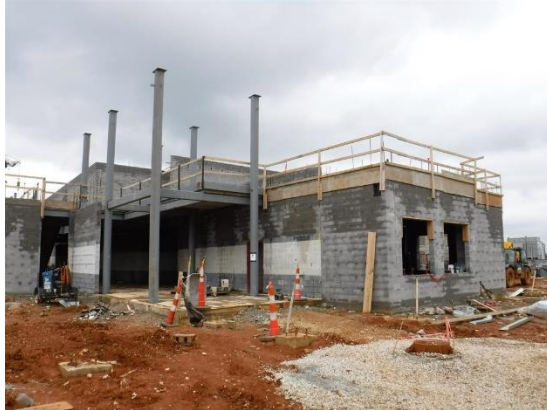
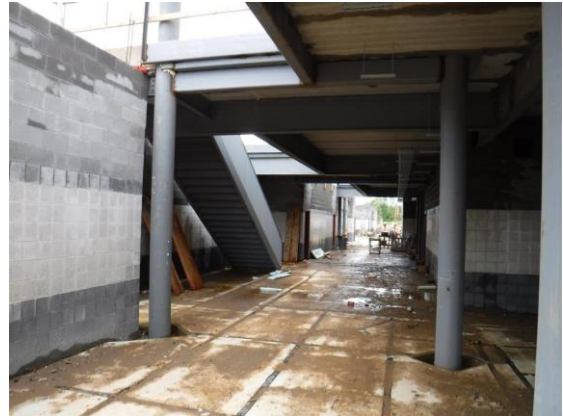
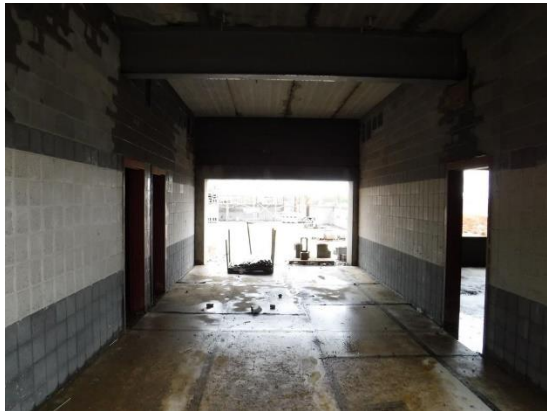
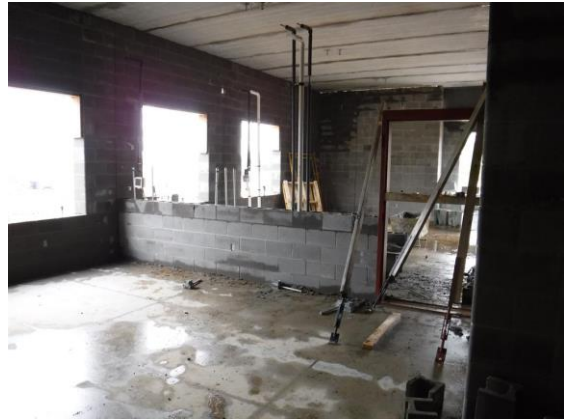
- d) Concrete planks are in place at the north side of Area B, ready for the next slab pour. The interior wall in the Resource Rooms was being laid by the masons.

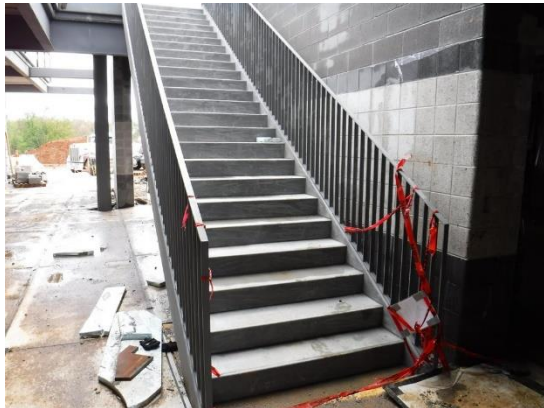
- e) Stair ST-C at the east side of Area B is in place and the treads have been filled with concrete. This provides access to the second floor of Area B.

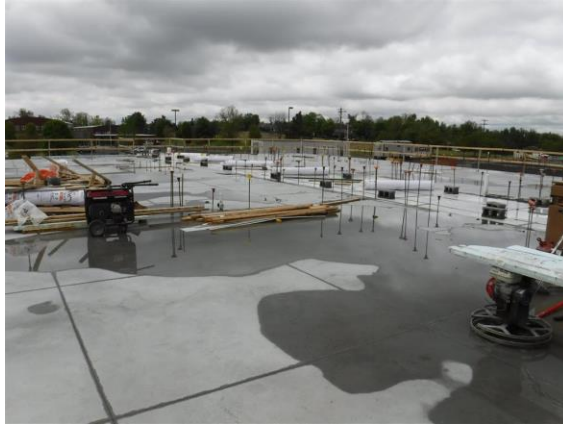
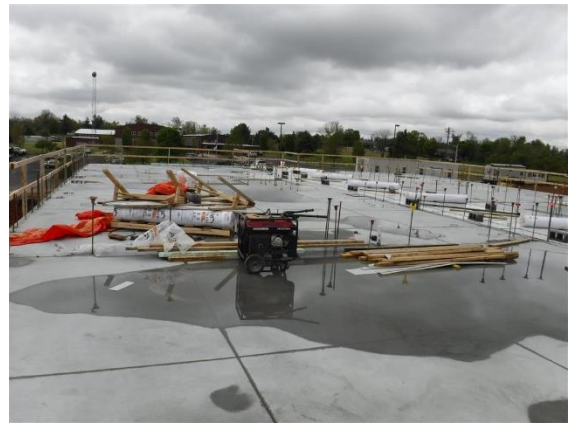
- f) The second floor slab at the south side of Area B has been poured and control joints sawcut into the concrete. Water was ponding from the rain on Thursday.

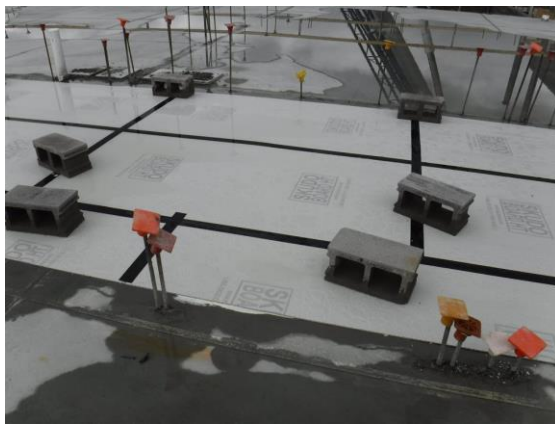
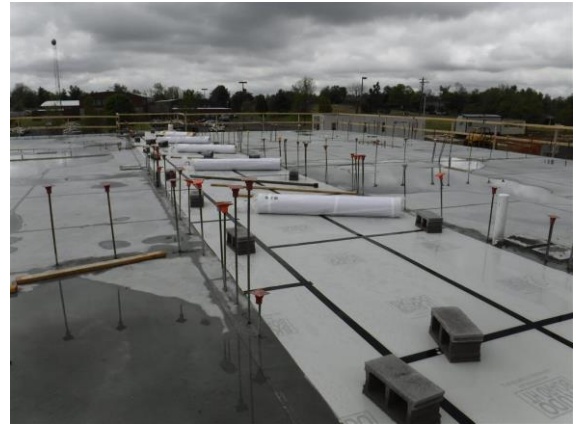
- g) The Skudo protection system has been installed over the location for the corridor in the Area B classroom wing. Block has been used to keep the system from being displaced by winds.

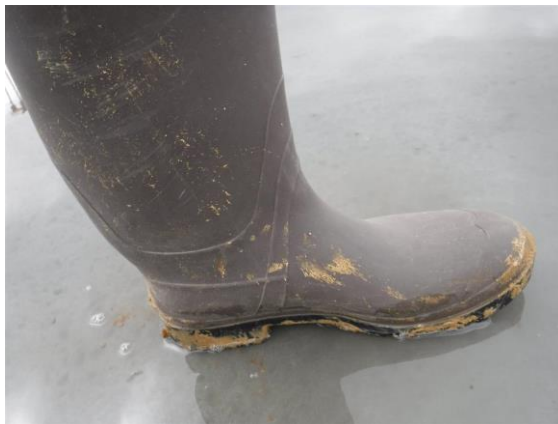
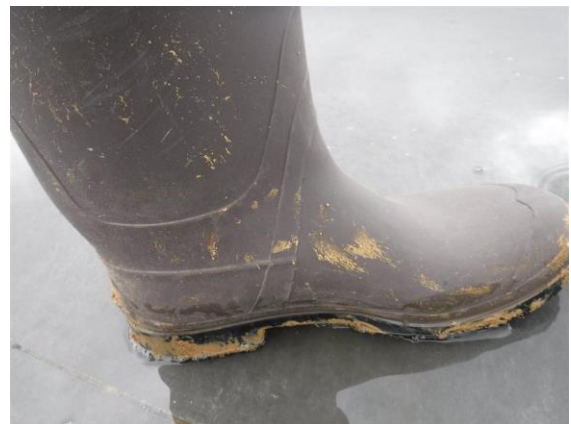
- h) Standing in two of the ponded areas on the slabs, I noted that the depth of water on my boots was minimal.

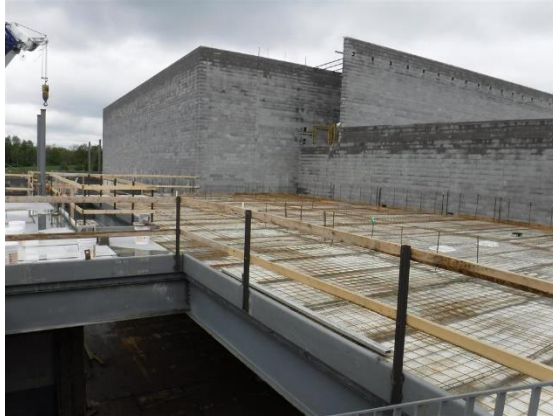
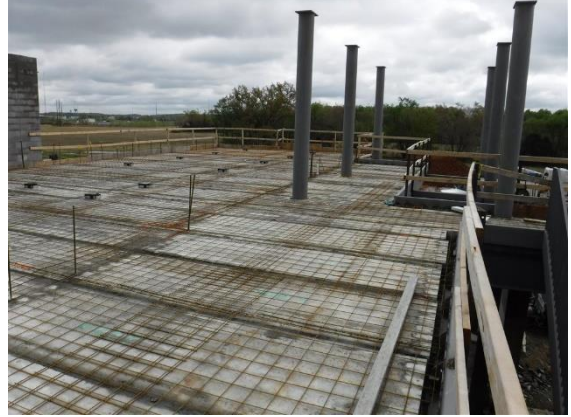
- i) The precast concrete planks over the north side of Area B have been covered with welded wire reinforcement (WWR) ahead of pouring the concrete slabs in this area.

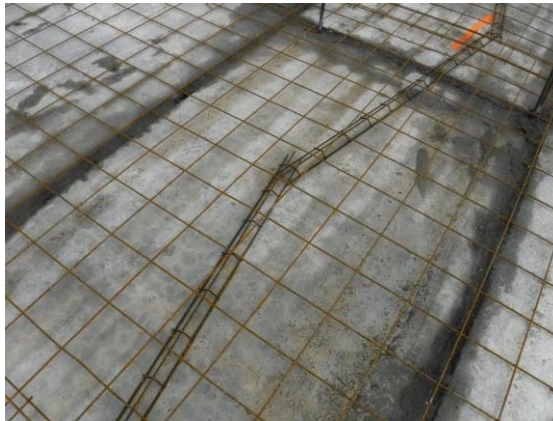
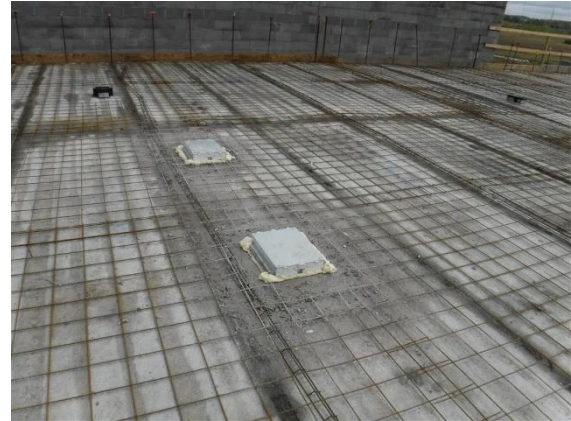
- j) The WWR is supported by wire supports.

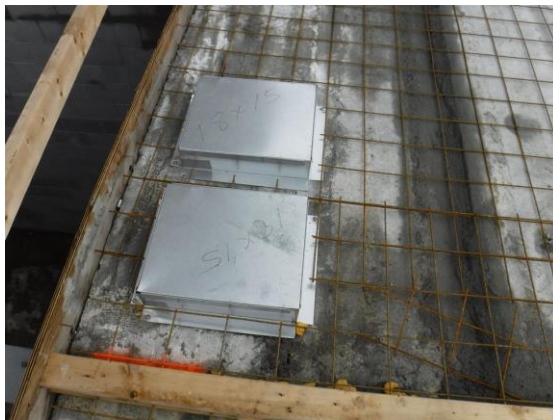
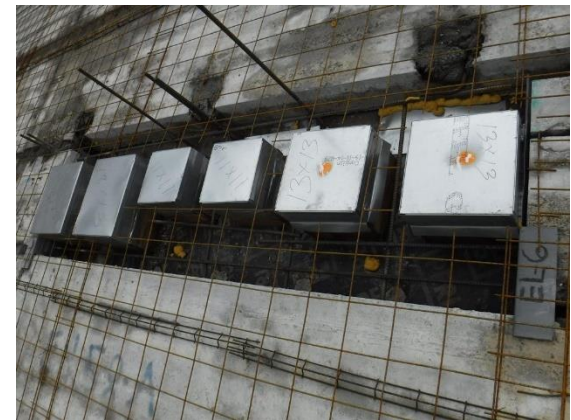
- k) Galvanized metal pans have been placed at HVAC penetration locations in the slab. These are capped to reduce the amount of water that can drain to the first floor until the roof is in place over the second floor.

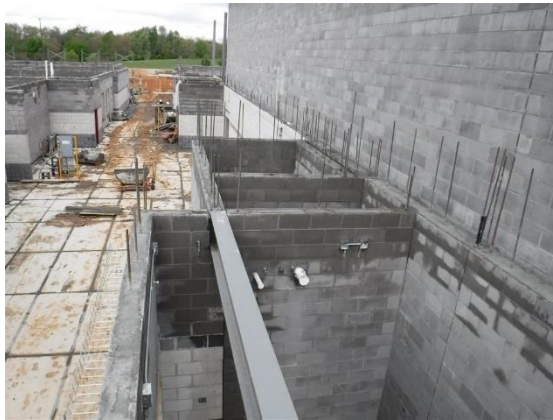
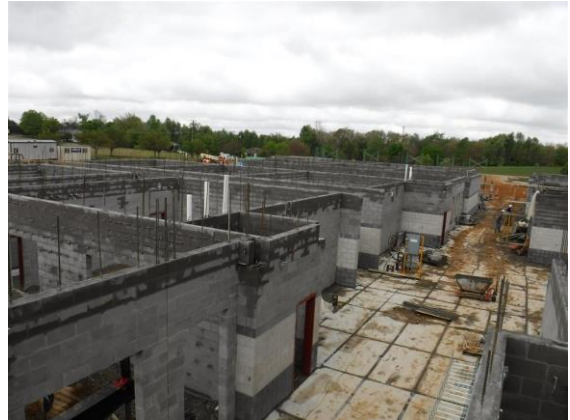
- l) From the second floor of Area B looking to the west, the main corridor on the first floor and the two classroom wings in Area A are visible. Except for the opening at Stair ST-A outside the Gym, most of this area will be covered with the second floor.

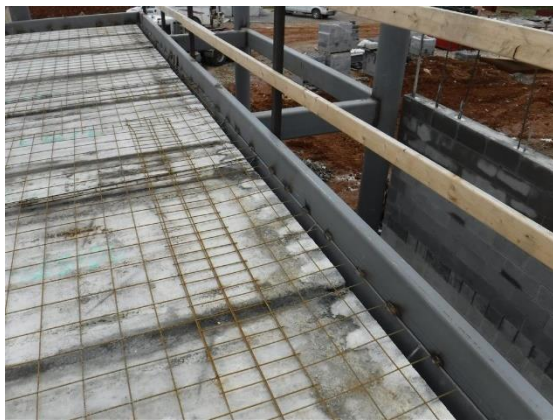
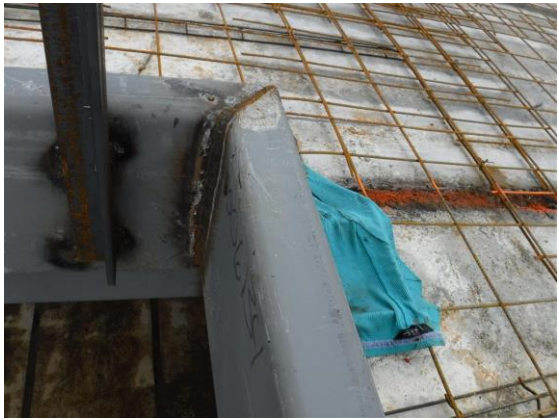
- m) The steel tubes around the floor openings at the east end of Area B will need detailing to meet the appearance requirements of the specifications.

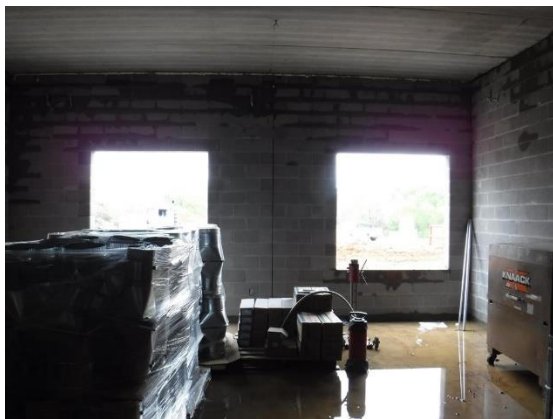
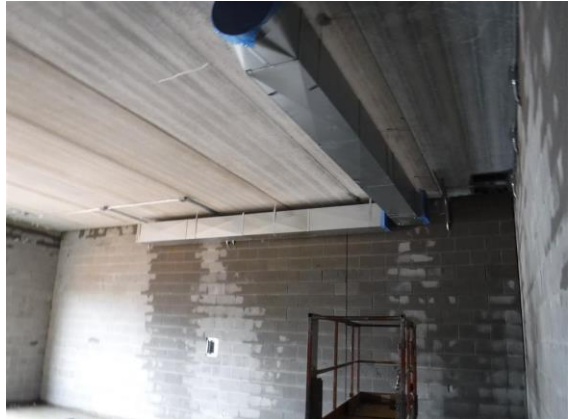
- n) Mechanical/electrical materials are being stockpiled on the first floor of Area B. Ductwork, piping and conduits are now being installed. The ductwork openings are covered with plastic to keep dust out of the system.

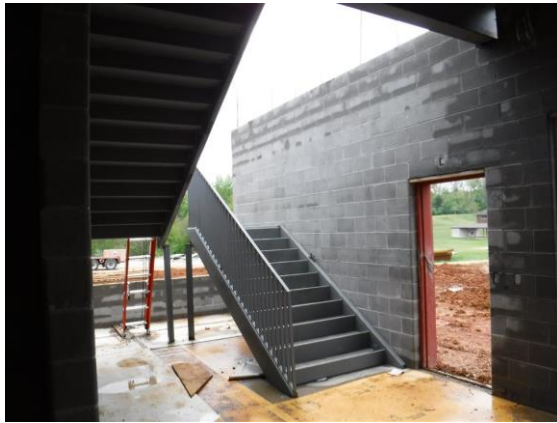
- o) Both runs of Stair ST-E are in place but the landing is not.

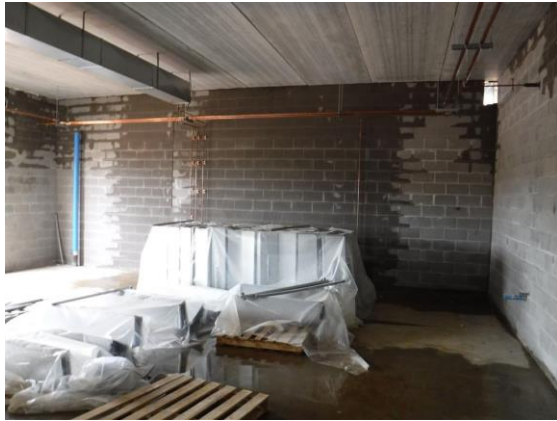
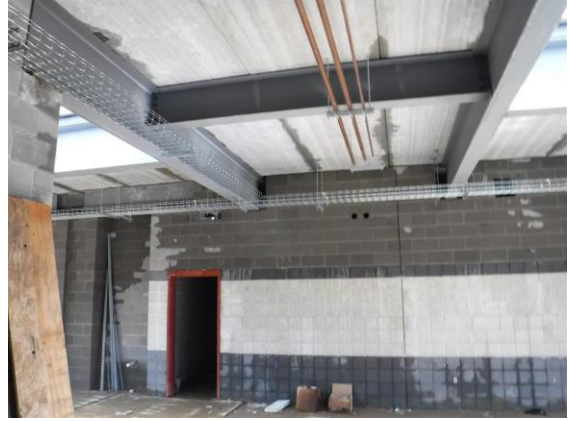
- p) Piping has been run under the concrete planks over Area B.

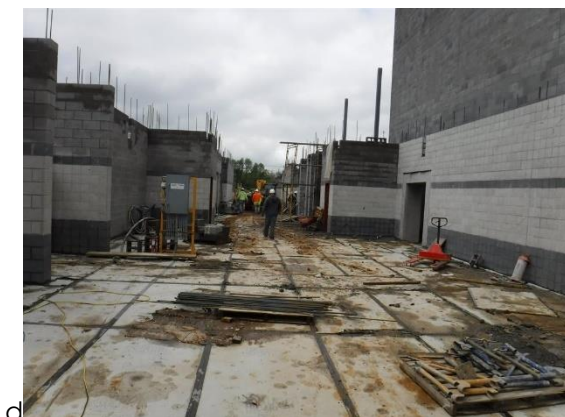
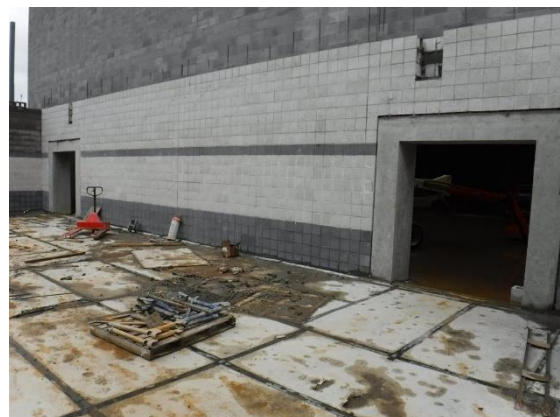
- q) The Skudo protection system is over the main corridor. Some of the panels have been displaced and need to be properly located and taped back into place.

- a. Maintain the Skudo system so that it protects the corridor slabs.
- b. Verify that the bearing elevations for concrete block wall are per the drawings.

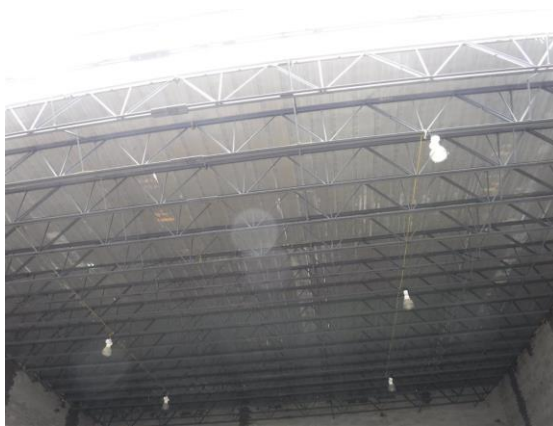
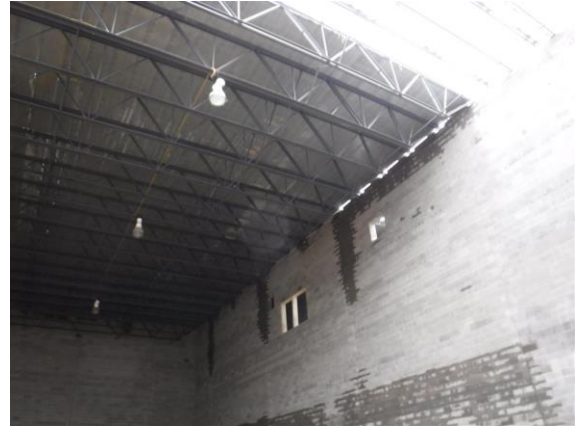
- r) Metal roof deck is being installed over the Gym. The roofing system will be able to be installed over this area. When this is in place, it will provide a covered area for materials storage.

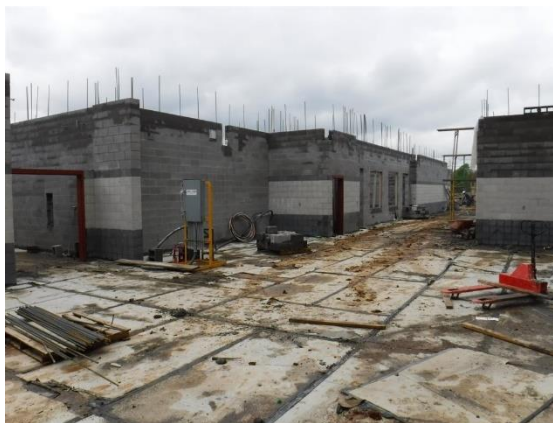
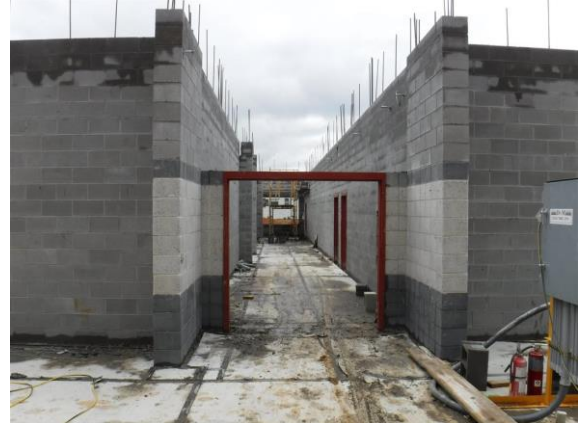
- s) The blockwork in the classroom wings in Area A have laid up to plank bearing elevation. The next step will be the placement of steel beams across open areas to support the concrete planks.

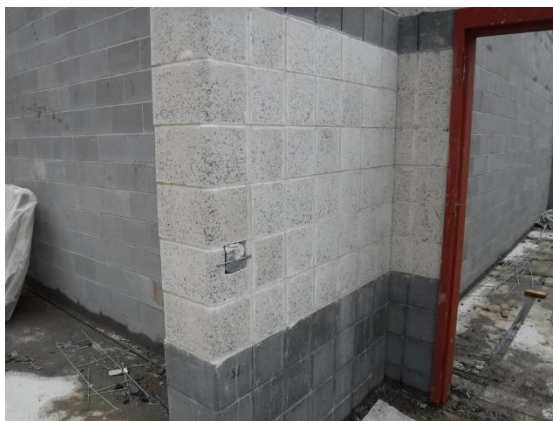
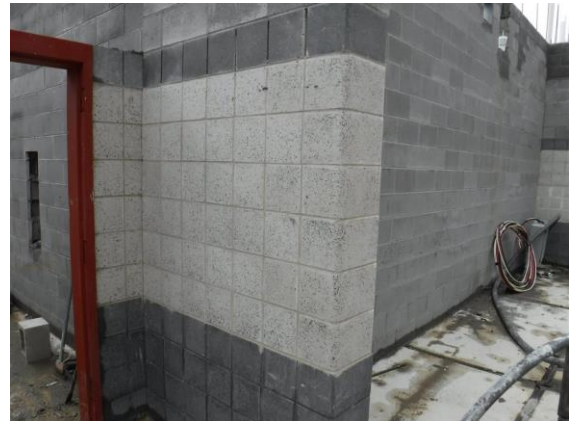
- t) The ground faced block with tooled joints look good but additional detailing is required for a finished appearance.

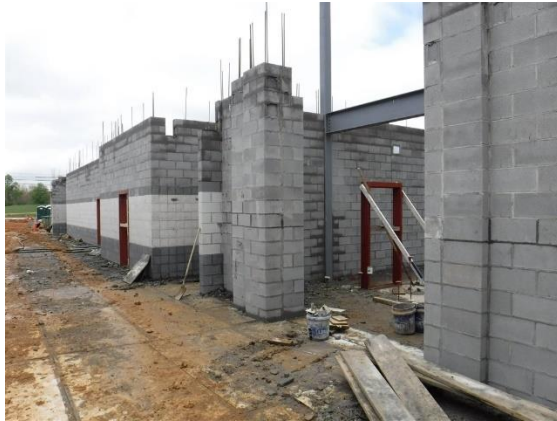
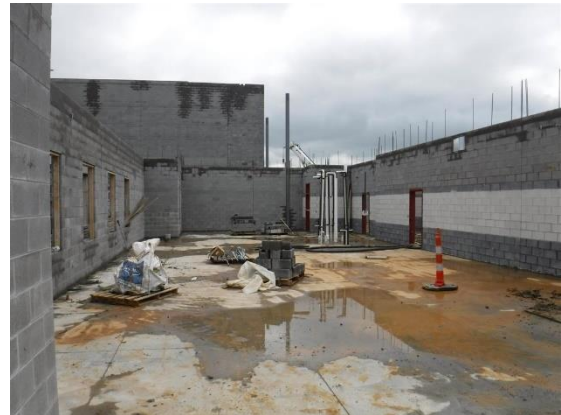
- u) Blockwork surrounding the administrative area in Area A has been laid up to plank bearing elevation. The interior office walls will be drywall on metal studs.

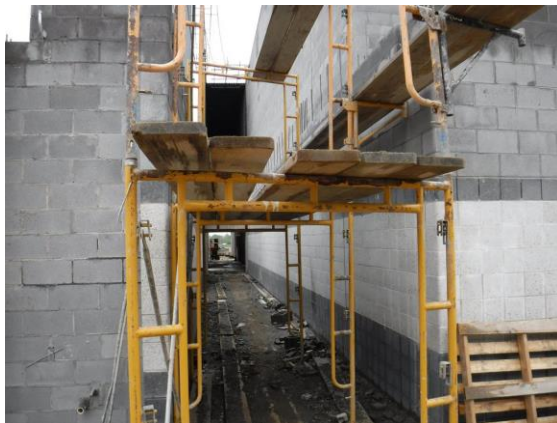
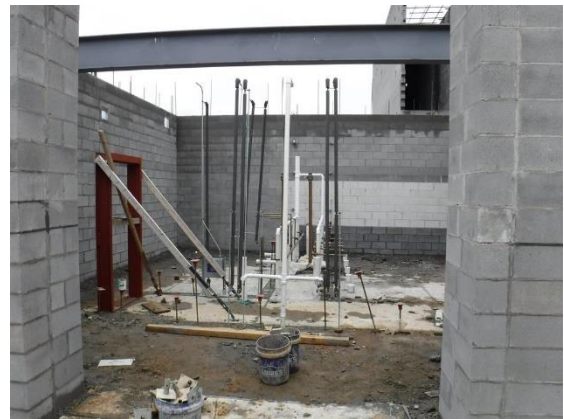
- v) Blockwork remains to be laid for the interior toilet walls in Area A and the north-south corridor to the west of the Gym.

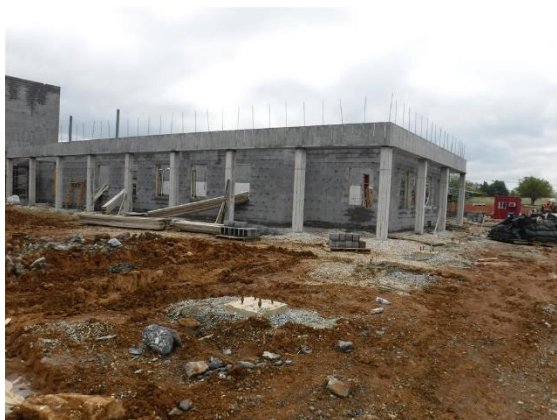
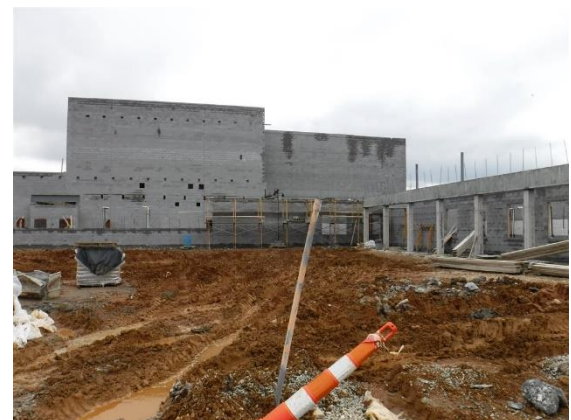
- w) The exterior walls around Area A are in place for the first floor. The exterior walls on the west side of Area D will be the next focus for masonry work as the concrete planks and slabs are added to the first floor of Area A.

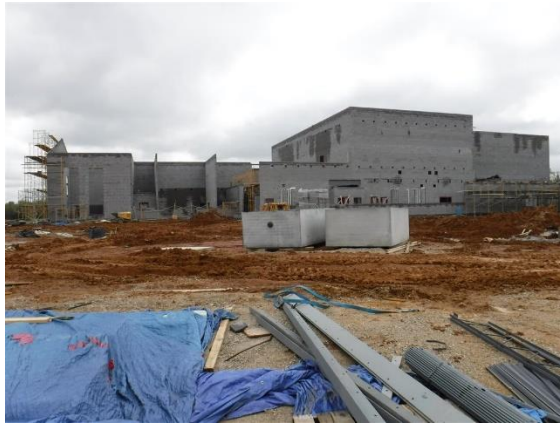
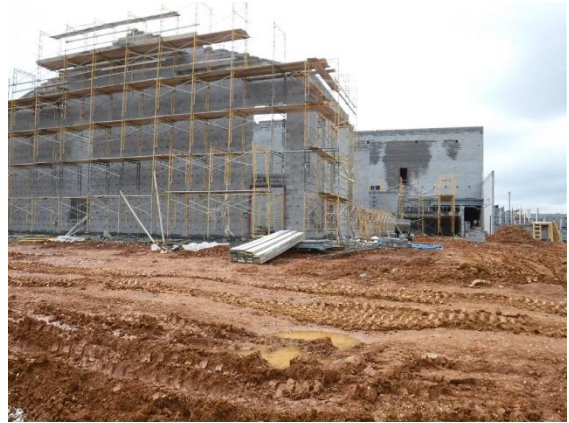
- x) The block walls enclosing the art and music classrooms on the west side of Area D will complete that area.

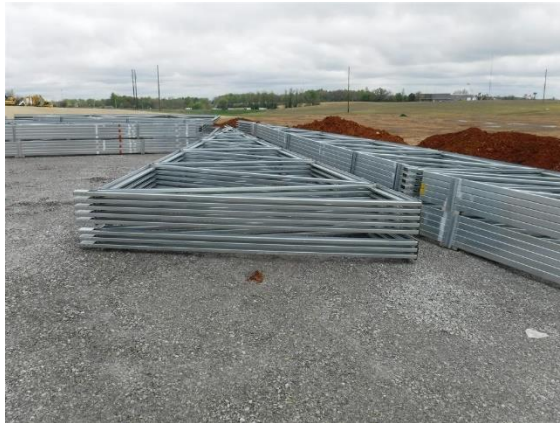
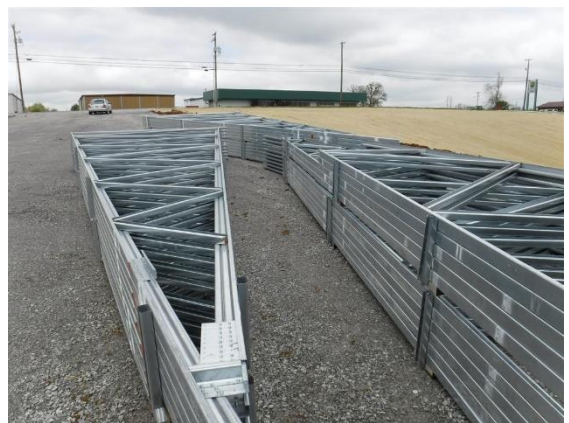
- y) Light gauge roof trusses are stockpiled on the gravel base for the parking area to the northwest side of the site.

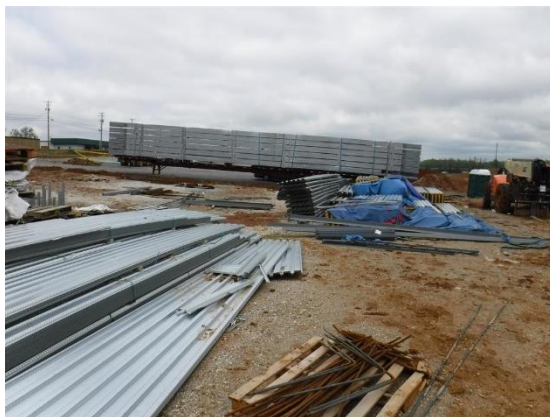
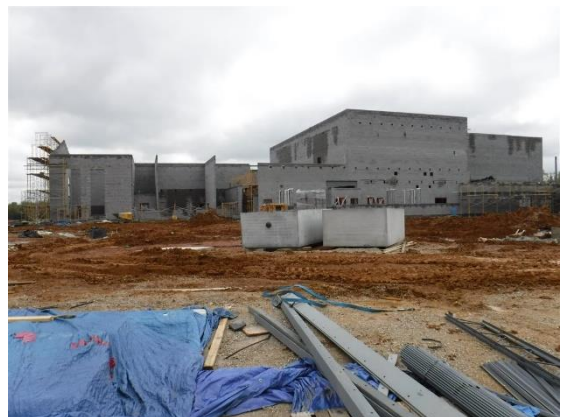
- z) Steel framing and metal deck is stored on site.

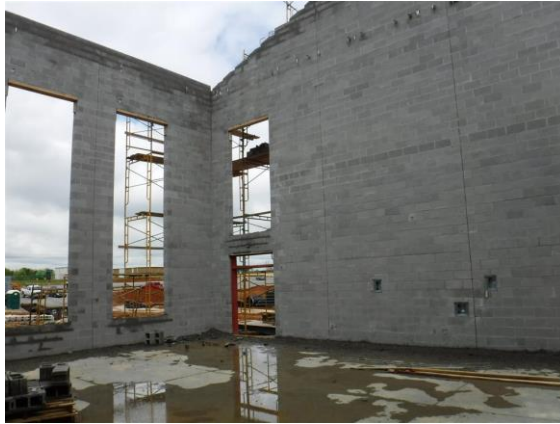
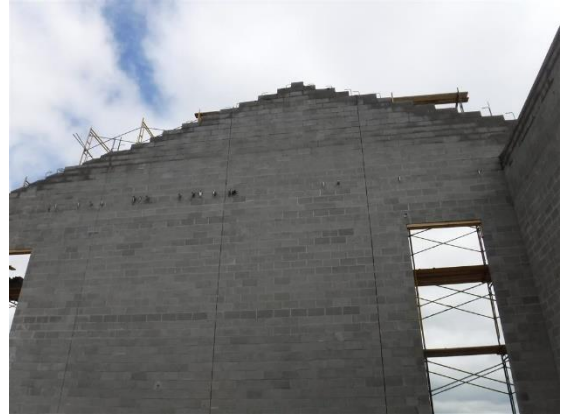
- aa) The block walls at the exterior of the Band Room are in place. The sloped beam at the top of the gable that defines the north end of the building needs to be formed and poured.

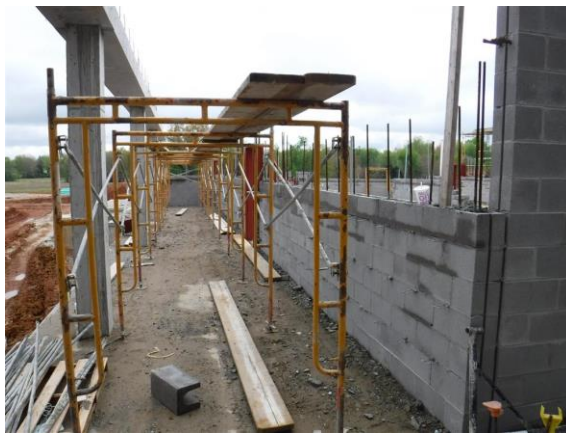
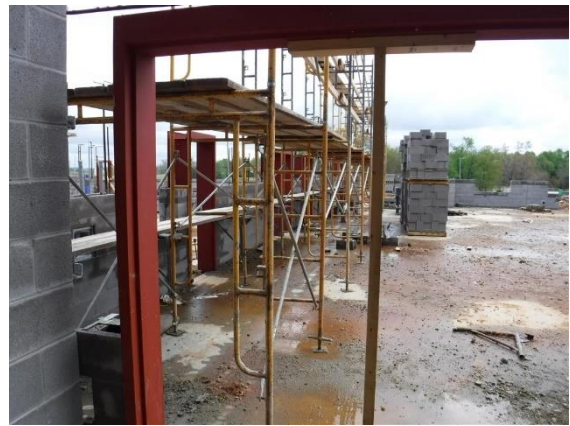
- bb) The blockwork in the Kitchen/Cafeteria area is lagging behind the other areas of the building. These can be laid when the second crew of masons are on site next week.

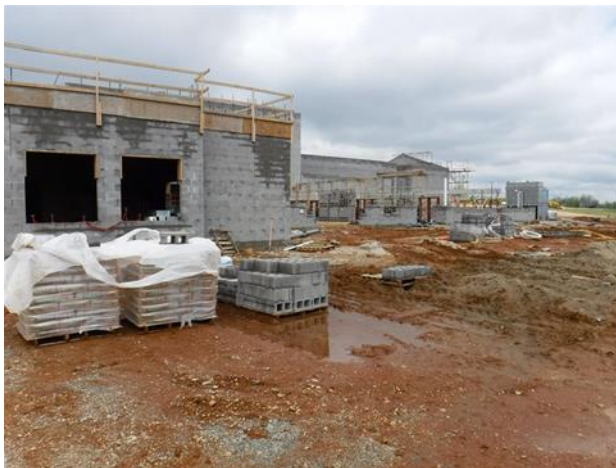
- cc) A view of Area C from another angle shows the work remaining to be done in that area.

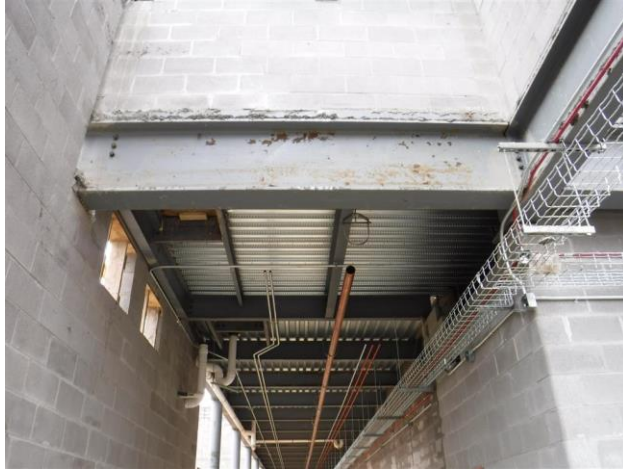
- dd) Steel members need to be cleaned to remove mud and repainted where primer is missing.
