FIELD OBSERVATION REPORT

Lincoln Trail Elementary School, Hardin County Schools, Elizabethtown, KY 201752 -CA8

Date: 4/24/2020

Report No: 21

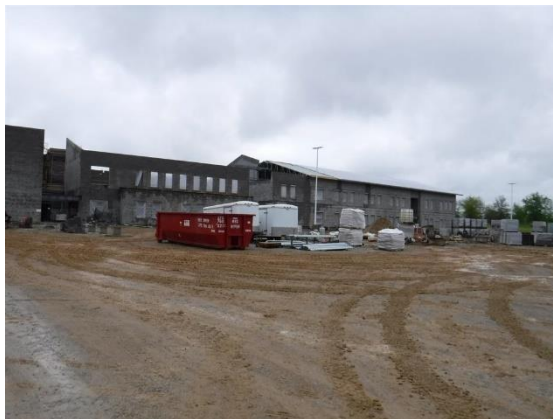
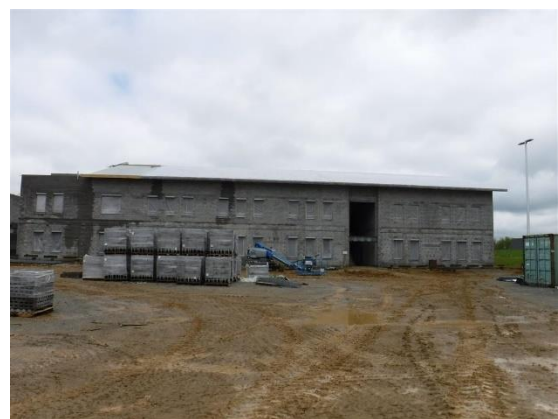
- b) The installation of the roofing system over Area C has begun. Zack Hadden, Garland Roofing's representative, was on site while the work was being done. The lower membrane and most of the rigid installation and the top membrane were installed before the rainy weather stopped work. Standing seam metal roofing will be installed over that. Zack issued a field report concerning his observations and expressed no concerns. Normally, the installation of the roof system is the signal that a project is about 50% complete. Once the light metal trusses and deck are installed over Area B and roof joist and deck installed over the Cafeteria and the Gym, the roofer will be able to move from Area C then to Area B and on to Area A. Of course, their work will depend on the weather.

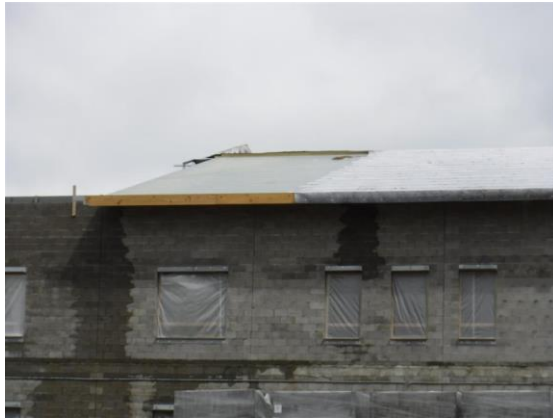
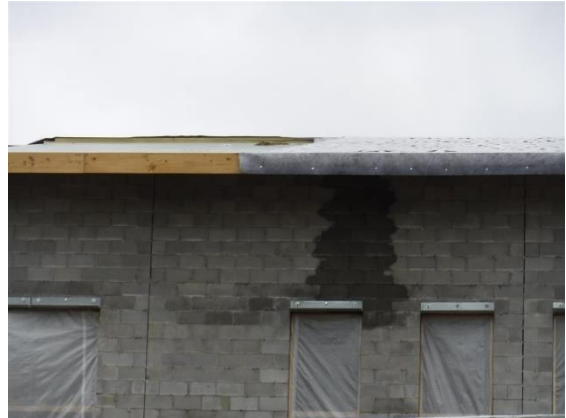
- c) When work was stopped on the installation of the roofing system, a seal was made at the edges so the rigid insulation would not get wet. The lower side of the top membrane was carried over the edge of the wood edge blocking and nailed in place. The lowest layer of membrane is showing past the insulation.

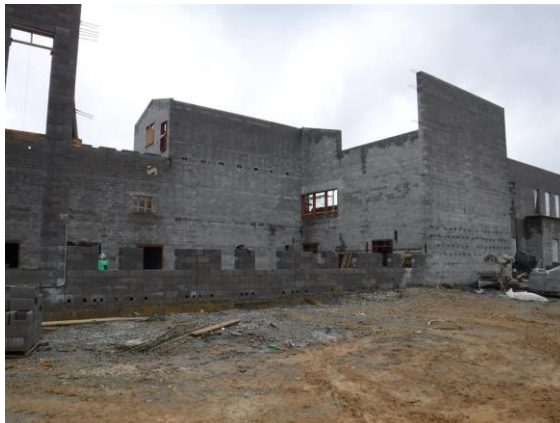
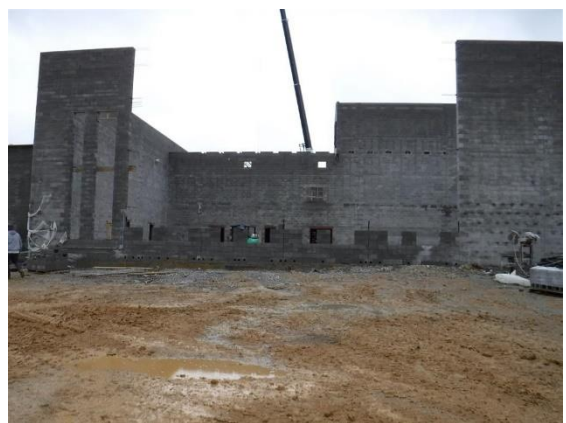
- d) When I arrived on site, the lower portion of the south wall for the Cafeteria had been laid. Through this opening the highest point on the building was visible. This is the structure that houses the upper mechanical room.

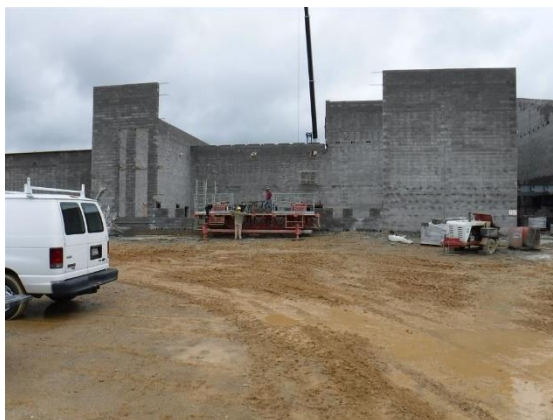
- e) As I was leaving, the mason had moved the Hydra-lift scaffolding system into place to lay the rest of the south wall of the Cafeteria.

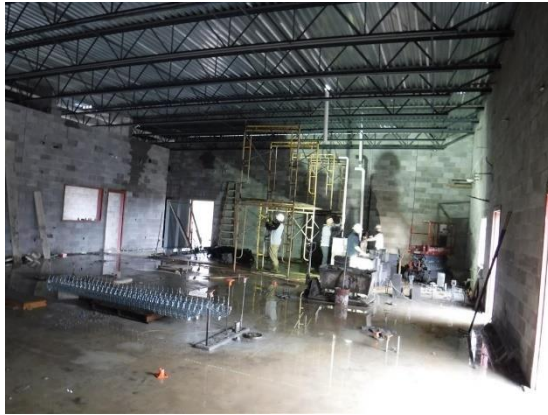
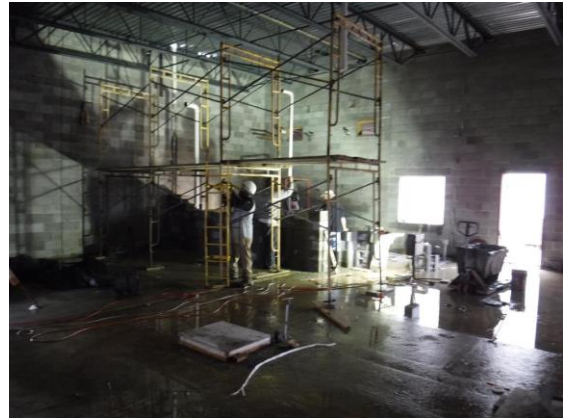
- f) The masons were laying block in the Kitchen while working with the plumber to install piping in the walls.

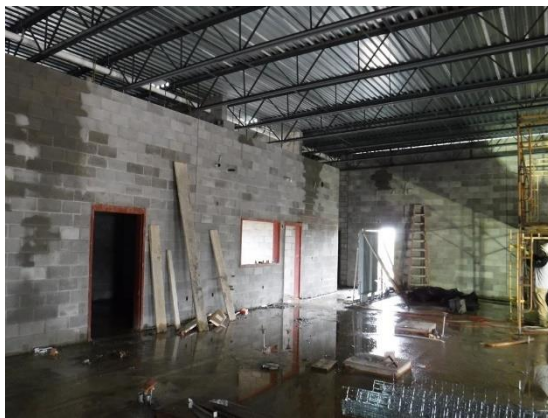
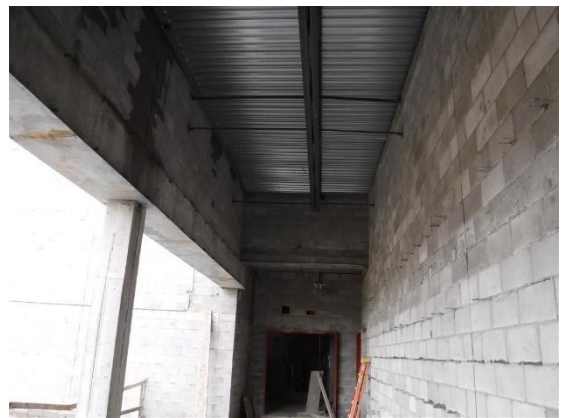
- g) Roof deck and joist are in place over the Kitchen and the Loading Dock. When the weather is dry, Gerald plans to have the roof systems installed over these areas. Most of the interior blockwork is in place along the west side of the Kitchen.

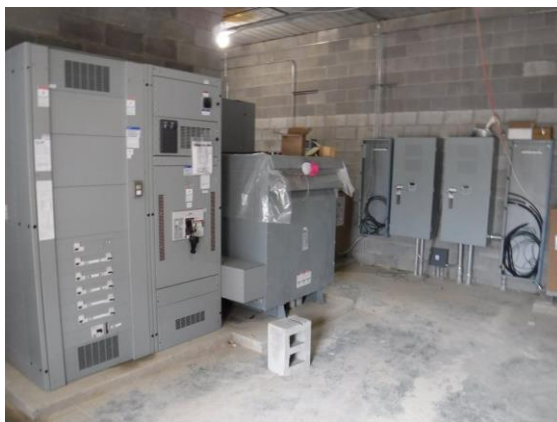
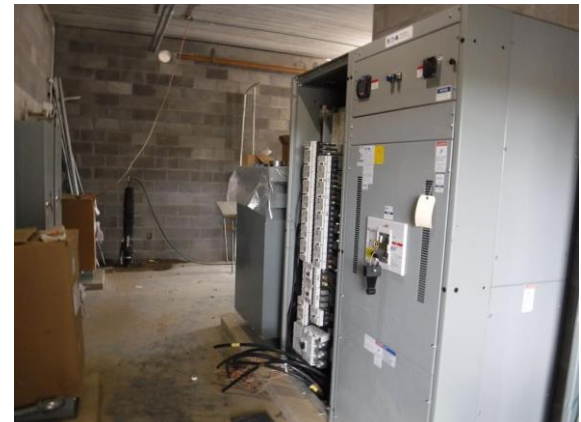
- h) Fortunately, the slab construction above the Mechanical Room kept this room with its moisture sensitive electrical equipment dry.

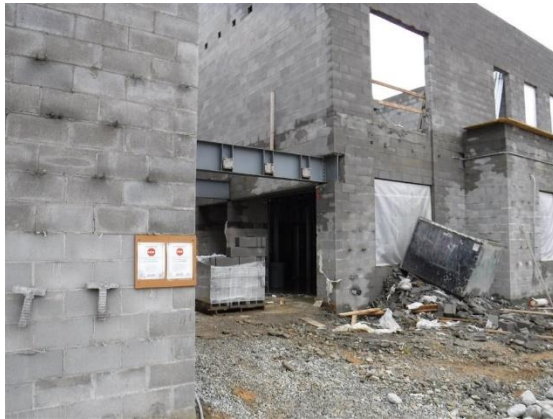
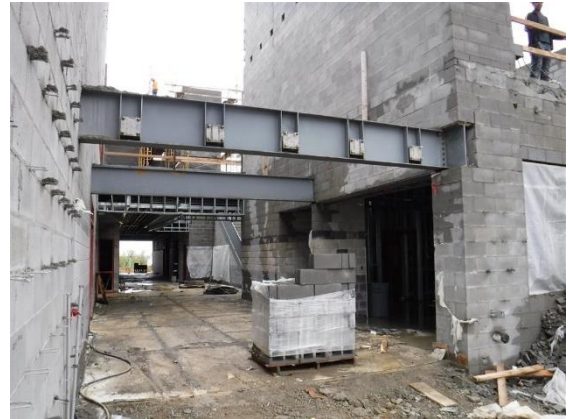
- i) The canopy attachment plates mentioned in Icon's report had been installed on the beam across the main entrance to the building.

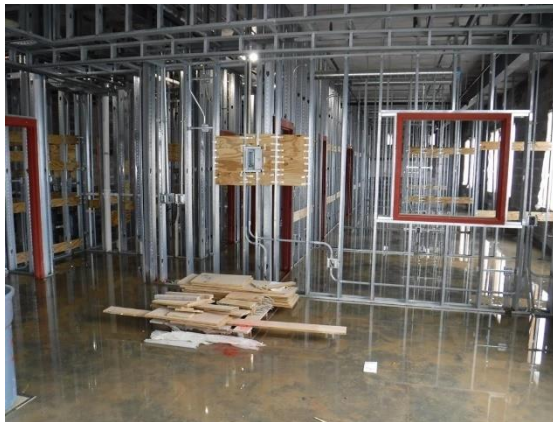
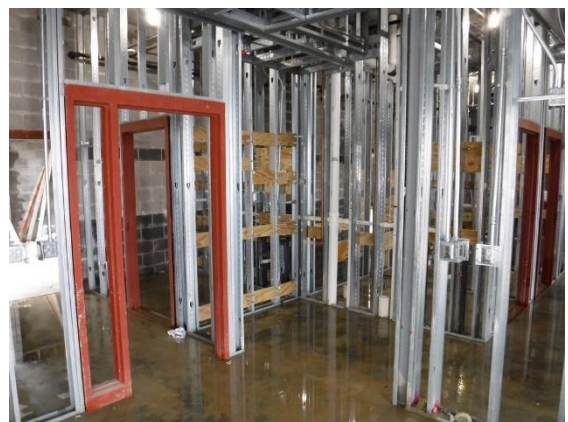
- j) The slab in the administrative area was covered with water. It did not appear that the wood blocking mounted to the steel studs had been affected by the water since it migrated to the slab from the main entrance and floor opening.

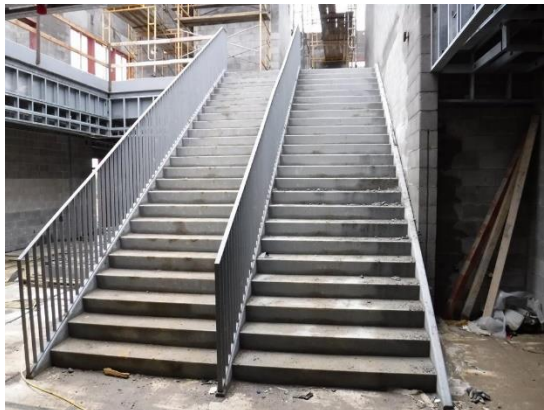
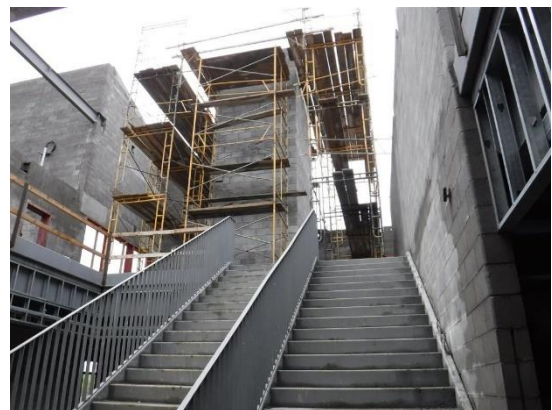
- k) The building is open to sky at the main lobby until the steel trusses and roof deck is installed over Area B. The elevator shaft has been laid up to the top. Metal floor decking and a concrete slab will be installed to seal the top of the shaft.

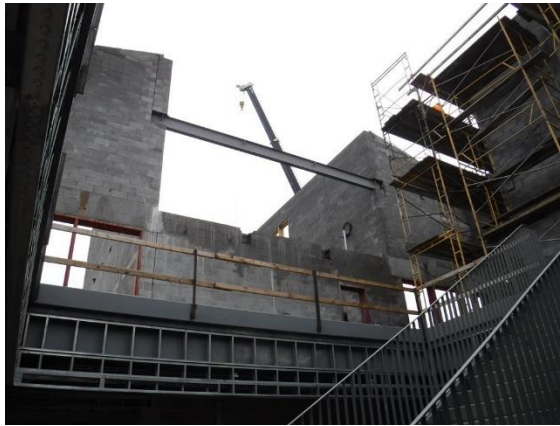
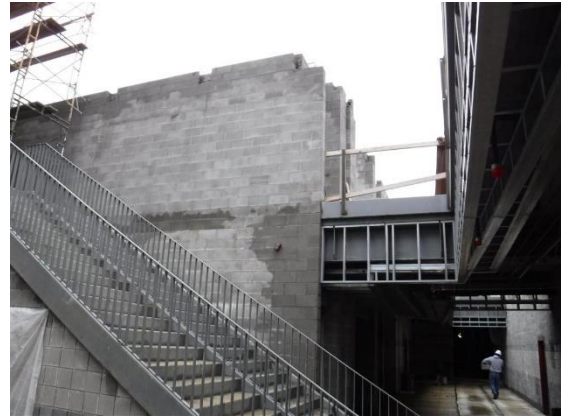
- l) The sloped top block walls are visible through the floor opening in the main lobby. The walls will be capped with concrete beams. When this, the steel framing and the mechanical platform deck and slab are in place, the trusses and roof deck can be installed over the area.

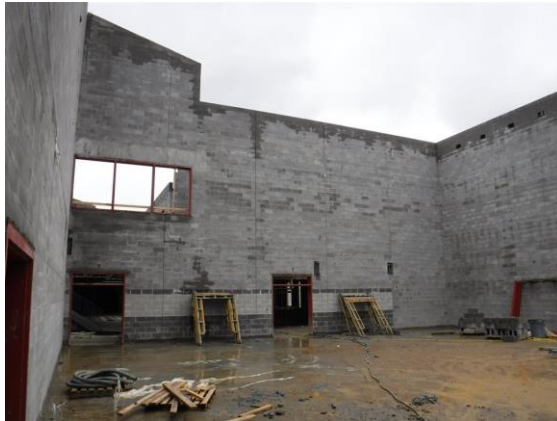
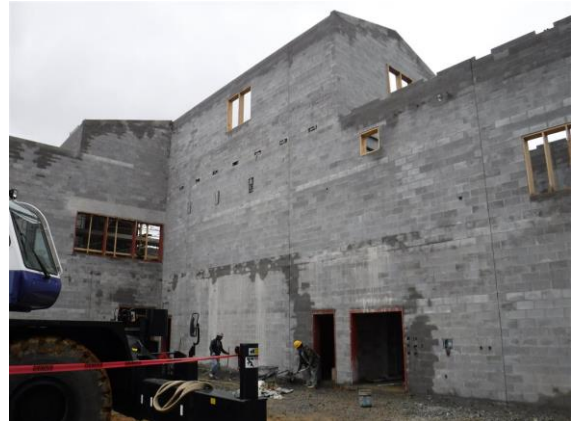
- m) The tops of the high walls around the Cafeteria and the Gym are in place. The upper mechanical room is clearly visible from the Gym. Mason helpers were cleaning the bottom of the gym wall where block was laid above.

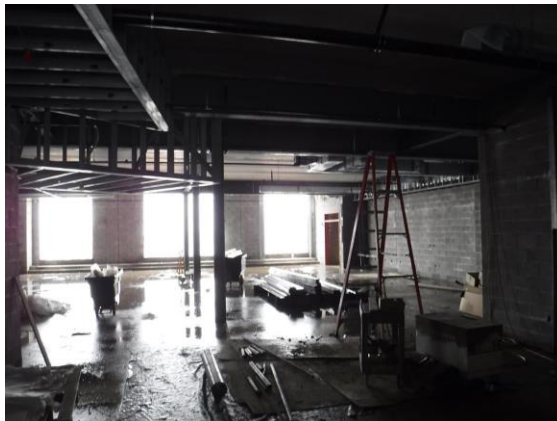
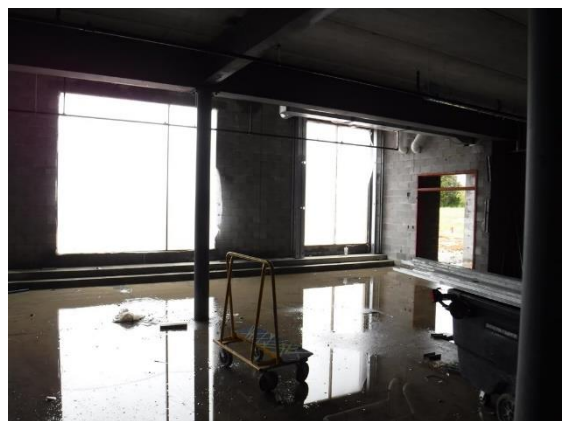
- n) The Library/Media Center had quite a bit of standing water from the storm.

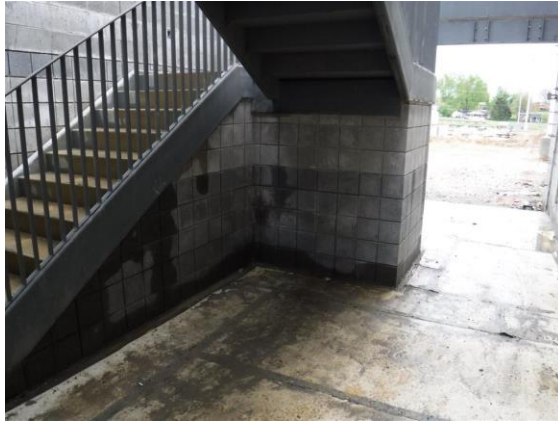
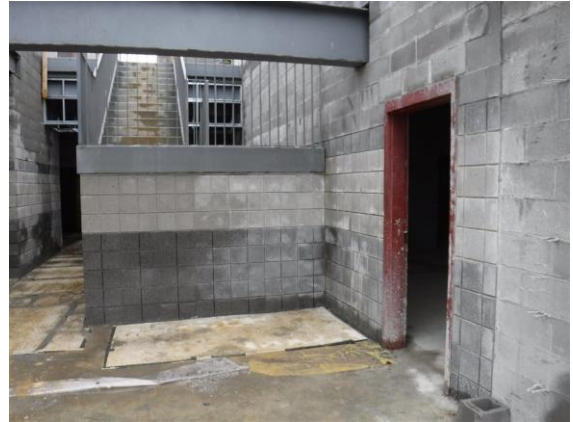
- o) The mason had completed the realignment of the ground faced block at the entry to the Family Resource Room and covering the wall below Stair ST-B with ground faced soaps.

- a. Keep as-built locations for site utility work up to date.
- b. Keep as-built locations of plumbing and electrical lines up to date.
- c. Maintain site silt control measures.
- d. Develop a plan to repair the ground face block.
- e. Develop a plan to repair damage to the floor slabs to be polished.

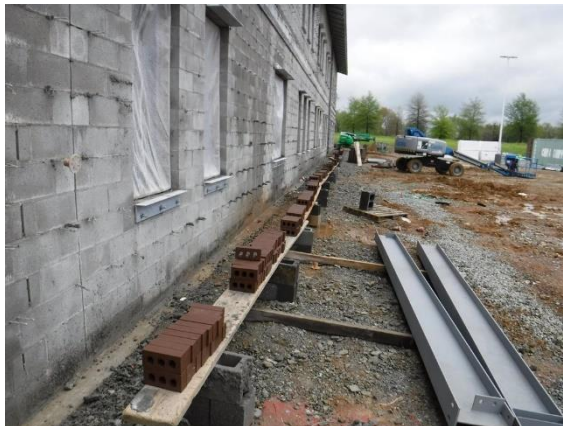
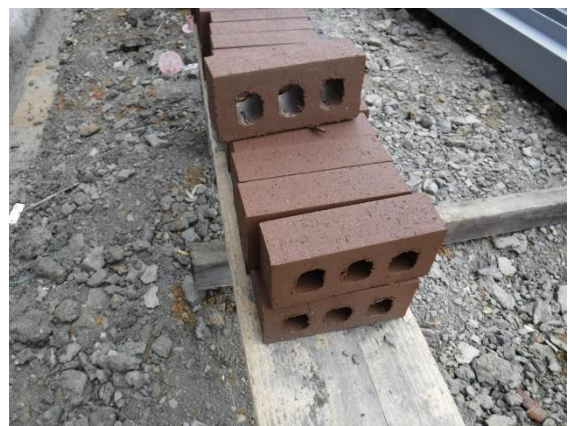
- p) Brick was staged at the south wall of Area C. Three courses of brick will be laid. These brick will be below grade and the base flashing. Spray foam insulation will be applied to the exterior block walls above the flashing.

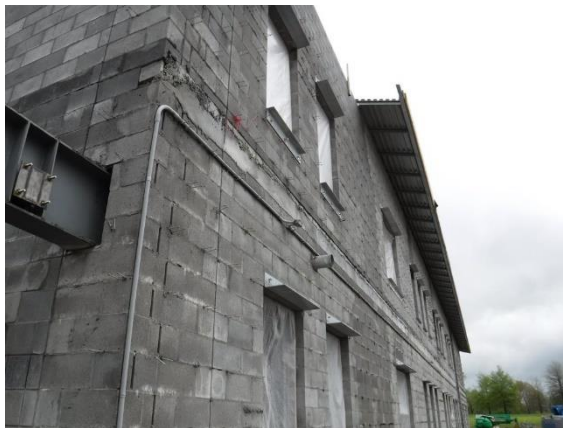
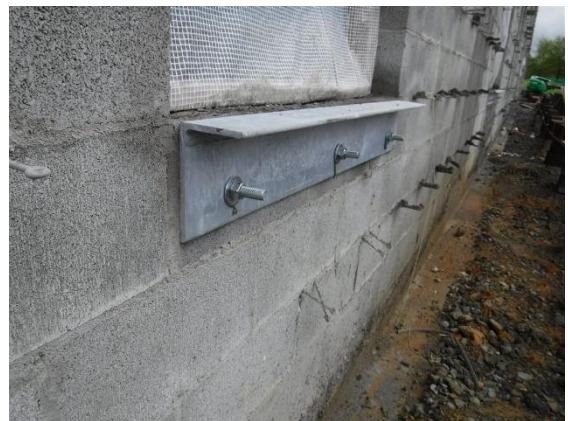
- q) The galvanized lintels and sill angles had been installed on the south face of Area C. Refer to the SPIN report for comments on this.

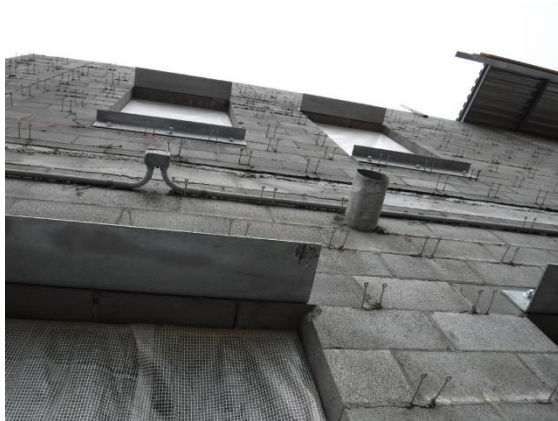
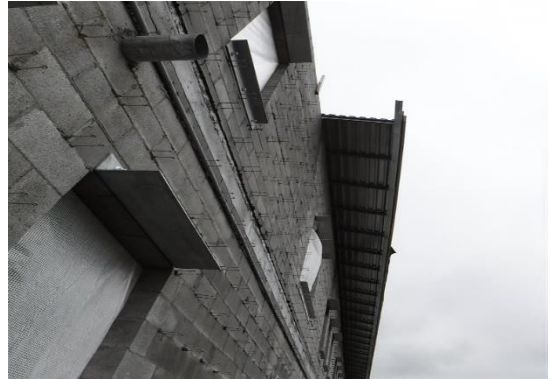
- r) The foam insulation will cover all but the eyes on the brick ties. The brick will set on the lintels and a through wall flashing.

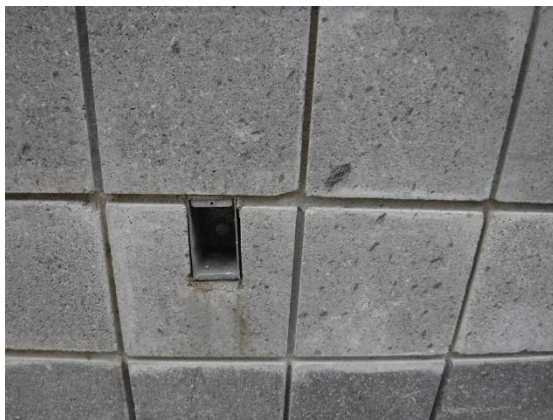
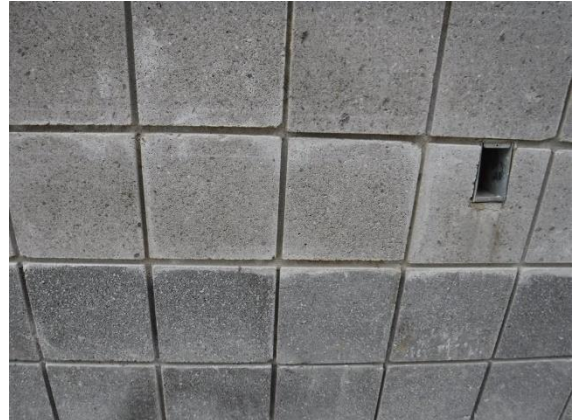
- s) If the joints and false joints in the split faced block are not filled with mortar, a considerable amount of repair will need to be made to the damaged block. Most of this is the result of chipped corners.

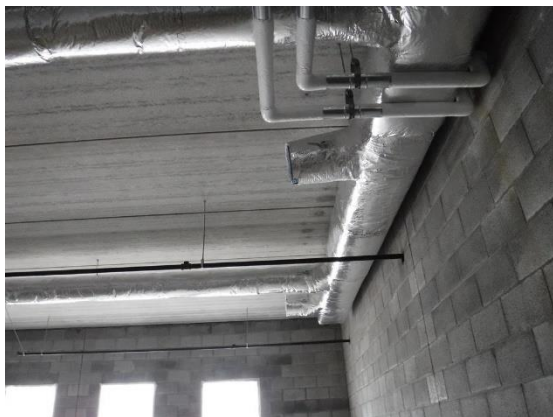
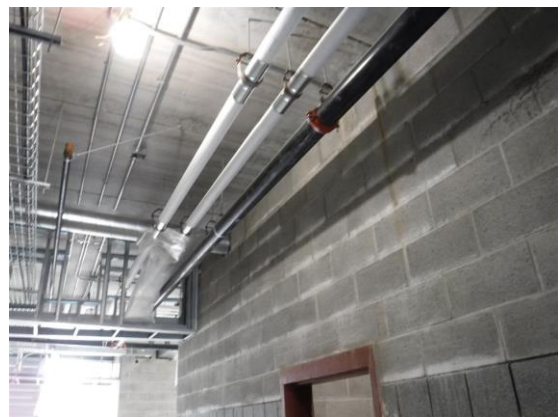
The mechanical/electrical and fire protection trades continue to install rough-ins. Water piping has been installed in the first floor and insulated. Some of the insulation have been covered with plastic to avoid water damage and some has not. If the insulation gets wet and damaged, it will have to be replaced.

- t) Ductwork and piping are insulated on the first floor. Gerald told the contractors that they either need to cover this with plastic or be ready to replace any insulation damaged by moisture.

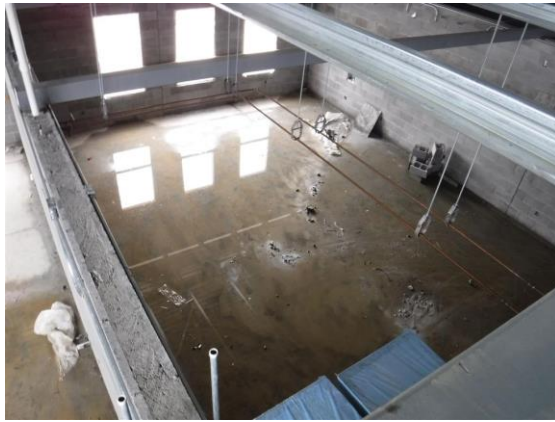
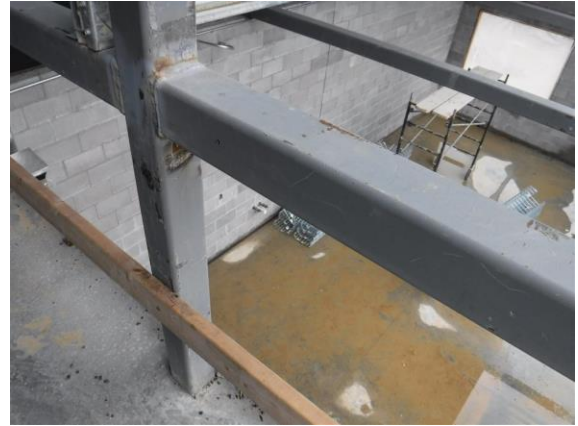
- u) Some of the floor slabs on the second floor of Area C are dry and some had standing water. The water migrates to some areas due to the open end of the floor areas. This will continue until the building is totally dried in.

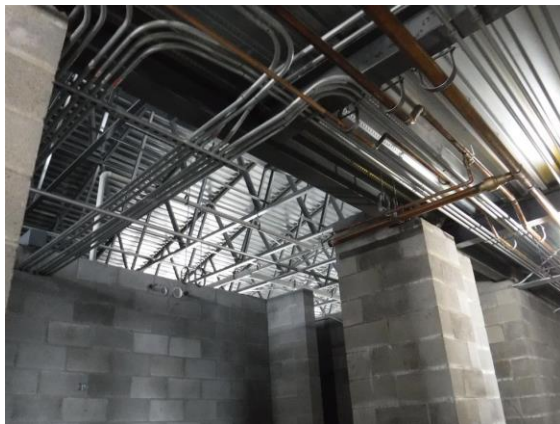
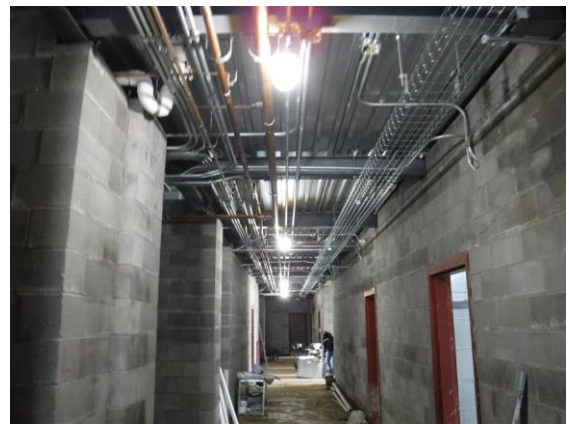
- v) A significant amount of the mechanical/electrical rough-ins are in place over the second floor of Area C.

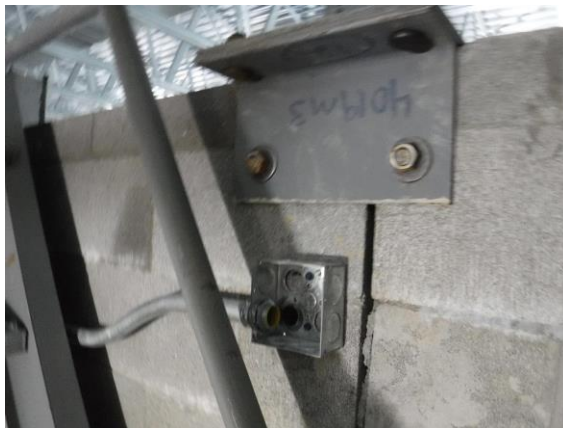
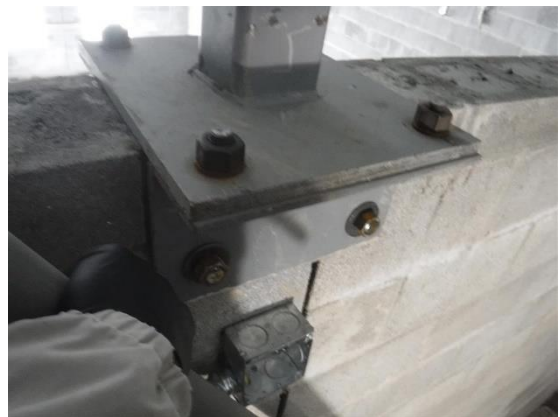
- w) This is the truss base plate mentioned in the supplemental instruction from Icon. If the edges and corners are rounded, there will be sufficient clearance. The electrical box may need to be relocated since it will be in the way of the handhold at the railing.

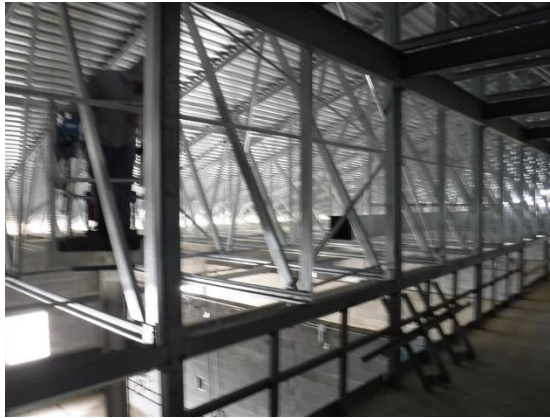
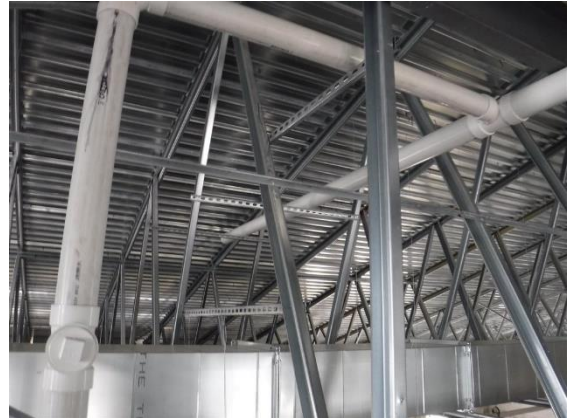
- x) Ductwork was being run through the trusses over the second floor of Area C.

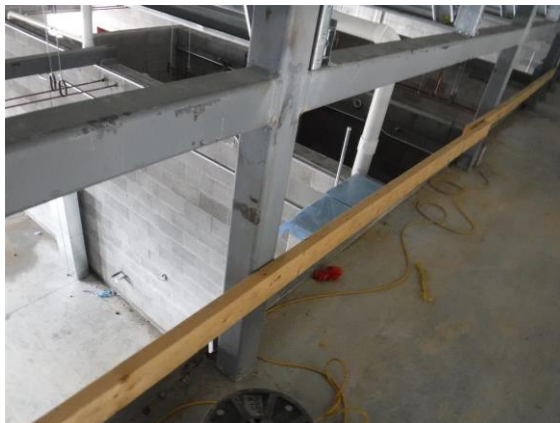
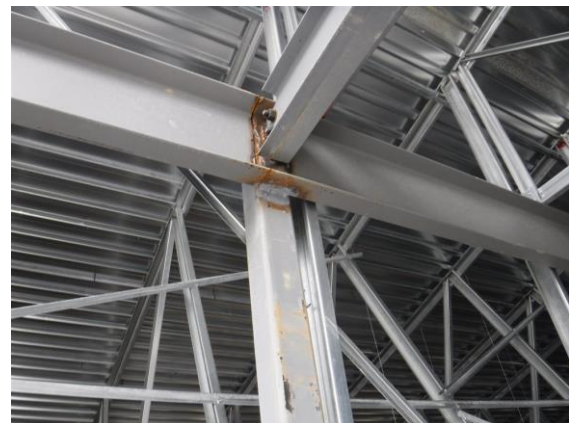
Work Gerald and I discussed during our call after my last visit was mostly complete on this visit. The most visible new work was the placement of roof underlayment and rigid insulation over Area C. This protects most of Area C from direct rain. That being said, parts of the first floor were fairly wet from driving rain entering at the open entrances and migrating back into the first floor rooms. The second floor was relatively dry. I did notice that most of the bottoms of the concrete planks were dry. All the moisture that has entered the building has taken a toll. Ferrous metals that are not completely primed are starting to rust. All the corroded ferrous metals need to be cleaned and repainted per

- y) There is a significant amount of missing primer on the steel allowing rust to form. The rust must be removed and the primer repainted per the scope in the steel trade contract.

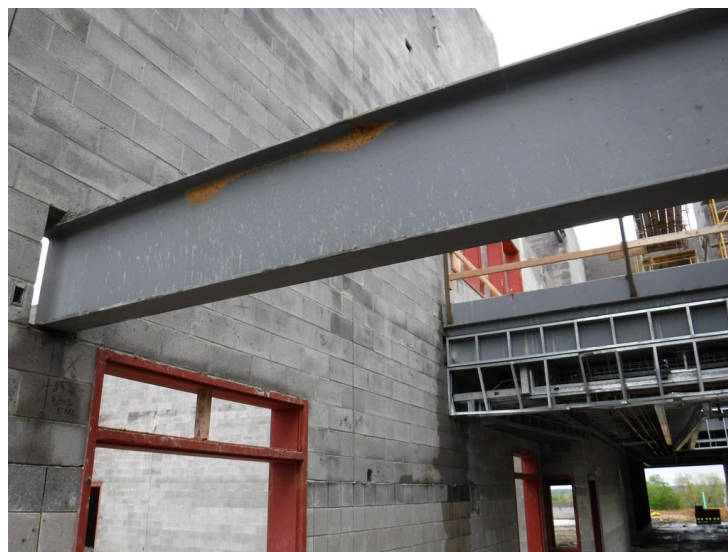
the scope of work for the trade contractors. Another result of the rainy weather is mud appearing on structural steel and the roof trusses as a result of the material being stored on the muddy site. With the building quickly becoming enclosed, the mud needs to be washed off the steel as soon as possible.

- z) The steel framing needs to be cleaned. Mud is visible on some of the members. This must be done before any finish material would be affected by the cleaning process.

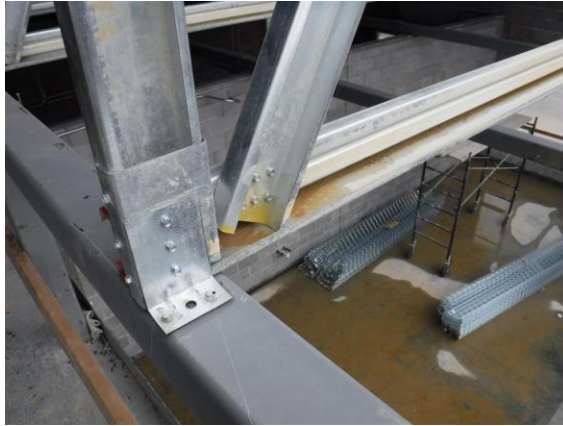
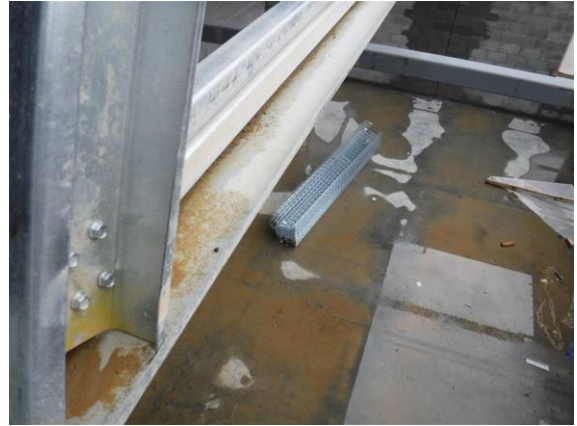
- aa) The roof trusses need to be cleaned. Mud is visible in several places on the framing. This must be done before any finish material would be affected by the cleaning process.

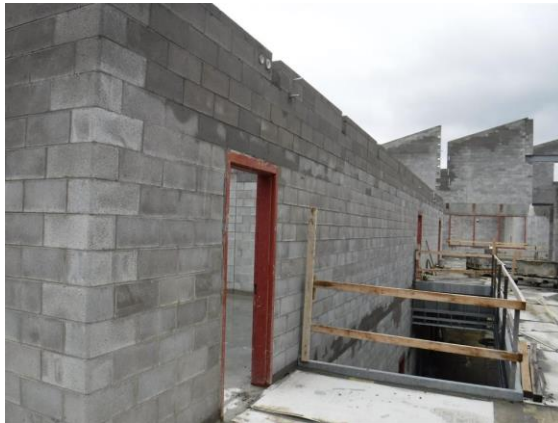
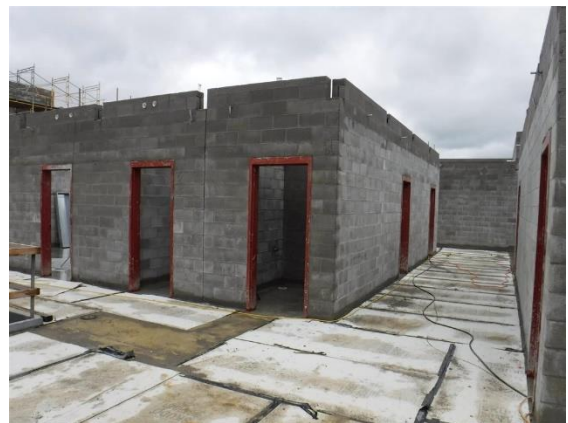
- bb) Interior block walls on the second floor of Area B are mostly complete. The mechanical platform will be placed at the tops of the walls after the steel is placed. Gerald said the Skudo protection system has been repaired in places where it is dislocated.

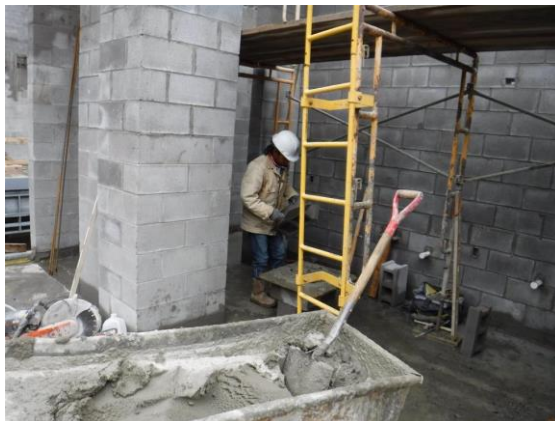
- cc) Masons were completing the last of the interior walls on the second floor of Area B. They still need to build block chases around the vertical ductwork in the corners of the rooms.

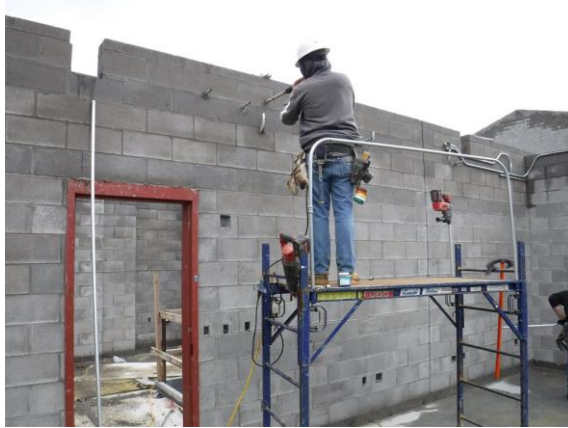
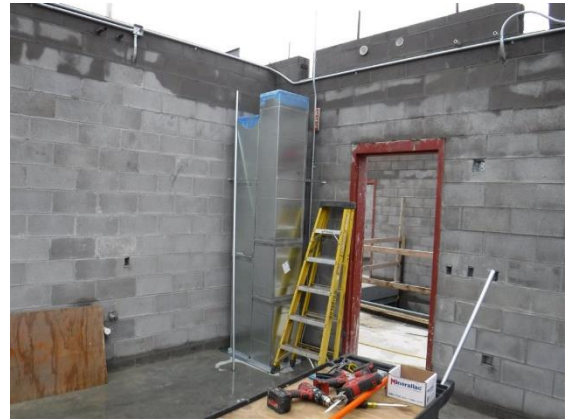
- dd) Electricians were installing conduits in the rooms on the second floor of Area B. The ductwork that will be in chases serving the first floor are in place. The chases will be constructed with block.

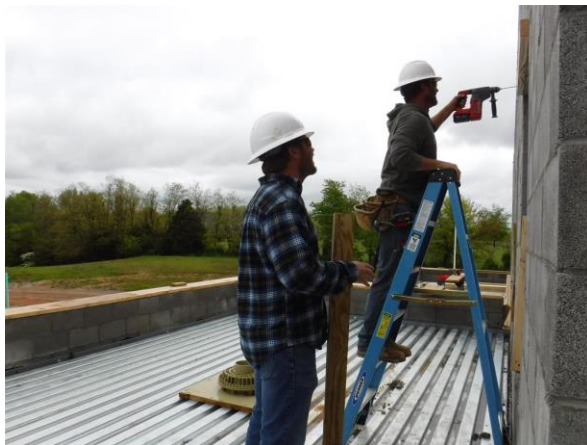
- ee) Carpenters were installing pressure treated wood blocking at the window heads over the low roof areas. These areas will receive the fiber cement panels system.

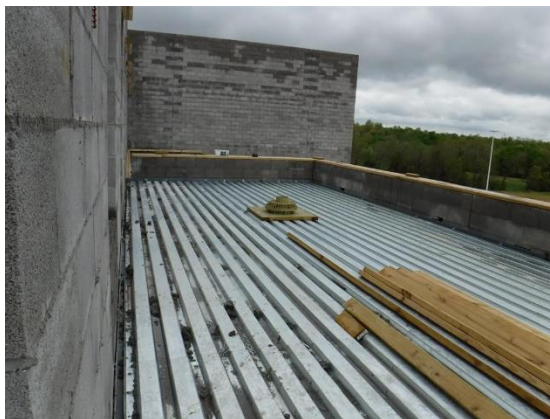
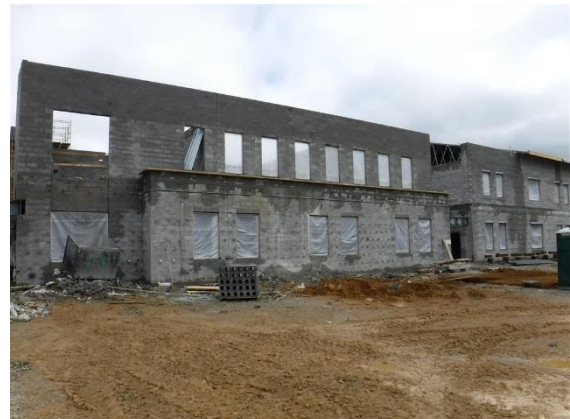
- ff) Pressure treated wood blocking has been installed on top the parapets at the low roof areas.

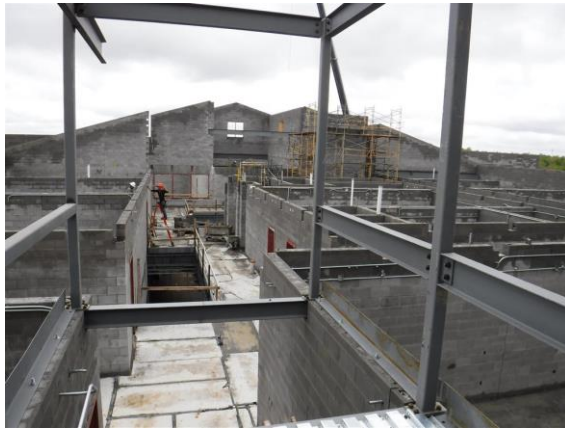
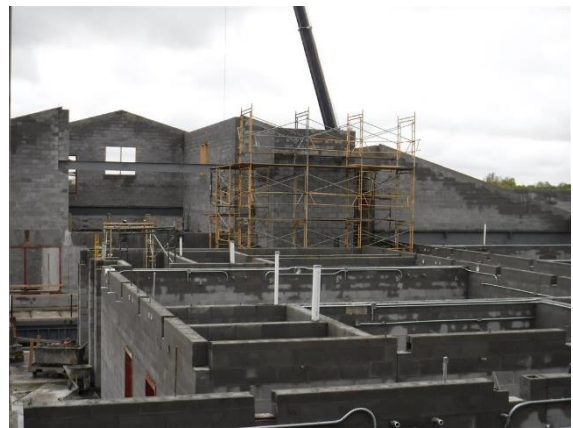
- gg) From the mechanical platform, the tops of the classrooms walls in Area B are visible as are the gabled walls at the east side of Area A and the peak of the upper mechanical room wall. The mechanical platform will be installed on the tops of the classroom walls extending it to the upper mechanical room.

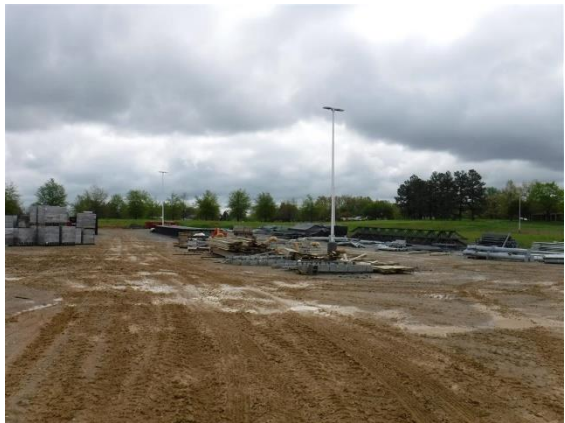
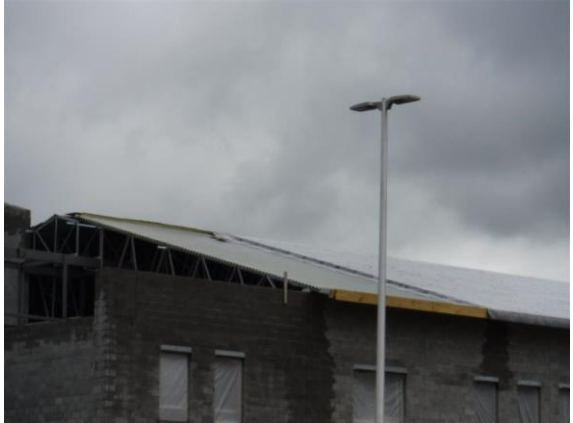
- hh) The site lighting poles and fixtures are in place. They are protected by a concrete base. Care needs to be taken when moving construction equipment around the site so that these poles are not damaged.

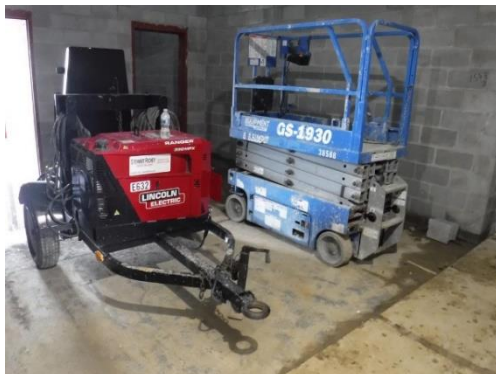
- ii) A welding trailer and lifts are located on the second floor. Gerald said that he stressed that care must be taken when moving these to avoid damage to wall, door frames and other materials in place.
