FIELD OBSERVATION REPORT

East Hardin Middle School, Hardin County Schools, Elizabethtown, KY 201752.01 -CA8

Date: 6/4/2020

Report No: 24

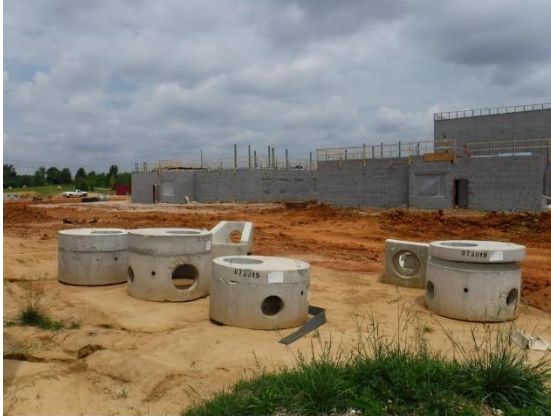
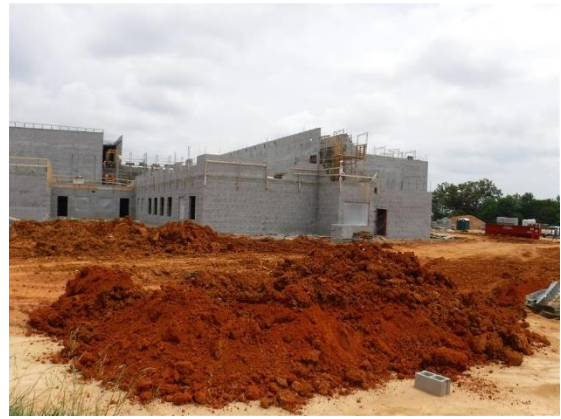
- b) New work visible from the office trailer includes the new slab edges over the classroom wing in Area A, the temporary wood railings around Area A and the blockwork on the second floor of the classroom wing at Area B. Until the rain came as I was leaving the site, the site was dry making it possible to do some grading.

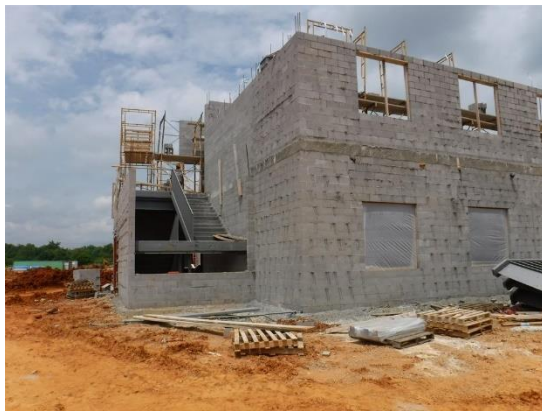
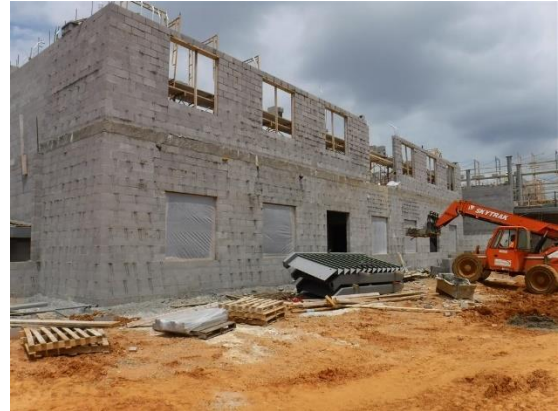
- c) From the rear of the site, the window openings on the second floor of Area B are now visible. The exit stair is visible at the end of the wing. The exterior block will be covered with brick.

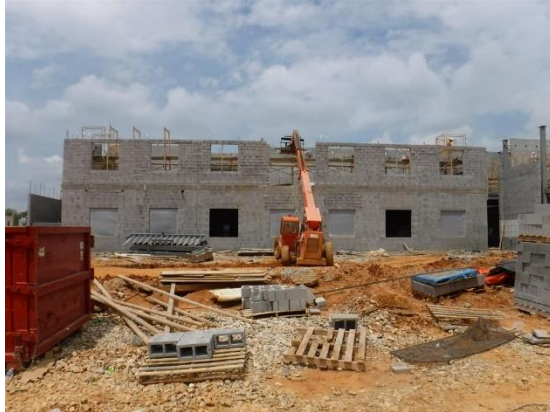
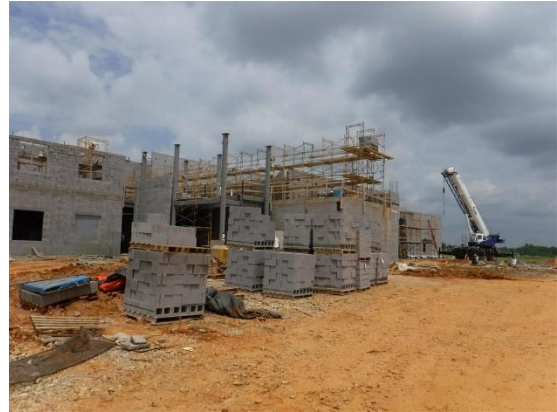
- d) As the rear of the classroom wing transitions to the rear main entrance, work is progressing to tie this area into Area C including the Cafeteria and the Kitchen.

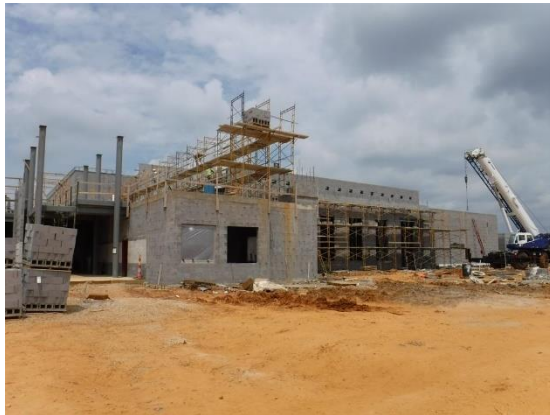
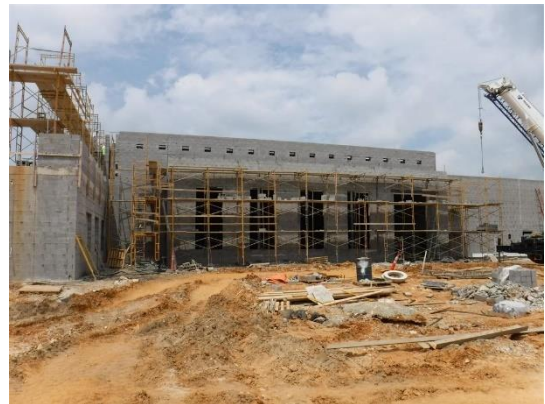
- e) From the rear of Area B, the Cafeteria is visible. Masons were laying block in this area to tie Areas B into Area C.

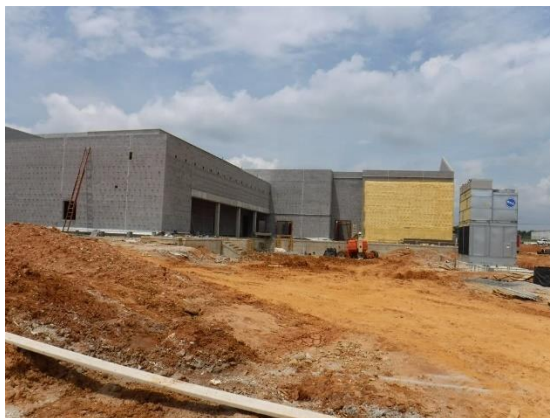
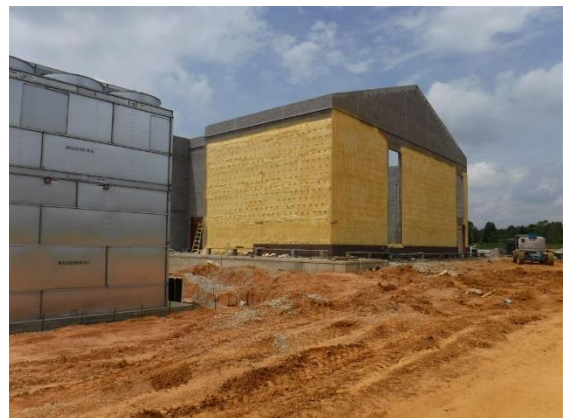
- f) To the other side of the Cafeteria, is the Kitchen and loading dock. Beyond that is Area D containing the music rooms. The exterior walls of Area D are being covered with brick over the spray foam insulation. These areas are one story tall allowing the brick to be laid to the full height.

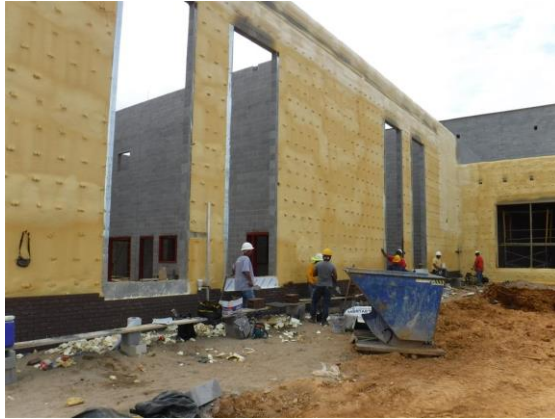
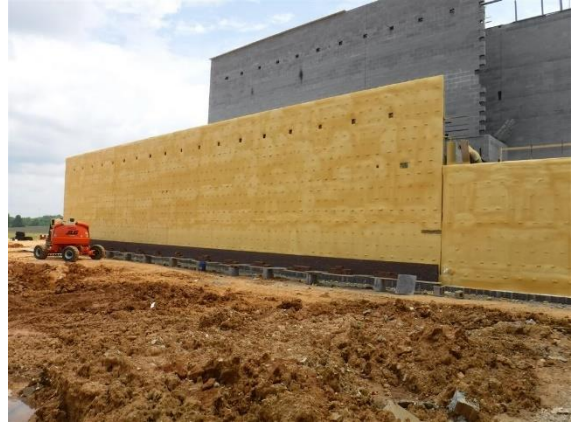
- g) Masons were laying brick at the front of Area D for the music rooms. The large opening are windows. The blank wall is the exterior of the PE locker rooms and storage.

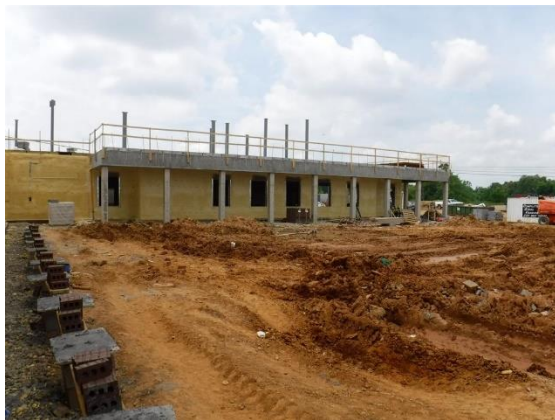
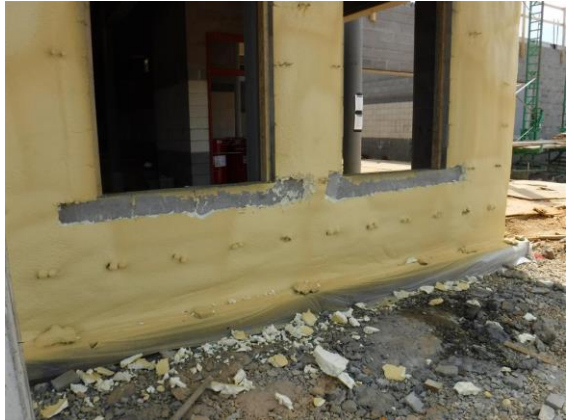
- h) The administrative offices are on the first floor of Area A and will be covered with brick. The exterior walls had been sprayed with foam insulation. Metal angles are installed at the window openings to attached the windows and terminate the insulation. The foam is removed to attached the window sill flashing and repaired after the flashing is in place.

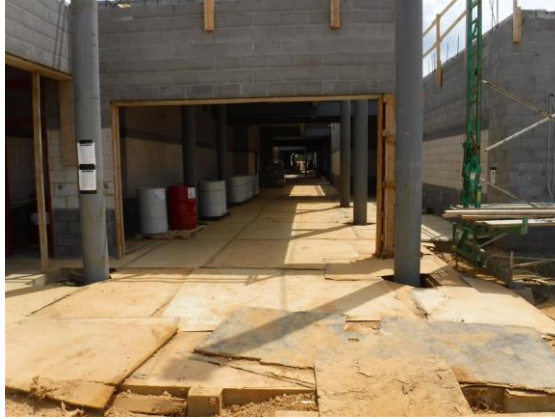
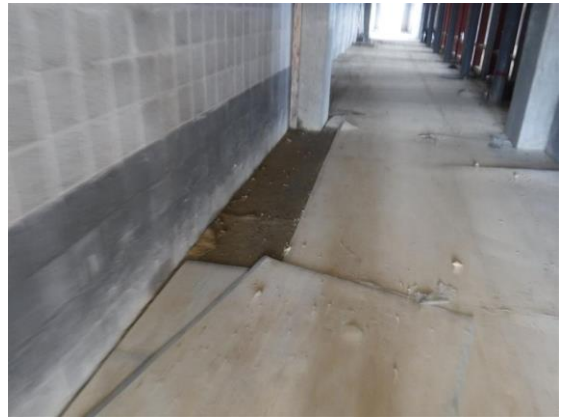
The Skudo system still needs to be reinstalled over the main corridor.

- i) At the main entrance looking down the main corridor, several of the Skudo protection board top sheets were displaced. In some areas the top sheet is completely displaced. The slab should still be protected by the bottom layer, but the full system is needed to insure protection of the slabs to be polished. Another reason to make corrections is the undulating nature of the top sheets once the system has been forced to move by construction traffic.

- a. Maintain the Skudo system so that it protects the corridor slabs.
- b. Clean mud off of steel, and reprime areas where the primer was scraped off of the steel.
- c. JRA is reviewing the wall detail at the curtainwall window at the stair in Area B.
- d. STW is reviewing the routing of piping and the cable tray in Area A near the stair at the Gym.

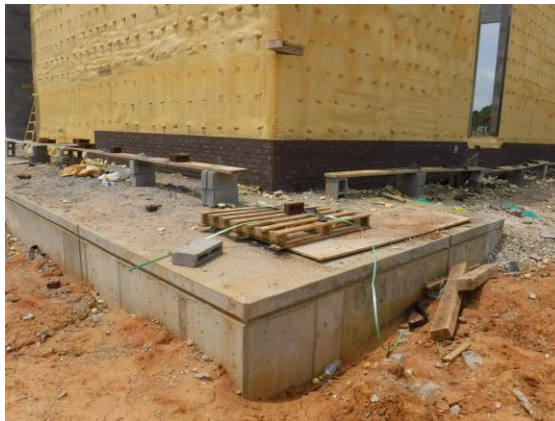
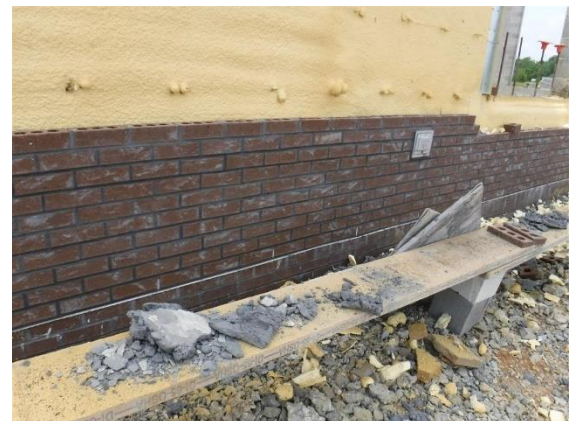
- j) Where brick had been laid up to the window sills at the end of Area D, the brick had not been cleaned but I observed that the brick was in plane and the joints were even.

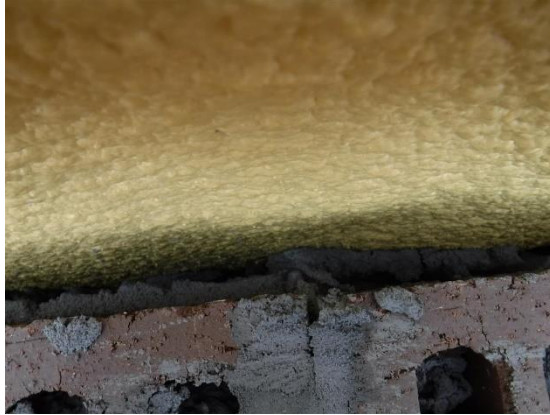
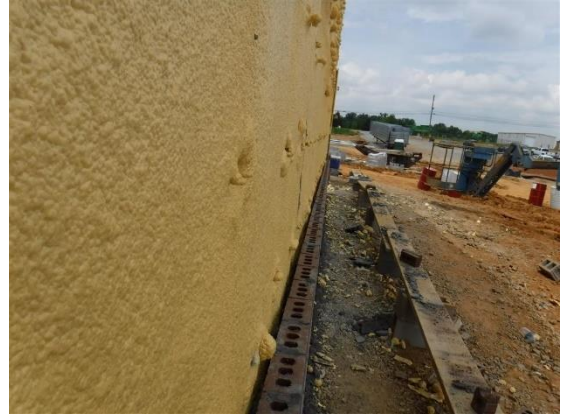
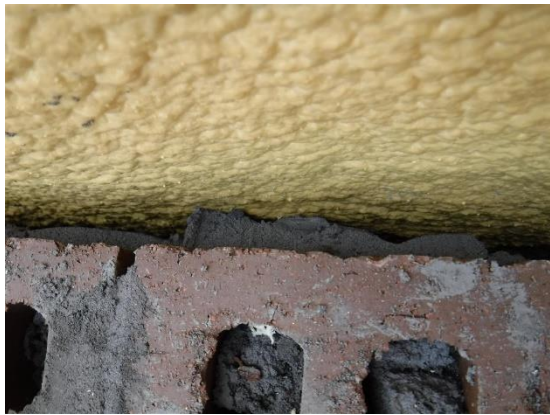
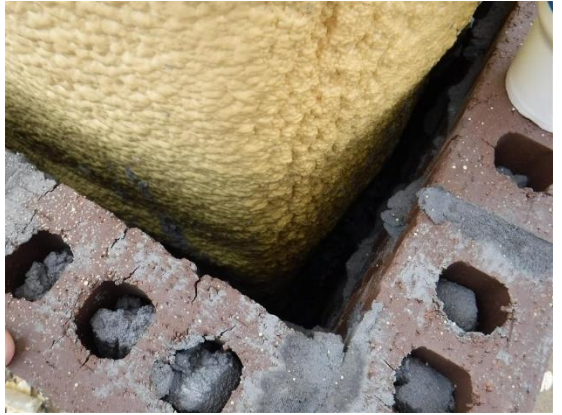
- k) Upon closer examination of this wall, I observed that the 1-3/4" wide brick cavity was filled either with mortar or foam insulation. The cavity must be open to allow for drainage and drying of the inner parts of the exterior wall. Mortar bridging can force water the in the wall toward the insulation and perhaps find a weak point where it would then enter the building. Doyle and Jerry, the masonry foreman, said that spray foam insulation foreman did not watch his installer closely enough. Jerry said that he would take corrective measures to make sure that the cavity was open in all areas. Note that as the cavity turns the corner it is more open.

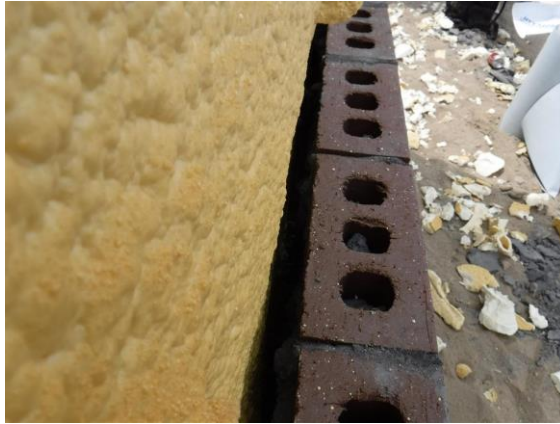
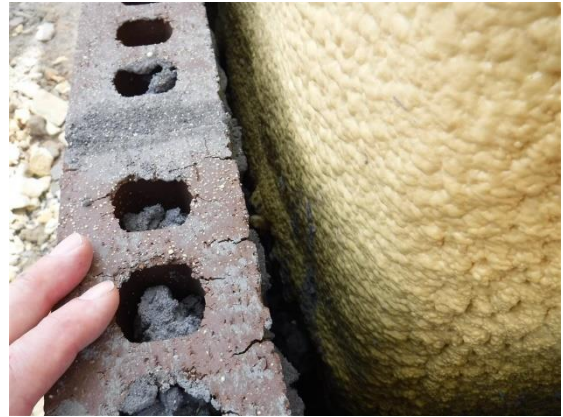
- l) At the front of Area D, the cavity was more open even though it was not the full 1-3/4" in width. It is important that the insulation is on average 3". Some variance is expected due to the nature of the spray foam insulation expanding.

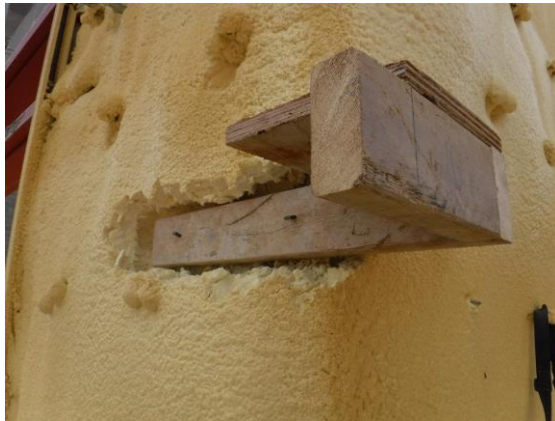
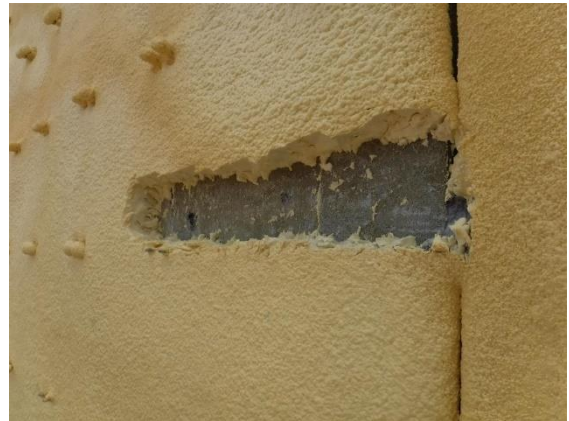
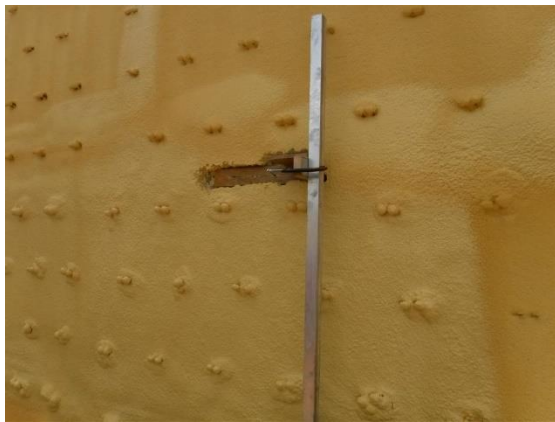
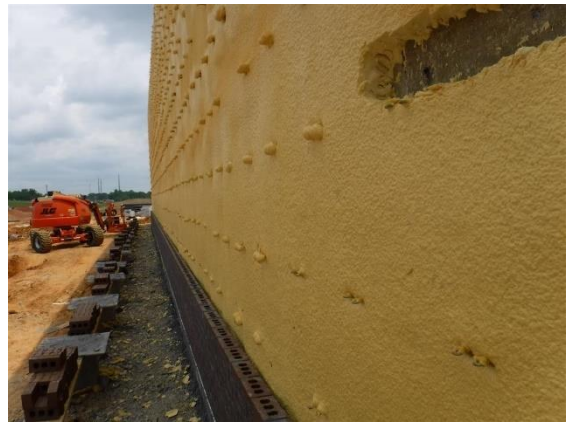
- m) As was the case at LTES, the foam insulation had to be removed to attach outriggers to block for string lines and story poles. The mason contractor reported that they will use the same insulation material and sprayer device to make repairs. These repairs need to completely fill the holes in the insulation.

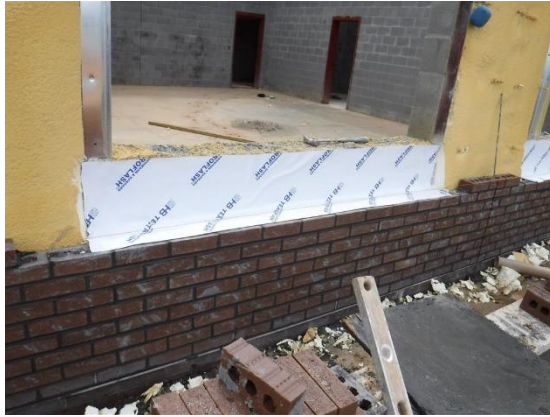
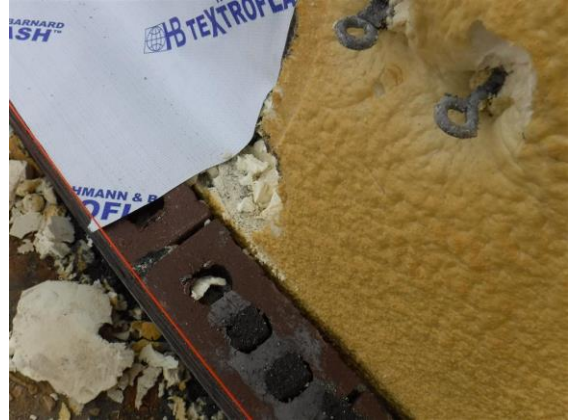
- n) A membrane through wall flashing is required at all places in the brick wall where water can enter the system such as at a window sill. The flashing carries the water to the face of the brick through weep holes or vents. For the flashing to work properly, end dams must be installed at both sides of the flashing. These are pieces of the membrane turned up into the vertical brick joint. Jerry said they he fully understands this and will install end dams at every location required. Before the brick covers the flashing, 3" of spray foam insulation must be applied to provide continuous insulation and vapor barrier.

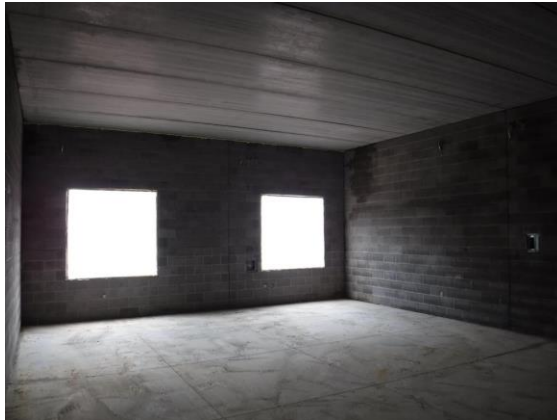
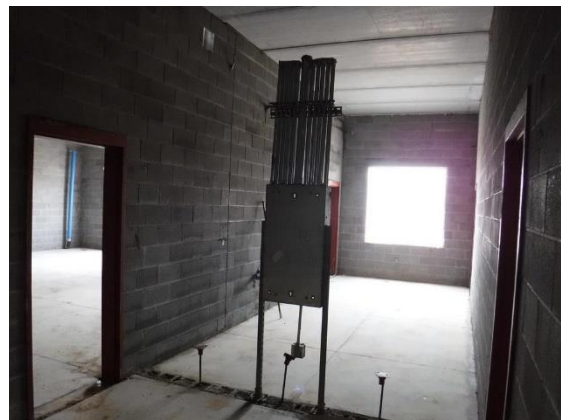
- o) With the planks over the classroom wings in Area A, there are several places where MEP trades can be installing rough ins.

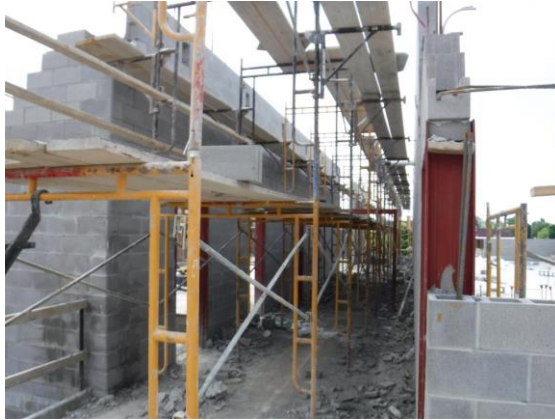
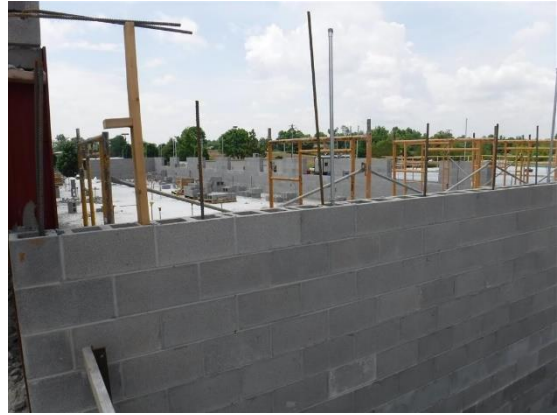
- p) The walls for the second floor classroom wing are being laid and include grouted steel reinforcement, hollow metal door frames, plumbing piping and electrical conduits. Openings for ductwork are formed as the block is laid.

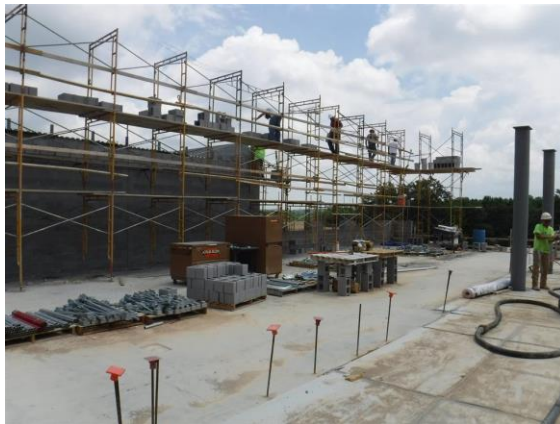
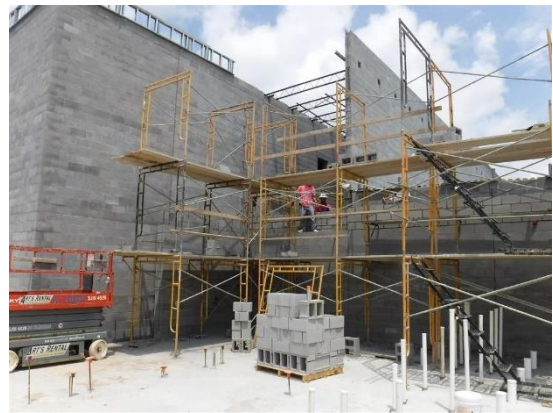
- q) Block walls opposite of the classroom wing are being laid up to roof level. These walls tie into the walls at Area C around the Cafeteria.

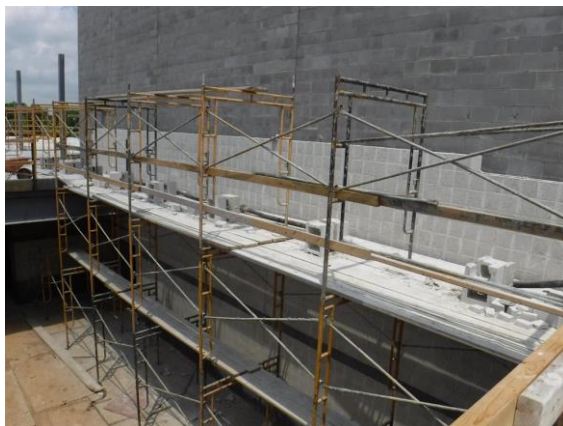
- r) Ground faced block is being laid at the Gym/firewall. This is the location of the large open stair in the middle of the building.

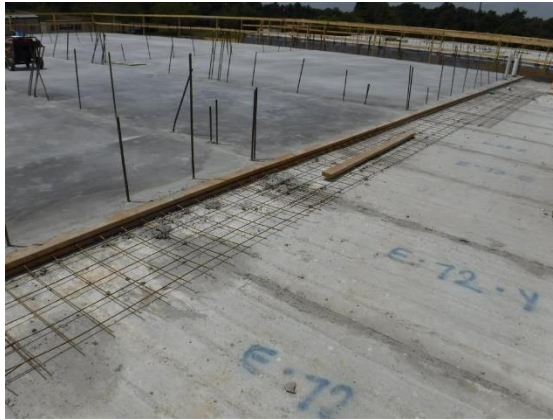
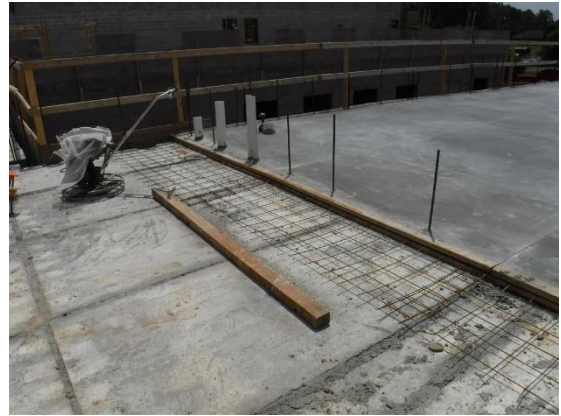
- s) The topping slab has been poured over the concrete planks for the classroom wing in Area A that is closest to Area B. The edge form consists of two 2X4's and 2 spacers totaling about 4" in depth. The slab is consistently about 1/2" below the top of the form. The slab is indicated to be 4" thick on the plans.

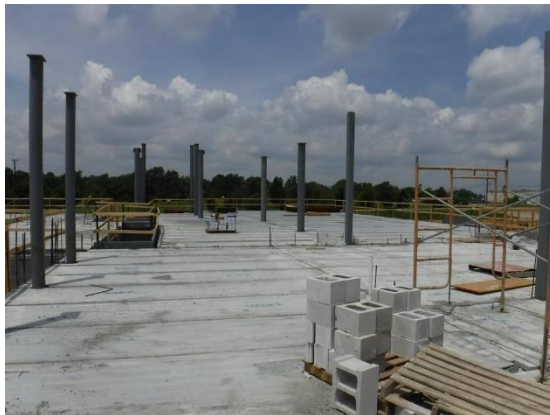
- t) The rest of the second floor topping slabs are scheduled to be poured over the next two weeks.

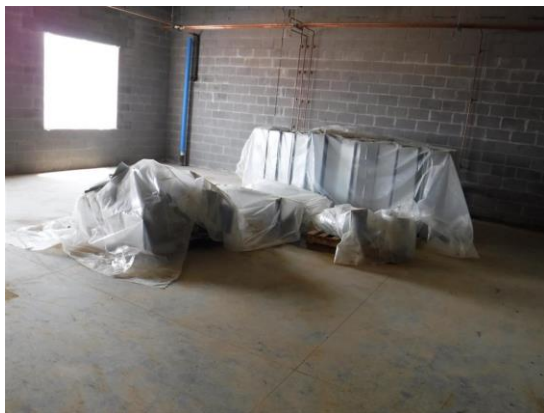
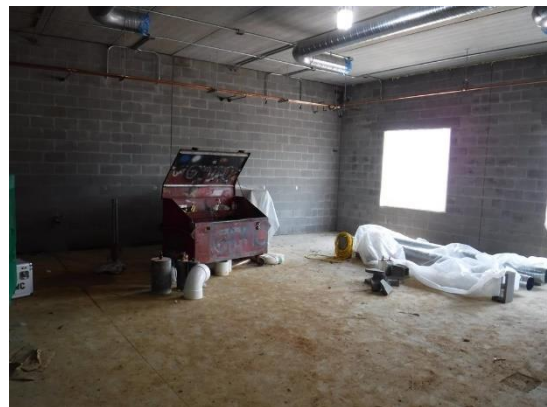
- u) Ductwork stored on the floor was covered and ends of ducts were sealed with plastic.

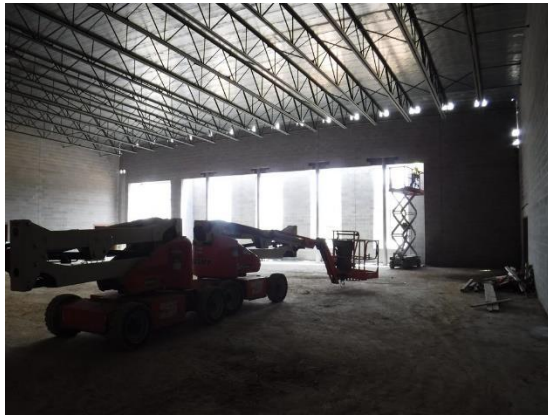
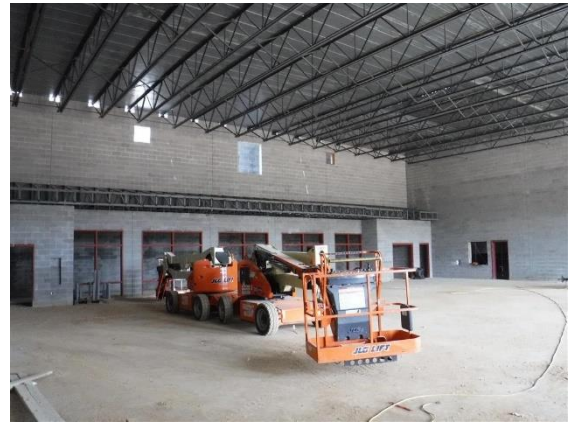
- v) Steel bar joists and metal roof decking has been installed over the Cafeteria.

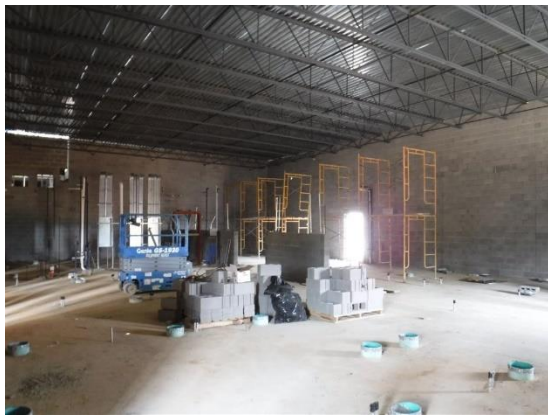
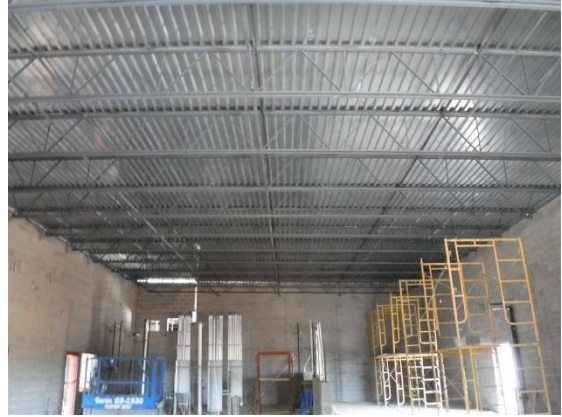
- w) Steel bar joists and metal roof decking has been installed over the Kitchen.

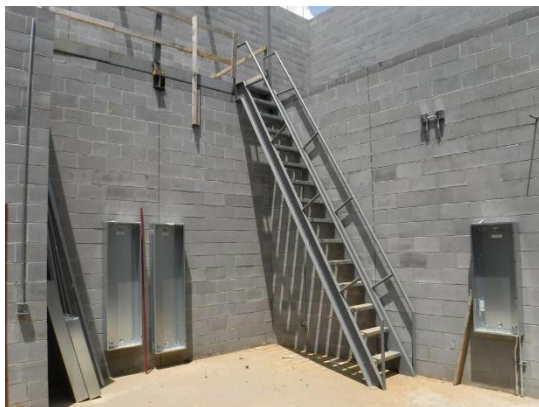
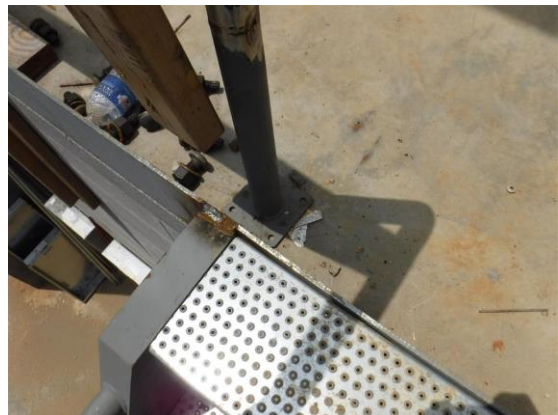
- x) The steel ships ladder has been installed in the Mechanical Room to provide access to the mechanical platform around the Gym and connecting to the platforms over the second floor areas in Areas A and B.

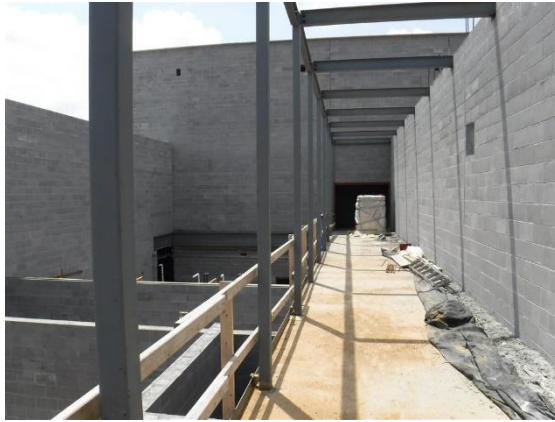
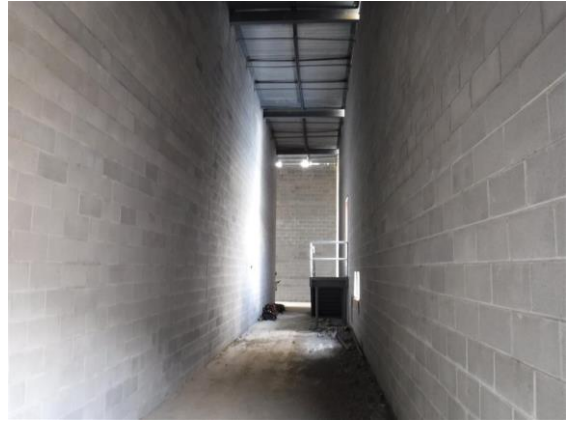
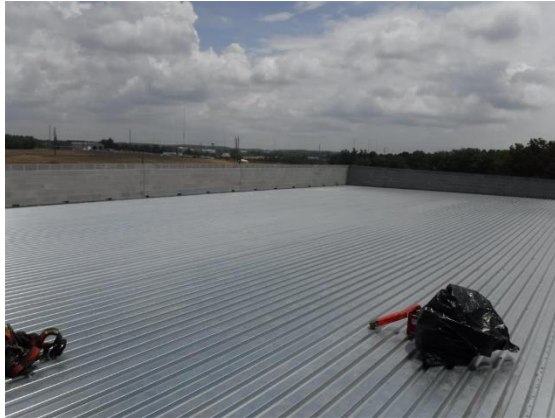
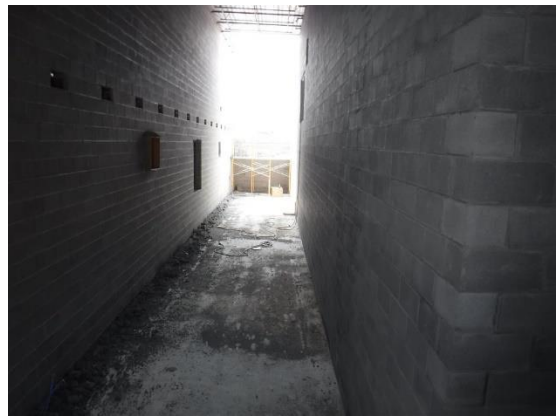
- y) The mechanical platform runs from the Mechanical Room into the space around the Gym. Stairs are located off of the platform to access low sloped roof areas over Area D. Roofers were preparing to start the low sloped roofing system installation.

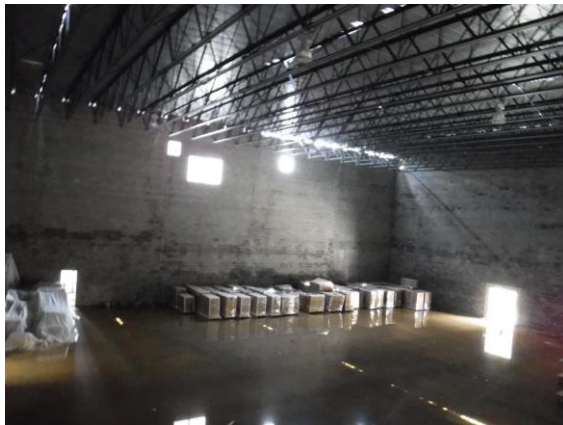
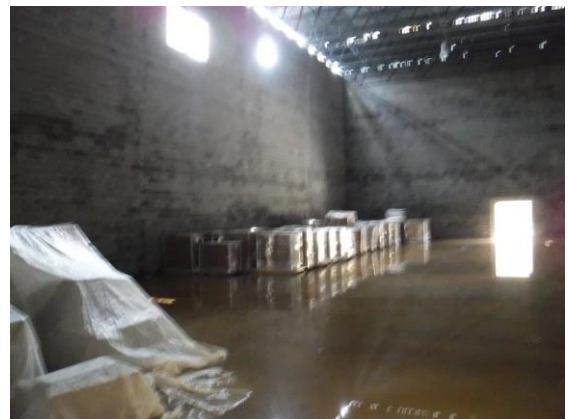
- z) Roofing materials were stored on pallets in the Gym above the water covering the slab.

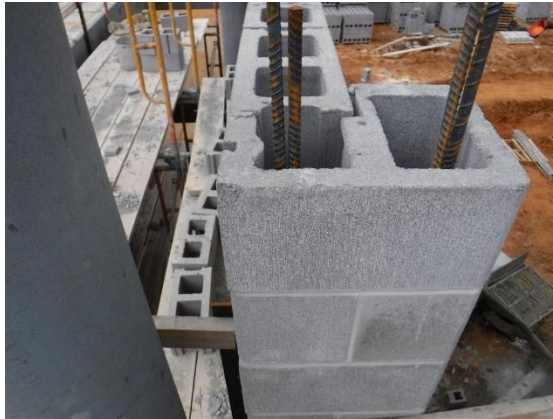
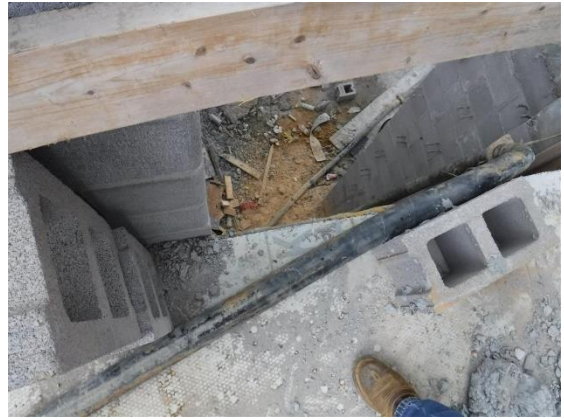
- aa) JRA is reviewing the detail for the block at the curtainwall window at the end of the stair in Area B.
