## FIELD OBSERVATION REPORT

Lincoln Trail Elementary School, Hardin County Schools, Elizabethtown, KY 201752 -CA8

Date: 6/04/2020

Report No: 24

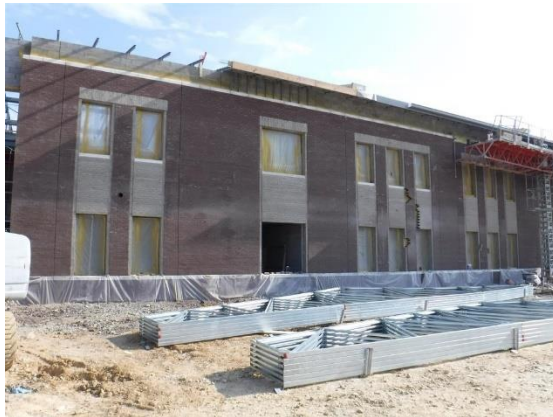
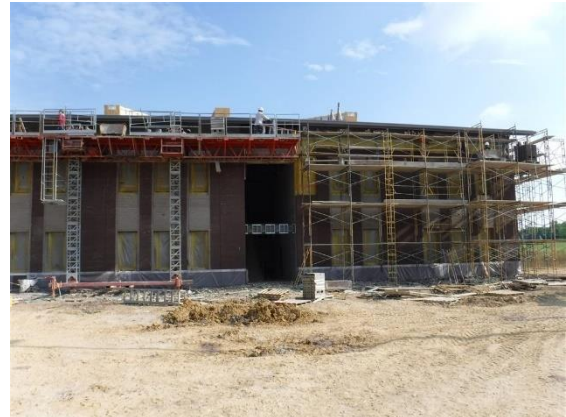
- b) The brick and stone band have been laid up to the eaves on the south wall of Area C. They were at the top of the wall on the east end of Area C. The design requires the mason to recess some brick, to lay some brick in stacked bond and some as soldier courses. All of this was done to add interest to this facade of the building. In spite of the alignment issue, it was good to see progress with the brick. The masons appear to be on their way to laying all masonry. Then, the block needs a final cleaning and detailing. The brick and mortar joints need to be cleaned and detailed.

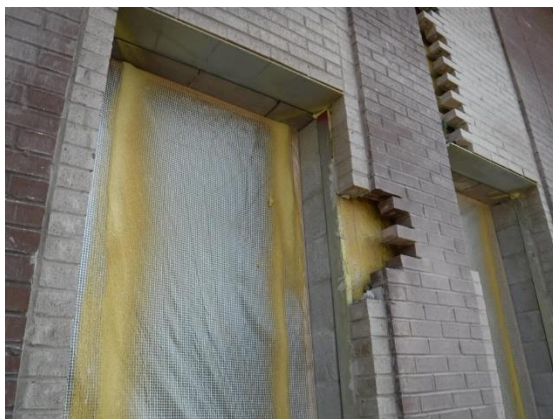
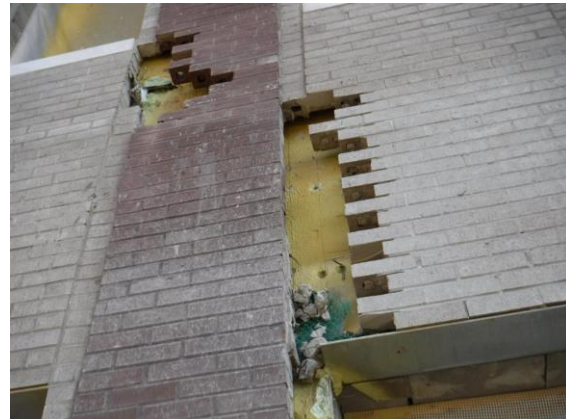
Gerald reviewed the alignment situation with the brick at the windows in Area C. He said the brick that was the most misaligned had been removed. He also said that the remaining brickwork was not perfect but looked acceptable overall. The remaining misalignment was most pronounced standing under the brick edges and looking straight up. Since this is not a normal way of looking at the building, the overall effect is acceptable. There will be some bricks that will need to be replaced after the wall is observed after the brick is cleaned. He said the masons will continue to lay brick and stone trim up to the eaves at Area B and C and at the Gym.

- c) After John Stith had questioned the alignment of some of the brick at the windows earlier in the week, the mason had removed the worst of the misaligned brick for realignment. This was confined to one area based on the brick which had been removed.

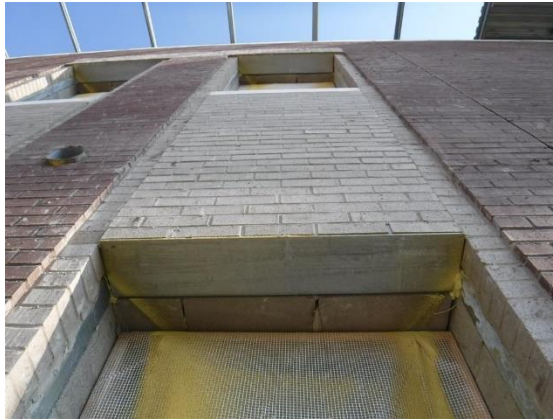
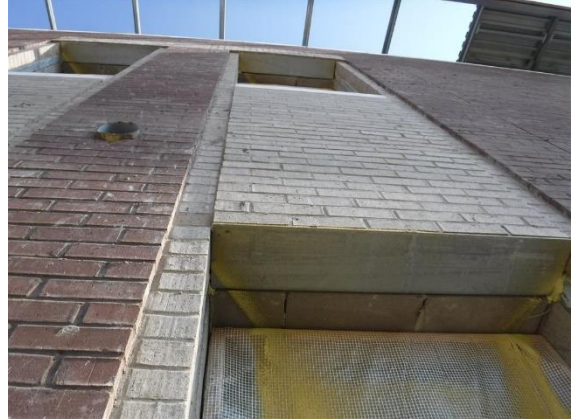
- d) While the brick edges appear to be fairly straight from a distance, viewing up the wall reveals that there is a considerable amount of variation. This is not the normal way that people will observe the building.

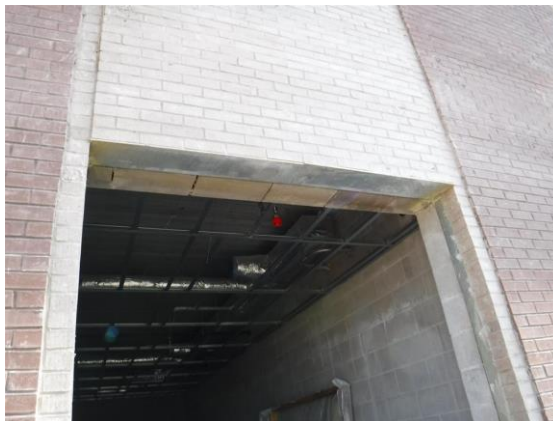
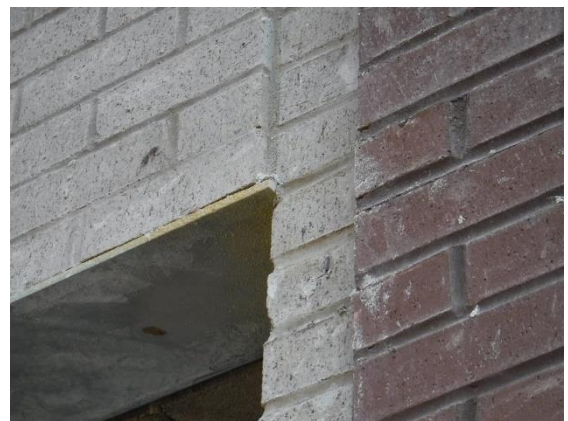
- e) Part of the misalignment is caused by the steel lintels over the heads of the window openings. They are bolted to the back of the block at the exterior wall. It is no longer possible to obtain block that is uniform in thickness and plane. Block suppliers reuse their molds thus resulting in the uneven molds and masonry units. The brick panels over the windows were adjusted for these variations in projection and angle.

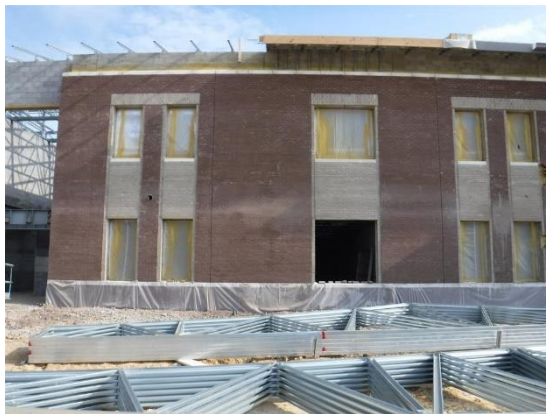
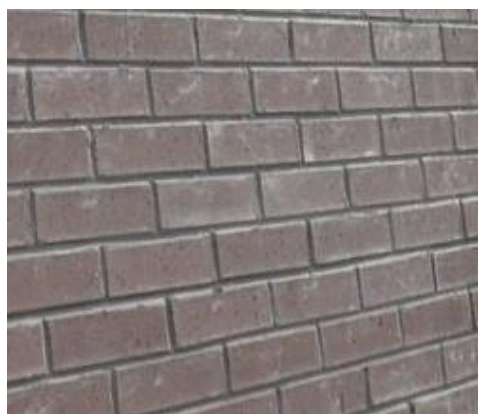
- f) Some brick are misaligned in the field panels and will need to be replaced.

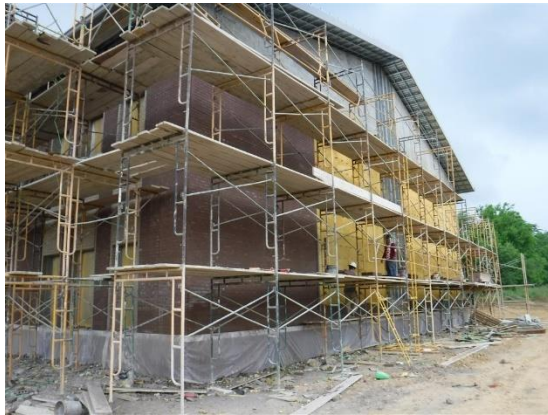
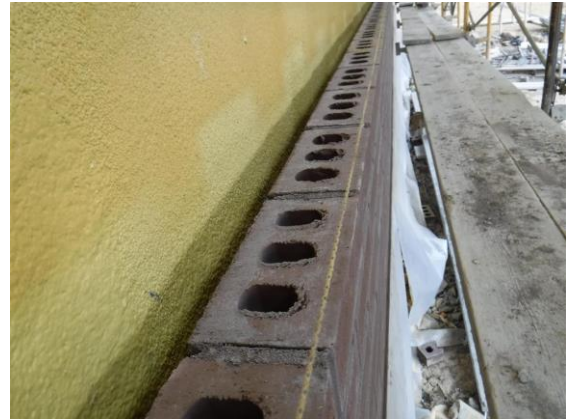
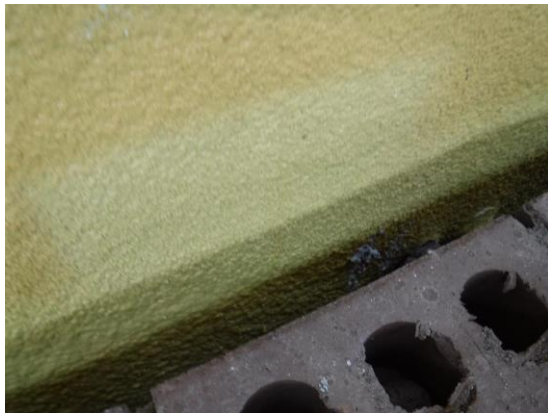
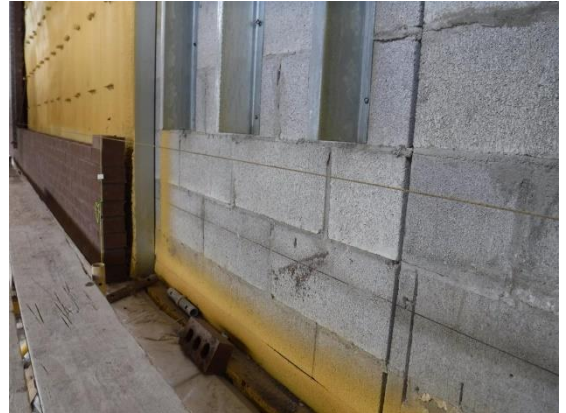
- g) Brick was been laid on the east end of Area C. The brick cavities appeared to be the proper width, were fairly clear of mortar and uniform in size. The walls were in plane.

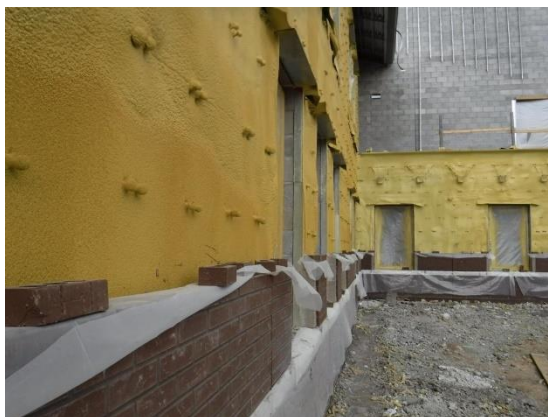
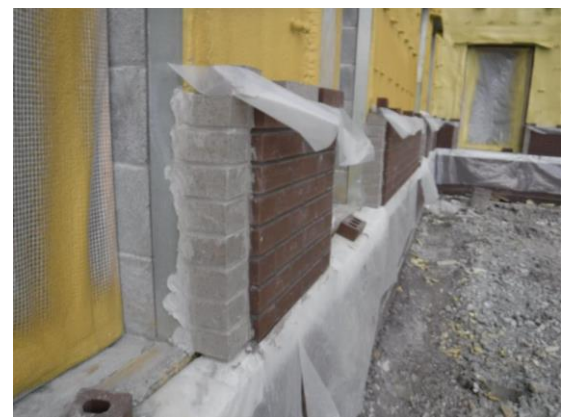
- h) Brick had been laid up several courses on the north side of Area C and B on to the Preschool area. It is good to see brick covered to keep water out of the cores where work was not ongoing in this area.

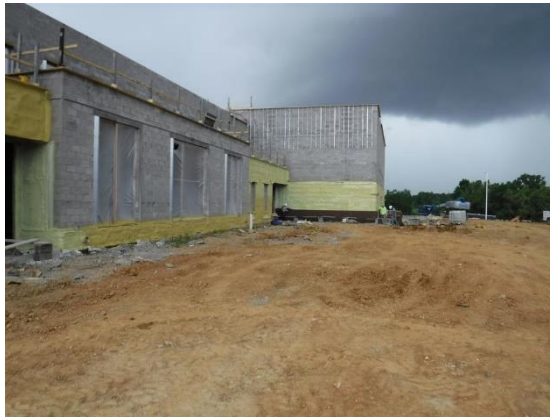
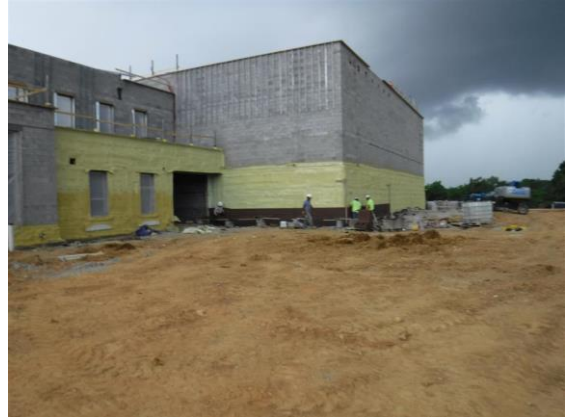
- i) The bottom courses of brick were being laid at the Library/Media Center and on around the Gym.

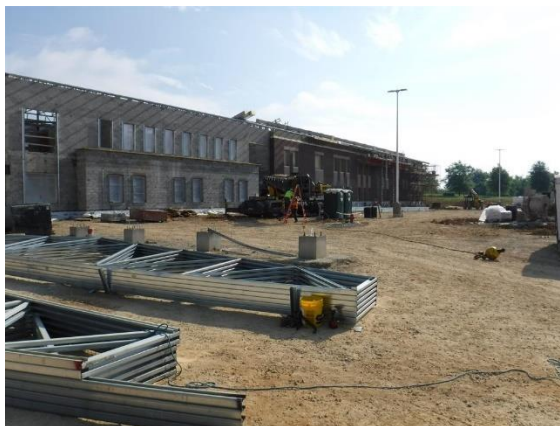
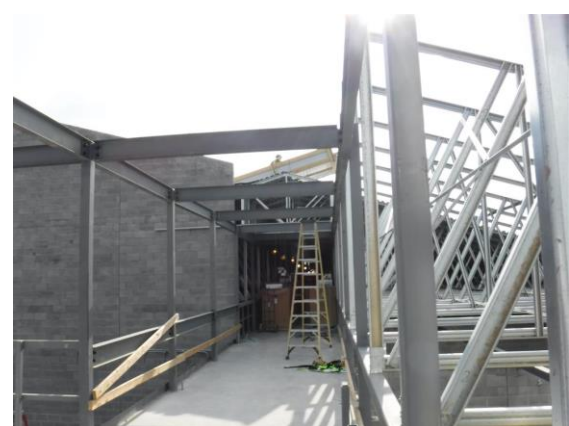
- j) Metal roofing panels were being installed over Area C. Underlayment board and insulation had previously been installed and sealed to prevent moisture from entering the system. Edge trim, gutters and blocking were in place.

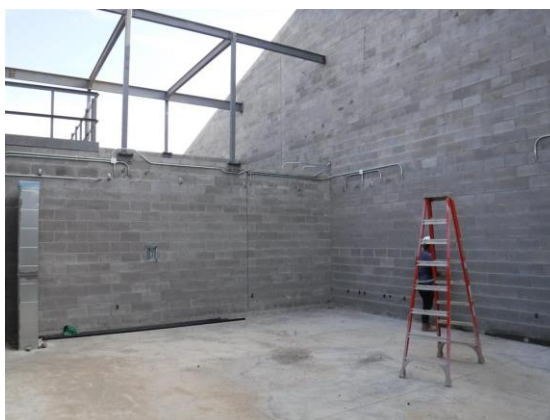
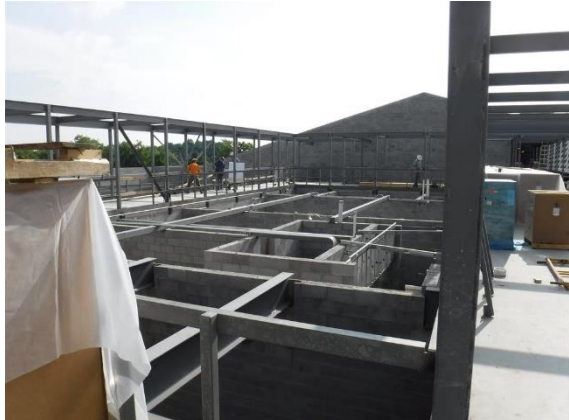
- k) The steel framing over Area B has been installed to carry the mechanical platform and the light gauge roof trusses.

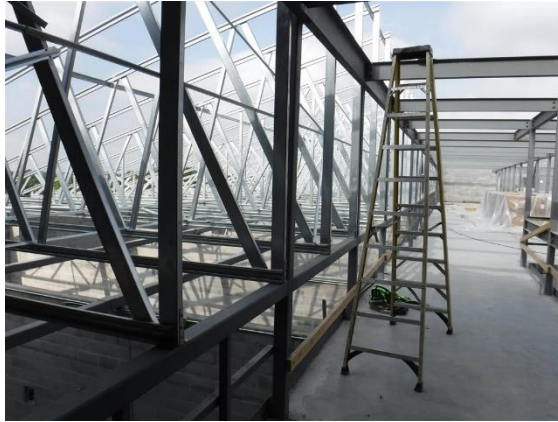
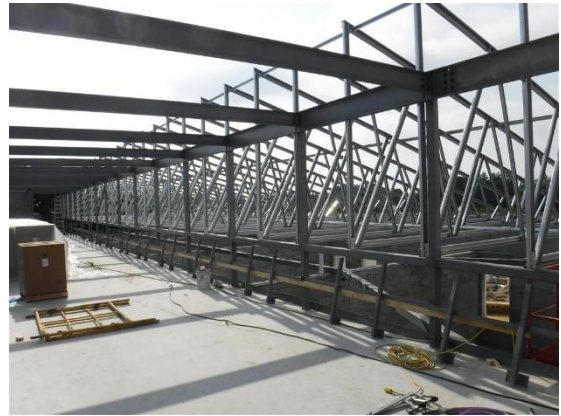
- l) Light gauge roof trusses were installed over the front portion of Area B. Gerald reported that the work had been slowed due to a mechanical problem with the crane. It had been repaired.

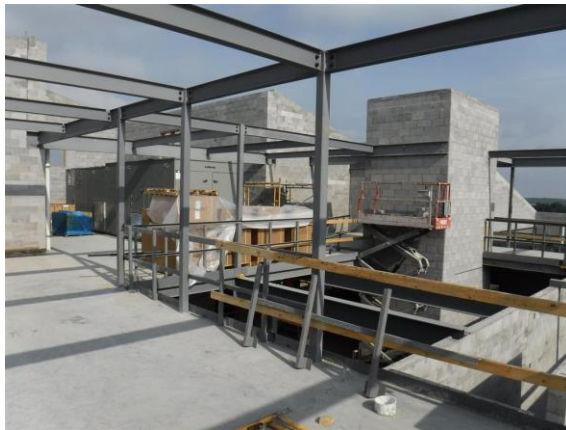
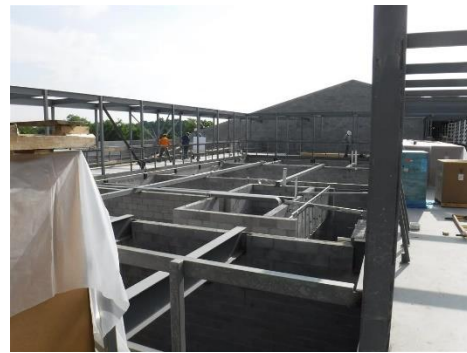
- m) Erectors were installing the steel railing around the mechanical platform over Area B.

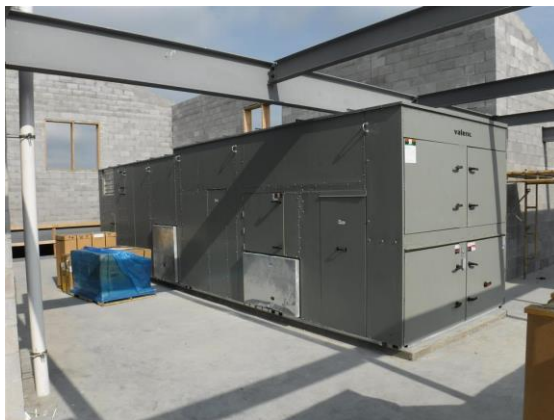
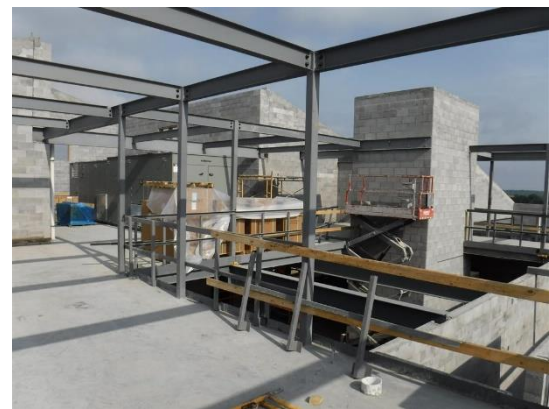
- n) The energy recovery unit had been lifted to the mechanical platform level and was sitting in the mechanical room over Area A.

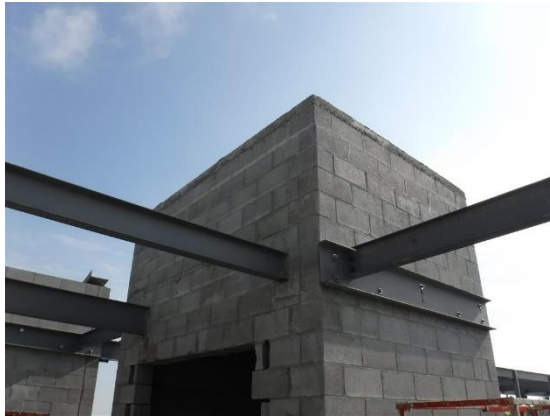
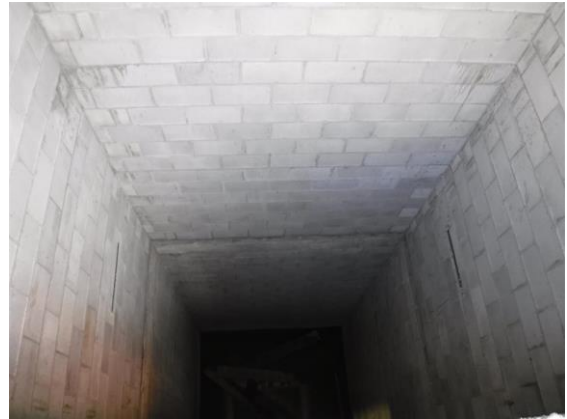
- o) The concrete slab over the elevator shaft is in place. When the roof over Area B is in place, the elevator can be installed in the shaft.

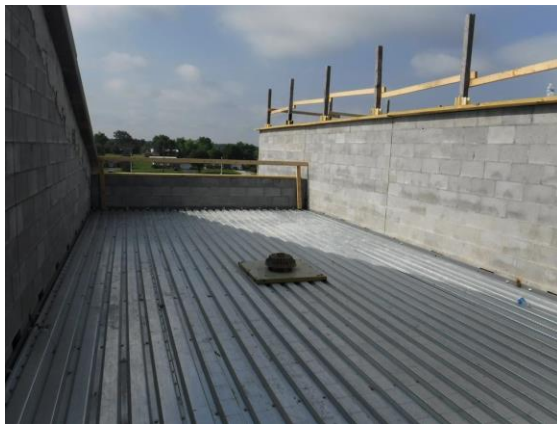
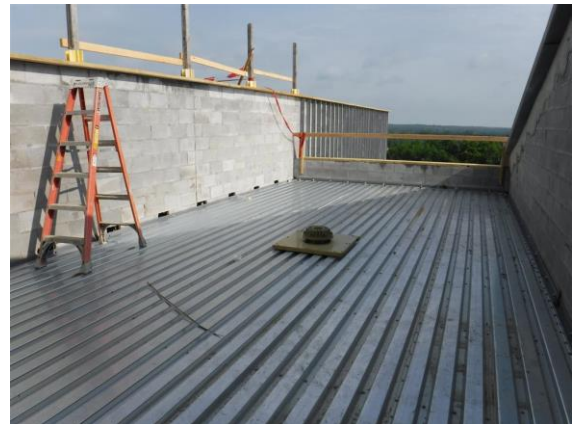
- p) The steel bar joist and metal roof decking over the front and rear entrances to the building at Area B are in place. These areas are ready to receive the low sloped roofing systems.

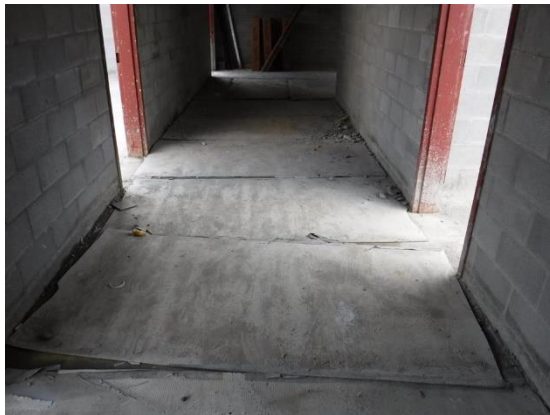
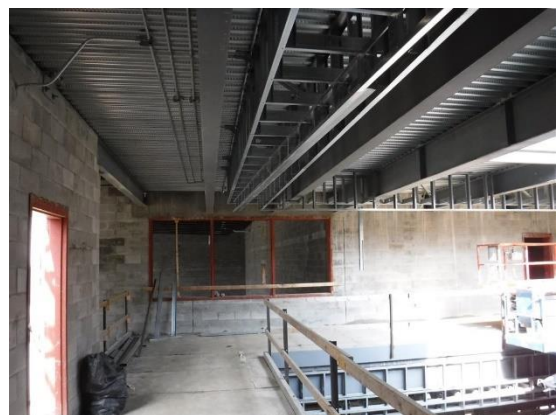
- q) Now that the corridors are covered on the second floor, this is a good time to straighten up and retape the Skudo board protection system.

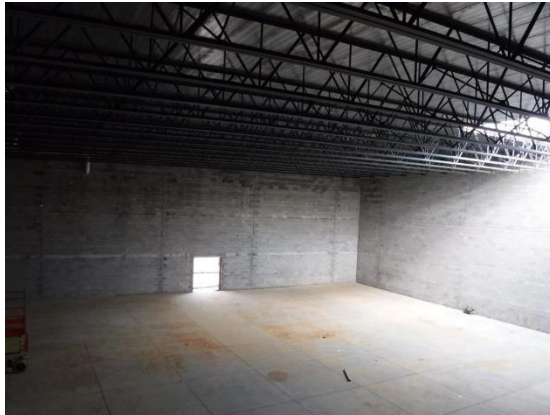
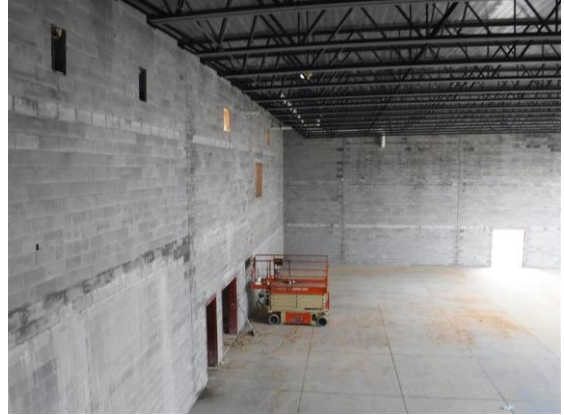
- r) The steel roof joists and most of the metal deck are in place over the Gym. Also note that the floor slab is relatively clean. The steel bar joists and metal roof deck are also in place over the Cafeteria.

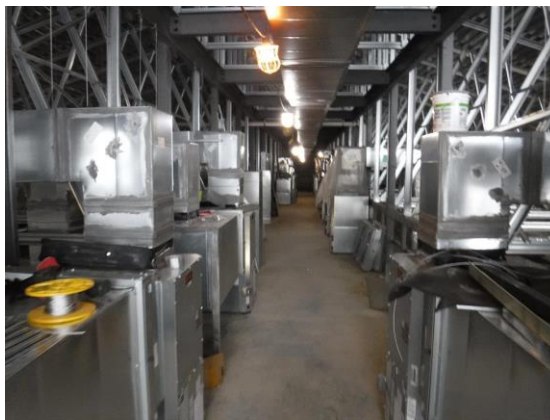
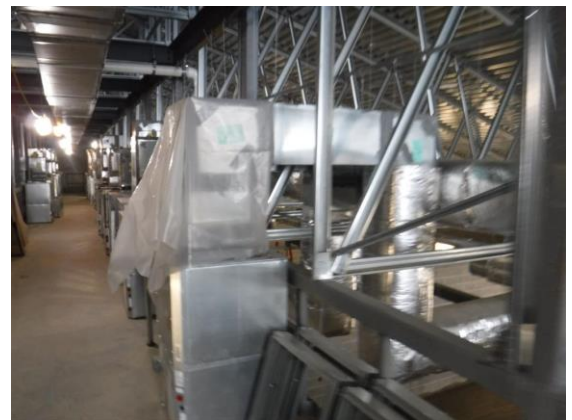
- s) Ground source heatpumps are installed on the mechanical platform over Area C. Most are connected to ductwork and are insulated.

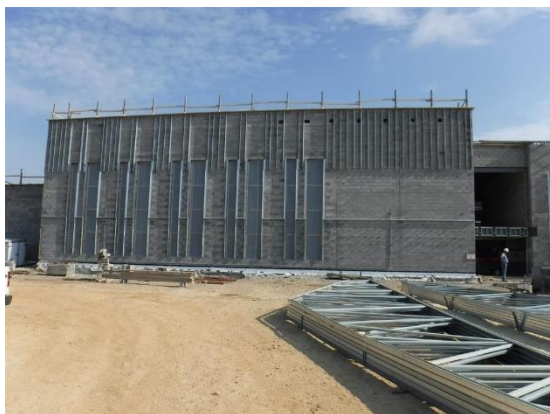
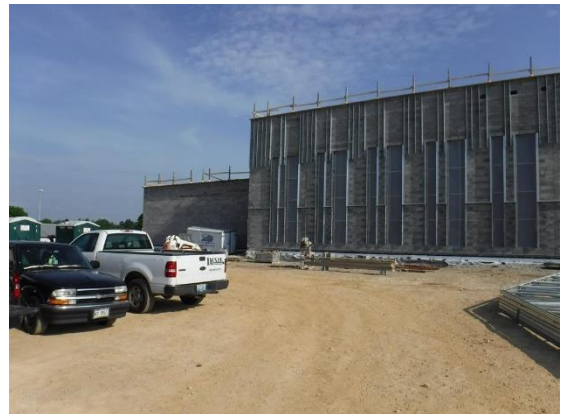
- t) Metal angles have been applied at the top portion of the Cafeteria wall to receive the composite panels. Brick will be laid from grade up to the panels.
