## FIELD OBSERVATION REPORT

East Hardin Middle School, Hardin County Schools, Elizabethtown, KY 201752.01 -CA8

Date: 7/2/2020

Report No: 26

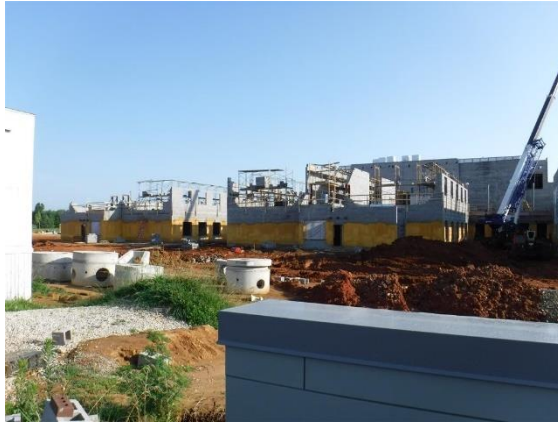
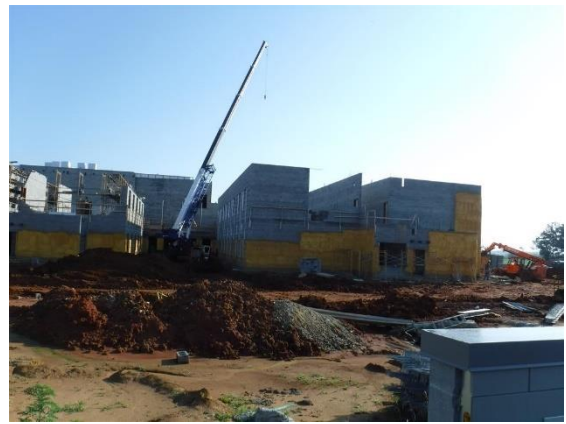
- b) Since my last visit, there has been progress in the classroom wings in Area A. The block walls are being extended to truss bearing heights. The masons are moving back and forth to the wings to allow the grout lifts to reach full strength.

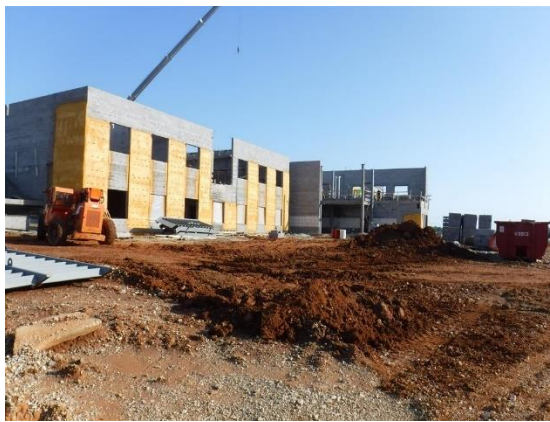
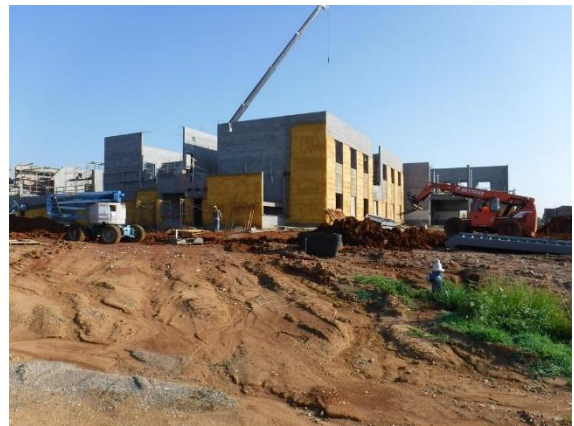
- c) At the back of Area B, the walls are extended to truss bearing height except at one bay being used to stock block for the interior partitions still being laid in the area.

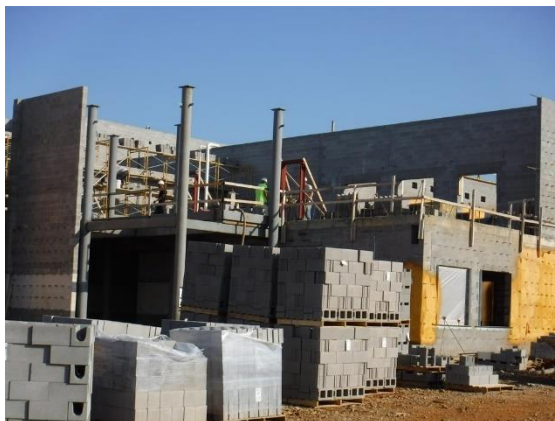
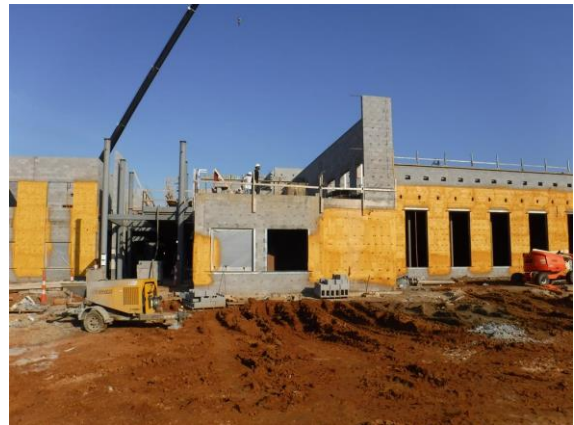
- d) It is good to see masons laying block at the resource rooms across the main corridor from the classroom wing in Area B. Laying these walls to bearing height will tie the rear of the building together with full height block.

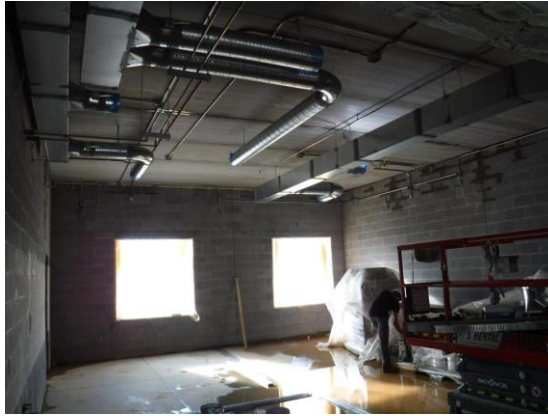
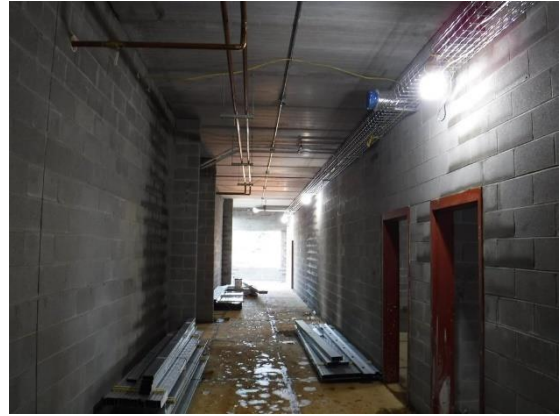
- e) With each visit I can see steady progress with overhead HVAC, electrical, plumbing and sprinkler systems in the classrooms wings on the first floor of Area B and A. With the concrete planks in place, these trades have ample area to work in dry conditions.

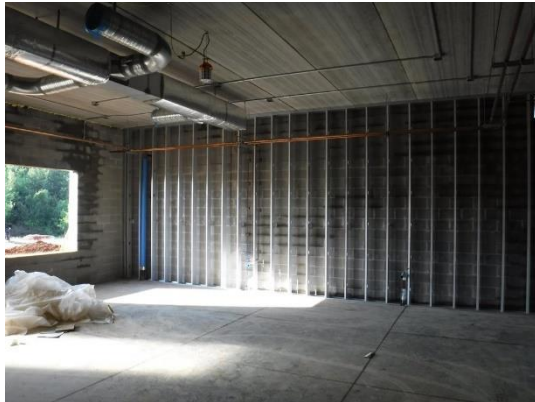
- f) Framers are installing metal studs at the plumbing walls in the science labs.

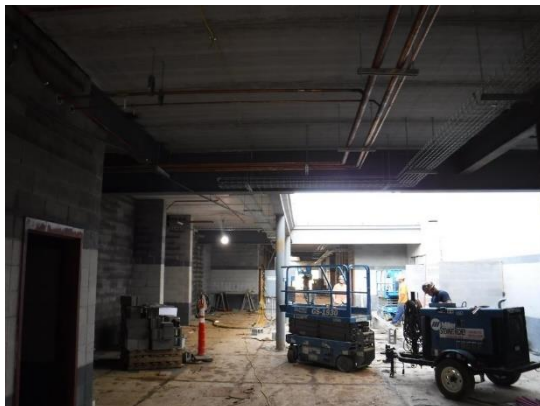
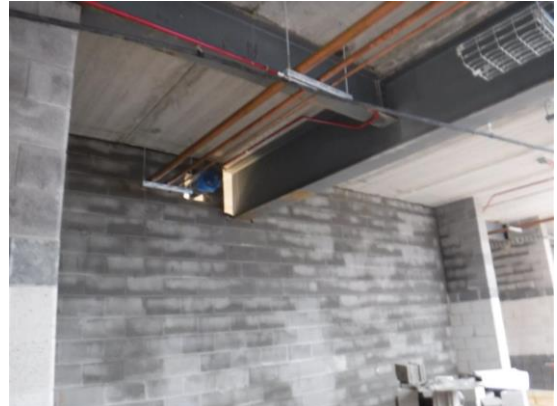
- g) With the routing resolved for plumbing, data cabling and sprinkler lines in the central lobby area, these systems are all being installed.

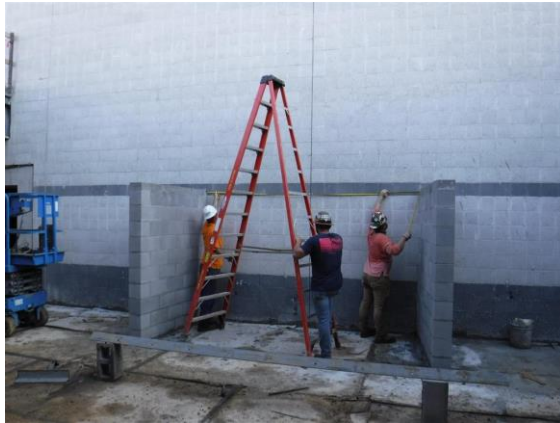
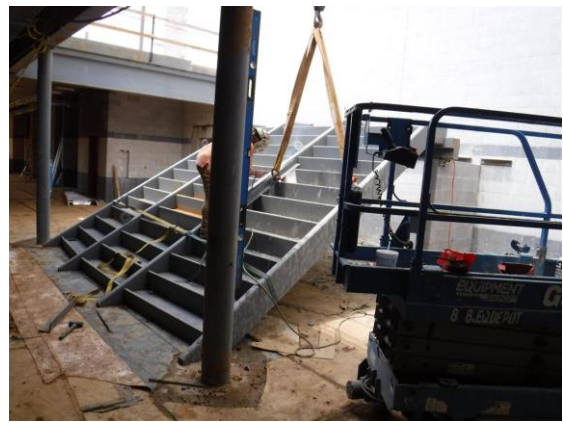
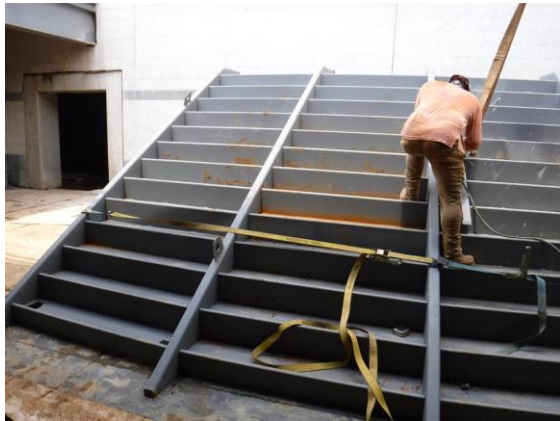
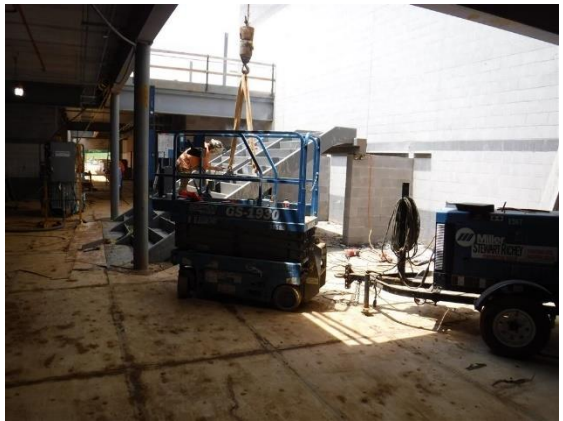
- h) When I first arrived, the erectors were measuring for the central stair outside the Gym. Later in the day they were securing the lower run of steps into place.

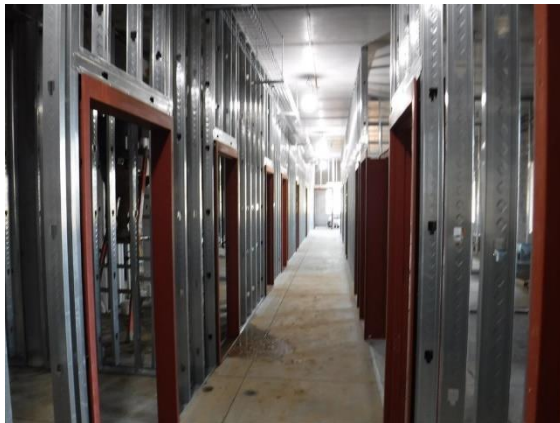
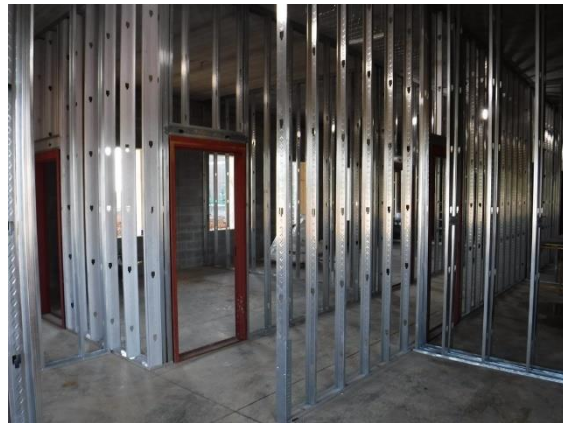
- i) Since my last visit, framers and carpenters had installed the metal framing for the drywall partitions and metal door frames in the administrative area.

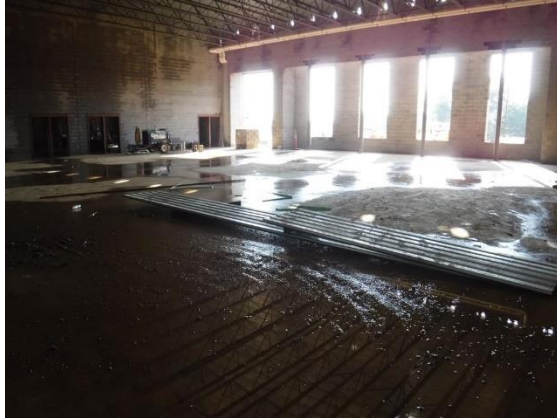
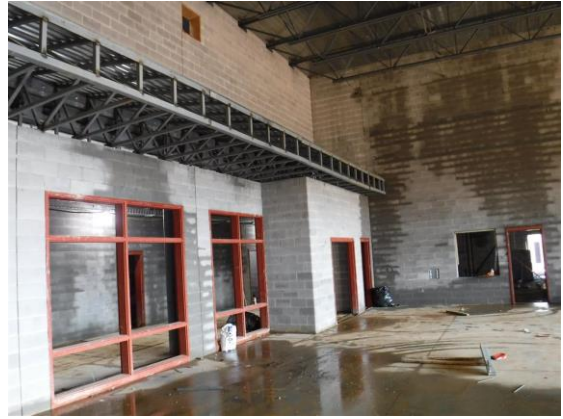
- j) From the rain on Monday, the Cafeteria is still somewhat wet. Roofers are working to dry in this area. The metal framing for the canopy at the entrance needs some adjustment.

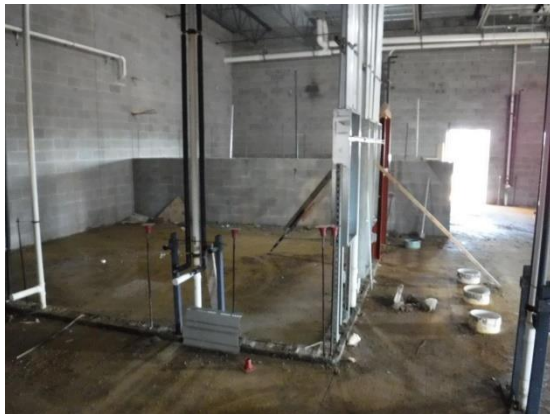
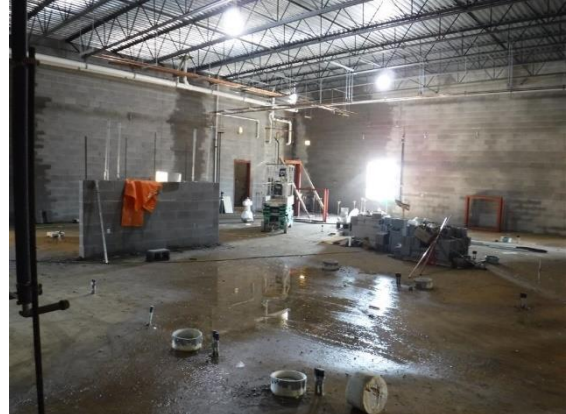
- k) Additional rough ins have been installed in the Kitchen. The next step is to add the block walls for the interior spaces.

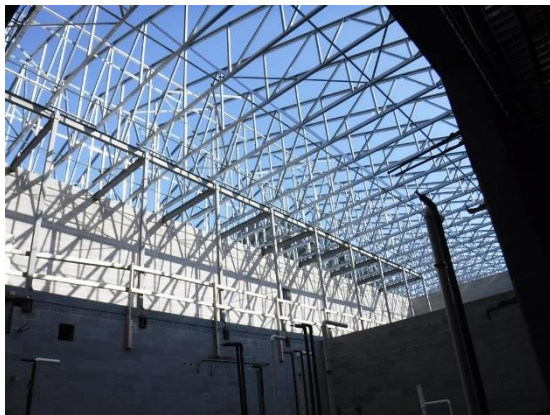
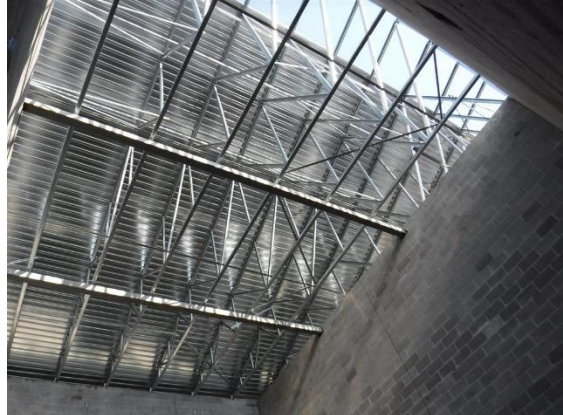
- l) The roof trusses that were being installed over Area D during my last visit are now complete. Metal roofing decking was being installed on the trusses while I was on site.

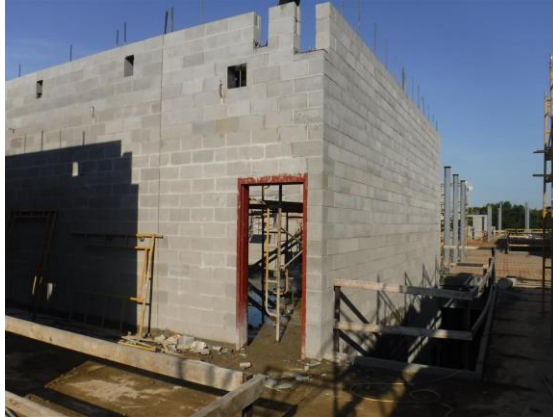
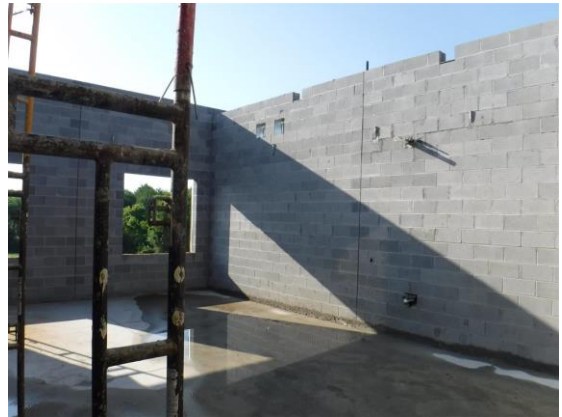
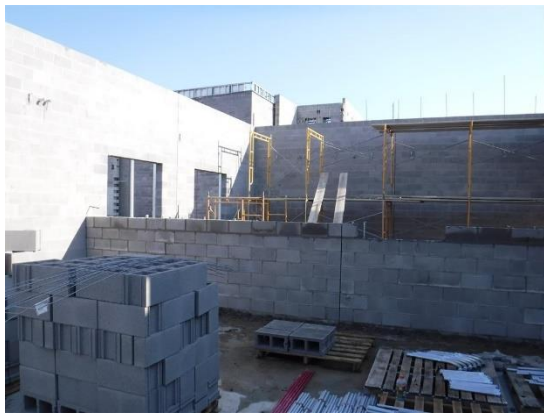
- m) The classroom wing in Area B is up to truss bearing height, Most of the interior partitions are in place. Masons were laying block at the remaining interior partitions.

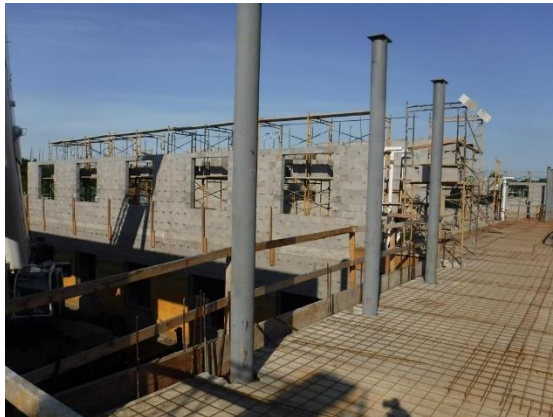
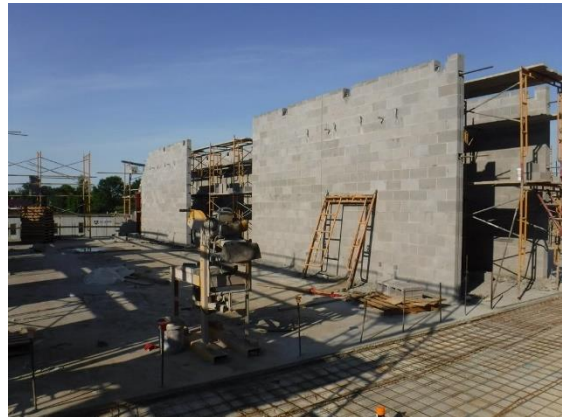
- n) Blockwork is being laid for the classroom wings in Area A. Both interior and exterior partitions are being laid.

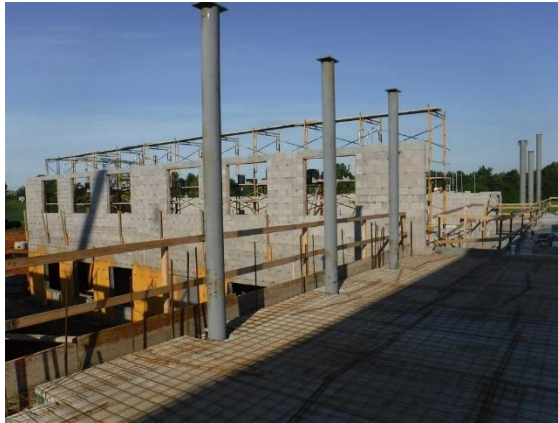
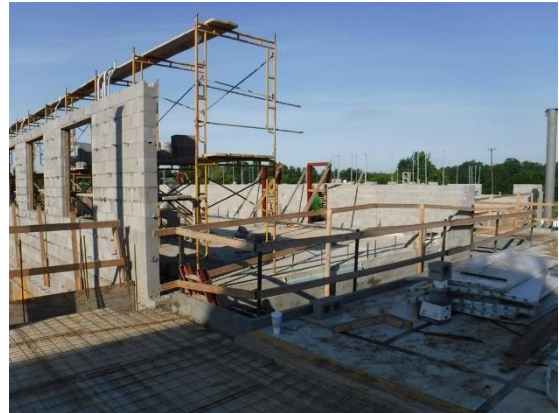
- o) The interior and exterior block walls are being laid in the front most classroom wing in Area A.

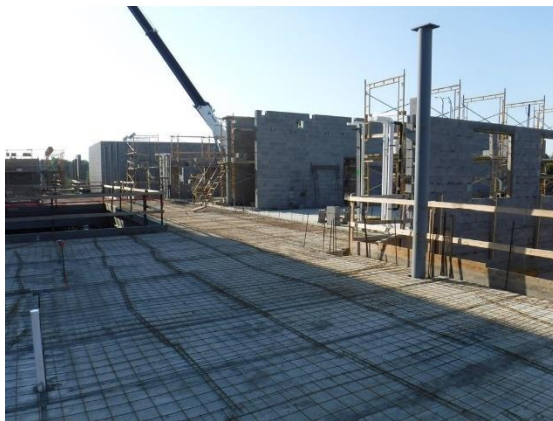
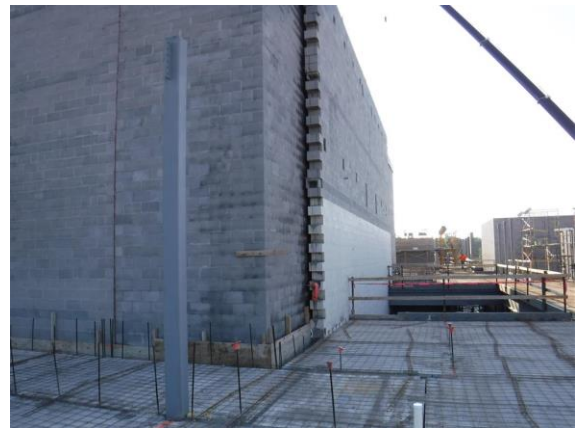
- p) The last slab over concrete planks is prepared for the pour the first of next week. This completes the interior concrete slabs for the building except for those on the mezzanines above the corridors.

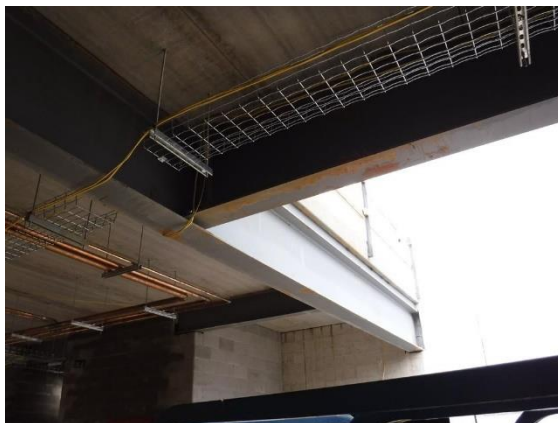
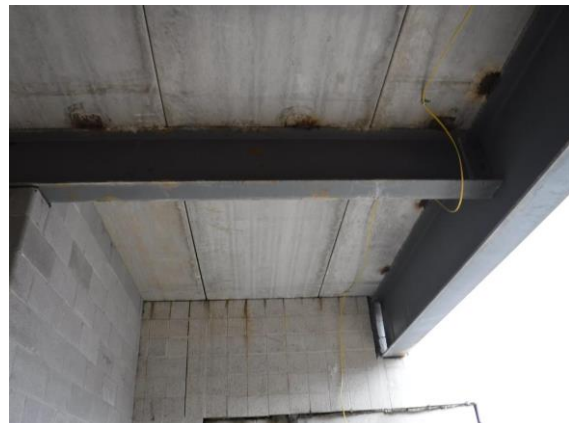
- q) Cable trays are being installed in the main corridor. The beams surrounding the central lobby are the deepest due to the spans. Some of the utilities are being rerouted around these beams.

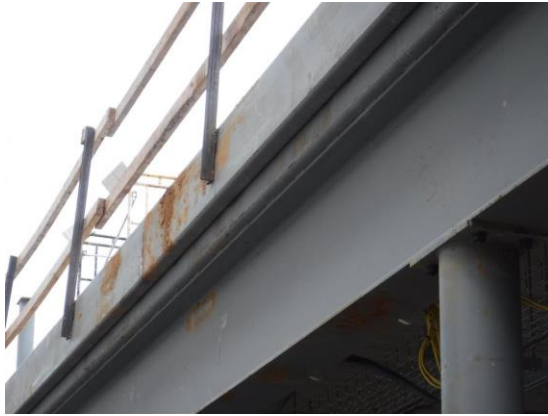
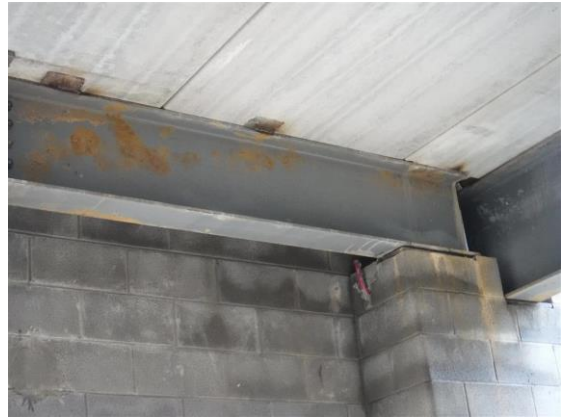
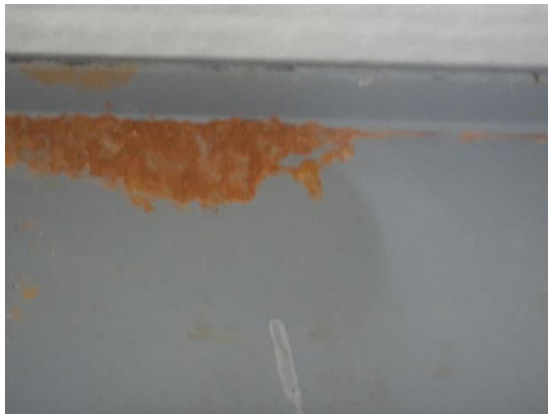
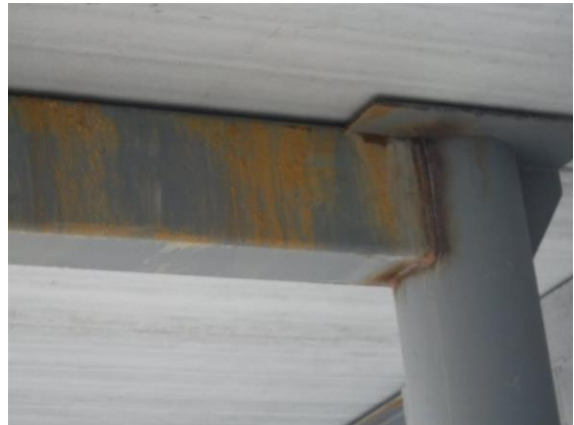
- r) Doyle assured me that all of the rust and mud on the structural steel framing will be removed with a wire brush and the primer touched up. That special attention to steel that remains exposed to view after finishes are installed. These surfaces must be prepared for finish painting.

- a. Maintain the Skudo system so that it protects the corridor slabs.
- b. Clean mud and rust off of steel, and reprime areas where the primer was scraped off of the steel.
- c. All trades shall keep the building and site clean by properly disposing all bottles, bags, wrappers, trash, debris, etc.

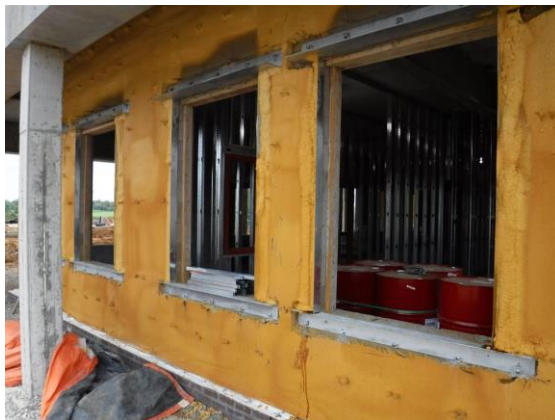
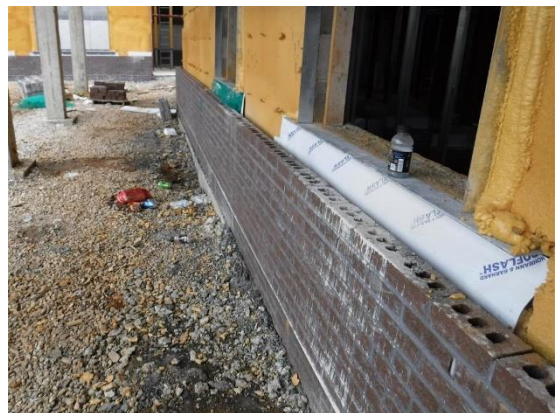
- s) The front of the administrative area has been sprayed with foam insulation and is ready for brick. Brick has been laid on the side of the administrative wing. Note the water bottles and trash on the ground. Billy Parsons stressed to the trades at the progress meeting that they need to throw trash away in proper containers.

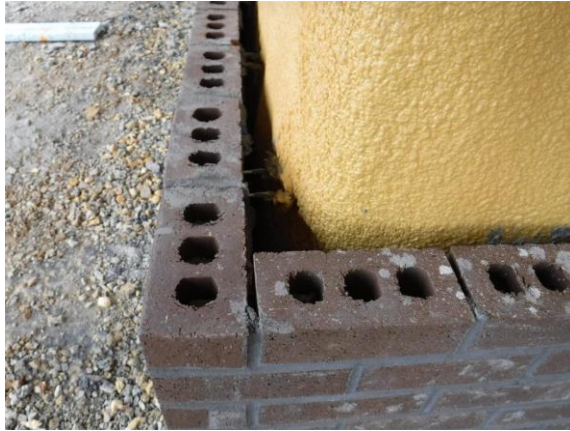
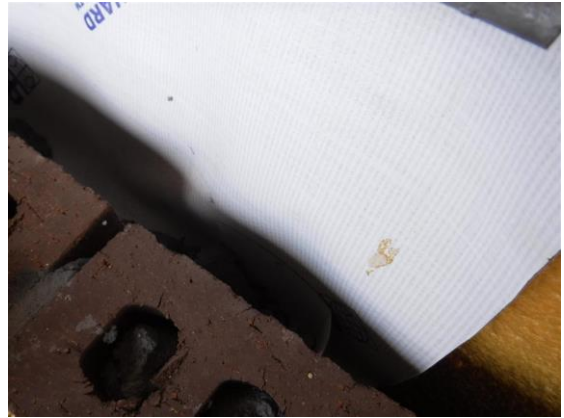
- t) The brick cavity at this corner is adequate to allow ventilation of the back of the brick to keep the wall dry. Flashings with properly installed end dams are also critical in keeping water out of the interior of the wall that might migrate to the interior of the building.

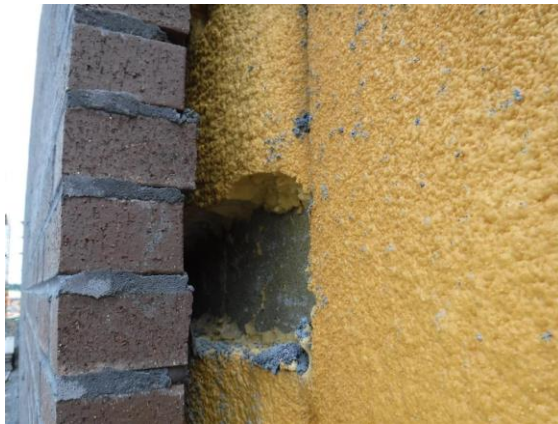
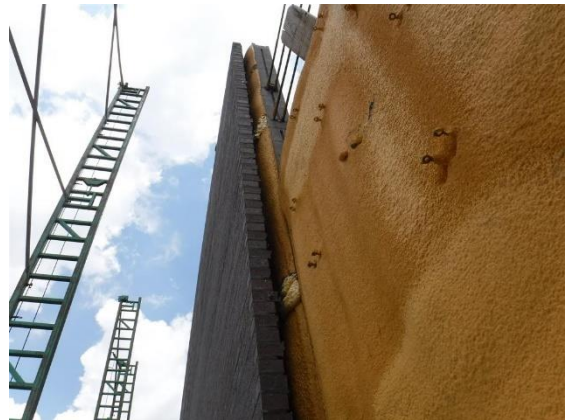
- u) The masons are repairing the foam insulation after they remove the outriggers for their plumb lines. In the case below, it appears that they ran out of foam before they laid brick over one of these places needing repair. This can still be corrected, but the mason needs to make sure that these repairs are made to avoid cold spots in the wall and gaps in the vapor barrier provided by the foam insulation. If these problems do occur after the project is complete, brick will need to be removed to assure that these repairs have been properly made. Obviously, this is not an acceptable way to deal with this. These repairs must be made before the brick is laid!

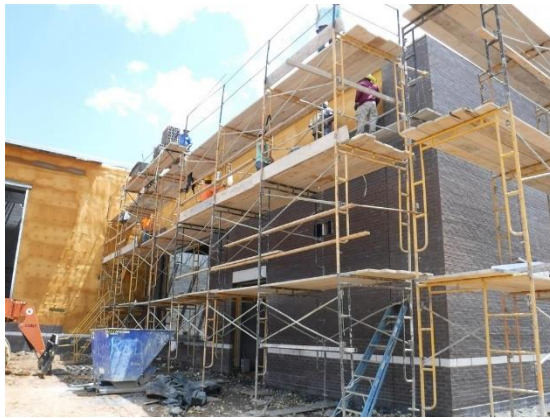
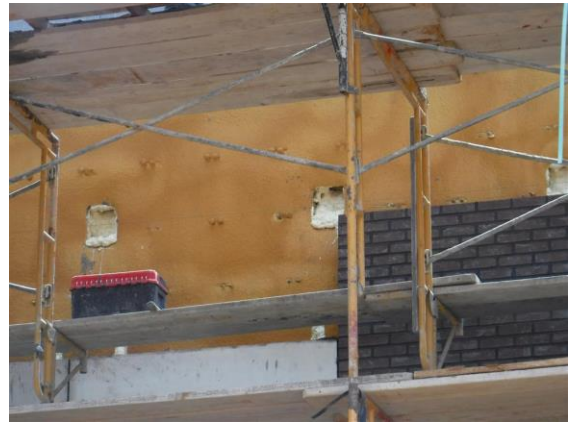
- v) Masons were laying brick over the exterior walls at Area D. There were several places where the foam insulation needed to be repaired. Again it appears that they ran out of the repair foam. By the time I had Doyle and Jerry look at this, they had covered the unrepaired areas. Jerry assured me that this would be corrected.

Another concern raised at the progress meeting by John Stith is the staining by the red clay on this site. Doyle told me that Jerry intends to use straw. If straw is used, it must be maintained until sod is placed around the building. John said that permanent staining to the brick will result in the removal and replacement of the damaged brick.

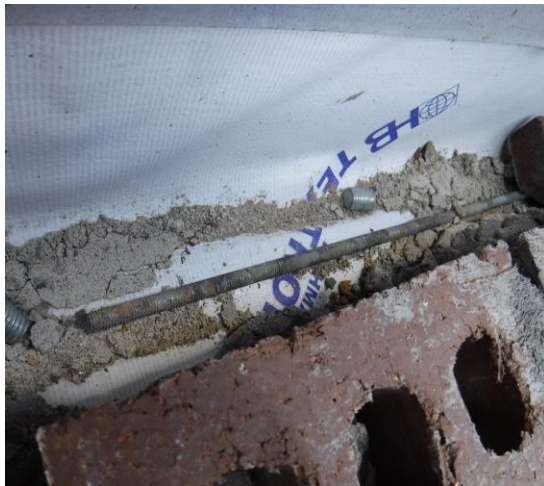
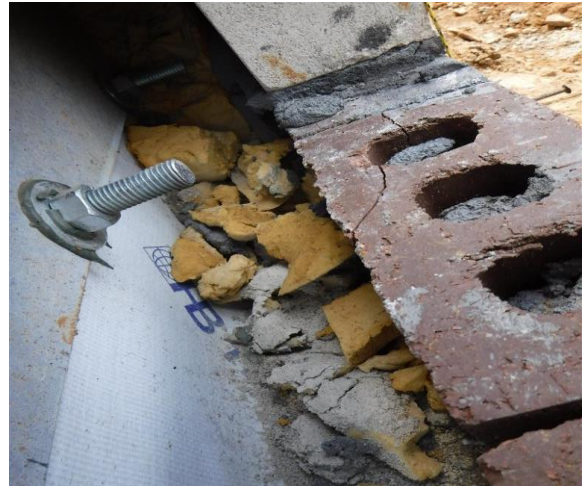
- w) The spray insulation also needs to be repaired at the through wall flashings. Before this is done all treaded rods, mortar, loose foam insulation and trash needs to be removed. By the way, the brick in the image to the right is broken and needs to be replaced.

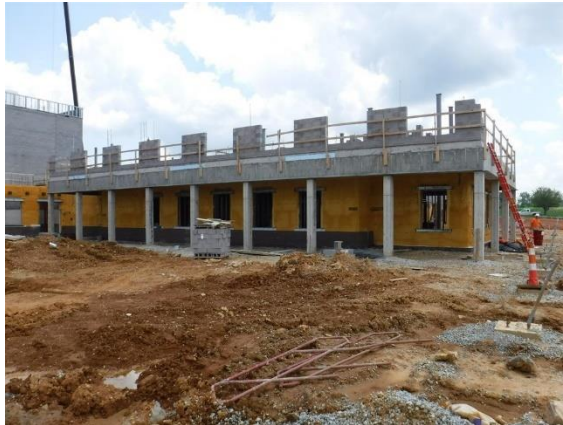
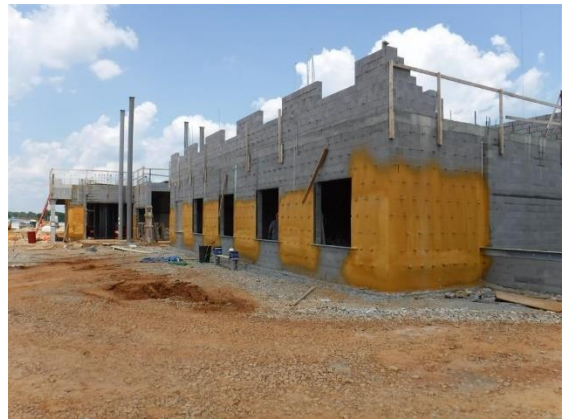
- x) The exterior block walls at the front of Area A for the Library/Media Center and classroom wing are being laid.
