## FIELD OBSERVATION REPORT

Lincoln Trail Elementary School, Hardin County Schools, Elizabethtown, KY 201752 -CA8

Date: 7/2/2020

Report No: 26

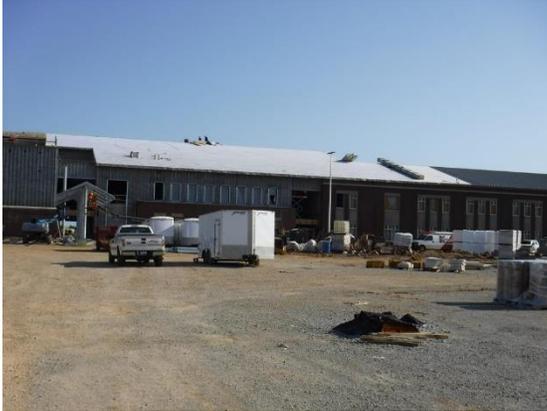
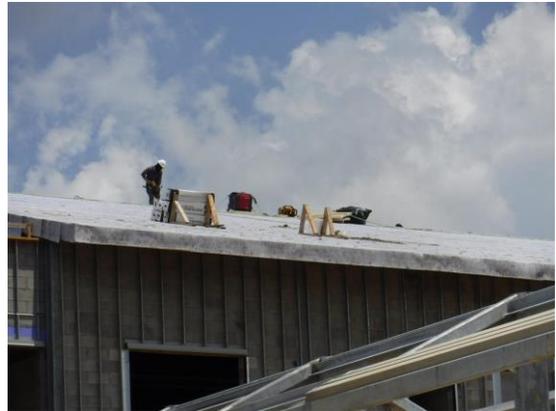
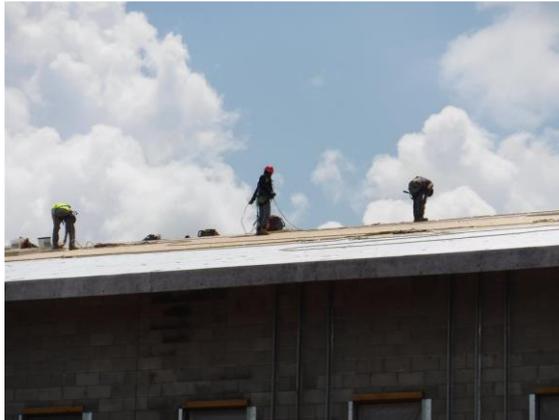
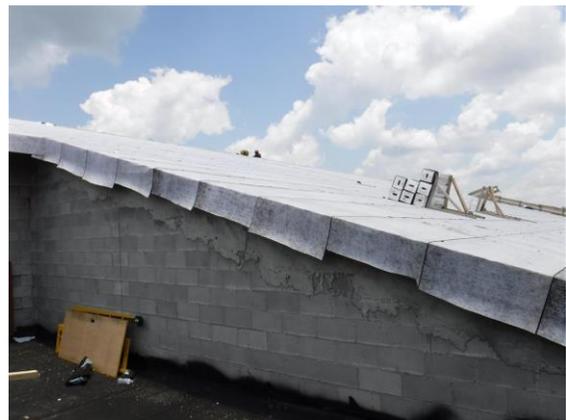
- b) Roofers were being to install the standing seam metal roofing system over rigid insulation and the vapor barrier over Area B as I arrived on site.

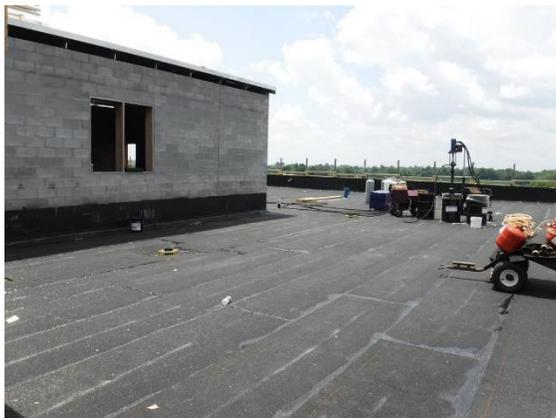
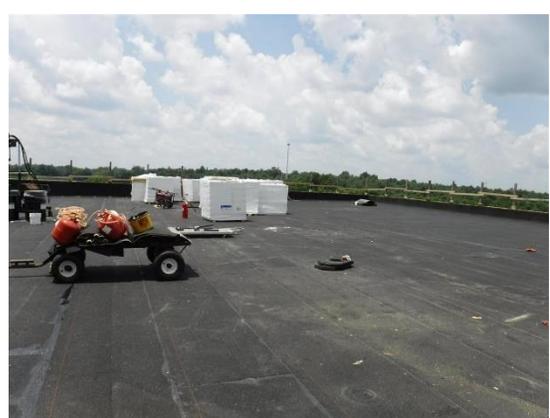
- c) Materials were stockpiled on the Gym roof to complete the roofing system. The Gym is dried in with the installation of the vapor barrier over the protection board.

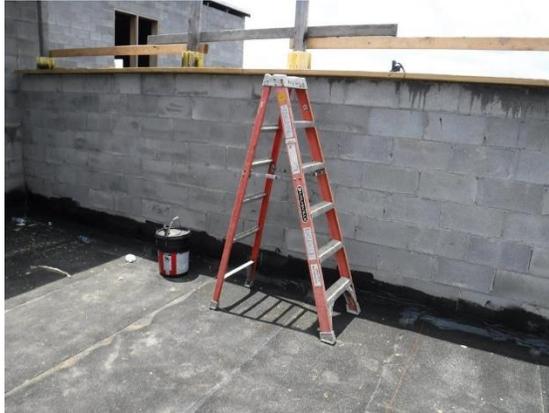
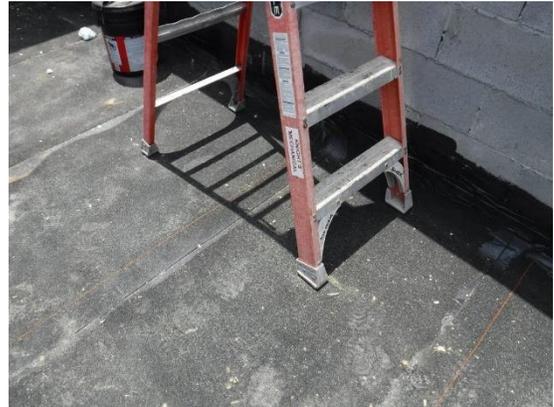
- d) A work ladder and a can of roofing emulsion were on the roof over the rear main entrance. Nothing should be placed on roofing materials that are in place without laying plywood down first to spread the load and prevent damage to the roofing.

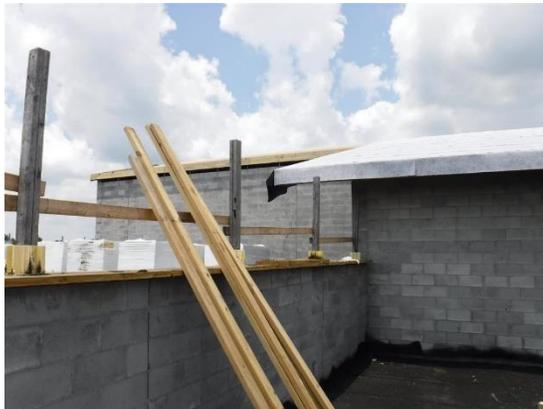
- e) At the roof over the main entrance, lumber had been stockpiled to be installed for wood blocking. This material must not be placed on the roofing material in a way that would damage the membrane.

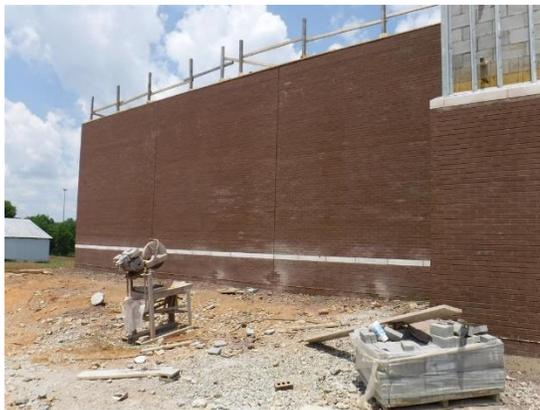
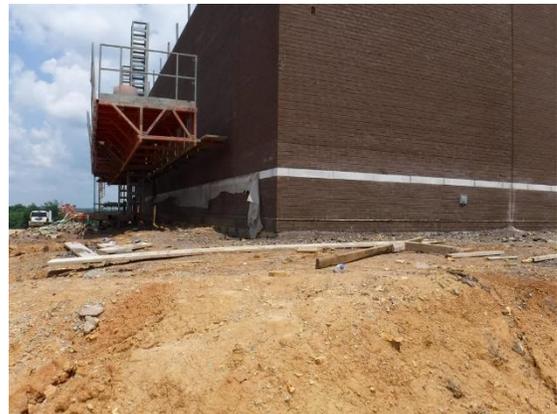
- f) During the progress meeting John Stith expressed his concern about protecting the brick from stain from the clay soil around the building. Some areas of ground had been covered with straw but not all. The area at the Kitchen/Cafeteria needs attention.

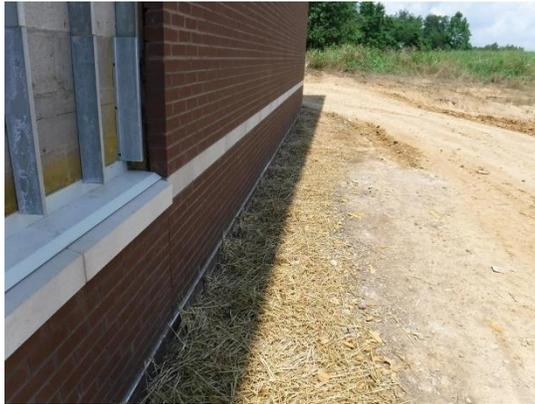
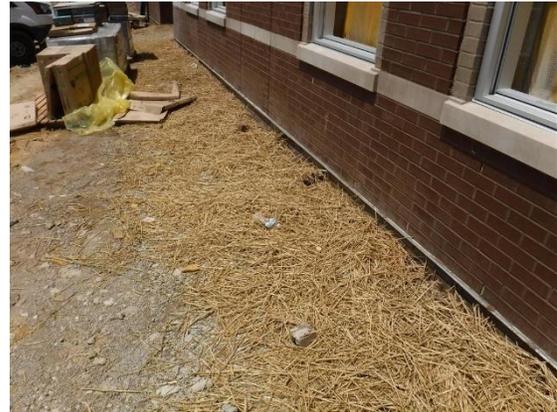
- g) Straw has been placed around Area C where the brick has been washed. There is still some staining of the brick that needs to be removed.

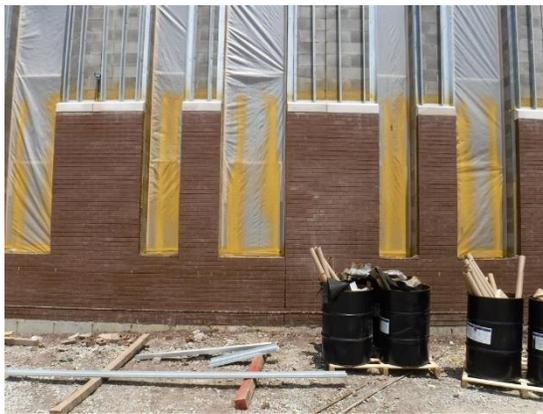
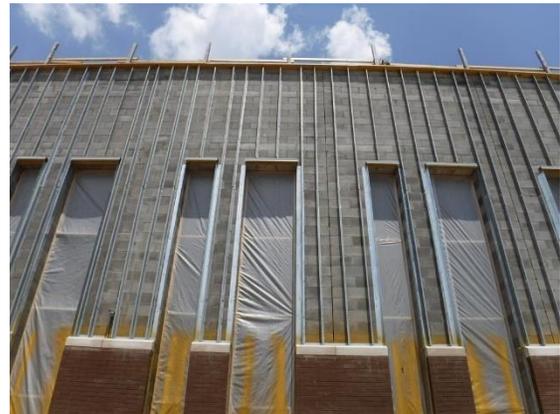
- h) Brick and stone have been laid on the south elevation of the Cafeteria. Above the stone band, metal Z's have been installed to receive the composite panels after spray insulation is applied between the metal framing.

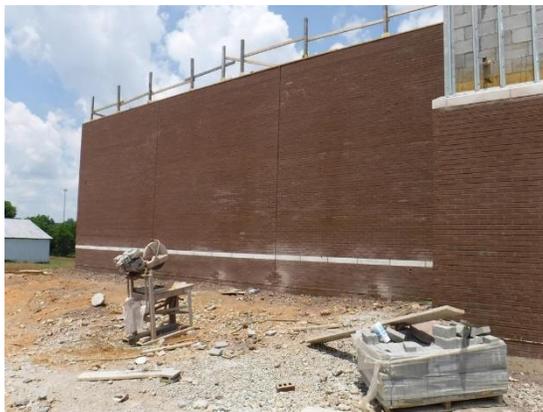
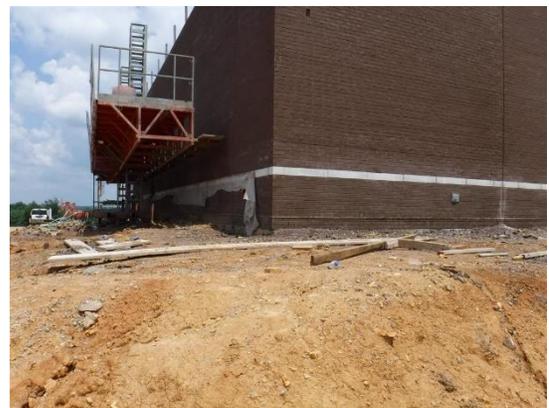
- i) Brick and stone has been laid on the south and west elevations of the Kitchen. The mason replaced some brick that was not aligned with the adjoining brick.

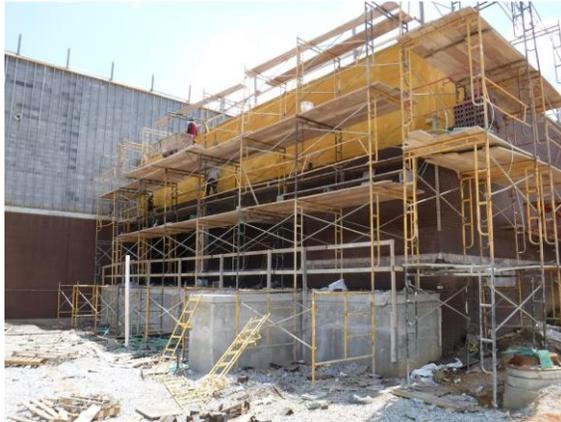
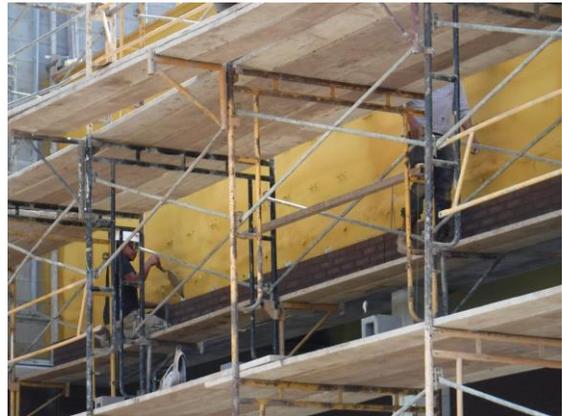
- j) Masons were laying brick over the loading dock. Most of the brick is in place on the building.

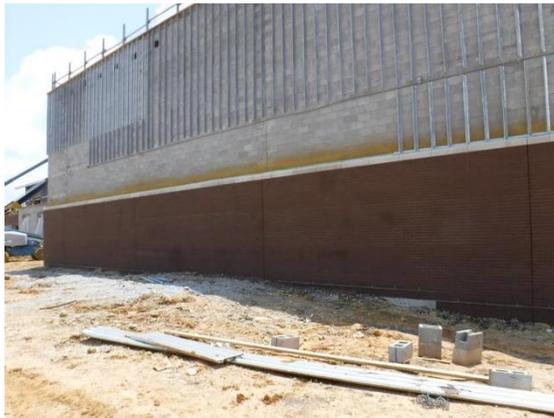
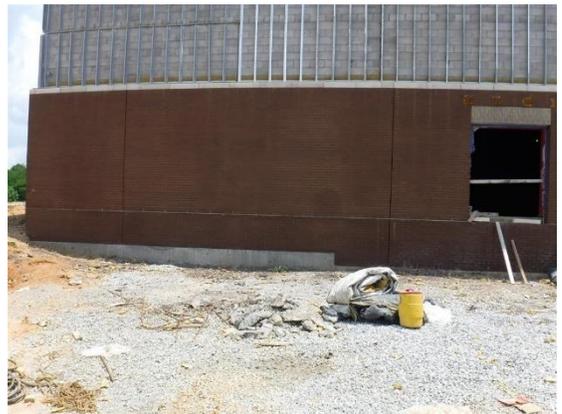
- k) The lower portion of the Gym walls have been covered with brick and stone. Composite panels will be installed above the stone band.

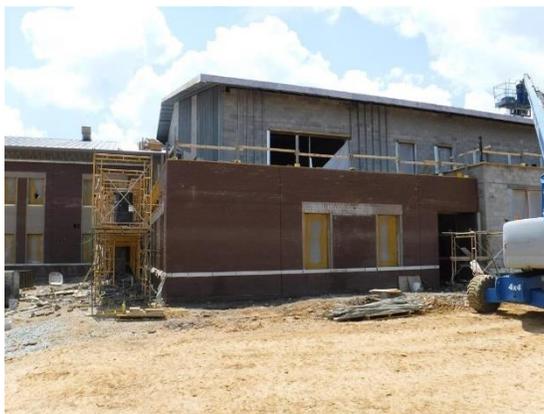
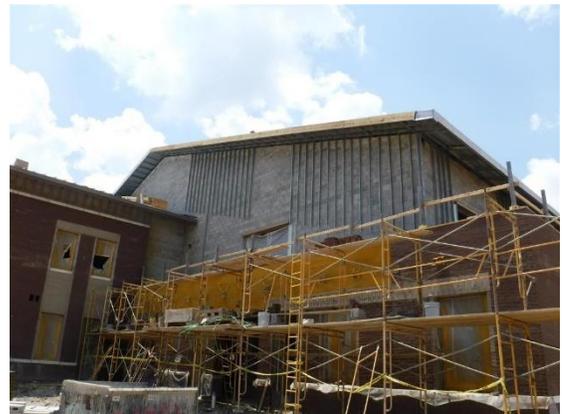
- l) Brickwork is almost complete over the Preschool rooms in Area B. The upper walls of Area B will be covered with composite panels.

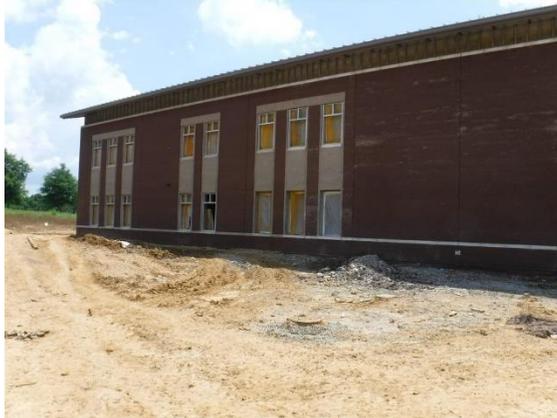
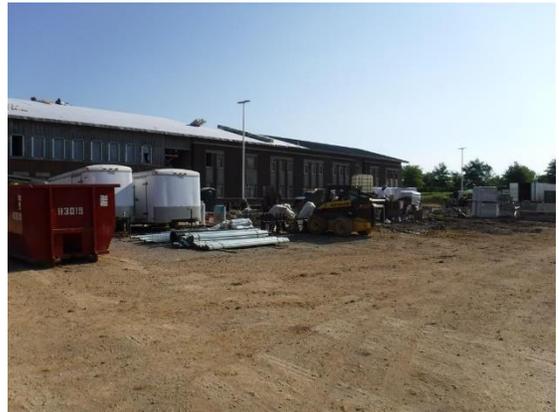
- m) Most of the window frames have been installed in the rooms for Area C. The glass will be installed starting July 9<sup>th</sup>.

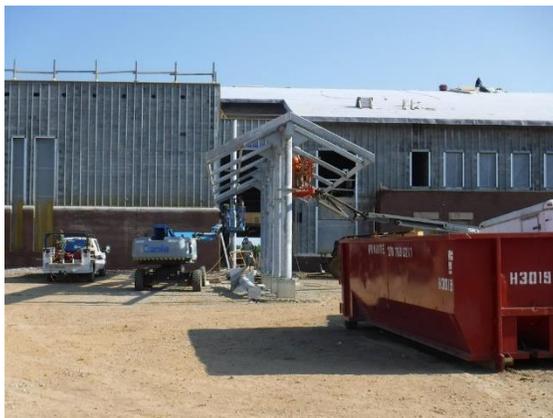
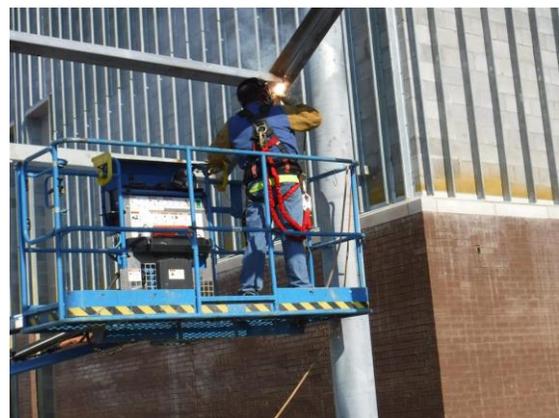
- n) The structure for the main canopy is almost complete.

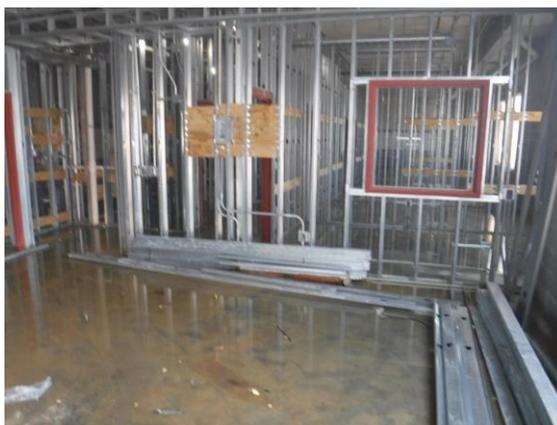
- o) With the front entrance open, rain can enter the administrative area. The floor was covered with water.

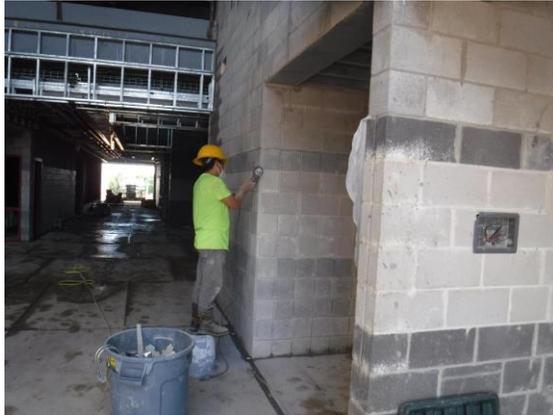
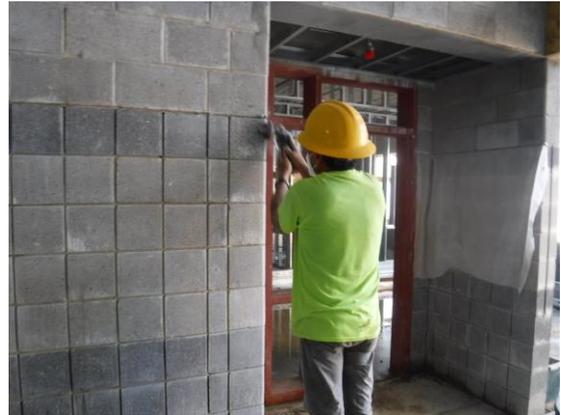
- p) A masonry worker was detailing the ground faced block in the main lobby. It looks good thus far. It will have to receive final cleaning to determine if the final appearance is acceptable.

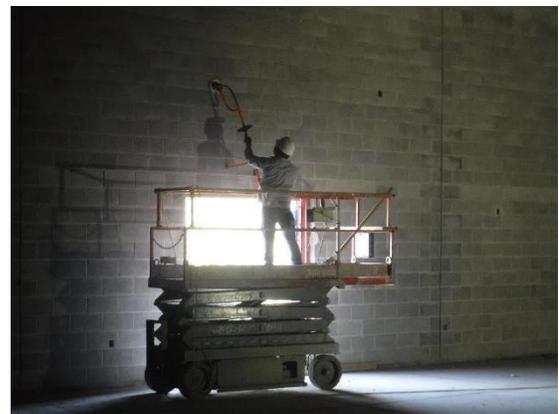
- q) Masonry workers were detailing the block in the Gym. The lack of temporary lighting makes it difficult for the workers to see their work and for the architects and engineers to inspect the work.

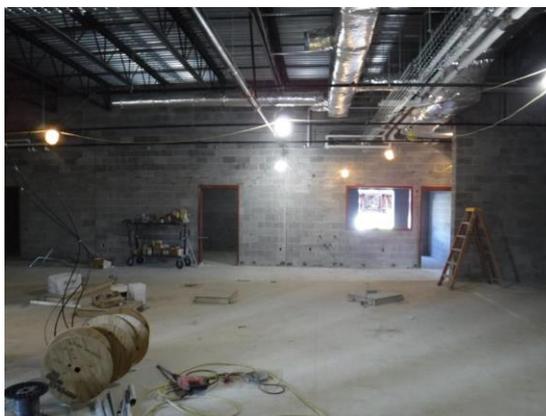
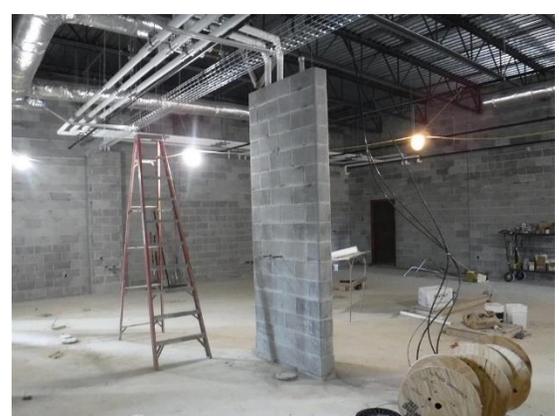
- r) Overhead mechanical/electrical work has been installed in the kitchen.

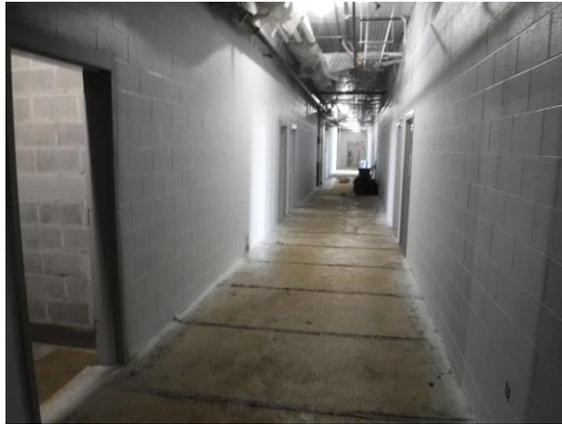
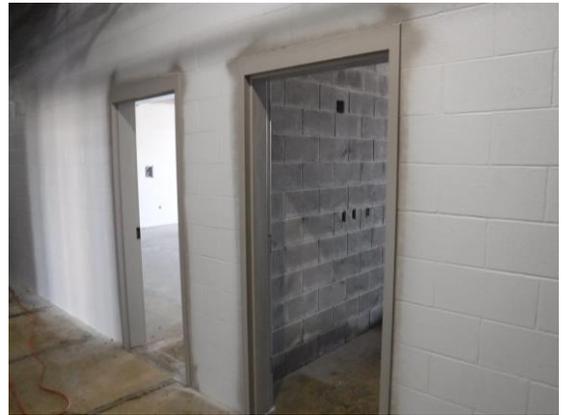
- s) The corridors walls and door frames in Area C have been given the first coat of paint over the block filler. The door frames have been sprayed. The final quality of the finish will depend on the amount of preparation given to smooth the metal. Due to the lack of temporary lighting it is difficult to determine the quality of the paint work. Since water has entered the building, the painter has expressed concern over the negative impact the moisture will have on the paint.

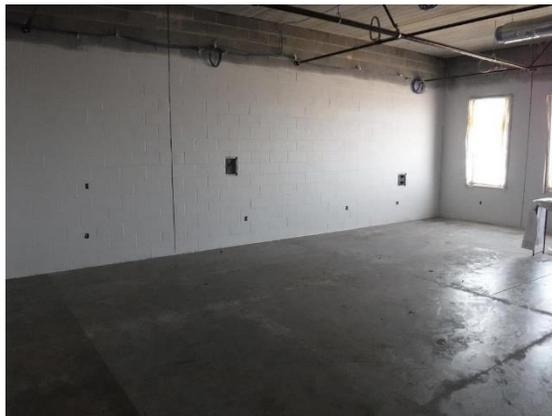
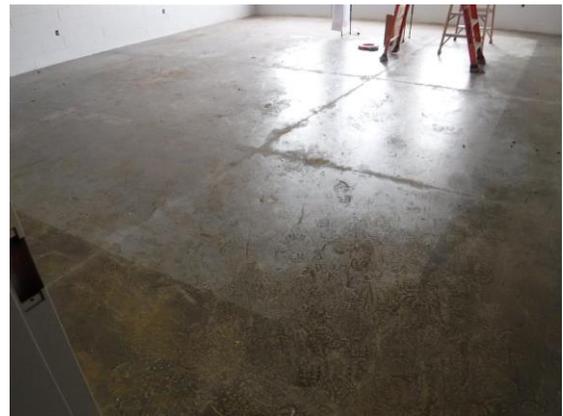
- t) The field color of paint is a white tint making the rooms very bright. The painters masked the floor around the base of the walls. There was overspray that hopefully will not affect the polishing of the concrete.

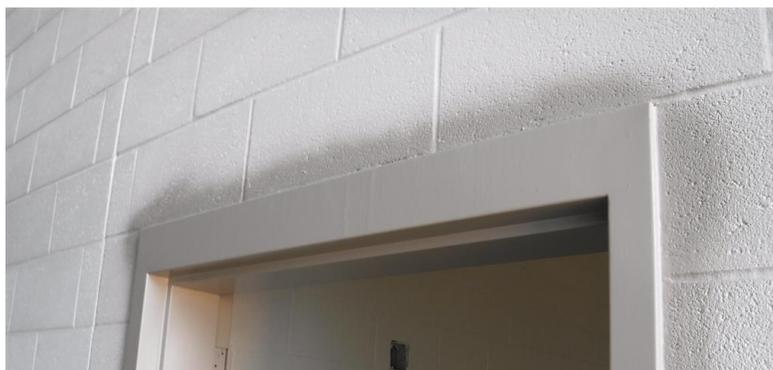
- u) This frame for Resource 143 will need to be sanded and repainted.

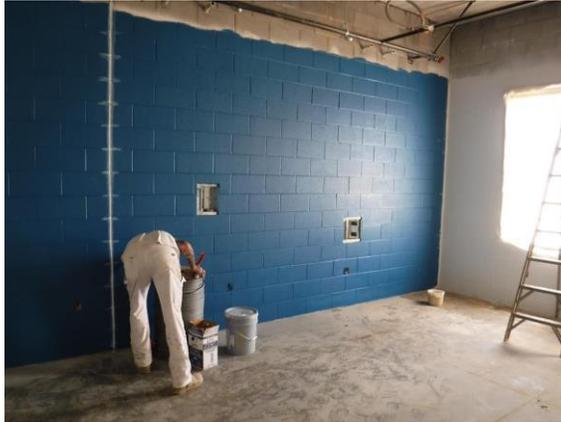
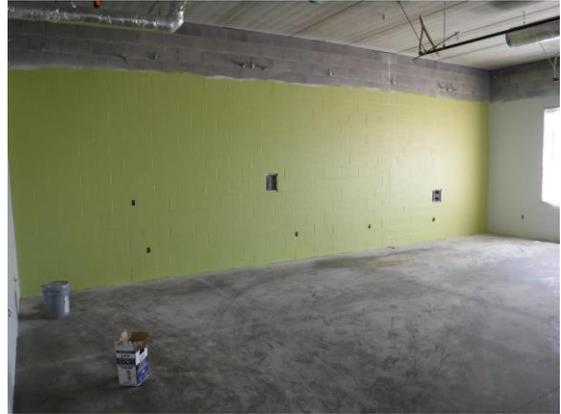
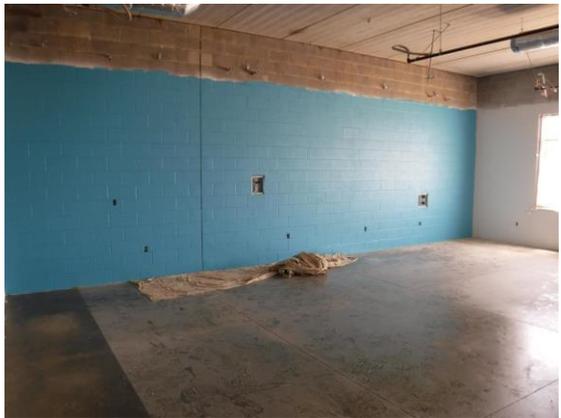
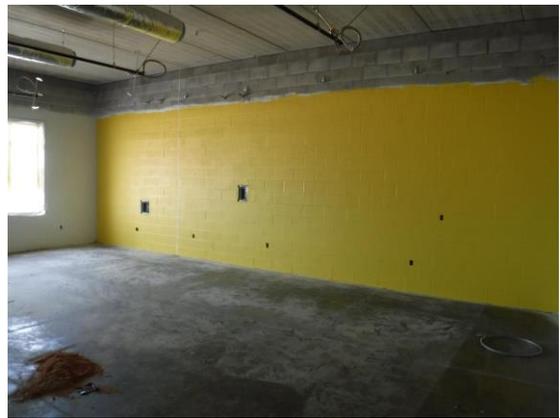
- v) There are four accent wall colors. The painter needs to refer to the ASI issued by JRA for color changes in rooms. Two of the original colors were deleted in the final color selections and one of these four colors was substituted.

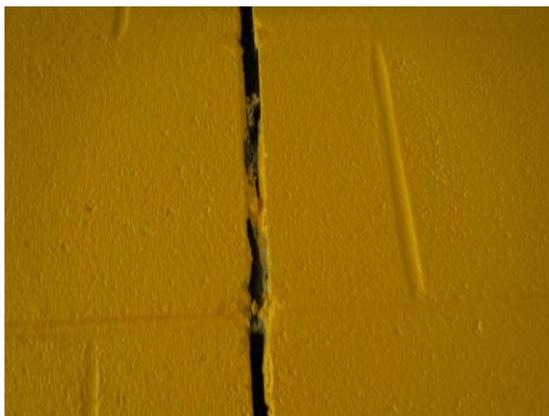
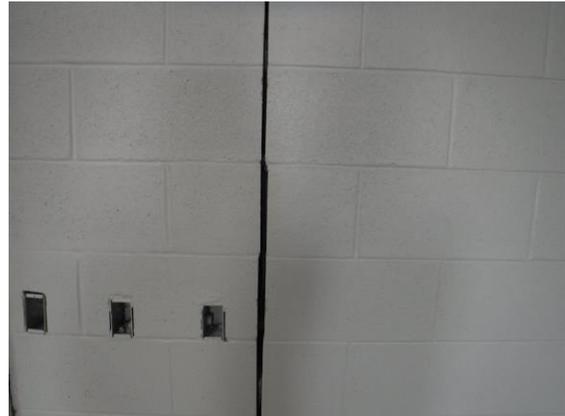
- w) The painter complained that the control joints were not properly prepared by the mason. I agree with the painter. The joints are not straight, not even and filled with mortar. This needs to be corrected before the joints are caulked.

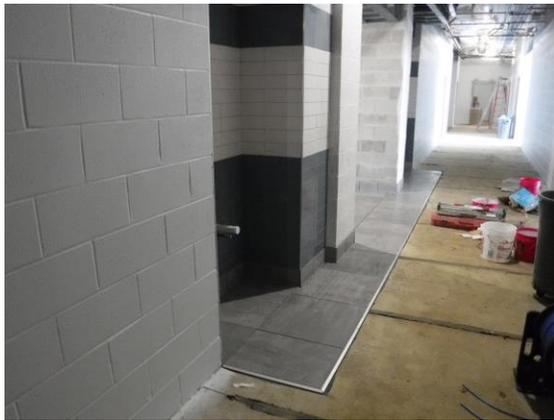
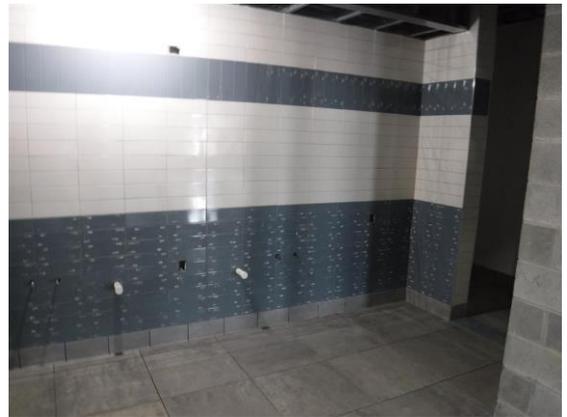
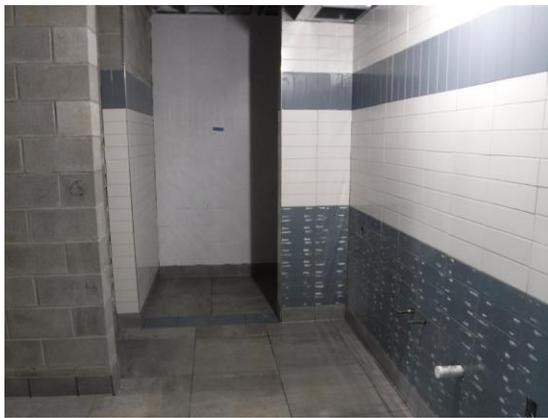
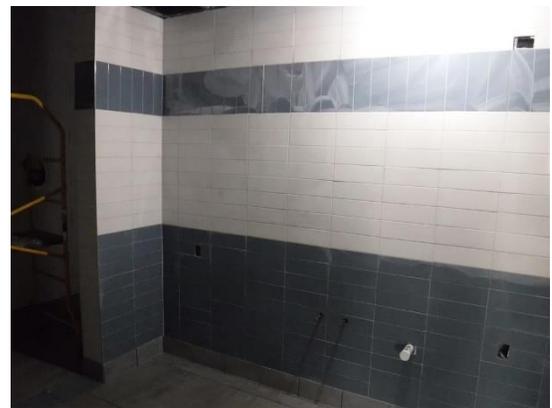
- x) The ceramic floor and wall tile has been installed in Area C. The work looks good so far.

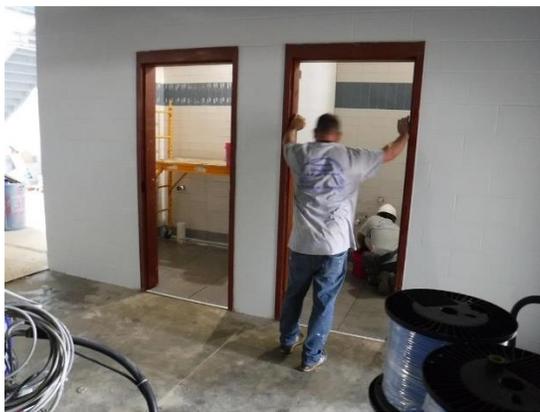
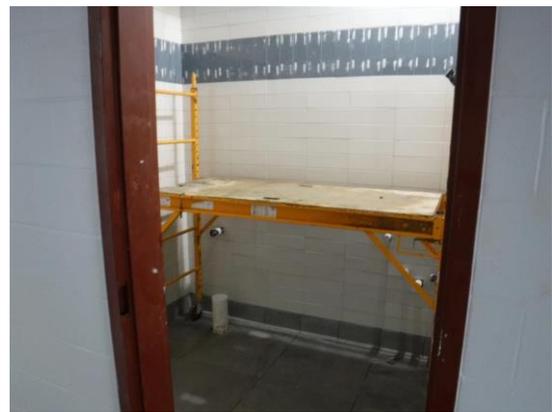
- y) Ceramic floor and wall tile is being installed in the staff toilets.

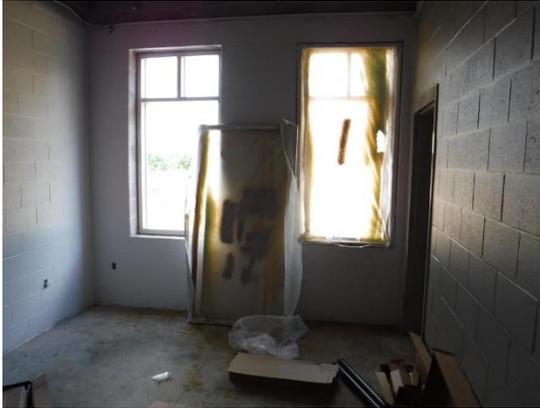
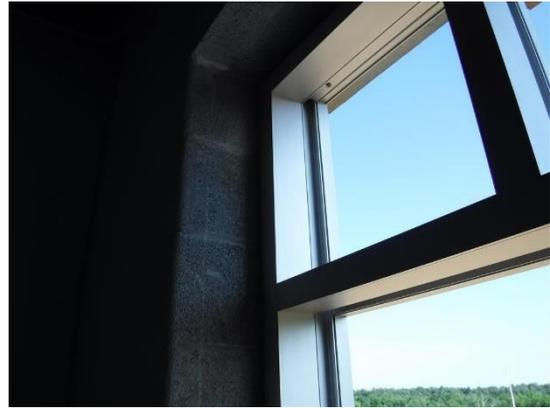
- z) The aluminum window frames are installed in Area C but the glass is not installed. The temporary coverings must be kept in place to keep water out of the building.

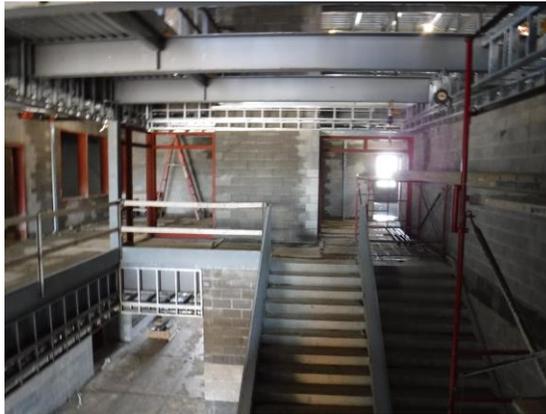
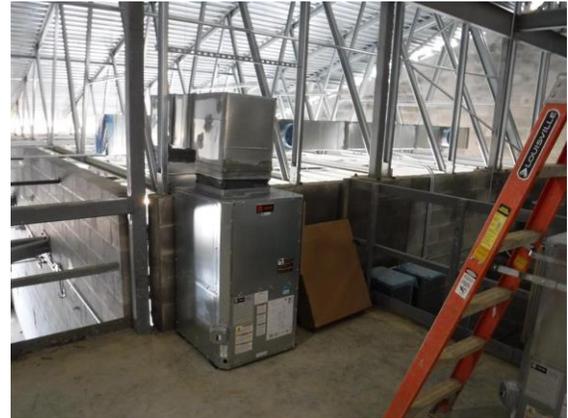
- aa) Area B is finally covered with metal deck and soon will have the permanent roofing system installed.

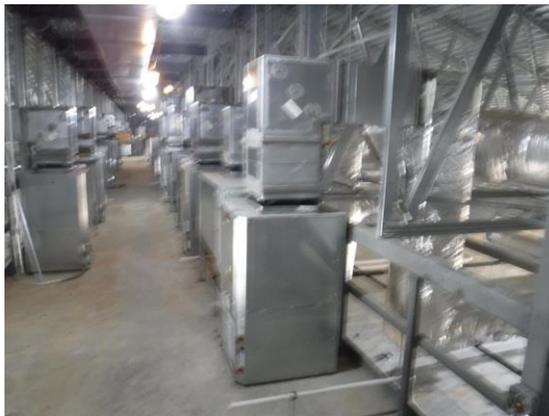
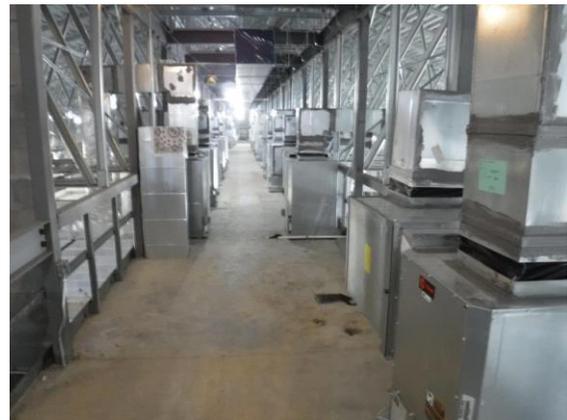
- bb) HVAC installers continue to add heatpumps on the mezzanine above Areas B and C and then making duct connections to for ductwork serving the rooms below.
