## FIELD OBSERVATION REPORT

East Hardin Middle School, Hardin County Schools, Elizabethtown, KY 201752.01 -CA8

Date: 8/14/2020

Report No: 29

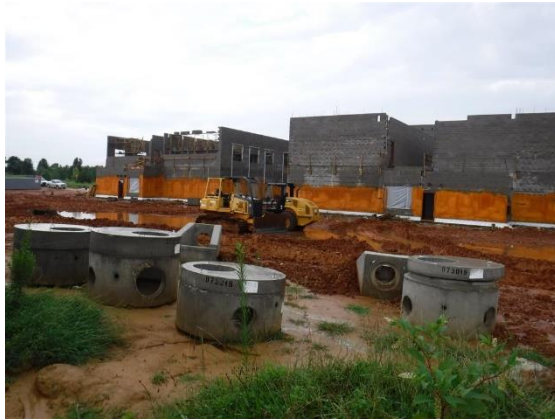
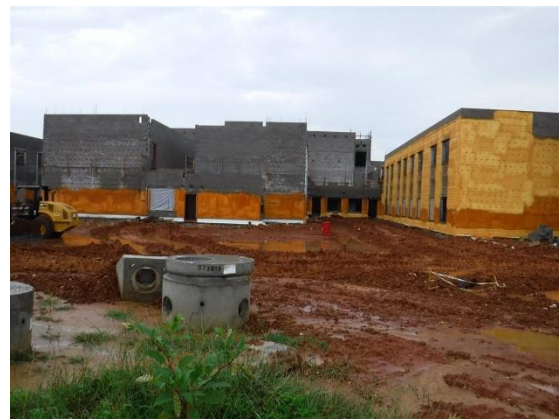
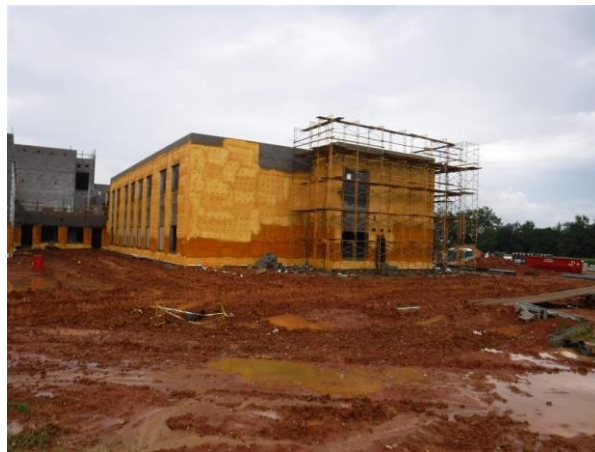
- b) The three classroom wings are approaching top of wall heights with the wing in Area B at the back of the building the closest to being able to receive roof trusses.

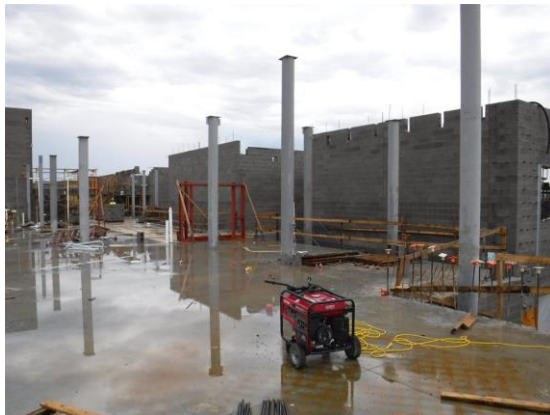
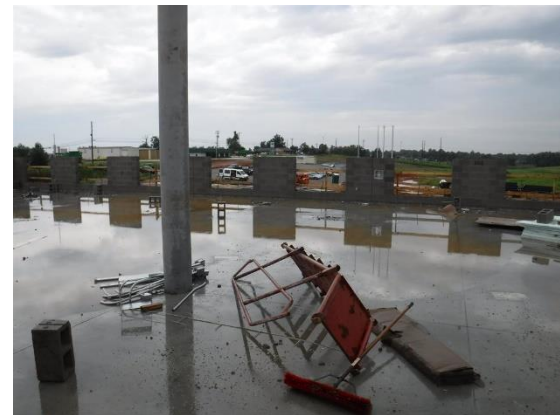
- c) Most of the remaining blockwork is at the front of Area A on the second floor including the completion of the classroom wing and the Library/Media Center interior and exterior walls. They were grouting the classroom wing walls while I was on site. I have not heard an update from Doyle about the reconstruction of the piers at the LMC exterior.

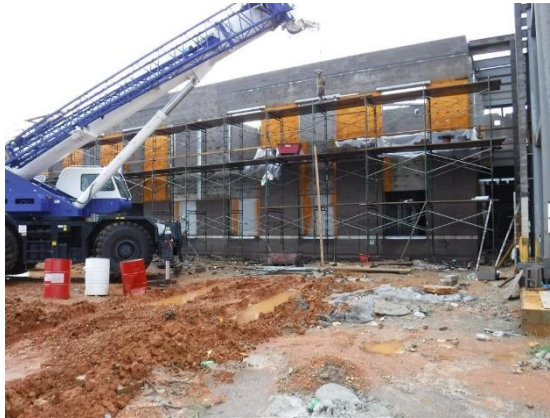
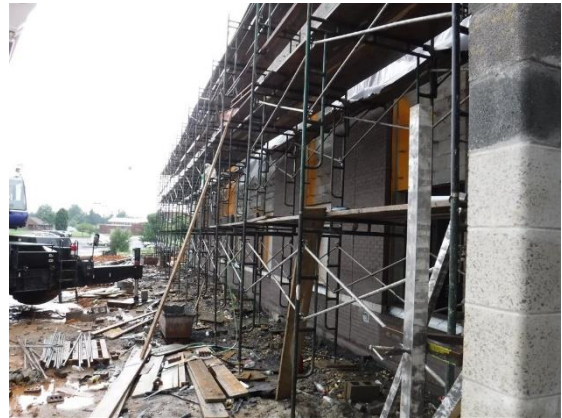
- d) Masons had begun laying brick on the back of the Area B classroom wing. They were not present in this area while I was there due to the rain. The brick is almost up to the first floor window heads.

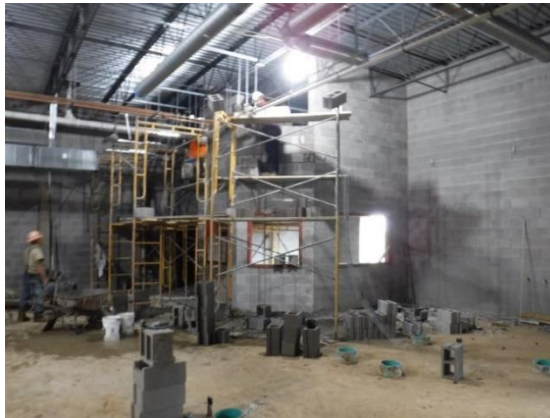
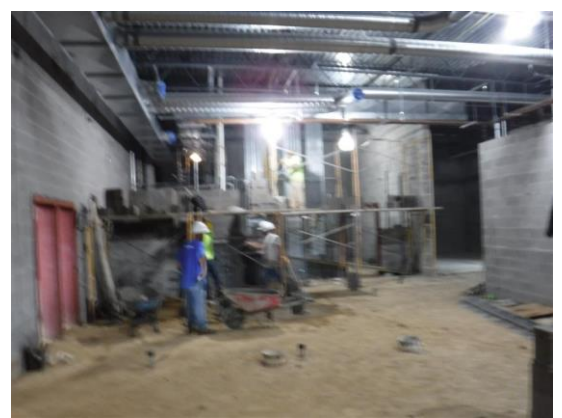
- e) Masons were laying block at the office area and dry food storage room in the Kitchen since it was out of the rain.

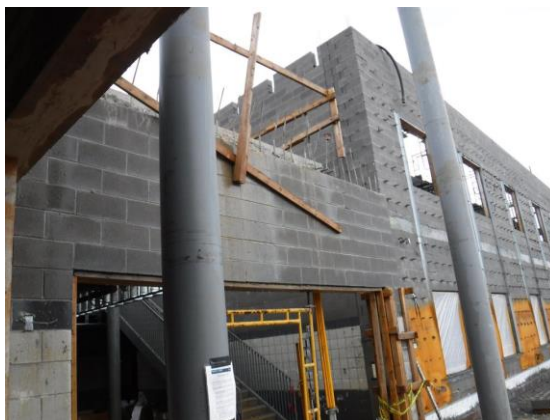
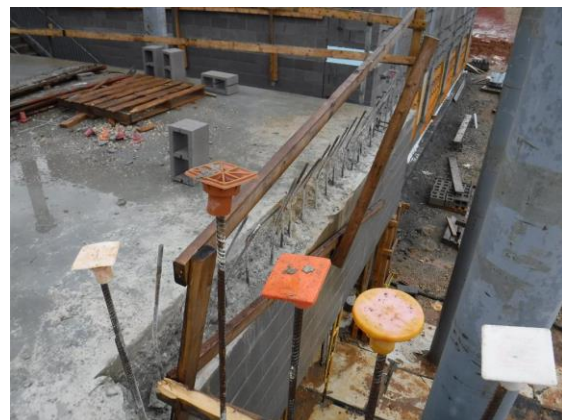
- f) The block and slab overpour at the main entrance had been removed in preparation for the installation of the block per the structural detail.

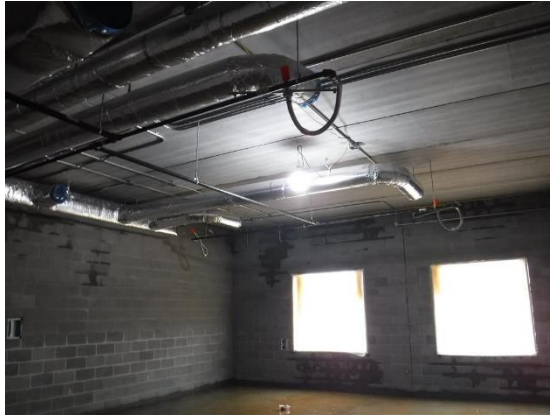
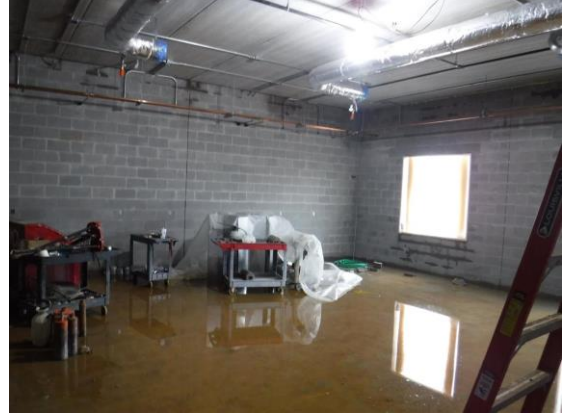
- g) The mechanical, plumbing, electrical and fire suppression contractors continue to install rough-ins in above ceiling spaces that are available.

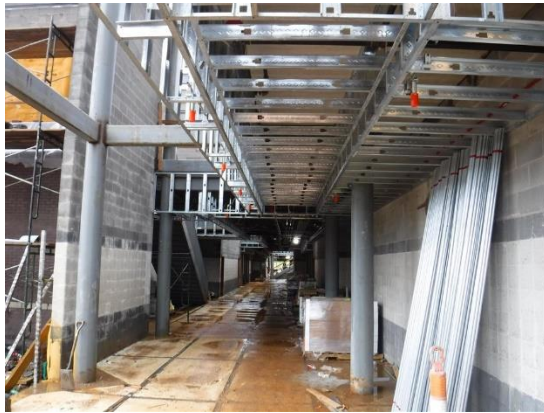
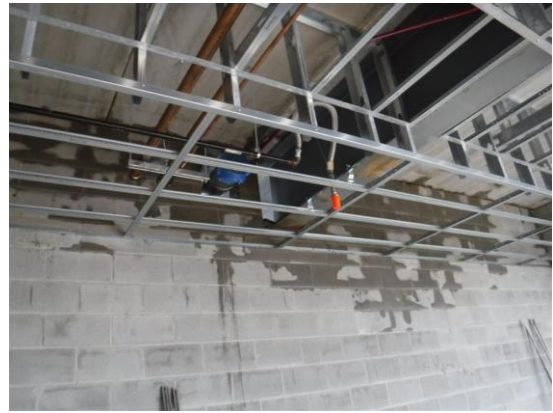
- h) Metal framing has been installed down the main corridor for soffits.

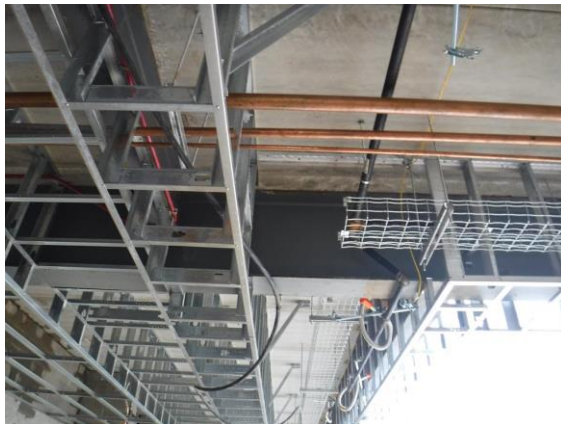
- i) In the Progress Meeting, GBMC discussed their proposal to offset and run their piping through the classrooms. Now that the soffit framing is on place, it appears that there is room to run this piping in the soffit. This is being verified by the mechanical contractor.

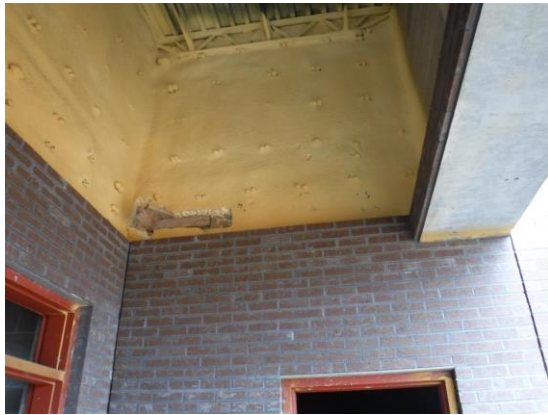
- j) The spray foam insulation needs to be repaired above the soffit at the loading dock.

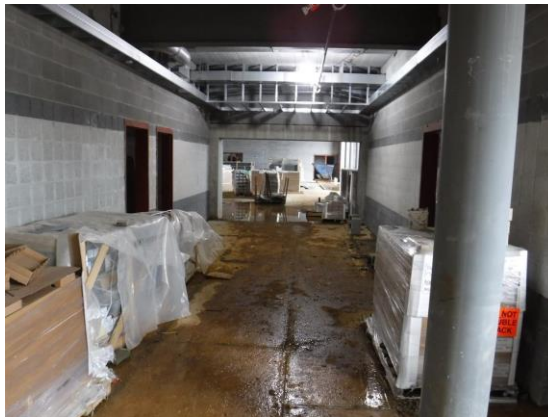
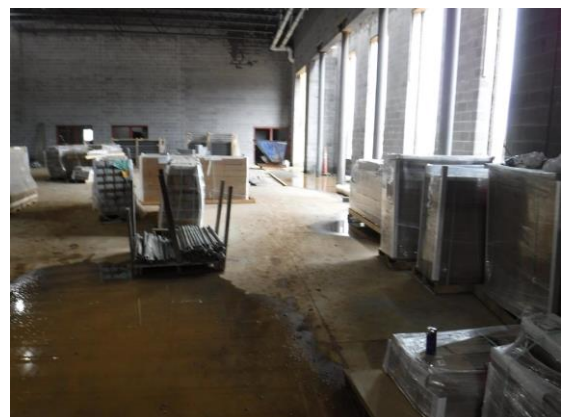
- k) On a wet day like this one, water is in spaces that have been recently fairly dry such as the Cafeteria. They are in the process of applying plastic over the window openings. This needs to be done in the Cafeteria.

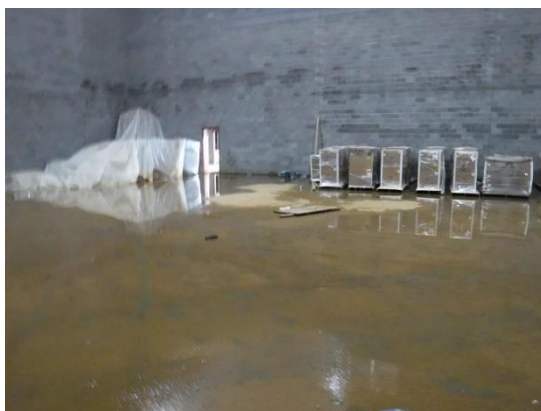
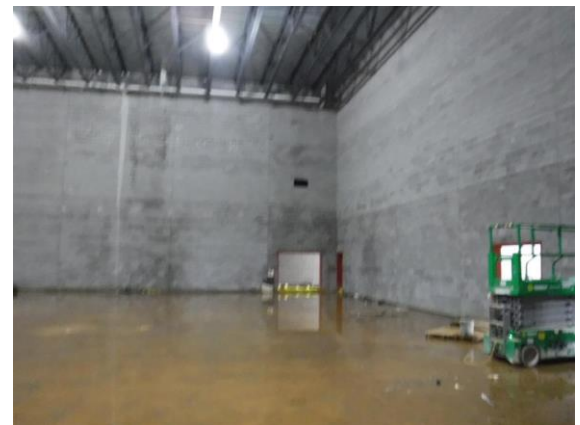
- l) In spite of the rain, the Gym was drier than I have recently seen. Alliance had provided a sump pump shop vacuum and it had removed the water to the lowest level it could pump. There are areas where the floor is completely dry. They had sandbagged the door openings and the roof is now dried in. Very little water was getting in while I was there.

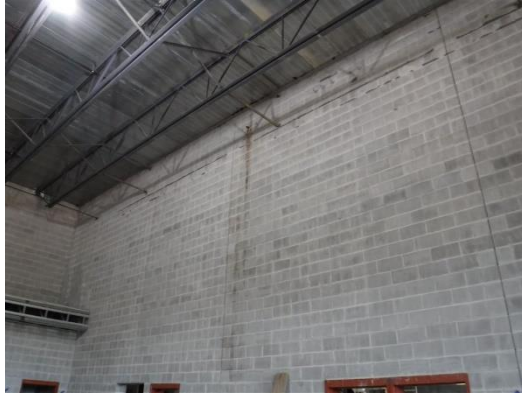
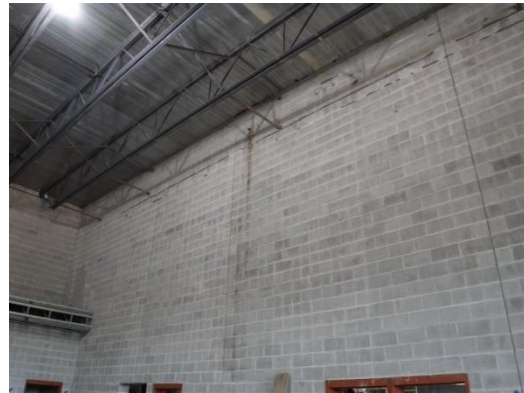
- m) Asphalt from the roof ran down the block wall in the Cafeteria. The roofer needs to clean this off of the block so it does not show when the wall is painted.

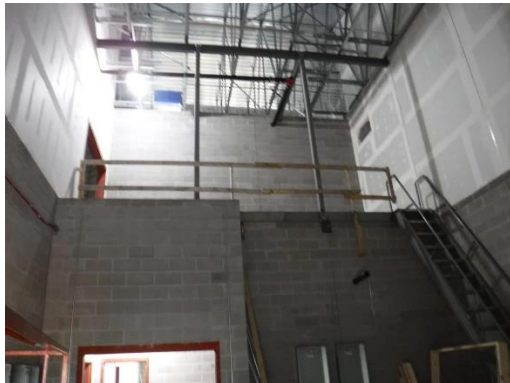
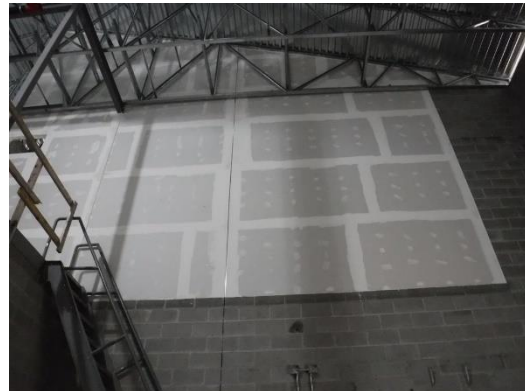
- n) In the Mechanical Room, drywall partitions have been extended up to the roof. The door on the mechanical platform was relocated to facilitate the removal and installation of equipment on the platform. A proposal is being considered that will add a slab over the double door recess and a beam for a chain hoist to lift the equipment on and off of the platform. Doyle reported on the discussion in the progress meeting about the supports for the piping out of the room to the platform. There are supports on the platform but the roof trusses over the room cannot support the pipes from the room to the supports. Mike Childers is reviewing a solution to this issue.

- a. Maintain the Skudo system so that it protects the corridor slabs.
- b. Clean mud and rust off of steel, and reprime areas where the primer was scraped off of the steel.
- c. All trades shall keep the building and site clean by properly disposing all bottles, bags, wrappers, trash, debris, etc.
- d. Verify service access for heat pumps on the mechanical platform around the Gym.
- e. Determine structural supports for the piping from the Mechanical Room to the platform above.

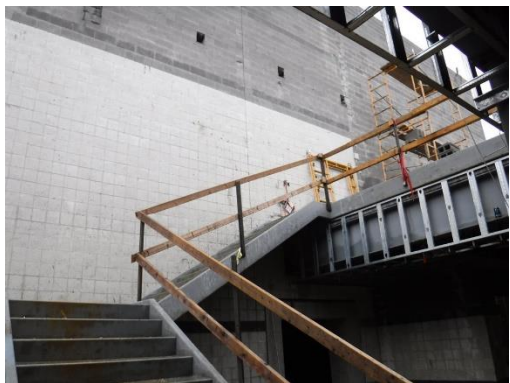
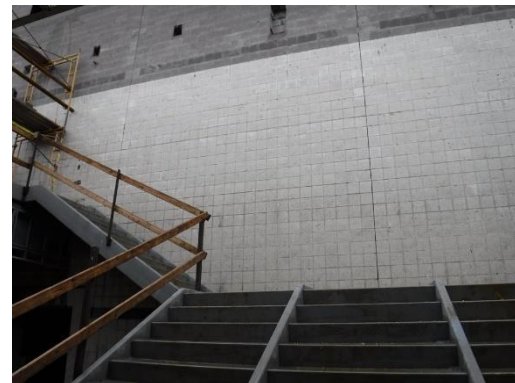
- o) Splatters on the ground faced block at the central stair need to be removed.

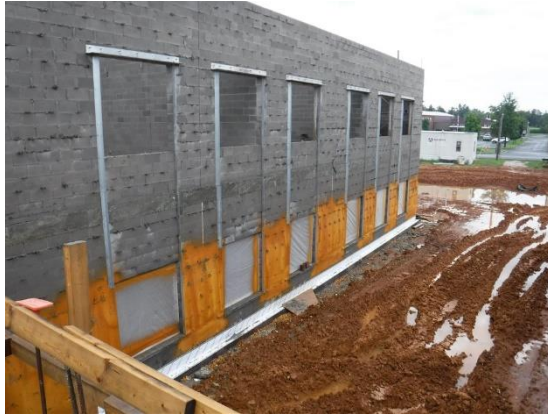
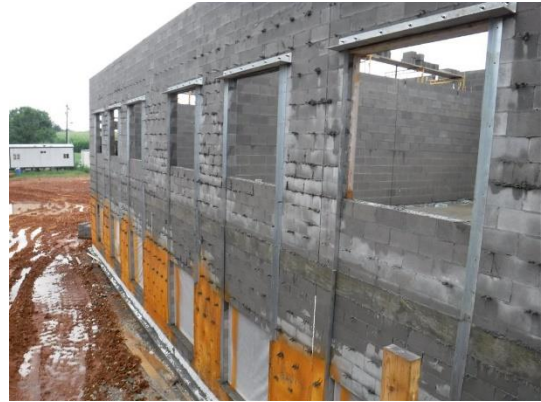
- p) The classroom wings are approaching completion. Window closure angles and lintels are in place. The brick below the base flashing has been laid, sprayed insulation is up to the tops of the first floor window openings,

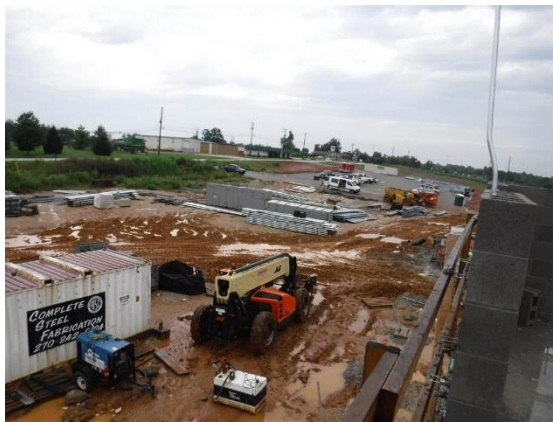
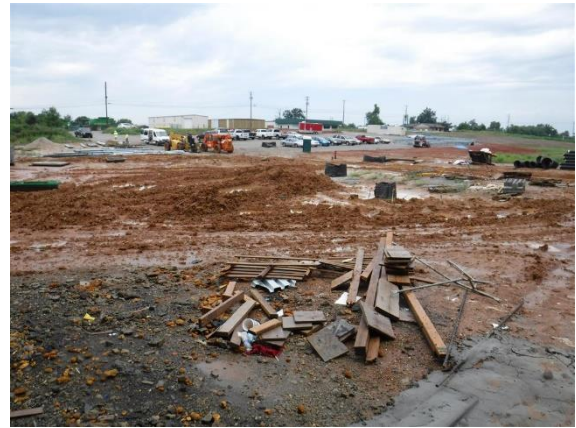
- q) Even on a rainy Friday afternoon, there were a number of vehicles in the contractor parking area. Some workers were working out in the rain.

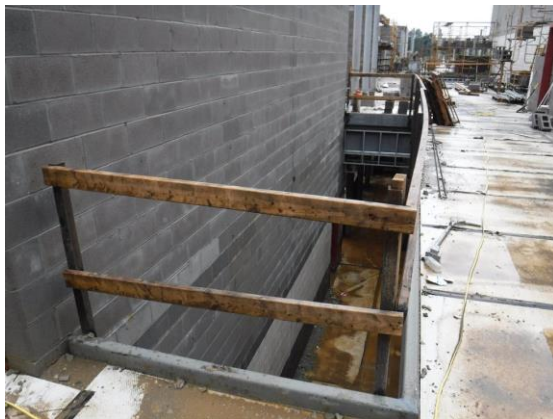
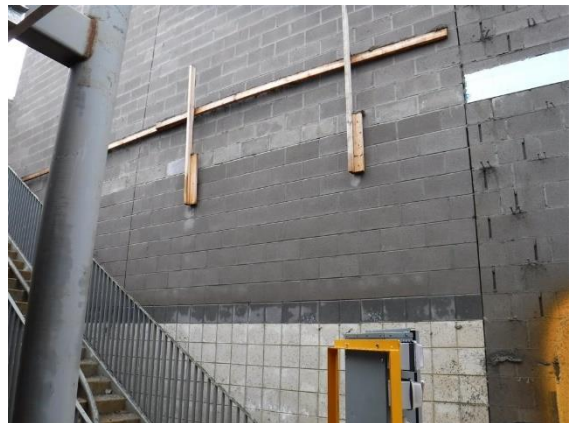
- r) The two story high walls in the floor openings have been corrected so only block is showing. The concrete slabs were cut back and block soaps laid to correct this condition.

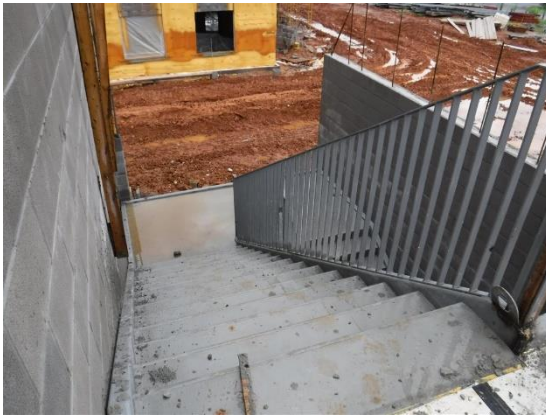
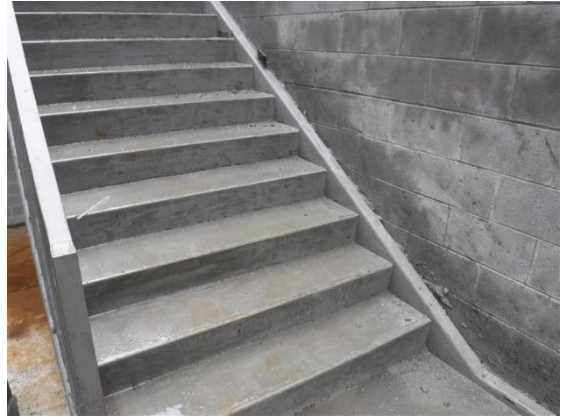
- s) The exit stairs at the ends of the classroom wings in Area A have been installed.

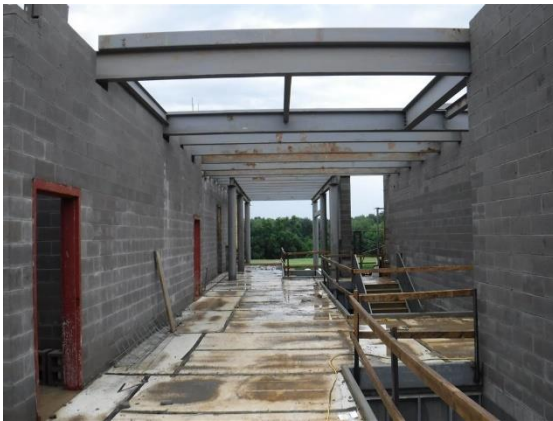
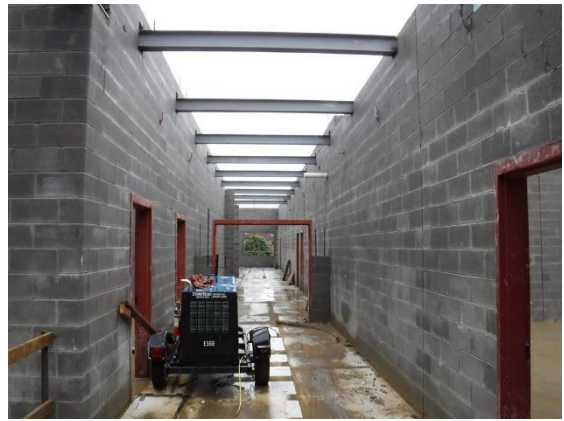
- t) Steel framing for the mechanical platforms has been installed over Area B.

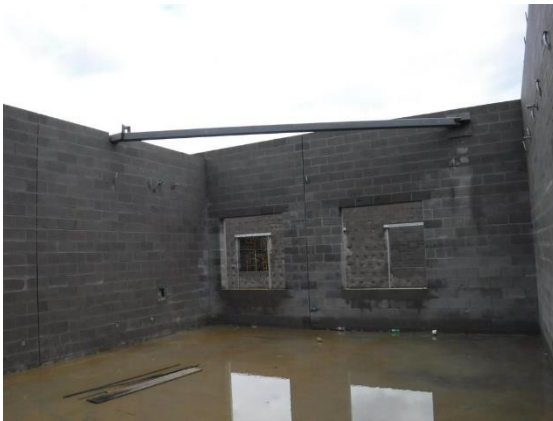
- u) Seismic wall bracing has been installed over the second floor classrooms in Area B.

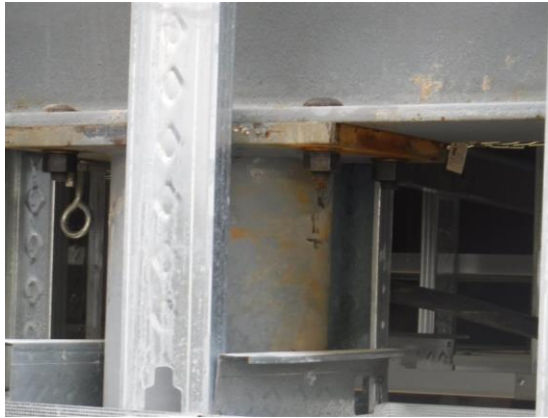
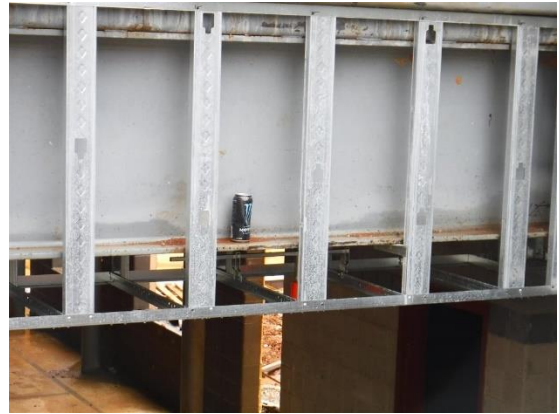
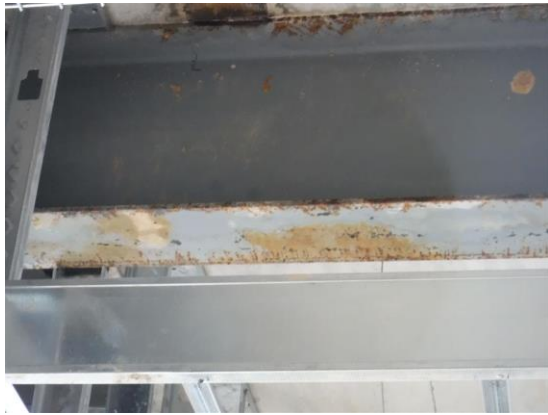
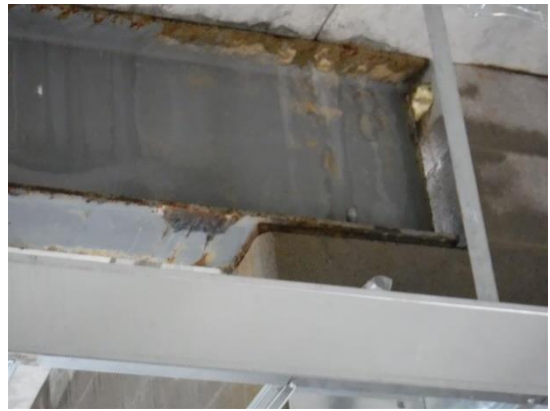
- v) Even though several reports have cited steel members that have considerable rust and mud on them and I was told this would be corrected, I saw many places where soffit framing is now covering the structural steel. These members must be wire brushed and the primer repaired before drywall is installed.

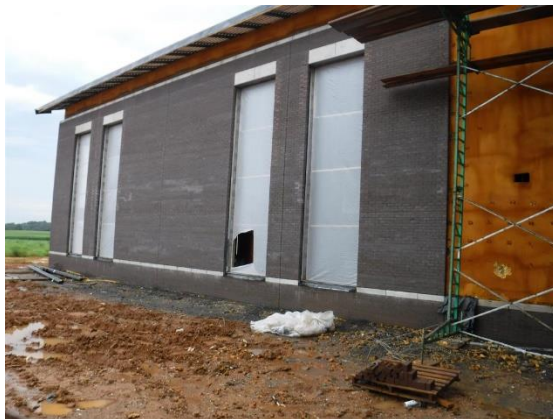
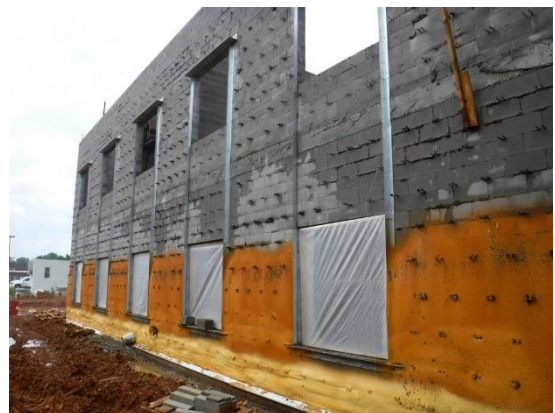
- w) Some of the window openings have plastic over wood frames to keep water out of the building. Some of the plastic is torn. A effort must be made to keep these openings sealed an water out of the building.

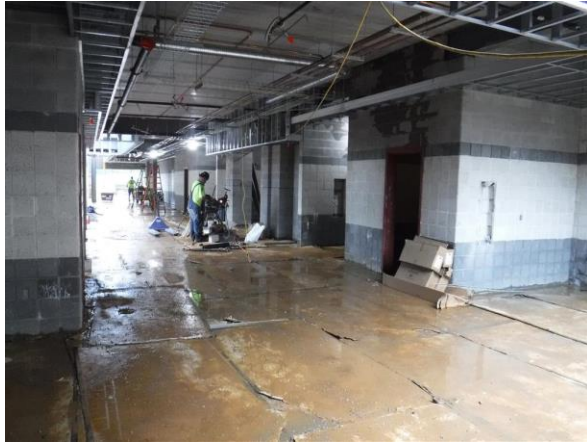
- x) There was enough rain that the top layer of the Skudo system was floating on the water. Keeping this system in place in an open building is difficult under the conditions you would expect to have during construction,

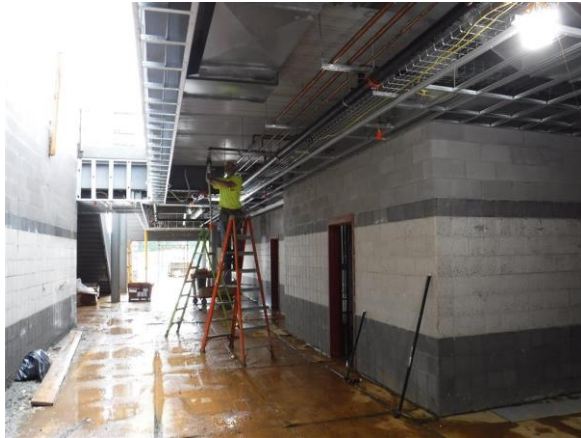
- y) The fire suppression contractor was installing piping on the first floor.

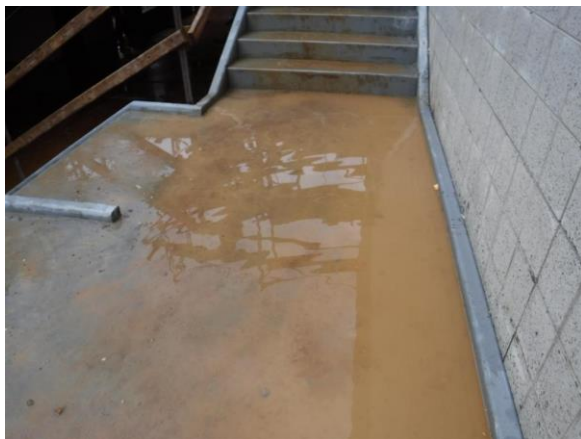
- z) The landing of the central stair was holding a considerable amount of water toward the wall.
