## FIELD OBSERVATION REPORT

Lincoln Trail Elementary School, Hardin County Schools, Elizabethtown, KY 201752 -CA8

Date: 8/14/2020

Report No: 29

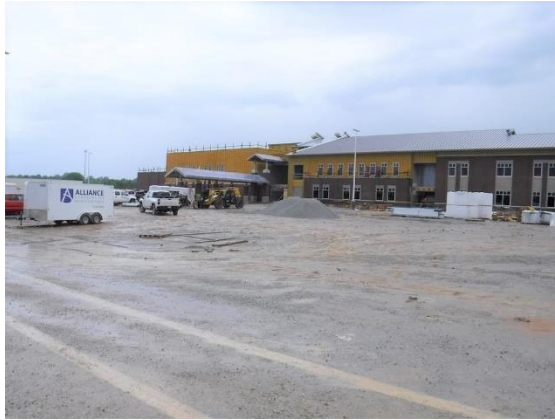
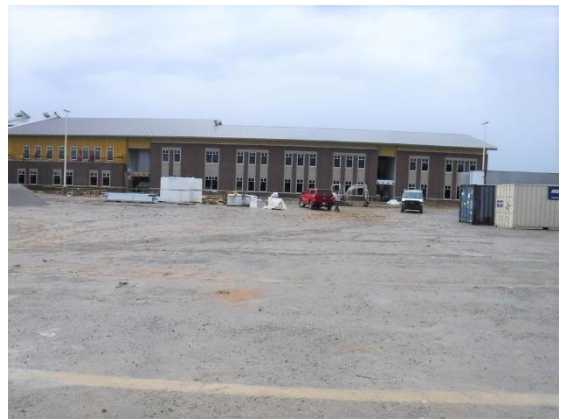
- b) From the front of the site, the remaining exterior work required is apparent. Cover the Cafeteria walls with composite panels, finish the standing seam metal roofing, install the aluminum entrance including doors and install the downspouts. Also note that the front of the site has been cleaned up of the masonry debris noted in my last report.

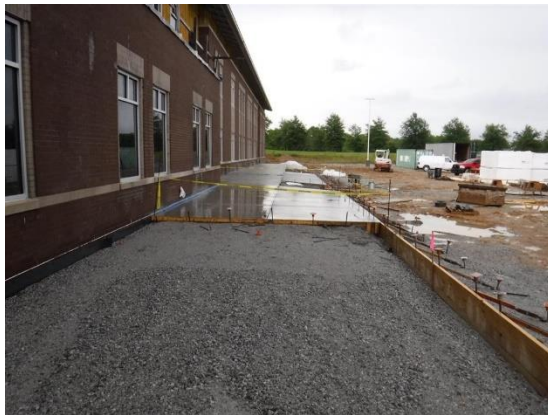
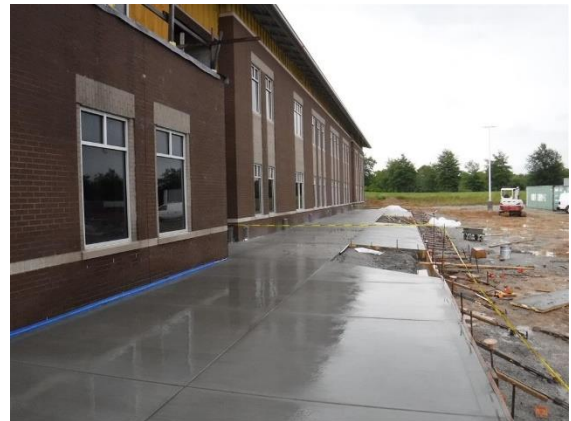
- c) Concrete walks have been poured in front of Area C and half of Area B. This provides the base for the aluminum entrances as requested by the window installer. It also provides a place for the water falling out of the gutters to land this preventing mud from splashing on to the brick. This is not the case at the east end of Area C where there is no walk.

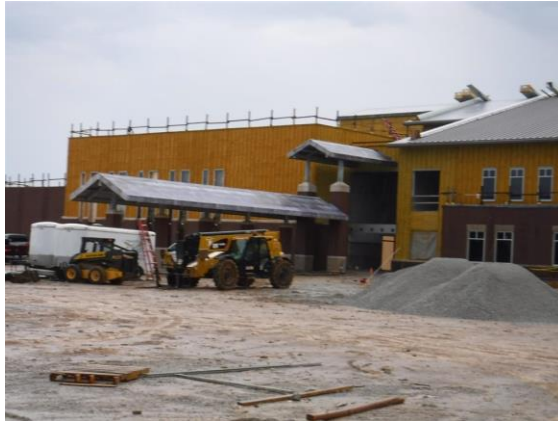
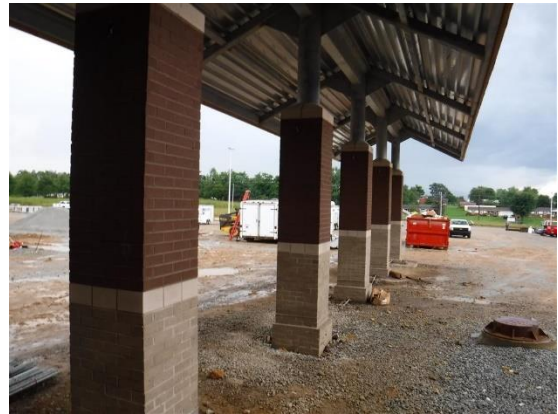
- d) The main canopy is complete except for the metal roofing, painting and electrical work.

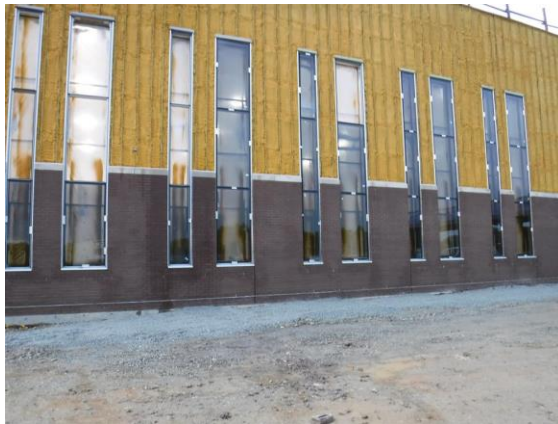
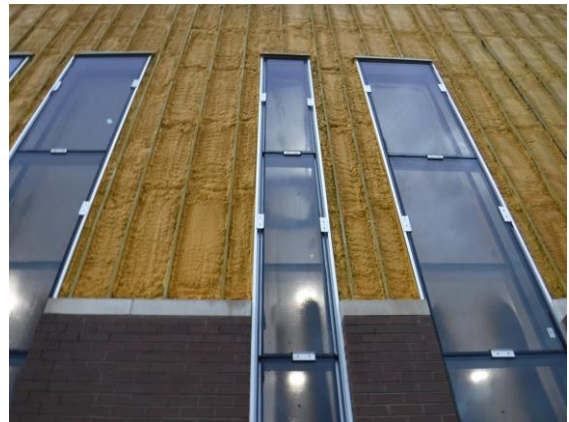
- e) The interior aluminum frame for the Cafeteria windows are in place along with the glass units. The spray insulation will be covered the intumescent fire proofing and then the composite fiber cement panels.

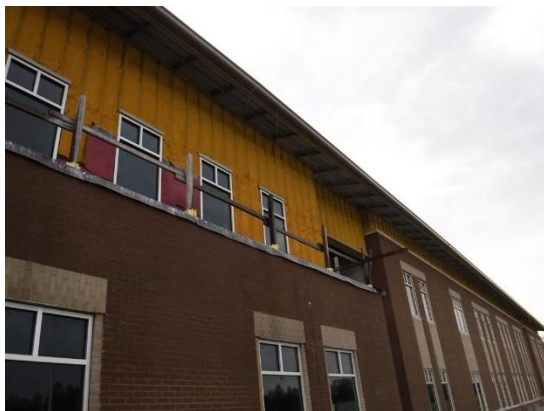
- f) The second floor of Area B and top of Area C will be covered with the composite panel system.

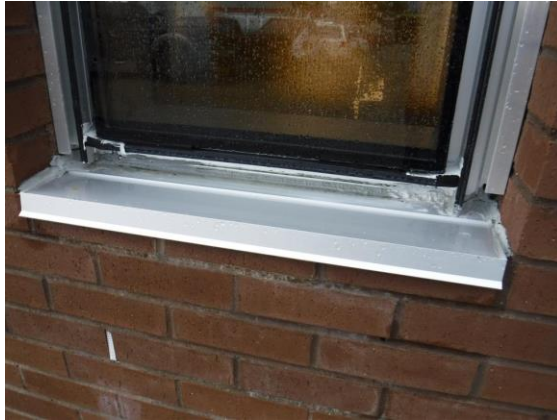
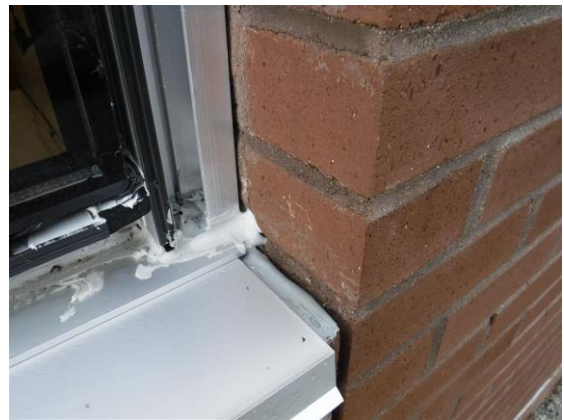
- g) The windows have been sealed to the brick. This appears to be a temporary seal that will be covered by the face caps. All joints will need to be completely sealed to the brick. All exposed sealant must be evenly tooled and must provide a finished appearance.

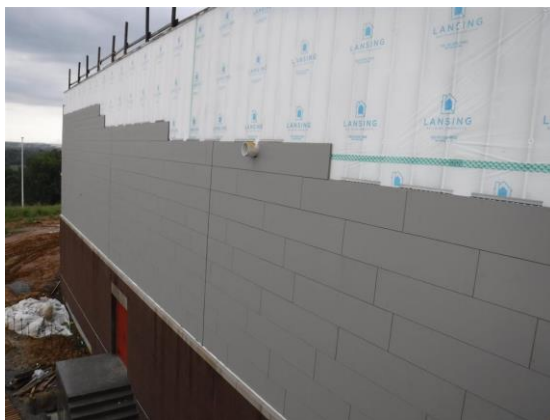
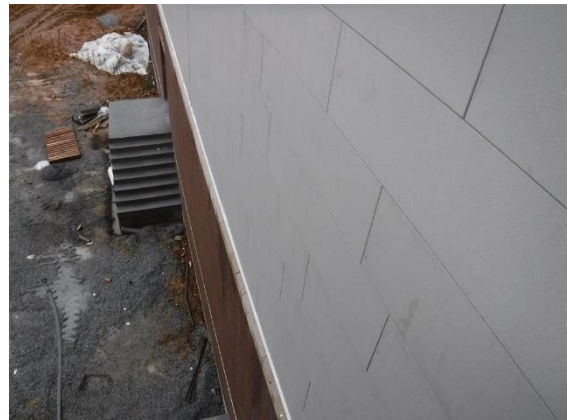
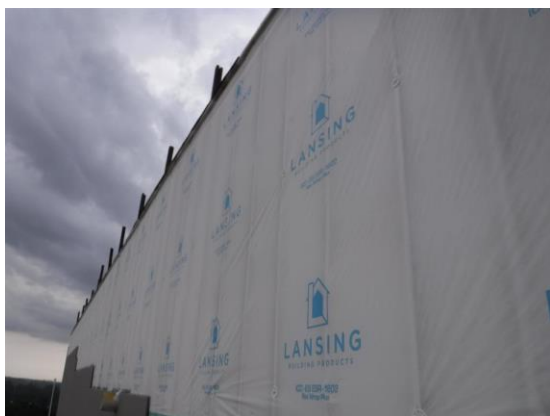
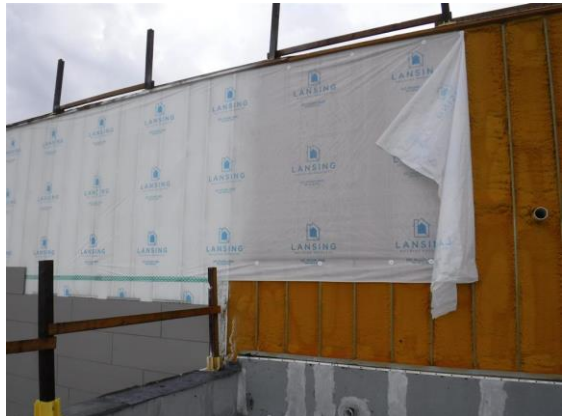
- h) The fiber cement composite panel system is installed on the west side of the Gym. The joints are even, the panel are in plane and are level. Note that the vapor barrier was extended over the exterior wall above the Kitchen without applying the intumescent fire proofing. This must be applied before proceeding with this area. Also note that the concrete exterior exit stair for the Gym has been construction.

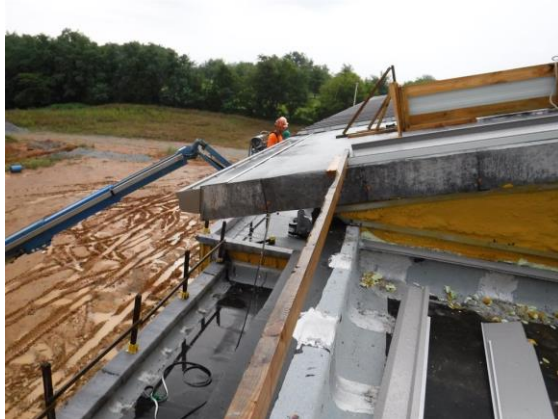
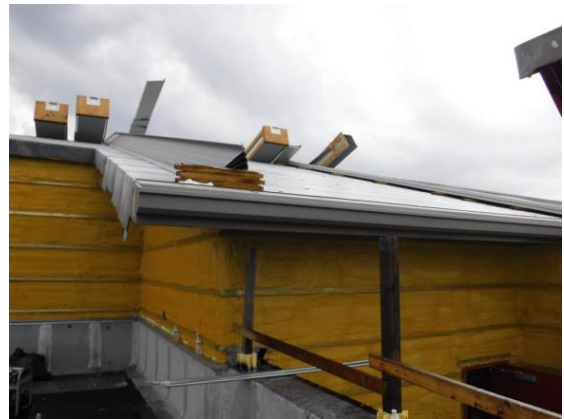
- i) The roofer was completing the sheet metal fascia and gutter on the north side of Area B. Once this is complete, the standing seam metal roofing can be completed.

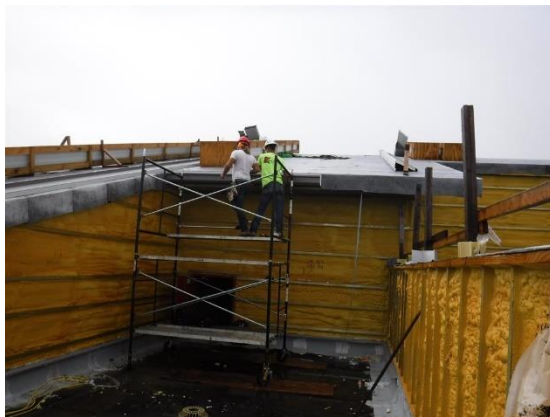
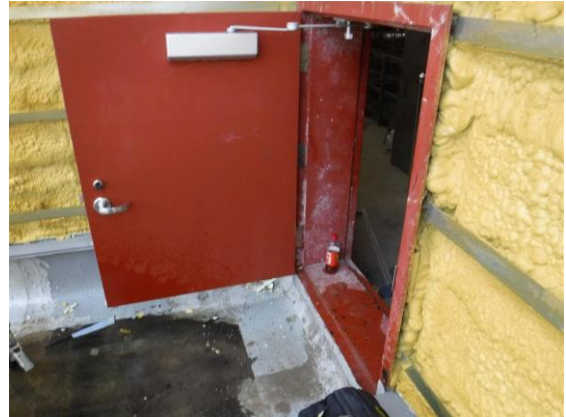
- j) Roofers were completing the fascia and gutter at the west end of Area B. Their scaffolding was properly located on plywood protection panels on one side and on the roofing membrane on the other. The hollow metal door and associated hardware to this roof area has been installed.

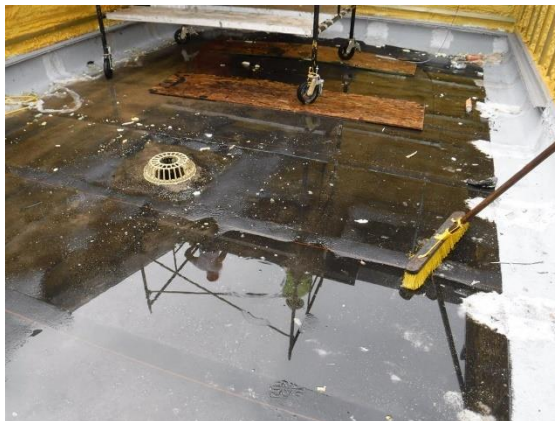
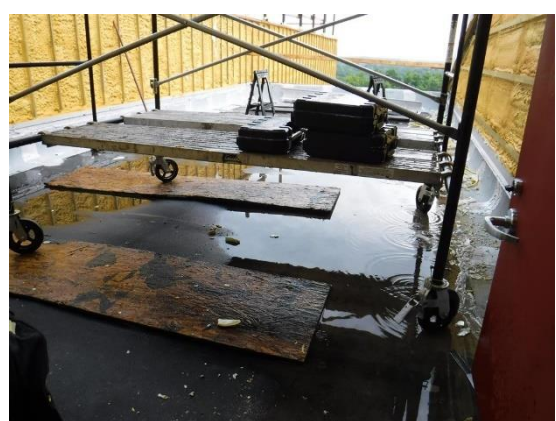
- k) It was raining when I took these pictures. There was a considerable amount of water ponding on the roof. It appears that the roof does not slope to the drain sump.

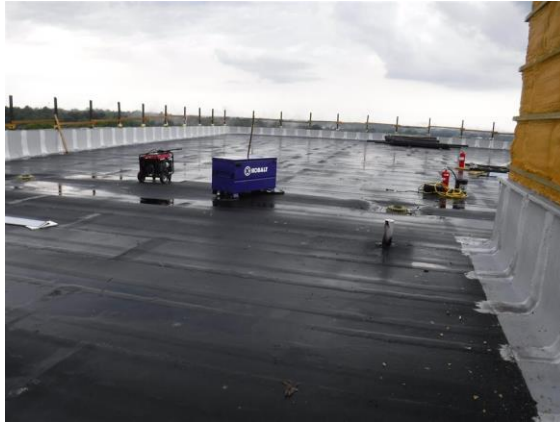
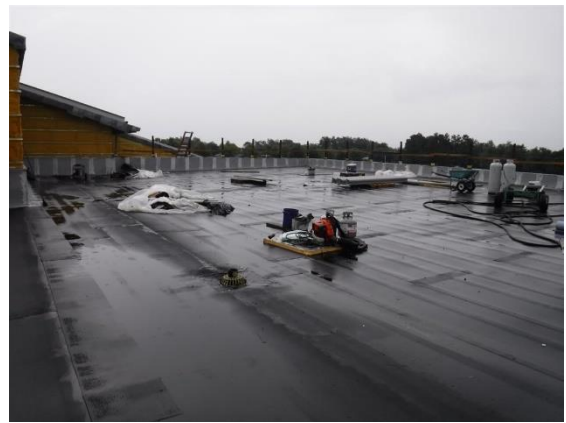
- l) The low sloped roofs over the Gym and Cafeteria appear to drain well while rain is falling.

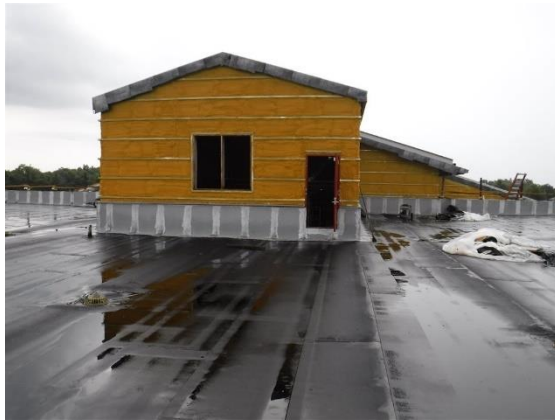
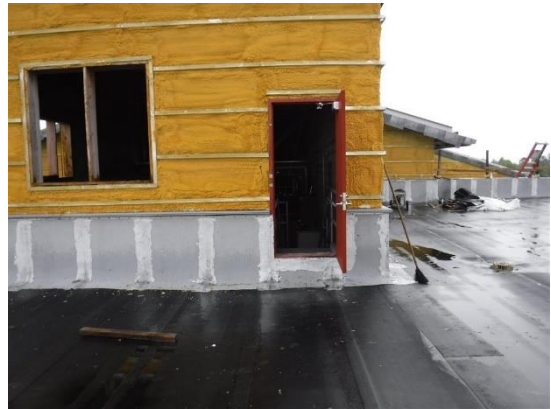
- m) The door to the Gym/Cafeteria roof is now in place. This opens into the mechanical platform above the second floor. The opening in the middle of the exterior wall is for the louver for the energy recovery/makeup air unit.

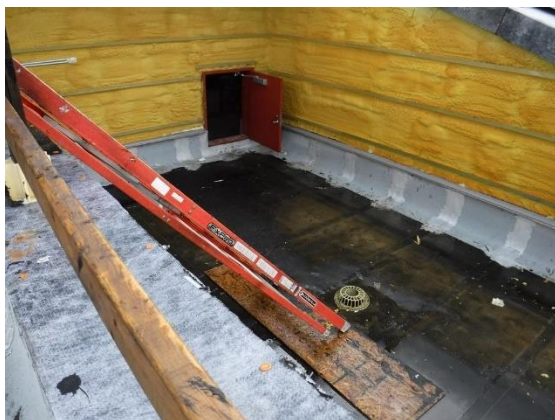
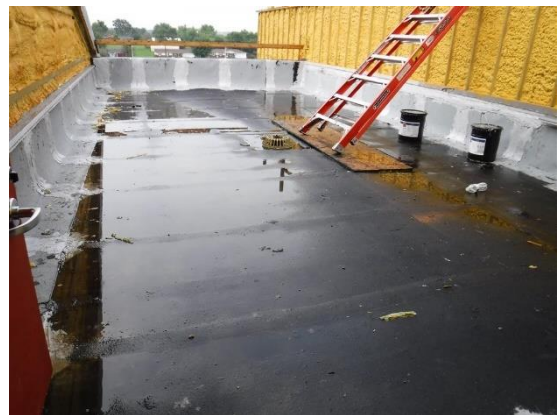
- n) The low sloped roof over the front entrance appear to drain well. The door to the mechanical platform is in place. The work ladder to the sloped roof was properly placed on a protection board.

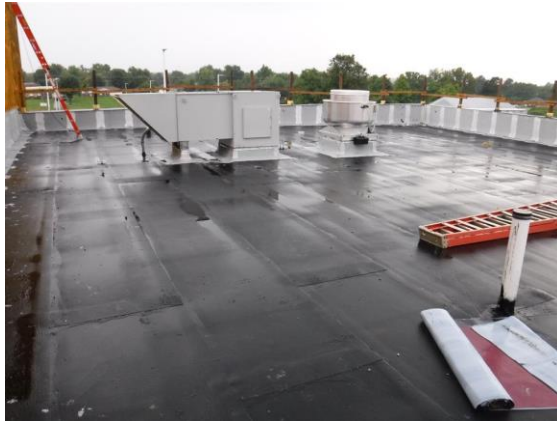
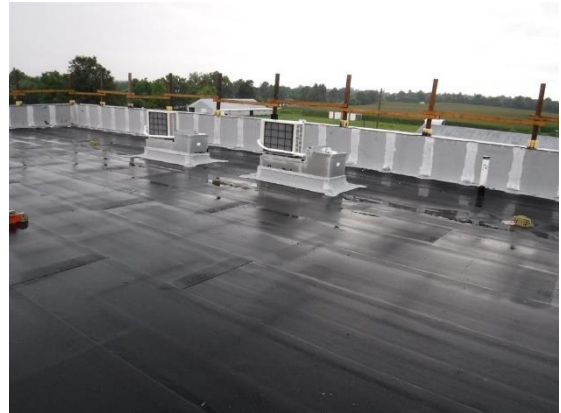
- o) The range hood exhaust unit and the refrigerant units for the walk-in coolers are in place over the Kitchen roof.

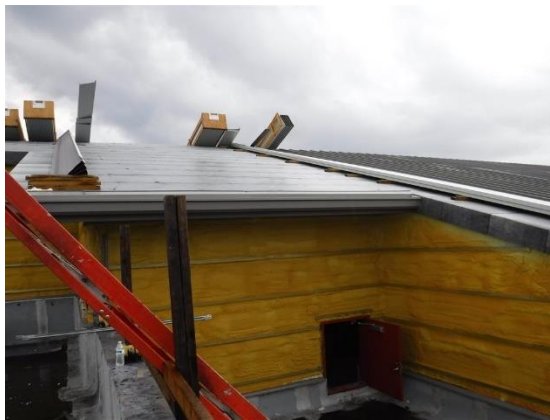
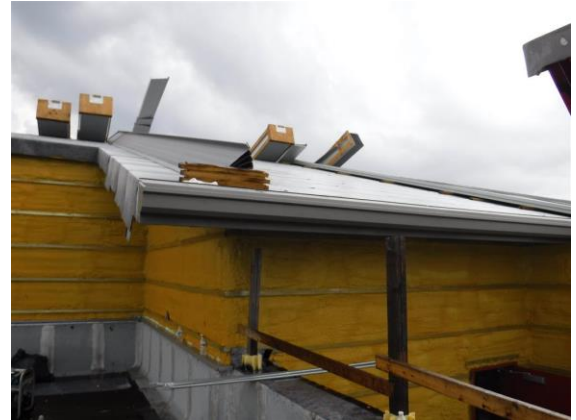
- p) The standing seam metal roof remains to be installed over the west end of Area B and the roof over the mechanical space over Area A. The composite panel system remains to be installed..

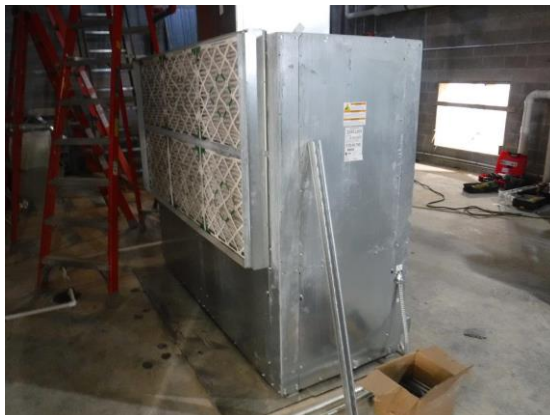
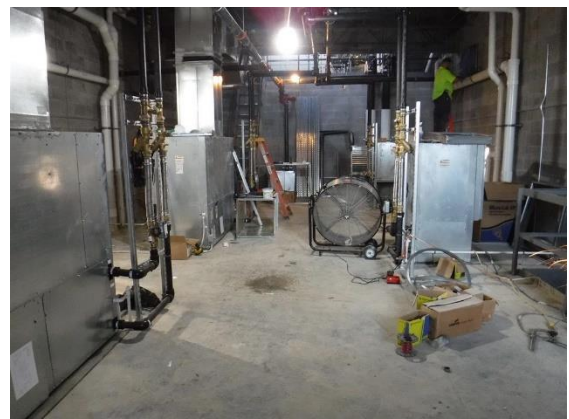
- q) The heat pumps serving the Gym and Cafeteria are in place in the second floor mechanical room.,.

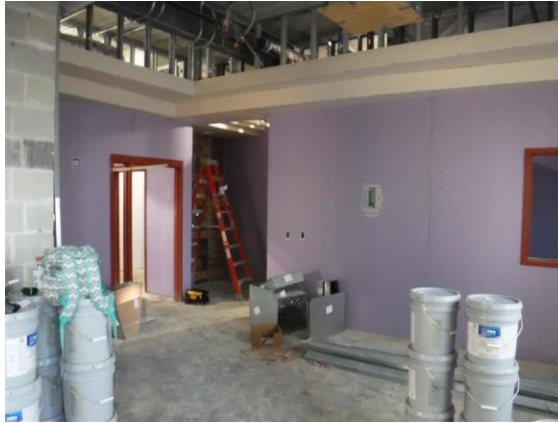
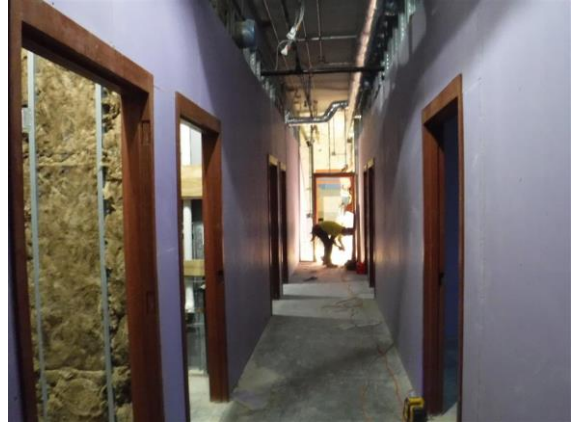
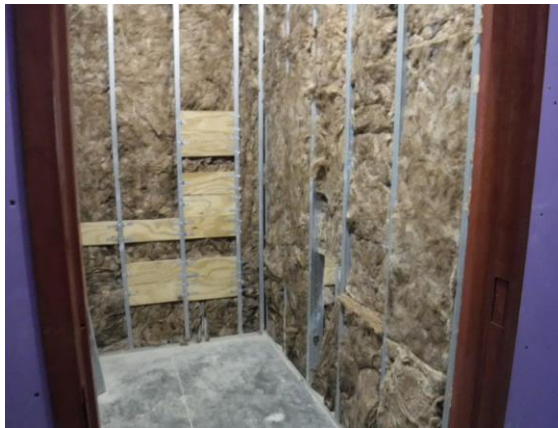
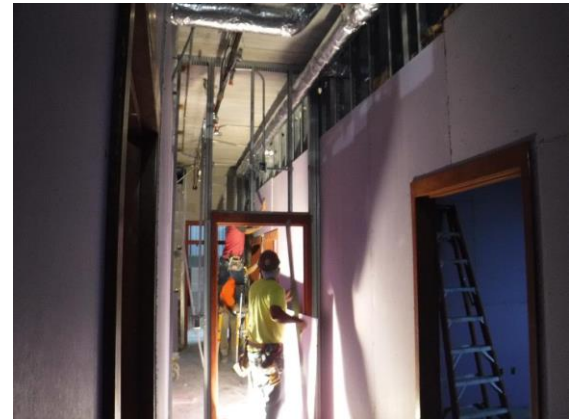
- r) Water resistant drywall was being installed in the administrative area. Mineral wood sound insulation is required in the stud spaces for the walls in this area.

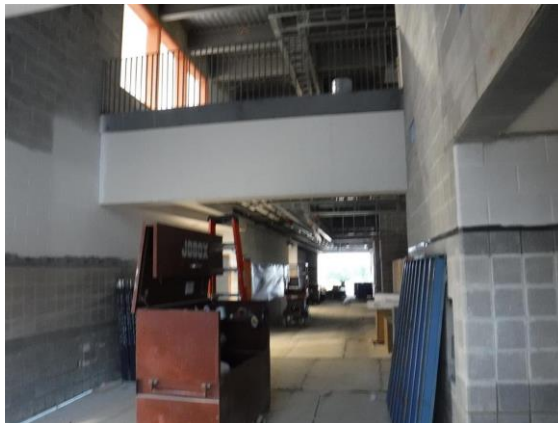
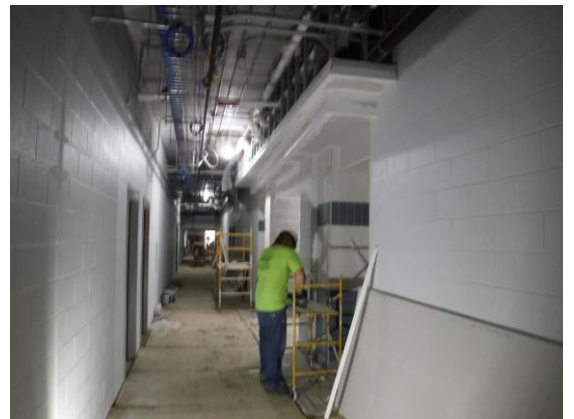
- s) Drywall soffits are being installed and in some cases they have been painted.

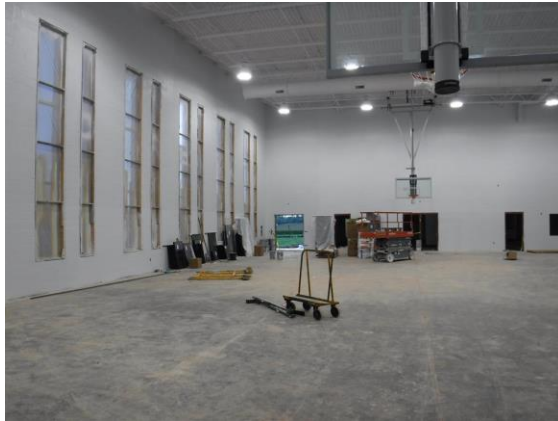
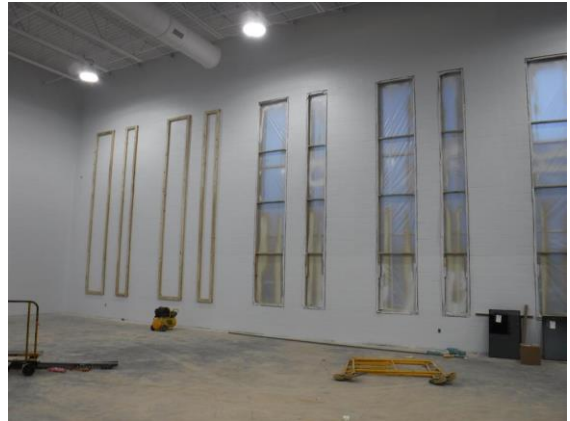
- t) The Cafeteria has been painted. Blocking is installed for the pin frames and the windows are in place. The basketball backstops are installed.

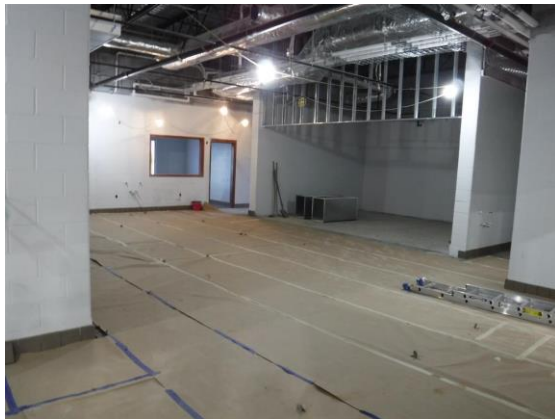
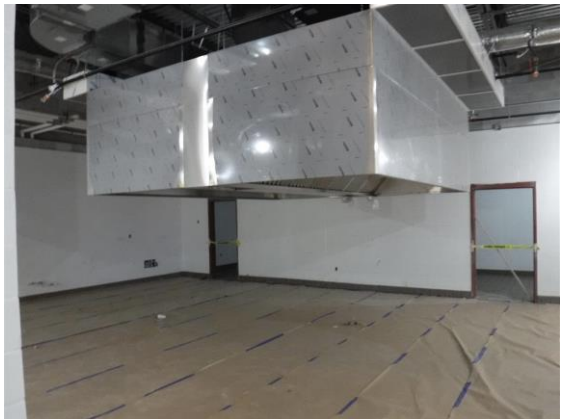
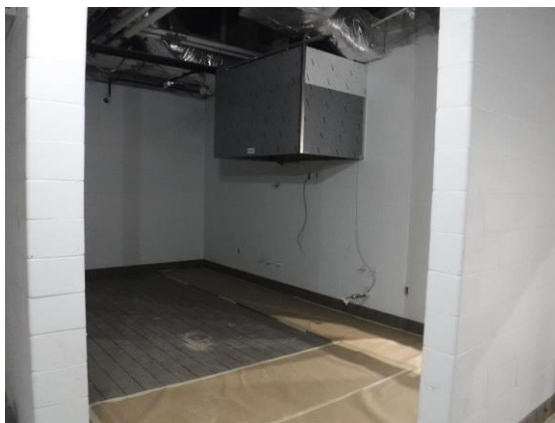
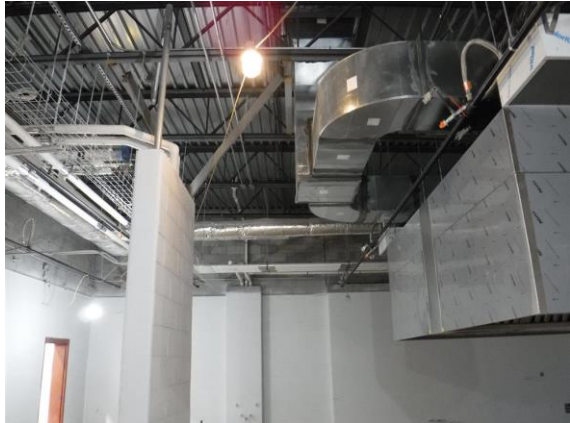
- u) The quarry tile floors have been laid in the Kitchen and are covered with protection board. The joints are not grouted. The hoods are installed.

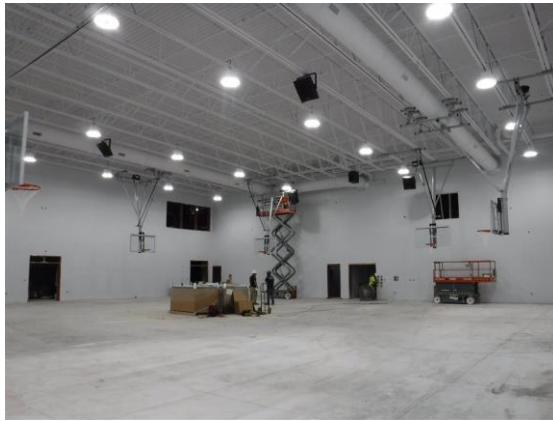
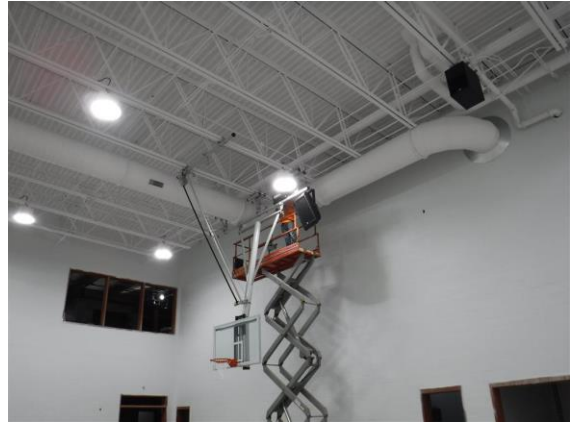
- v) In the Gym, the basketball backstops are installed. The speakers were being installed.

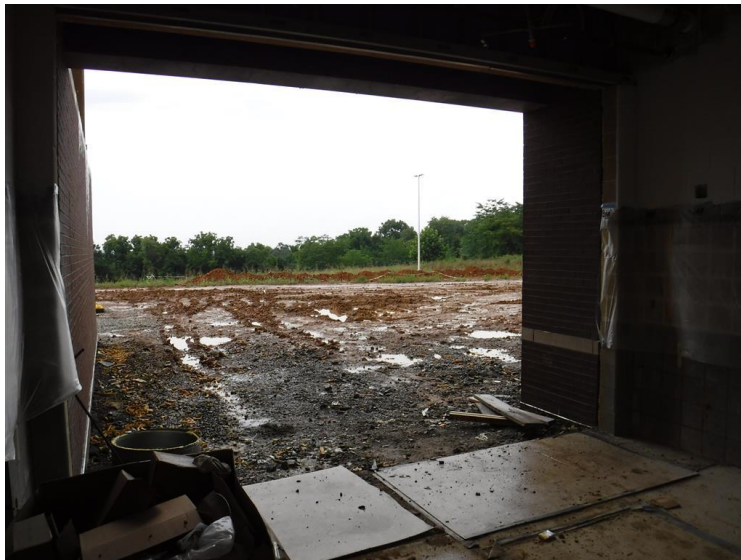
- w) The rear entrance is not installed leaving this area open to the elements.

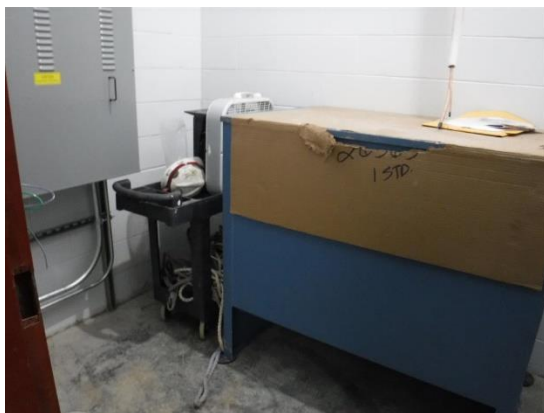
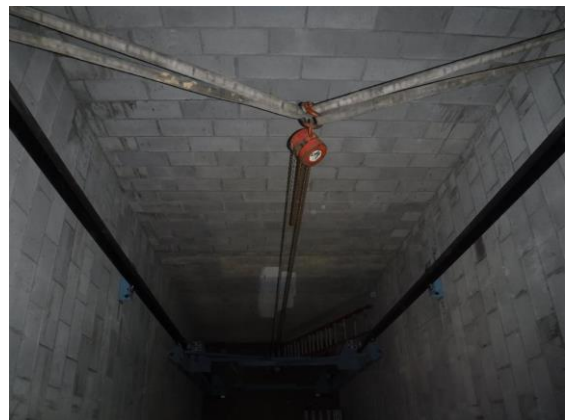
- x) The elevator pump is installed and the platform is being installed.

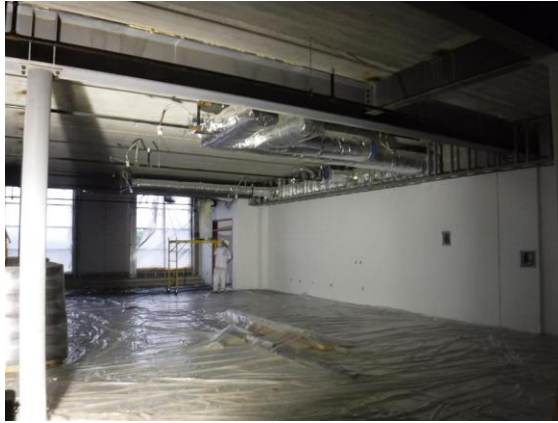
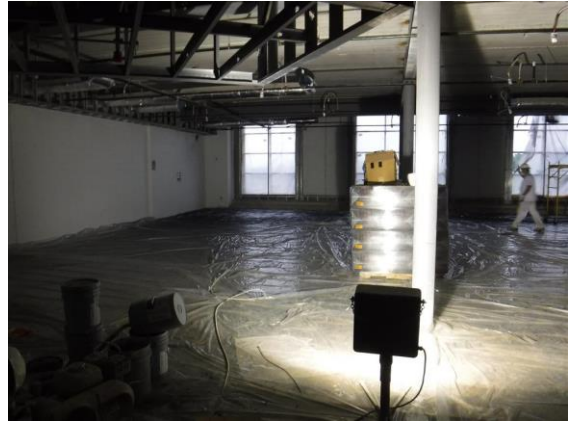
- y) The Library/Media Center was being painted with dryfall paint.

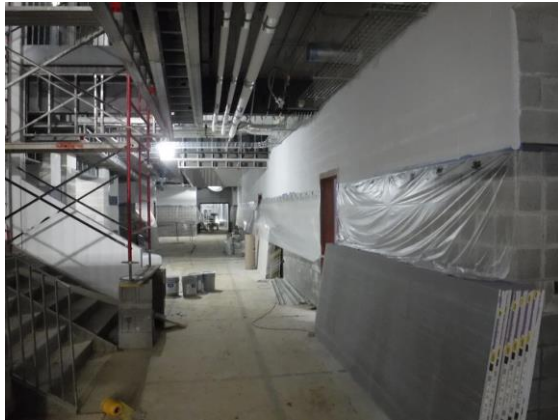
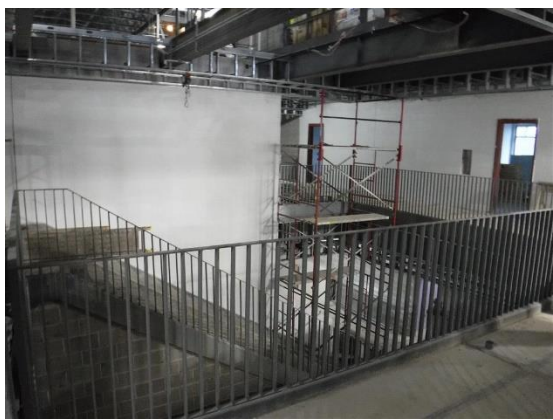
- z) The corridors walls in Area B have been painted. The ground faced block was protected from overspray of the paint.

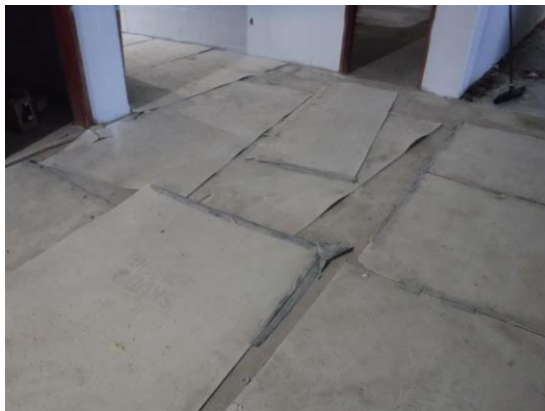
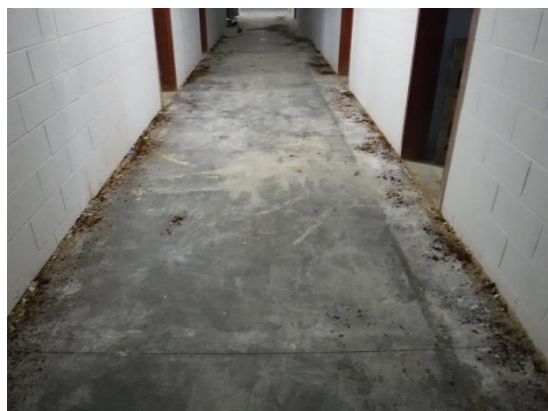
- aa) The Skudo board protection system was being removed and the corridor slabs cleaned. Very little of the wax layer from the protection layer remains. Although there will be some construction work performed over the corridors, the heavier work is now complete.

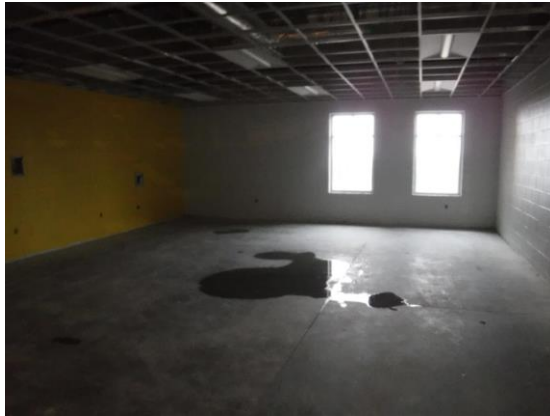
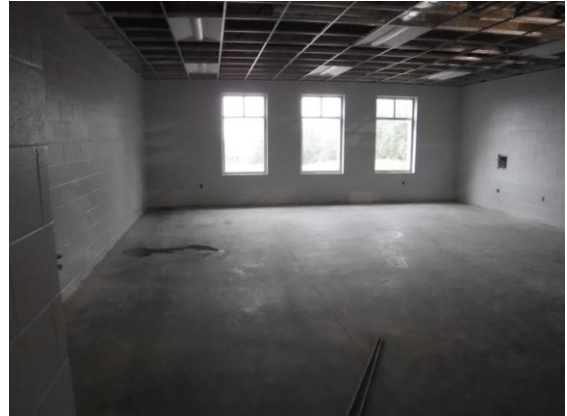
- bb) Although most rooms are dry, a small amount of water is getting into the building.

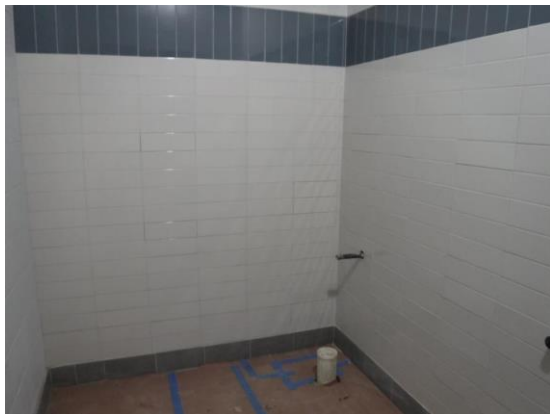
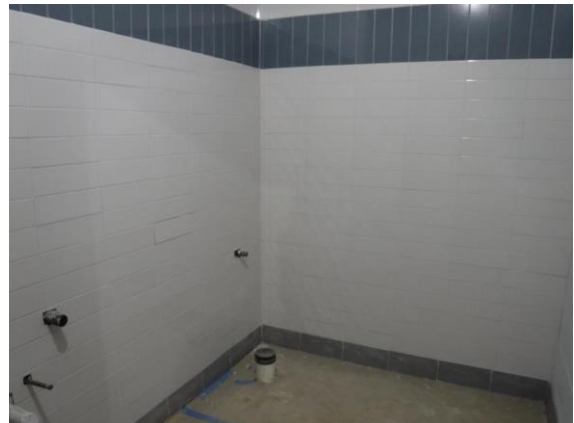
Ceramic tile walls have been installed in the student toilets, but as noted in previous reports there were numerous wall tiles that were out of plane with adjoining tiles. An attempt had been made to correct this by removing the worst offenders and installing new tiles. The walls are better, but not perfect. Additional corrective work will need to be done before final acceptance. They have installed most of the quarry tile in the Kitchen from what I could see since most of it was covered with protection paper. I could observe that some tiles were missing at the door openings and the joints were not grouted.

- cc) Although the wall tile walls look better after some of the tiles have been replaced, there are still areas that need attention.

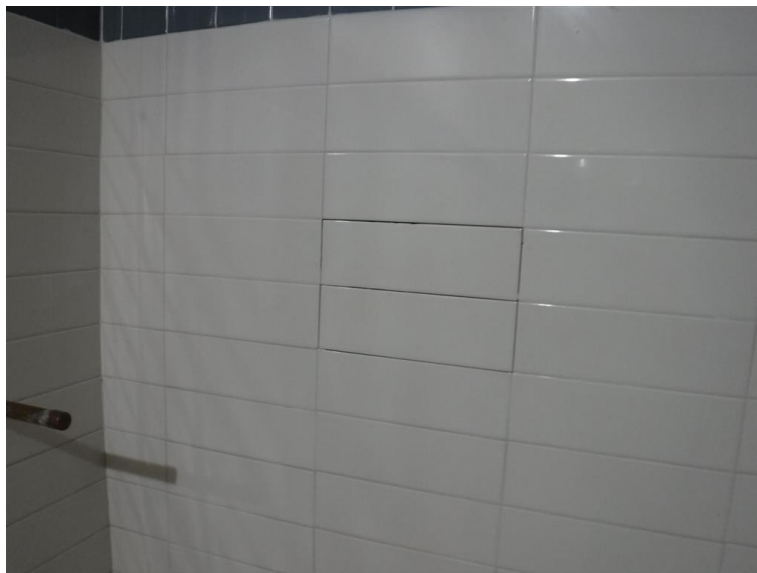
- dd) Tiles that do not have grouted joints are the ones that have been replaced.

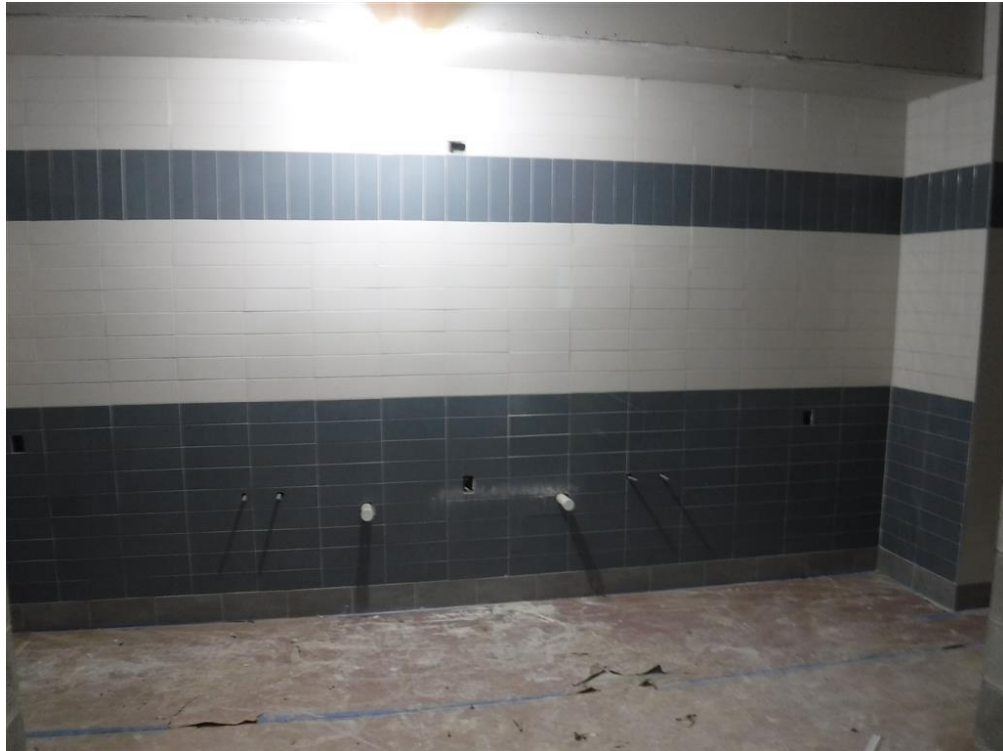
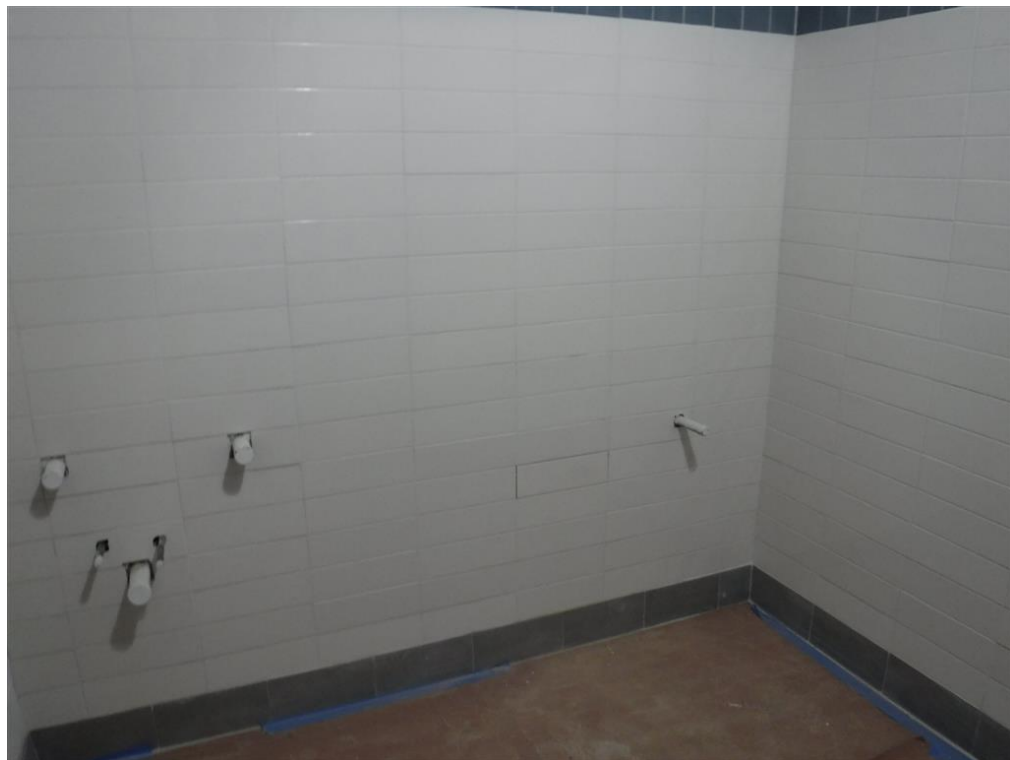
- ee) The entry to this toilet group and typical wall in the toilets still have tiles that are noticeably out of plane. These out of plane tiles need to be replaced.
