FIELD OBSERVATION REPORT

East Hardin Middle School, Hardin County Schools, Elizabethtown, KY 201752.01 - CA8

Date: 9/03/2020

Report No: 31

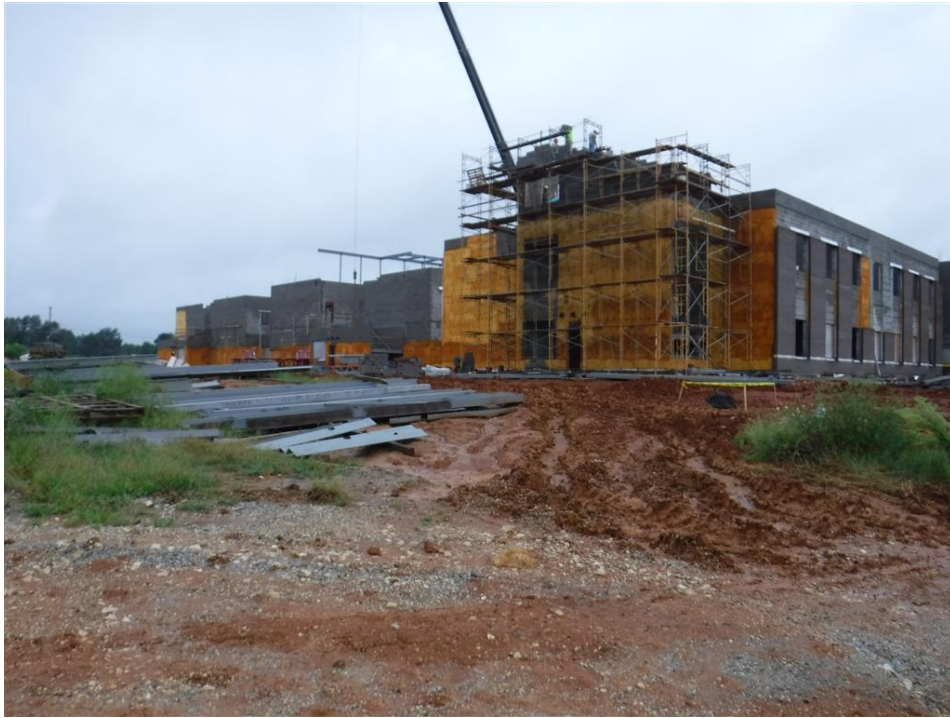
- b) The three classroom wings are approaching top of wall heights with the wing in Area B at the back of the building the closest to being able to receive roof trusses. The addition of the gabled end moves that closer at Area B.

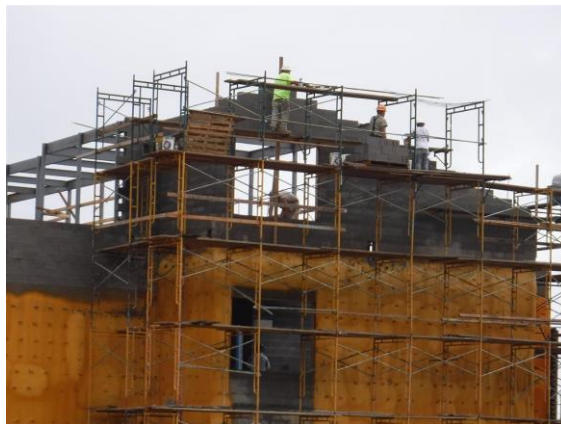
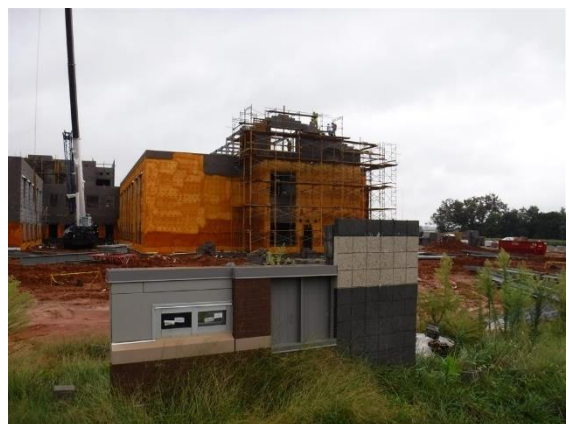
- c) The block at the end of the classroom wing will be topped with a concrete cap angled to match the roof slope. Light rain was still falling from the storm during the night, but the masons were continuing to work.

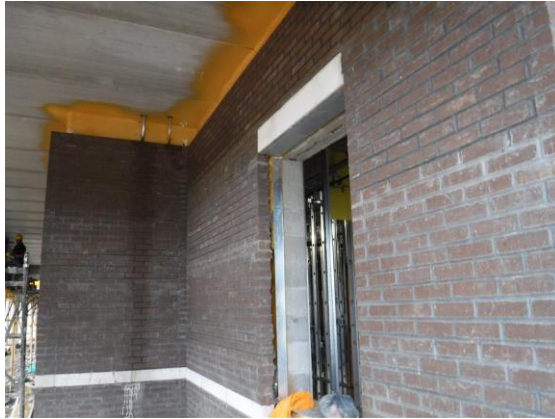
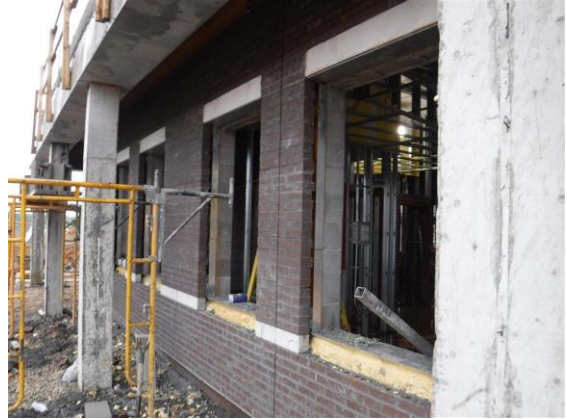
- d) Masons had laid brick at the exterior of the administrative area to a point above the soffit.

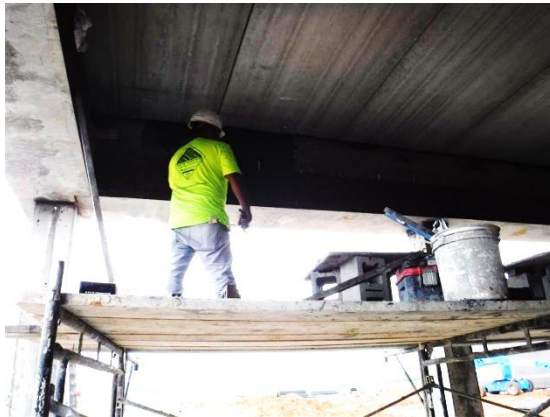
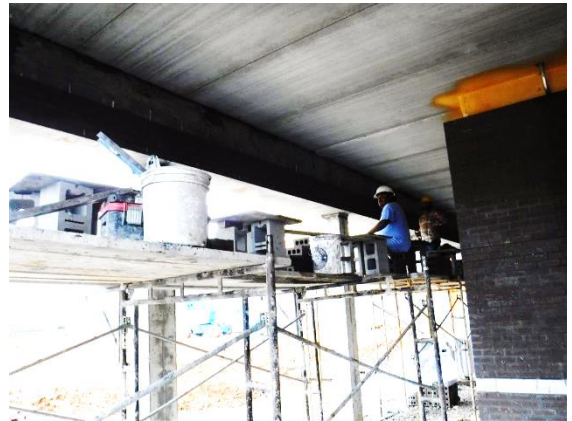
- e) Masons were laying brick over the concrete beam surrounding the administrative area. This brick will be below the soffit surrounding the administrative area.

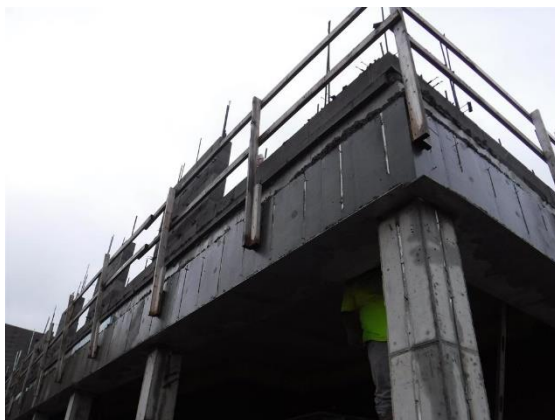
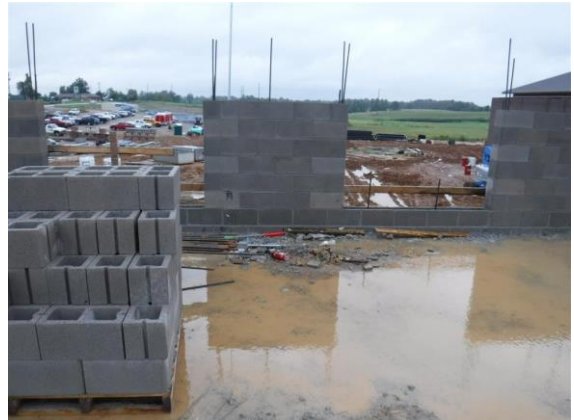
- f) The "piers" between the windows at the exterior walls of the Library/Media Center have been laid. Icon has inspected the reinforcement and directed the masons on the placement.

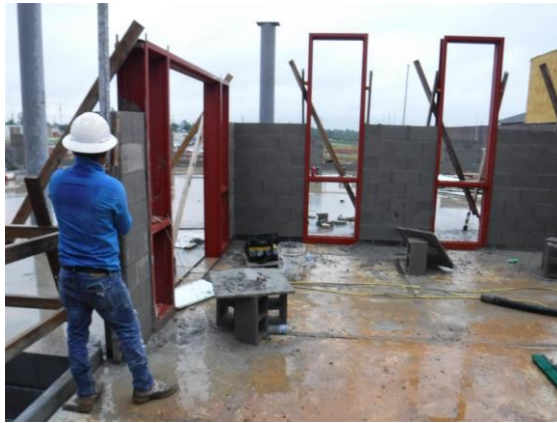
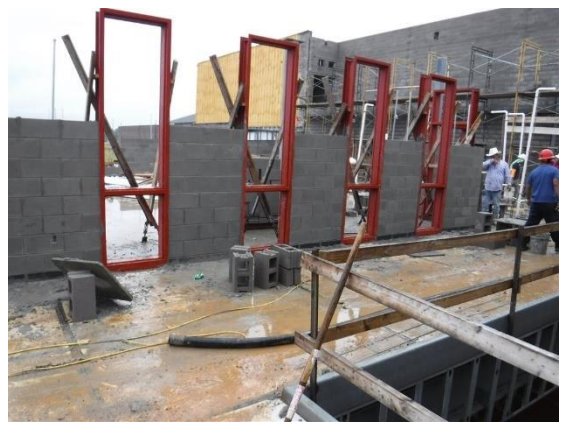
- g) The corridor wall at the Library/Media Center is being laid.

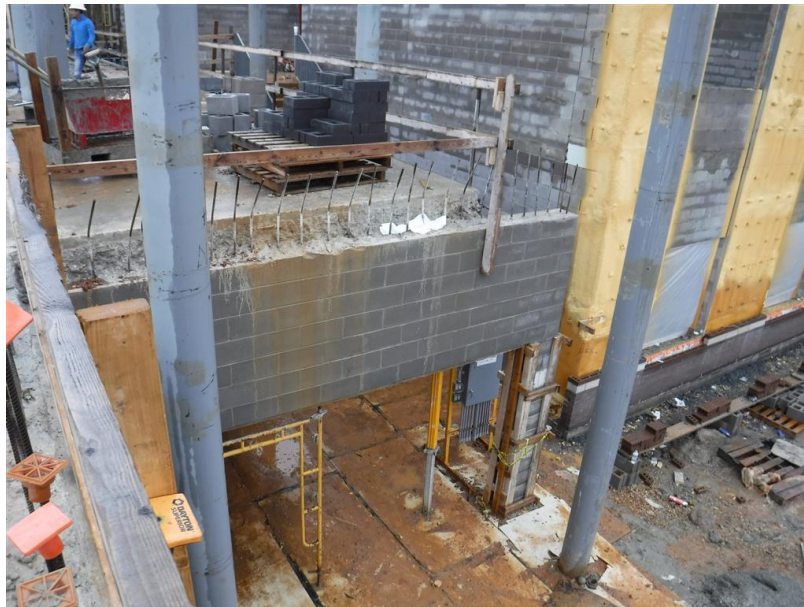
- h) The CMU wall at the main entrance has been prepared for the placement of reinforcement according to instructions from Icon.

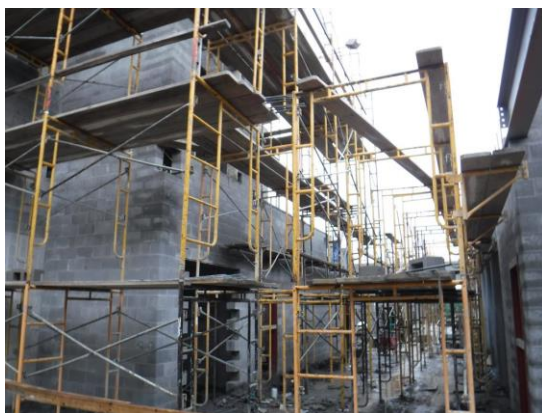
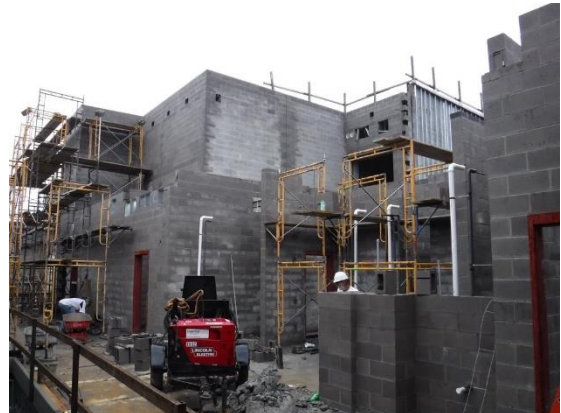
- i) The blockwork continues at the connection between Area B and Area C.

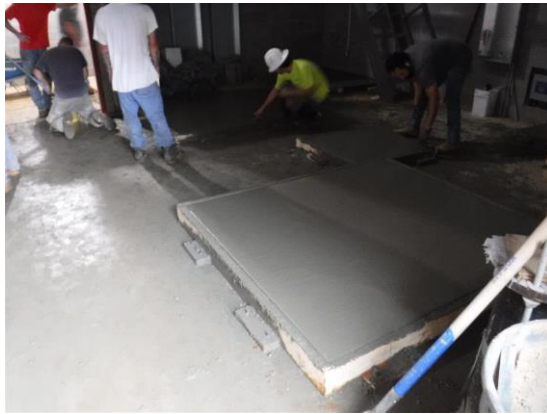
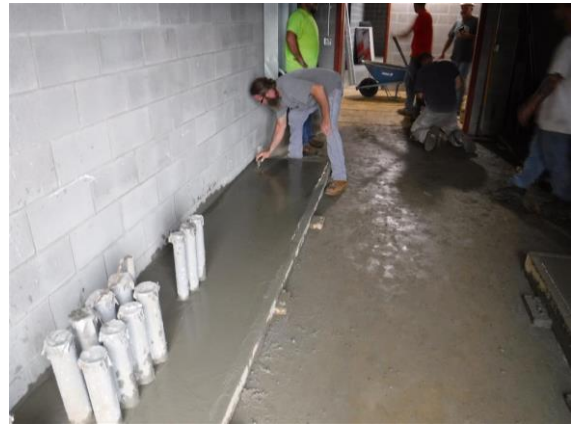
- j) The electricians were pouring concrete housekeeping pads in the Mechanical Room.

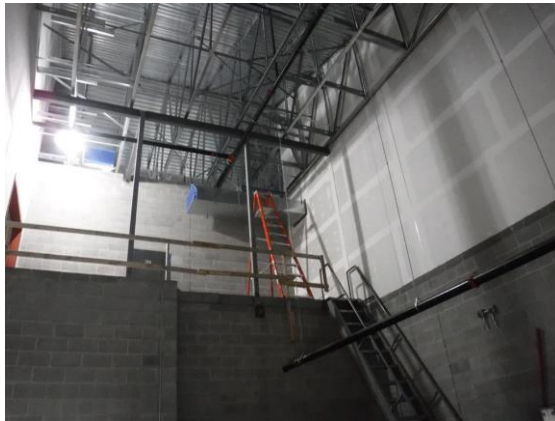
- k) Fire protection piping and ductwork has been hung above the Mechanical Room.

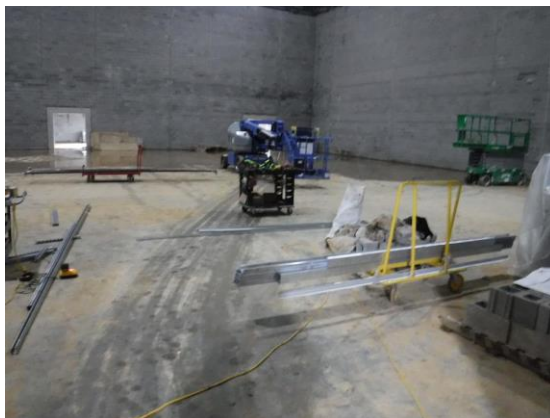
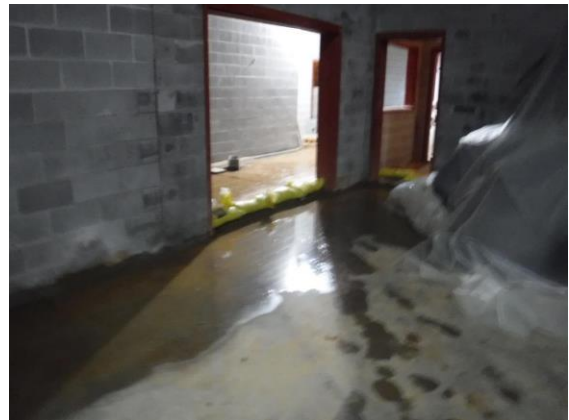
- l) The Gym slab is mostly dry even after significant rains the night before. The sandbags at the doors appears to be working.

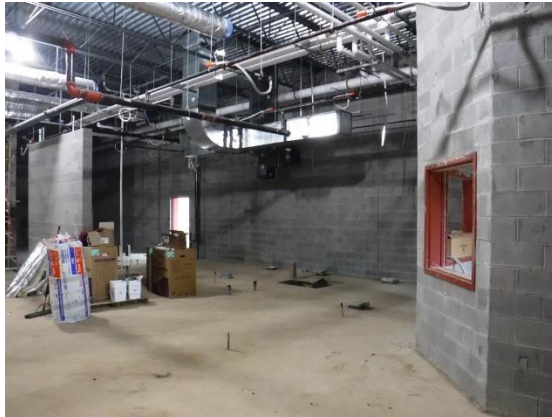
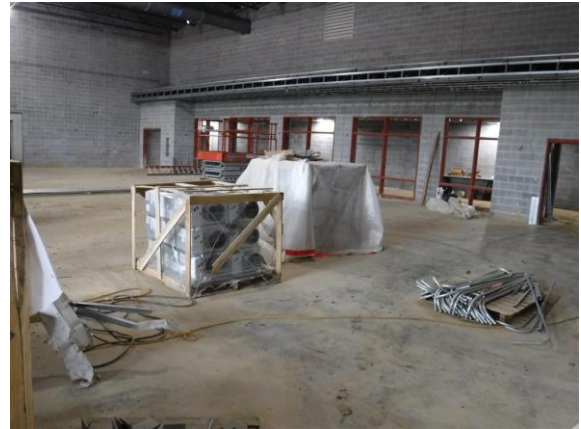
- m) Rough in work continues in the Kitchen and Cafeteria. Most this is above where the ceilings will be in these rooms.

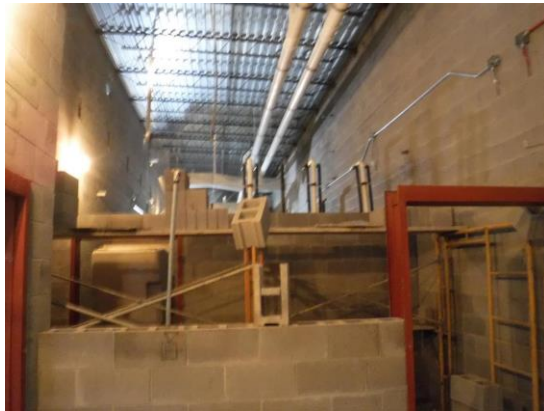
- n) Now that the roof is over the support rooms for the Gym, overhead rough in work is ongoing in these spaces.

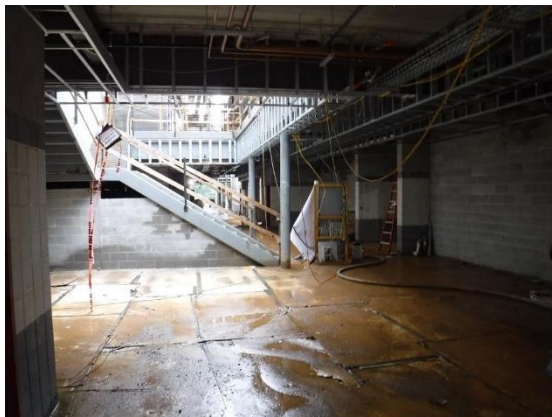
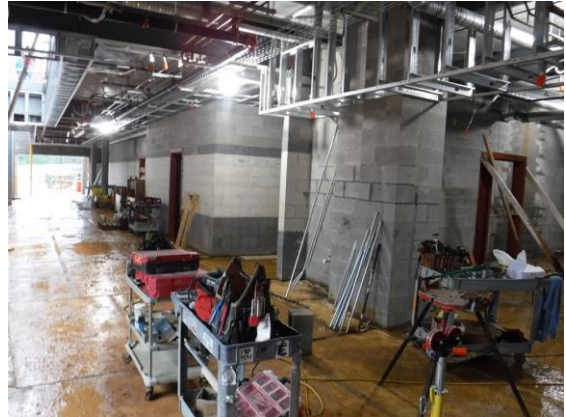
- o) Above ceiling rough ins are ongoing in the main corridor on the first floor. Metal stud framing has been installed for drywall soffits.

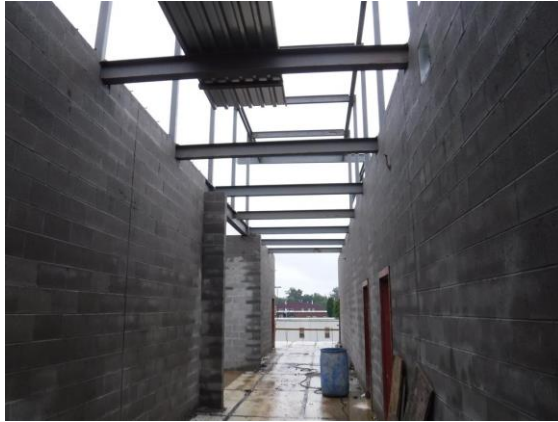
- p) The installation of steel framing for the mechanical platform over the middle classroom wing has been started. This framing also provides the bearing for the light gauge trusses that will go over this area.

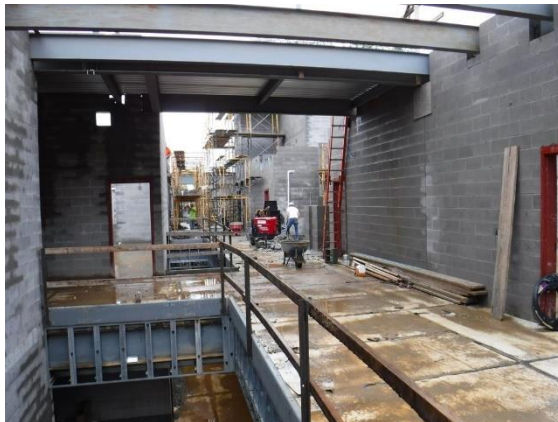
- q) The masons are laying block along the second floor corridor so that the mechanical platforms can be installed over that area and connected to those at the Gym enclosure and to those over the classroom wings.
