## FIELD OBSERVATION REPORT

Lincoln Trail Elementary School, Hardin County Schools, Elizabethtown, KY 201752 -CA8

Date: 9/3/2020

Report No: 31

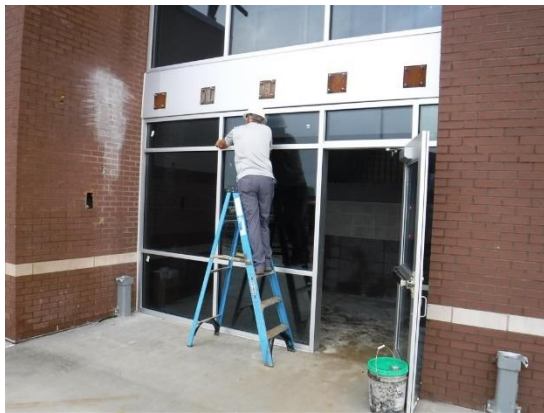
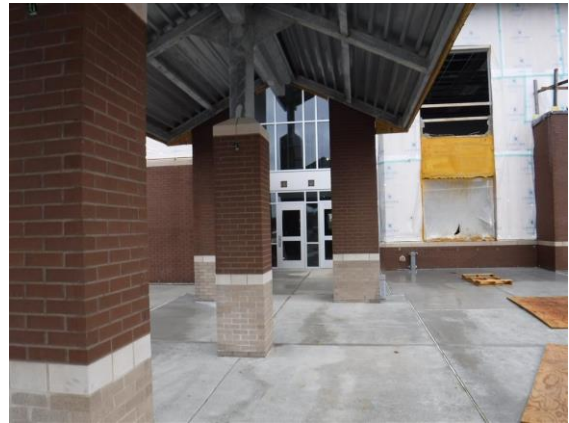
- b) The glazer was installing glass in the curtain wall framing at the front of the building.

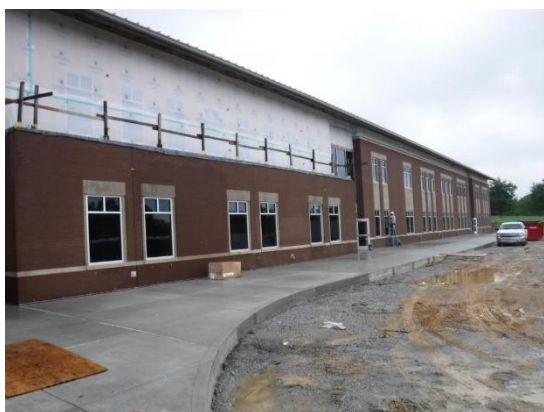
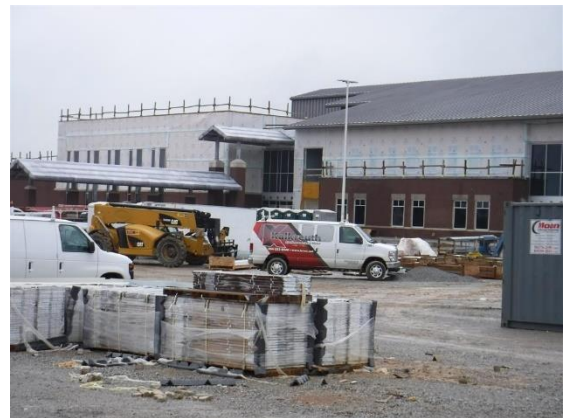
- c) Concrete walks are complete at the front of the building. The downspouts are not in place. The plastic weather barrier is in place for the application of the cement panels.

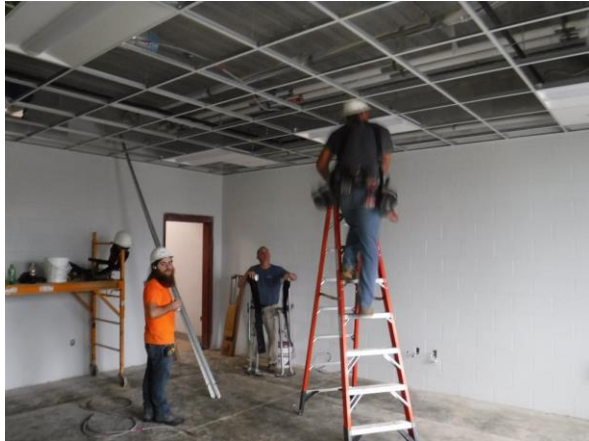
- d) Light fixtures were being connected in Area B.

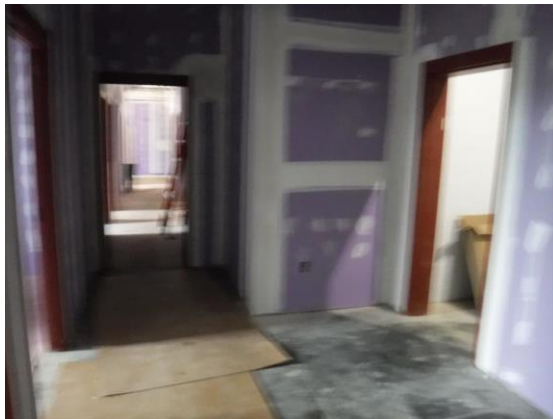
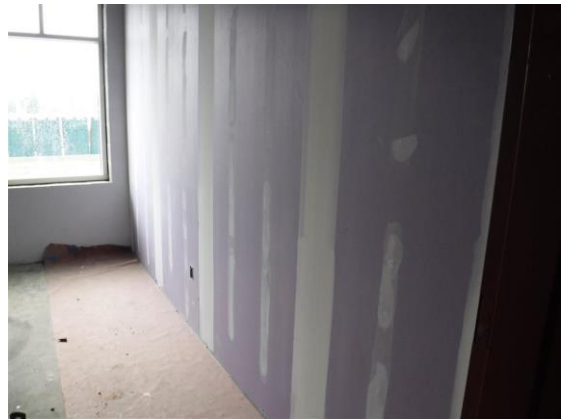
- e) The drywall is finished in the administrative area.

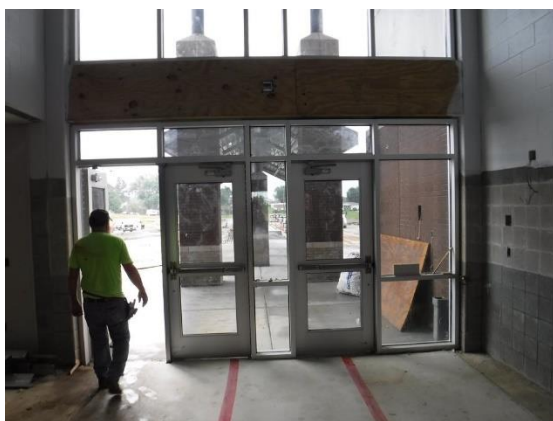
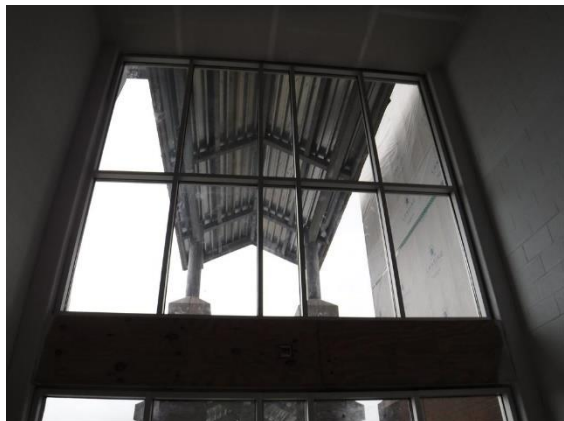
- f) The curtainwall framing, doors and glass are in place at the main entrance.

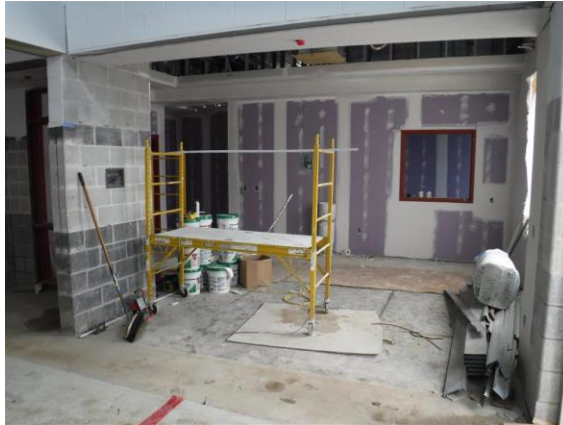
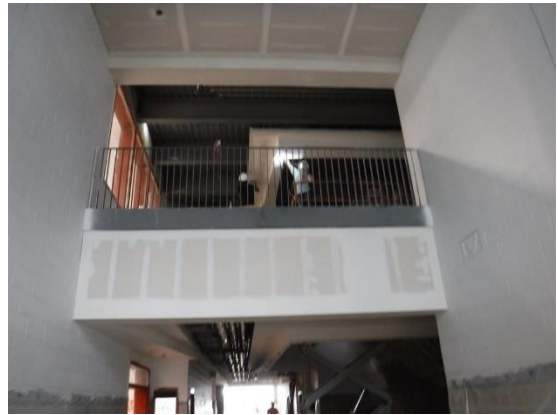
- g) Drywall is being finished on walls and soffits making them ready for paint.

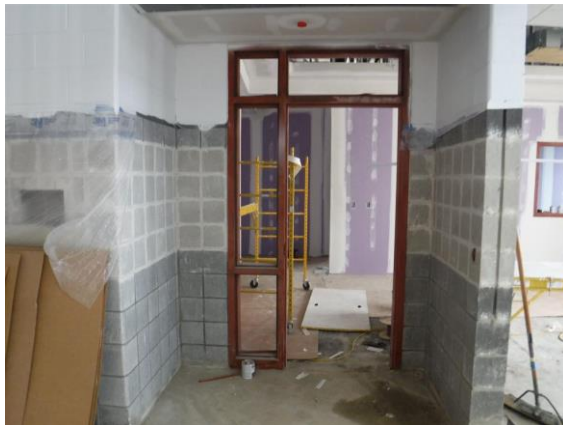
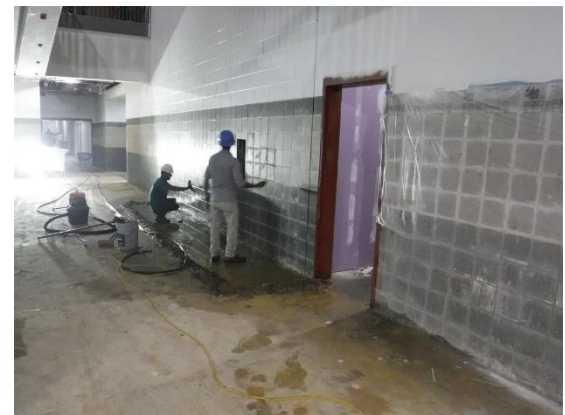
- h) The masons were detailing the block joints in the ground faced block. They had placed a dam to control the waste water from the process.

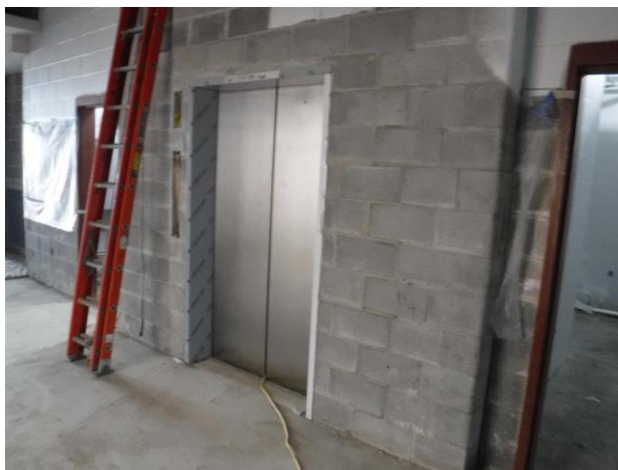
- i) The elevator entrance doors are in place.

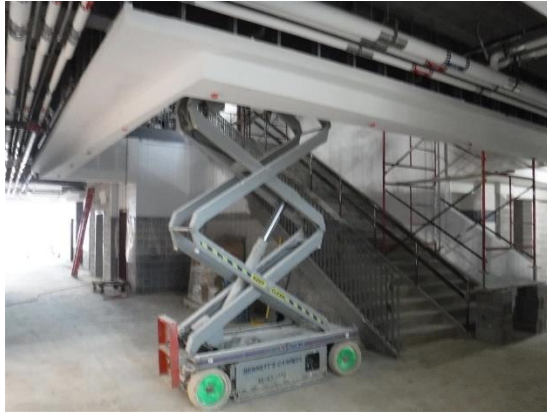
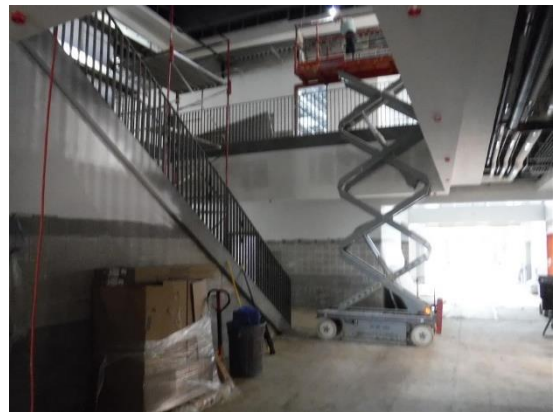
- j) The drywall soffit around the central lobby was being finished,

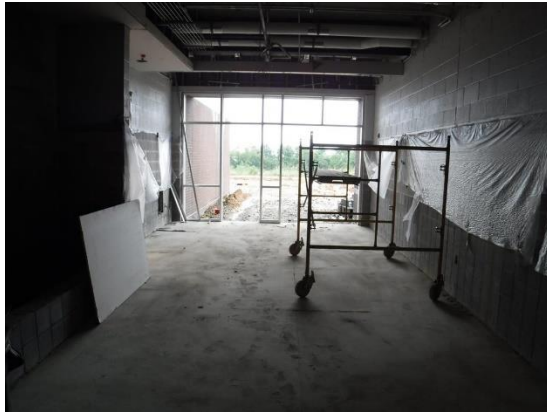
- k) The framing for the rear entrance is now in place leaving doors and glass to be installed.

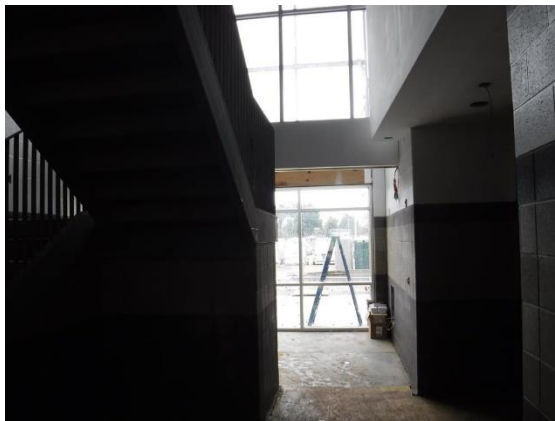
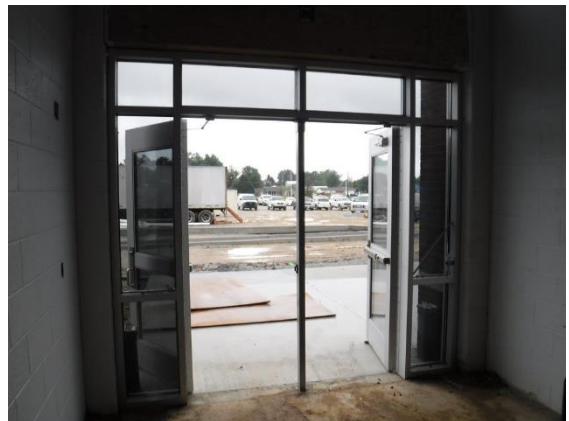
- l) The entrance at the east side of the Area B is on place. Gerald has instructed all workers to not prop the doors open. This will be critical when the HVAC system is operational to maintain environmental control.

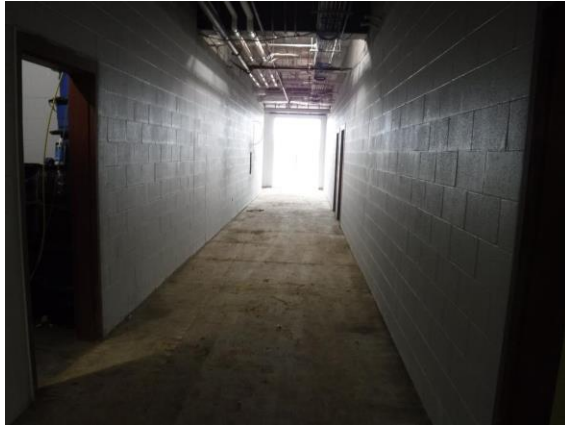
- m) The entrance to the corridor by the preschool rooms has not been installed.

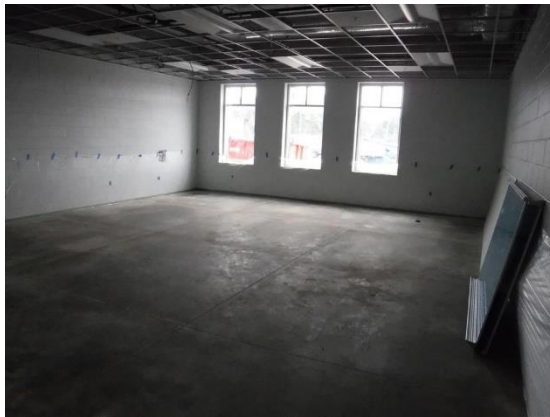
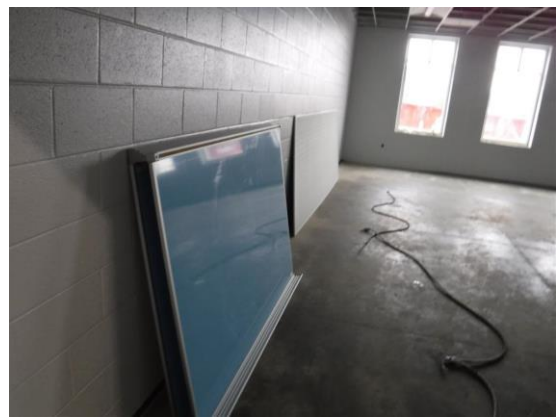
- n) The marker boards have been placed in some of the classrooms.

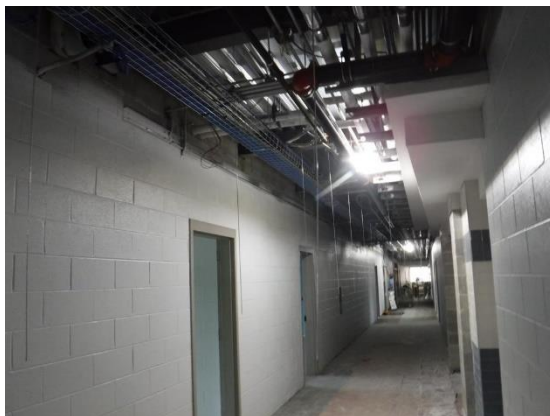
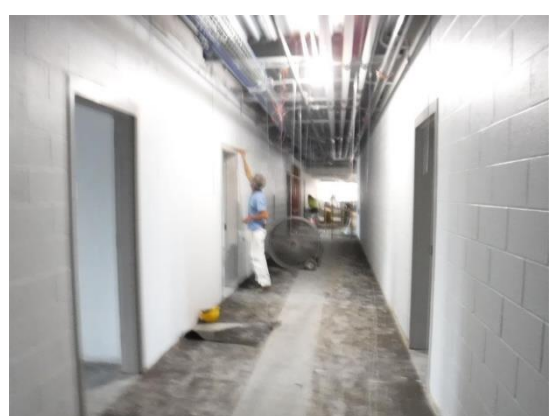
- o) Hanger wires for suspended ceilings had been hung in the main corridor. Painters were painting the door frames.

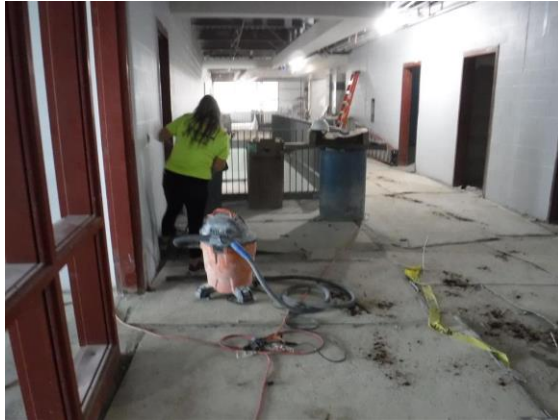
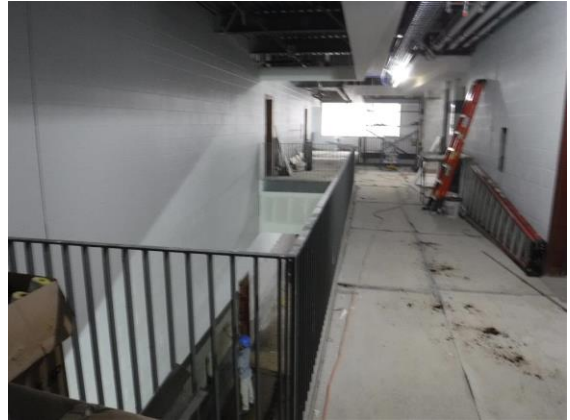
- p) Workers were cleaning rooms on the second floor of Area B.

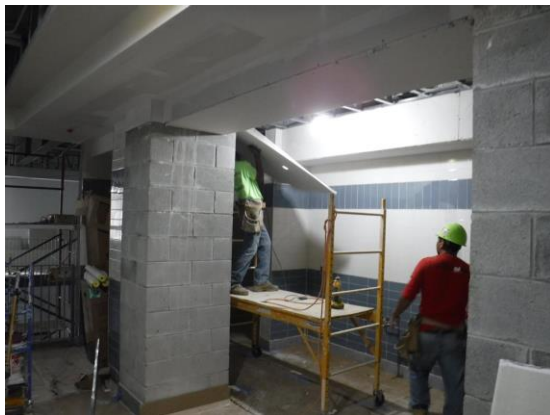
- q) The drywall soffit was being hung at the entrance to the student toilets on the second floor.

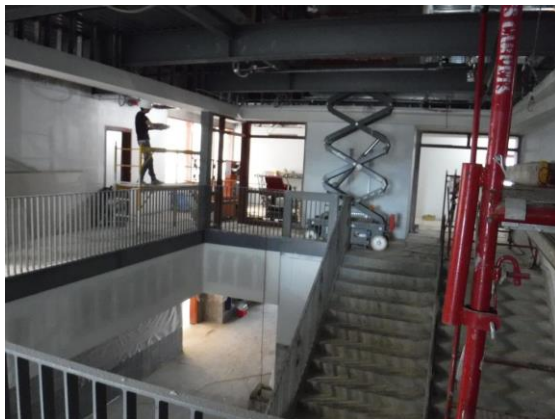
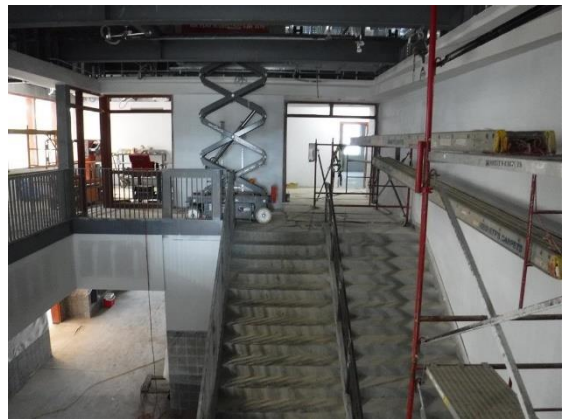
- r) The guardrail around the central lobby on the second floor is in place. Note that the gate to the slide is in place.

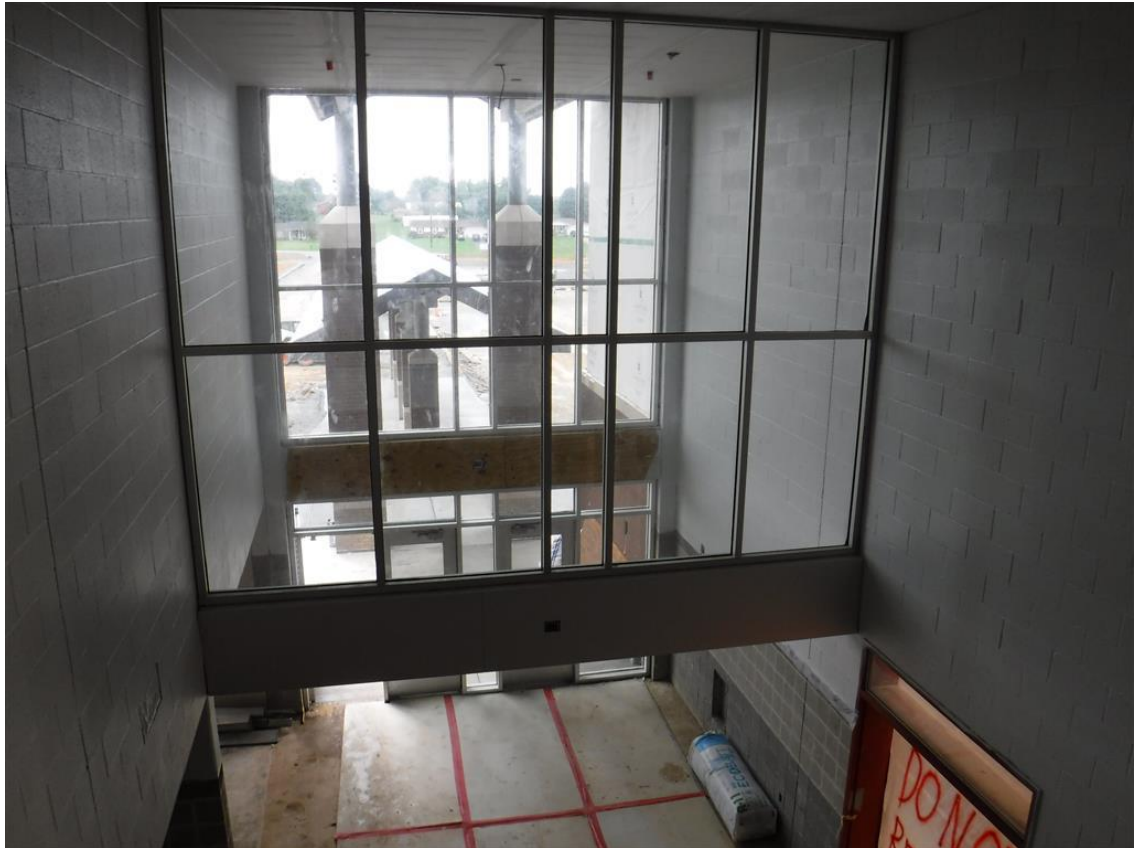
- s) The vestibule at the main entrance is taking shape now that the curtainwall framing and glass is in place. The inner doors of the vestibule are not yet in place.

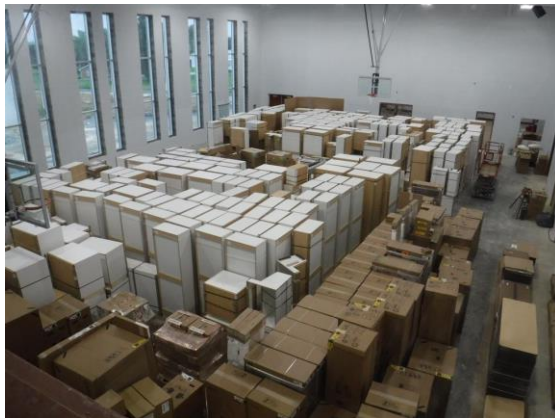
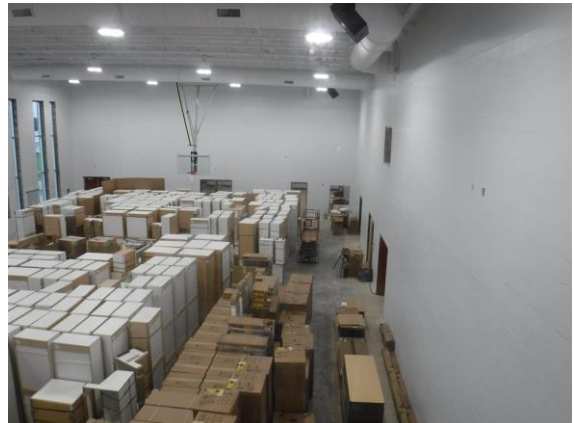
- t) Looking down into the cafeteria, the casework and some of the furniture is stockpiled for the building.

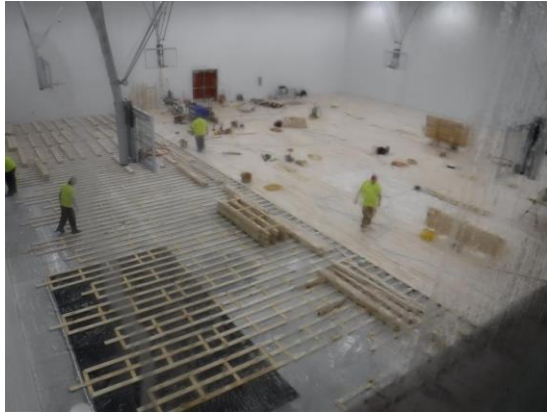
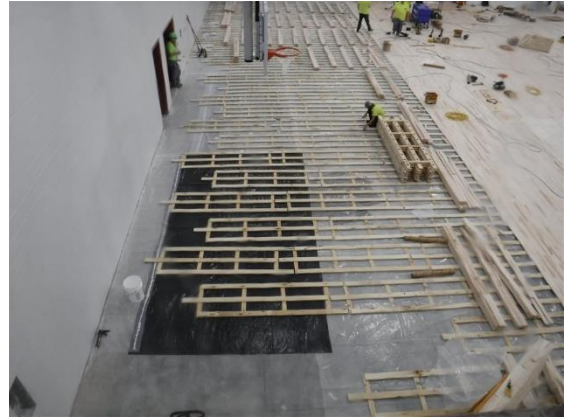
The gym flooring installer was installing the flooring system in the Gym. This was going very well except for a small water drip from the metal deck ceiling near the Coaches Office. The roofer later discovered that there was an unfinished joint in the siding above this area that was probably the cause of the moisture. The amount was so small that the flooring installer said that this would not affect the wood but would affect the finish as it was being applied.

- u) From the second floor, you can see that the installation of the gym flooring system is more than 50% complete. The sleeper system is to the left and the maple flooring is to the right. The white bucket is under the drip from the ceiling.

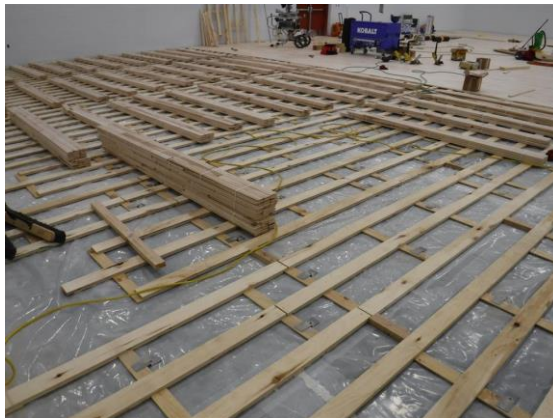
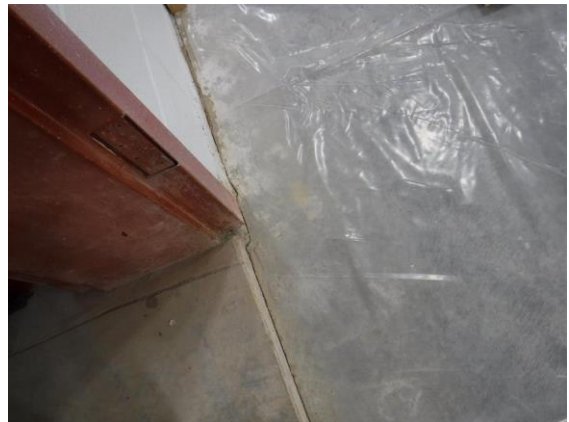
- v) The sleeper system is laid over a plastic vapor barrier. The threshold at the entrance will be extended over the expansion space and returned back to the outer edges of the frame.

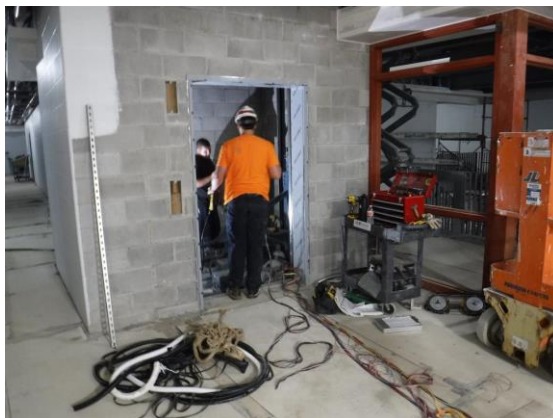
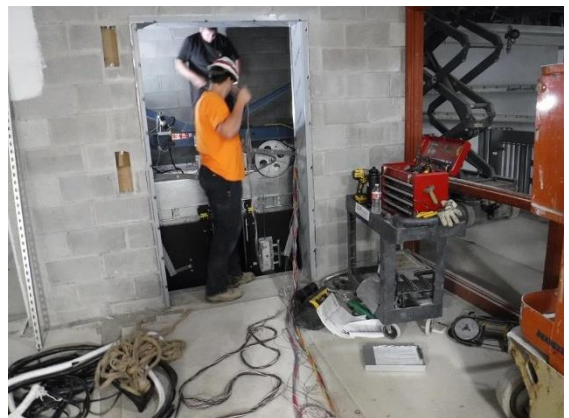
- w) The elevator installers were completing the installation of the platform.

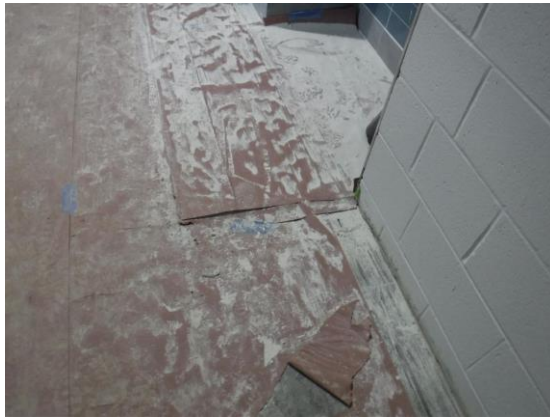
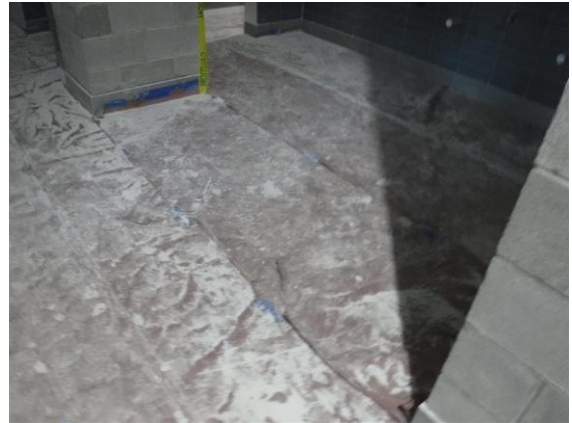
- x) The red paper protection was replaced over the tile pavers at the entrances to the student toilets.

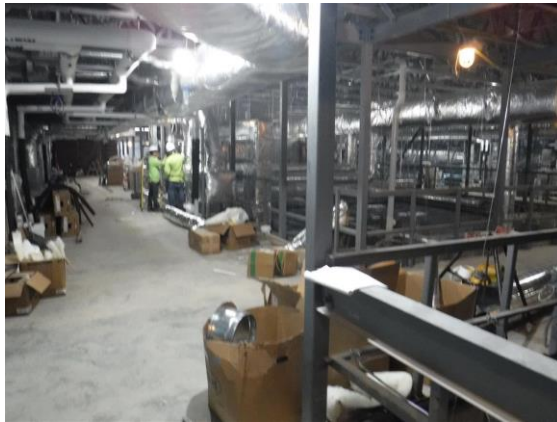
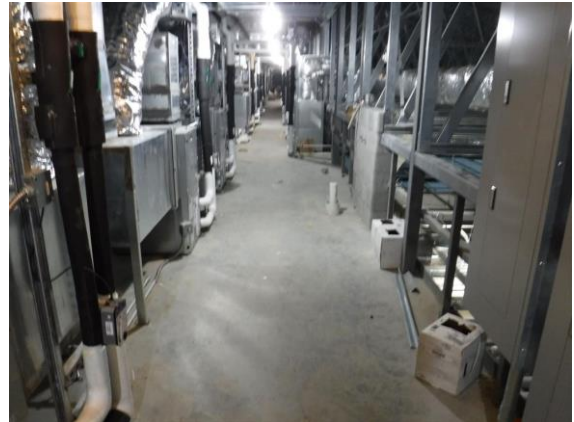
- y) On the mechanical platform, piping was being insulated and controls were being connected.

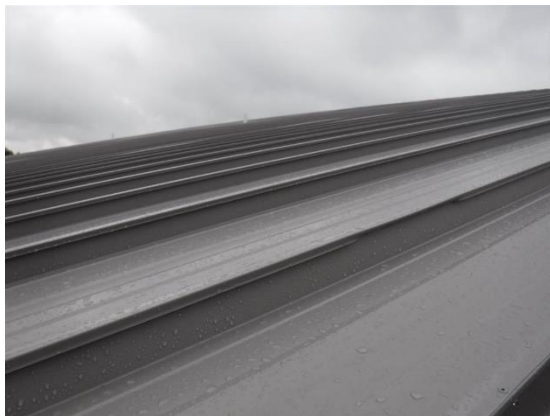
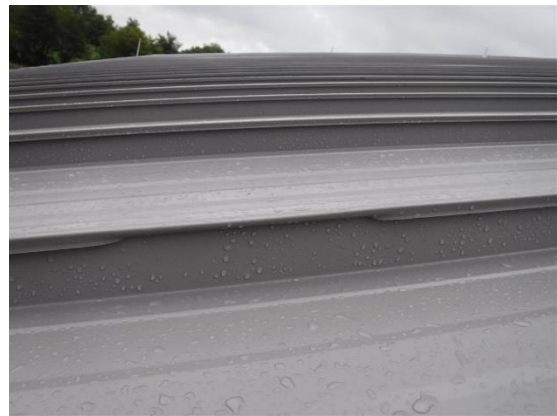
The roofer is almost complete with the roofing. The low sloped built up roofs will have an asphalt flood coat and gravel applied. The standing seam metal roofing needs to be sealed with a robotic seaming device run along the seams. This will make the roof look uniform. The sheet metal installers were installing sheet metal panels. The roofers have

- z) The seams for the metal roofing have been hand crimped at about 4' centers. The seams will be completely crimped with a robot device.

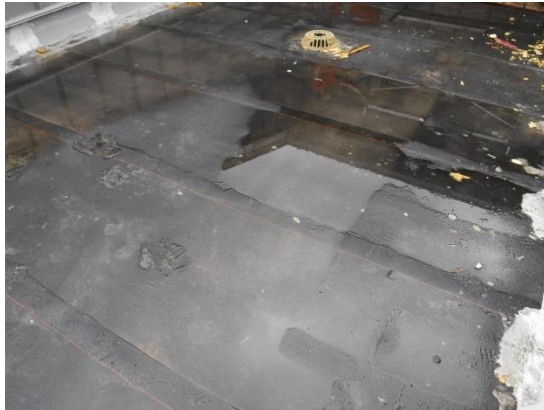
corrected three leaks. One was caused by the mason not protecting the small low sloped roof area off of the mechanical platform. They made eight punctures of the roof membrane. Gerald had told them to lay down protection board before they worked over the membrane. Without following his direction, they stored block and used a masonry saw directly on the membrane. Another leak was at a curb for the rooftop unit serving the kitchen equipment. The roofer has corrected this leak. The other leak was over the Gym. Refer to the comments below about this leak. We discussed the drainage for the small roof area off of the mechanical platform. Zach said that plies will be added in the low areas to create positive drainage.

- aa) The small roof area off of the mechanical platform does not drain well. The roofers will add roofing plies in the low areas to direct water into the drain.

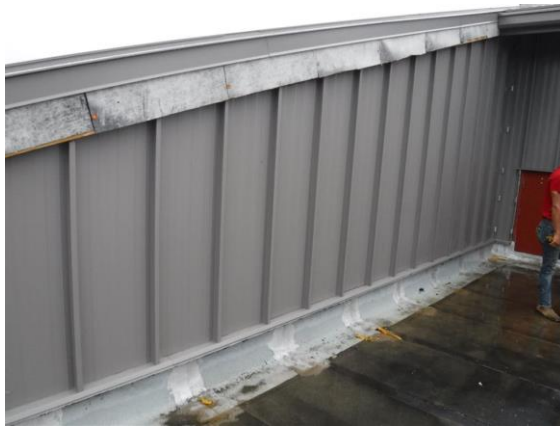
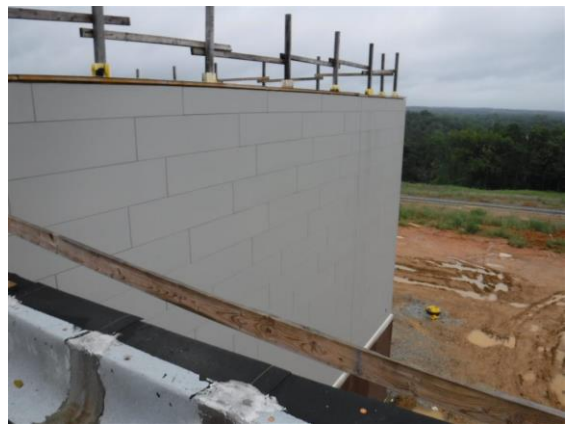
- bb) At higher areas of the building, sheet metal siding and fiber cement panels have been installed. Sheet metal trim and copings are required to complete the work.

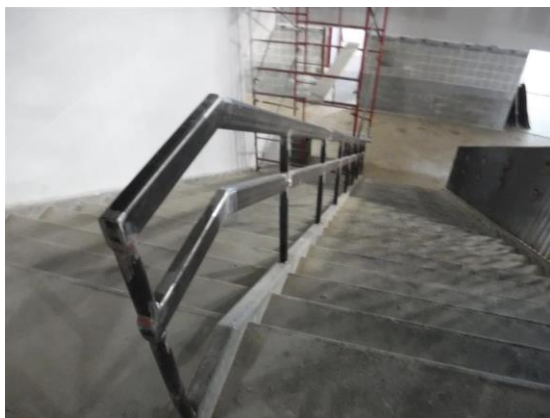
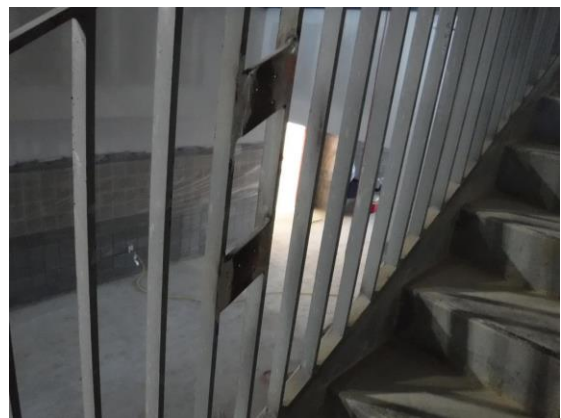
- cc) The stair railings in the central lobby are nearing completion with the addition of the center handrail and attachment plates for the handrails on the guards.

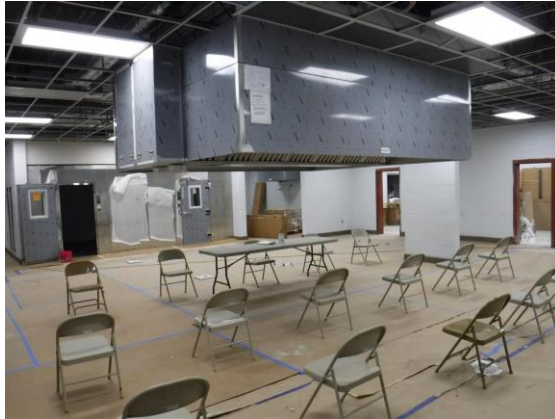
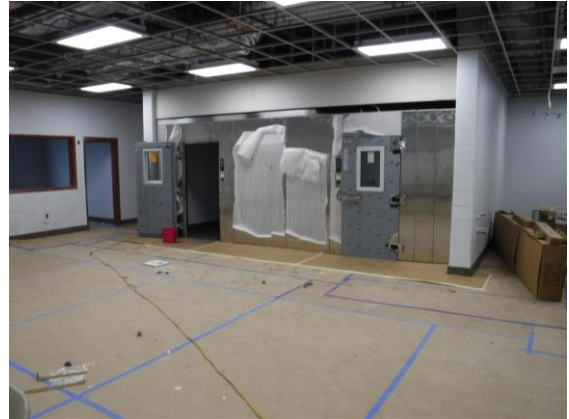
- dd) Since the construction trailer had to be sent off site to complete the site work, Gerald has converted the Kitchen into a temporary construction office. The cooler/freezer boxes were installed.
