FIELD OBSERVATION REPORT

East Hardin Middle School, Hardin County Schools, Elizabethtown, KY 201752.01 - CA8

Date: 10/7/2020

Report No: 34

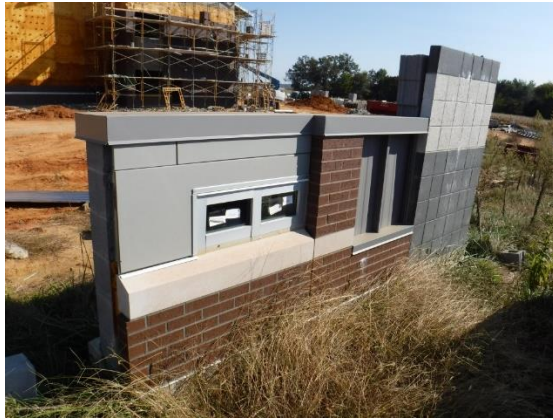
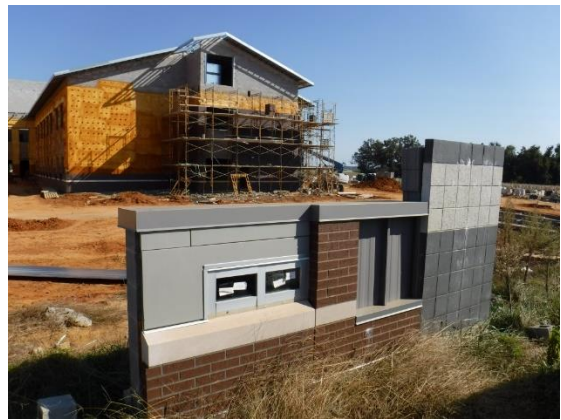
- b) The metal trim will be like that on the mock panel with the refinements approved at LTES.

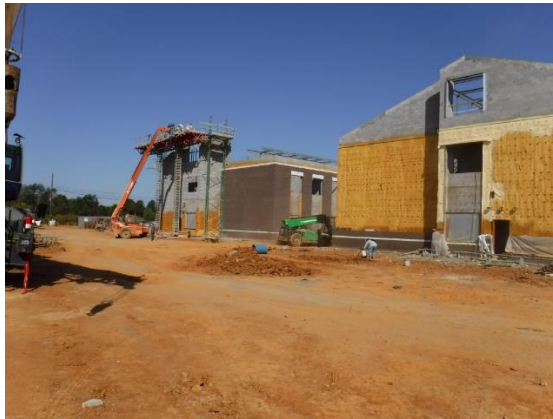
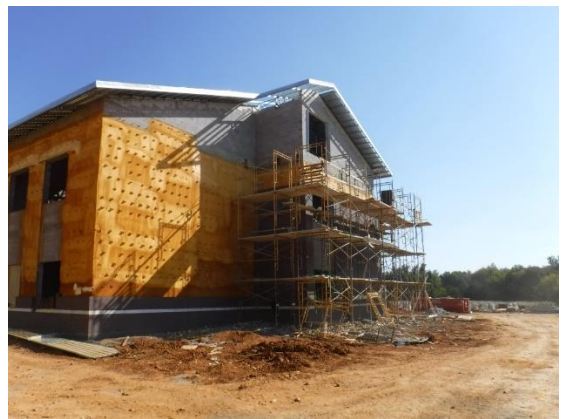
- c) The three classroom wings are taking shape. Metal deck is being installed over the rear wing in Area B. Roof framing is in place to receive the trusses over the middle wing and the masonry is being topped out for the front wing.

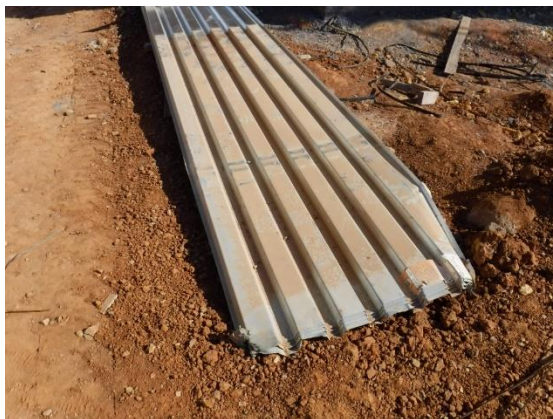
- d) Metal decking laying on the dirt.

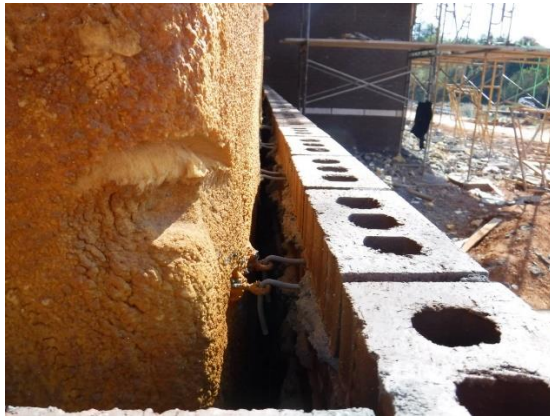
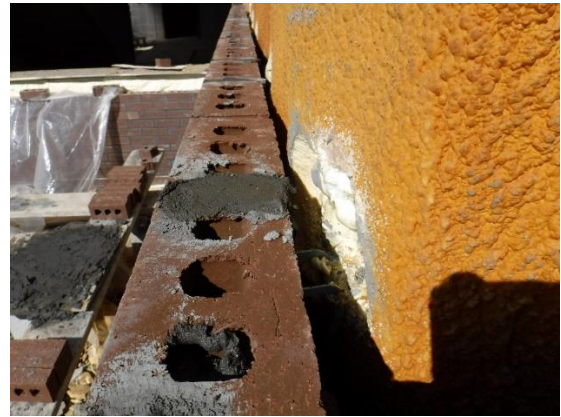
- e) The brick cavity continues to have adequate spacing with a few exceptions.

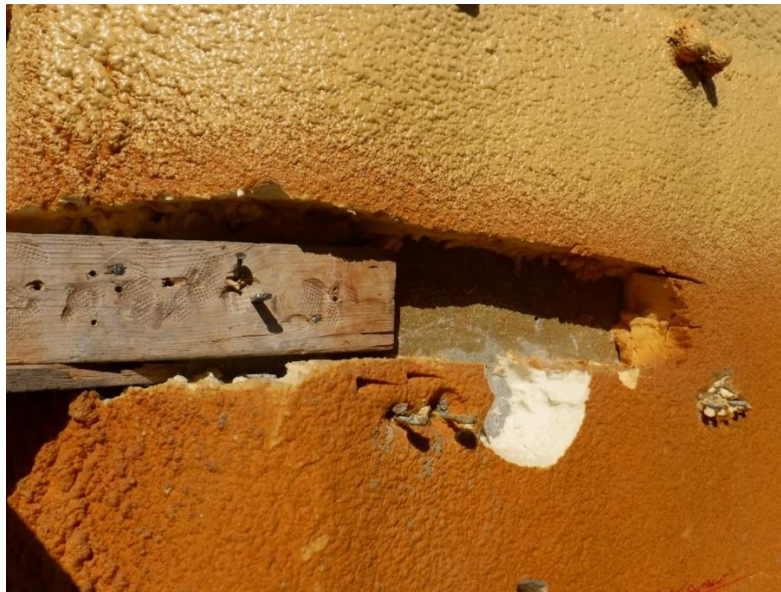
- f) Again, all missing spray foam insulation must be repaired before covering with brick.

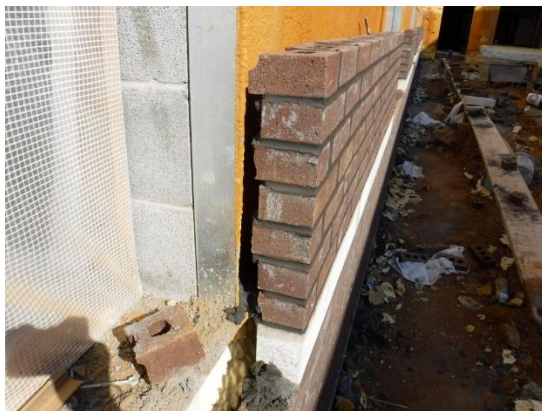
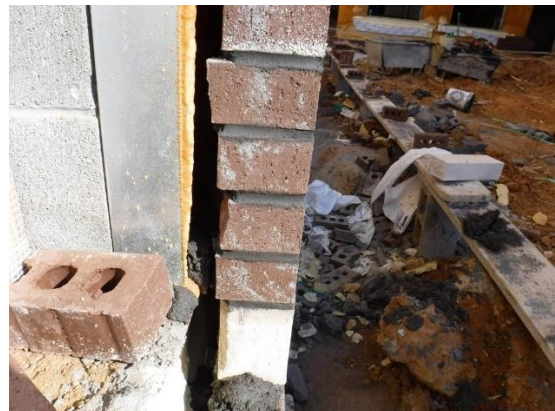
- g) The windows on EHMS set back 2" from the face of the brick. The brick returns at the window jambs appear to be adequate to receive the window frames and sealant.

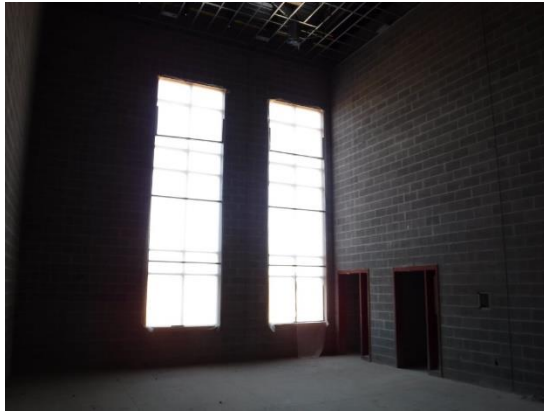
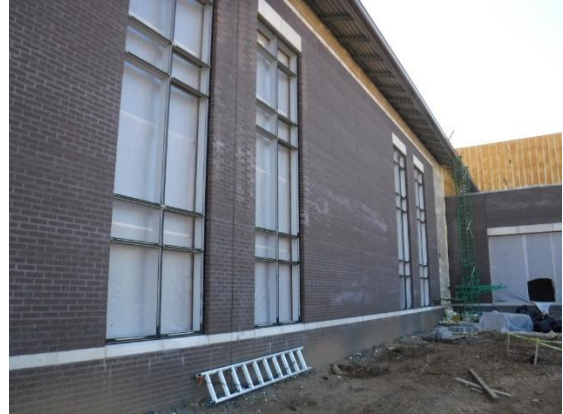
- h) As noted previously, the window frames in the music rooms are in place. The temporary plastic is still in place to keep rain out of the building.

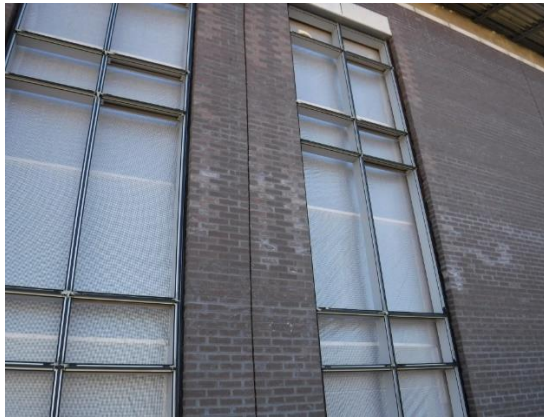
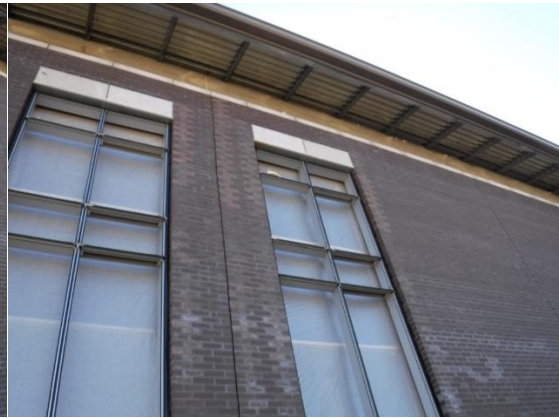
- i) The discoloration of the brick at the jambs has decreased since it was laid. I assume that this because the wall has been washed with rain. Too bad, that the brick was cleaned before the window framing was installed.

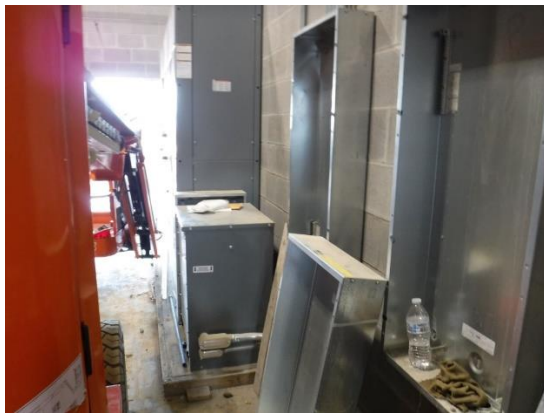
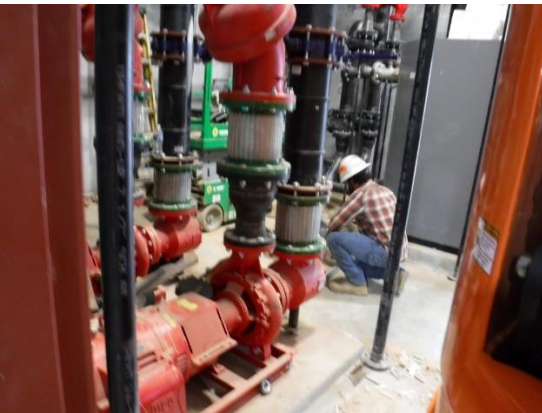
- j) The HVAC installers were working on their systems in the main mechanical room.

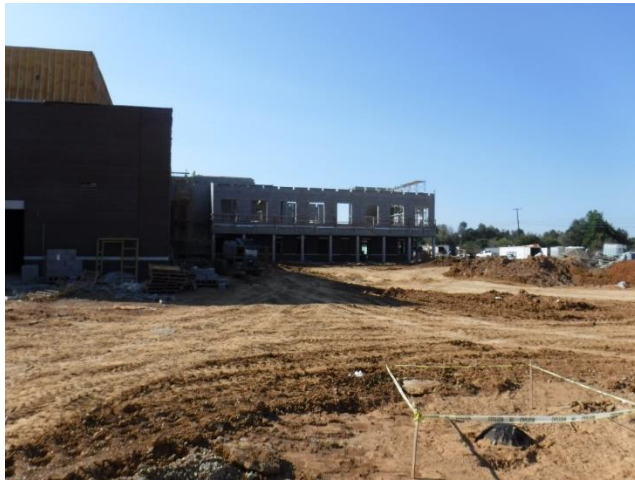
- k) The Library/Media Center viewed from outside Area D.

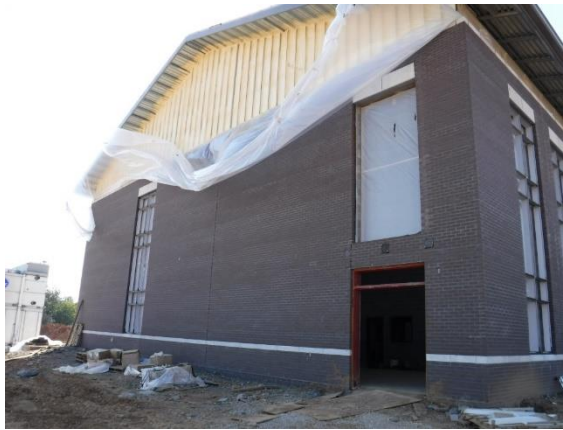
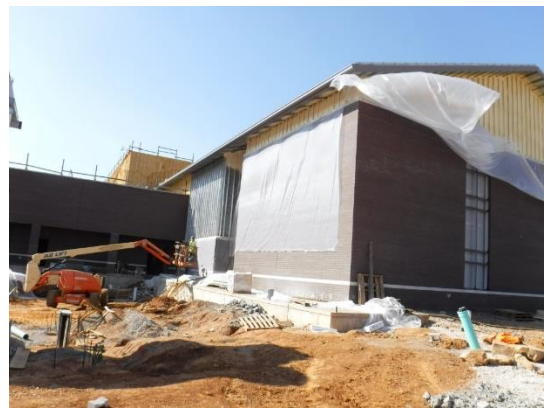
- l) Spray foam insulation has been applied from the top of the stone band up to the soffits of Area D. Metal "Zs" are in place to receive the composite panels.

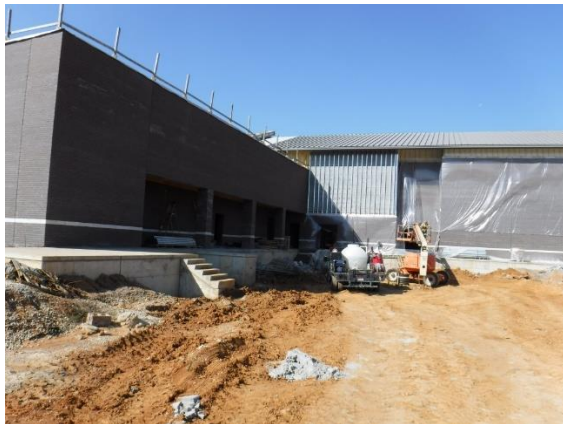
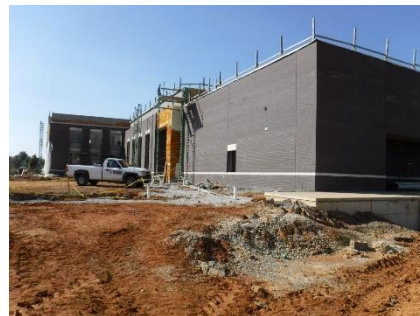
- m) Brick has been laid up to the top of the parapets at the Kitchen/Cafeteria.

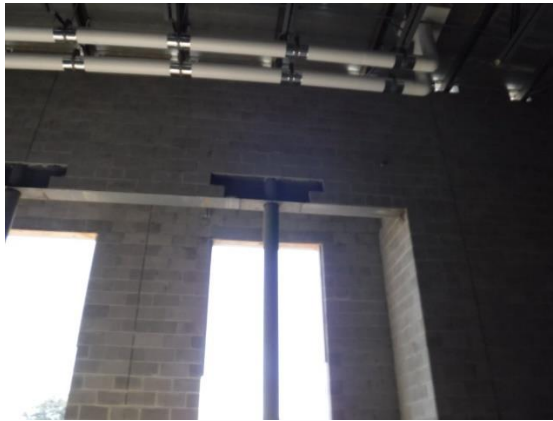
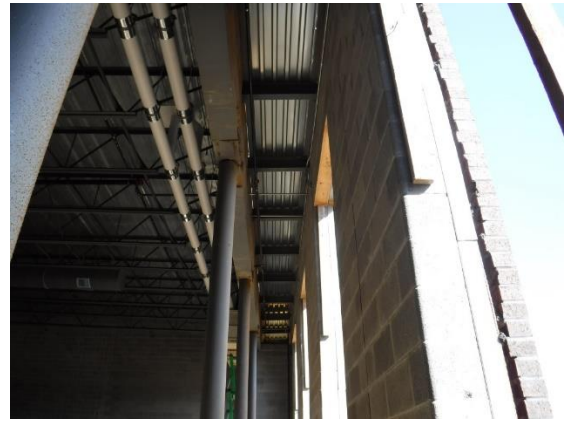
- n) The cafeteria is completely cover with metal deck and built up roofing.

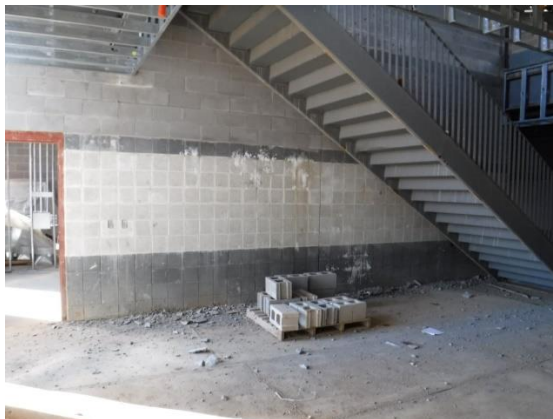
- o) The ground faced block under the central stair has lime staining from being in the weather.

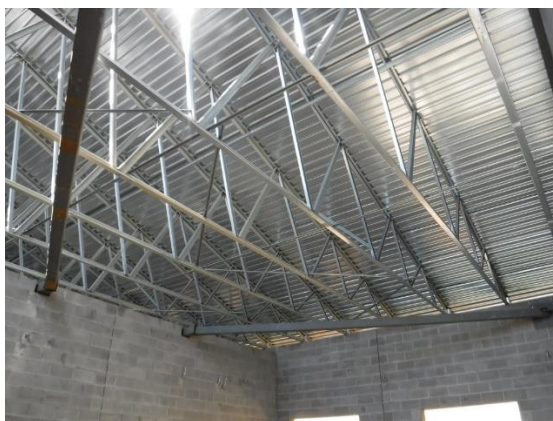
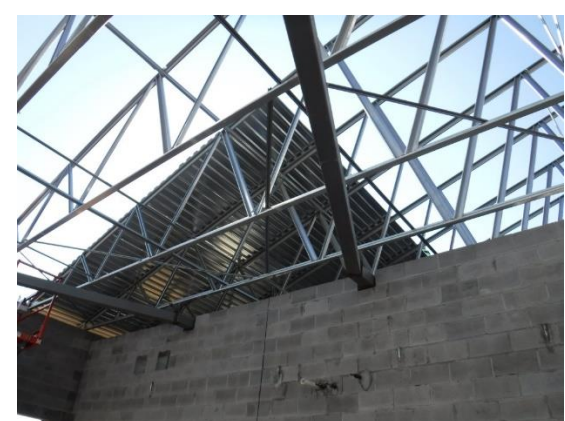
- p) Metal deck was being installed on the metal trusses over the classroom wing in Area B.

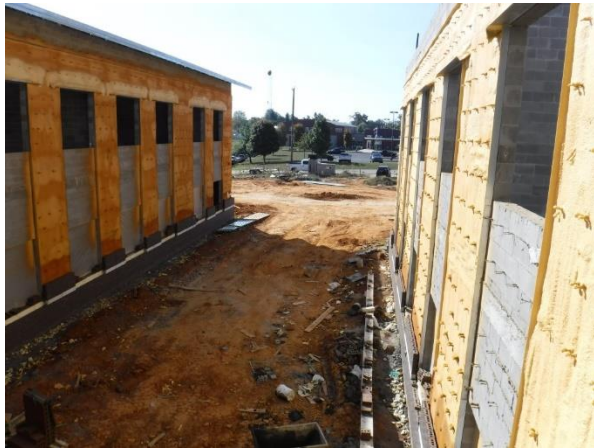
- q) Brick is being laid along the classroom wings in the courtyards.

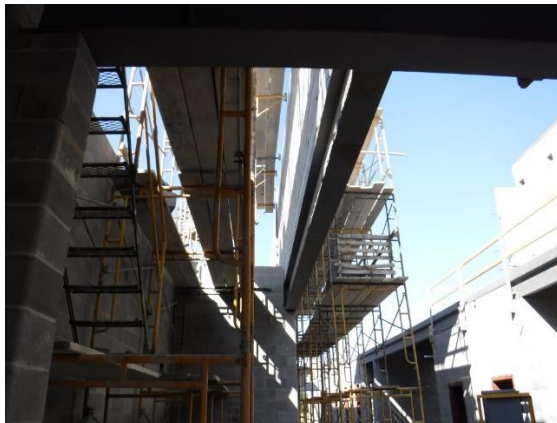
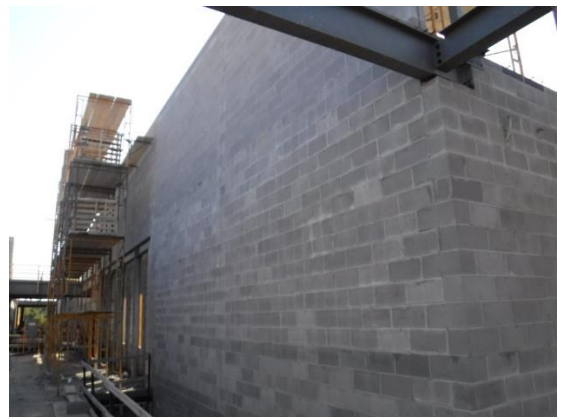
- r) The high wall along the main corridor was being topped out.

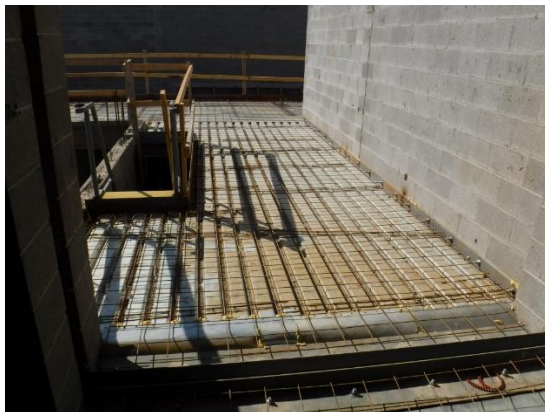
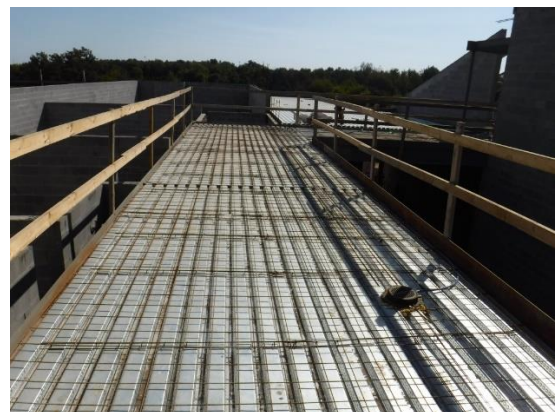
- s) Most of the mechanical platform had been prepared for a concrete slab pour. Welded wire fabric was on wire chairs.

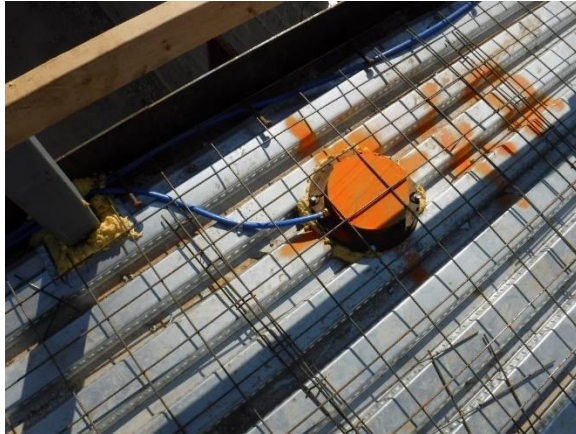
- t) A floor drain on the mechanical platform was connected to a trap primer.

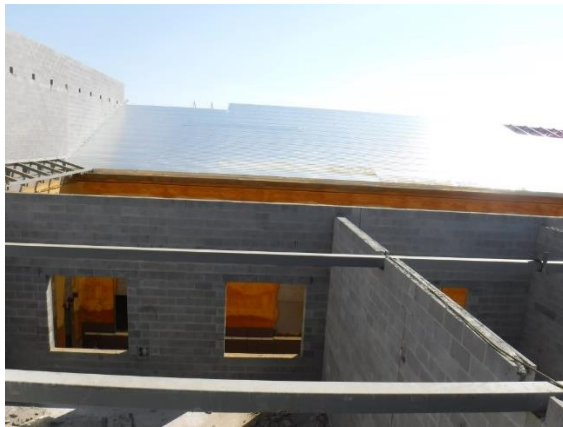
- u) The metal roof deck over the classroom wing in Area B can be seen over the middle classroom wing. The seismic wall bracing can be seen running from wall to wall.

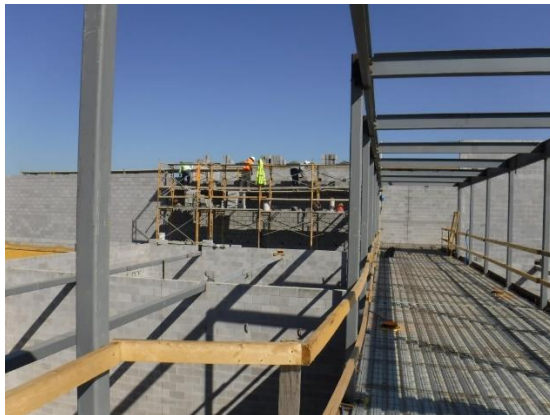
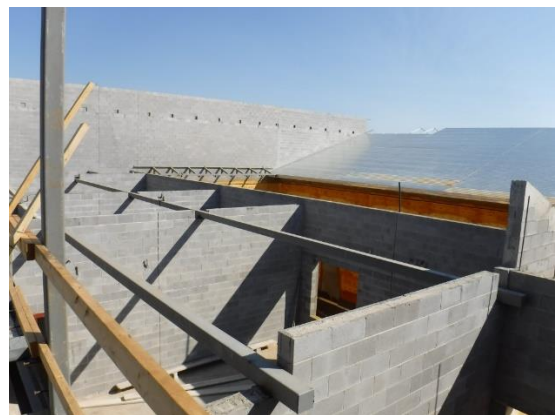
- v) The roof framing that will support the metal trusses is in place over the middle classroom wing.

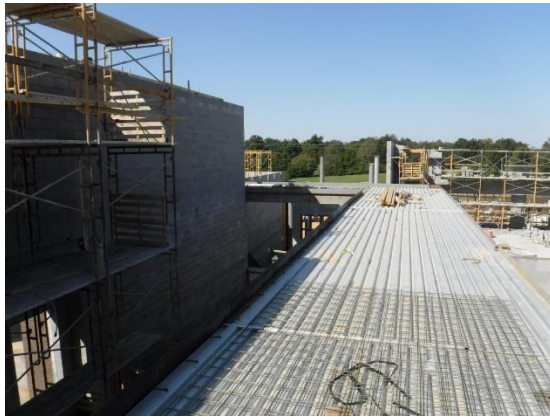
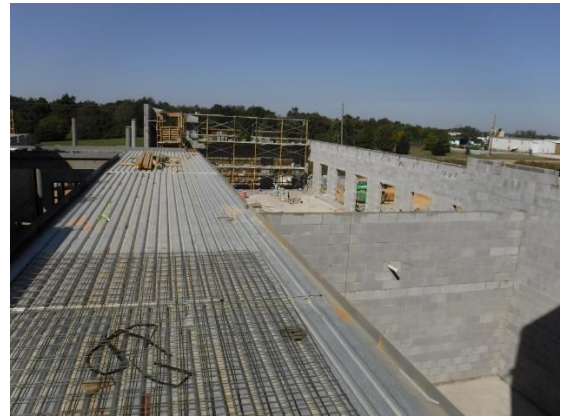
- w) The mechanical platform will be poured all the way to the front of the building.

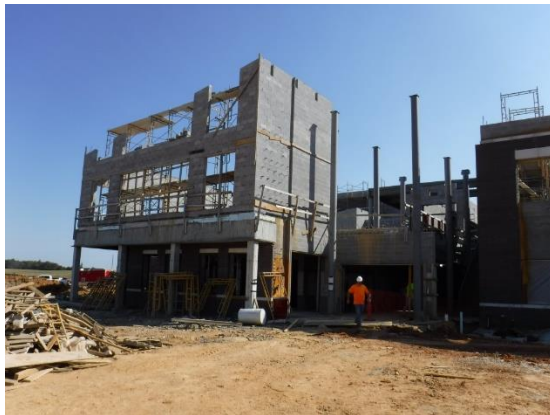
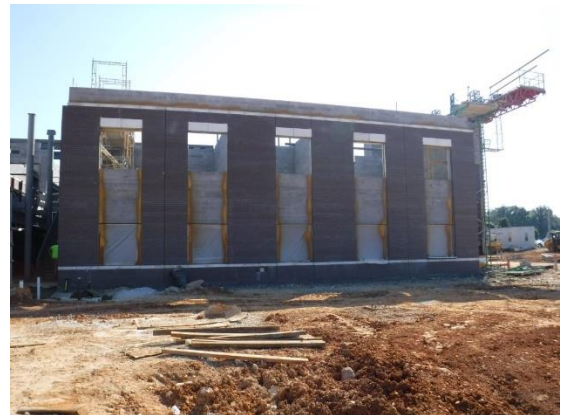
- x) The sloped front of the Library/Media Center is defined by the block walls. The roof sheds from the main corridor down to the opposite wall. The front classroom wing is covered with brick.

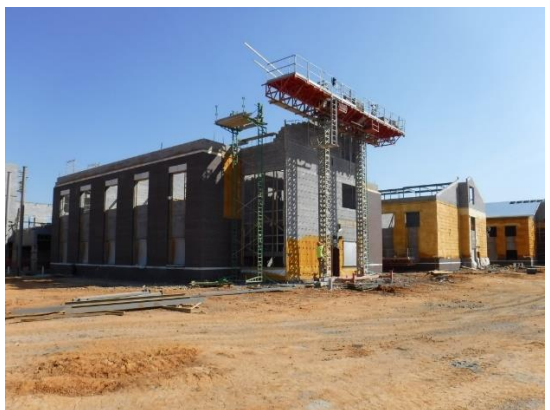
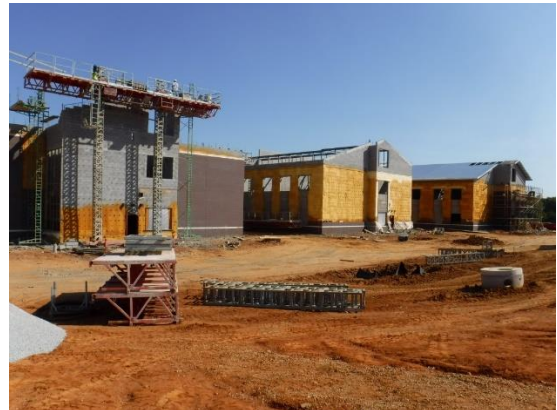
- y) Masons were laying block on the gable end of the front classroom wing.

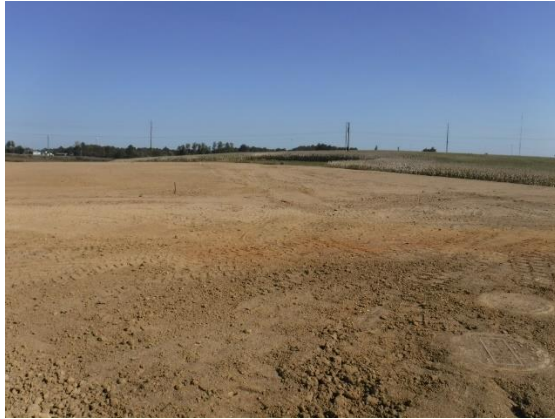
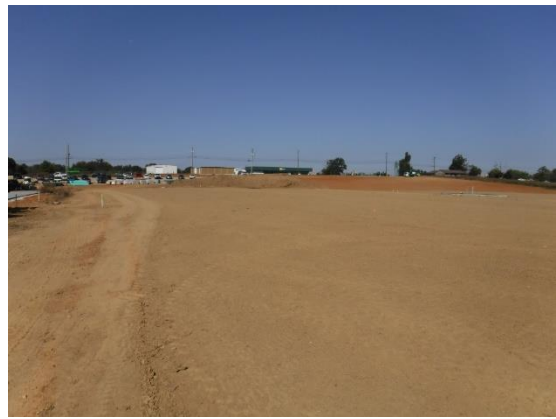
- z) The football field has been graded with topsoil spread over the area.

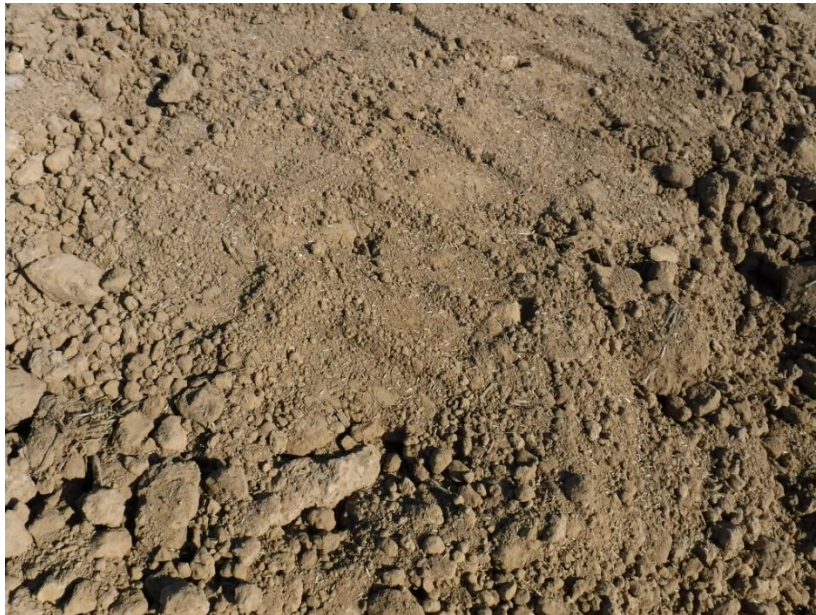
- aa) Grass seed can be seen in the topsoil on the football field. This will need irrigation to germinate.
