## FIELD OBSERVATION REPORT

Lincoln Trail Elementary School, Hardin County Schools, Elizabethtown, KY 201752 -CA8

Date: 10/7/2020

Report No: 34

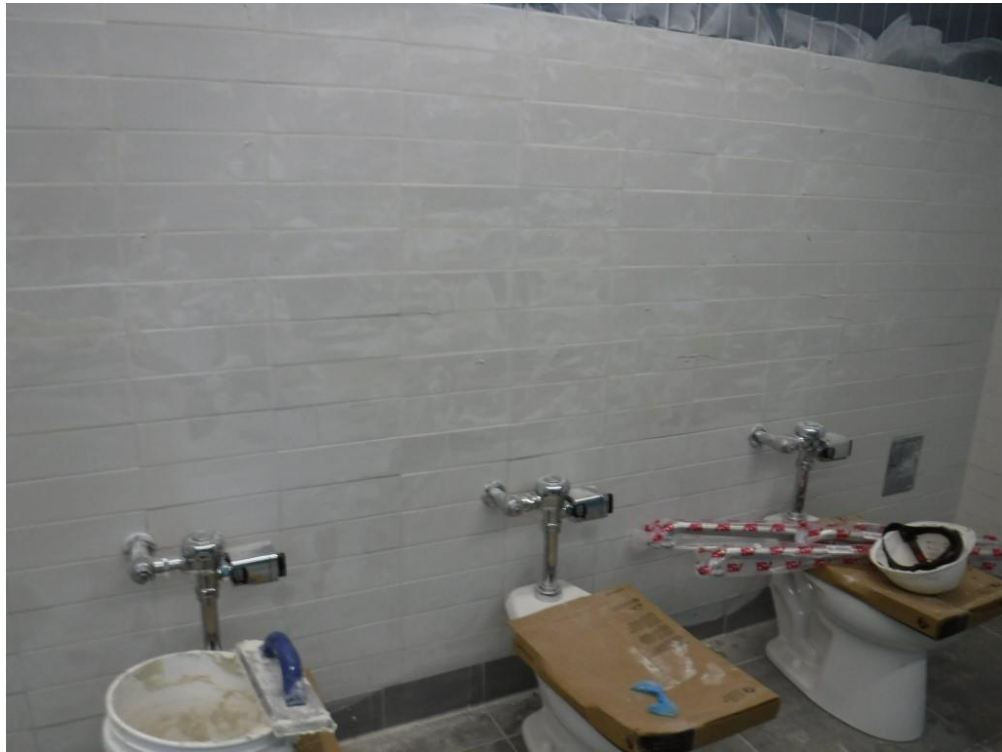
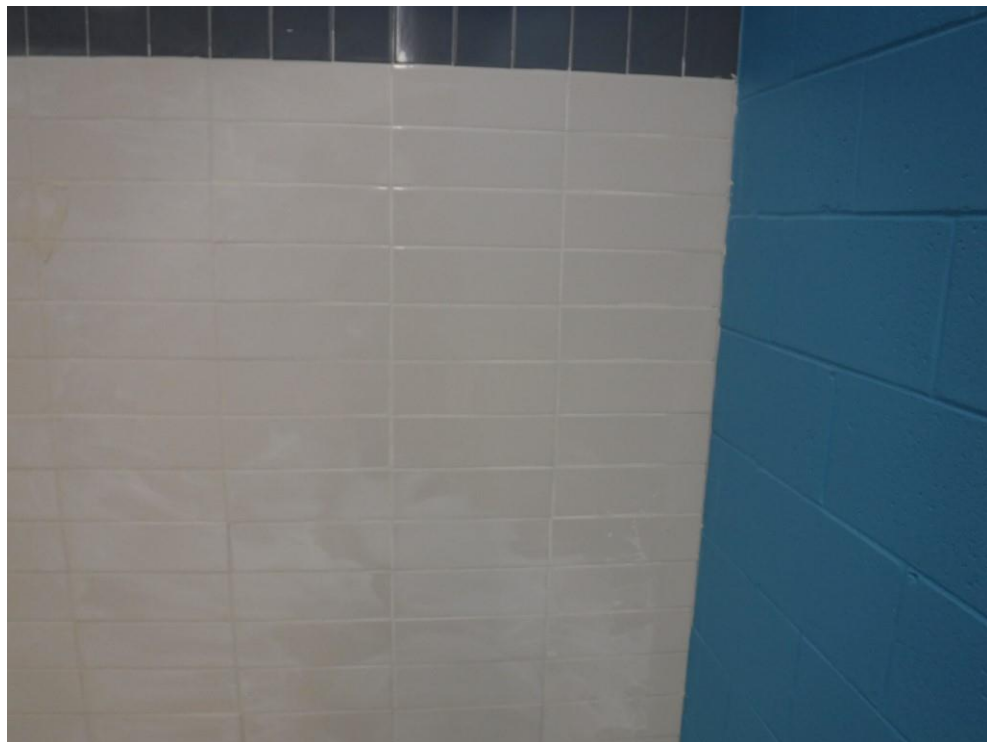
We have not seen improvement in the appearance of the ceramic wall tile after several attempts of repairs. Gerald and I met with the installer to go over the requirements to achieve an acceptable appearance. We discussed the uneven grout joints again with the installer. The installer agreed to regrout the joints to produce a sample of work that could be reviewed for approval. Gerald again noted that there are numerous places in the Kitchen floor where joint grout is missing. Gerald told the installer that the trim installed at the edges of the ceramic tile pavers at the toilet entrances is a trip hazard. The trim does not match the ramped trim profile indicated on the drawings. The trim must be replaced with a profile that matches the drawings. The installer said he only installed the trim that was given to him by Smith Interiors. After my meeting at EHMS, I returned to view a sample of the repairs. It had even joints and was acceptable. I instructed the installer to match the sample for all the other tile walls in the building. Gerald agreed to take pictures of the repairs the next day and send them to me. On 10/7/2020, he reported that the repaired wall looked much better and could be used as a sample for repairs for all other tile work. From the images we received from Gerald, we agreed with Gerald's recommendation. There are still defects in the joints that will need to be corrected before completion.

- b) The wall tile on the fixture wall in one of the toilet groups had been regouted by the installer. On the lower image, a small section on the end wall was cleaned to reveal a sample of what this might do to the appearance of the tile. We agreed that the sample was acceptable and we would examine the joints again the next day.

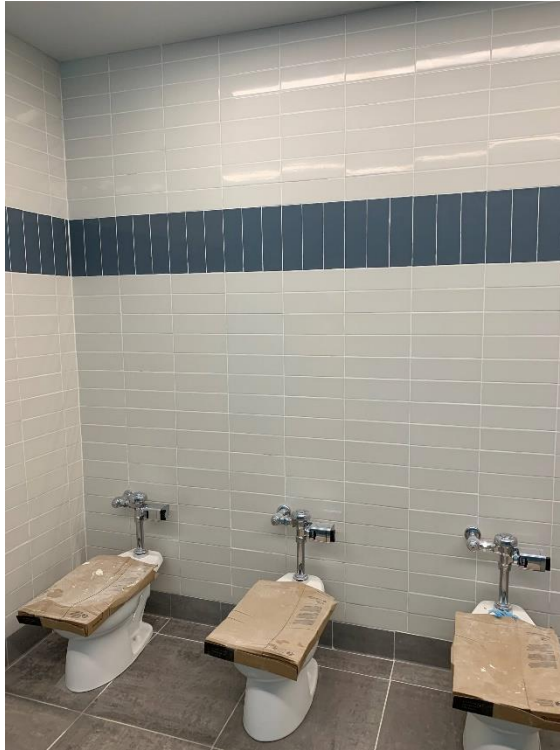
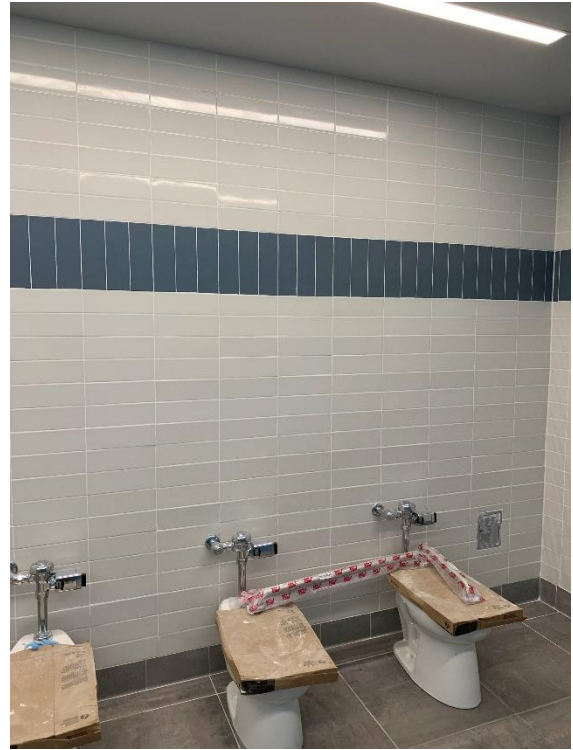
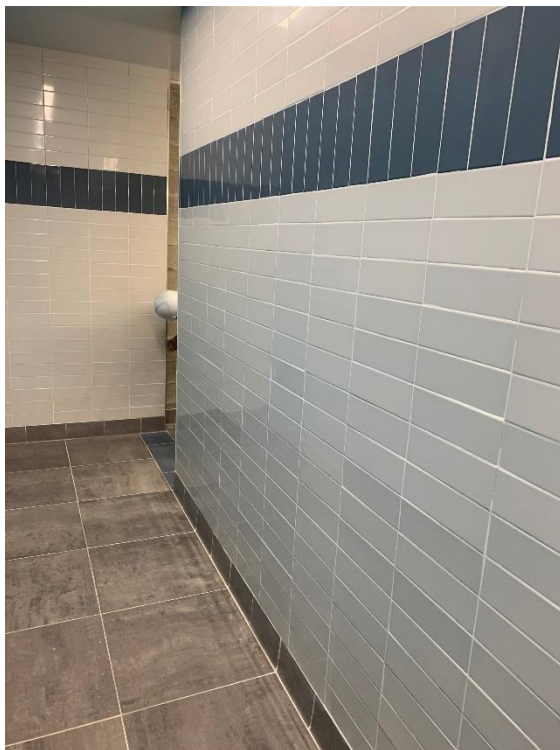
- c) Gerald sent these images of the walls after cleaning the next day. While they appear to be better than the previous efforts, defects in the grout are still visible. These will have to be corrected.

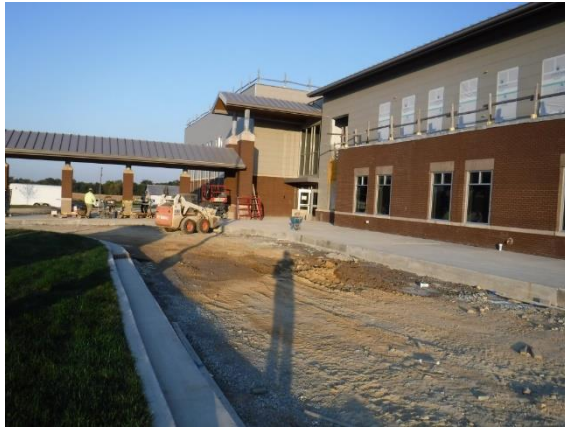
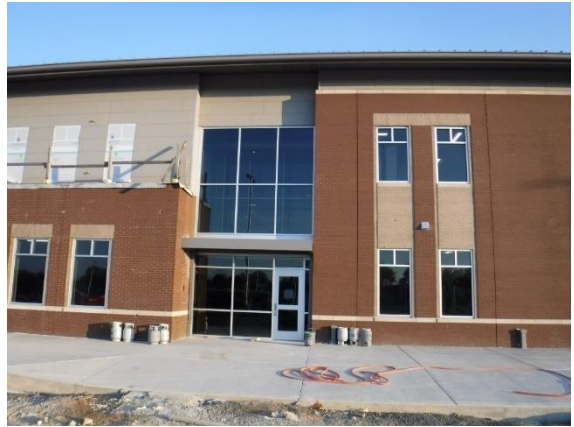
- d) The temporary railing at the low roof areas will remain in place until the roofers apply the flood coat and install the copings at the top of the parapet walls.

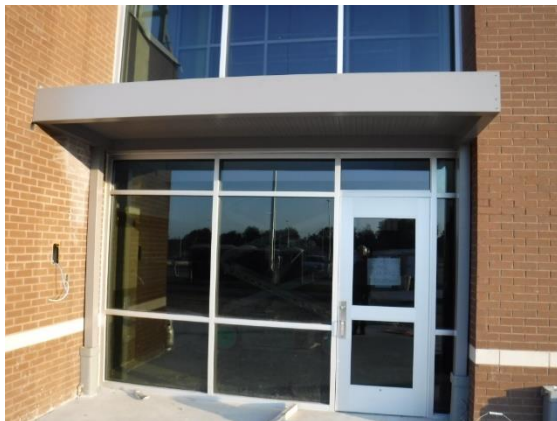
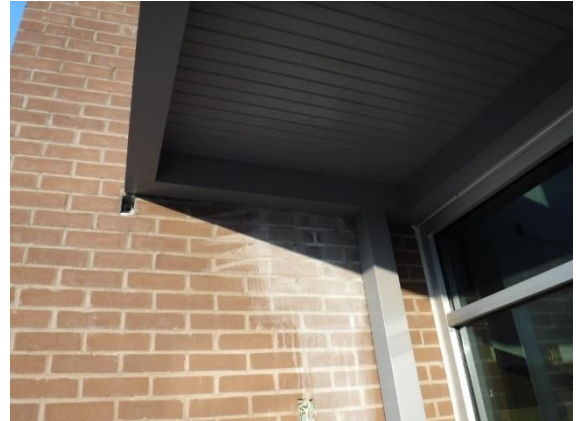
- e) The canopy was installed at the entrance at the center of the classrooms. Unfortunately, this was done before the stain was cleaned off the brick. This will now need to be done without damaging the canopy. In addition, the canopy partially covers the back box for a wall mounted light fixture. This may need to be moved.

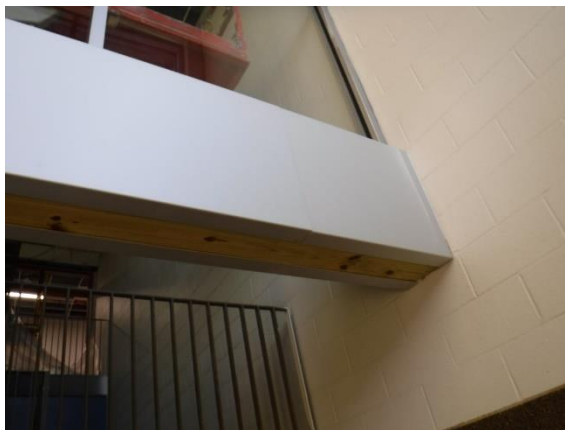
- f) The soffit at the entrance has been wrapped with aluminum. The inner vestibule wall and doors still need to be installed.

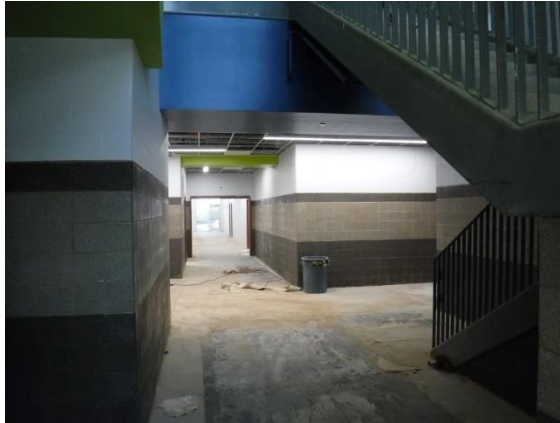
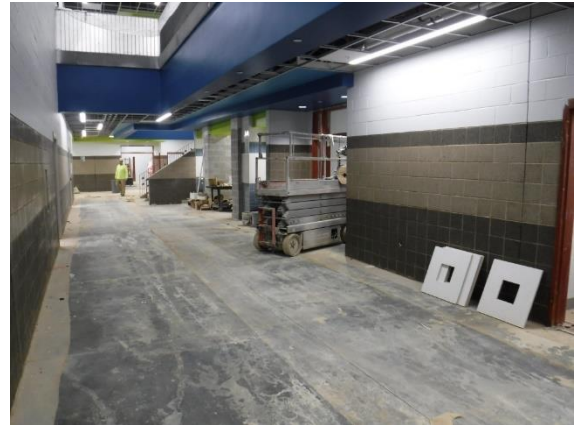
- g) The main lobby floor has been cleared of the Skudo system in preparation of polishing the slab.

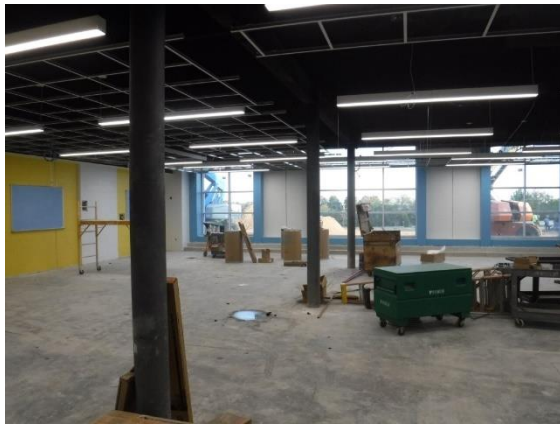
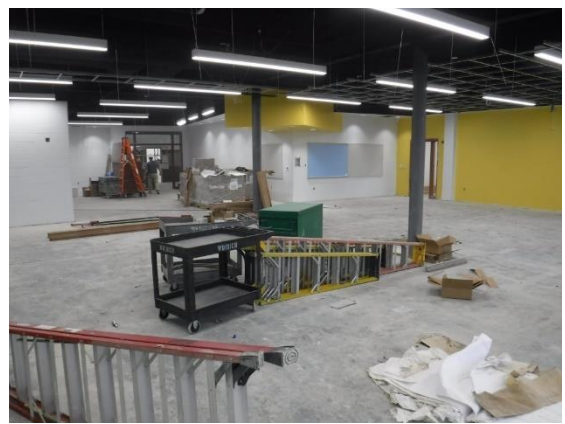
- h) The Library/Media Center is mostly painted. To complete the area, ceiling tile needs to be laid into the clouds, flooring installed, and the library furniture installed.

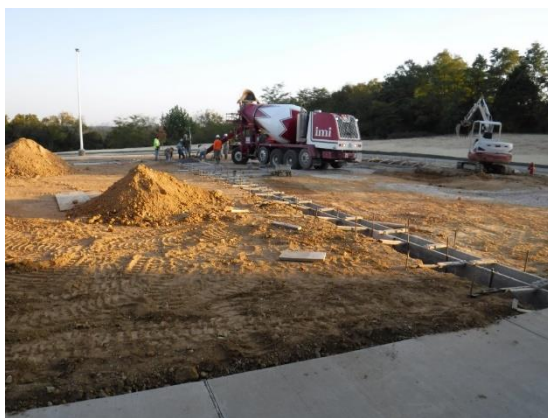
- i) The concrete walks at the rear of the site were being poured and finished.

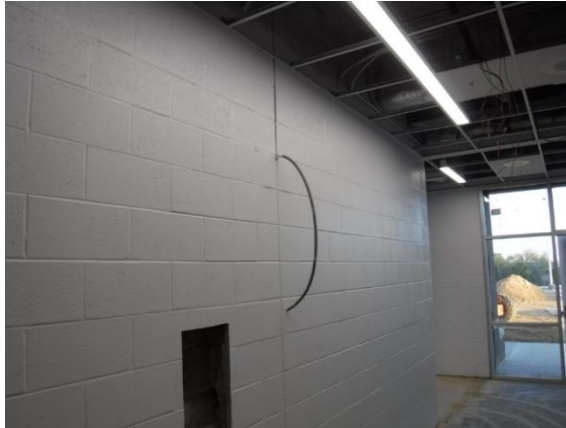
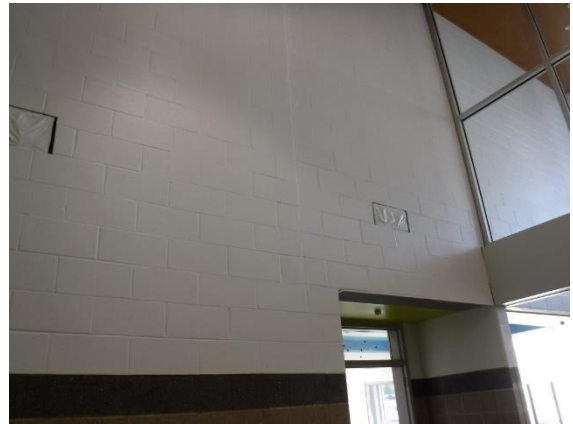
There are many sealant and caulk joints on the exterior and interior of the building that remain open. There are many caulk joints in the building that were not installed properly. Some joints do not have sufficient caulking material to produce a concave joint. Many joints have the final coat of paint over caulking smeared on the face of the concrete block. When this was noted on the mockup wall, we were told that this would be corrected, but we continue to see this unacceptable work throughout the building. This does not provide an acceptable appearance and must be corrected.

- j) There are many open caulk joints. Unfortunately, the caulking in the joint over the main entry is smeared on the block. This must be corrected as is the case for all joints like this one.

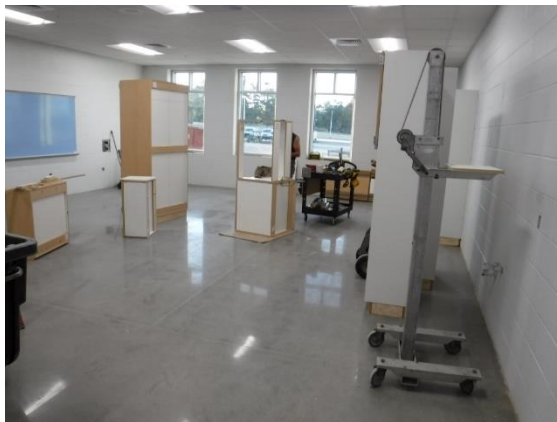
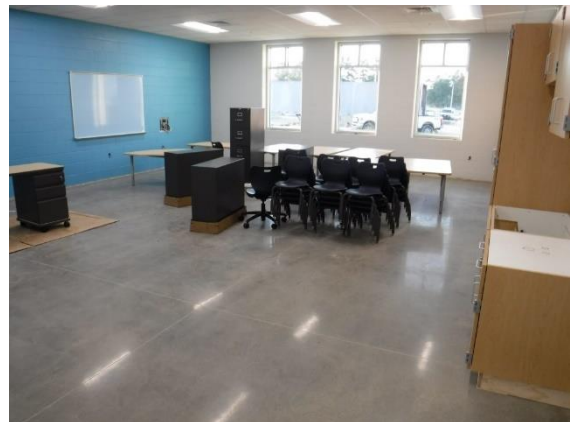
- k) The typical classroom has had the floors polished and the casework installed or waiting to be installed.

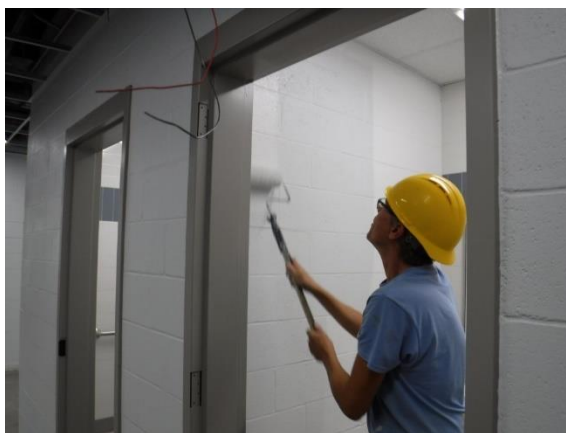
- l) Painters were observed correctly painting hollow metal frames with a roller.

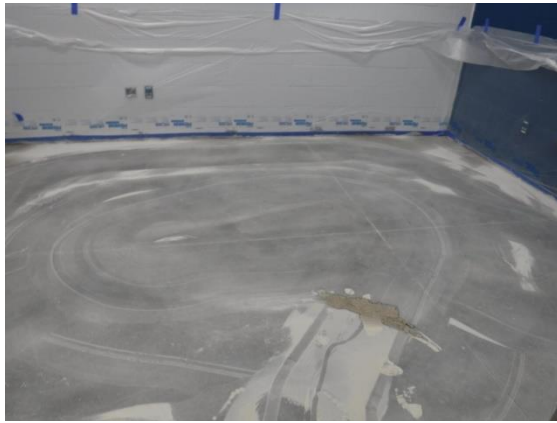
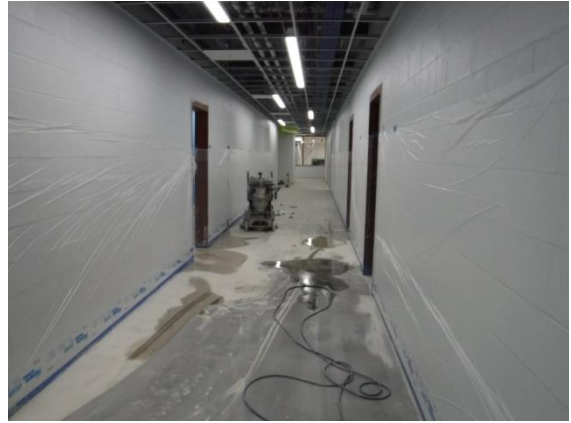
- m) The polishers were still grinding the slabs in Area B. They were nearing completion.

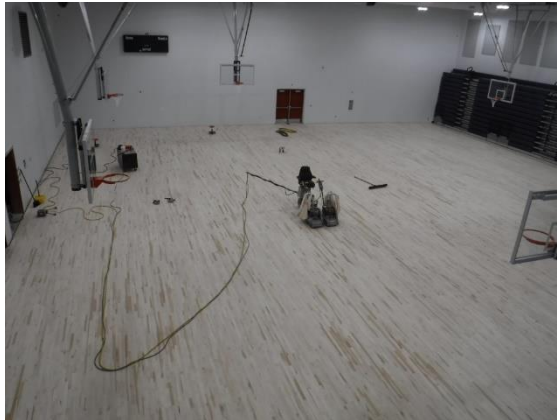
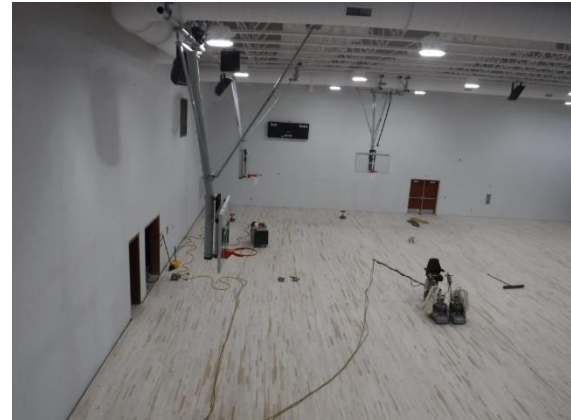
The gym flooring installer cannot start the final sanding sealing of the gym floor until all of the electrical and acoustical panel work is complete.

- n) The sanding and sealing of the Gym floor cannot be started until the acoustical panels are in place and the electrical work installed.

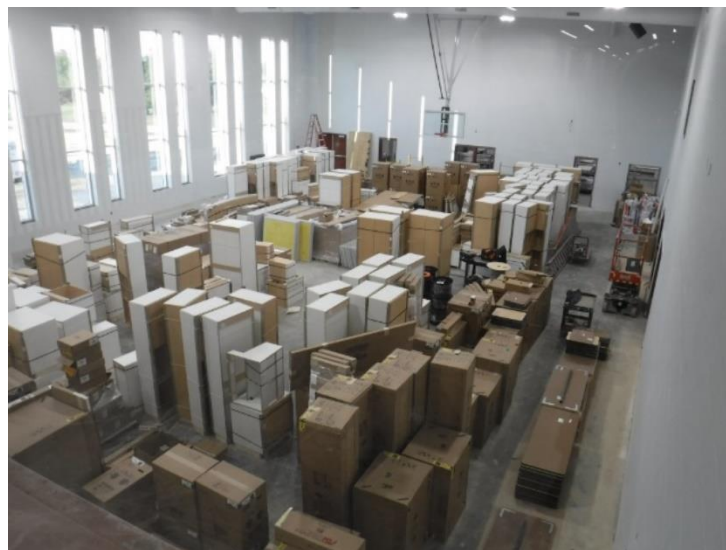
- o) The cafeteria is still be used to store casework and furniture. Work to complete this space cannot be done until this equipment is moved from the room.

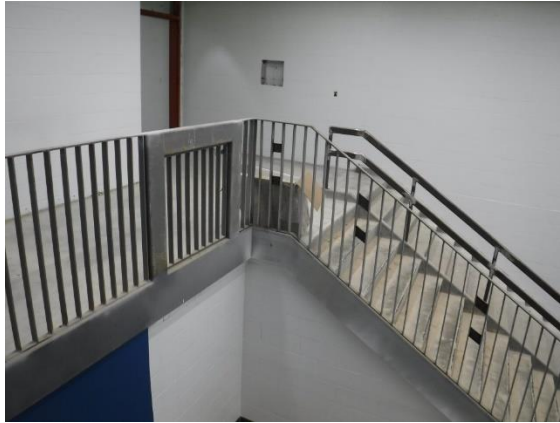
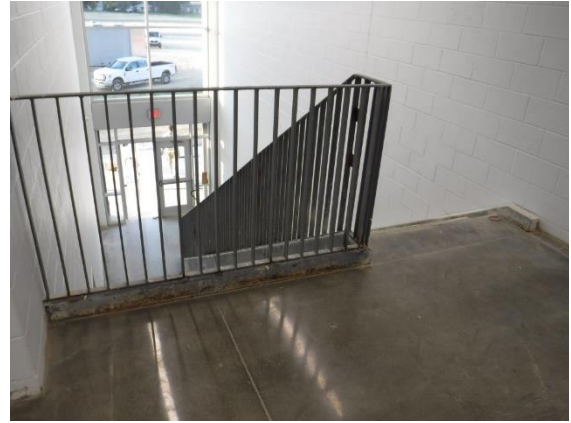
The steel stairs still need to be detailed ahead of the painting. They have a rough unfinished appearance with incomplete welds, rust spots and other defects that must be repaired before the stairs can be painted.

- p) Final detailing of the welds on the stairs must be done before they can be painted.

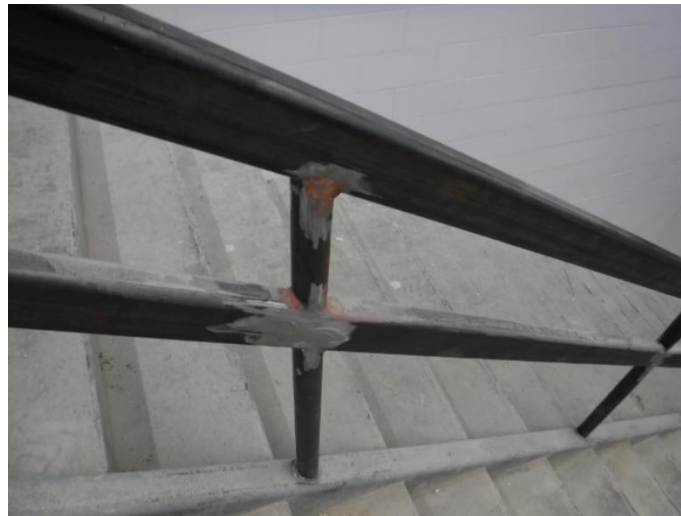
- q) Welds on the railings were ground, but primer was not applied.

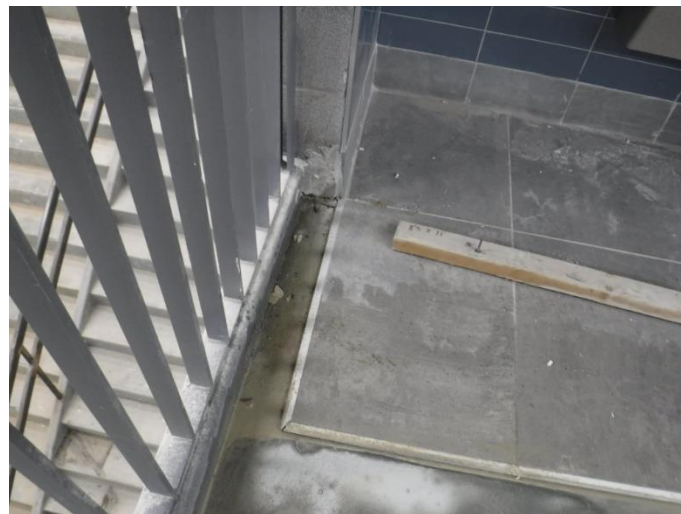
- r) A large glob of mortar is still at the bottom of the wall at the toilet group in Area B.

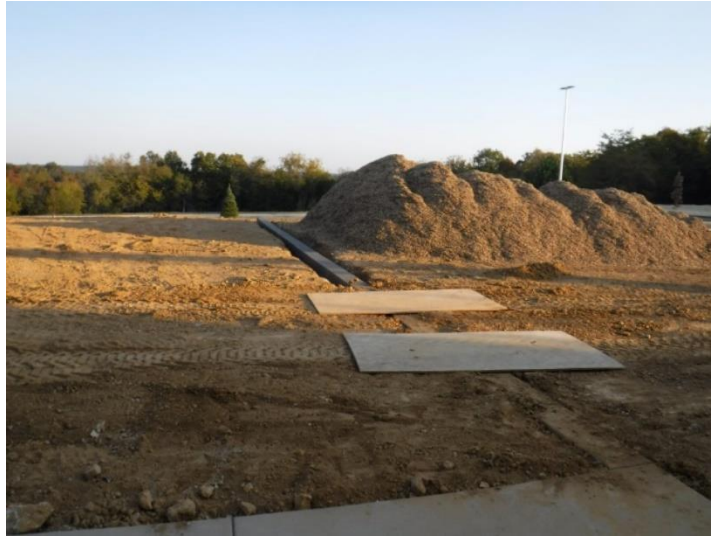
- s) The mulch for the playground is stockpiled near the area.

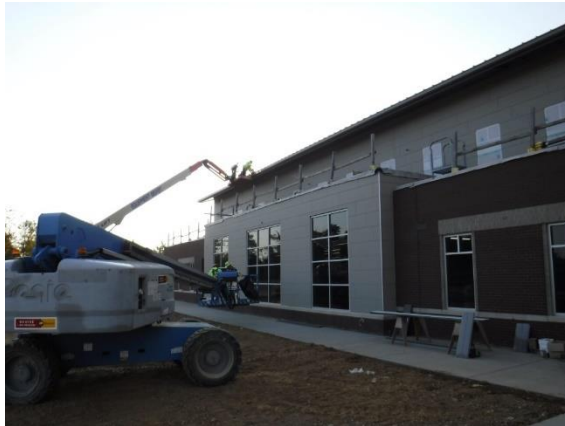
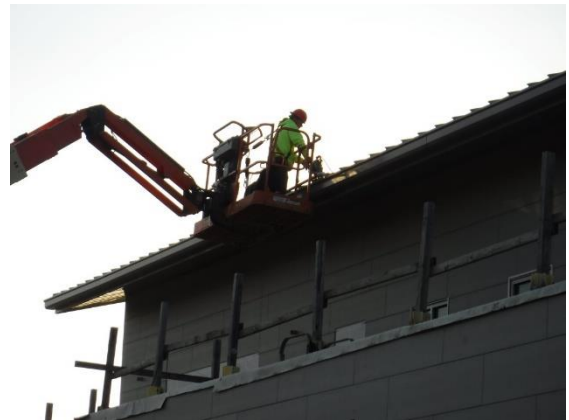
The roofer was seaming the standing joints in the metal roofing over the building using a robotic machine.

- t) The roofers were using a robot to seal the seams in the metal roofing.

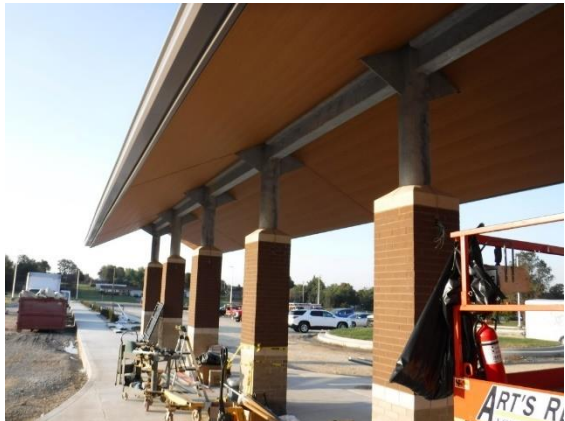
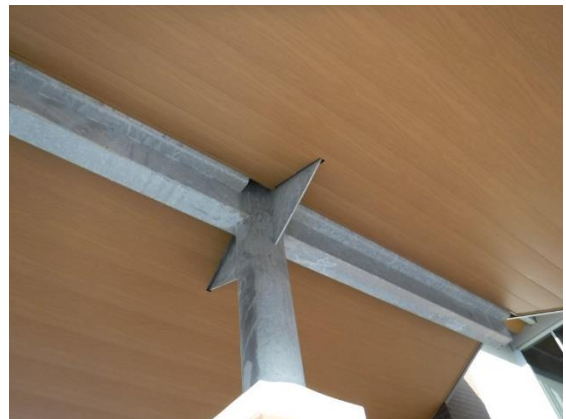
- u) The bent plates at the steel frame do not close to the columns. This must be corrected to avoid having a place where birds and insects can enter the soffit at the canopy.

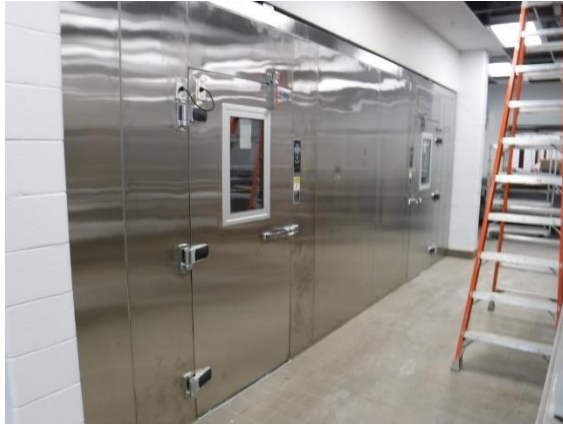
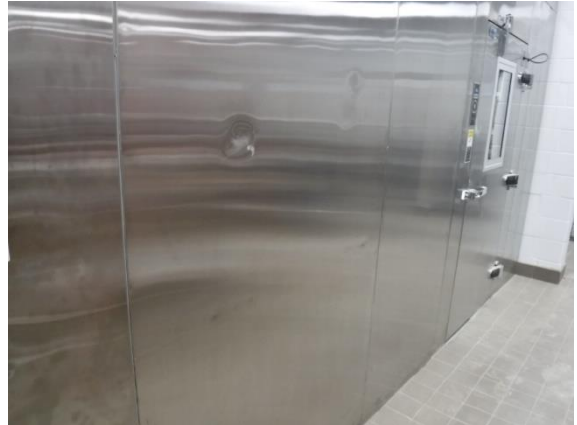
- v) The cooler/freezer wall was damaged during installation. This must be replaced.

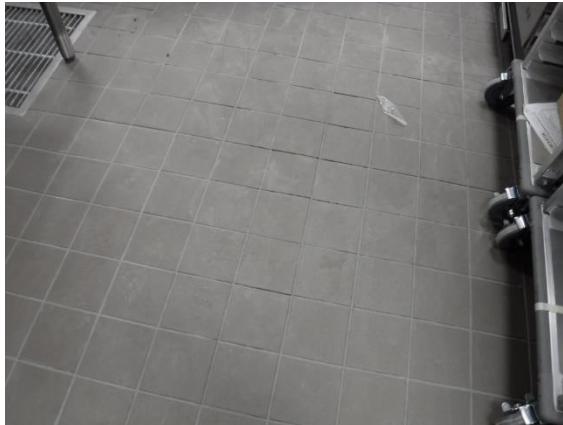
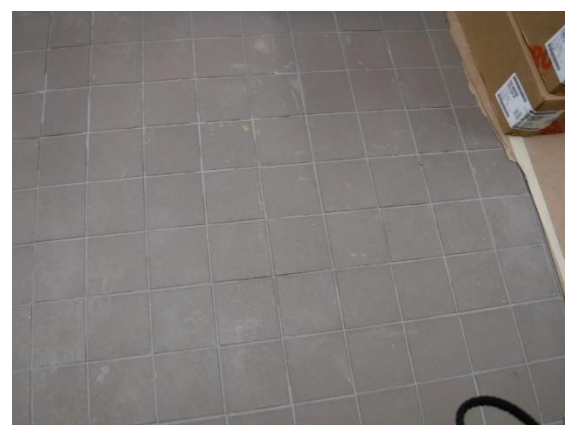
- w) The epoxy grout joints in the Kitchen floor are not completely filled. This must be corrected.

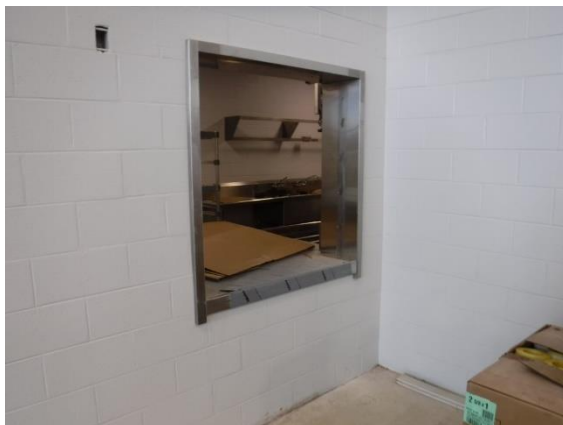
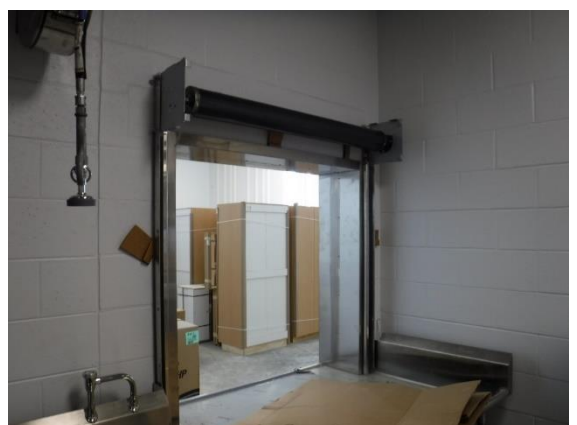
- x) The fire curtain at the dish return is missing parts.

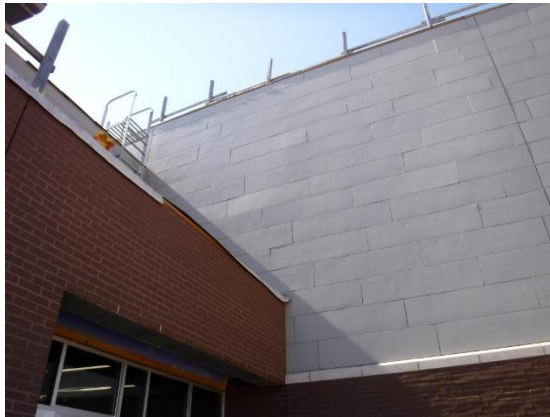
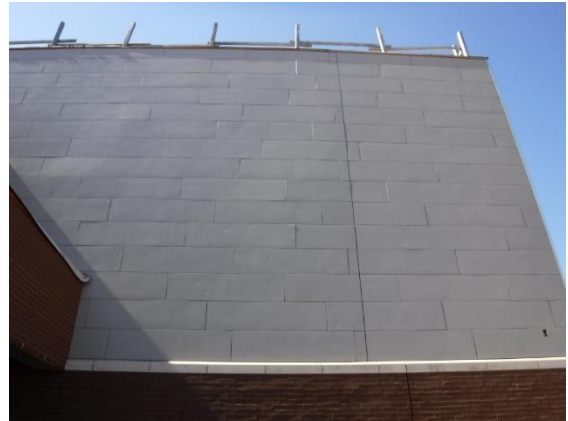
- y) When the sun passes a certain point, it reveals uneven textures in the fiber cement panels. This appears to be all in the panels and not the installation.

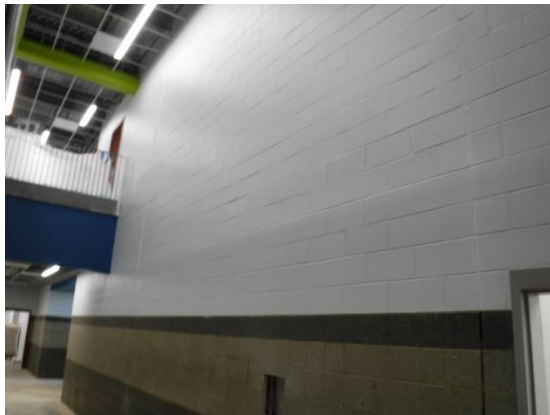
- z) The concrete block on the two-story wall in the main lobby is especially rough. This must be corrected.

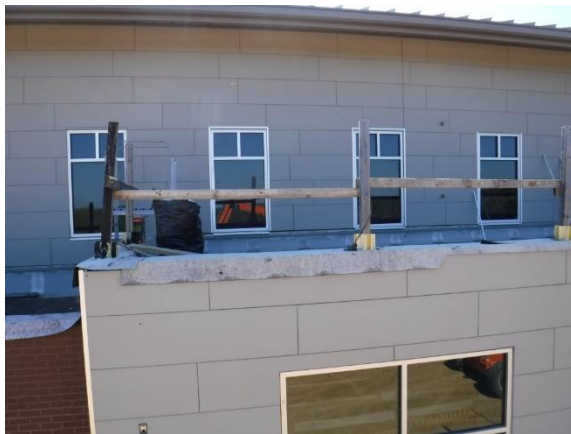
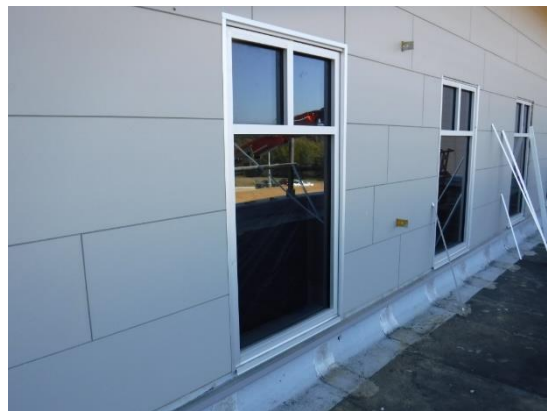
We met with representatives of Edgar Belle and Dixie Exteriors to examine the samples for the trim around the windows at the fiber cement panels. The metal matches the window frames. They were installing the trim angle with a 1" wide leg showing on the face of the panels. The trim must be fully adhered to the insulation stop in the wall and be fully adhered to the fiber cement panels. The exposed flashing along the counterflashing also needs to be covered with panels.

- aa) The 1" aluminum trim around the windows in the fiber cement panels was reviewed. We found this to be acceptable.

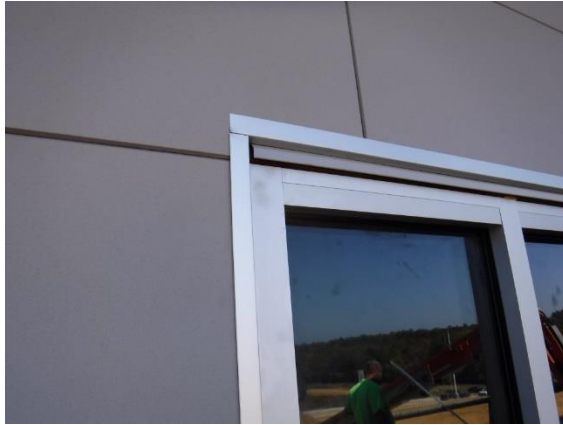
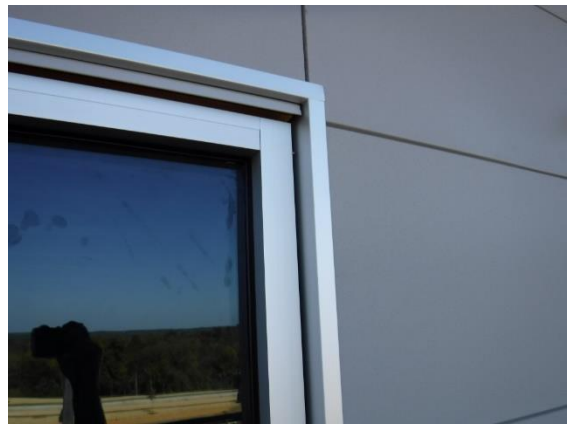
- bb) Care needs to be taken to provide square corners in the trim.

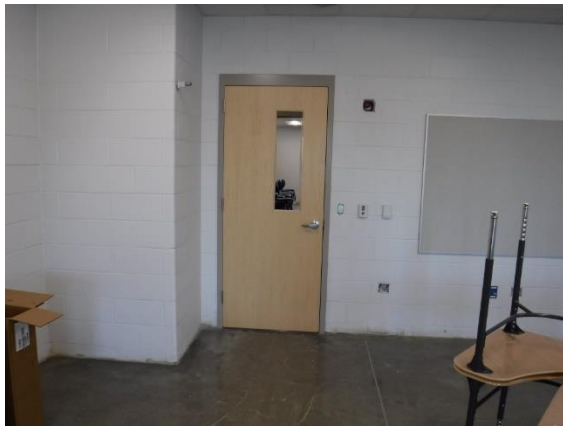
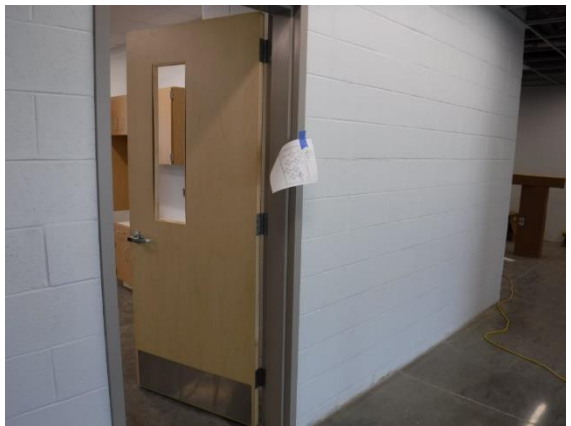
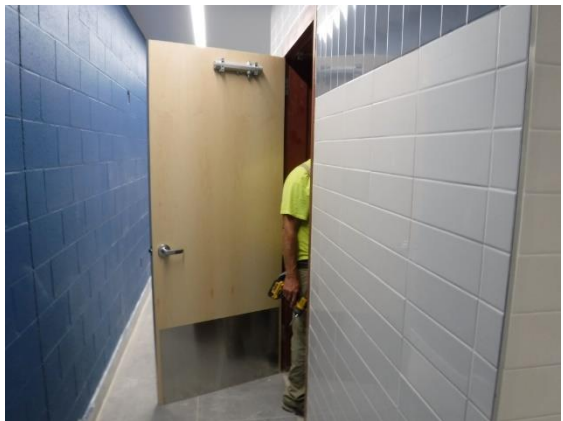
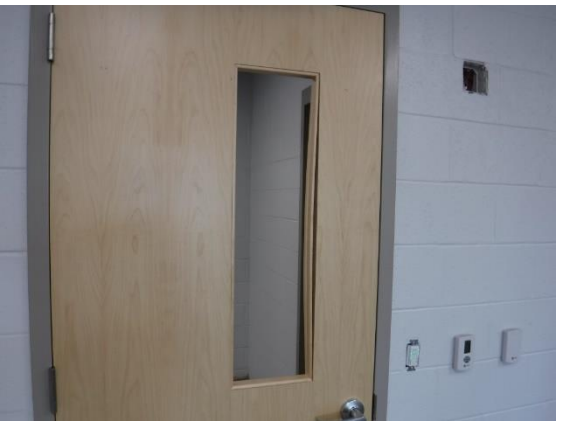
- cc) The wood doors were being hung. Unfortunately, this had to be done before the hollow metal frames were repaired and repainted. Repair work to the frames must not damage the doors.
