FIELD OBSERVATION REPORT

East Hardin Middle School, Hardin County Schools, Elizabethtown, KY 201752.01 - CA8

Date: 11/3&5/2020

Report No: 36

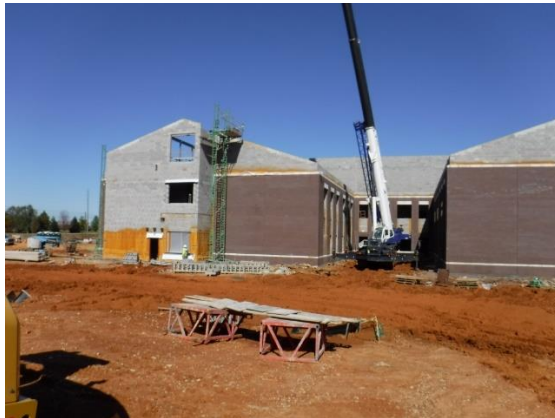
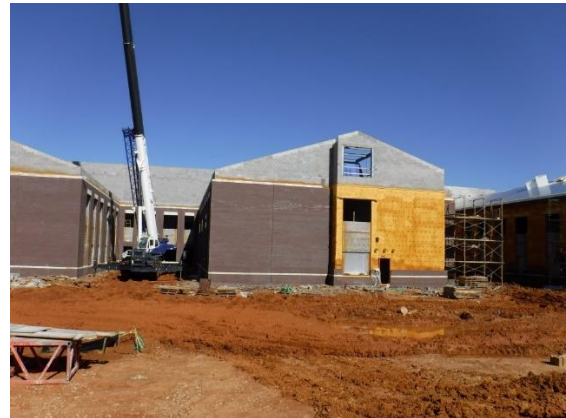
- b) The block walls on the classroom wings in Area A are topped out. Concrete beams have been poured on the gable ends. Masons continue to lay brick and stone trim on these wings.

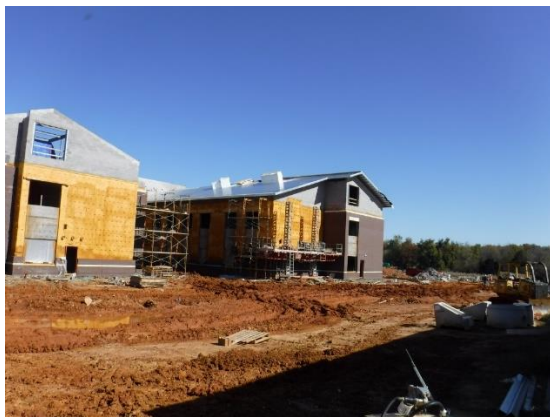
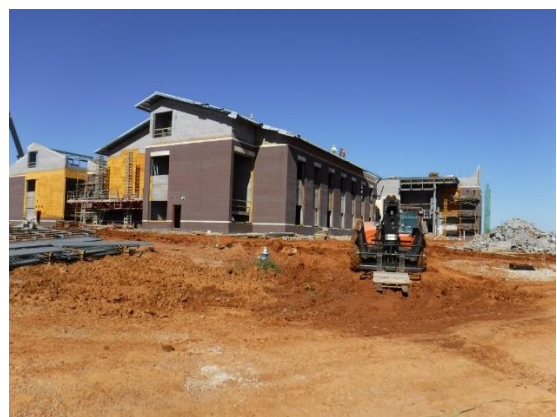
- c) Roofers were installing rigid insulation and vapor barrier over the metal deck over the classroom wing in Area B.

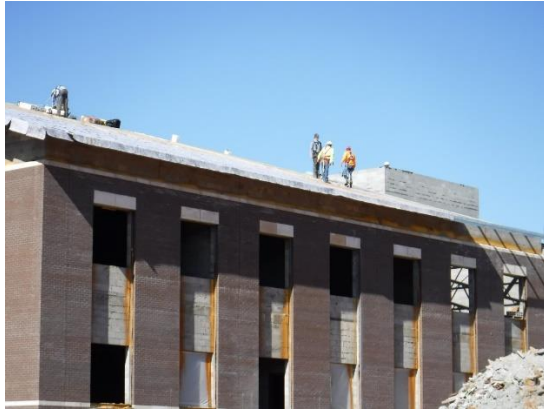
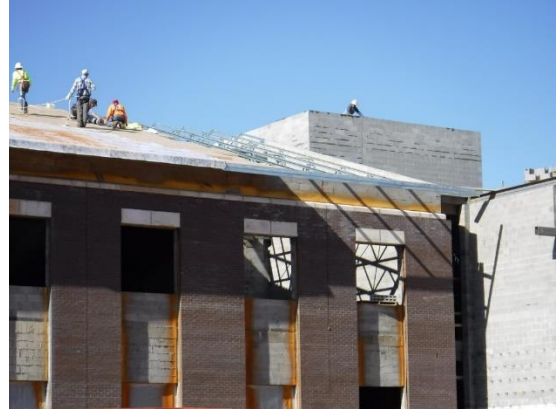
- d) A portion of the roof deck over the classroom wing was not in place due to a missing bent plate. The roofers installed the insulation and vapor barrier over all the metal deck that is on place.

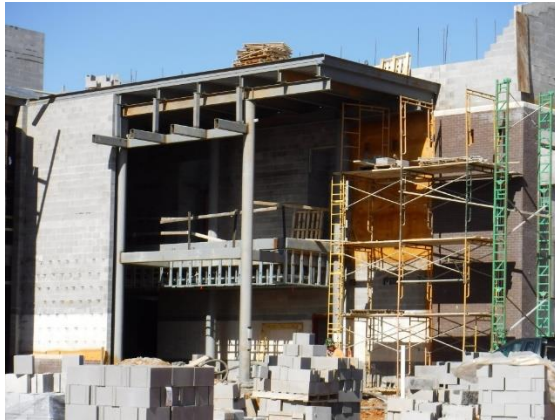
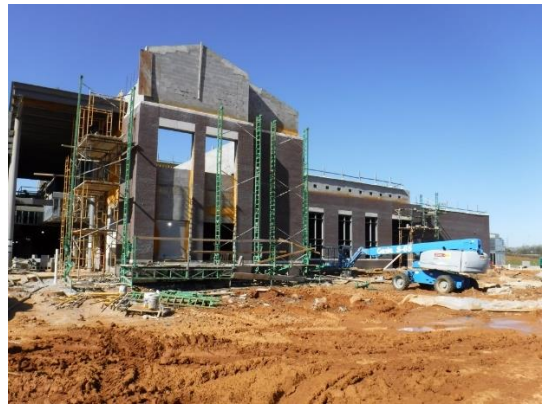
- e) The rear entrance at the end of the main corridor is ready for roofing, brick and curtainwall.

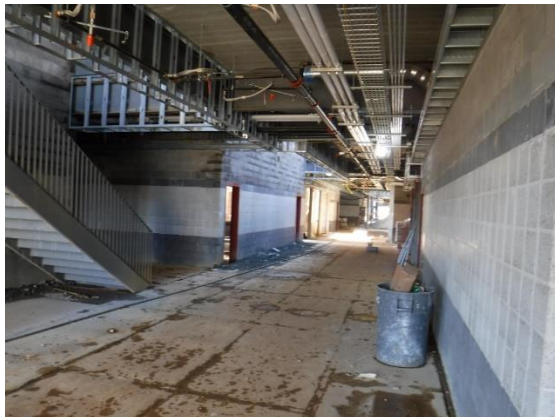
- f) The Skudo system on the first floor of the main corridor was relatively dry.

- a. Maintain the Skudo system so that it protects the corridor slabs.
- b. Clean mud and rust off steel and reprime areas where the primer was scraped off the steel structure.
- c. All trades shall keep the building and site clean by properly disposing all bottles, bags, wrappers, trash, debris, etc.

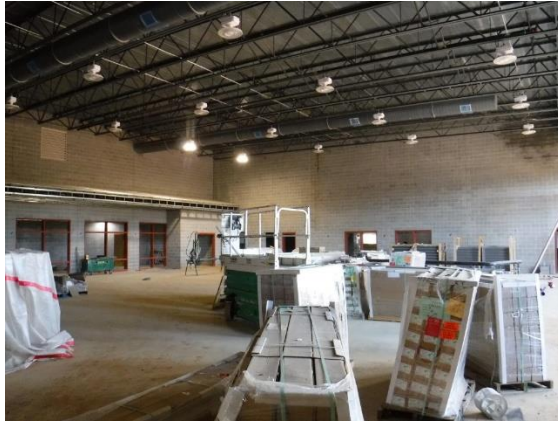
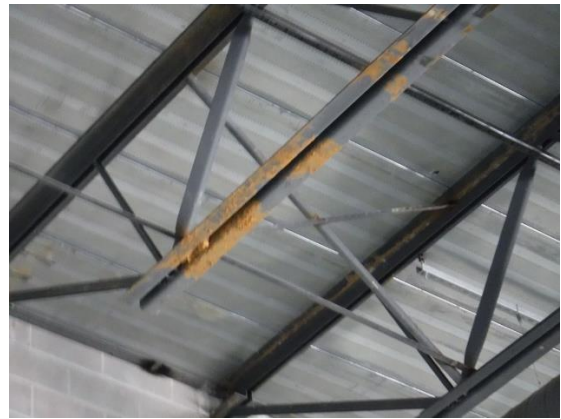
- g) The light fixtures are hung in the Cafeteria. Some of the steel needs to be cleaned.

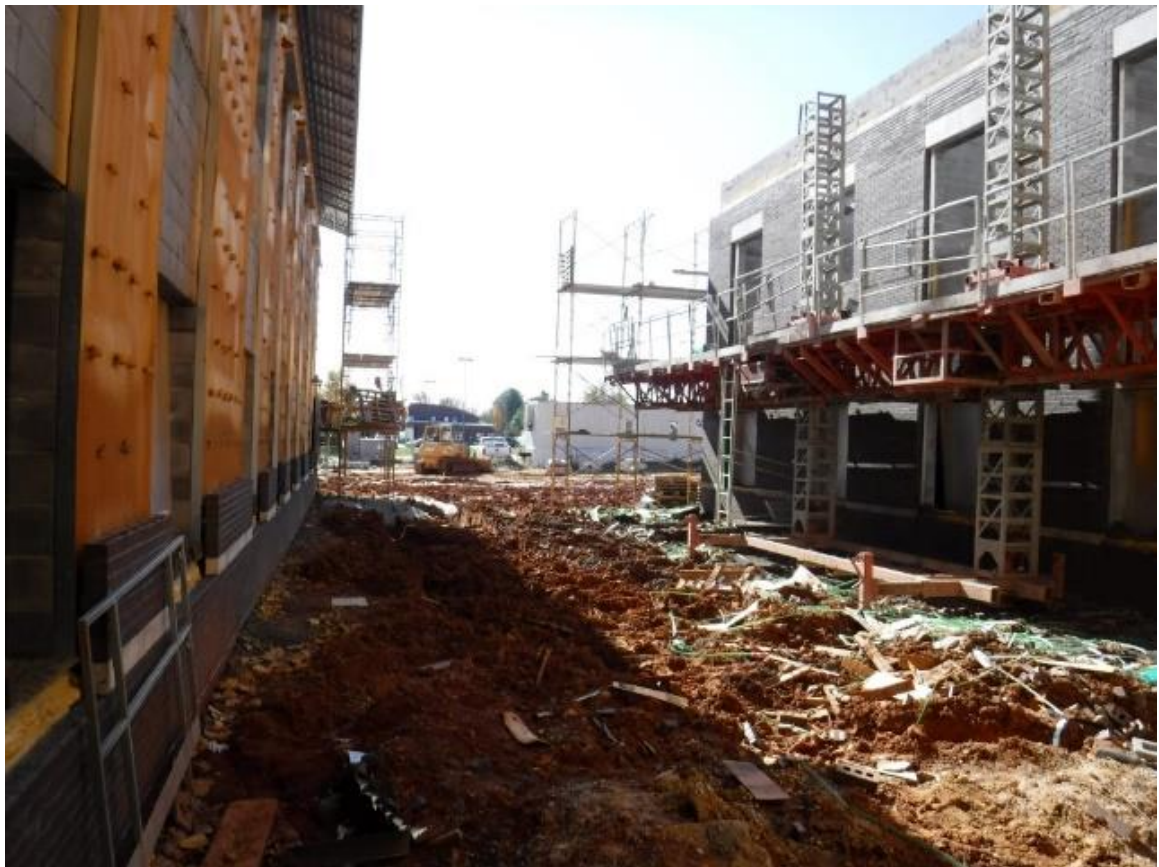
- h) Masons are laying brick between the classroom wings. The process makes the ground area very messy. When they pull out of the area, the ground needs to be cleaned and regraded.

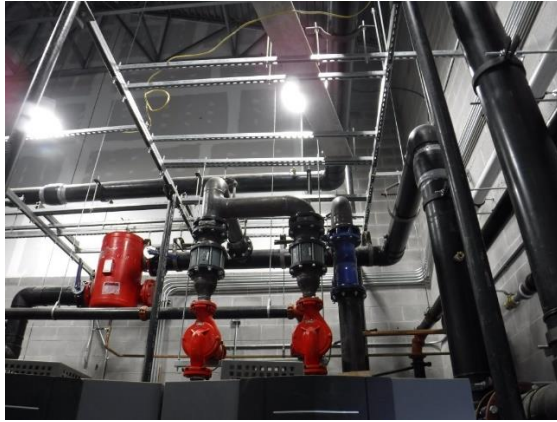
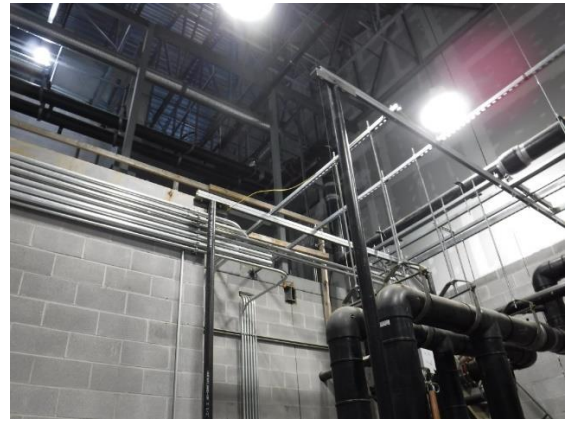
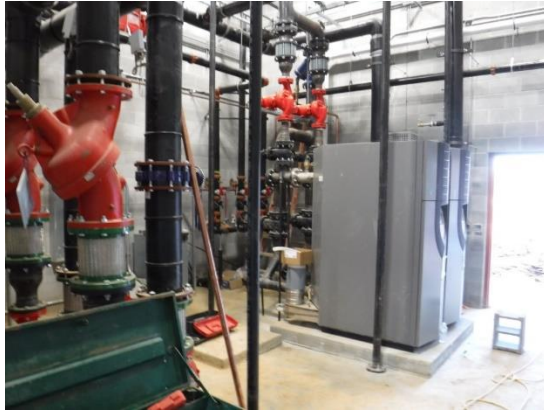
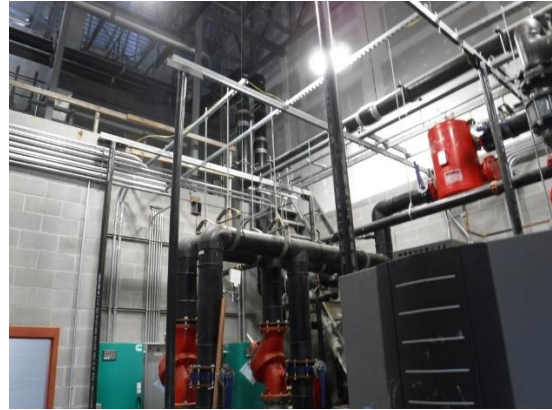
- i) The HVAC installers have placed the equipment, pumps and piping in the mechanical room. They have erected steel framing to support the hydronic piping extending up to the mechanical platform.

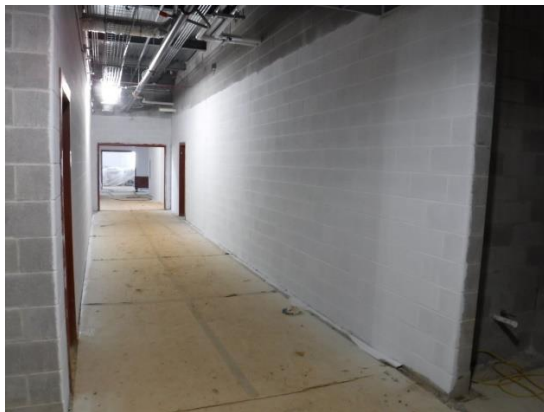
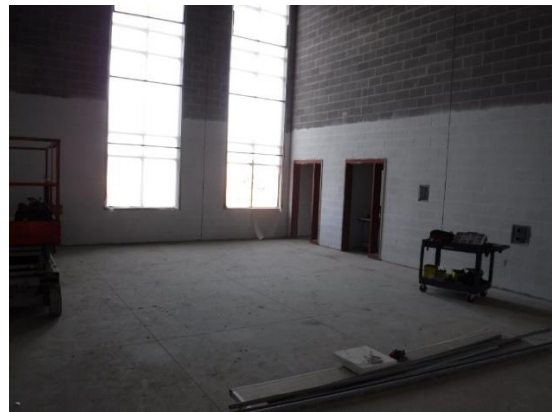
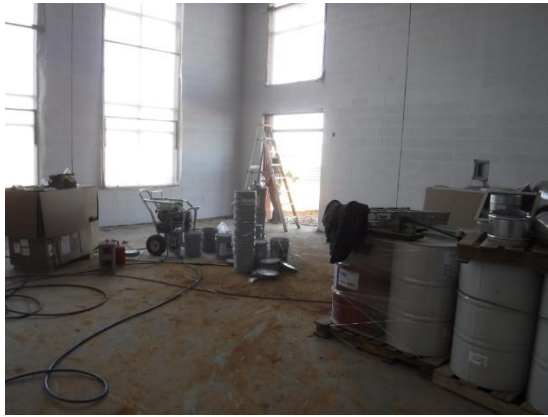
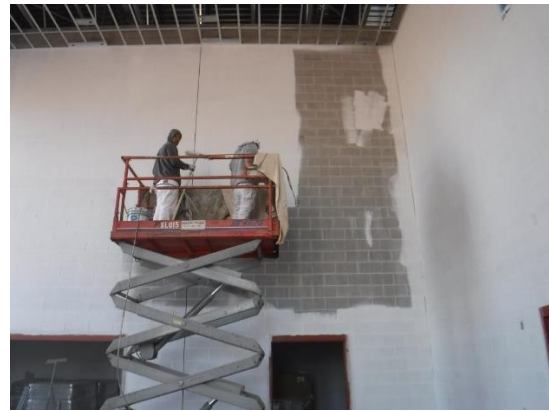
- j) The painters have been applying block filler in Areas C and D. With the high-quality temporary lighting, there is ample light for the workers to do their work.

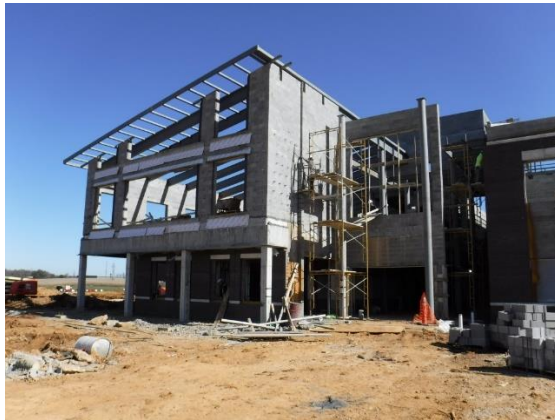
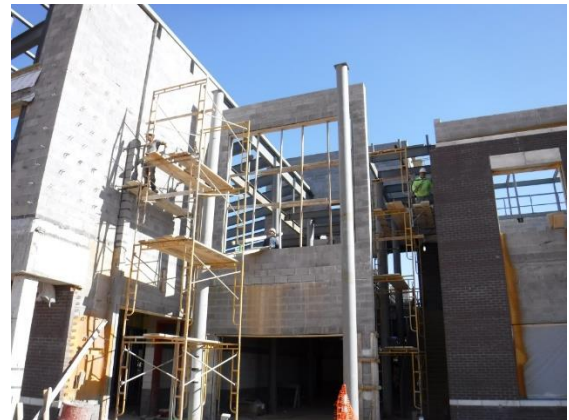
- k) The front wall of the Library/Media Center is on place and the steel roof framing is in place ready for metal roof decking. The repairs have been made to the block bearing and the wall at the back of the vestibule. Block pilasters were being added to the side walls.

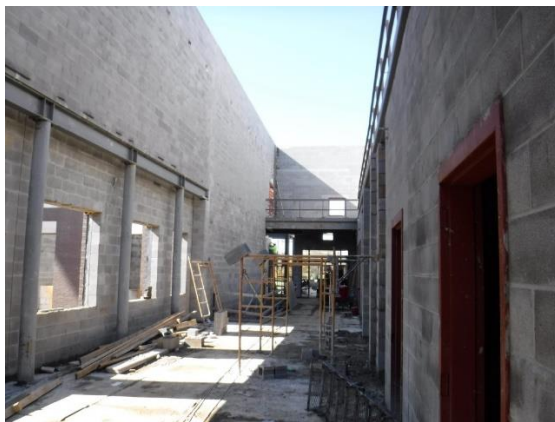
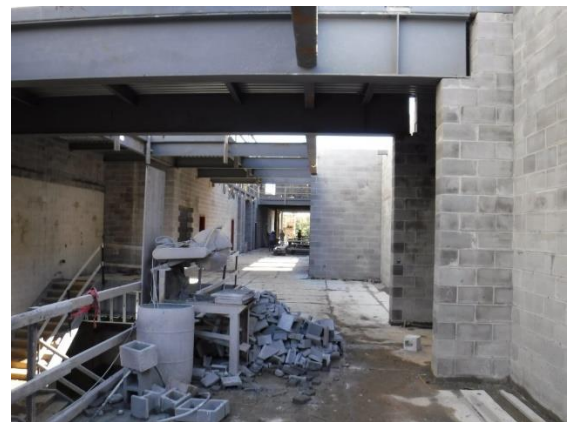
- l) The second floor of the main corridor is topped by a high wall that supports steel bar joist and metal deck. When these are in place the built-up roofing can be installed.

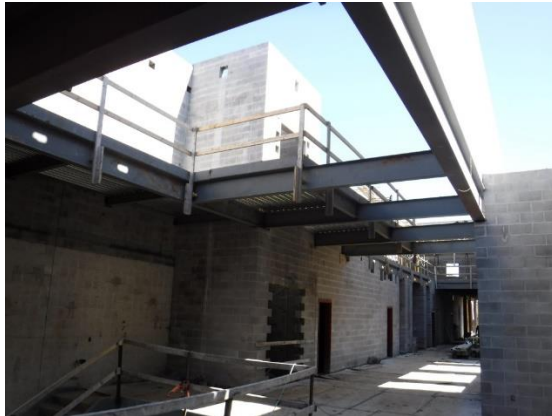
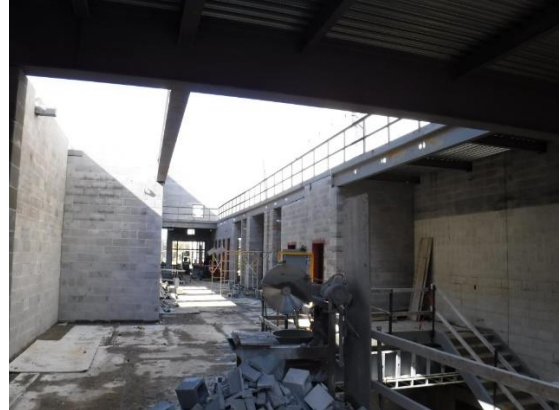
- m) The In the second-floor lobby area, the elevator shaft can be seen extending above the mechanical platform. All of this area will be covered with the built-up roof.

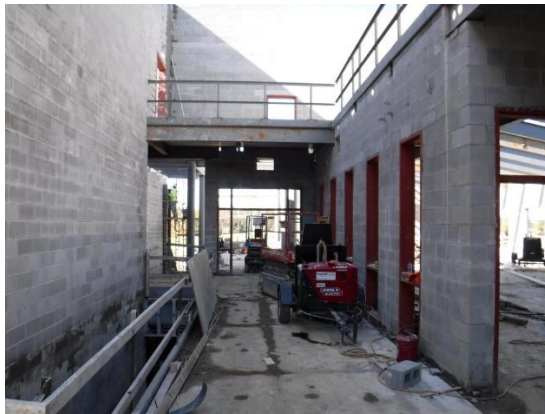
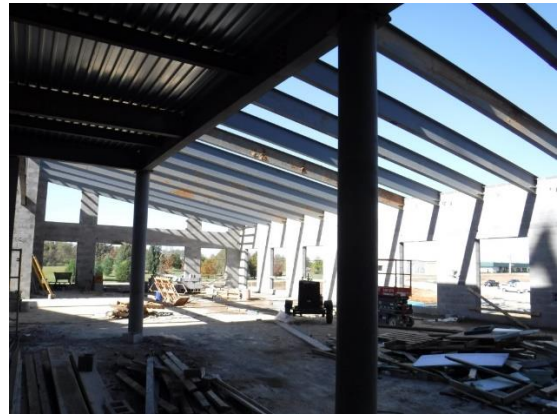
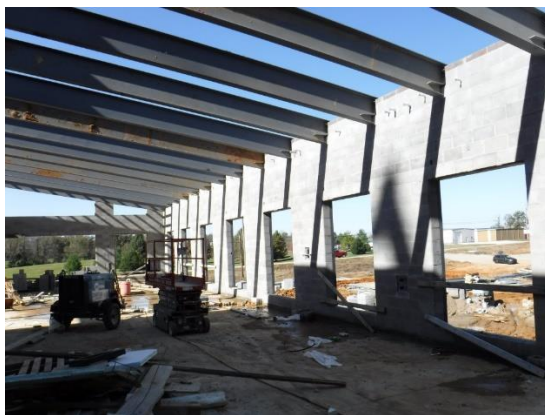
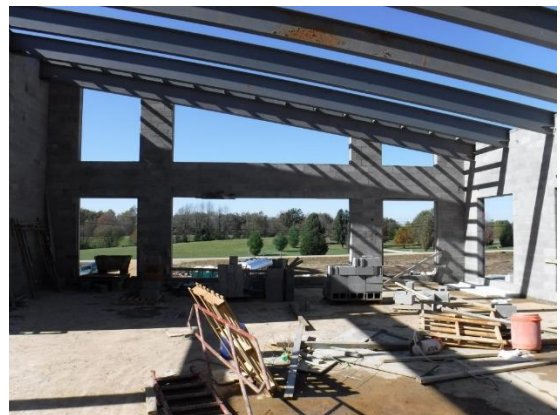
- n) The entrance to the Library/Media Center and the steel roof structure are in place. The front wall has high windows to allow ample light into the space. The roof structure is ready for metal roof decking.

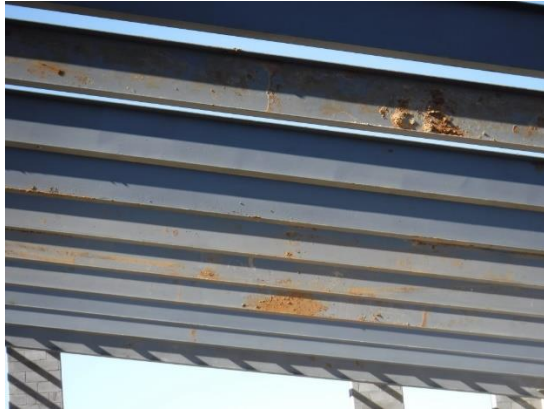
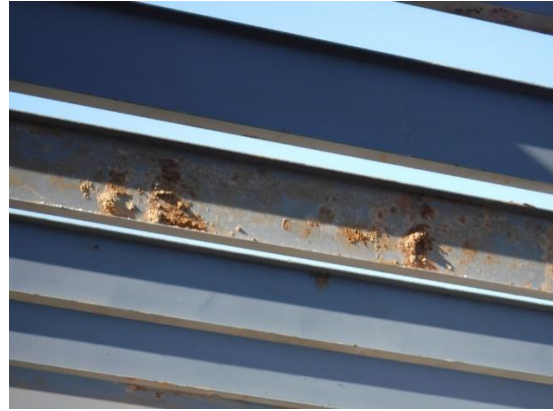
- o) Some of the steel framing over the Library has mud clumps that must be removed.

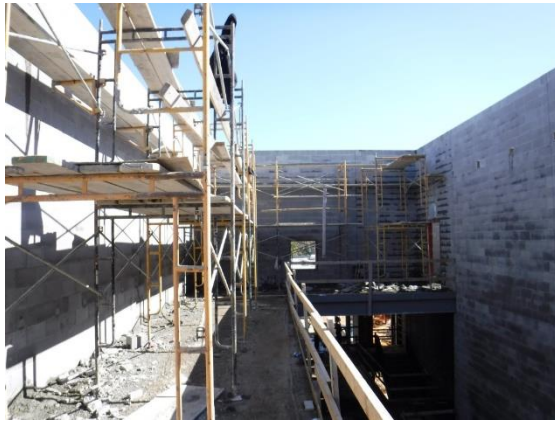
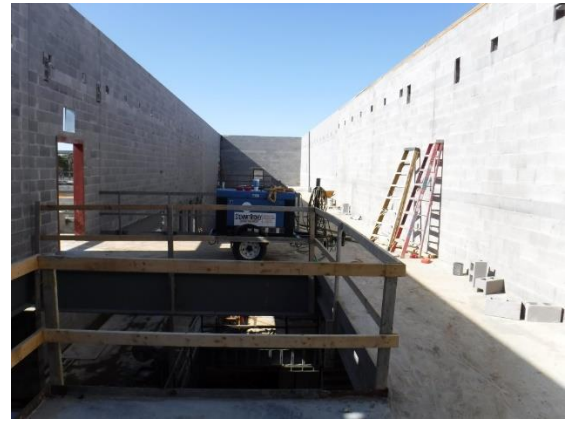
- p) The masons were completing the high wall over the main corridor. The holes near the top of the block will receive the steel framing for the roof.

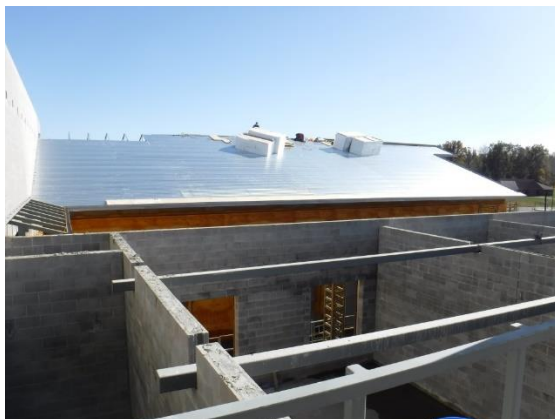
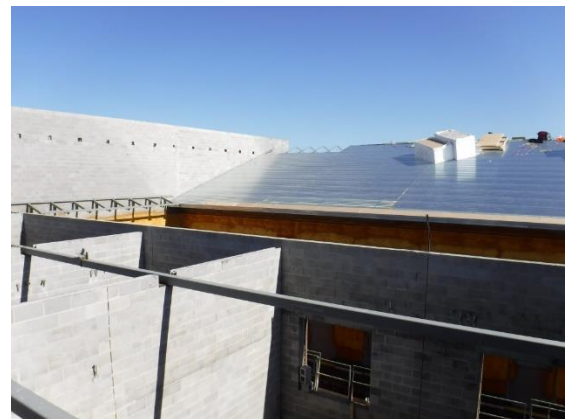
- q) Rigid roof insulation was stockpiled on the metal roof deck over the classroom wing in Area B. The roofers were working on the other side of the roof.

- d. Provide protection board for all ladders, equipment and materials staged on the low sloped built up roofing areas. Remove all screws, nails, sheet metal and other sharp objects from these roof areas ASAP.
- e. Do not damage materials installed by other trades.

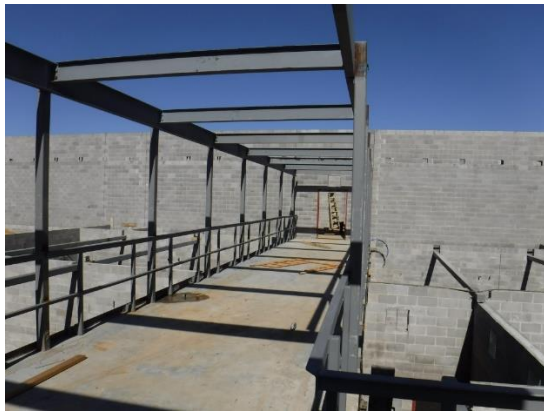
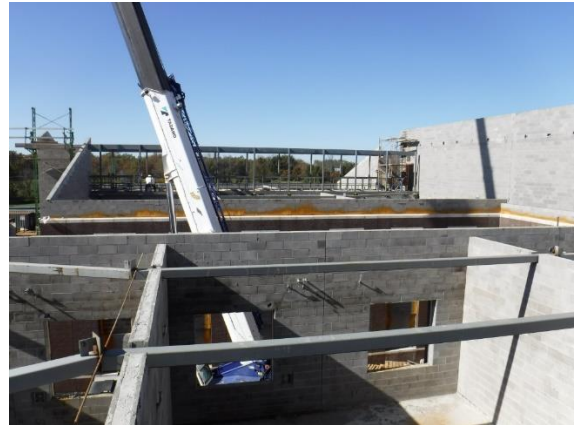
- r) The steel framing is on place over the two classroom wings in Area A. These are ready for metal roof trusses.

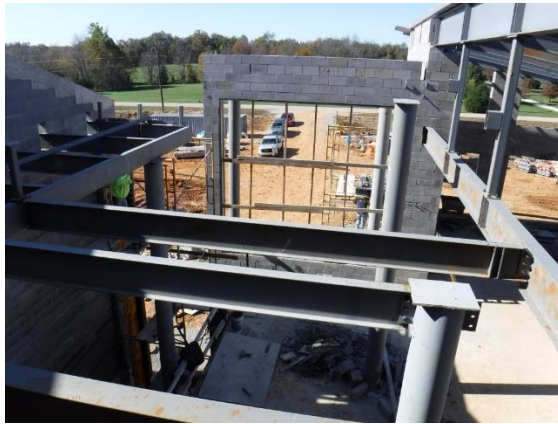
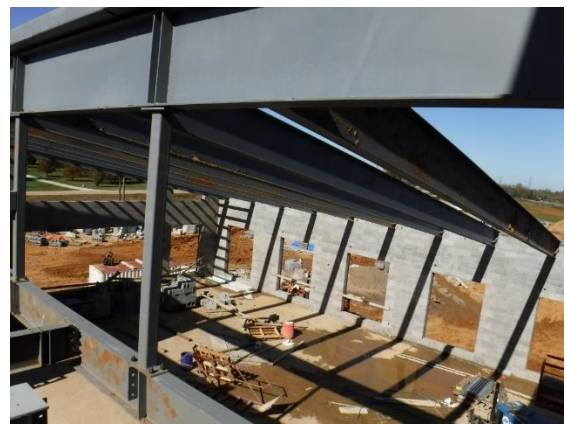
- s) From the end of the mechanical platform, the front vestibule and the Library/Media Center can be seen.

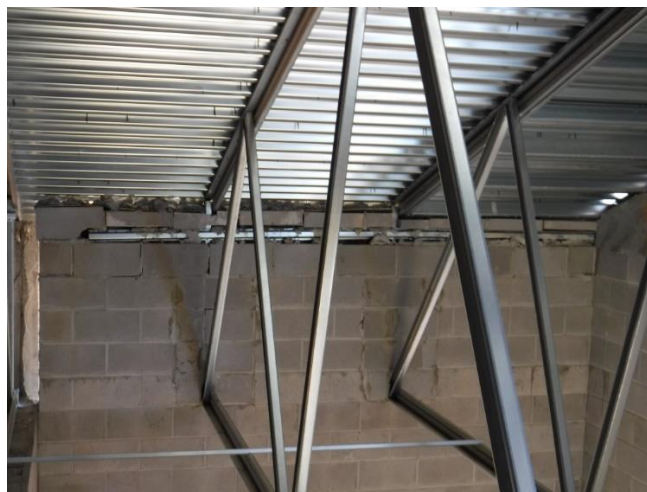
- t) Truss bracing at the end of the classroom wing in Area B is in the same plane as the block and does not allow the block to bear on the wall below. I asked Doyle to review this

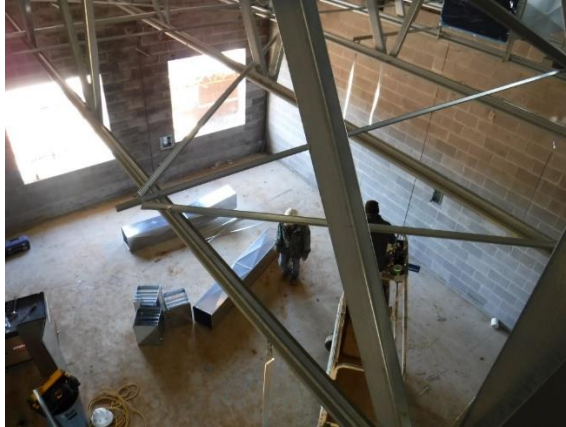
- u) From the mechanical platform over Area B, the HVAC installers can be seen preparing to install ductwork on the second floor.

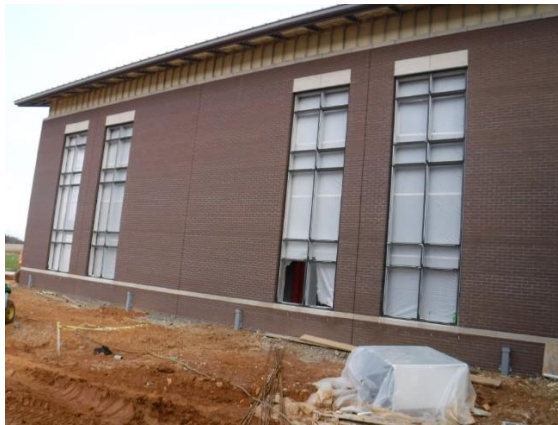
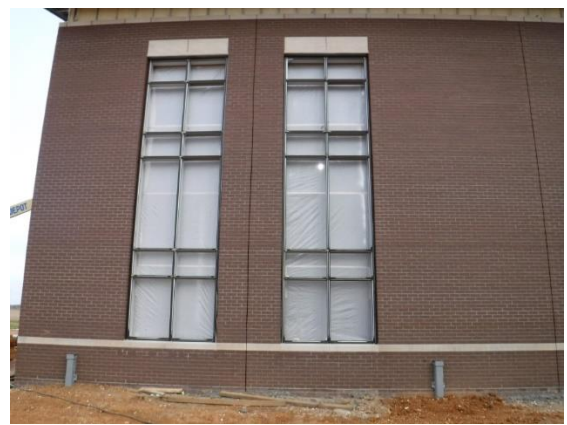
- v) The brick cleaner was cleaning the brick exterior walls at Areas C and D using a pressure washer. The manufacturer of the detergent being used by the cleaner had very restrictive instructions for applying their solution with a pressure washer. I sent a request to Doyle asking him to confirm that the cleaner is following the instructions. The good news is that most of the red mud that was on the brick near the ground was removed by this process. This needs to be reviewed again after the brick is dry and the sun is lighting the walls. Pressure washing must not damage the finished surface of the brick, stone and other materials such as the window framing.

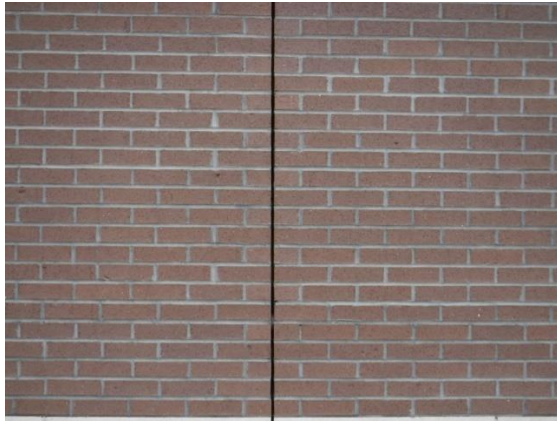
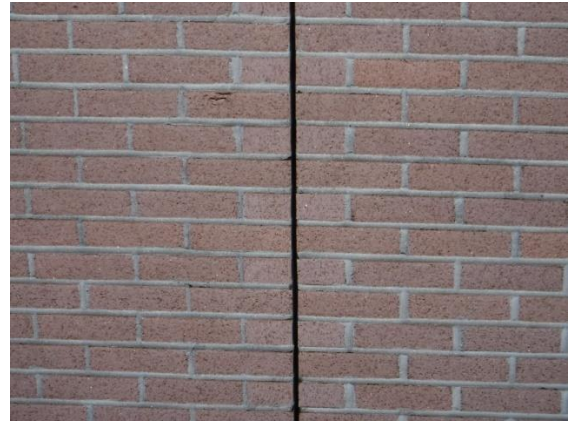
- w) The cut brick at the movement joints in the brick look better than they did when they were laid, but there still is a difference in color. The amount of this contrast varies with the direction of the sunlight. The brick supplier needs to review this on site and make a recommendation for correction.

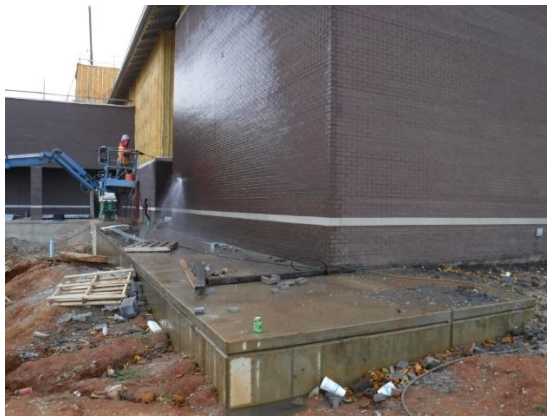
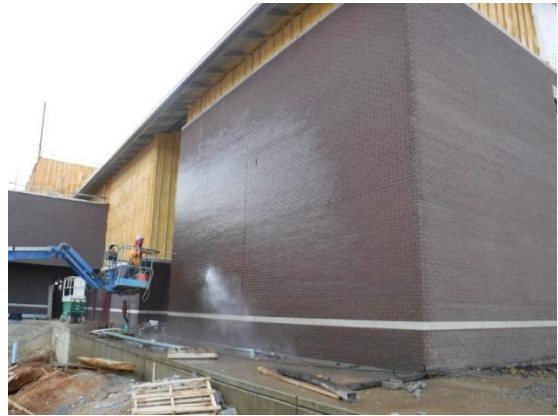
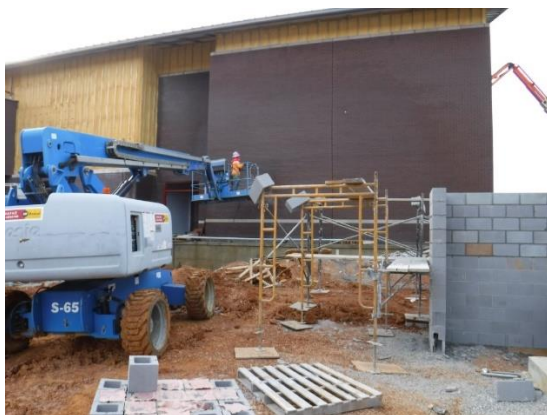
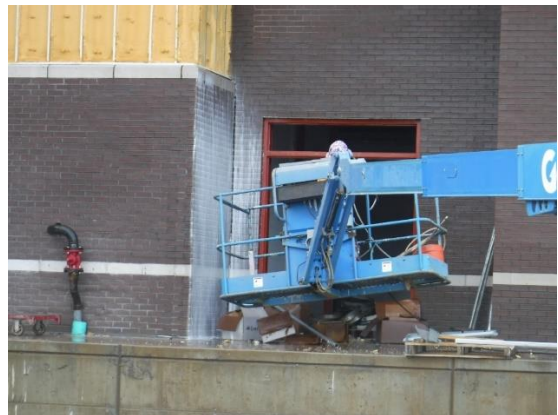
- x) The cleaner was washing the brick at the loading dock area.

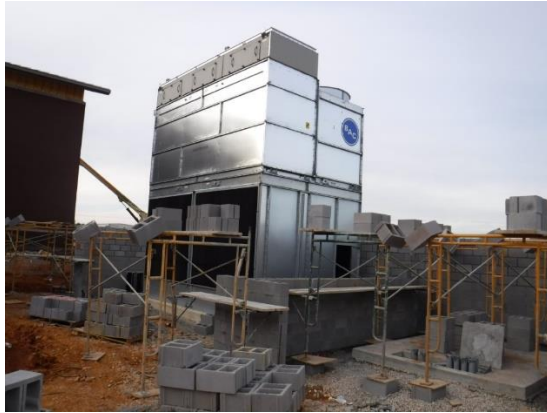
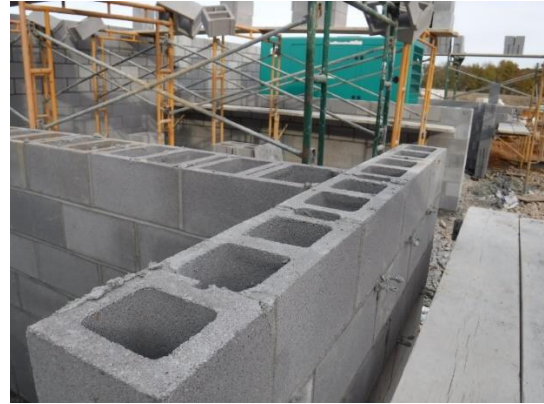
- y) The masons were laying the block backup for the screen wall around the exterior mechanical/electrical equipment. The cooling tower is considerably higher than the screen wall. A 4' high guardrail is yet to be installed on top of the cooling tower.

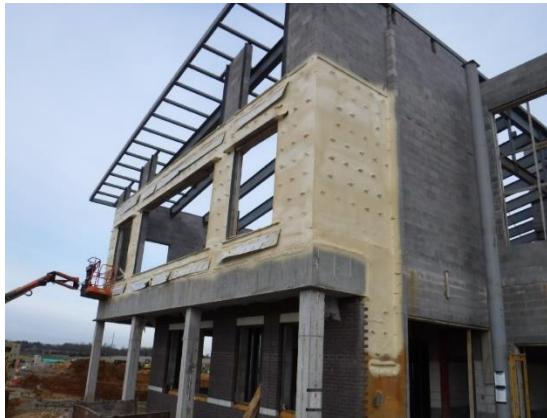
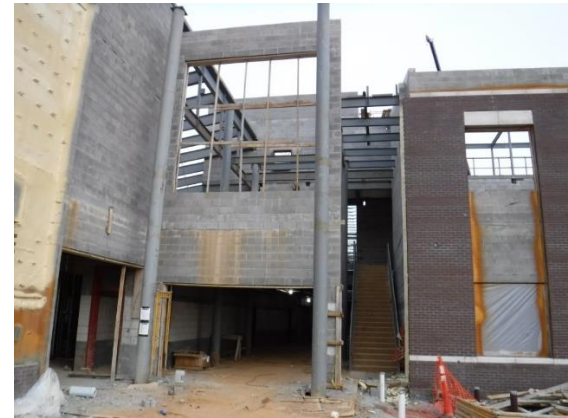
- z) The spray insulation installer had applied foam insulation to the exterior walls of the Library/Media Center in preparation for the walls being covered with brick.

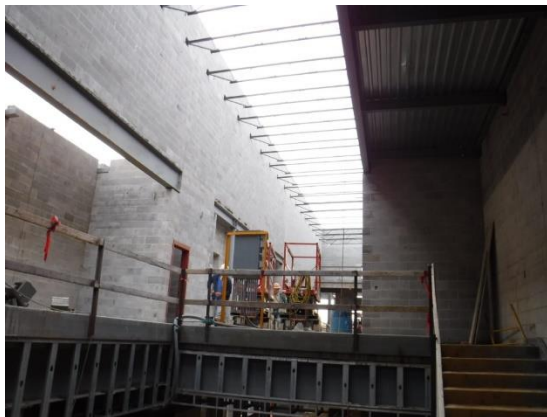
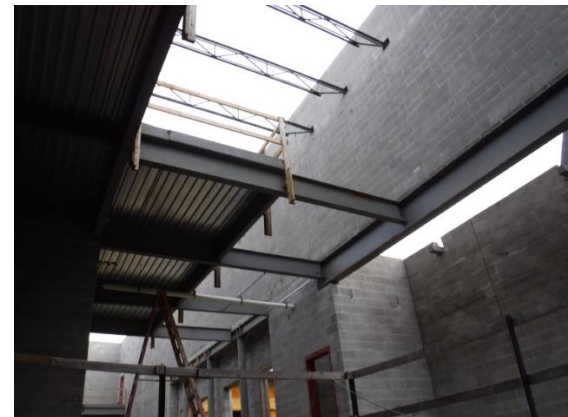
- aa) The steel roof joists were being installed over the main corridor. This work is now complete and steel roof decking installation has been started.

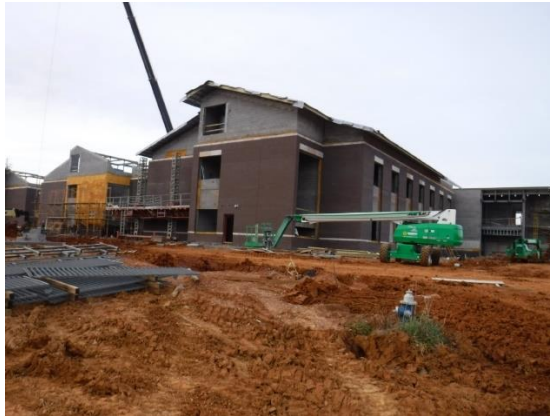
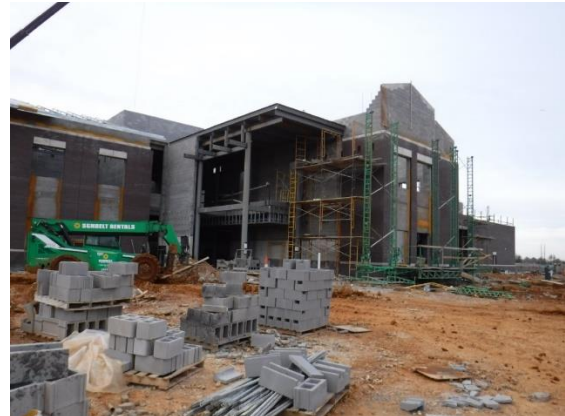
- bb) The rear of the building is almost ready for the installation of the composite panels. Metal "Z" furring and spray insulation will need to be installed first.

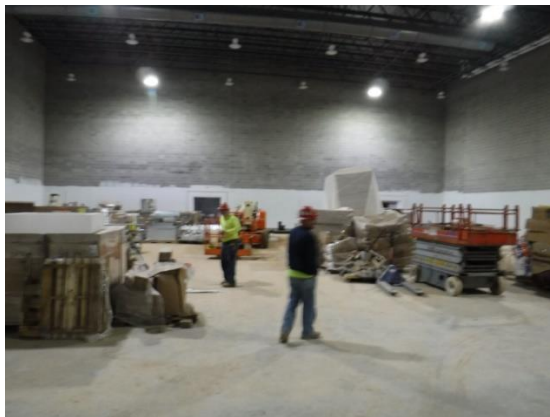
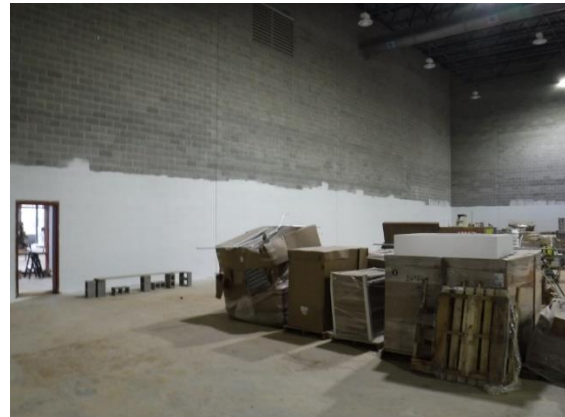
- cc) The painters had started the block filler in the Gym.
