## FIELD OBSERVATION REPORT

Lincoln Trail Elementary School, Hardin County Schools, Elizabethtown, KY 201752 -CA8

Date: 10/22/2020

Report No: 36

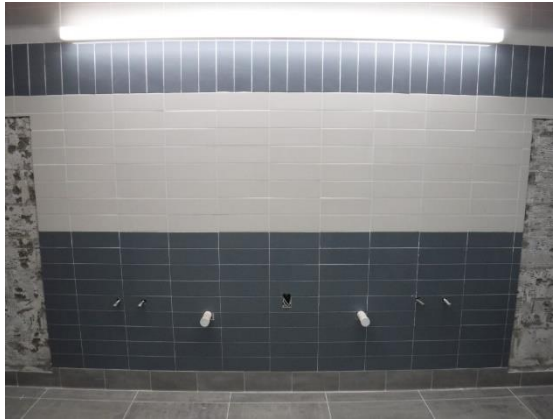
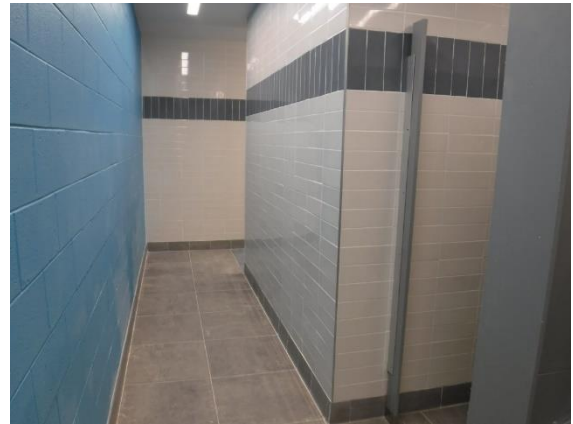
**Smith Interiors** – The tile setter was power hammering off the tile base he installed at the piers at the toilet entries. The wall tile is still unacceptable. The sloped transition strip makes a big difference, but the installation is sloppy. They still must make the tile acceptable and install paver tiles at the entrances.

- b) The wall tile is still unacceptable. The tile setter reported that he has not done a final cleaning on the joints. He believes that the appearance will improve after the cleaning.

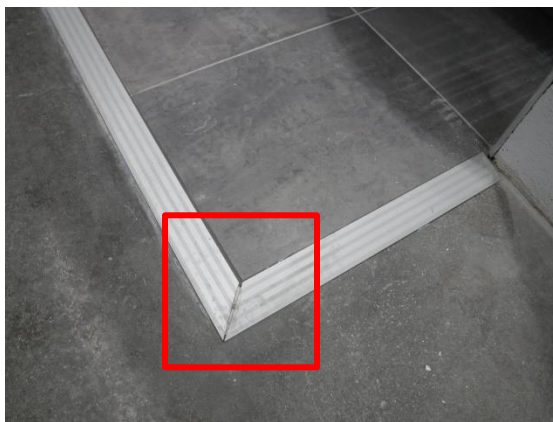
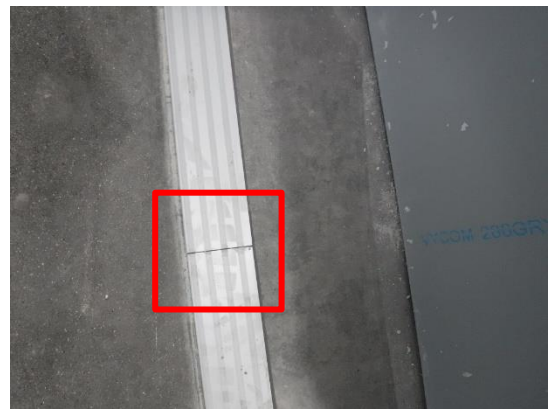
- c) The sloped transition to the tile pavers has improved this condition. The tile setter said that he will seal the joints to improve the appearance.

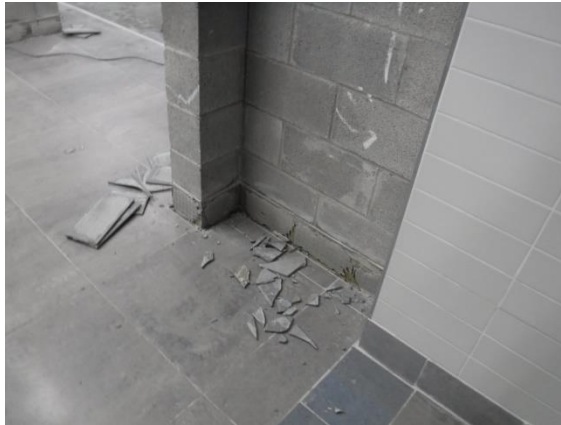
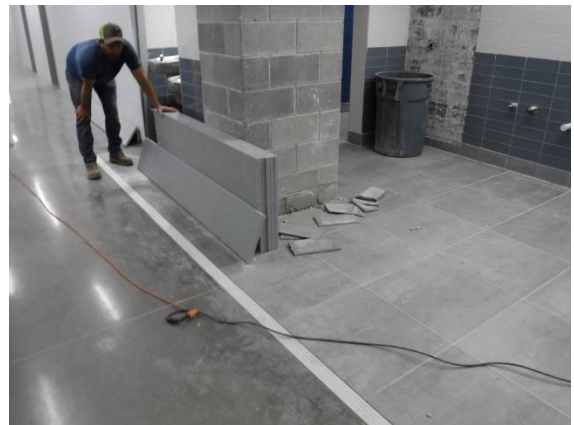
- d) The tile setter was removing the tile base at the piers in front of the toilet groups. This was being done so the solid surface panels can be placed from floor to ceiling.

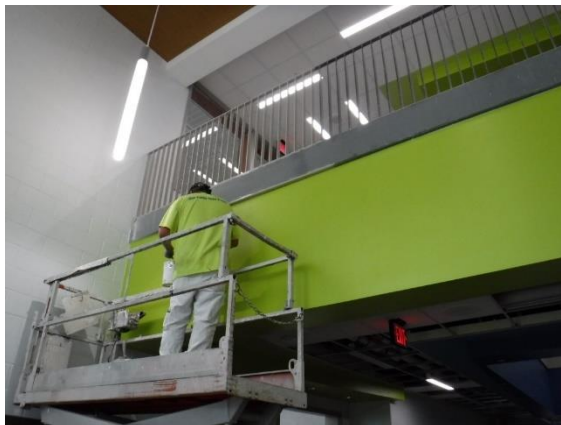
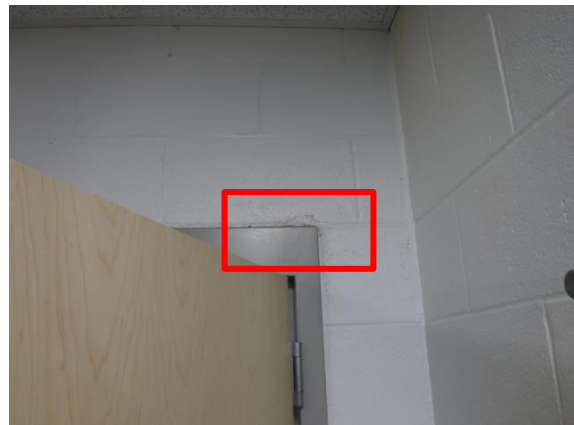
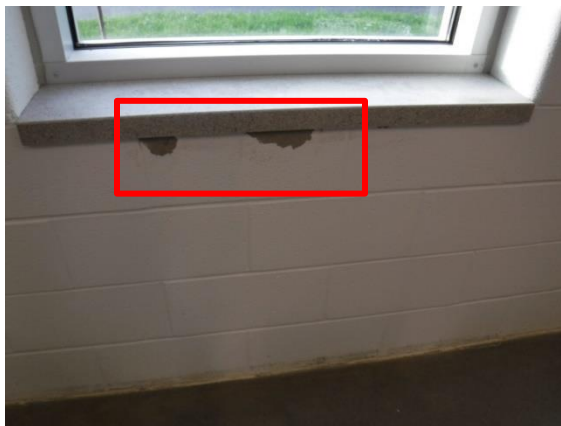
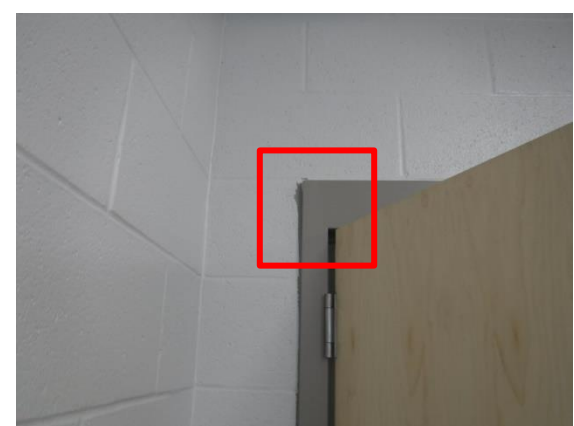
- e) Painting and caulking continue to be applied as the painters move to the west side of the building with final wall and trim paint. Once they reach the west side of the building, they need to return to the rest of the building to touch up paint especially at door and window openings. In some cases, repairs are also required to the walls.

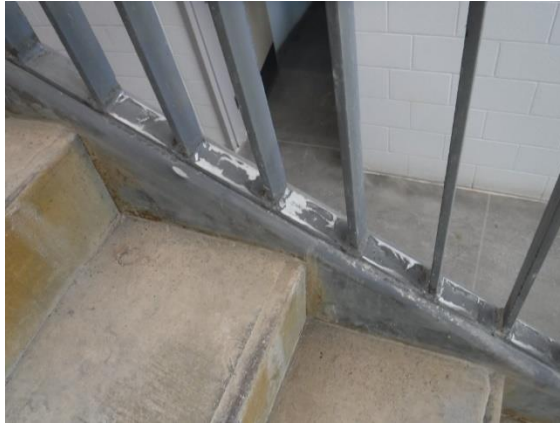
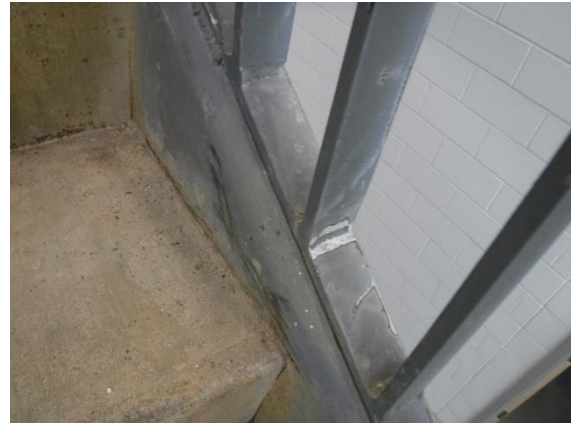
**Stewart-Richey Erecting** – They have made an attempt to detail the welding on the stairs. Gerald said they have been on site the last three weeks. The welds are better but still need improvement. The welds are far from continuous and ground smooth as required by the specifications. They were welding closure plates to the canopy structure.

- f) The erectors had ground some of the welds on the handrails. Some of these are smooth and continuous. However, many and especially the fillet welds on the sides of the bottom bar are not smooth and not continuous as specified.

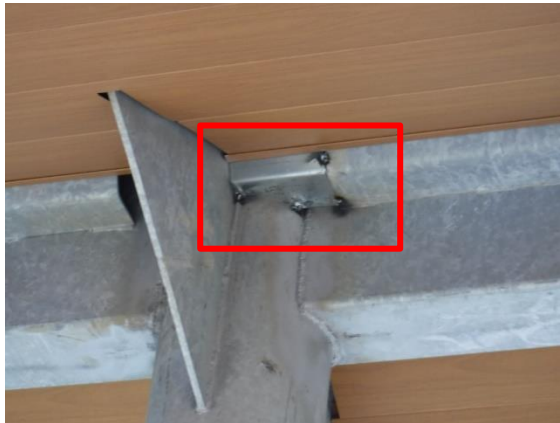
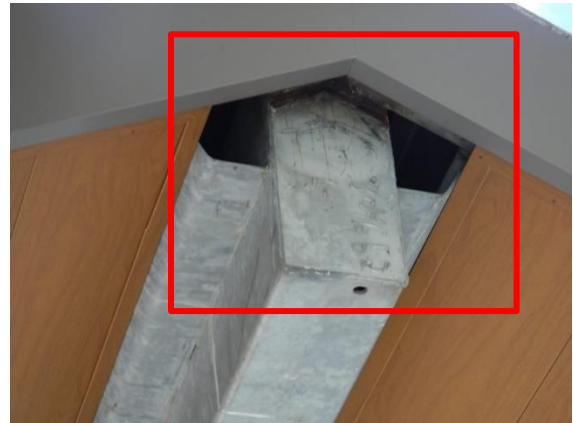
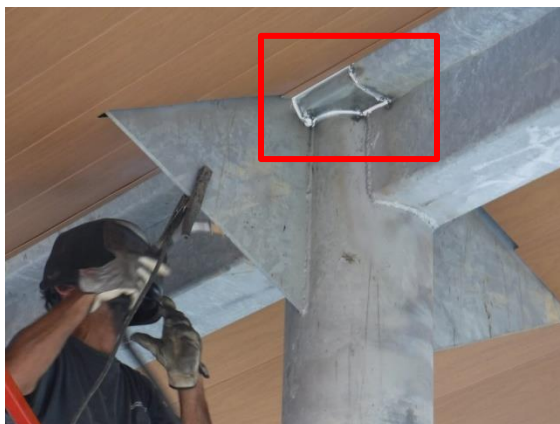
- g) Closure plates were being welded in place at the gaps in the structure at the canopy. Later, the seams between the plates had been sealed. The ends of the bent plates must also be sealed, and the soffit panels closed to the plates so there is no gap in the canopy soffits. The end plate must be ground smooth removing the mill marks.

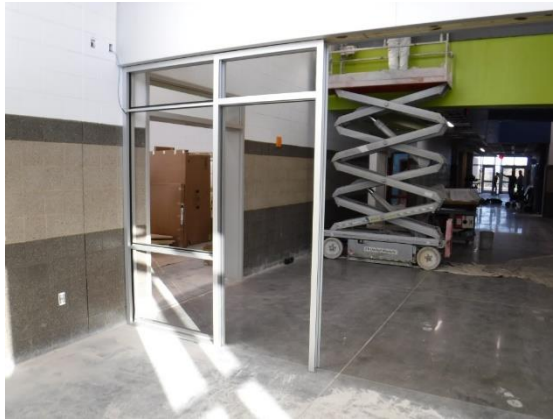
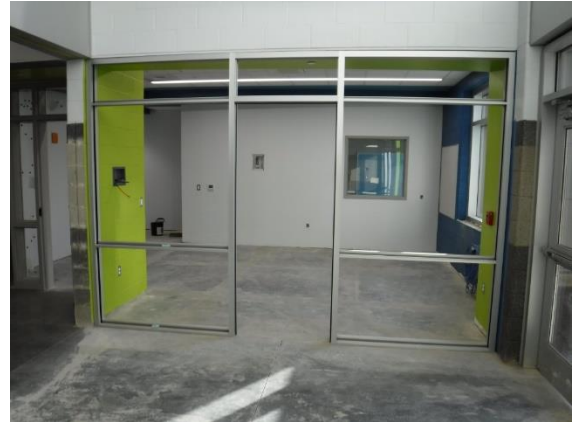
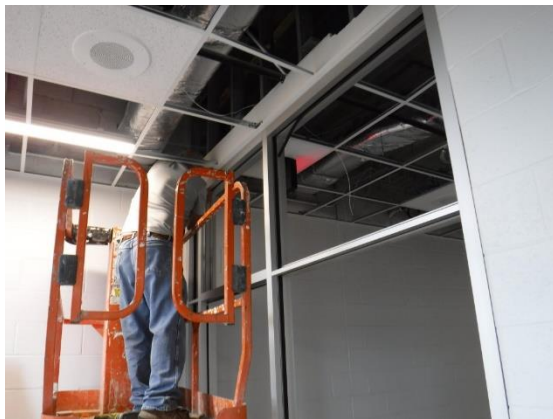
- h) The interior vestibule framing is being installed. Paver tile and walk off carpet still needs to be installed in these areas. After the framing is installed, glass, doors, hardware and security systems need to be added to these assemblies.

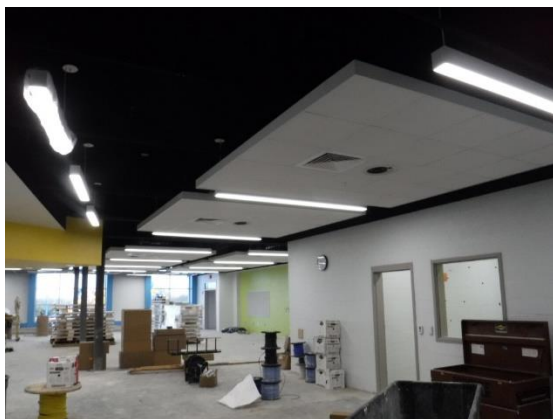
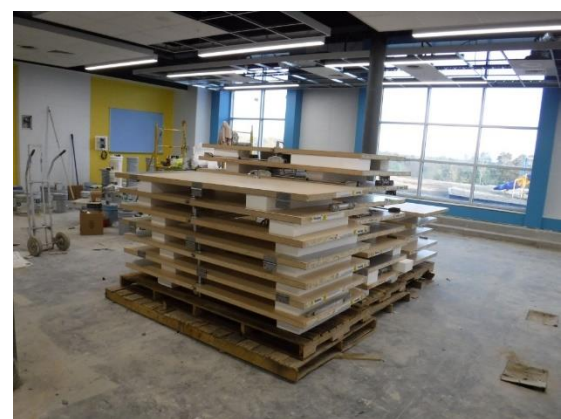
**Atlas Library Equipment** – The Library is a storage area. Until this material is removed the flooring cannot be installed and also the equipment.

- i) The Library/Media Center is nearing completion but is still be used as a place to store materials for other rooms in the building.

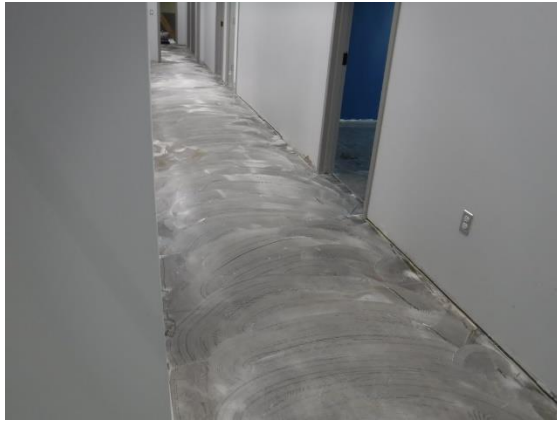
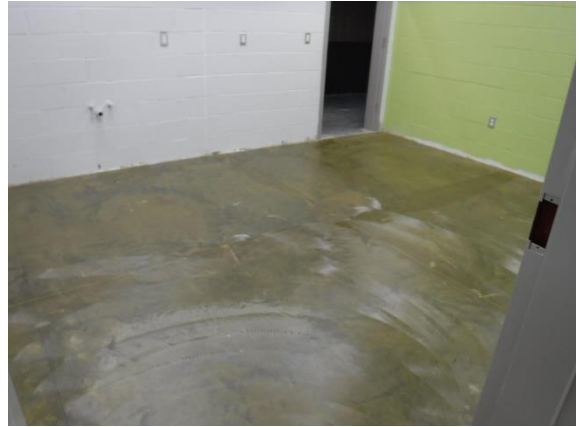
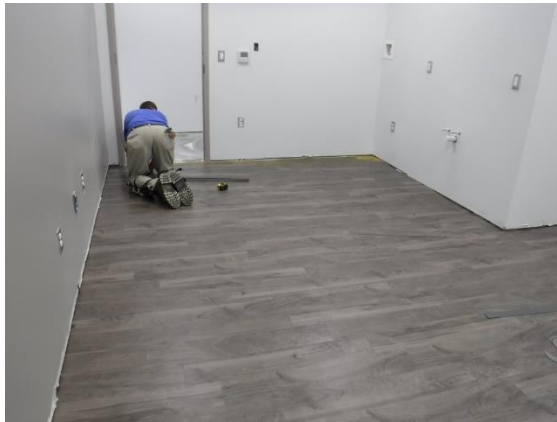
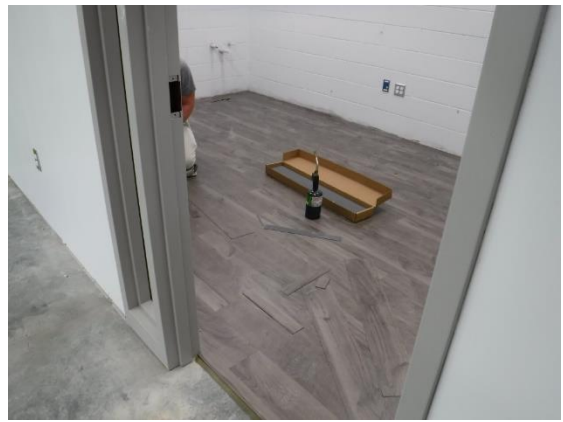
- j) Adhesive and then LVT flooring is being installed in staff areas and offices.

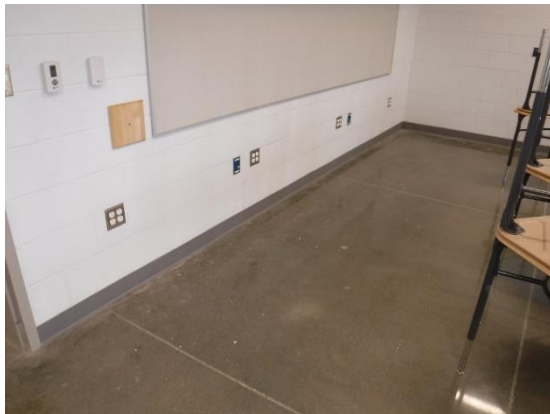
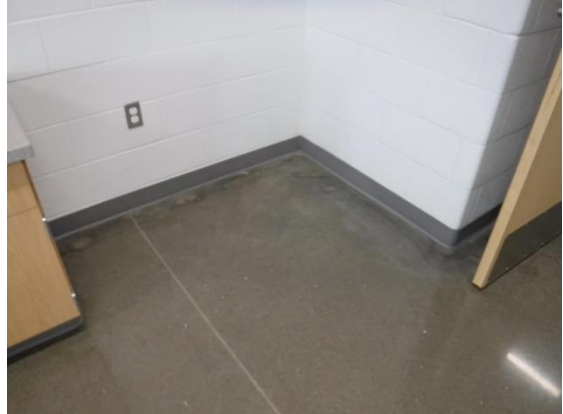
**Bennett's Interiors** – They were installing ceiling tile, LVT and floor base. Their foreman noted some issues with the base. In some case the 4" high square corner block that is the substrate was ground to a bullnose shape. He is repairing this so he can apply the same typical square corner. The top of the block which is supposed to 4" above the slab is less than that in many places. This causes the 4" base to be slightly higher than the block resulting in an uneven shadow due to the concave joint.

- k) 4" high vinyl base was being installed in rooms and corridors. The installer was making adjustments to keep the base tight to the walls with special detailing being applied to outside corners.

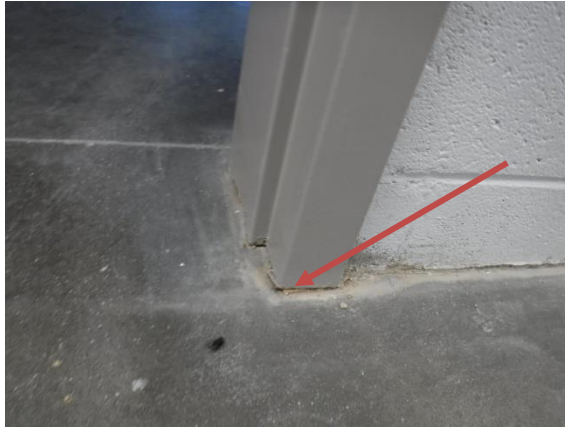
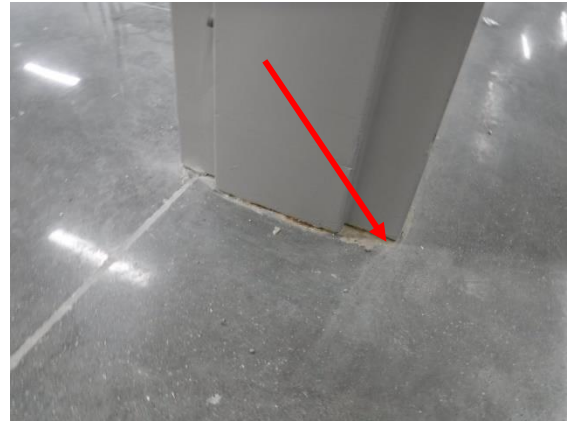
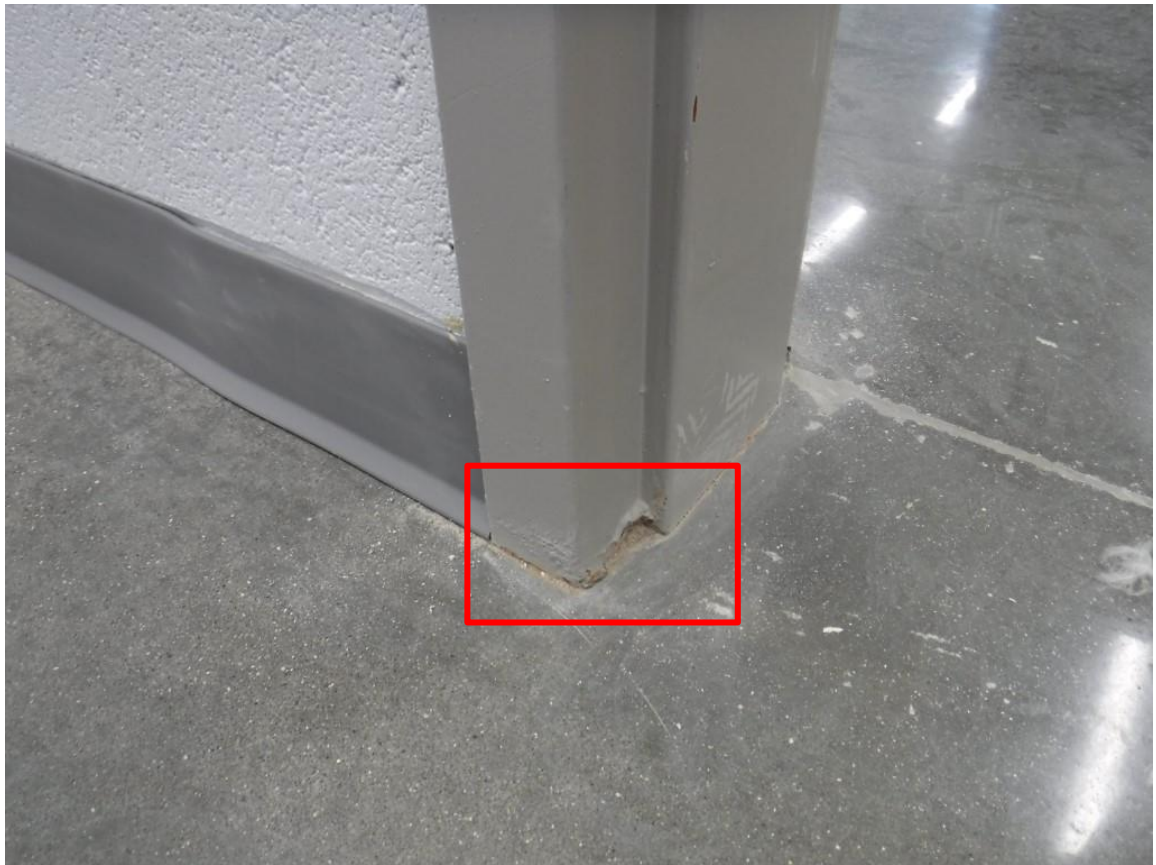
- l) Many of the hollow metal door frames do not fit tightly to the floor. Some have corrosion, cement and other foreign items in this area. The frames must be cleaned, painted and caulked to the concrete slabs.

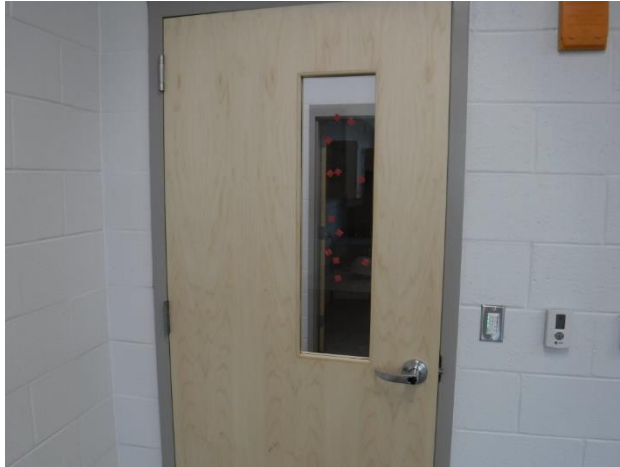
- m) Glass is being installed in wood doors as they are installed.

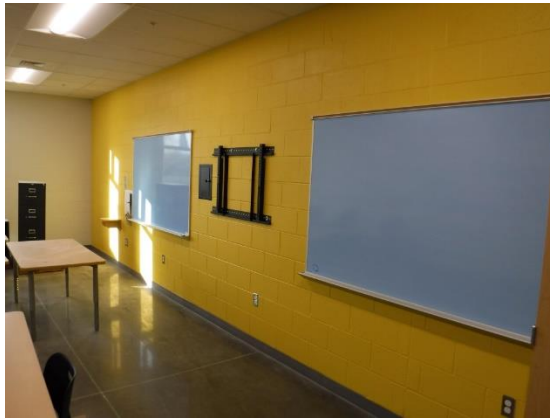
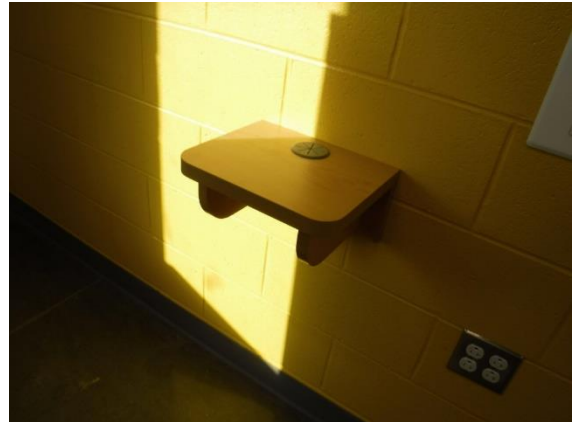
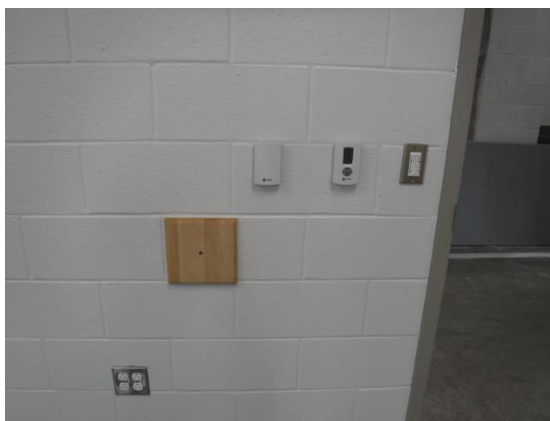
- n) Classroom accessories such as marker boards, smart board mount, pencil sharpener blocks, teacher's station shelf, and electrical/HVAC devices are being installed.

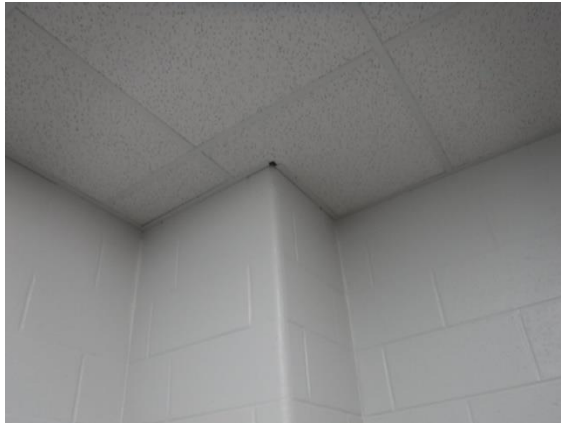
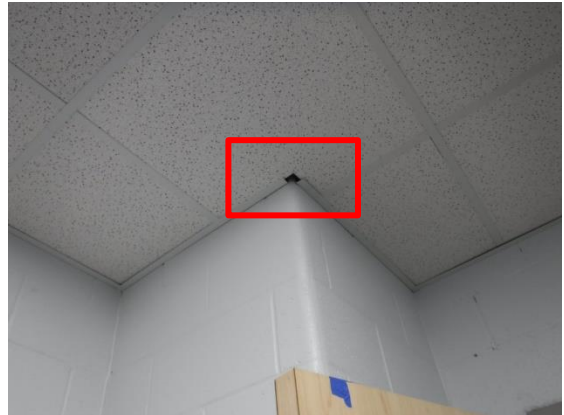
- o) Outside corner trim pieces are required at bullnose block corners. These have not been installed.

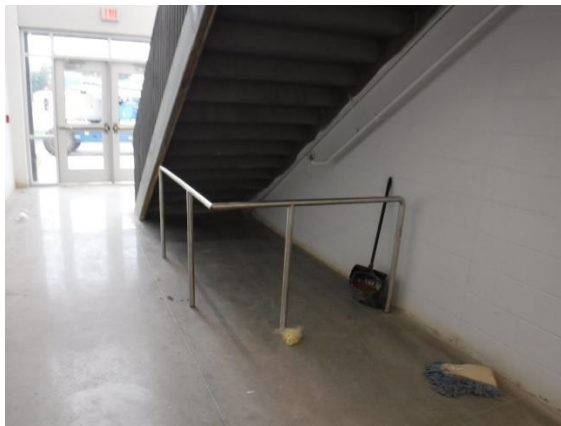
- p) The ADA required barrier railing was setting on the floor slab under Stair ST-C. The attachment of this railing to the slab must be made very carefully so it presents a finished appearance.

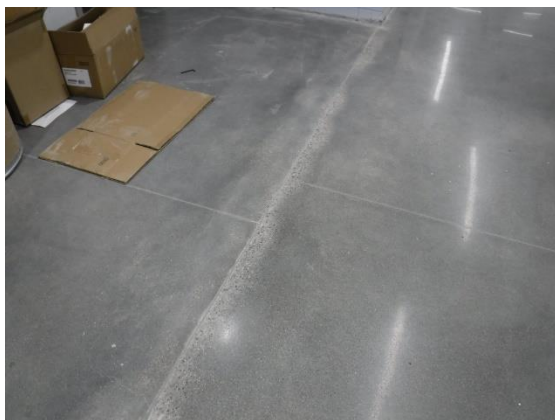
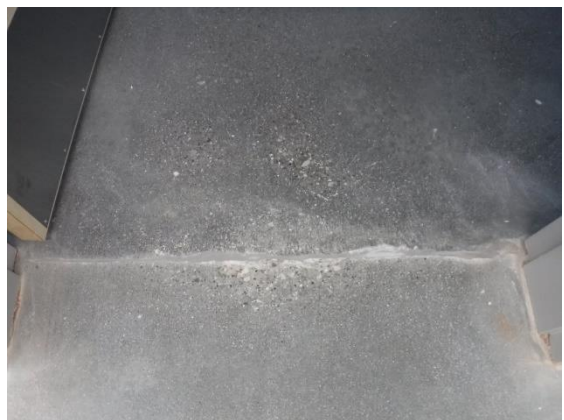
- q) Unfortunately, there is a deep grind in the polished floor at the intersection between two slab pours near the Art Room. This may not be fully correctable.

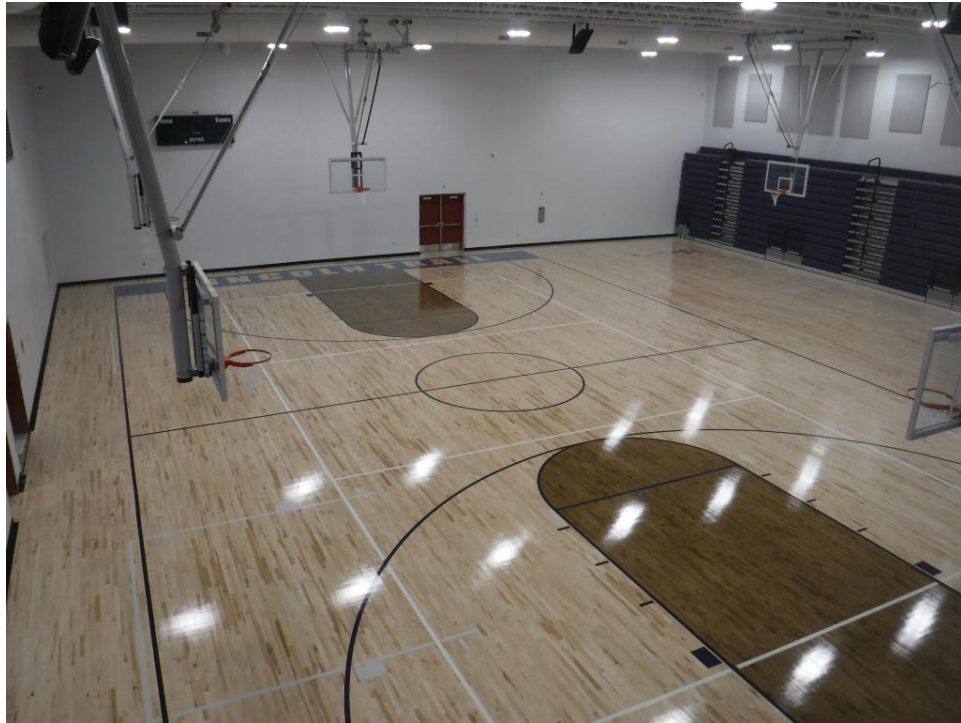
- r) The striping, lanes and lettering have been painted on the gym flooring and the flooring is sealed.

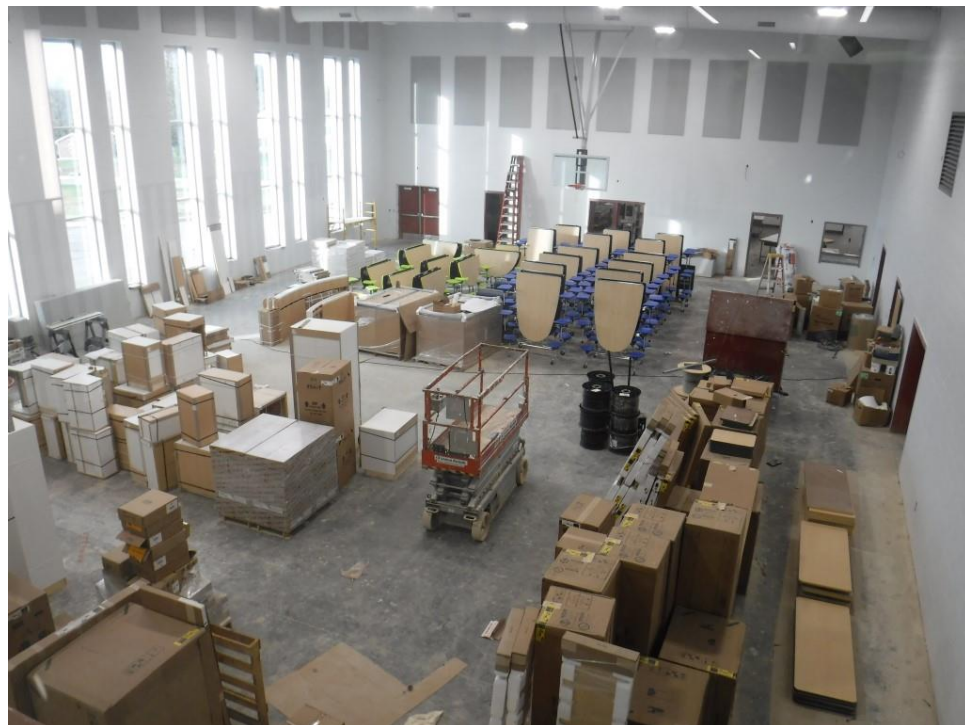
- s) Although a great deal of equipment has been moved from the Cafeteria, quite a bit still remains. The flooring and acoustical panels need to be installed in this room.

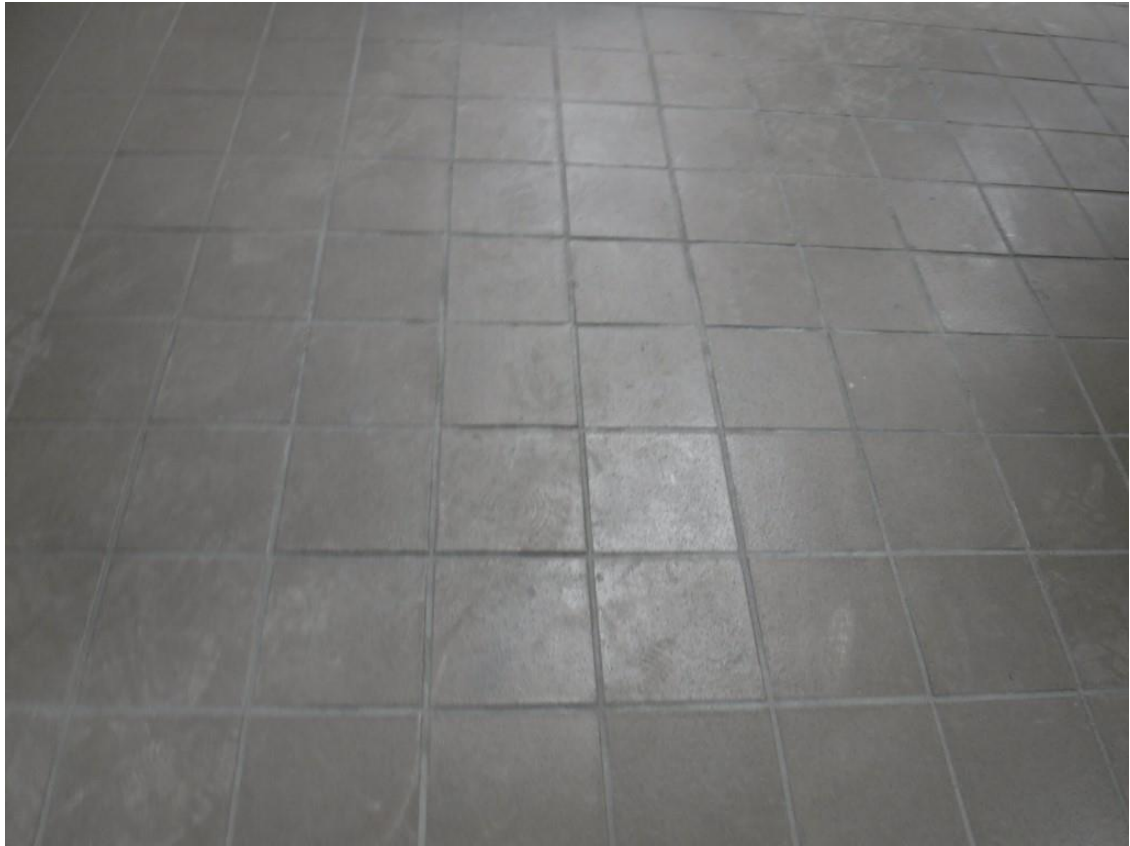
- t) The quarry tile Kitchen floor has been improved with additional grouting of the joints, but more correction is required.

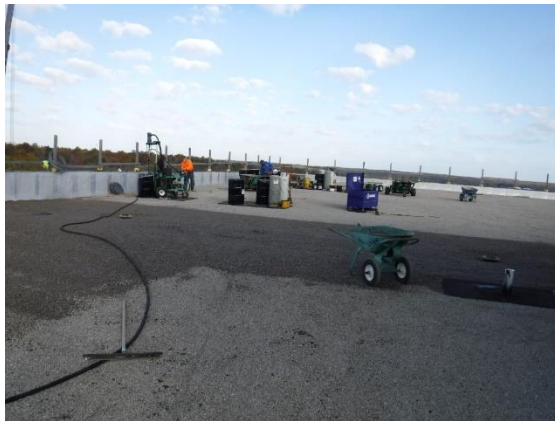
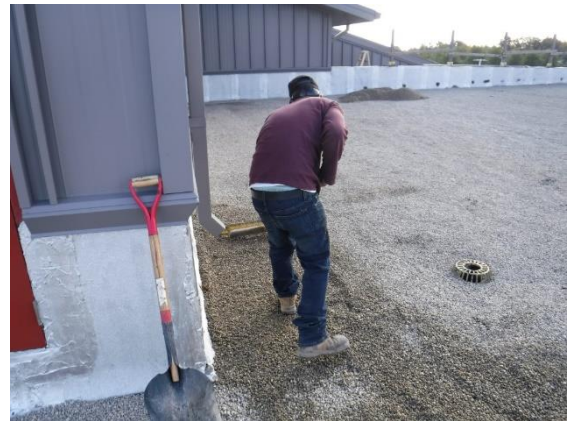
- u) The flood coat and gravel were being placed on the cafeteria/gym roof. Next will be the installation of the sheet metal copings over the parapet walls. The kitchen roof and low roof areas remain to be done.

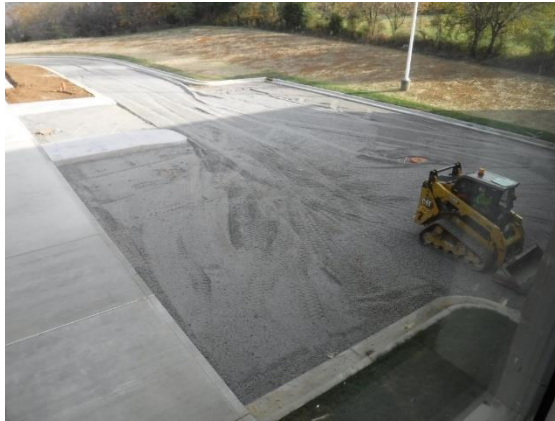
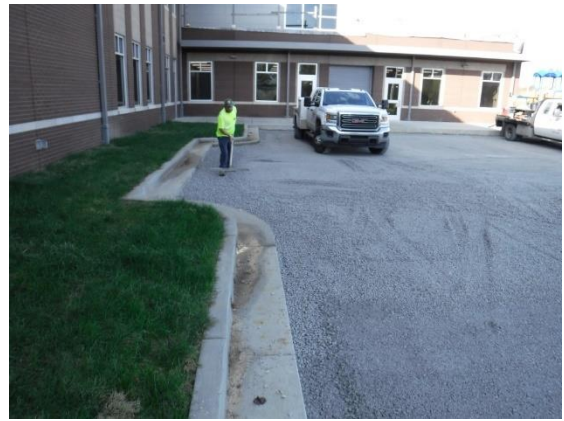
- v) Crushed stone was being placed on the parking and roadway areas at the rear of the building.

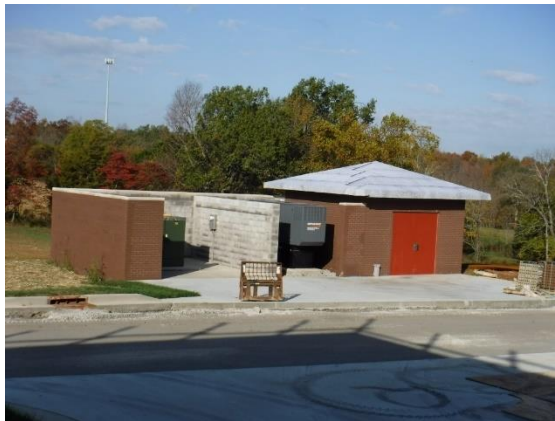
- w) The roof structure, sheathing, and synthetic felt are in place over the maintenance building.

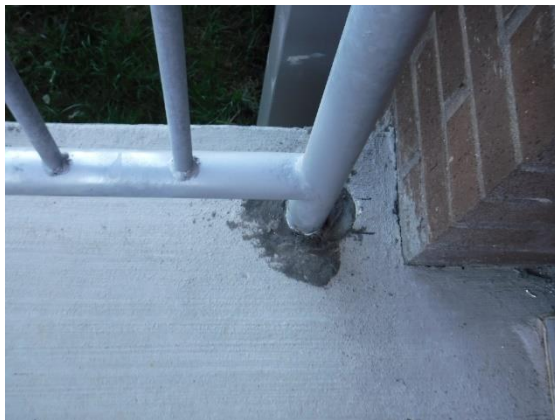
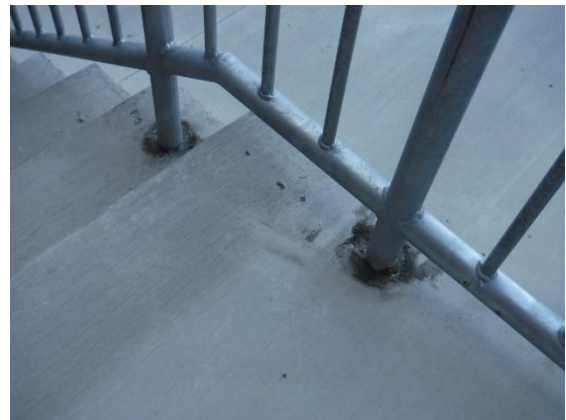
- x) The fill around the exterior stair railing posts into the concrete is sloppy. This must be corrected.

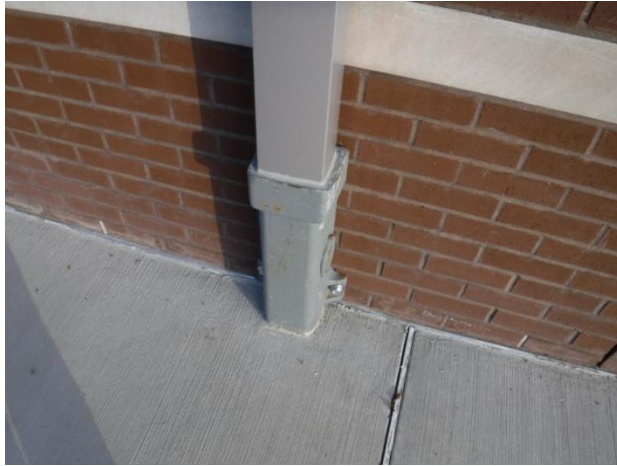
- y) The downspouts from the roof have been sealed into the boots. All the downspouts at the canopies are too short to be sealed into the boots. This must be corrected.

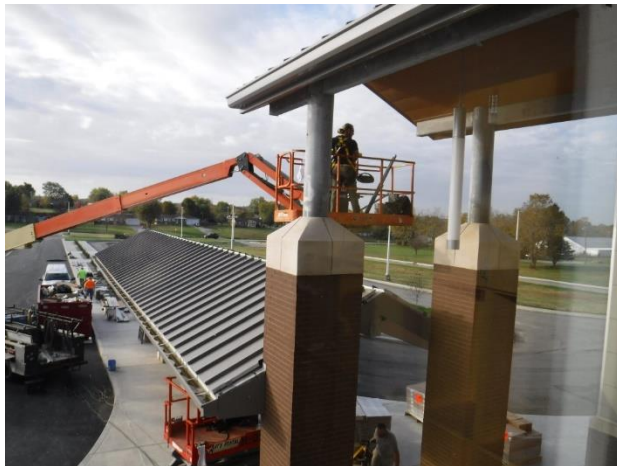
- z) Roofers were installing the gutters and downspout on the main canopy.

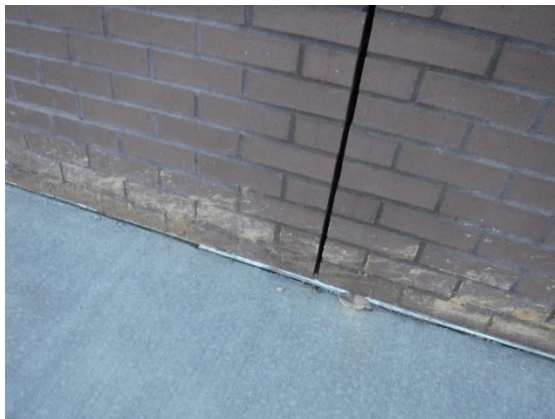
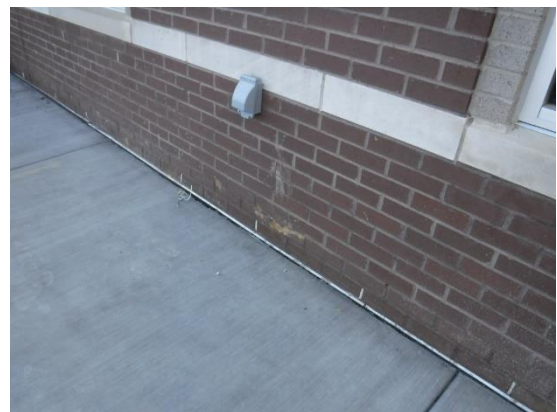
- aa) There is a considerable amount of mud and other staining of the brick around the base of the building. This must be removed.

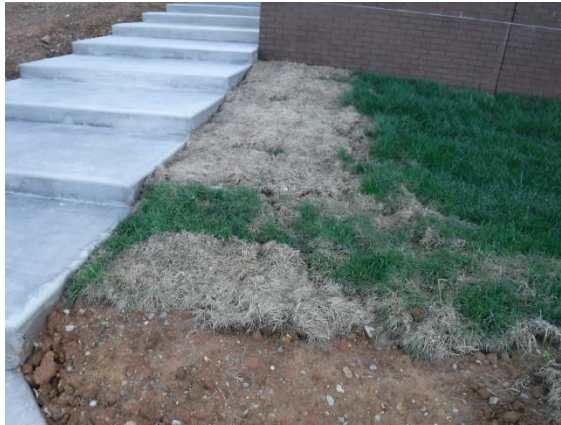
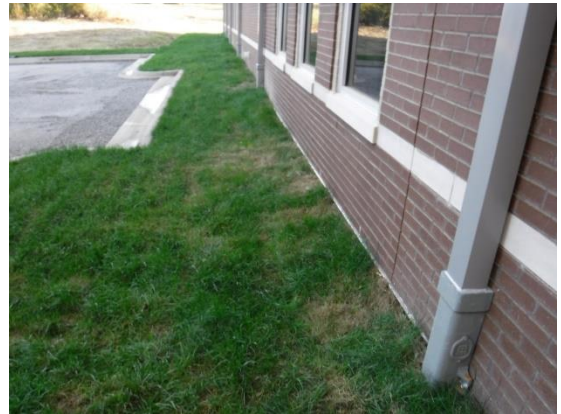
- bb) Some of the sod is dead and must be replaced.

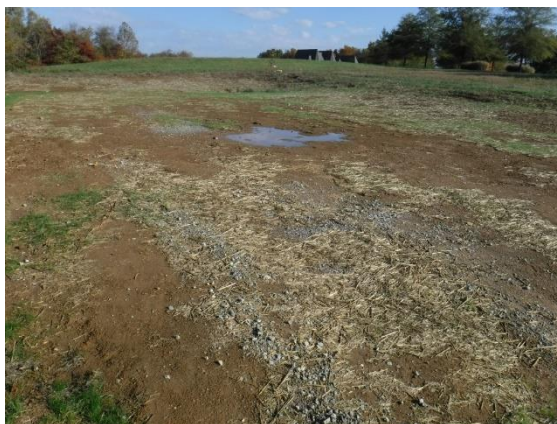
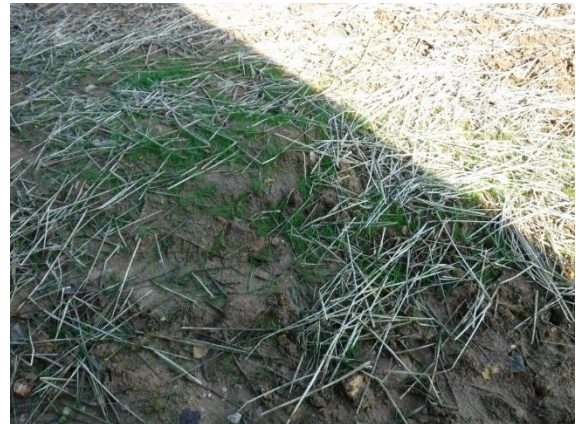
- cc) The grass seed is spotty or missing entirely. Some of the areas were not finished graded before seeding. Seeding will need to be redone next spring when growth can be assured.

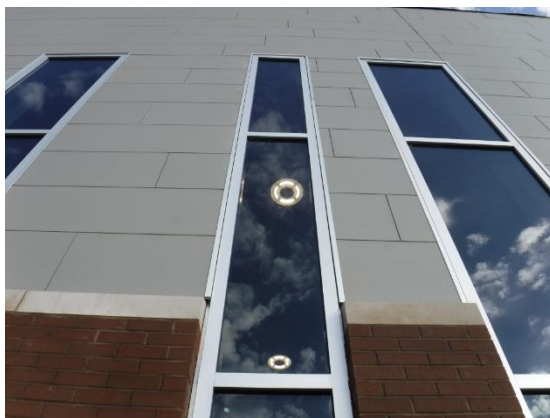
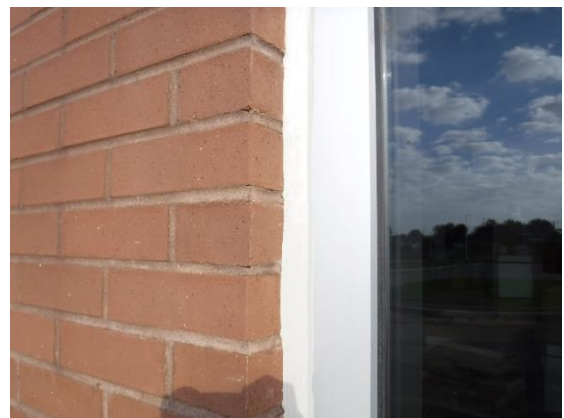
**G&M Glass** – Gary was installing the interior vestibule frames at the rear of the building. He hired a caulking contractor to finish applying sealants to the exterior sides of the windows. The joints at the curtain wall frames at the cafeteria are very wide due to the relationship between the back of the brick and the frame.

- dd) The cafeteria windows are being sealed to the brick and composite panels. The sealant must be uniform at the brick and form a straight line.

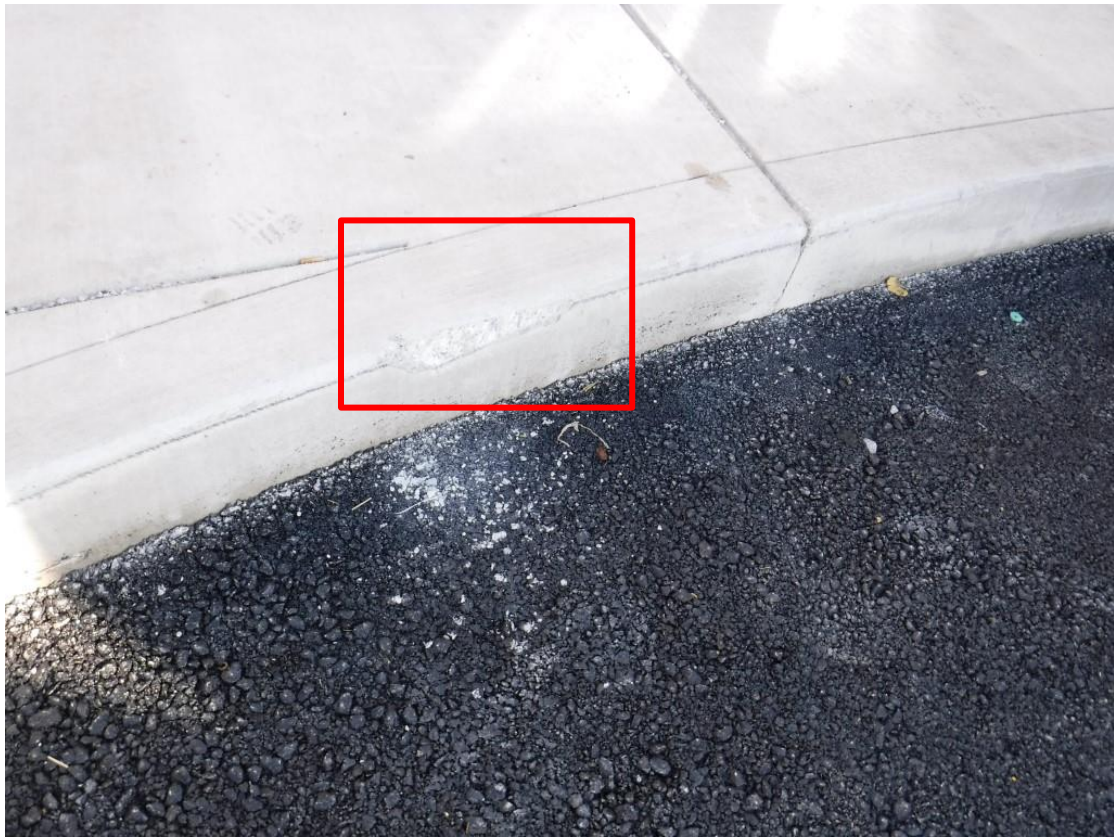
- ee) There are chips in the site concrete work that must be repaired.

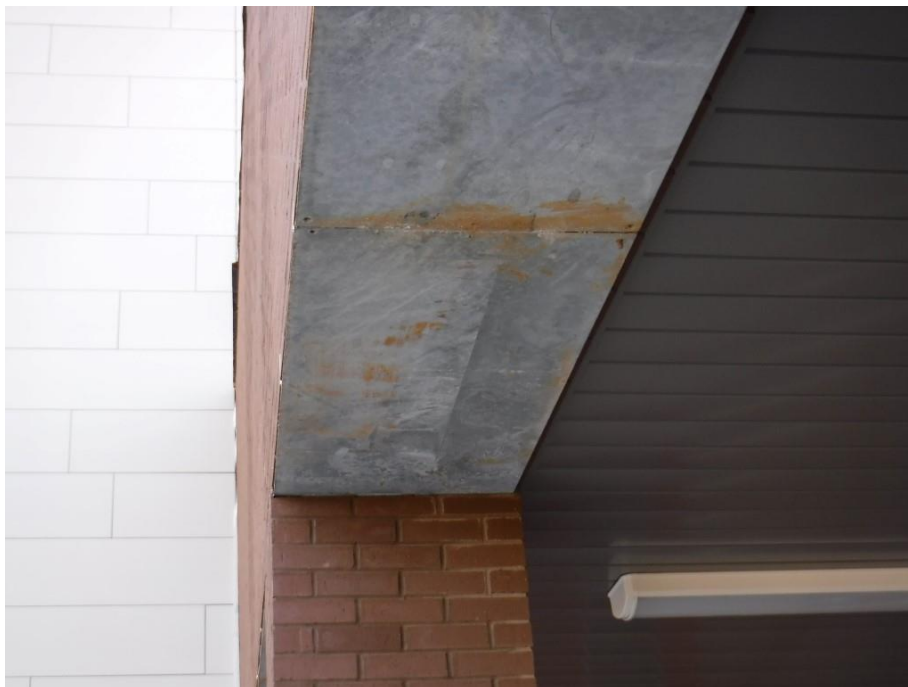
- ff) Corrosion/mud must be removed from the galvanized lintel at the dock before it is prime painted and final painted.

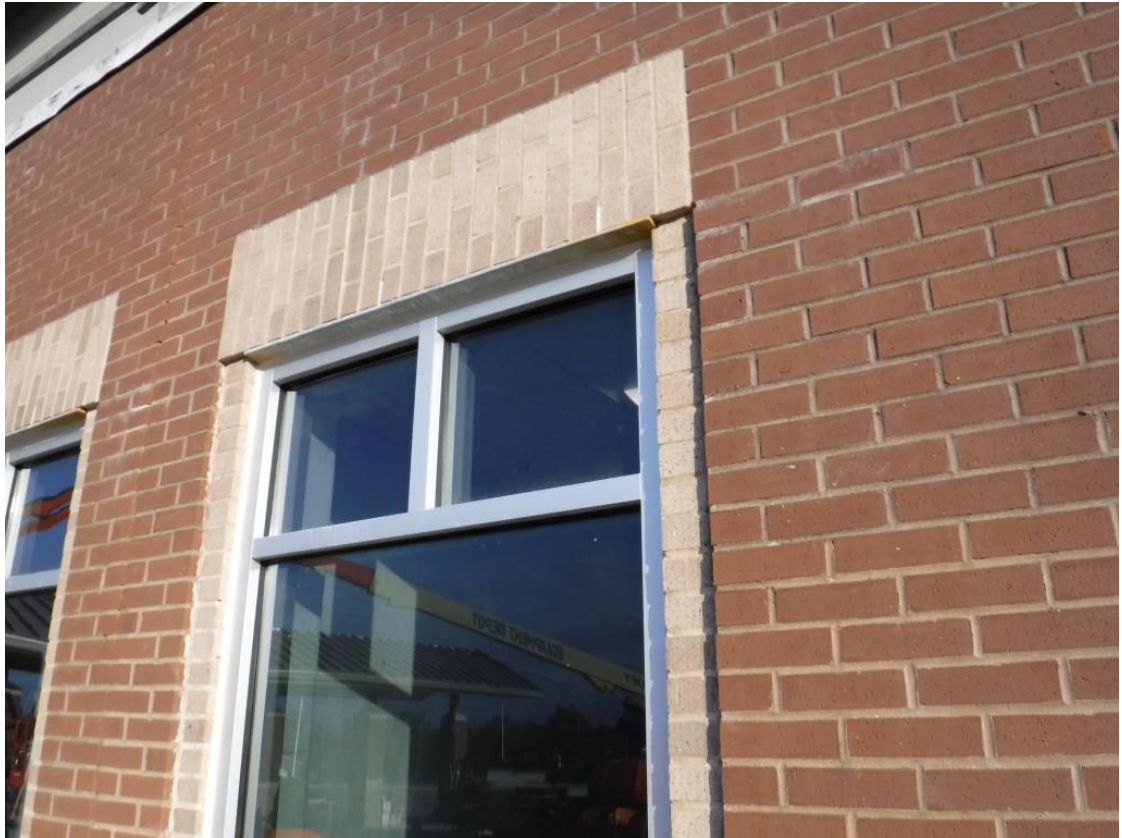
- gg) The spray insulation on the window lintels must be removed, the lintels prime painted and the final painting applied.

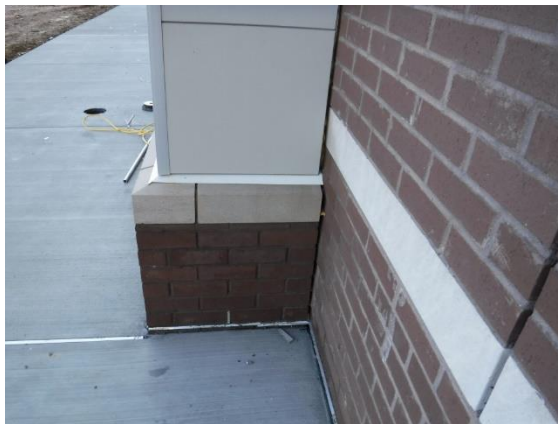
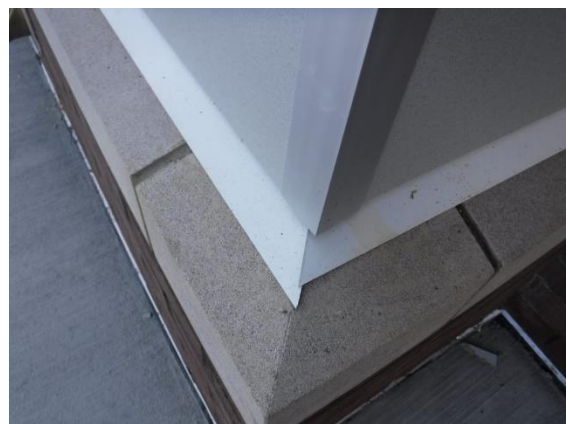
- hh) The base flashing under the composite panel must form a true miter at corners.

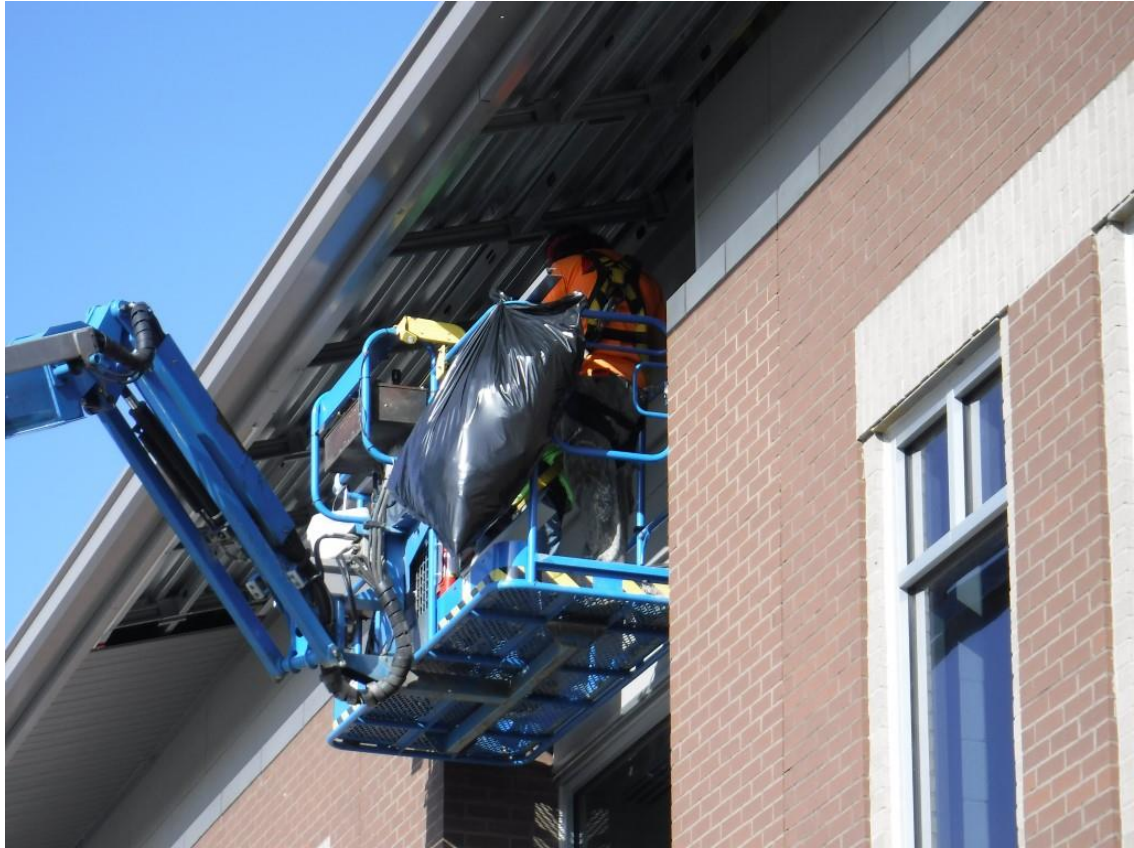
- ii) Roofers were installing soffit panels at the front of the building.
