FIELD OBSERVATION REPORT

East Hardin Middle School, Hardin County Schools, Elizabethtown, KY 201752.01 - CA8

Date: 2/4/2021

Report No: 43

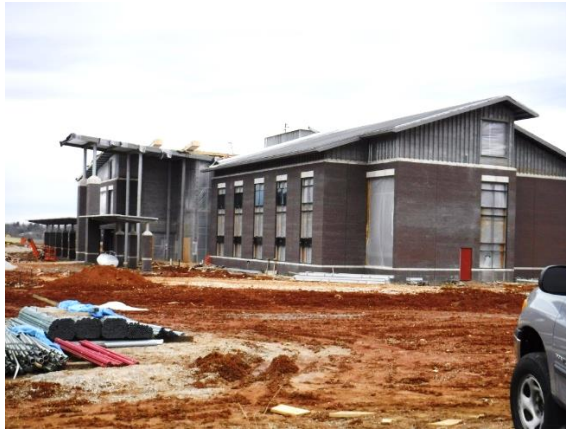
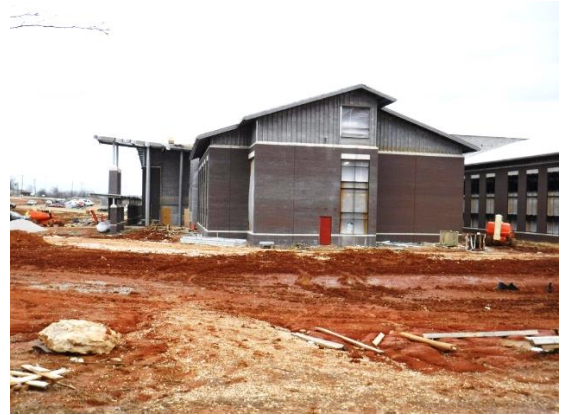
- b) The recently installed aluminum curtainwall framing is visible on the front classroom wing. The metal roofing over the main entrance had not begun. The spray foam insulation above the stone band has not been started. Doyle reported that the foam installer was on site to begin this work.

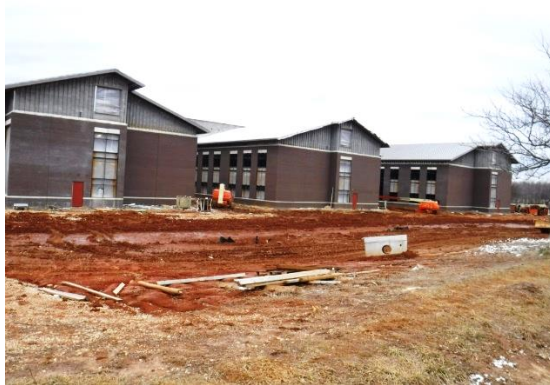
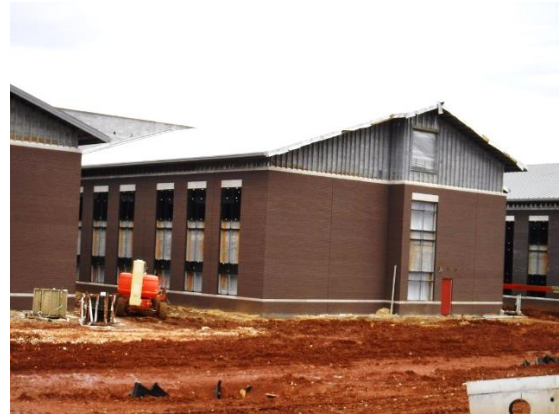
- c) The curtainwall framing was started on the middle classroom wing with the glass being installed.

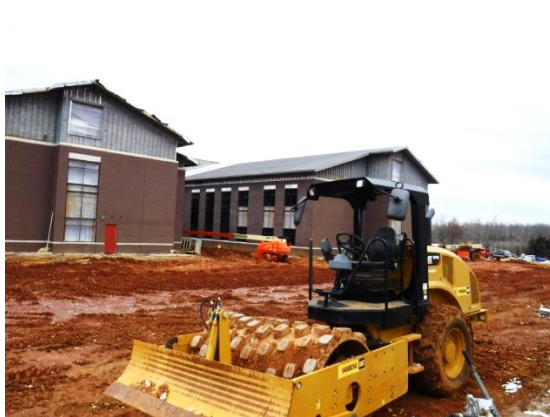
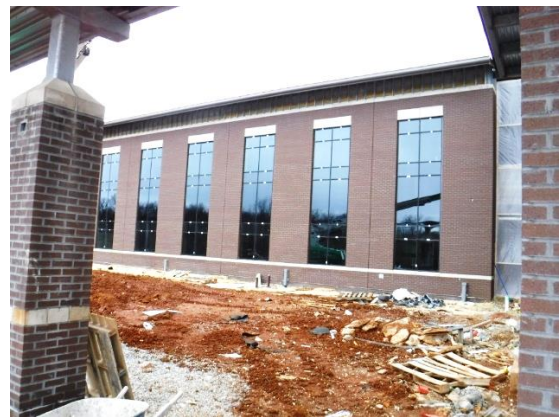
- d) Spandrel panels were being installed in the curtainwall at the classroom wing in Area B. The caps for the curtainwall will be installed as the system installation is completed.

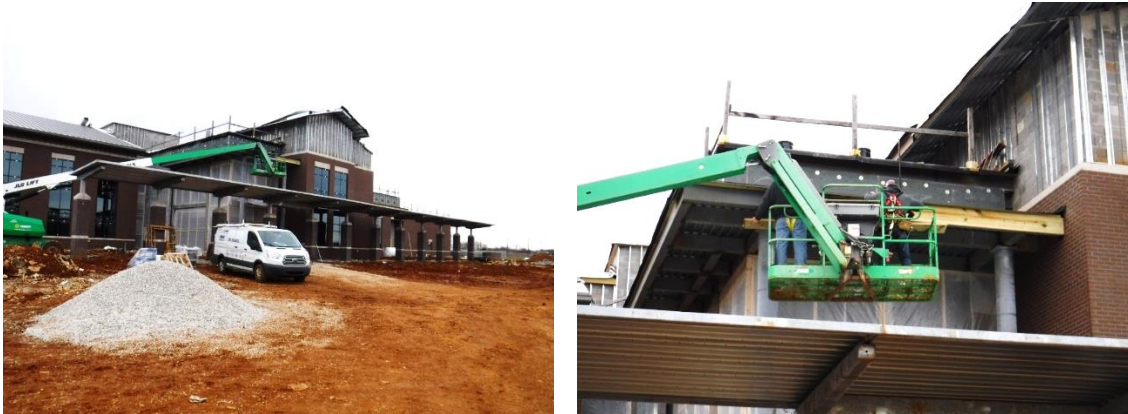
- e) Carpenters were installing wood blocking around the top of the curtainwall location over the rear entrance at Area B.

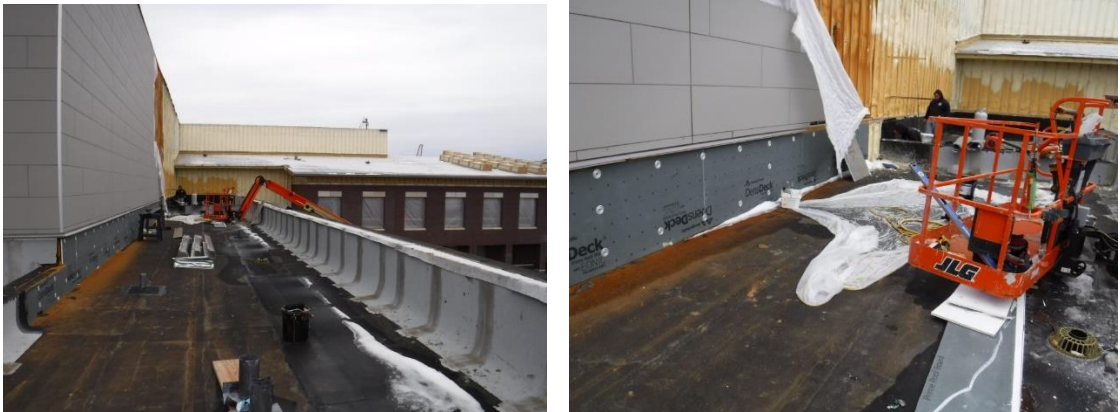
- f) Roofers were installing wall flashing material at the expansion joint and exterior walls at Areas A and D.

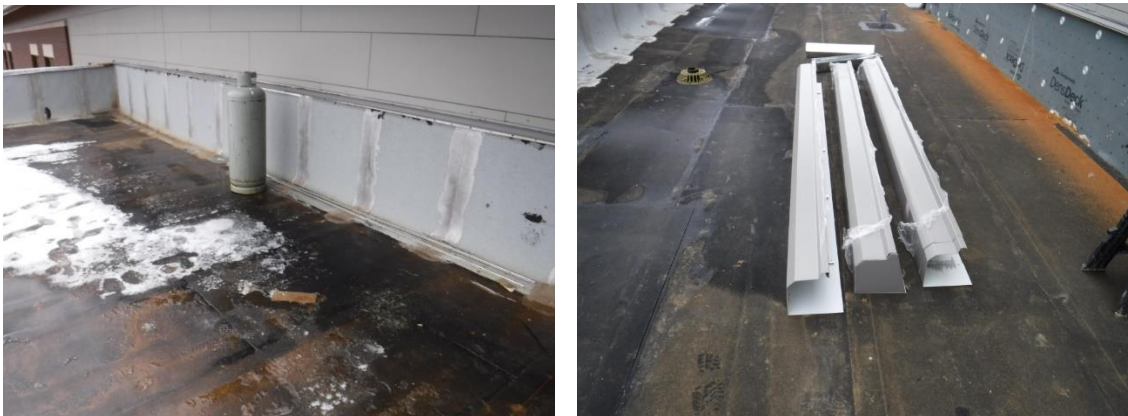
- g) Gas cylinder and gutters stored on roof membrane with no protection board.

- d. Provide protection board for all ladders, equipment and materials staged on the low sloped built up roofing areas. Remove all screws, nails, sheet metal and other sharp objects from these roof areas ASAP.

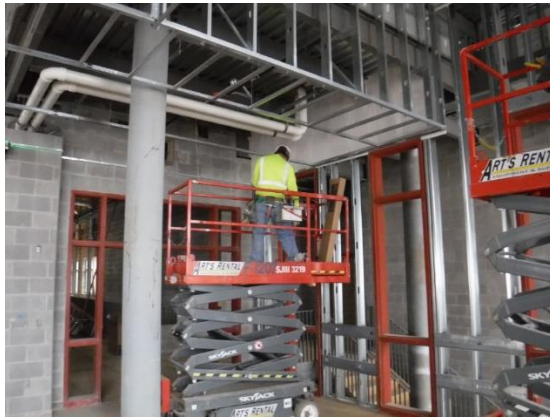
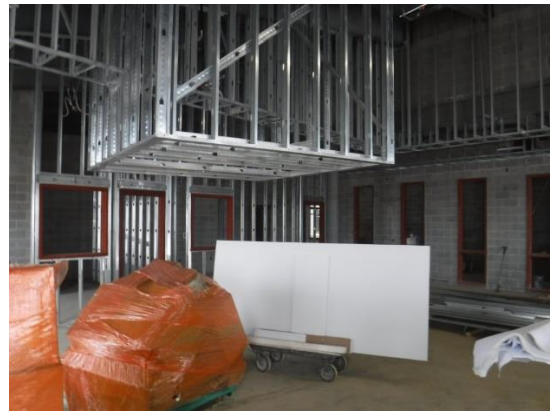
- h) Soffit framing continues in the Library/Media Center.

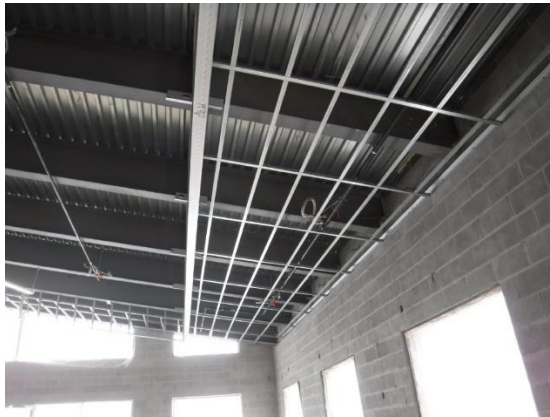
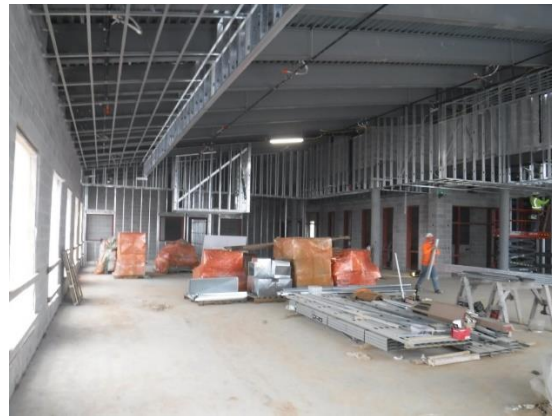
- i) Board suspension system is being used for soffits in the Library/Media Center.

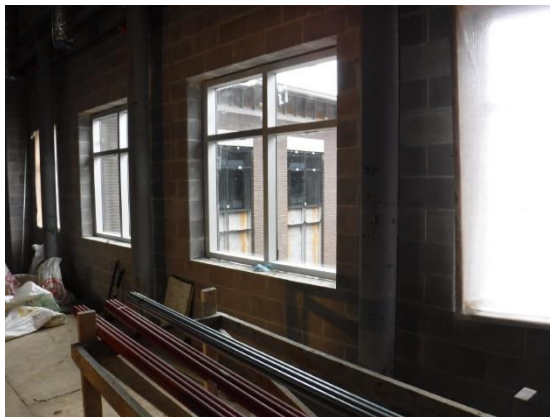
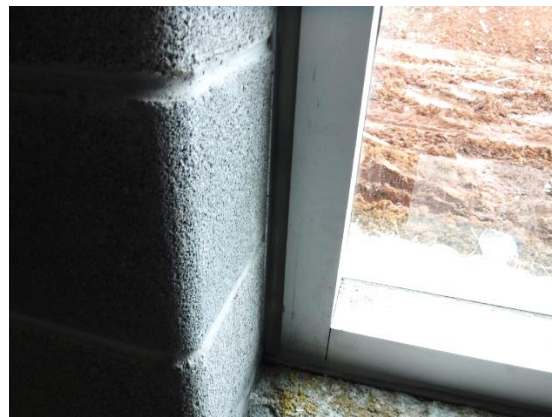
- j) Interior view of curtainwall framing and insulated glazing units.

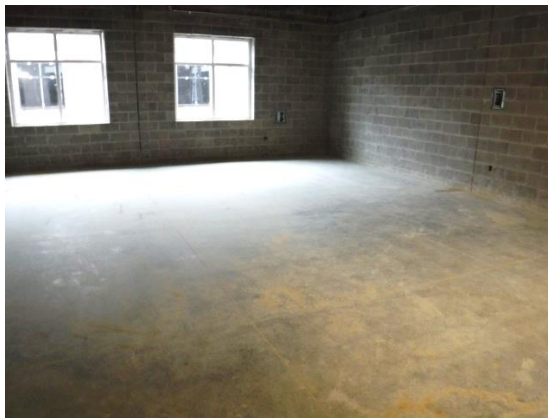
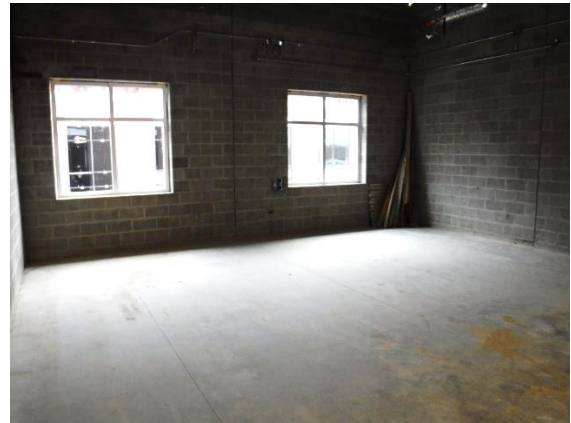
- k) Floor areas in classroom wings cleaned ahead of the application of paint and finishes.

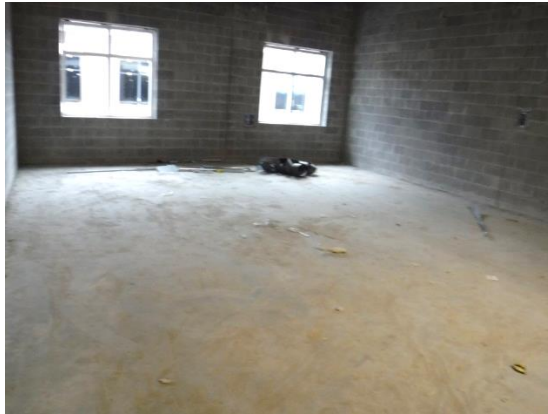
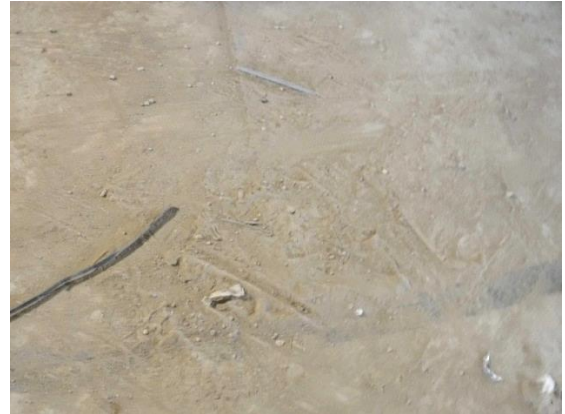
- l) Floors in Area A needing to be cleaned before finishes can be installed.

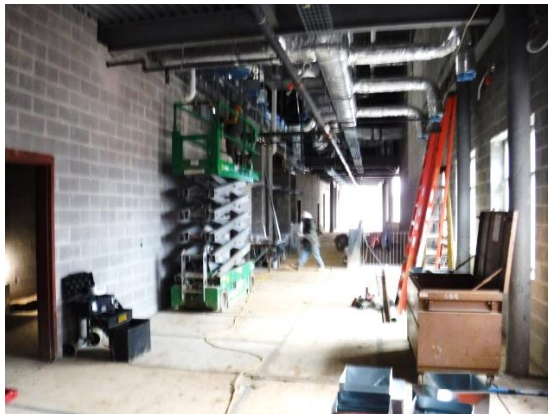
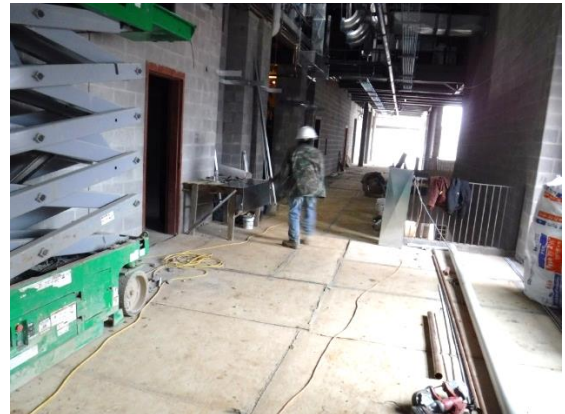
- m) Mechanical work continuing along the main corridor.

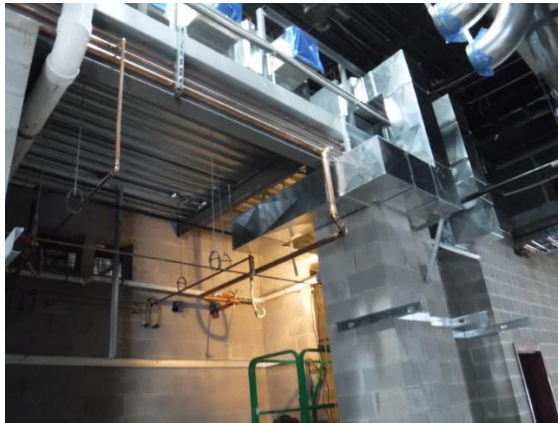
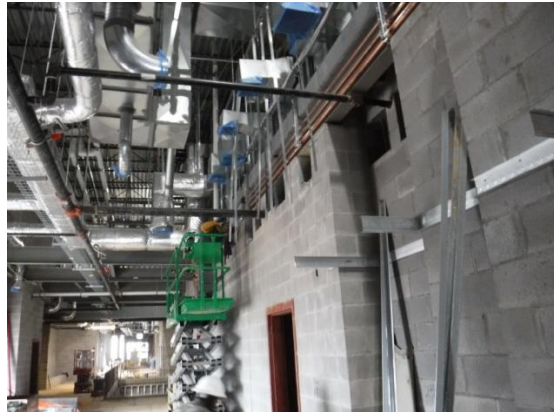
- n) Mechanical work along the main corridor.

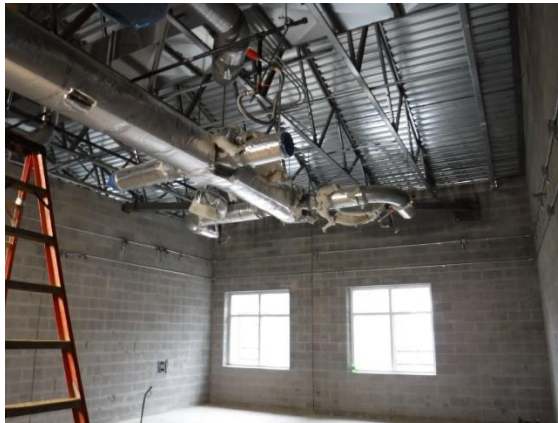
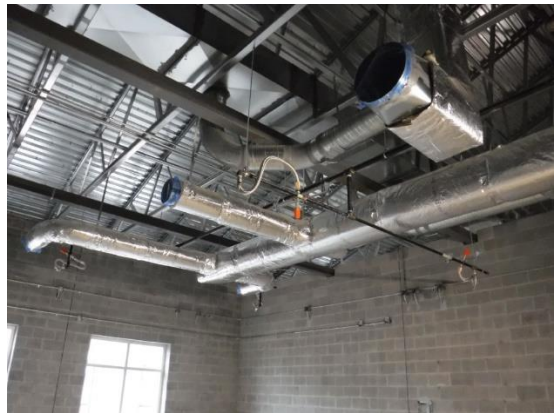
- o) Insulated ductwork in classrooms.

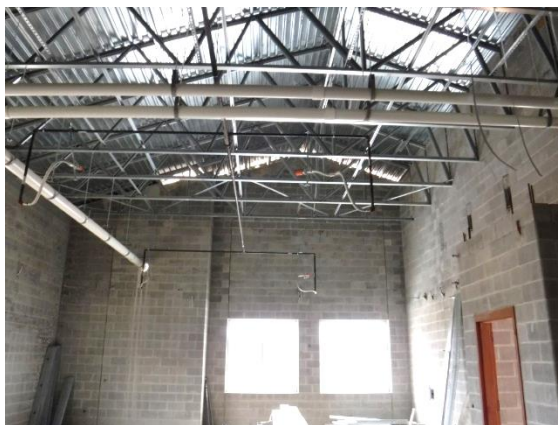
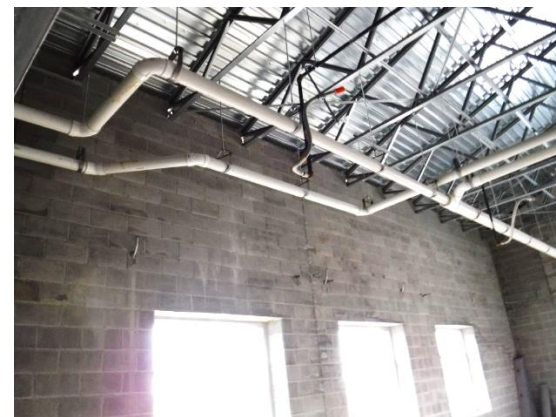
- p) Roof deck to block walls in Area B needing to be sealed to prevent air/moisture infiltration into building.

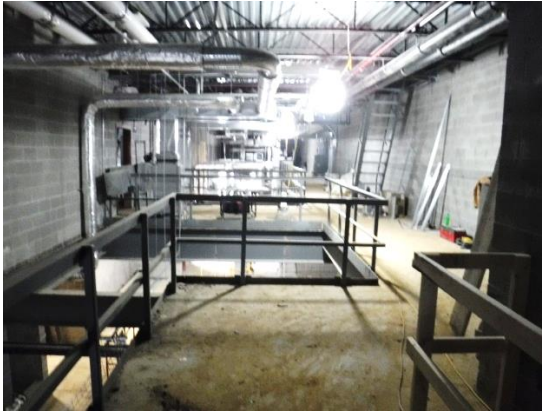
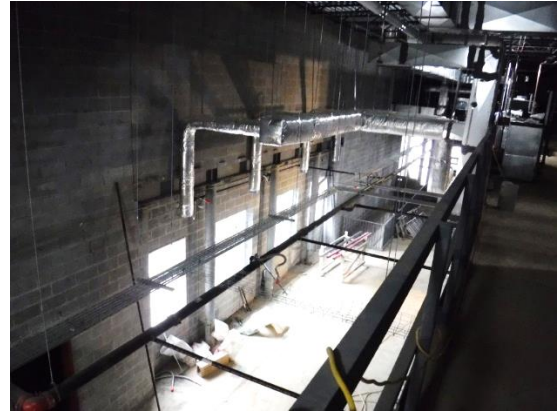
- q) Mechanical work continuing on the platform over the main corridor.

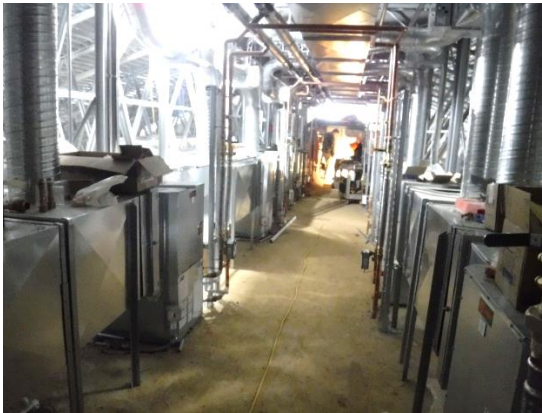
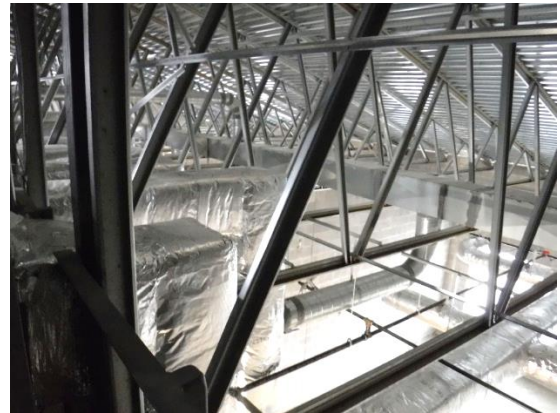
- r) Mechanical work continuing on the platforms over the classroom wings.

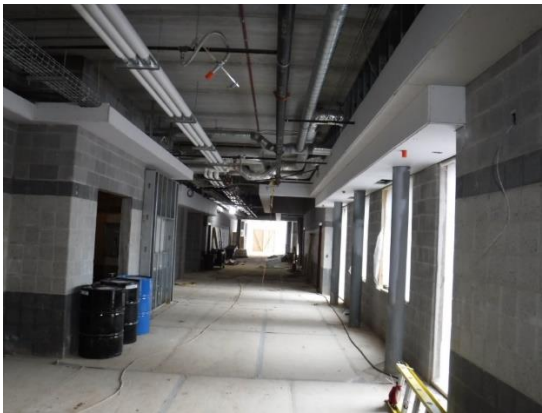
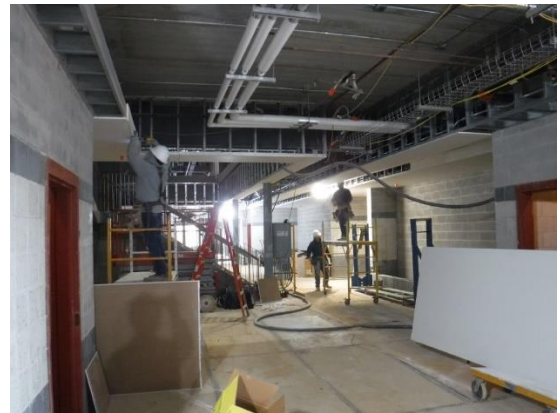
- s) Drywall being installed on soffits along the first floor of the main corridor.

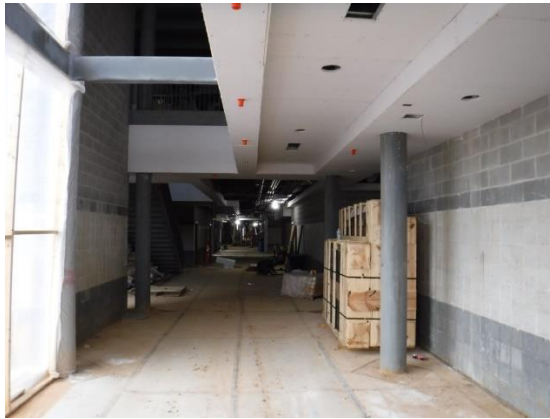
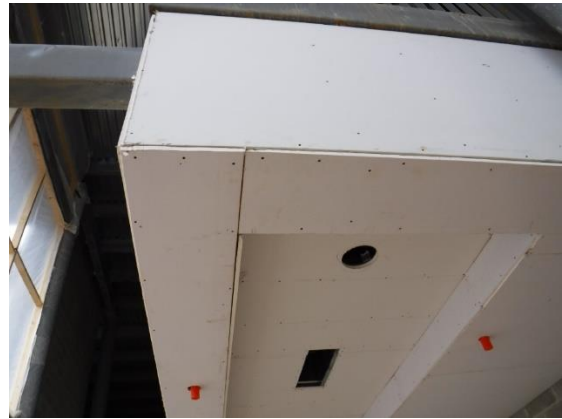
- t) Drywall soffits at rear entrance.

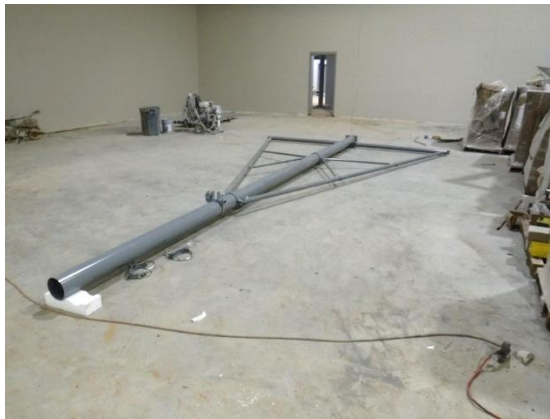
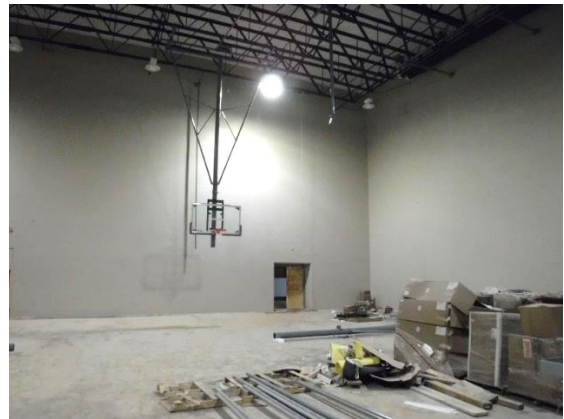
- u) Basketball standards and goals being installed in the Gym.

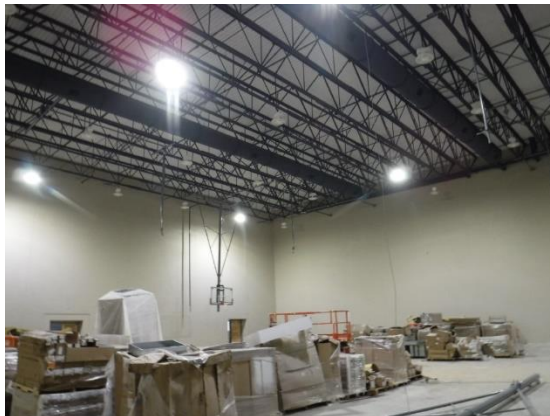
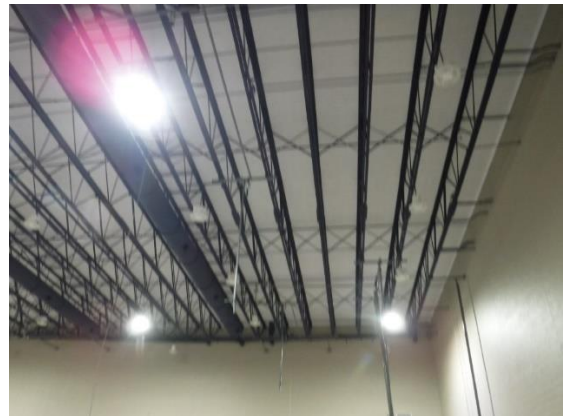
- v) Painting of ceiling complete in the Gym.

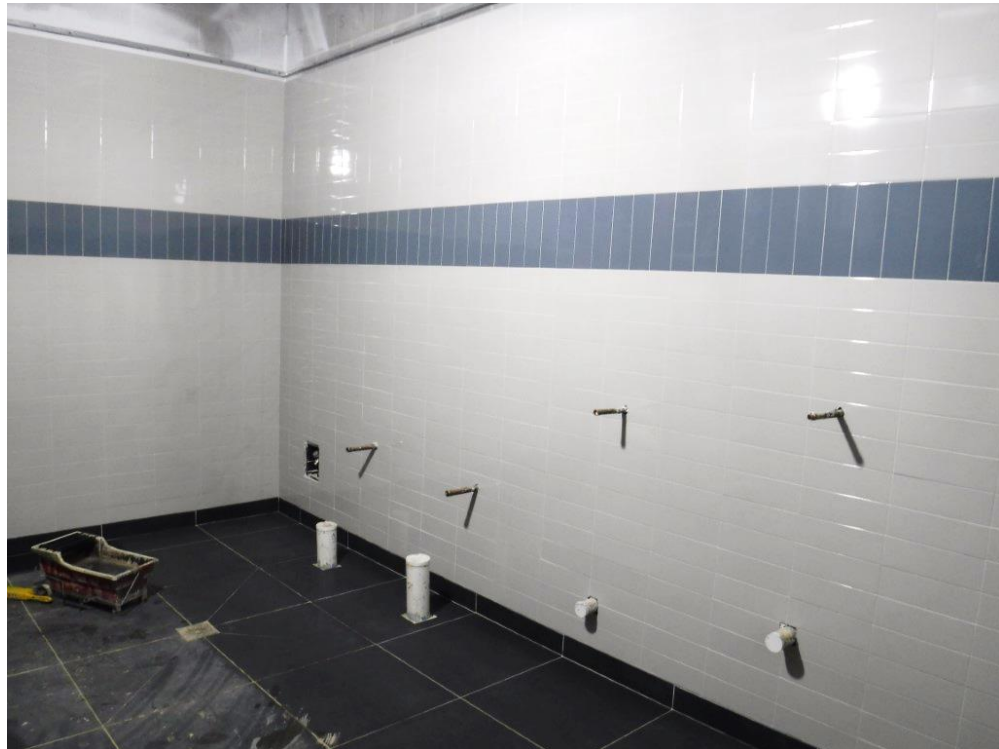
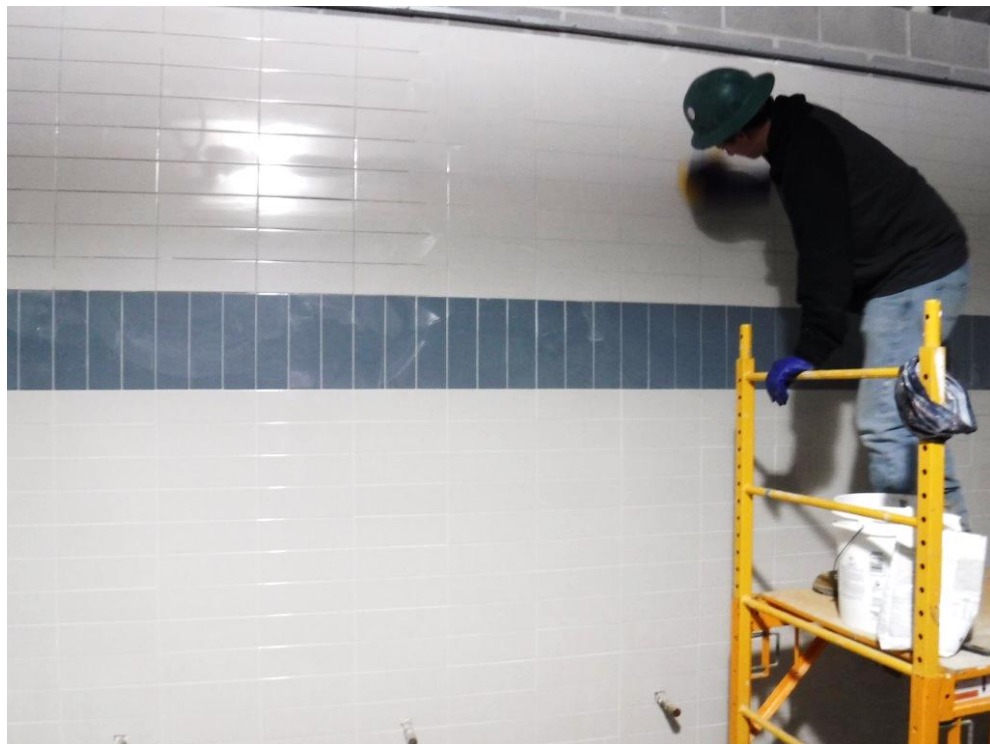
- w) Ceramic wall tile was being installed in the Area D Student Toilets. The joints were uniform, and the tiles were in plane. JRA has reviewed the tile submittal. Make corrections as noted.

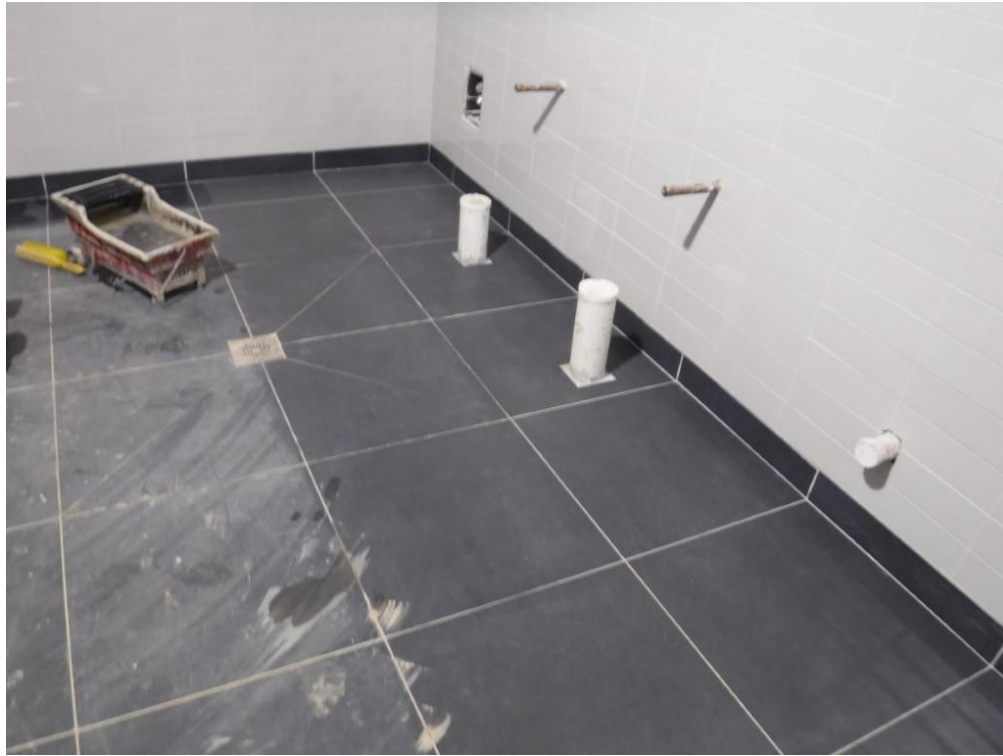
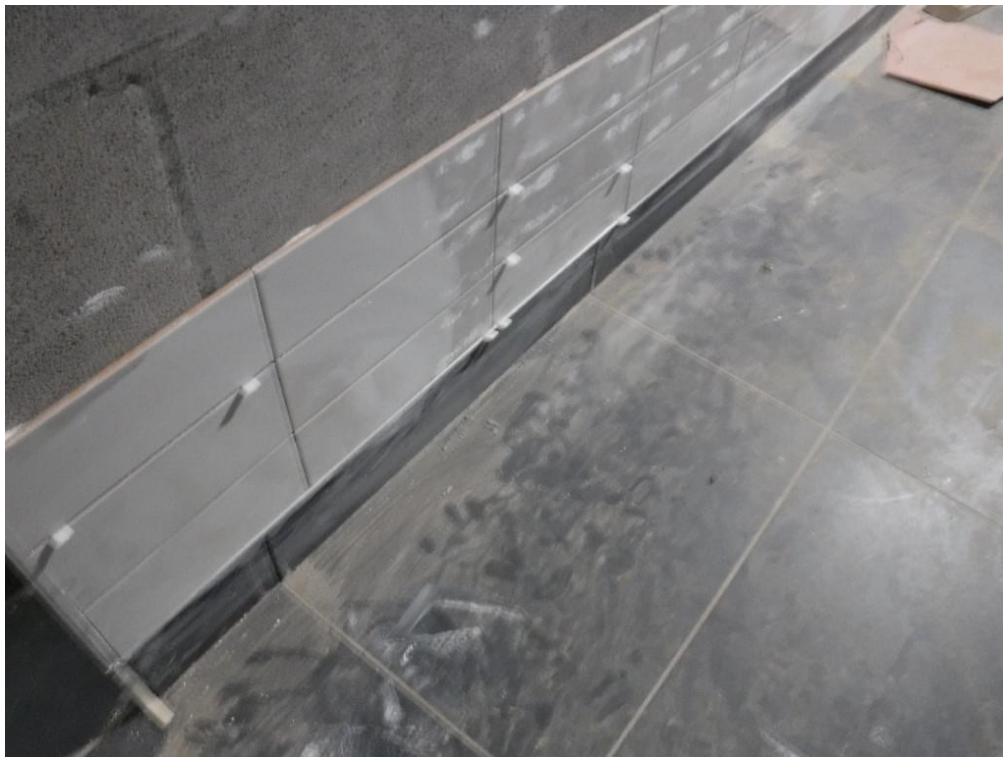
- x) Ceramic floor tiles and base were installed in the Student Toilets in Area D. The grout on the floor, base and walls tiles was being washed.

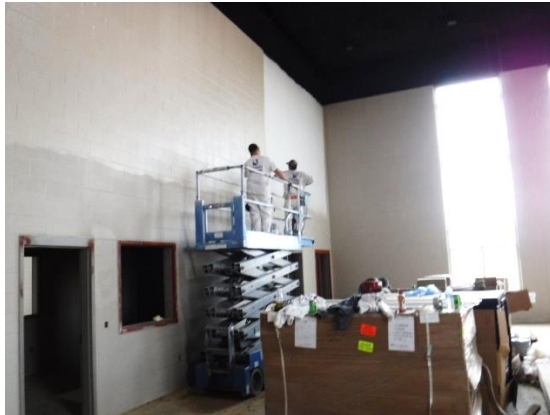
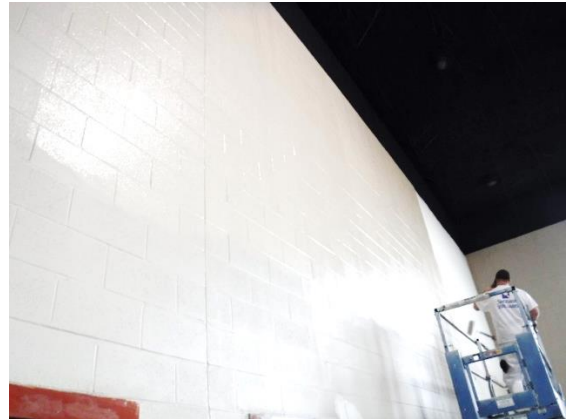
- y) Final coat of paint being applied to walls in the music rooms. Walls were fully covered with paint.

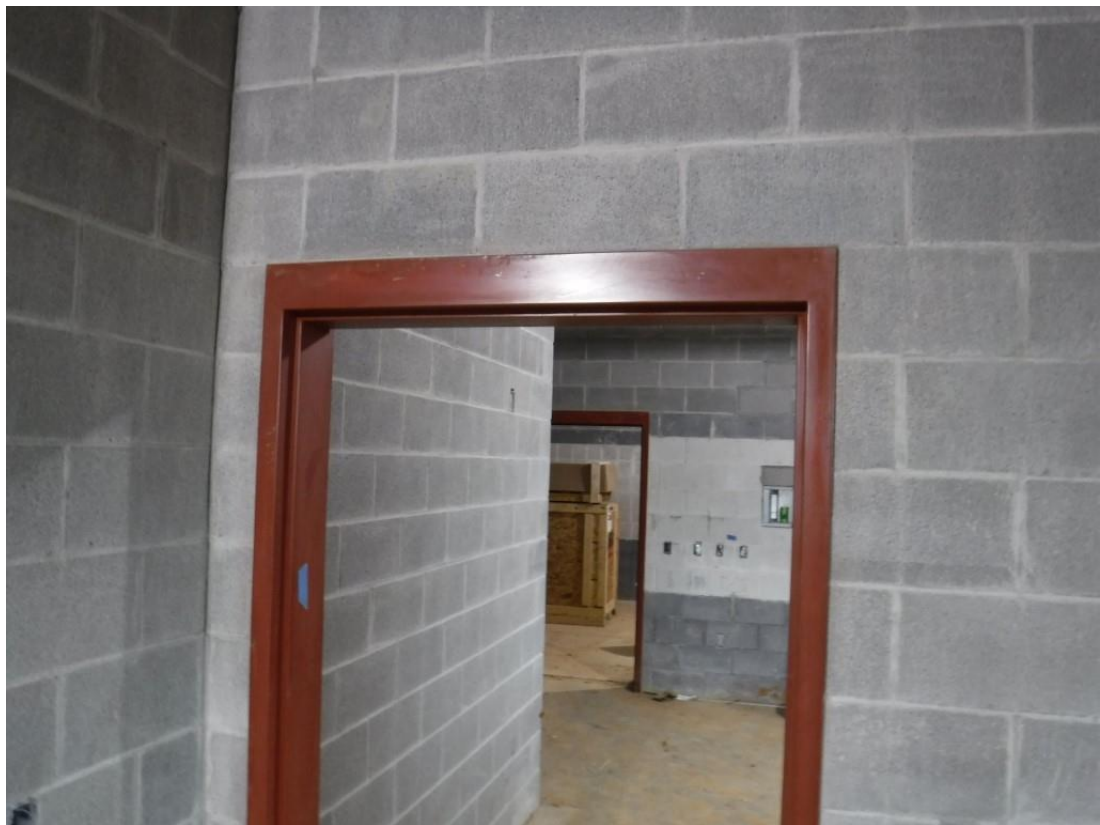
- z) Door frame repair required ahead of painting.

- e. Do not damage materials installed by other trades especially hollow metal door frames.
- f. Finish drywall frames so there are no dents, gaps, mortar and other materials that would prevent the final coat of paint from be smooth to the touch and the frames from having a completely uniform appearance on all surfaces. Do not bend the frames at the heads to install drywall.
